D. C. Cook Plant Nuclear Generation Group

**Restarting D. C. Cook
June 1, 2000**

Discussion of Containment Subcompartment Walls

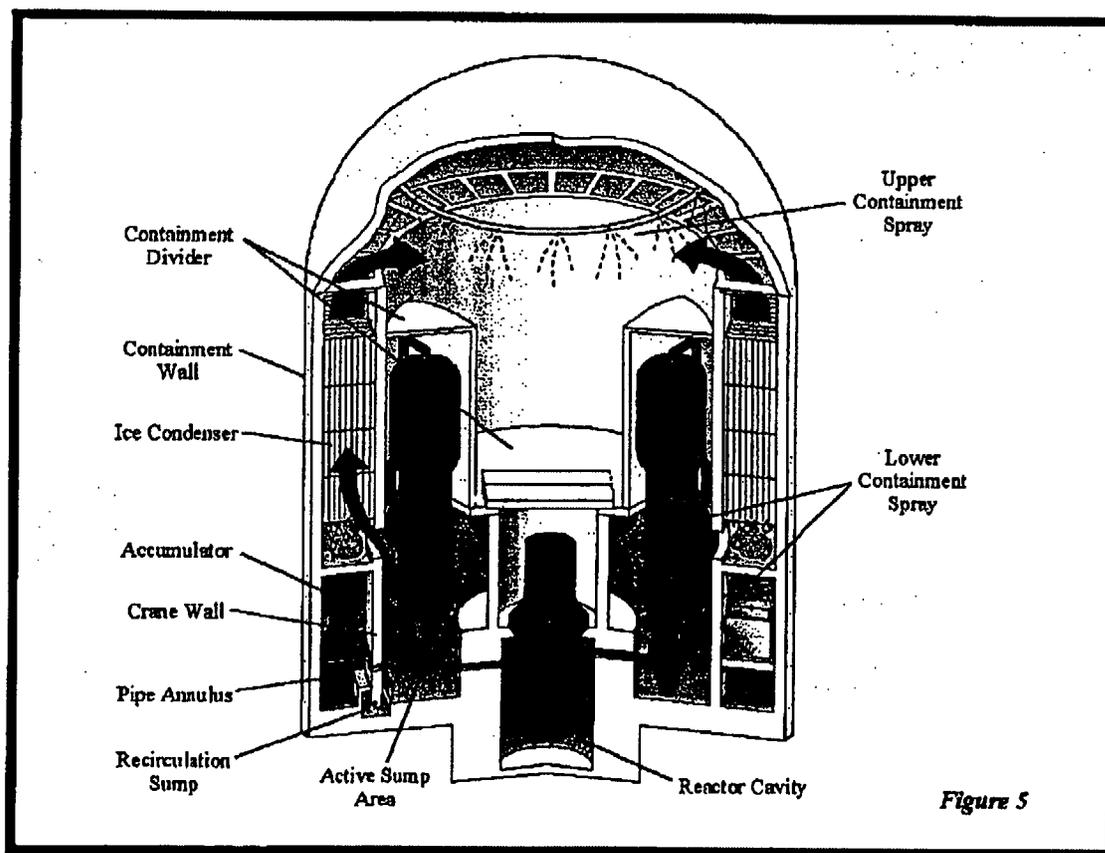
Background: Diagram of Containment Subcompartment Walls

■ Containment

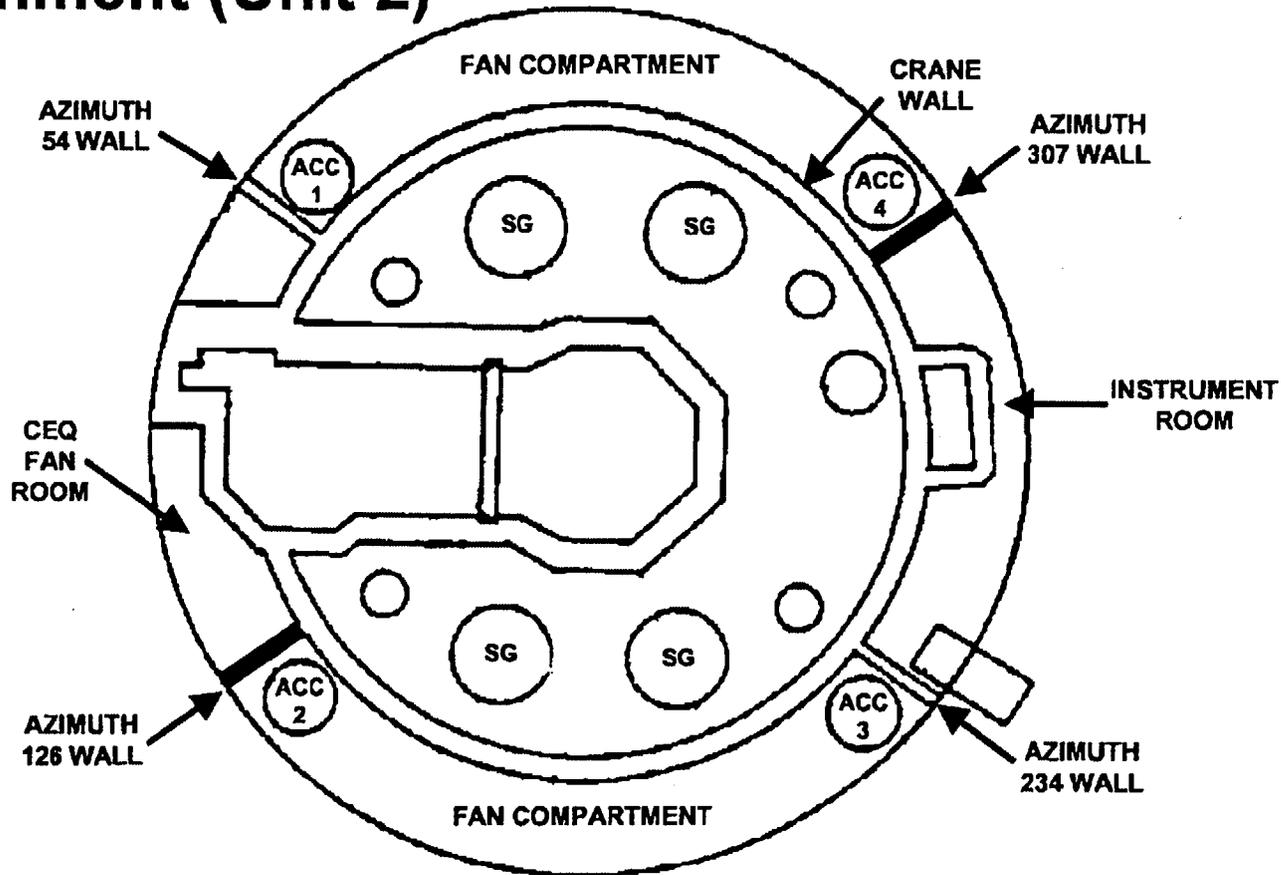
Background: Diagram of Containment Subcompartment Walls

■ Containment (Unit 2)

- **Four Walls in Each Unit**

- **Focus on Unit 2:**
 - **Two end walls of CEQ Fan Room (Upper Compartment)**
 - **Two end walls of Instrument Room (Lower Compartment)**
 - **All walls restrained at three sides**

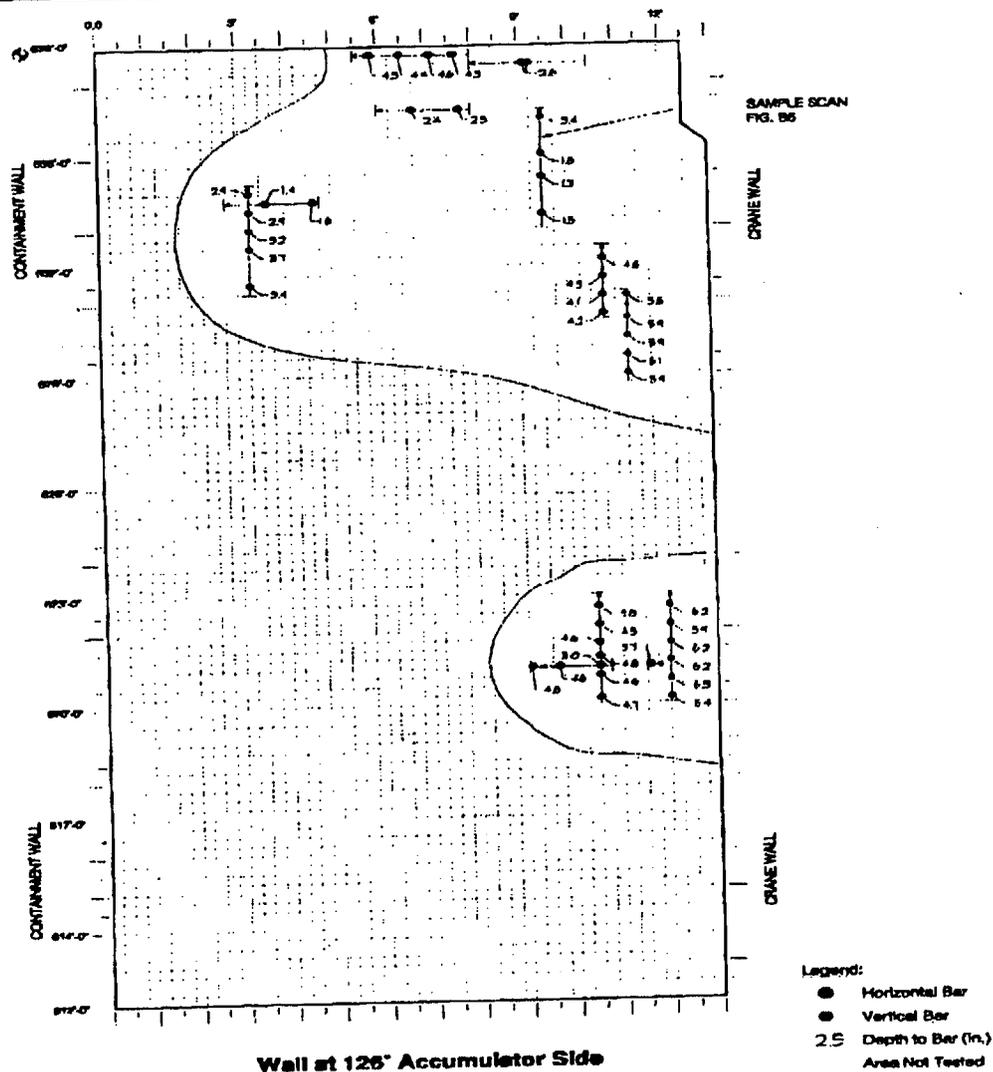
Description of the Issues: Wall Radar Mapping

- **Radar Mapping - All Four Walls**
 - **Critical accessible areas**
 - **Both sides of each wall**

- Horizontal bars per design
- Vertical bars
 - » Most areas per design
 - » Up to 15 inch spacing in limited areas

- Minimum ACI cover requirements met
- Average maximum depth developed for horizontal bars and vertical bars

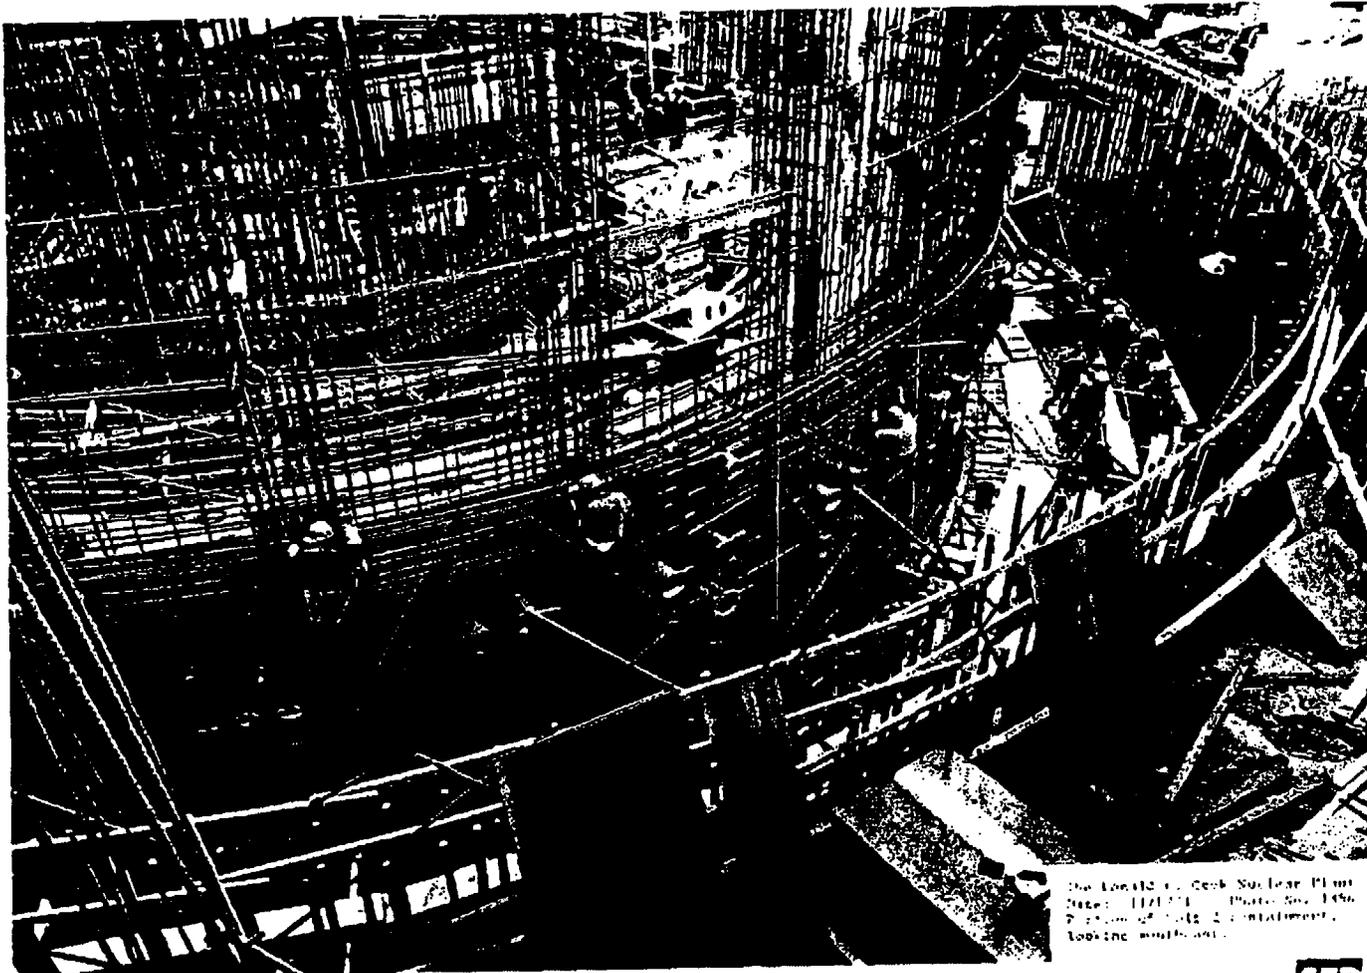
The Lovell Cook Nuclear Plant
Unit 2 Containment Under Construction
Photo No. 1456
System of Unit 2 Containment,
Looking South-East.

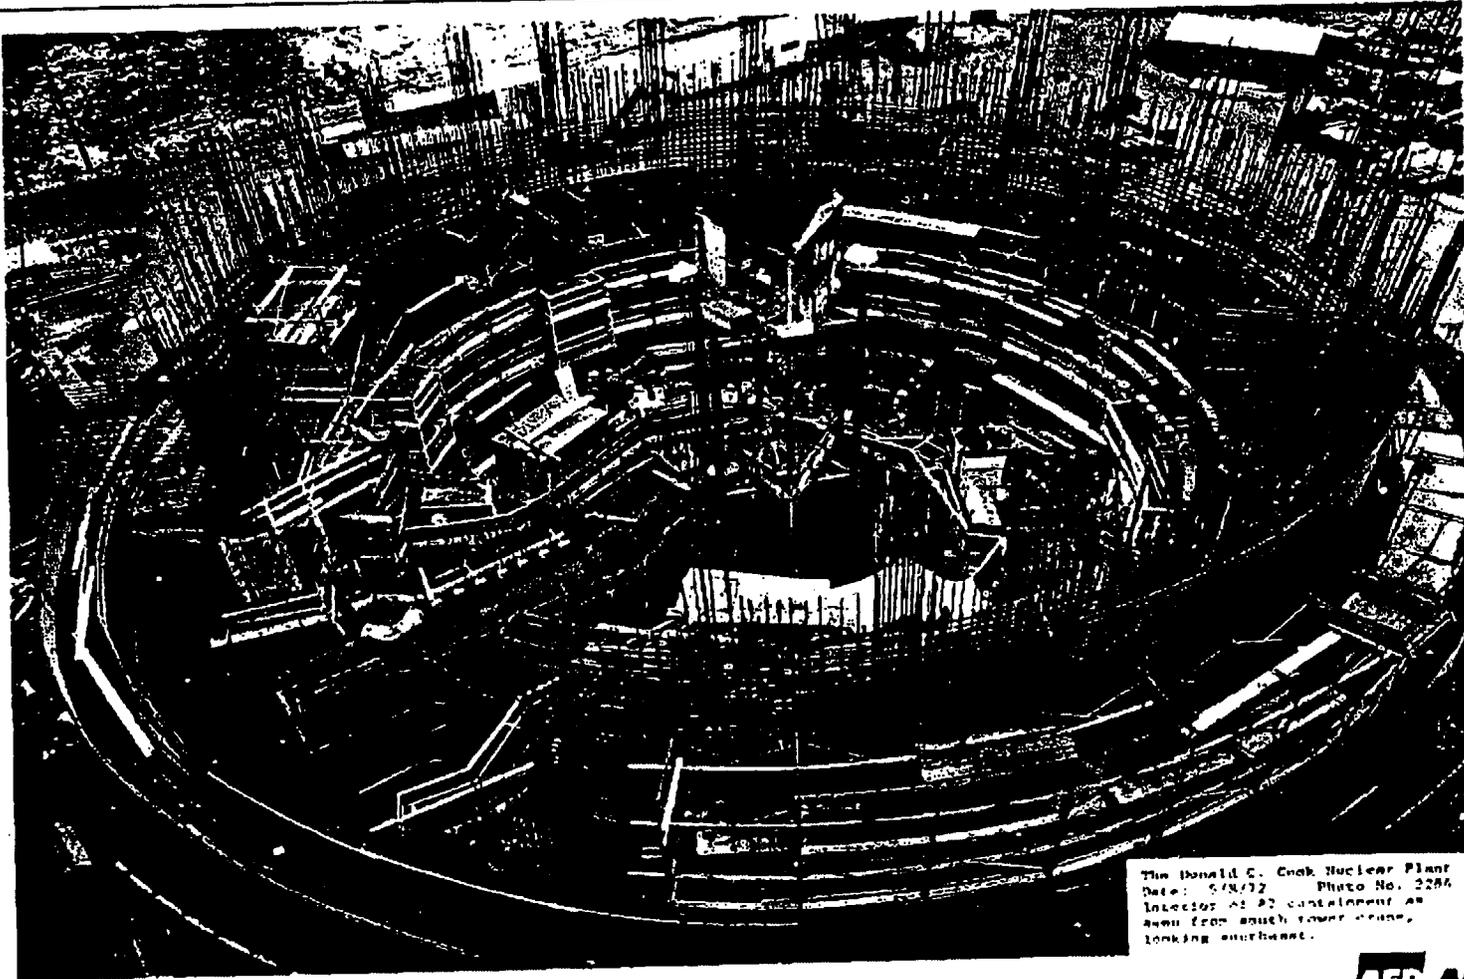
Unit 2 Containment Under Construction

The Donald C. Cook Nuclear Plant
Date: 5/8/72 Photo No. 2286
Interior of Unit 2 containment as
seen from south tower crane,
looking southeast.
