# Guideline for the Management of Adverse Localized Equipment Environments

EPRI created this document in response to requests from utility environmental qualification, license renewal, and cable-system engineers for guidance on management of adverse localized environments. The engineers were concerned with environments that could be consistently and significantly more severe than the surrounding ambient or bulk conditions. This guideline designates this type of environment as an “adverse localized equipment environment,” which includes “hot spots.” A full definition of the concept is provided in Section 1.2. “Equipment” has been included in the phrase because an adverse localized environment is of interest only when potentially susceptible equipment is within the localized environment.

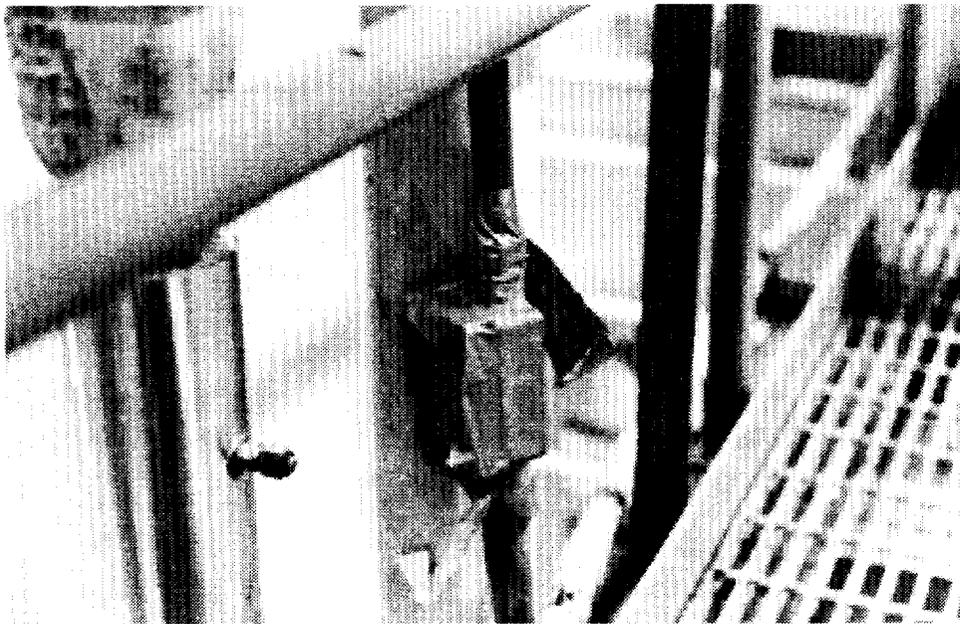
**Figure 3-4**  
**Example of an Installation That Could Create a Different Environment Than Assumed In Equipment Design—A Conduit Fitting with Duct Tape Rather Than Correct Cover and Seal, Which Could be Susceptible to Moisture Intrusion**

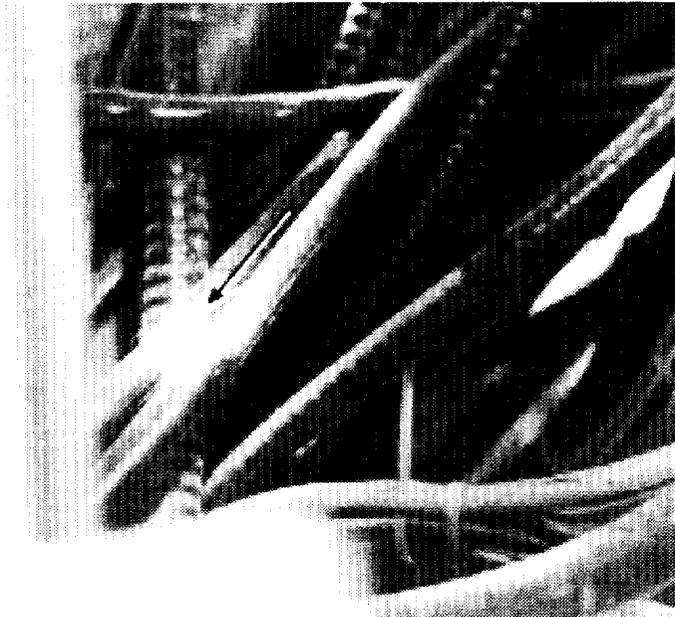
**Figure B-20**  
Cable Damage Apparently Caused During Installation
