BAW-10219
REV. 04
DECEMBER 2000

**ELECTROSLEEVING QUALIFICATION
FOR PWR RECIRCULATING STEAM
GENERATOR TUBE REPAIR**

**FRAMATOME TECHNOLOGIES, INC.
P.O. BOX 10935
LYNCHBURG, VA 24506-0935**

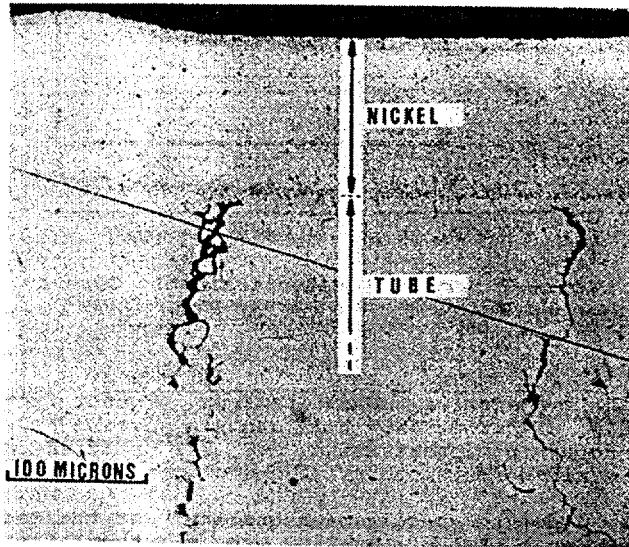
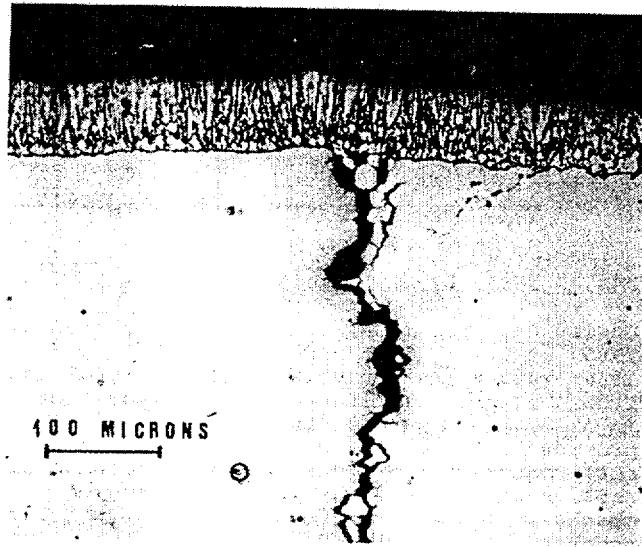
FIGURE 3.1
ELECTROPLATED TUBES PULLED FROM DOEL-2

Tube 18/51 pulled after 9 months of service

Tube 21/59 pulled after 2 years of service

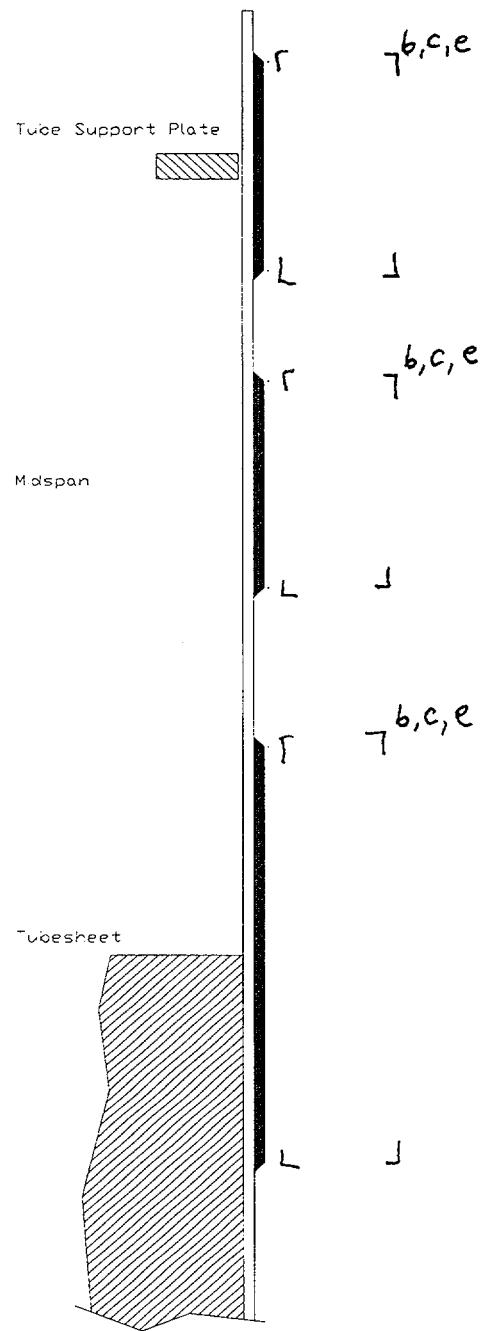
FIGURE 5.1.2
TYPICAL RSG TSP AND TS SLEEVE ARRANGEMENT

Figure 5.1.2 depicts a typical installed Electrosleeve™. The sleeve is designed to repair tubes by spanning the degraded region. The sleeve can be installed at any straight section of tubing including the expansion transitions, all of the TSP intersections, and the free-span areas. The electroformed repair is leak-tight because the nickel is bonded to the tube.

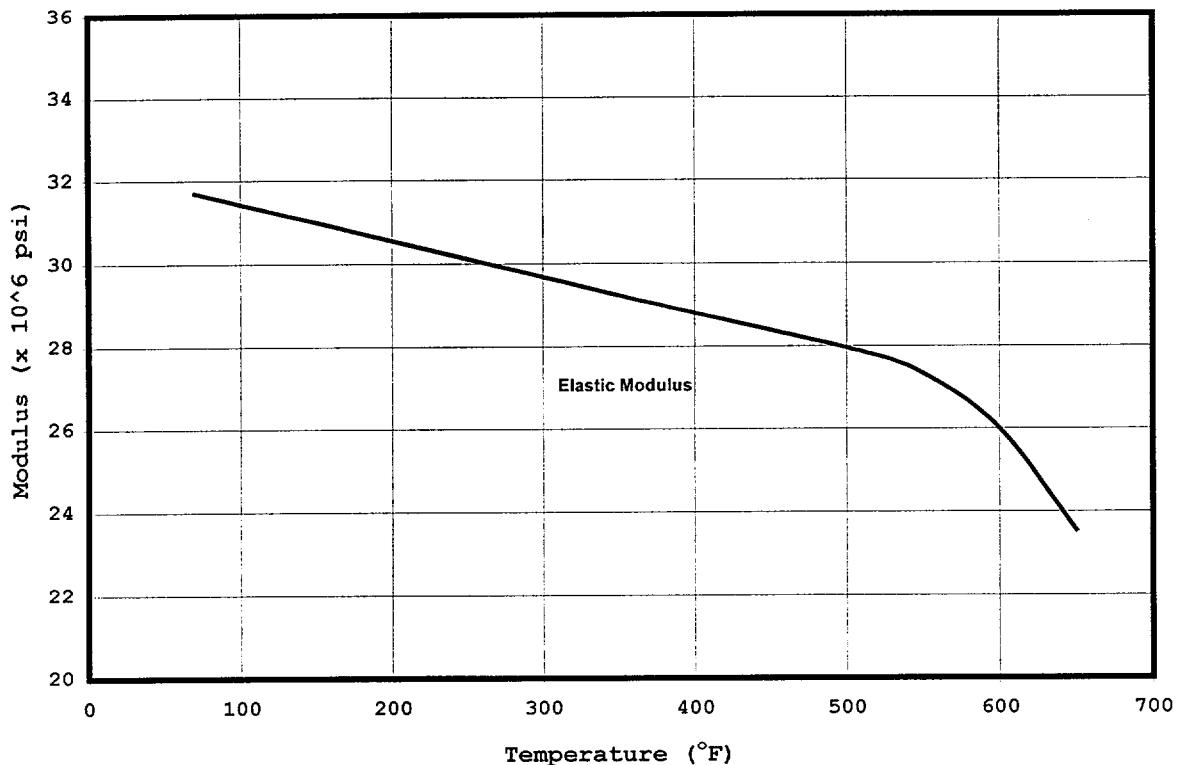
FIGURE 6.2.1
ELASTIC MODULUS VS. TEMPERATURE

[] specimens were tested to determine the modulus of elasticity for the material per ASTM procedure [13.15]. Of those, FTI tested four Alloy 600 tube sizes with installed electro sleeves:

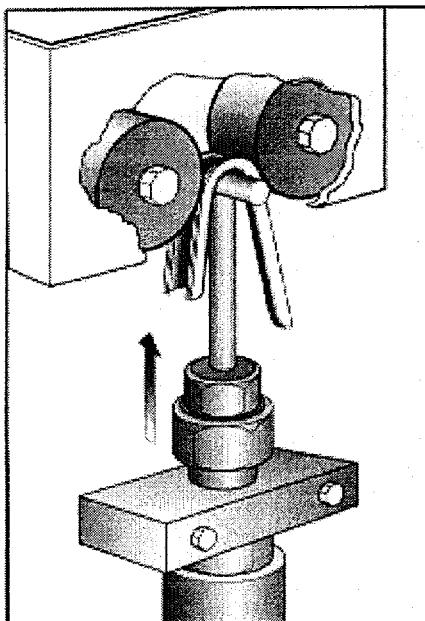
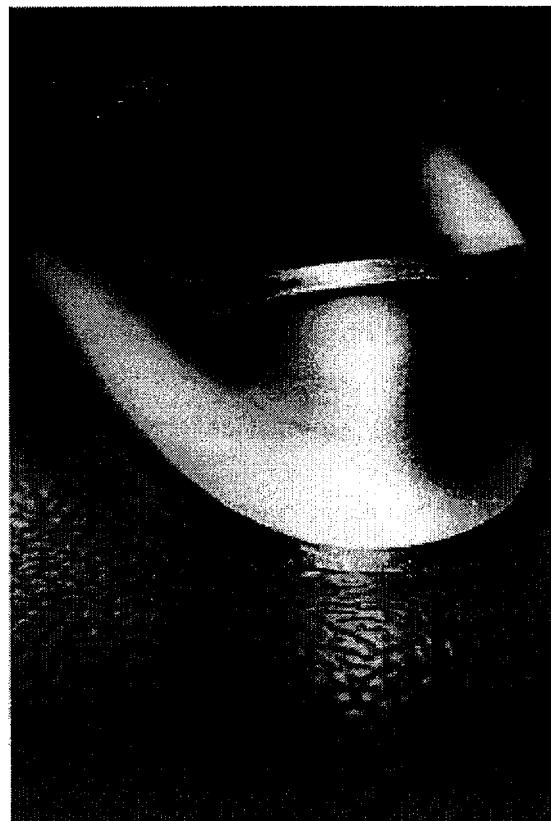
FIGURE 6.3.1
REVERSE BEND SPECIMEN

The above illustrations - from left to right - show a drawing of the reverse bend test set-up and a photograph of a reverse bend specimen.

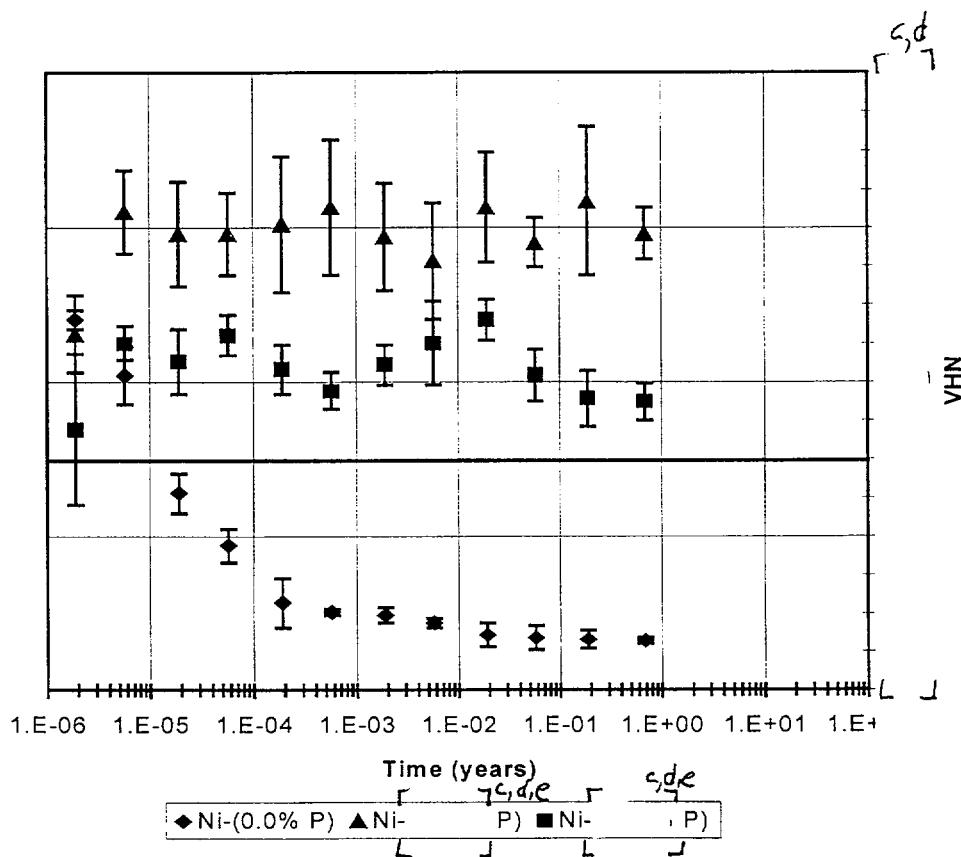
FIGURE 6.5.2
ELECTROSLEEVE™ THERMAL STABILITY TEST RESULTS AT 650°F

Figure 6.5.2 shows that pure nanocrystalline nickel decays rapidly [c] within the first few hours of annealing. This reduction is representative of rapid grain growth leading to a resultant grain size consistent with that of conventional polycrystals (i.e., 10 - 30 μm). The nanocrystalline nickel containing [d] phosphorus [e] shows no evidence of hardness decay within the total test period evaluated (i.e., approximately 10 months). The influence of minor solute additions on retarding grain growth in nanostructured nickel was previously documented [13.62, 13.63] and attributed to:

The testing results summarized in Figure 6.5.2 demonstrate that the Electrosleeve™ material is fully stable at the PWR design temperature of 650°F and at the lower operational temperatures. Additional testing at 675°F verified thermal stability. However, thermal destabilization will not result in catastrophic deterioration of the Electrosleeve™ material. Thermal destabilization will occur as a gradual reduction in the mechanical properties similar to conventional Ni₂₀₁.

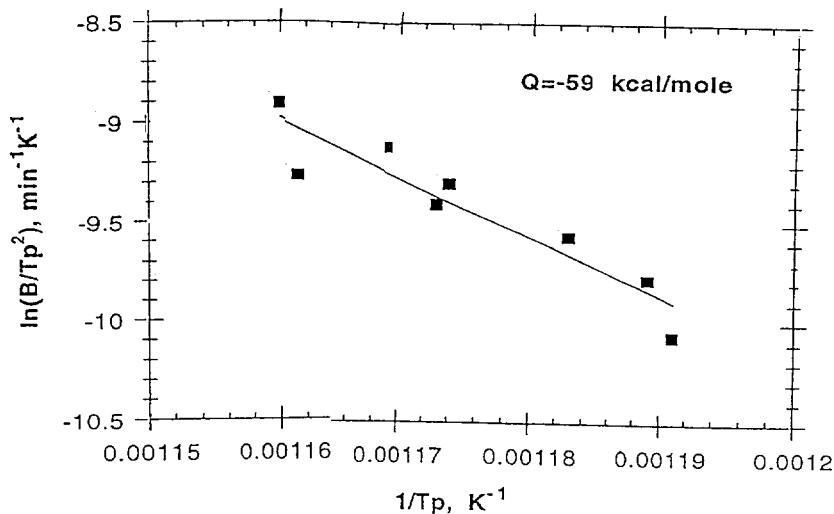
FIGURE 6.5.4
KISSINGER PLOT FOR ACTIVATION ENERGY

The margin of safety for the thermal stability of the Electrosleeve™ material was determined using differential scanning calorimetry (DSC) measurements. Figure 6.5.3 is a typical DSC scan for the Electrosleeve™ material. The DSC scan detected an exothermic peak at approximately 580°C (1076°F). The results of the DSC analysis shown in Figure 6.5.4 are in the form of a Kissinger plot [13.64]. In the peak temperature (T_p) range of 560°C - 580°C (1040°F - 1076°F) with heating rates ranging from 30 - 100 K/min., the shifts in the exothermic peaks are shown to yield an apparent activation energy of 59 kcal/mole.

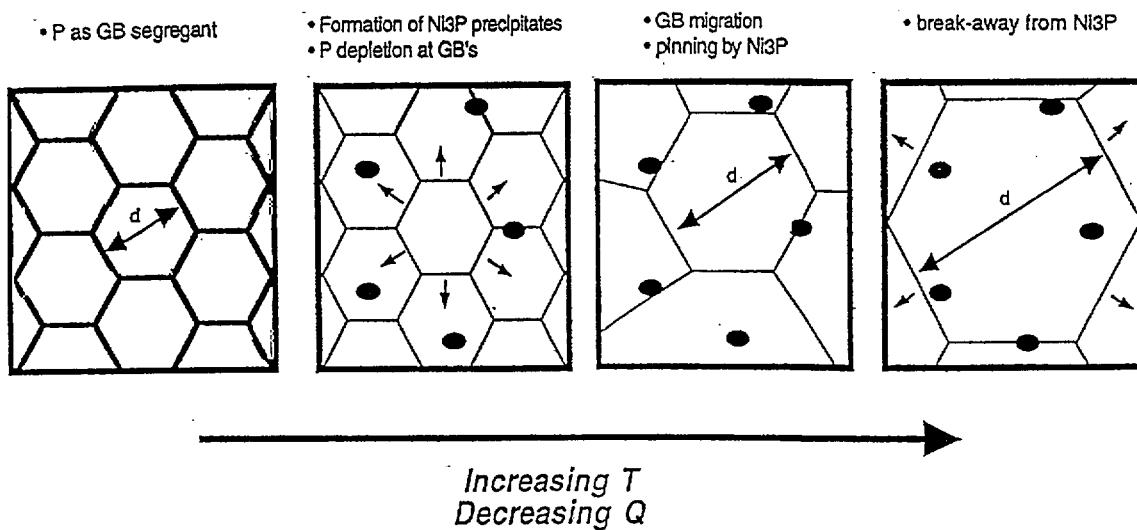
FIGURE 6.5.5
EXPECTED THERMAL DESTABILIZATION MECHANISM

Figure 6.5.5 shows schematically the expected mechanism for thermal destabilization of the Electrosleeve™ material. At temperatures below T_p (i.e., approximately 560°C or 1040°F), the Electrosleeve™ material structure is primarily stabilized by the presence of continuous phosphorous at the grain boundaries. At temperatures above T_p , the precipitate Ni₃P can form readily and results in phosphorous depletion at grain boundaries. Grain boundaries can then migrate; however, depending upon temperature, they may be pinned by the Ni₃P. At higher temperatures, the grain boundaries may break away from the precipitates and grain growth may continue. The process described predicted increasing activation energy with decreasing temperature. Some evidence for this phenomenon is seen in Figure 6.5.6 which shows activation energy values determined from microhardness measurements performed on thermally

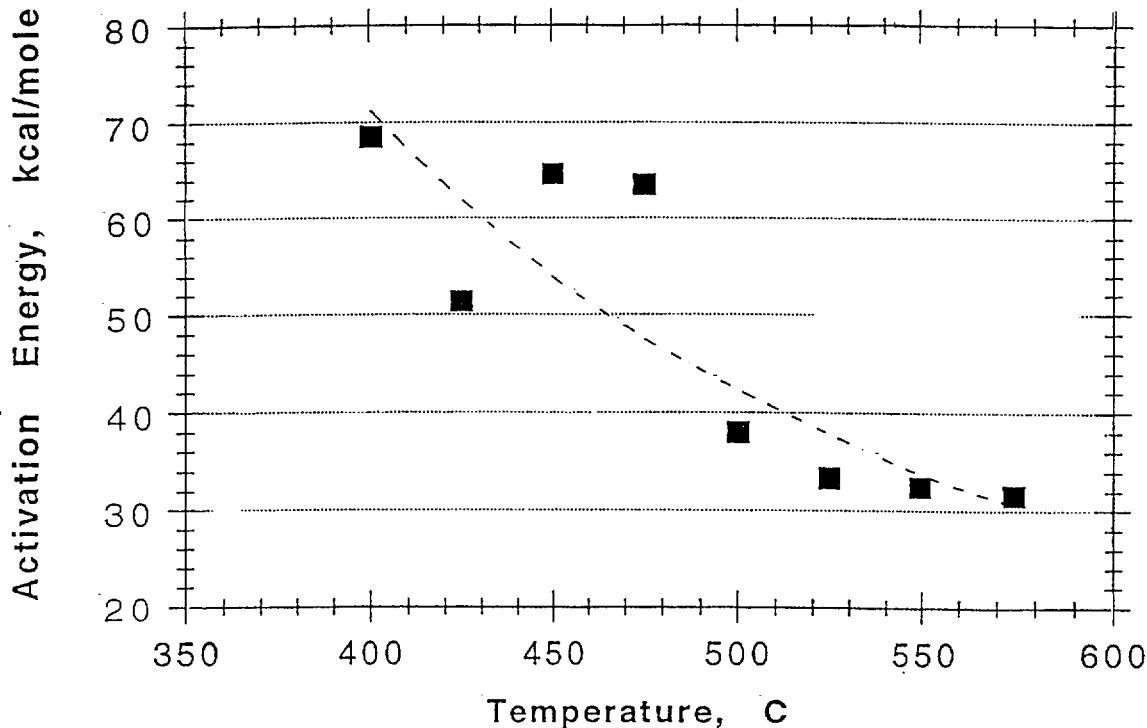
FIGURE 6.5.6
ELECTROSLEEVE™ ACTIVATION ENERGY VS. TEMPERATURE

While DSC analysis provides an approximate assessment of thermal stability associated with rapid grain growth processes the values of activation energy displayed in Figure 6.5.6 are more representative of the actual service conditions of an installed Electrosleeve™ in a steam generator. Figure 6.5.6 shows that, for long-term exposure to temperatures of approximately 350°C (662°F), the activation energy for grain growth of the Electrosleeve™ material is above 70 kcal/mole. This proves the excellent thermal stability of the Electrosleeve™ material at operating temperatures.

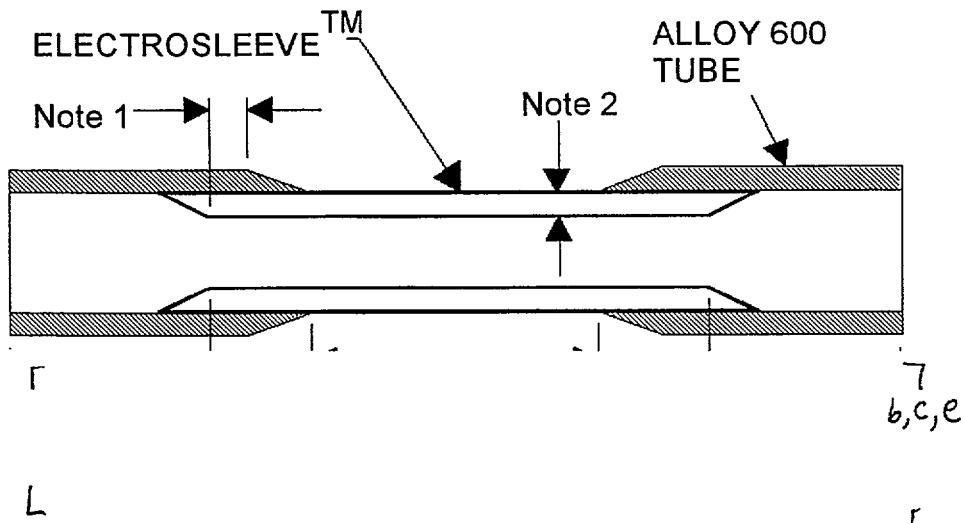
FIGURE 6.6.1
STANDARD CREEP SPECIMEN

- (1) The sleeve-to-tube bond length was nominally [] long, except for the minimum bond specimen, which had a [] bond length.
- (2) The wall thickness of the sleeve varied from [] depending on the specimen.

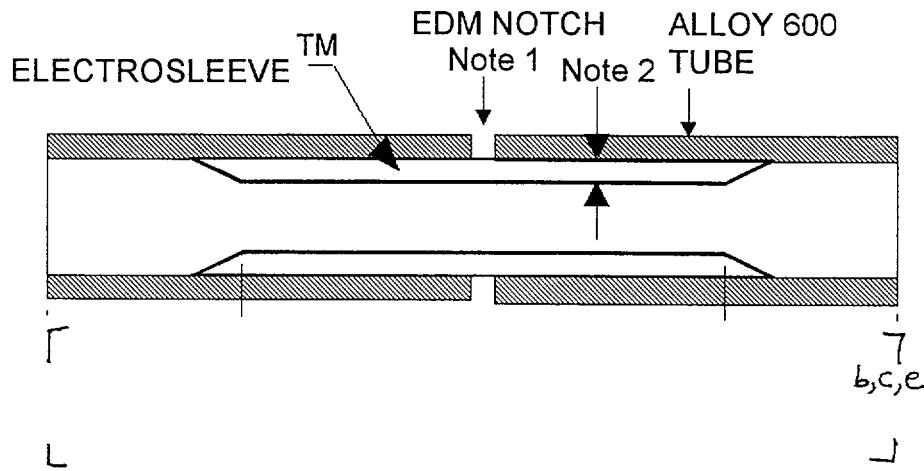
FIGURE 6.6.2
CIRCUMFERENTIALLY NOTCHED CREEP SPECIMEN

- (1) EDM notch specimens had a 360° circumferential notch, []^{b,e}.
- (2) The wall thickness of the sleeve varied []^{c,e}, depending on the specimen.

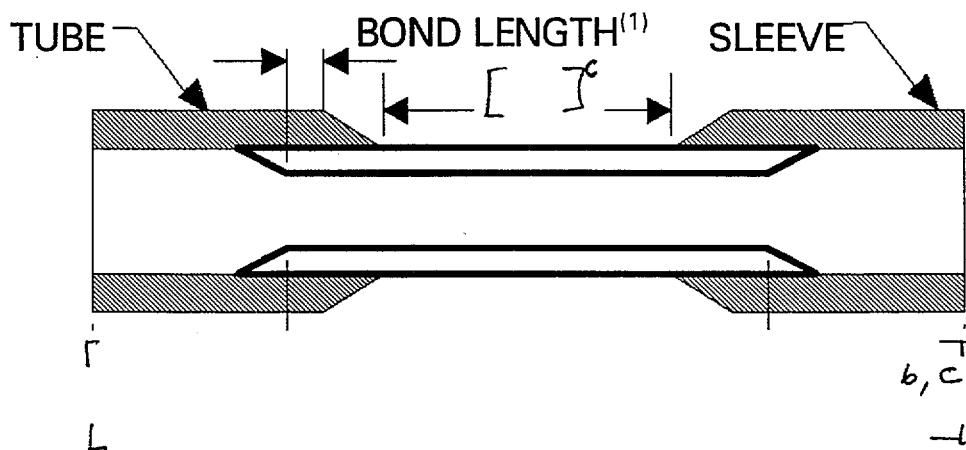
FIGURE 6.6.3
MECHANICAL TEST SPECIMEN DESIGNS
MINIMUM BOND FATIGUE AND BURST SPECIMENS

- (1) The sleeve to tube bond length for the minimum bond fatigue specimens was nominally []^{c,e}

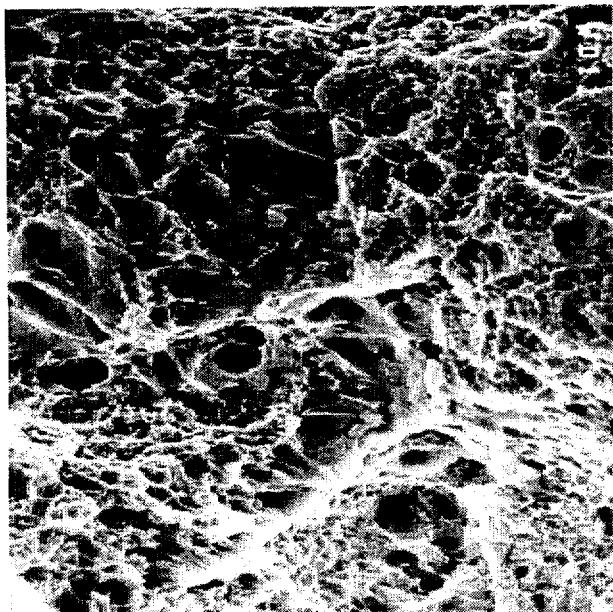
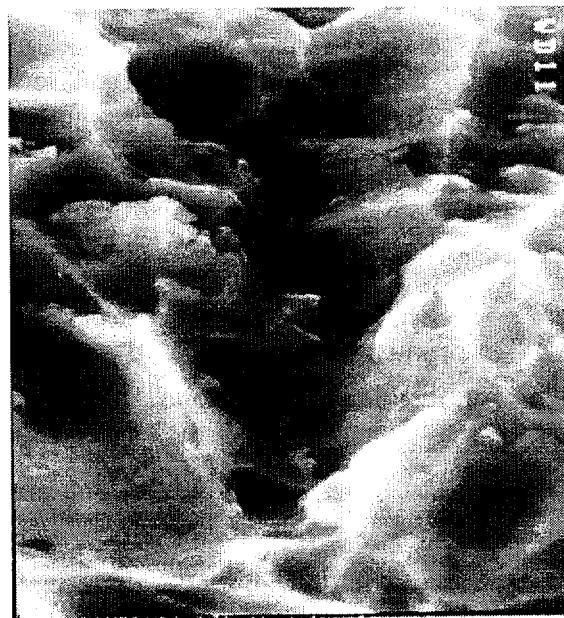
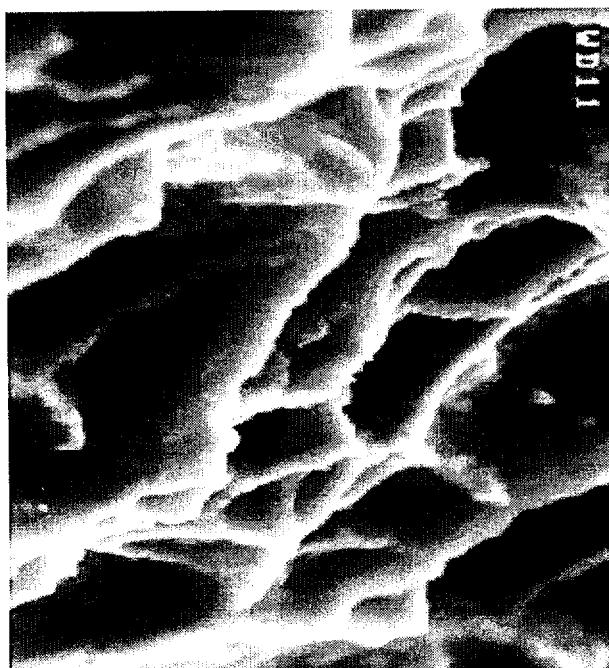
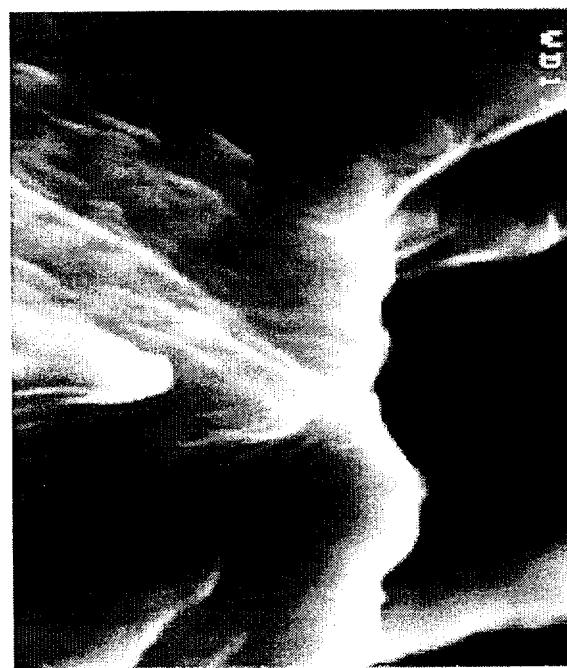
FIGURE 6.6.5
ELECTROSLEEVE™ TYPICAL FRACTURE SURFACE FRACTOGRAPHY

Magnified 5,000X

Magnified 30,000X

Magnified 110,000X

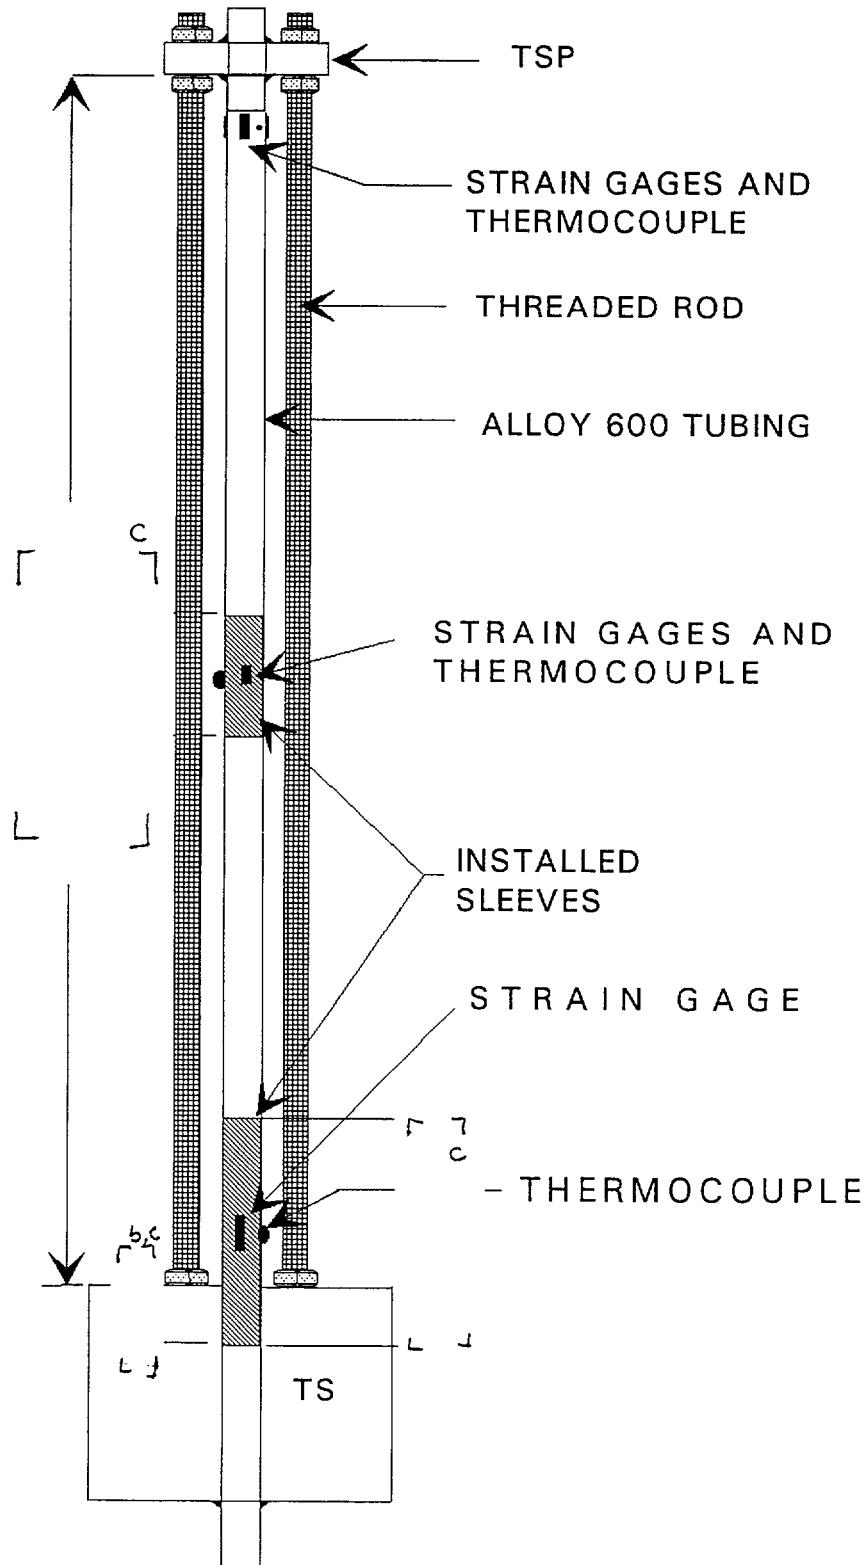
FIGURE 7.1.1
TYPICAL LOCKED TUBE MOCKUP TEST RIG

Table 7.1.1 shows the results for a 4-inch long Electrosleeve™ installed in the freespan.

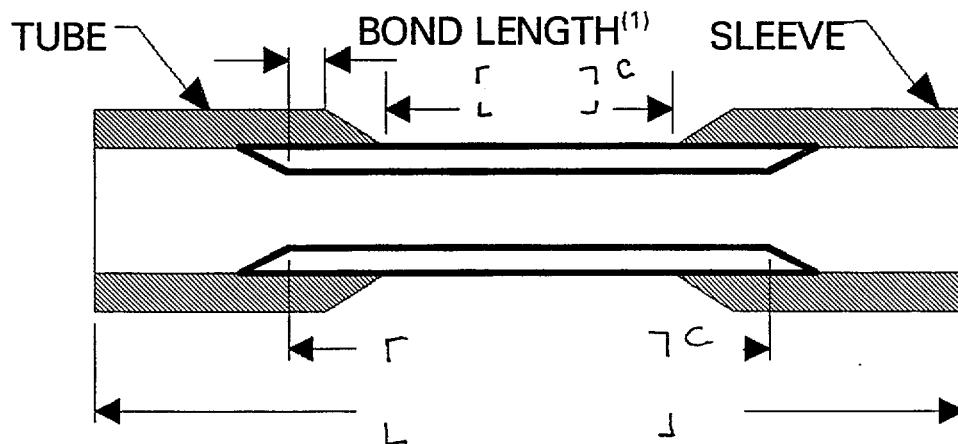
FIGURE 7.2.1
MECHANICAL TEST SPECIMEN DESIGNS
MINIMUM BOND FATIGUE AND BURST SPECIMENS⁽²⁾

- (1) The sleeve to tube bond length for the minimum bond fatigue specimens was nominally []. b, c
- (2) The tube and sleeve sizes for the test specimens are given in Table 7.2.1 and Section 7.3.

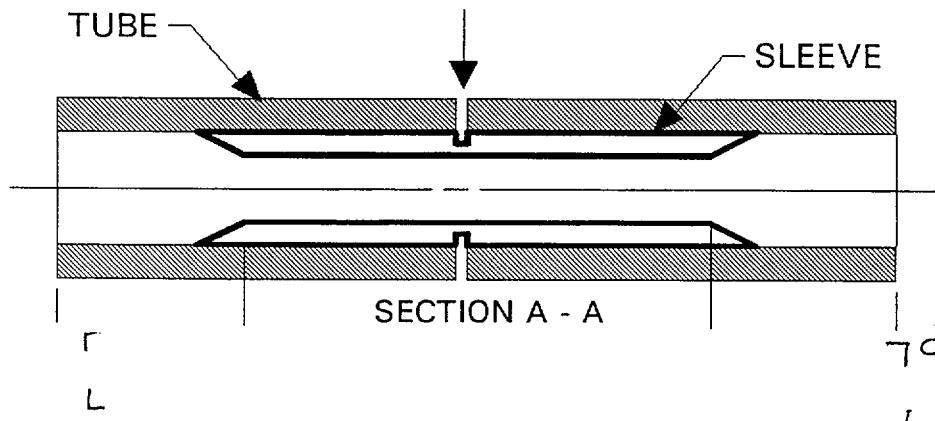
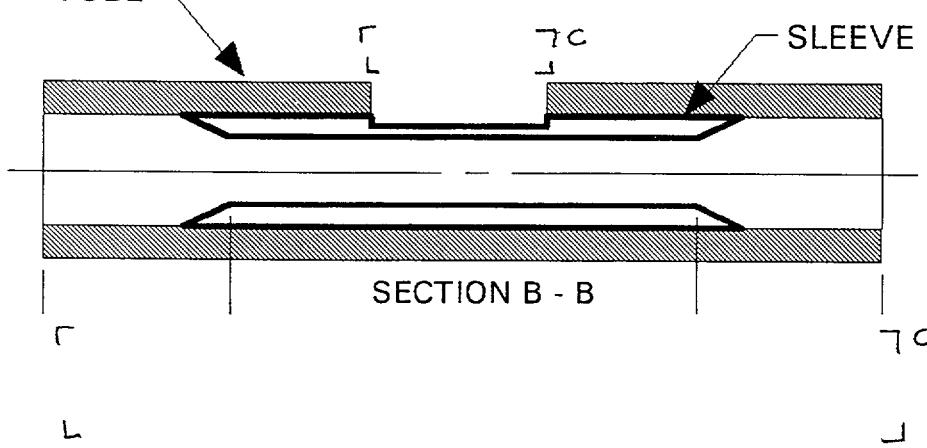
CIRCUMFERENTIAL EDM NOTCH⁽¹⁾

- (1) The circumferential EDM notch extended 360° around the specimen and [] into the wall thickness of the sleeve. []^{b,c}
- (2) The axial EDM notch was []^{b,c} long and extended []^{b,c} into the wall thickness of the sleeve. []^{b,c}

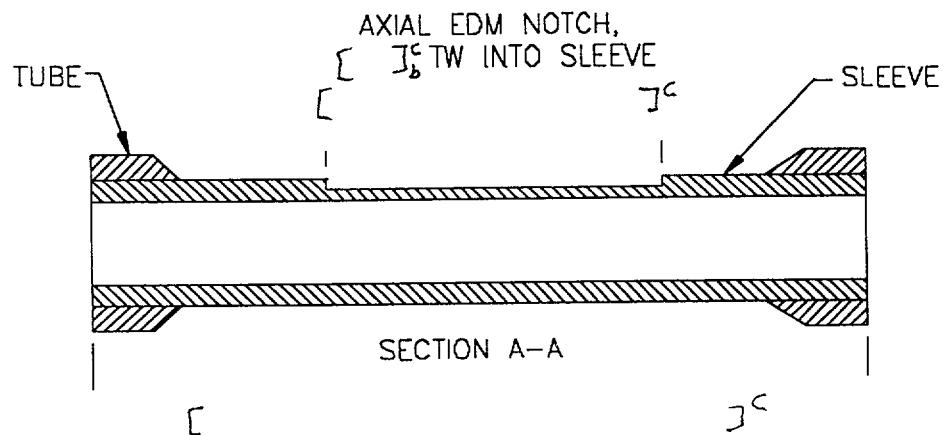
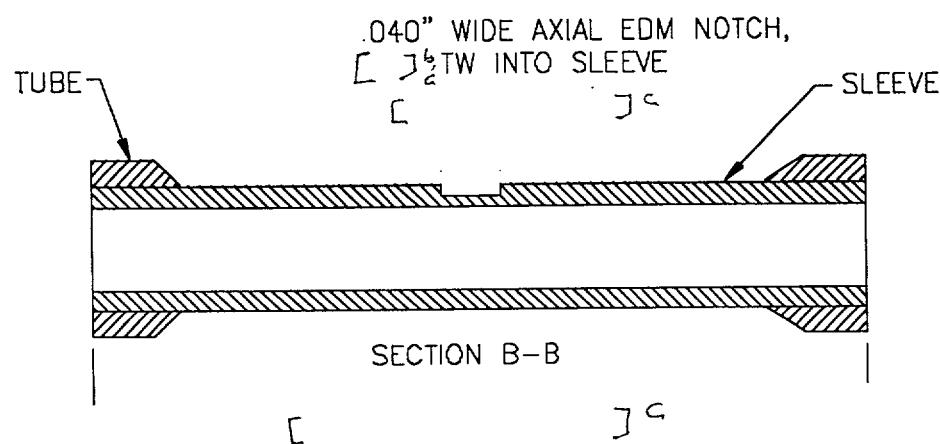
FIGURE 7.3.2
MECHANICAL TEST SPECIMEN DESIGNS
PLUGGING CRITERIA BURST SPECIMENS

The specimens, along with burst test results, are listed in Table 7.3.5.

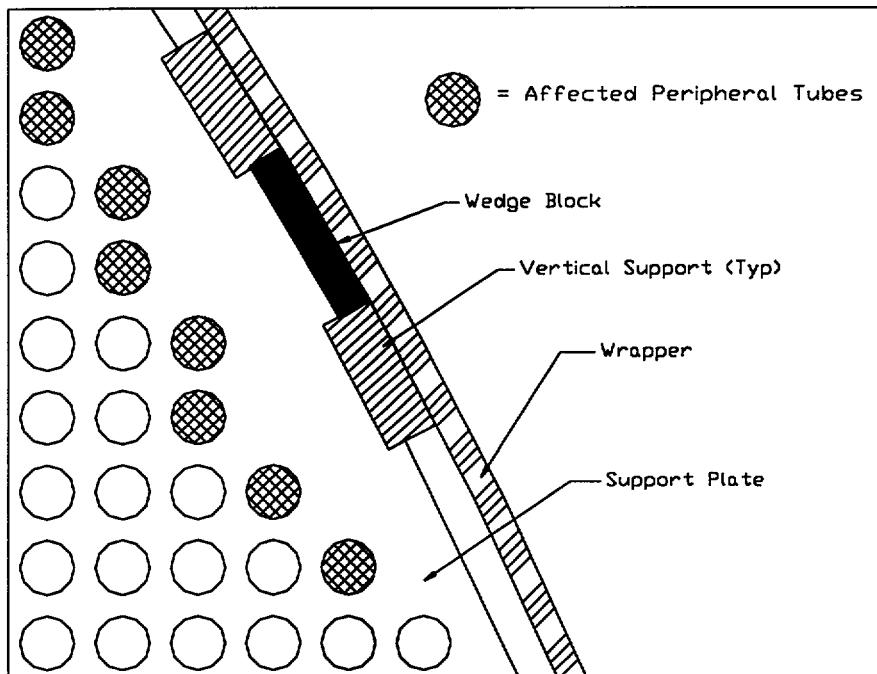
FIGURE 8.2.1
PERIPHERAL TUBES AFFECTED BY TSP-TO-WRAPPER SUPPORTS

Loads due to thermal and pressure transients were calculated for [] sleeved tube cases using the transients listed in Appendix A. Where possible, transients were grouped together and the number of cycles adjusted accordingly. The structural model for each of these cases considered a tube with sleeves installed at the top of the tubesheet and at least three TSP locations. [] b,c,e]. The sleeved tube conditions considered are:

- Sleeved periphery tube (severed and unsevered), and
- Sleeved interior tube (severed and unsevered).

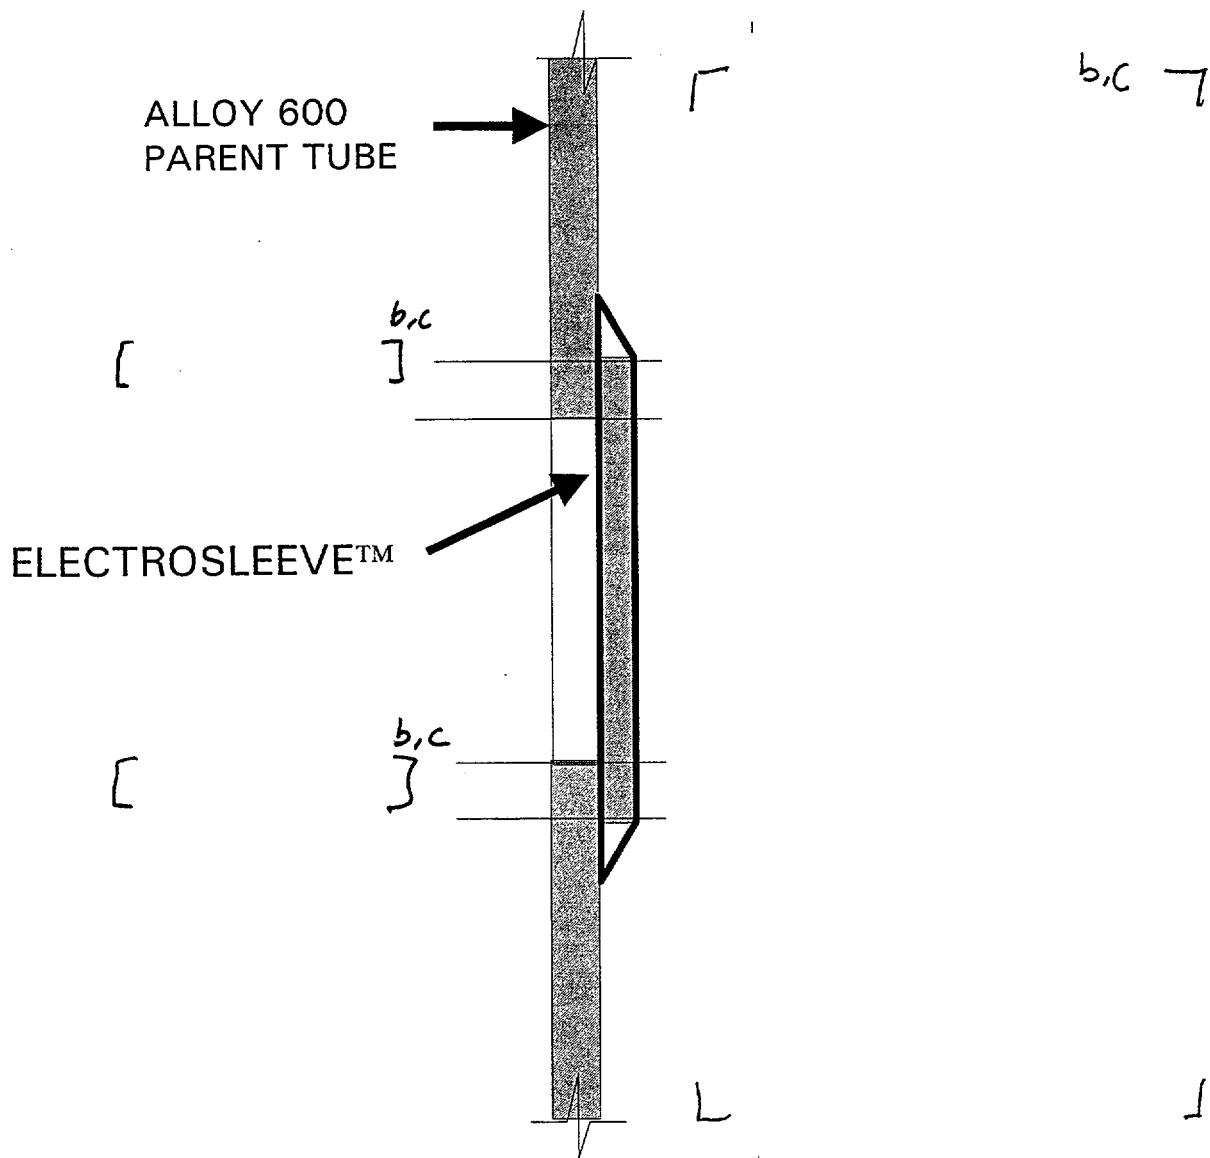
FIGURE 8.5.2
ELECTROSLEEVE™ PRESSURE BOUNDARY

Notes: Pressure Boundary is denoted by shaded areas.

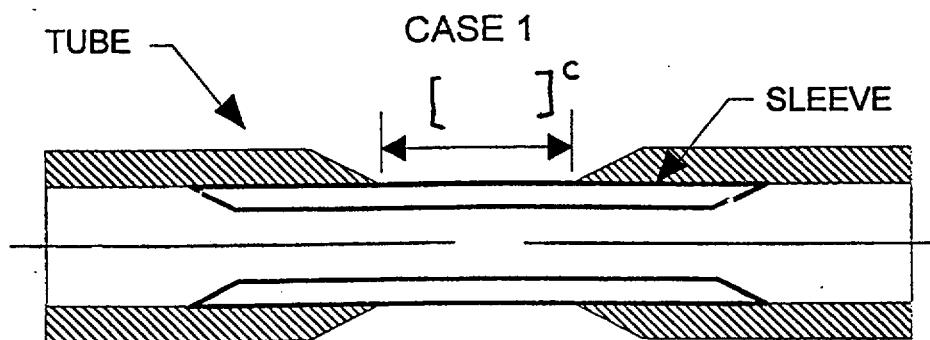
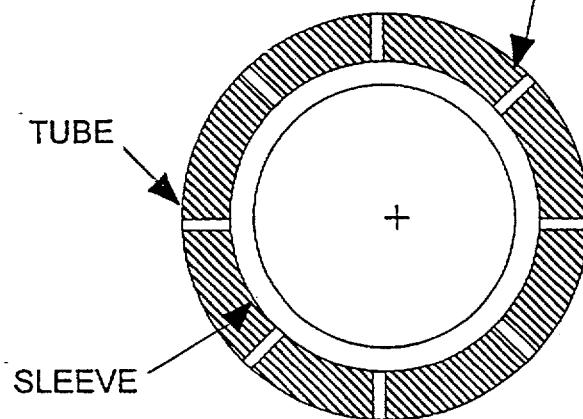
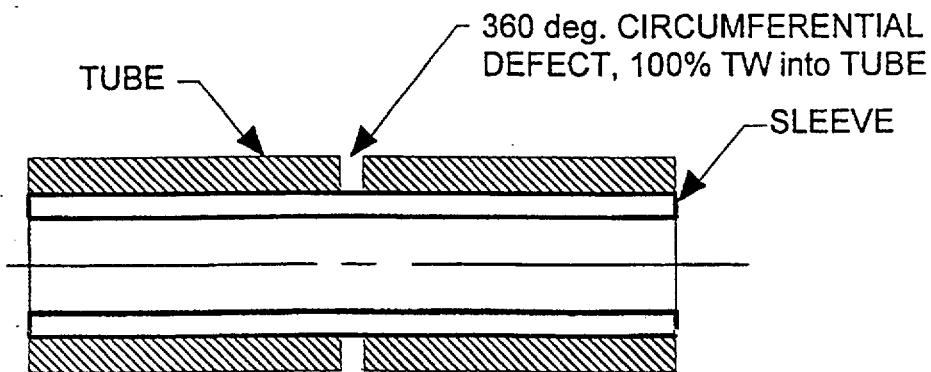
[] c INFINITELY LONG
AXIAL DEFECTS
100% TW into TUBE

With the exception of a sleeve at the secondary tubesheet face, each case was assumed to be a freespan tube defect to maximize the thermal gradient stress across the tube/sleeve interface. In each case, the tubing defect was modeled to extend 100% through-wall to the tube/sleeve interface.

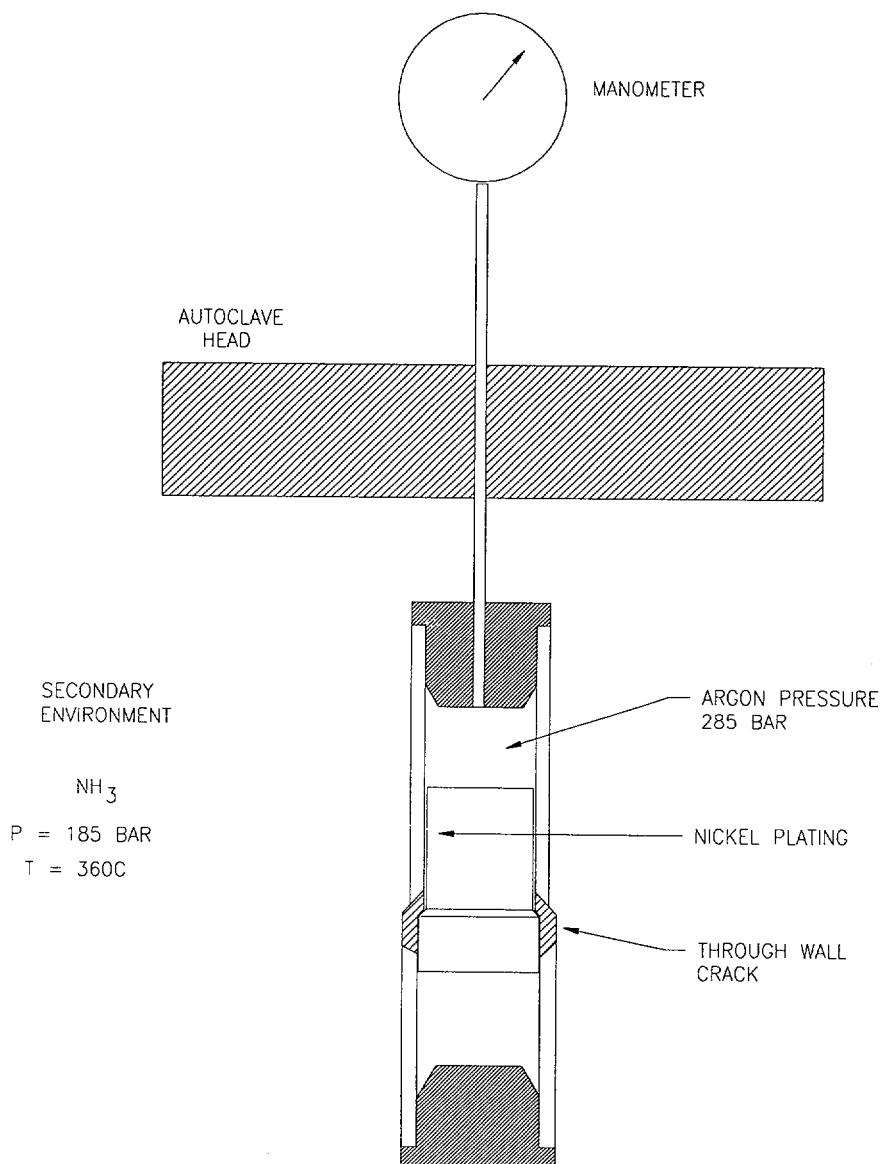
FIGURE 9.3.1
SECONDARY SIDE CAPSULE TESTS

The test conditions were as follows:

- Environment: []
,]^{b,c}

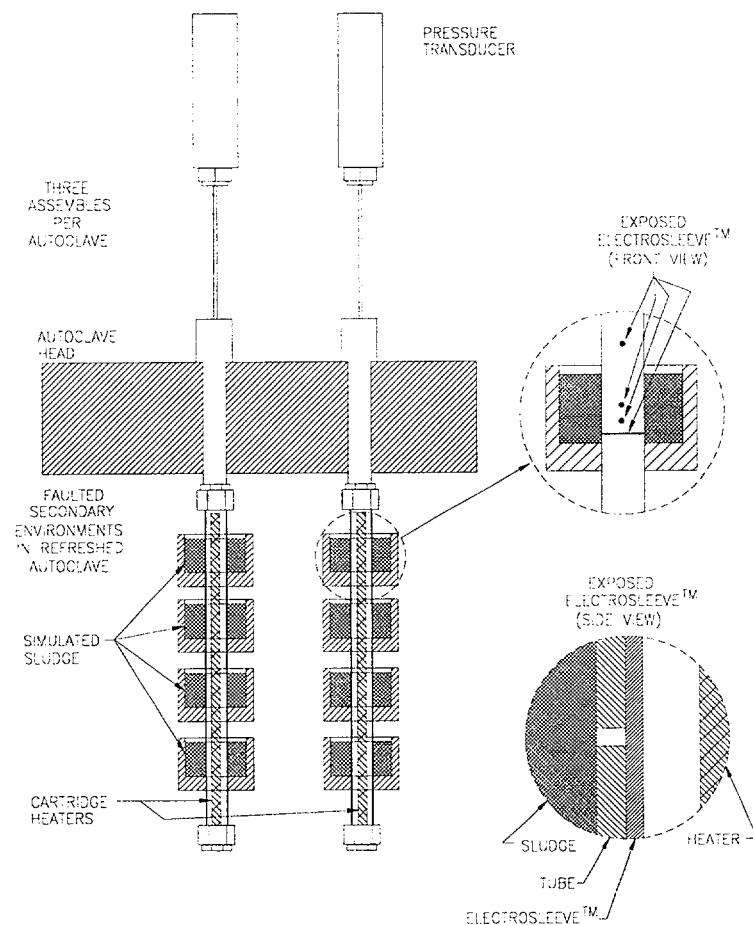
FIGURE 9.3.5
STEAM GENERATOR ELECTROSLEEVED TUBE MOCKUP
FOR SLUDGE AND FAULTED CHEMISTRY TESTS

The tube was hard rolled into [] carbon steel holders. Figure 9.3.5 presents the mockup arrangement.

Each holder was filled with a mixture of fossil boiler sludge consisting of ~70% magnetite and ~30% metallic copper with additional added species. The composition of the sludge mixtures are listed below:

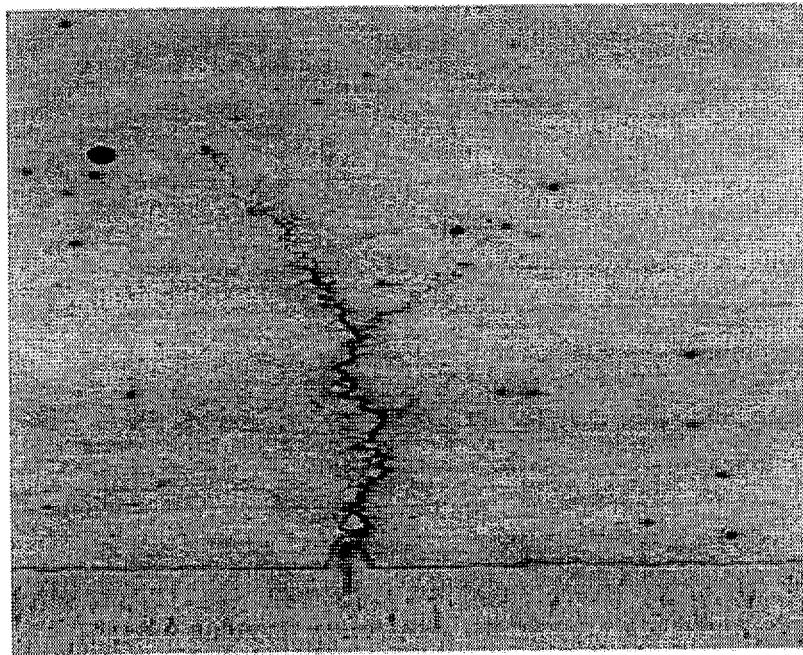
FIGURE 10.7.1
ELECTROSLEEVE™ INSTALLATION EXPERIENCE

Sleeving in a cracked tube

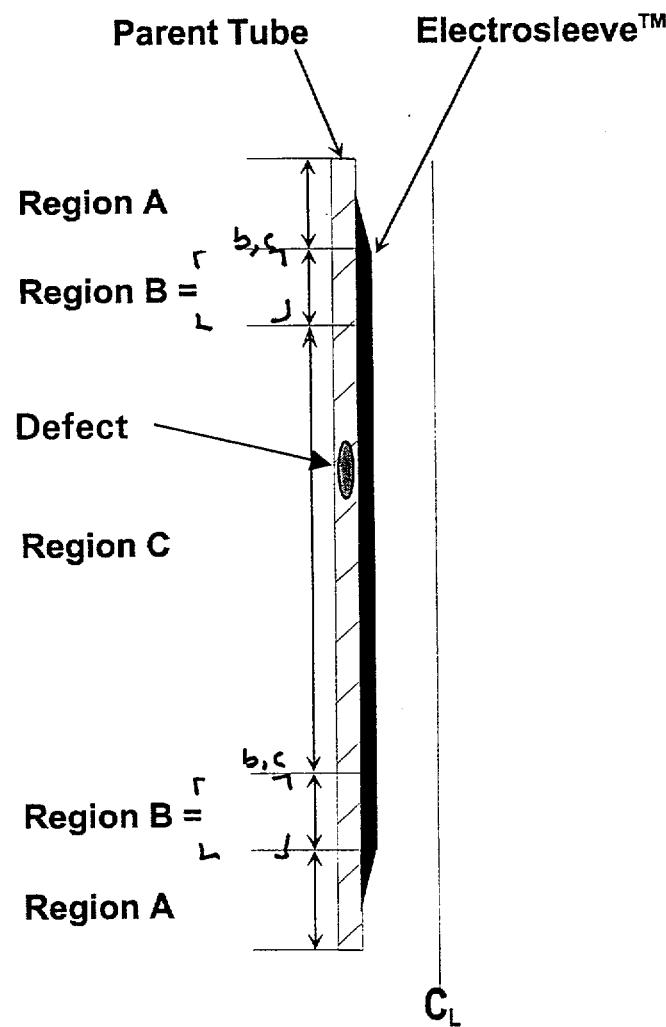
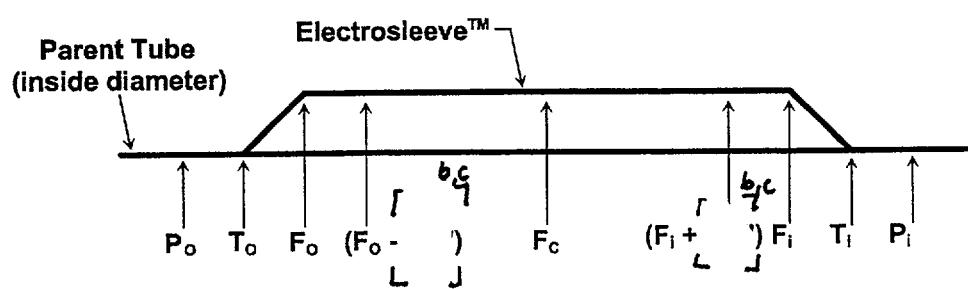
FIGURE 11.1.1
ELECTROSLEEVE™ NDE REGIONS

The tube is the pressure boundary in the taper region (Region A). Thickness measurements in Region A are required at the locations marked P_o and P_i , where the P represents parent tube and "o" and "i" represent the outlet and inlet of the sleeve installation probe flow, respectively. The zero thickness transitions (T_o or T_i) occur at the first presence of nickel plating.

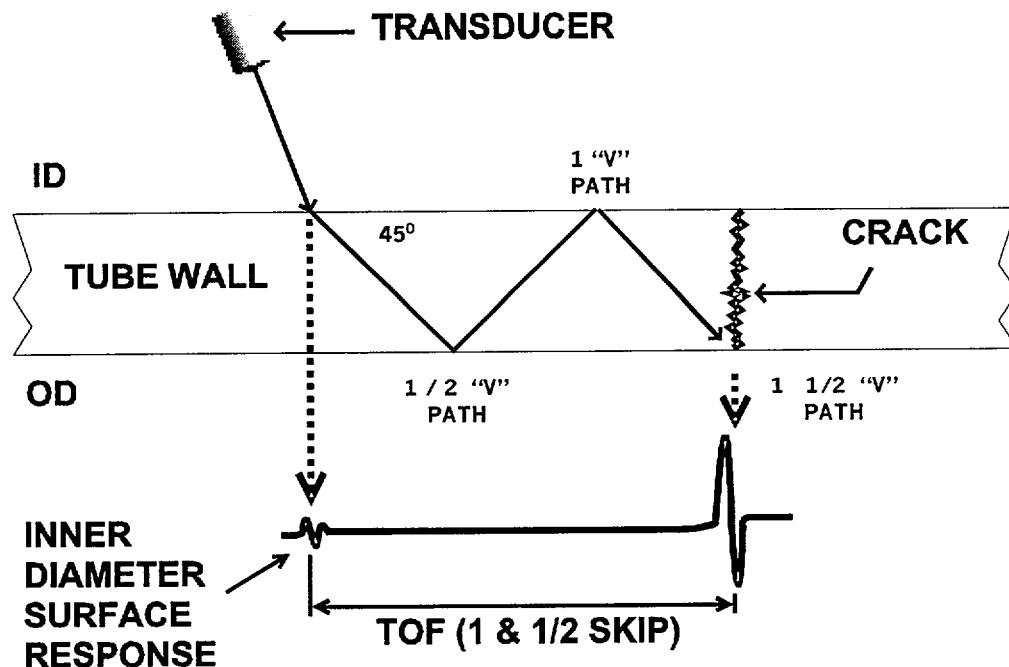
FIGURE 11.3.1
UT WAVE "V" PATH

The detection of axial or circumferential crack-like indications is performed using shear wave testing. The shear wave detects cracks as well as volumetric type indications with sharp edges. Two separate transducers are required for the shear wave examination. One transducer is mounted to produce an axial propagation of ultrasonic energy (along the length of the tube) for the detection of circumferential flaws. A second transducer is mounted to propagate the ultrasonic energy in a circumferential direction for the detection of axially oriented flaws.

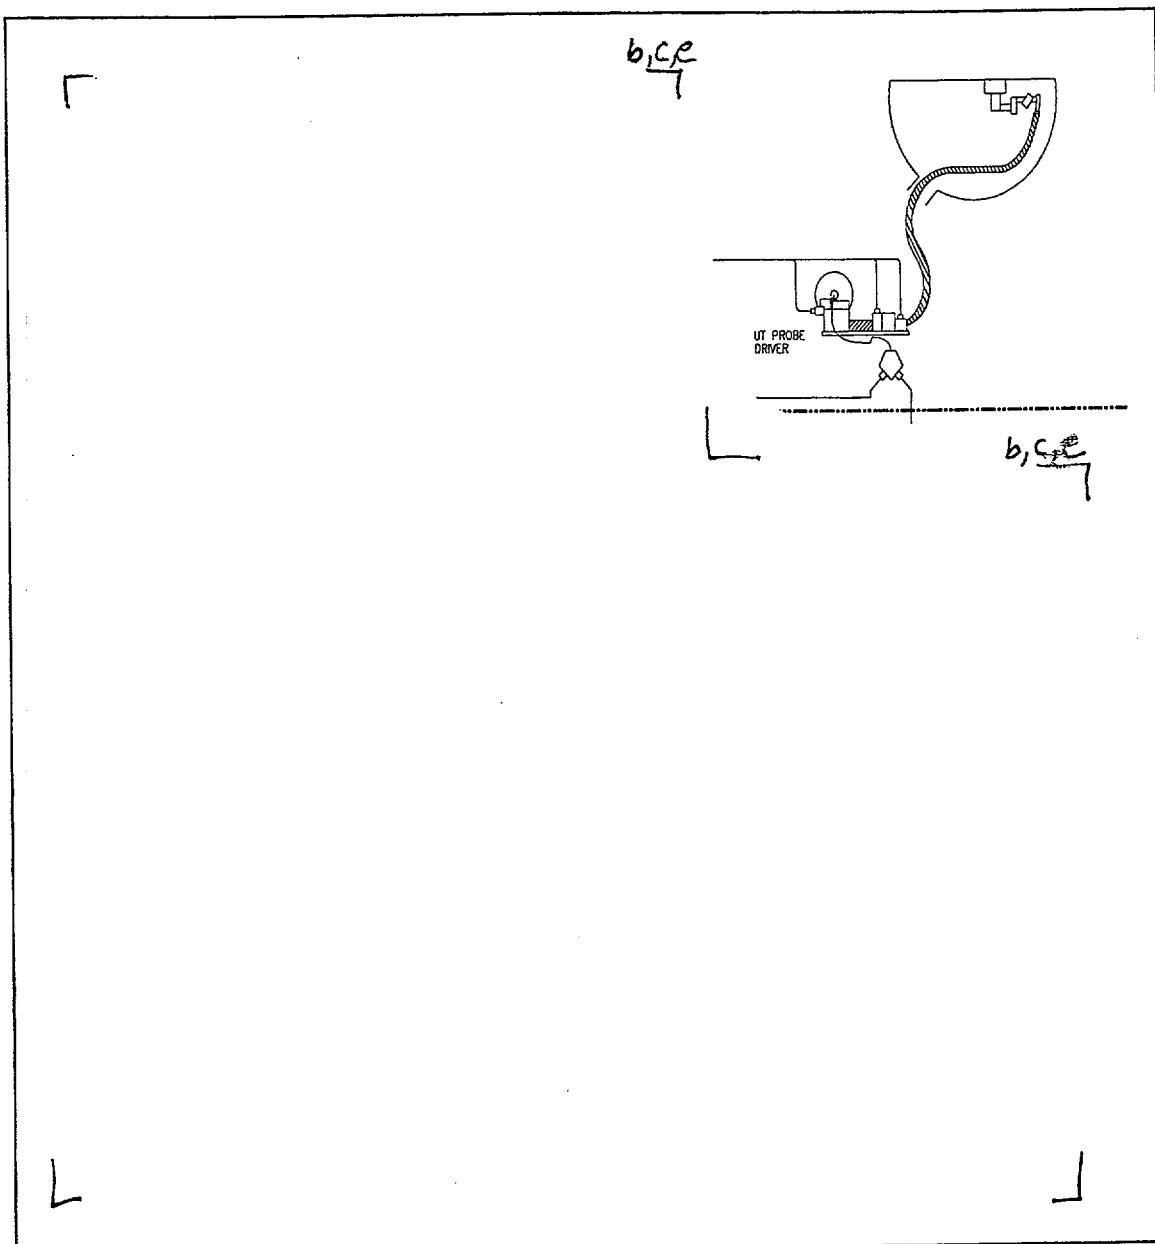
FIGURE 11.4.2
UT-360 SYSTEM DIAGRAM – CONTAINMENT

A typical UT-360 containment setup is shown in Figure 11.4.2.

The NIC box controller performs all acquisition functions, with the exception of the UT signal processing.
