BAW-10219
REV. 04
DECEMBER 2000

**ELECTROSLEEVING QUALIFICATION
FOR PWR RECIRCULATING STEAM
GENERATOR TUBE REPAIR**

**FRAMATOME TECHNOLOGIES, INC.
P.O. BOX 10935
LYNCHBURG, VA 24506-0935**

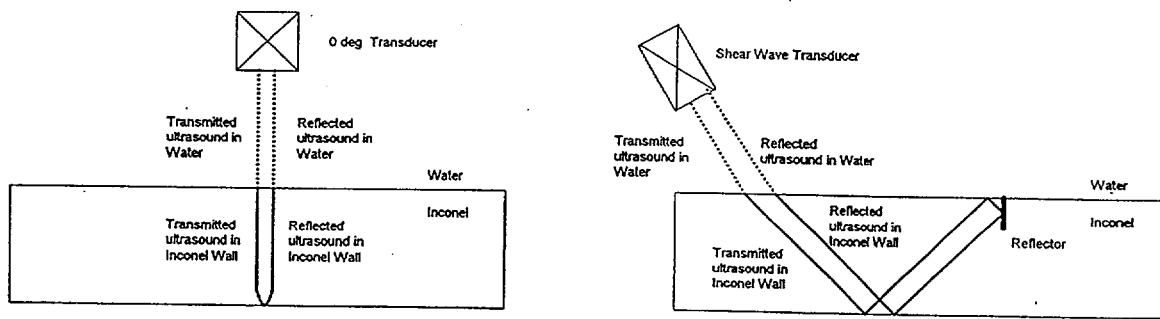
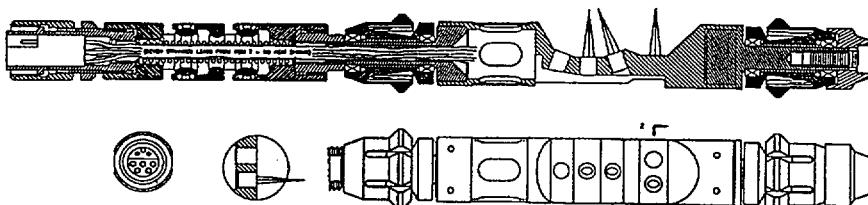
- Rotating 3 Transducer Probe Head
 - 0 Degree (thickness / profilometry)
 - 45 Degree axial beam (circ cracks)
 - 45 Degree circ. beam (axial cracks)

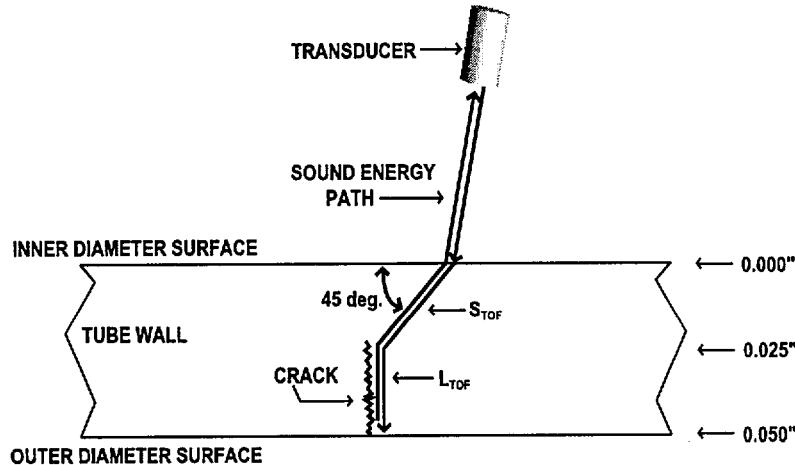
FIGURE 11.7.1
MODE CONVERSION METHOD EXAMPLE

In Figure 11.7.1, the symbols are defined as follows:

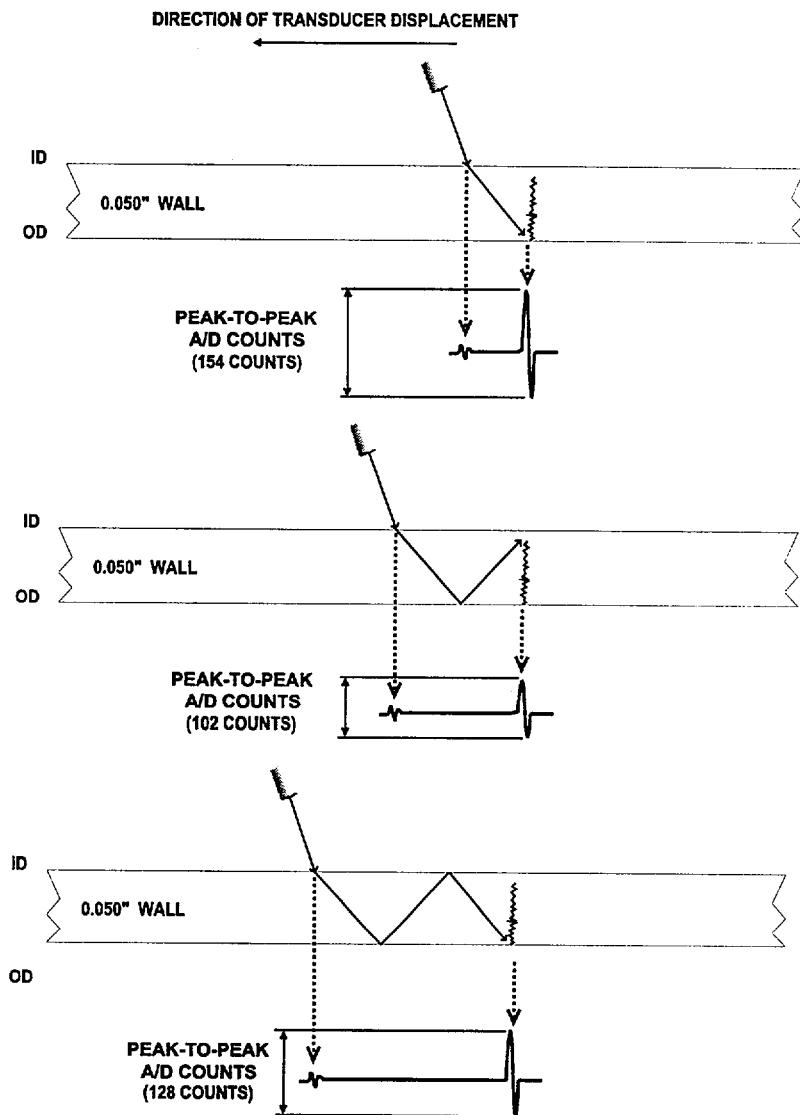
FIGURE 11.7.2
FULL SKIP NORMALIZATION METHOD

Normalized Result – the ratio of the full skip amplitude to the average of the two outer diameter skips, (half skip and the 1 1/2 skip).

$$\text{Normalized Result} = 102 / [(0.5 * (154 + 128))] = 0.723$$
