WSRC-TR-2001-00067

**Degradation and  
Failure Characteristics  
of NPP Containment  
Protective Coating Systems (U)  
Interim Report No. 3**

**SRTC Coating System No. 1**  
(Phenoline<sup>®</sup> 305 epoxy-phenolic topcoat,  
Carbozinc<sup>®</sup> 11 primer, carbon steel substrate)

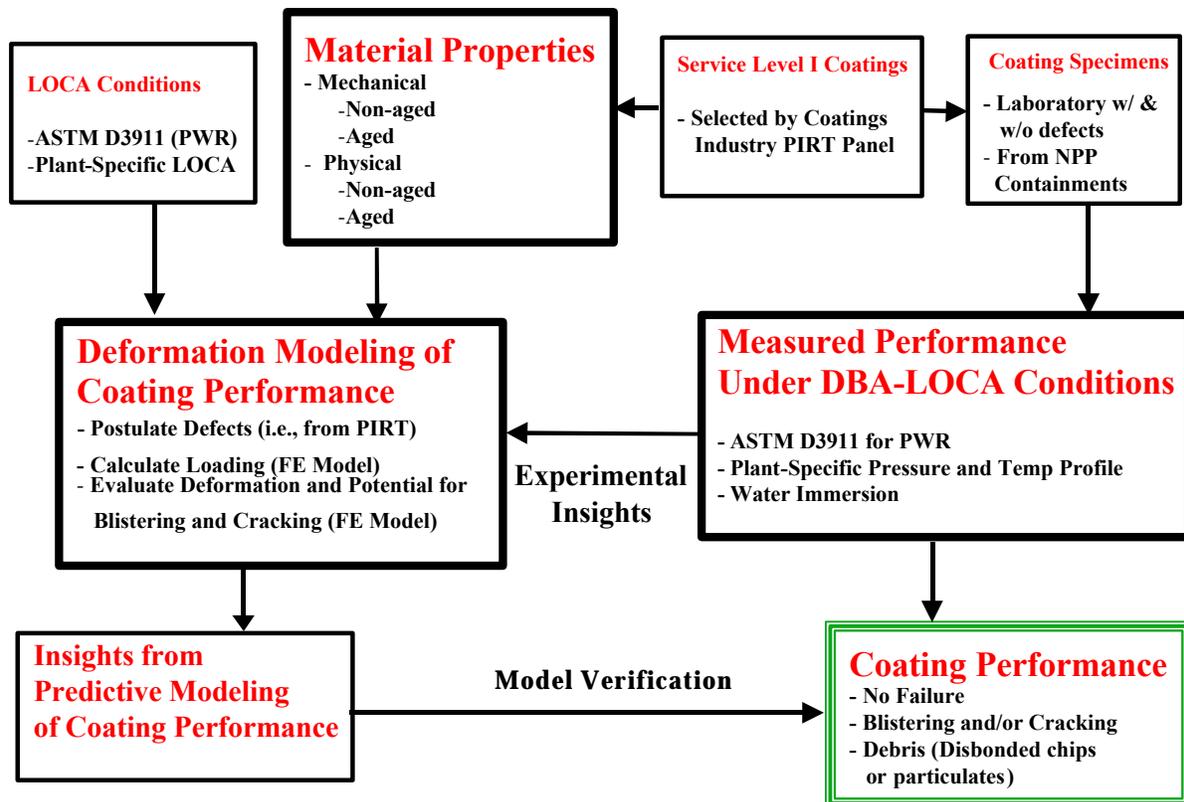
Figure 2-1. Task Logic Diagram for SRTC Project

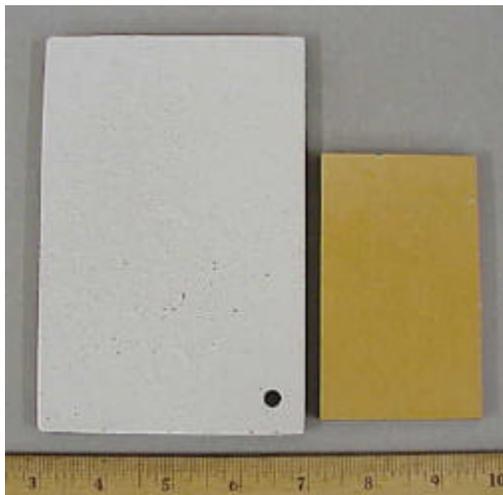
Figure 2-3. System 1 Laboratory Specimens before (left) and after (right) exposure to 10<sup>9</sup> Rad per ASTM D4082-95

The specimens also were fabricated to contain a Type 1 defect at the IOZ/steel substrate interface. Type 1 defects were created by either attaching 0.472-in.- (12 mm) diameter, 0.005-in.-thick glass discs to the steel, or by applying polytetrafluorethylene (Teflon®) on the steel in well-defined locations, prior to application of the IOZ primer.

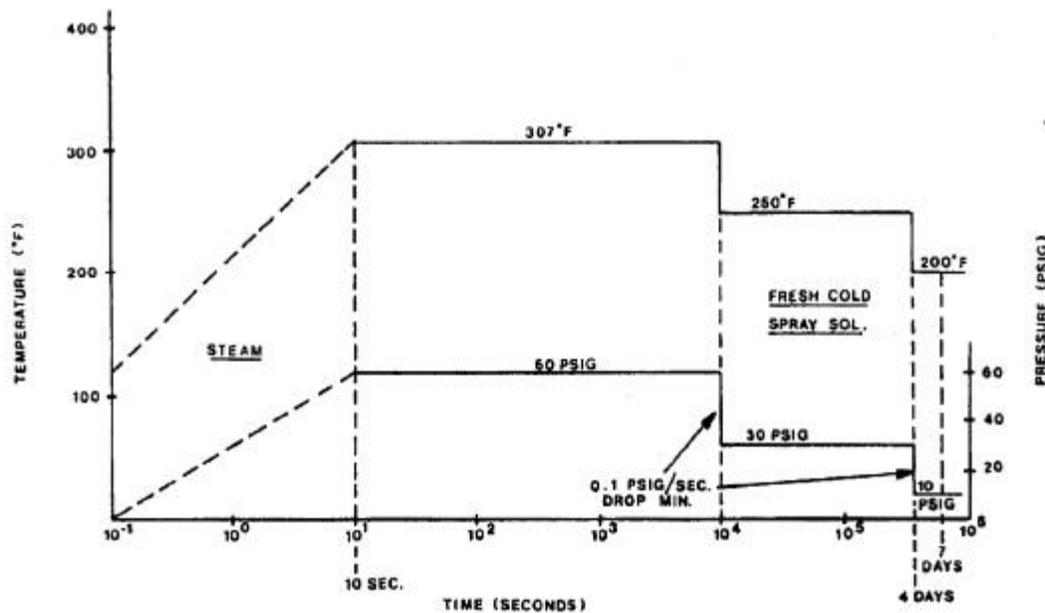
Figure 2-4. DBA Profile for PWR per ASTM D3911-95

There are two DBA profiles investigated in this study: the pressurized water DBA profile specified in ASTM standard D3911-95 [2.6], termed the “full DBA profile” in this report, and a plant-specific rapid pressure/temperature pulse test. Figure 2-4 below shows the ASTM profile, which is run for a total exposure period of approximately one week.

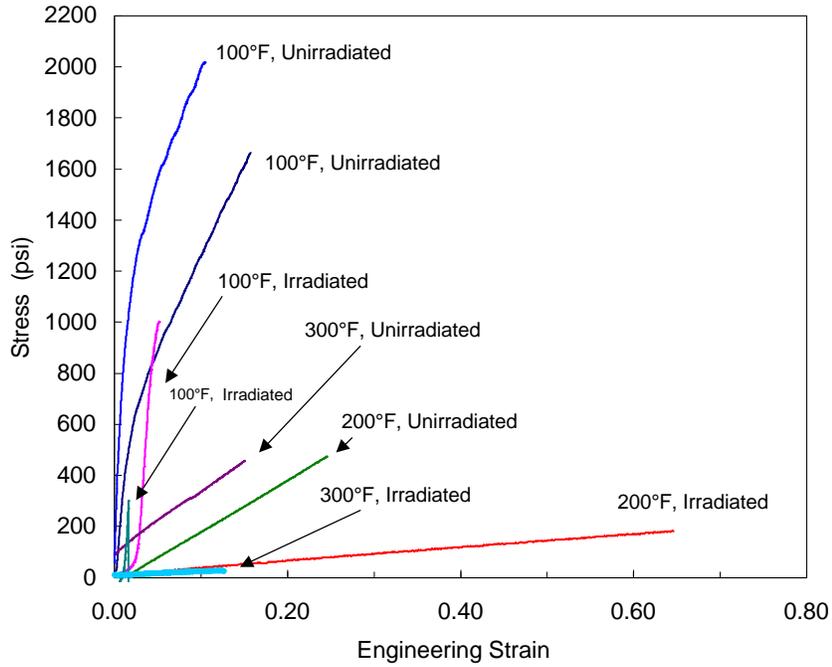
Figure 3-1. Free-film tensile test results for Phenoline<sup>®</sup> 305 in the dry condition

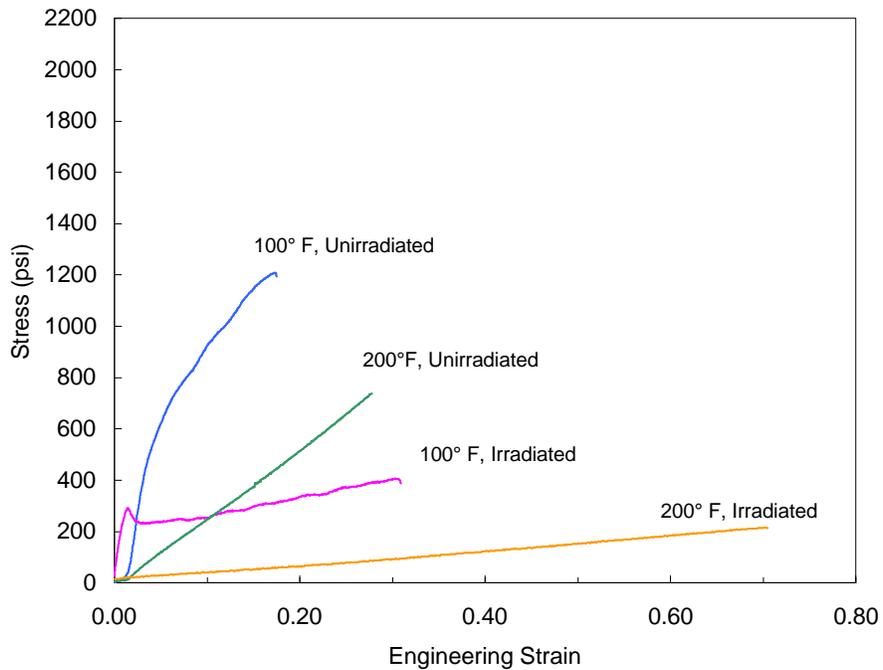
Figure 3-2. Free-film tensile test results for Phenoline<sup>®</sup> 305 in the wet condition

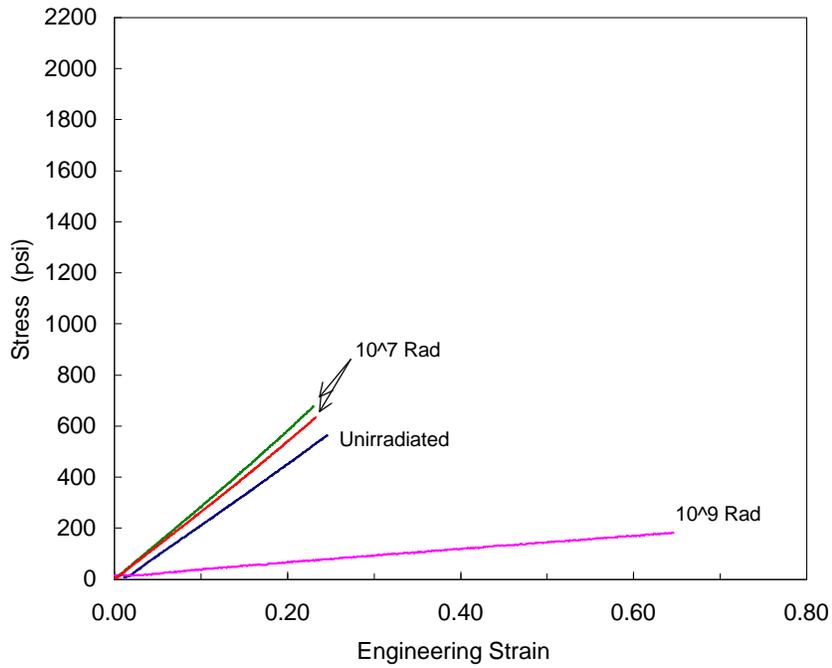
Figure 3-3 . Free-film tensile test results for Phenoline<sup>®</sup> 305 at 200°F in the dry condition

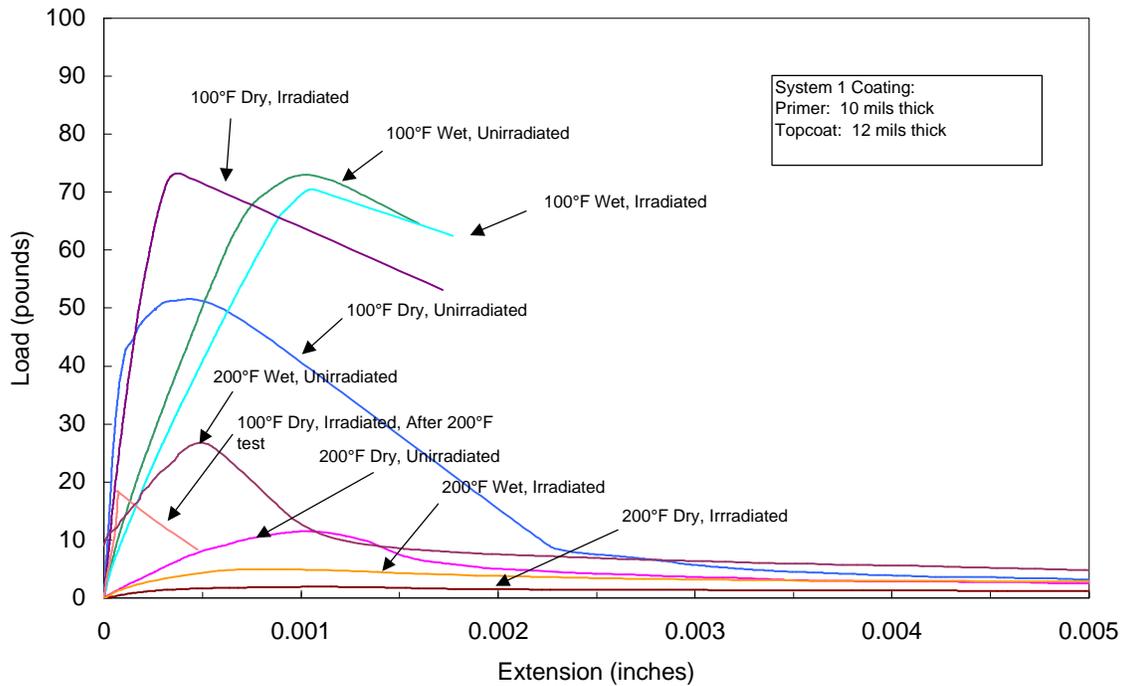
**Figure 3-4. Adhesion G-value test results for System 1**

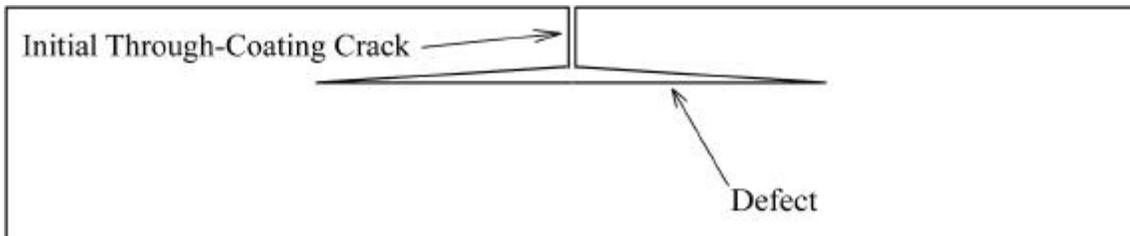
Figure 3-6. Mode 2 Analysis Model

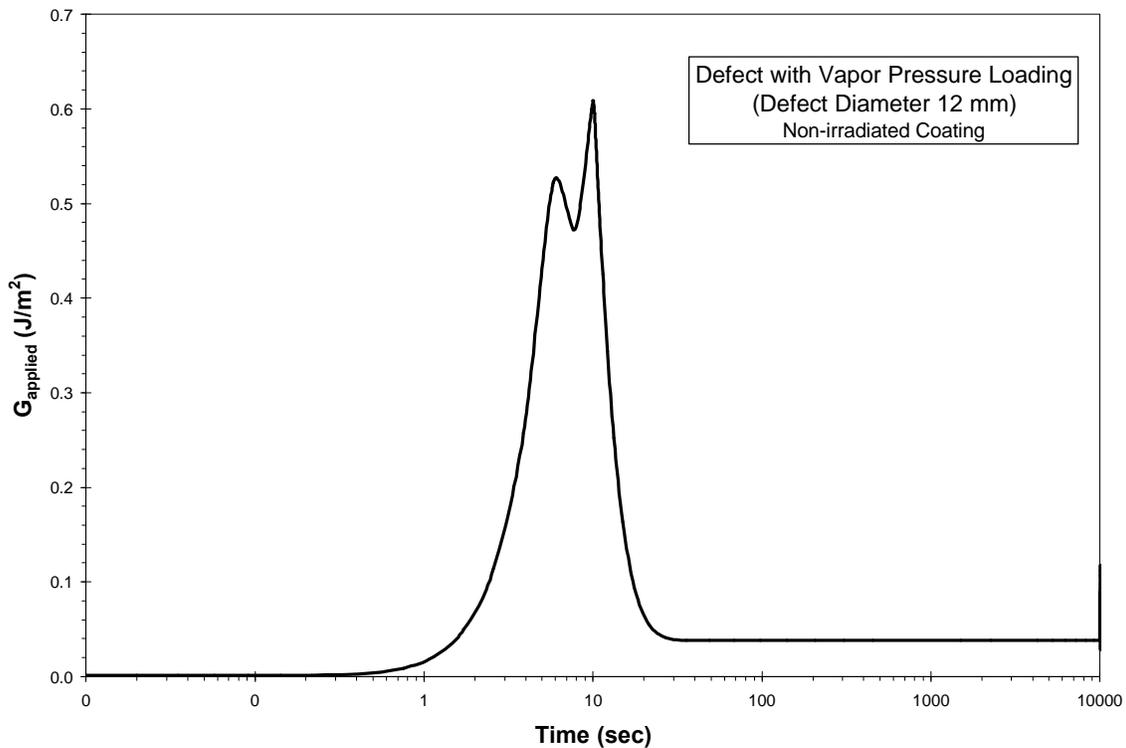
**Figure 3-7. Applied G-Values at the Edge of a dry Defect (Diameter 12 mm) during DBA Test (Logarithmic Time Scale)**

A Type 1 defect with diameter 12 mm was placed between the primer and the steel substrate. The J-integral option in the finite element code (ABAQUS) was used to evaluate the applied G-values for this defect with and without vapor pressure due to trapped water in the defect. When there is no vapor pressure present inside the defect, the applied G-value is mainly due to the thermal expansion mismatch. The maximum applied G-value ( $0.6 \text{ J/m}^2$ ) occurs about 0.1 seconds after the initial heating is complete (10 seconds and at 307°F), as shown in Figure 3-7. It can be seen that the peak value of the applied G-value is insignificant compared to the material G-values in Table 3-8 ( $98 \text{ J/m}^2$ ), and thus no delamination would occur. It can be concluded that this defect will not grow under the condition in which there is no trapped water in the defect.

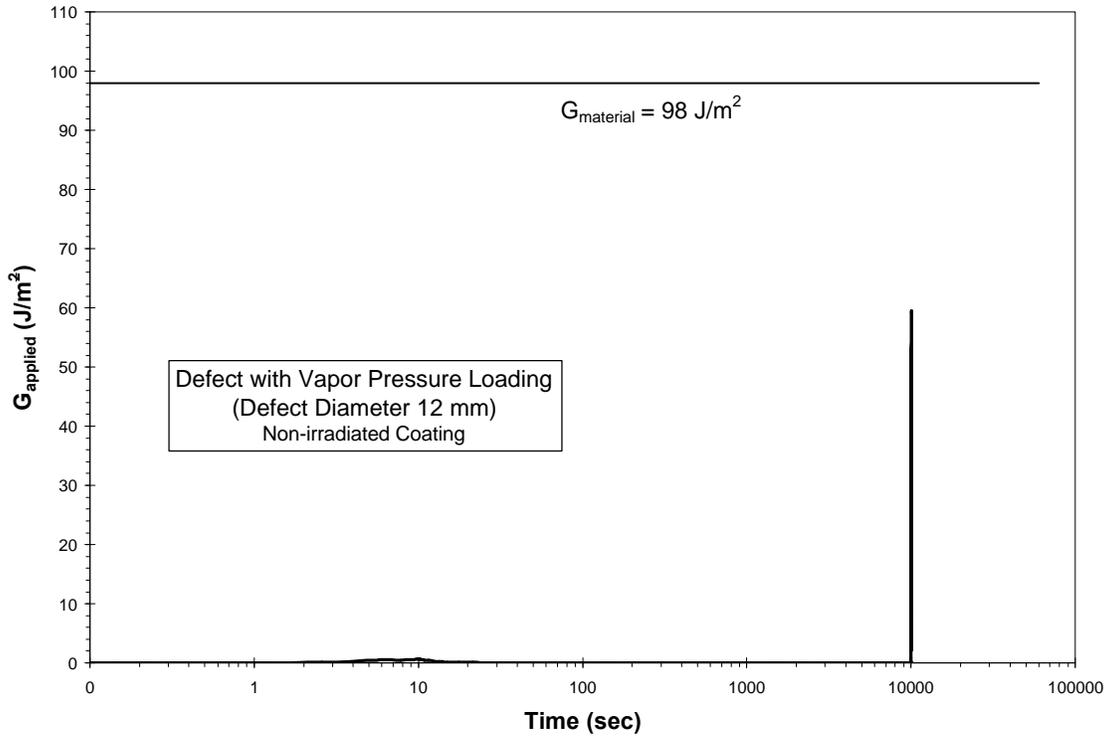
**Figure 3-8. Applied G-Values at the Edge of a Vapor Pressurized Defect (Diameter 12 mm) during DBA Test (Logarithmic Time Scale)**

The analysis results are consistent with the DBA tests in which no coating failures were observed.

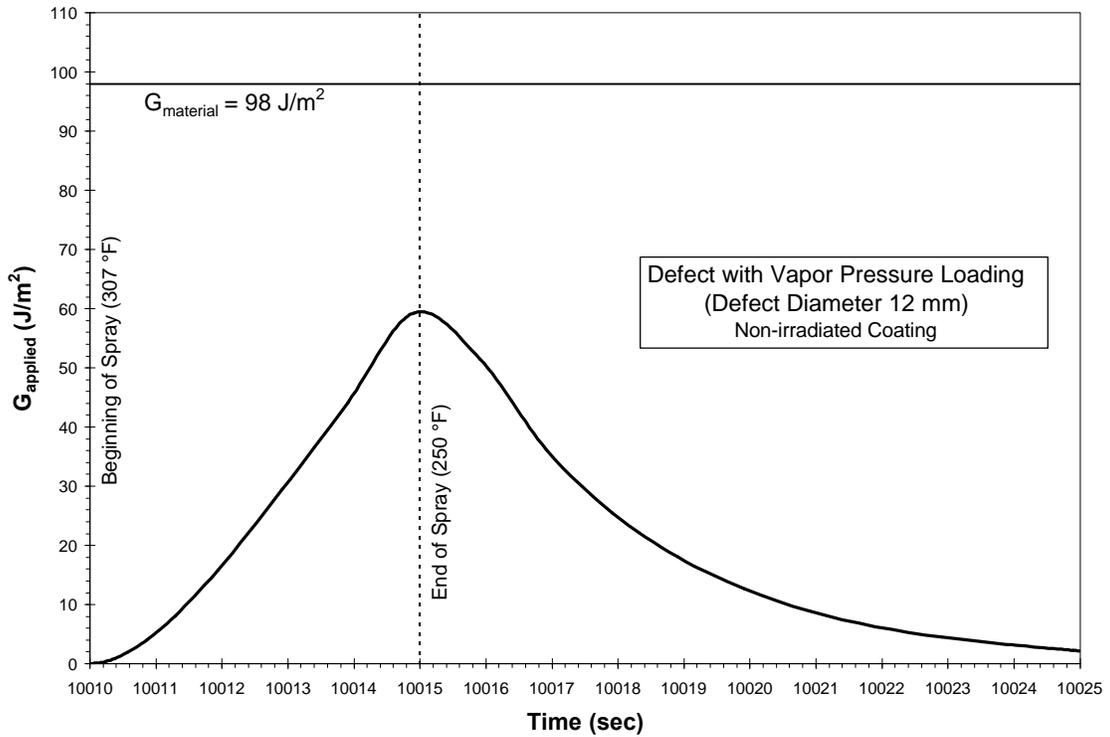
**Figure 3-9. Applied G-Values at the Edge of a Vapor Pressurized Defect (Diameter 12 mm) during Cooling Phase in DBA Test (Linear Time Scale)**

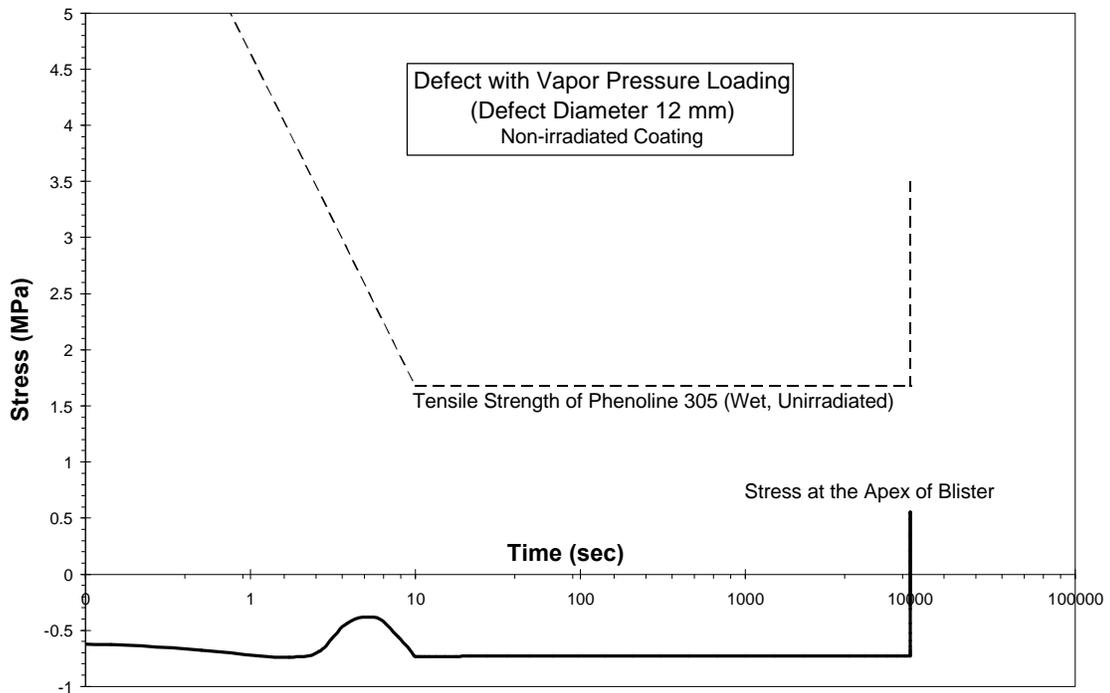
**Figure 3-10. Failure Assessment of Type 1 Defects Using the Peak Tensile Stress Criterion (Entire Time History with Logarithmic Time Scale)**

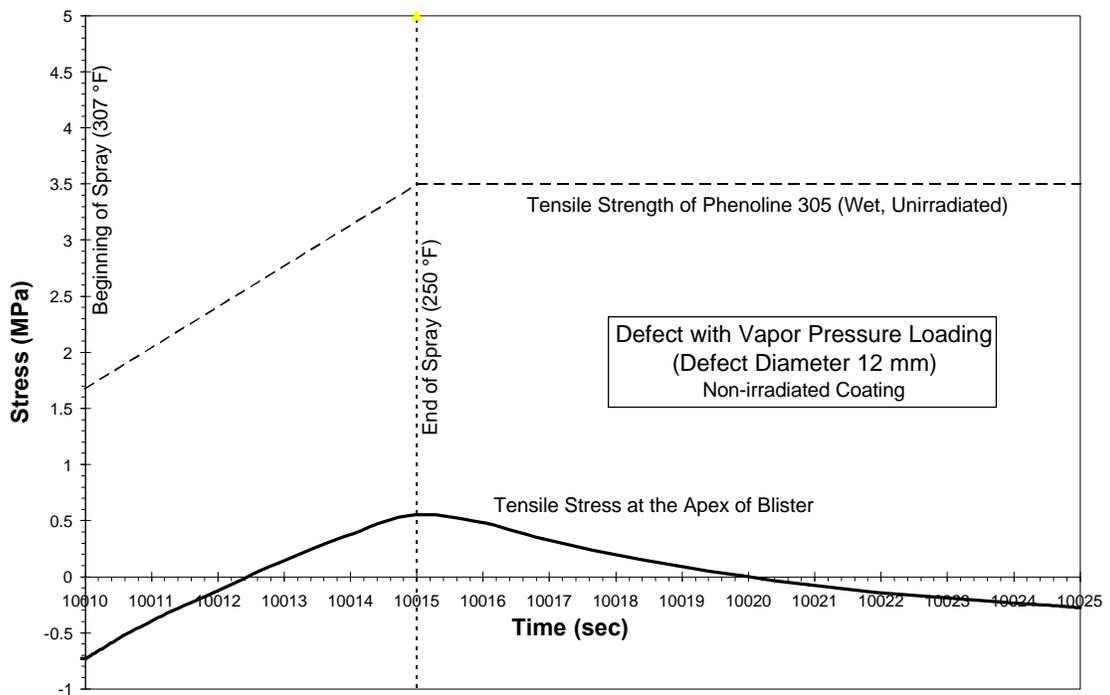
**Figure 3-11. Failure Assessment of Type 1 Defects Using the Peak Tensile Stress Criterion (Cool-down Phase with Linear Time Scale)**

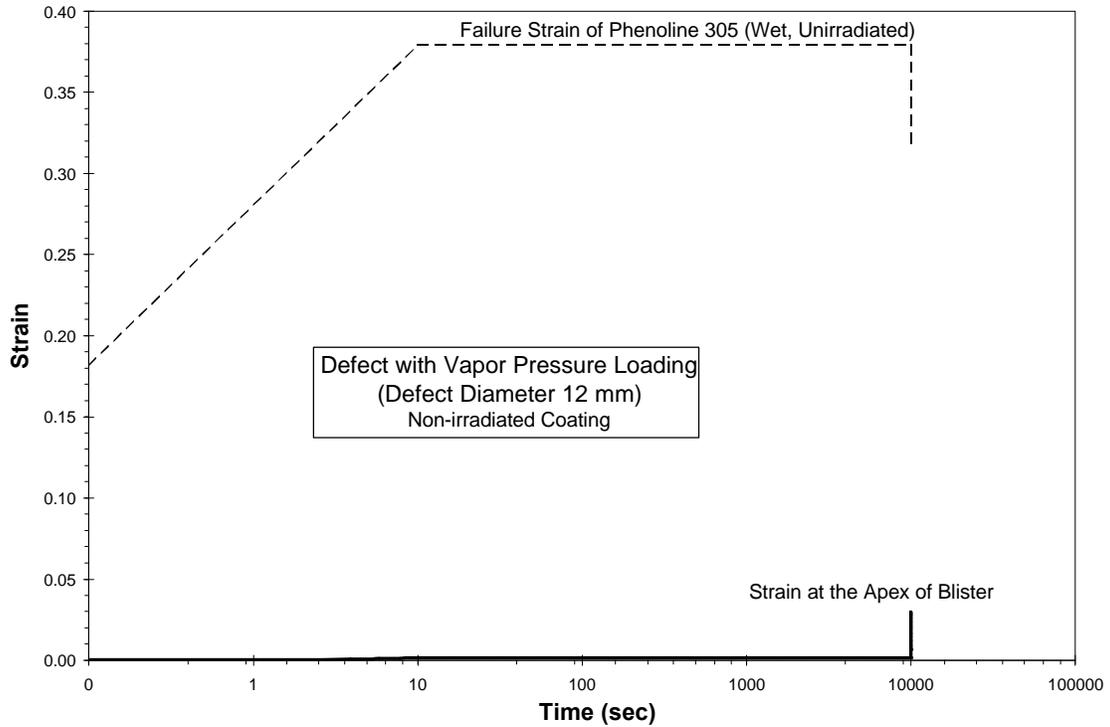
**Figure 3-12. Failure Assessment of Type 1 Defects Using the Failure Strain Criterion (Entire Time History with Logarithmic Time Scale)**

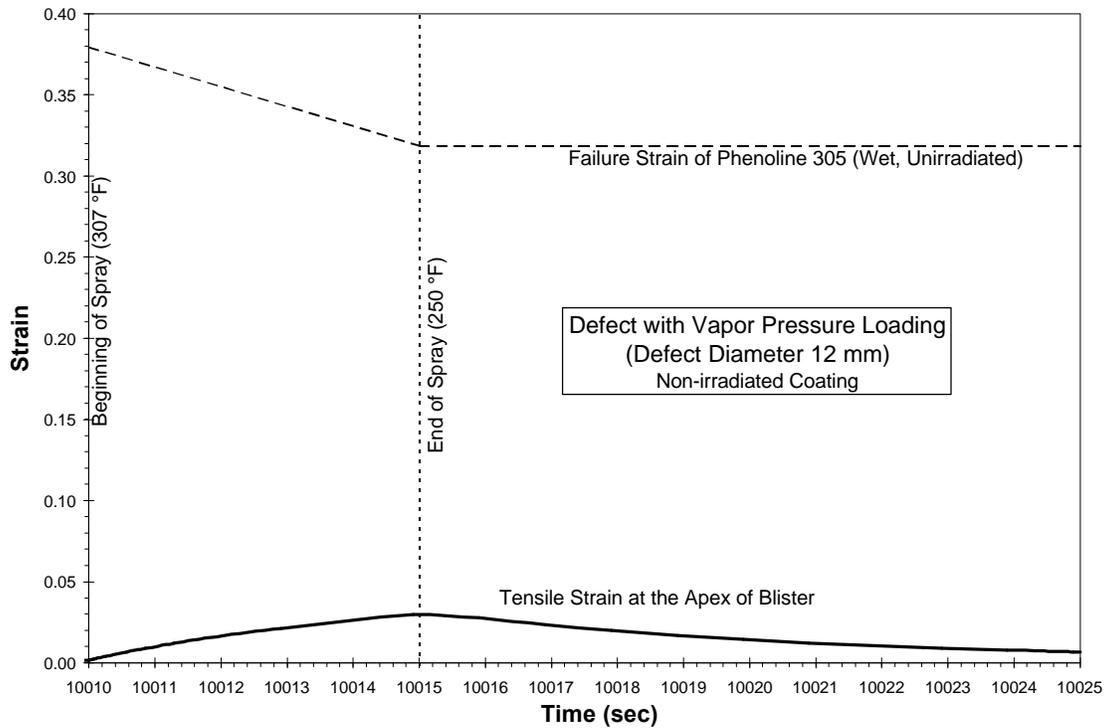
**Figure 3-13. Failure Assessment of Type 1 Defects Using the Failure Strain Criterion (Cool-down Phase with Linear Time Scale)**

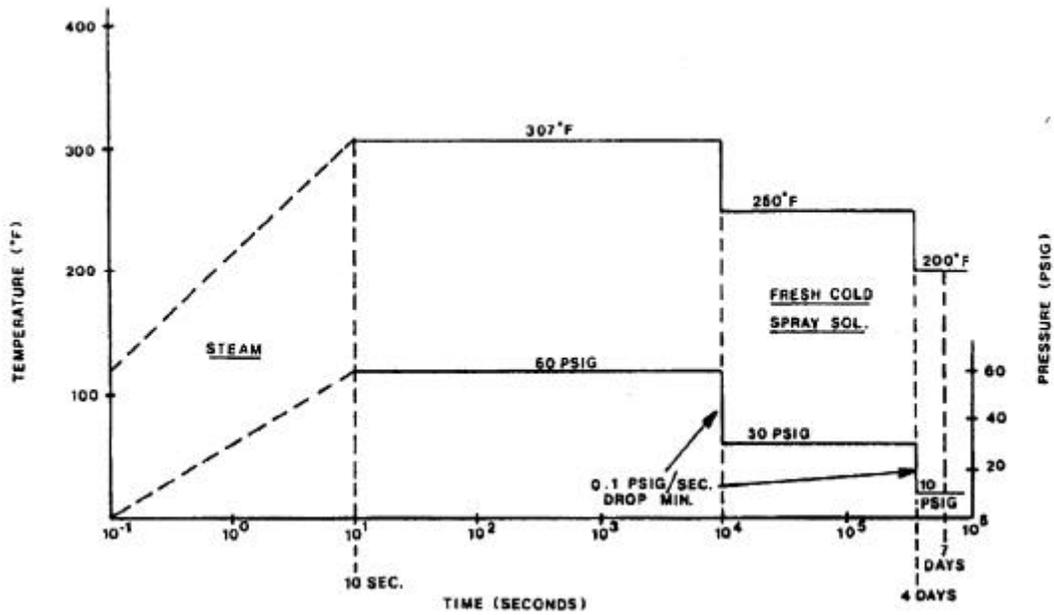
Figure 3-14. Typical Pressurized Water Reactor Design Basis Accident (DBA) Testing Parameters (from ASTM D3911-95). (Note: The ASTM figure contains an error: 30 psig should be 15 psig, which is equivalent to 30 psia).

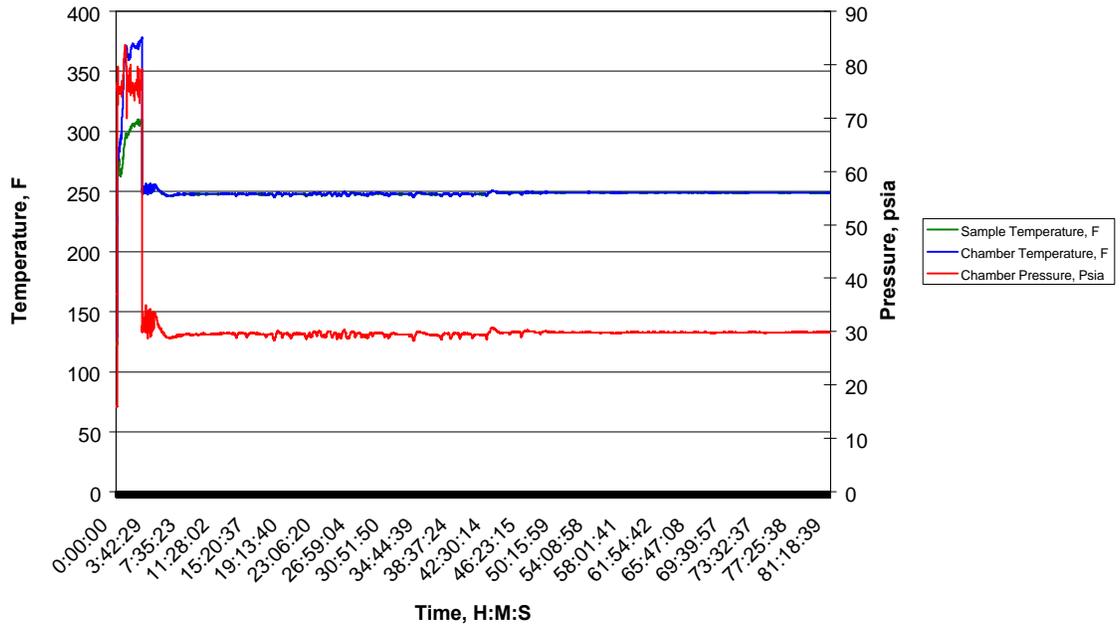
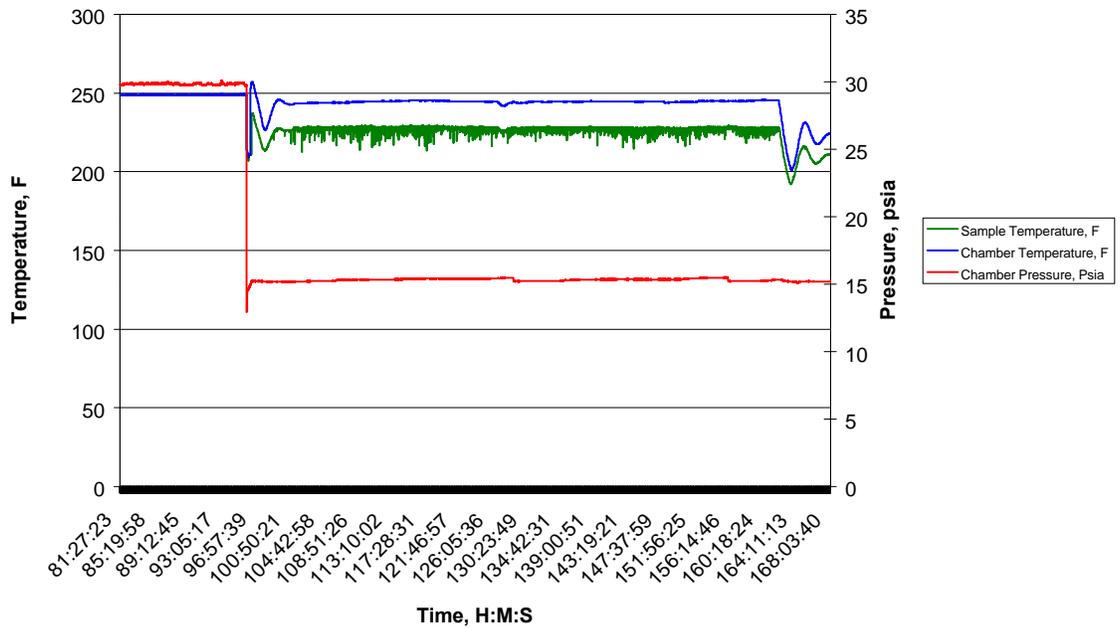
**Figure 3-15. Typical Temperature-pressure Profile from SRTC System 1 D3911 DBA-LOCA Test**

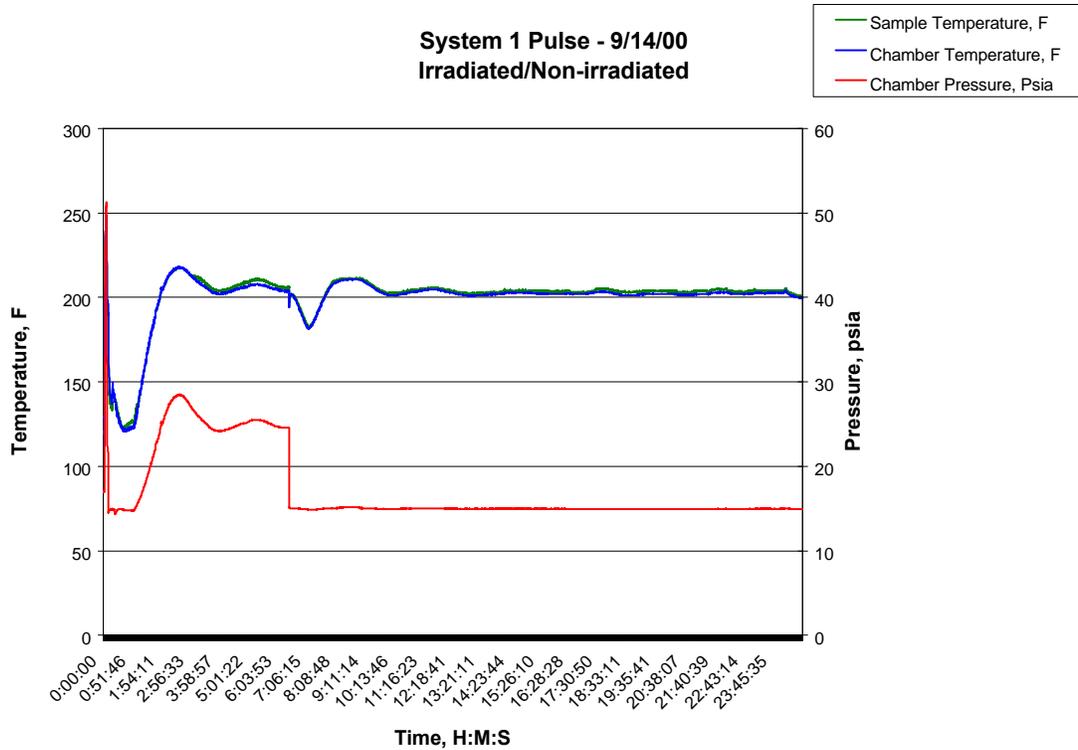
Figure 3-16. Temperature-Pressure Curves from Plant-specific LOCA Test

plant-specific LOCA event, the SRTC coatings performance evaluation system was used to subject aged and non-aged System 1 specimens to a rapid temperature-pressure pulse (Figure 3-16).

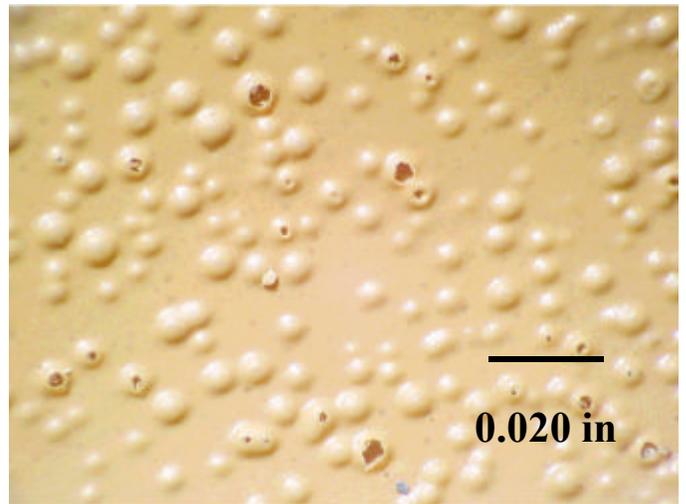
**Figure 3-17. Micrograph of blistering formed on Phenoline<sup>®</sup> 305 free-film specimen following irradiation to  $1 \times 10^9$  rads and heating to 200°F, dry; original magnification approximately 20x**

System 1 specimens, which were irradiation-aged, exhibited blistering after having been exposed to elevated temperature in air or in water. Similar blistering was observed during the testing of SRTC Systems 2 and 5 coatings. For example, numerous small blisters appeared in free-film specimens, which had been irradiated to  $1 \times 10^9$  rads, when they were heated in air to 200°F during tensile testing (Figure 3-17). The blisters were approximately 10 mils in diameter and remained intact. Similar small, but less numerous, blisters were formed when free-film specimens were irradiated to  $1.0 \times 10^8$  rads or  $2.5 \times 10^8$  rads, then immersed in 200°F water (Figures 3-18 and 3-19). Much larger blisters appeared when specimens which had been irradiated to  $1 \times 10^9$  rads were heated in 200°F water (Figure 3-20). In all cases, the blisters which were formed were quite thin compared to the nominal 12 mil coating thickness, and were quite fragile when dry. The thickness of the coating layer forming the blister was only about 0.001 inch (1 mil). The thickness of the blisters indicates they are formed in the darkened, ostensibly oxygen affected, outer layer of the irradiated coating. The blisters are presumed to be the result of agglomeration and/or expansion at elevated temperature of gases produced in the topcoat during irradiation.

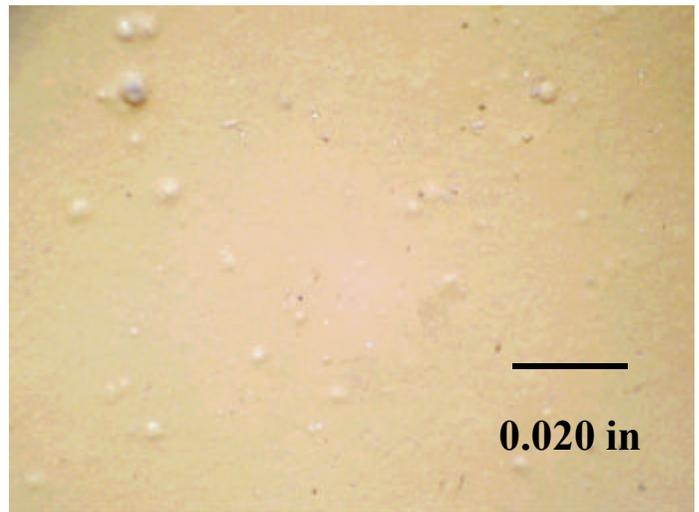
**Figure 3-18. Micrograph of blistering formed on Phenoline<sup>®</sup> 305 free-film specimen following irradiation to  $1.0 \times 10^8$  rads and immersion in 200°F water; original magnification approximately 20x**

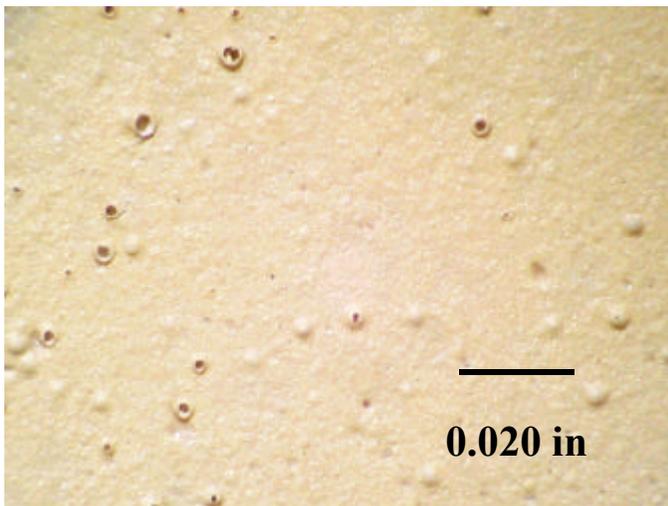
**Figure 3-19. Micrograph of blistering formed on Phenoline<sup>®</sup> 305 free-film specimen following irradiation to  $2.5 \times 10^8$  rads and immersion in 200°F water; original magnification approximately 20x**

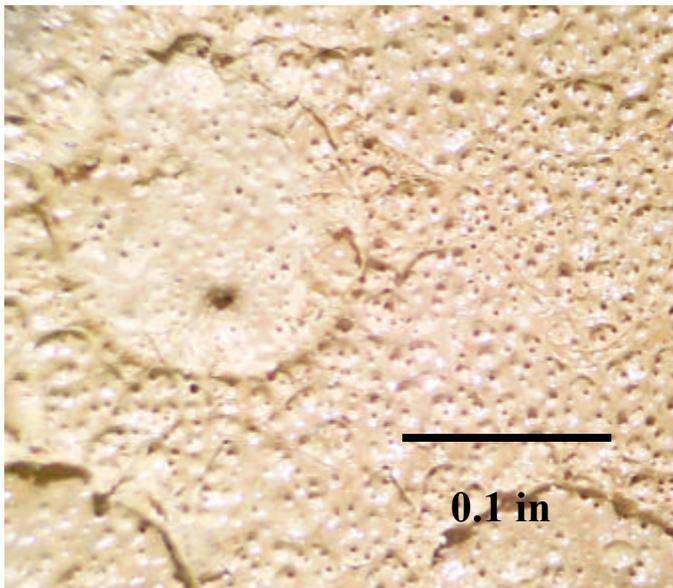
**Figure 3-20. Micrograph of blistering formed on Phenoline<sup>®</sup> 305 specimen following irradiation to  $1 \times 10^9$  rads and immersion in 200°F water; original magnification approximately 7x**

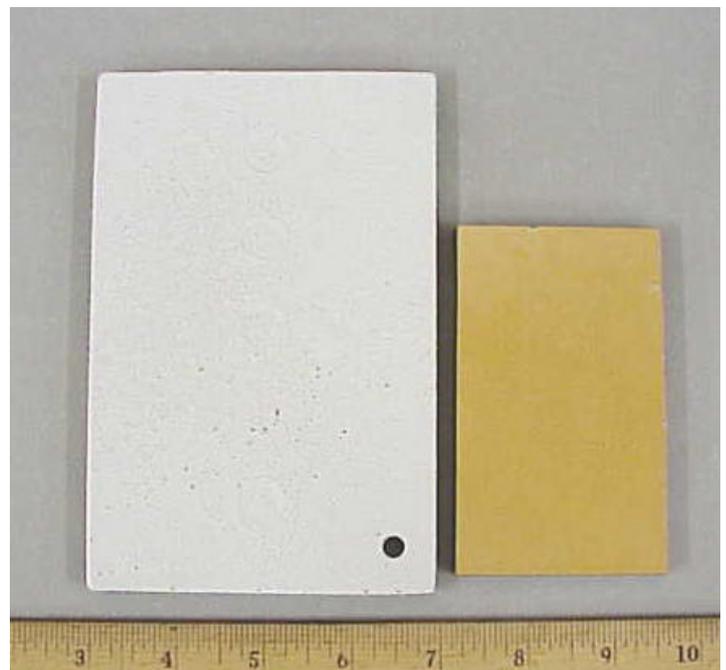
**Figure 3-21. Overall views of System 1 specimens before (left) and after irradiation-aging**

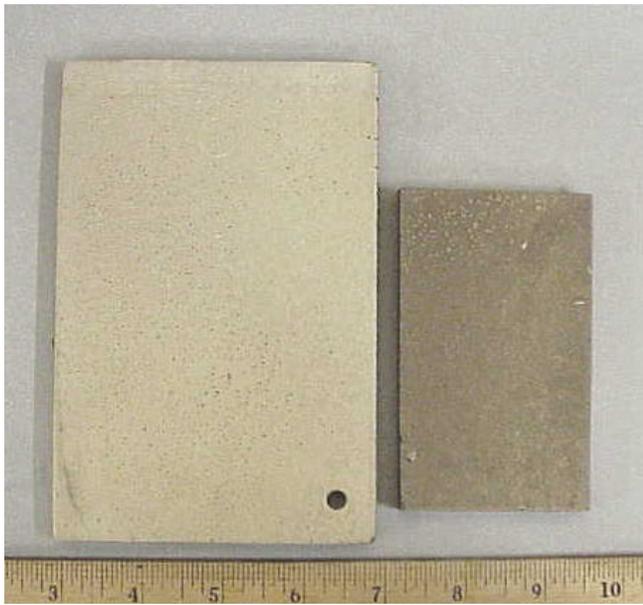
**Figure 3-22. Overall views of System 1 specimens after DBA/LOCA testing according to ASTM D3911-95**

Significant blistering was not observed in irradiated coating specimens during DBA-LOCA testing performed in accordance with ASTM D3911-95 (Figures 3-22 and 3-23). However, microscopic examination of the surface of the irradiated specimens following testing revealed evidence of coating softening and the presence of numerous pores in the coating (Figure 3-24). A cross-section of the irradiated coating made after DBA-LOCA testing (Figure 3-25) verified the pores are confined to the outermost layer of the topcoat. Therefore, it is possible any gases which formed in the topcoat during irradiation were released from the coating during the high-temperature steam exposure, which occurs during the first 2.8 hours of the DBA test cycle. During this time, the specimen is heated with 75 psia steam to 307°F. At this temperature, the coating may become so soft, and the gases so mobile, that the gas pressure is relieved through the coating without forming large blisters. It is probable, however, that small debris particles were released from the coating at this time, although this speculation has not been confirmed.

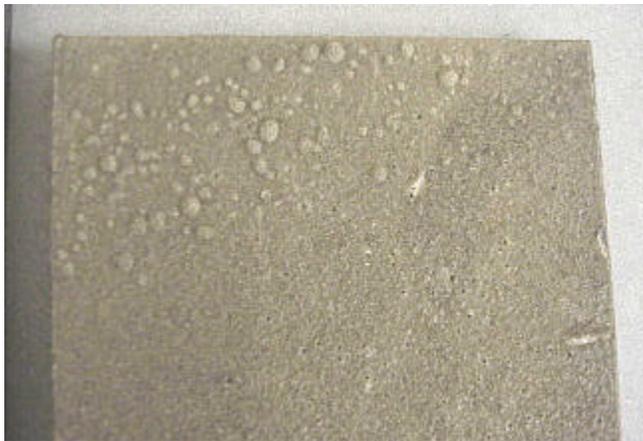
**Figure 3-23. Detail of the surface of the irradiation-aged specimen after DBA testing. Note the presence of intact blisters in the coating.**

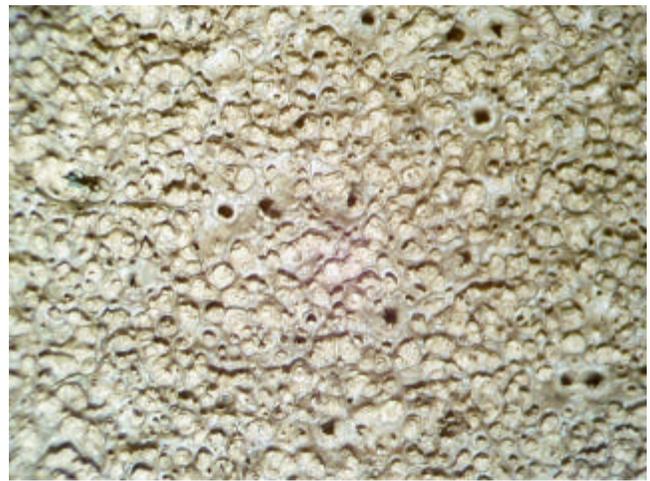
**Figure 3-24. Microscopic view of the surface of the irradiation-aged specimen after DBA testing illustrating evidence of coating softening and formation of pores. Original magnification 7x**

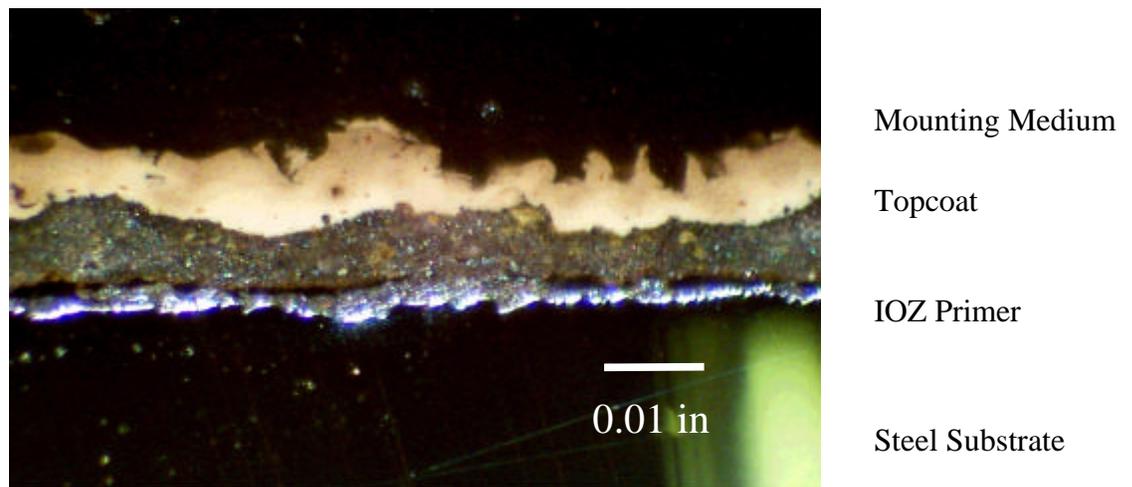
**Figure 3-25. Cross-section of the surface of the irradiation-aged specimen after DBA testing. Note the presence of pores in the coating. Original magnification 30X.**

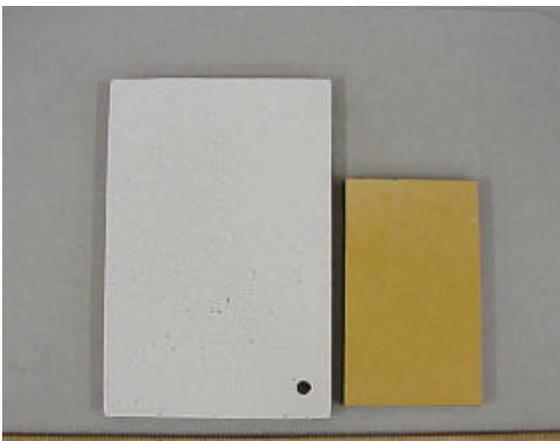
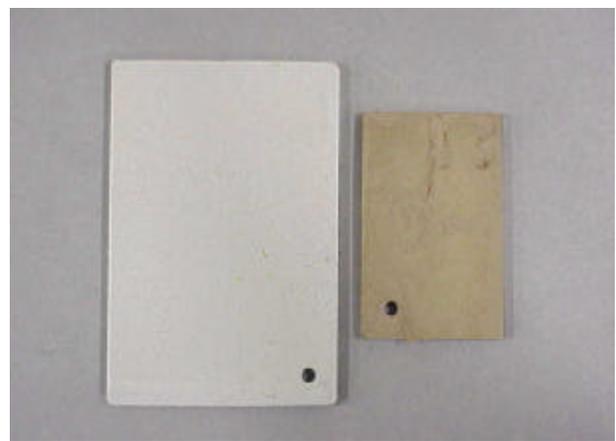
**Figure 3-26. Overall view of the non-aged (left) and irradiation-aged (right) System 1 specimens before (left photo) and after (right photo) a plant-specific DBA/LOCA test. The specimens in the left-hand photo are not the specimens used in the plant-specific test, but were identical specimens used in the full LOCA test and included here for illustration. The actual test specimens in the right-hand photo are oriented as they were during testing.**

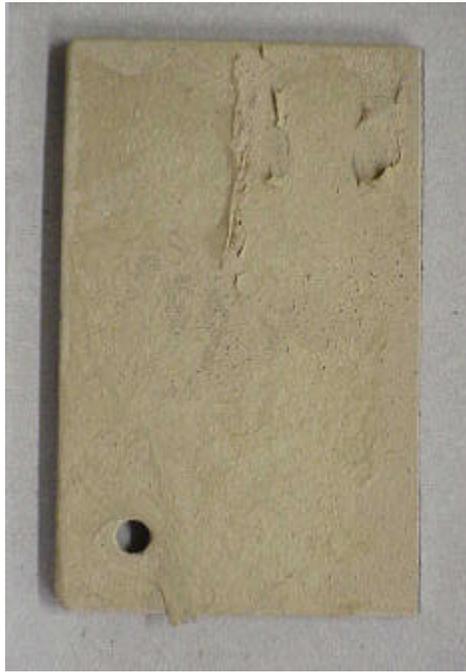
**Figure 3-27. Overall view of the irradiation-aged System 1 specimen, revealing blistering and sloughing of the topmost layer of the topcoat**

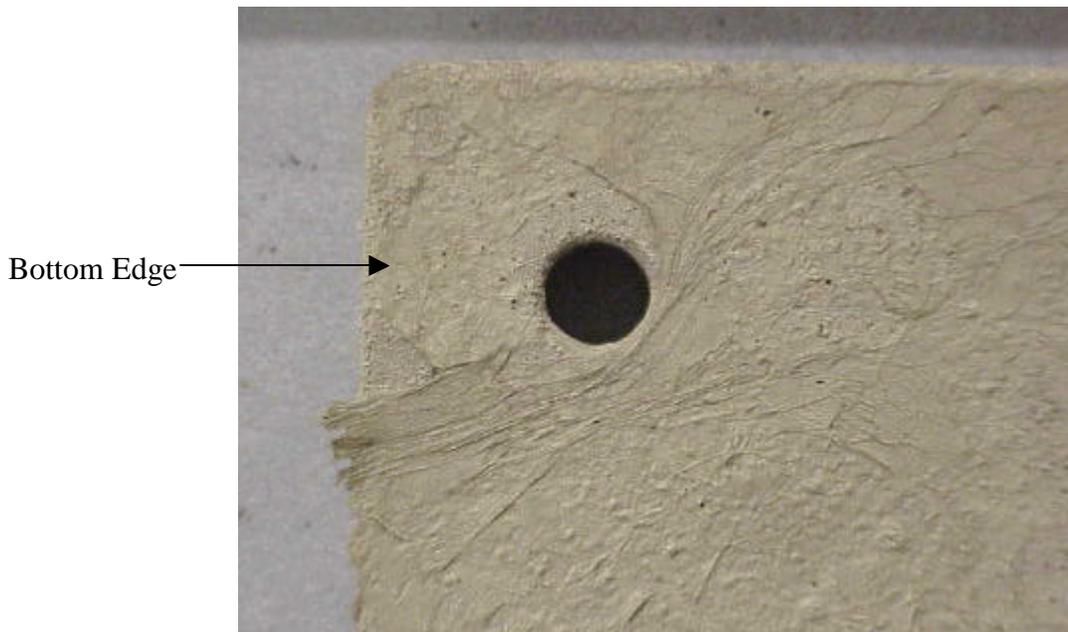
**Figure 3-28. Detail view of bottom of the irradiation-aged System 1 plate illustrating the sloughing of the topmost layer of the topcoat. The left side of the specimen, in this view, was placed down during testing. Note: The outermost layer of the topcoat has slipped beyond the edge of the plate.**

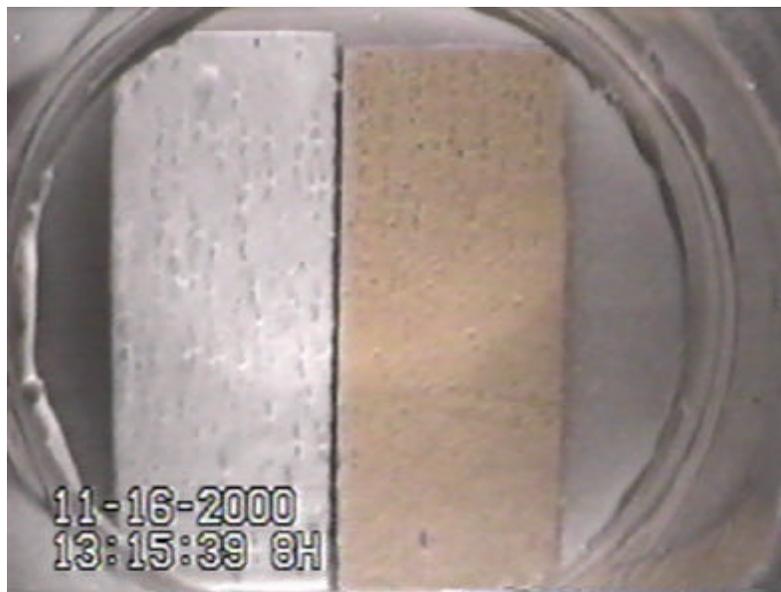
**Figure 3-30. System 1 specimens immediately after immersion in water preheated to 200° F; as-applied (left), irradiation-aged to  $1 \times 10^9$  rads @  $1 \times 10^6$  rad/hour and 120° F (right)**

3-33 below, which document blister formation and coating failure in a 200°F immersion test of irradiation-aged and non-aged System 1 coating specimens.

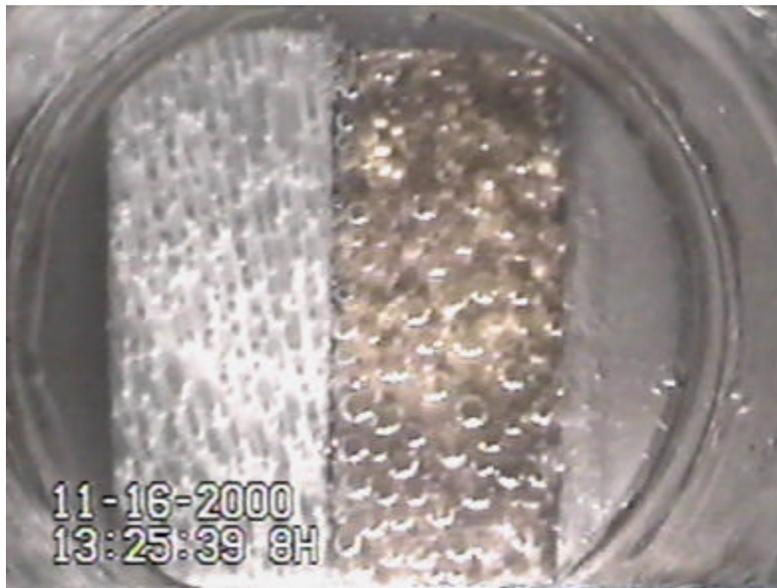
**Figure 3-31. System 1 specimens 10 minutes after immersion in water preheated to 200° F**

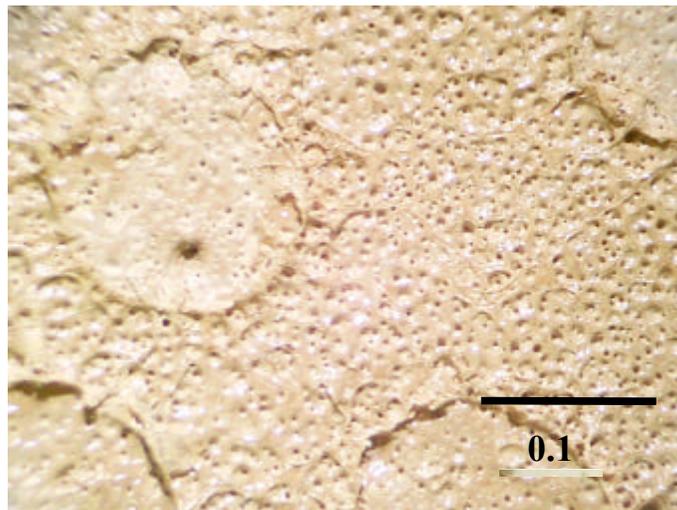
**Figure 3-32. Microscopic view of the surface of the irradiation-aged immersion test specimen illustrating the extent of blister formation and detachment. Note the presence of pores in the topcoat remnant. Original magnification 7X.**

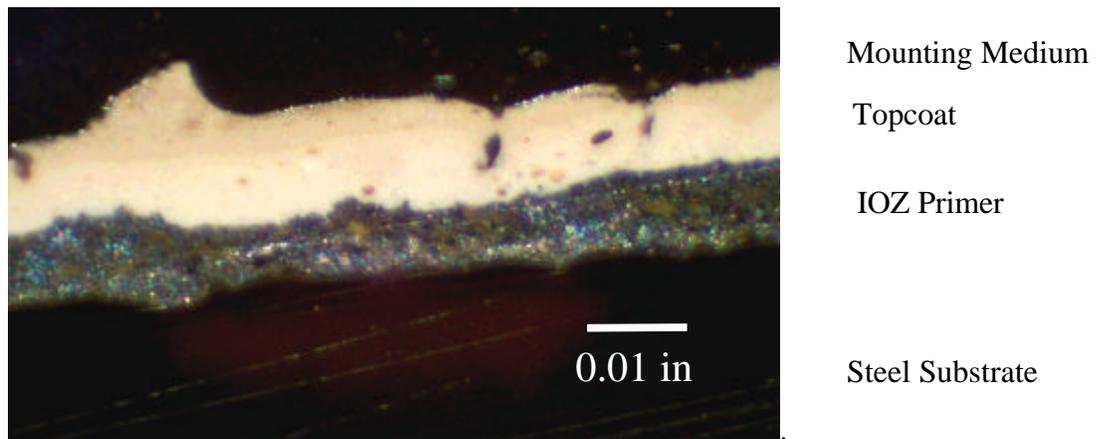
**Figure 3-33. Cross-section of the surface of the irradiation-aged immersion test specimen. Note the presence of pores in the topcoat remnant. Original magnification 45X.**

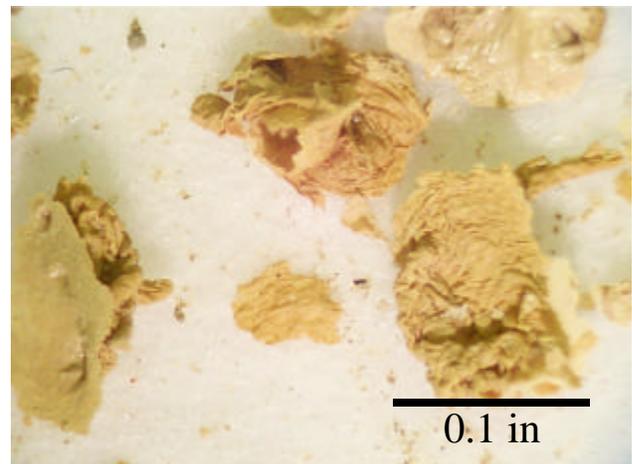
**Figure 3-34. Micrograph of typical debris particles generated from Phenoline® 305 in immersion testing. Original magnification approximately 7x**

omitted in this characterization technique, due to limitations in optical imagery (see Figure 3-34). To characterize the much greater number of smaller-diameter debris particles, an electrical sensing zone technique utilizing the Coulter Principle was employed to analyze a water sample containing debris generated during an immersion test of a System 1 plate specimen. The Coulter technique determines a size distribution of particles suspended in an electrically conductive liquid by measuring a change in current, which is proportional to the volume of the particle, as the particles are passed through an aperture.
