WSRC-TR-2001-00067

**Degradation and  
Failure Characteristics  
of NPP Containment  
Protective Coating Systems (U)  
Interim Report No. 3**

**SRTC Coating System No. 1**  
(Phenoline<sup>®</sup> 305 epoxy-phenolic topcoat,  
Carbozinc<sup>®</sup> 11 primer, carbon steel substrate)

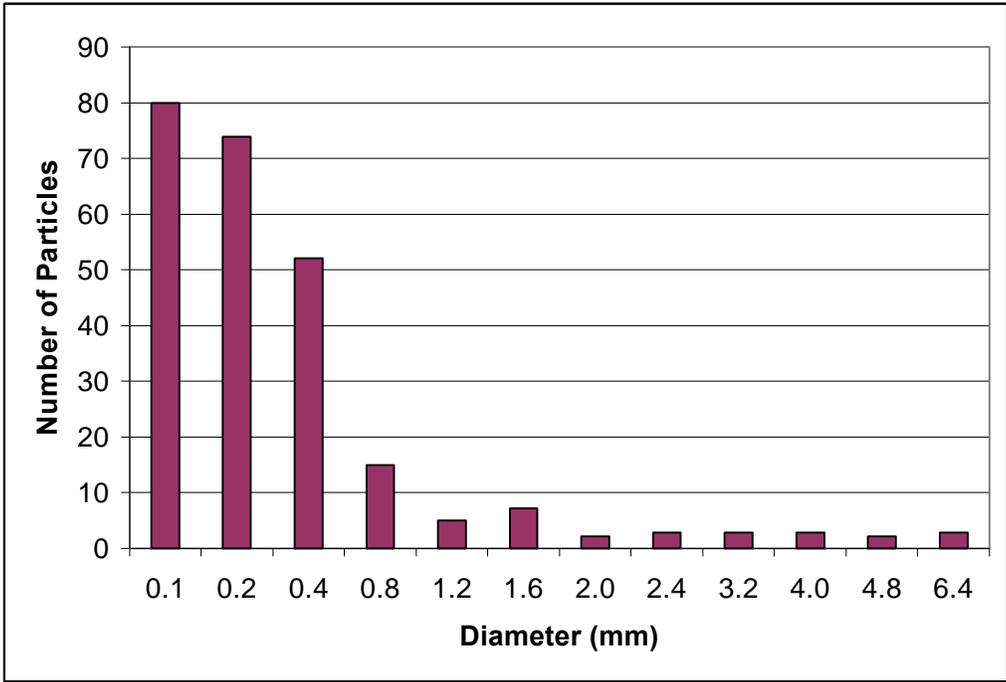
Figure 3-35. Histogram of larger debris generated in an immersion test of Phenoline<sup>®</sup> 305; debris size was measured optically

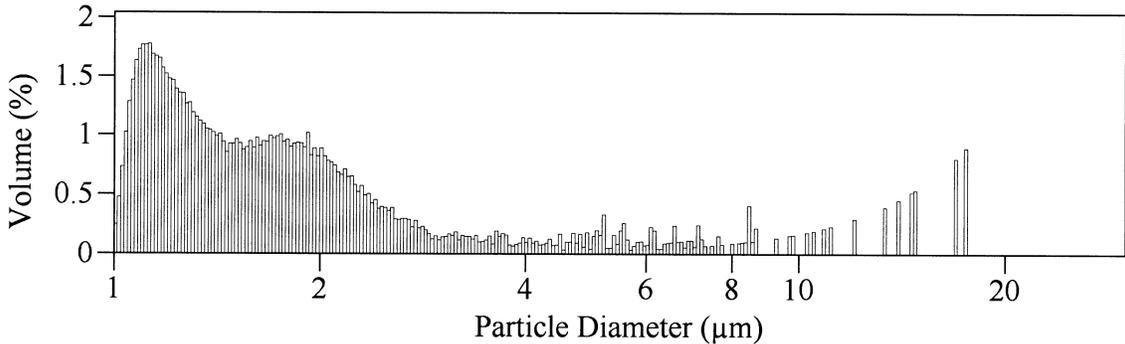
Figure 3-36. Histogram of small debris generated in an immersion test of Phenoline<sup>®</sup> 305; debris size was measured by Coulter counter

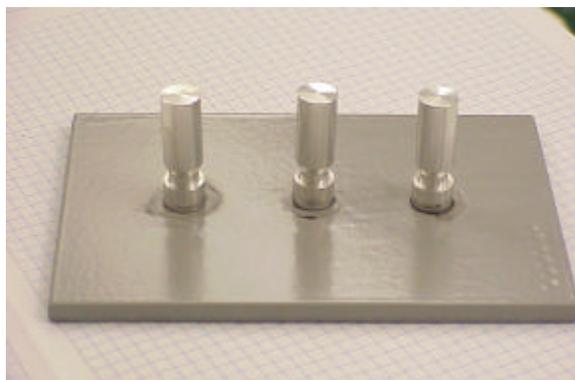
Figure A-1. Aluminum pullers as they appear affixed to a test coupon with epoxy adhesive

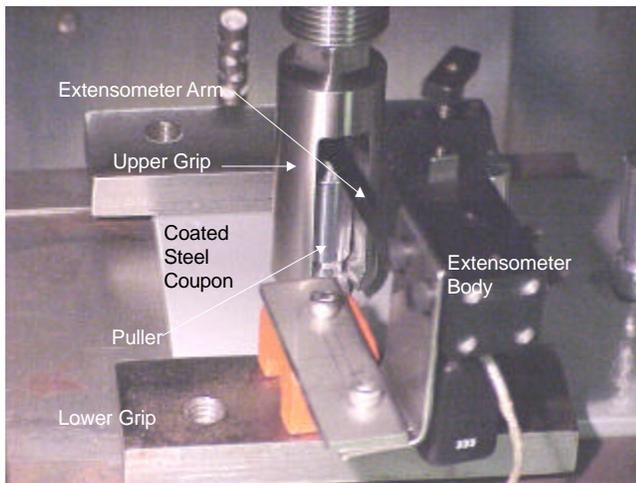
**Figure A-2. Extensometer and grip for aluminum puller**

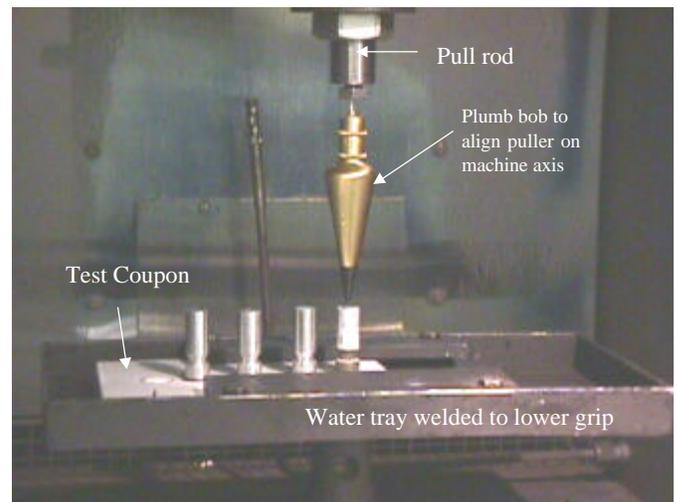
**Figure A-4. Plumb bob arrangement to locate center of puller on Instron load axis**

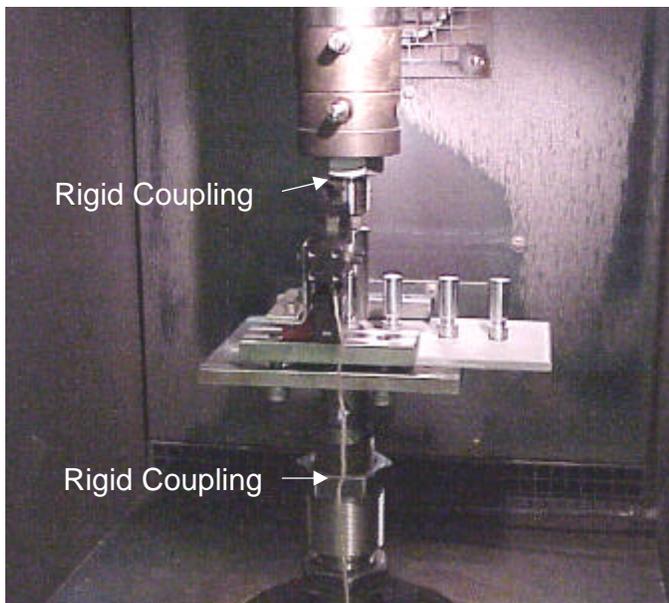
**Figure A-3. Rigid coupling of upper and lower grips to Instron**

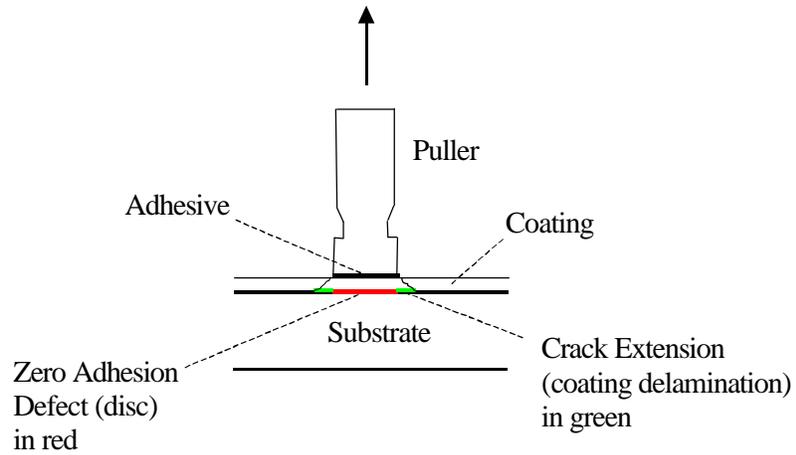
**Figure A-5. Schematic diagram of the adhesion G-value test**

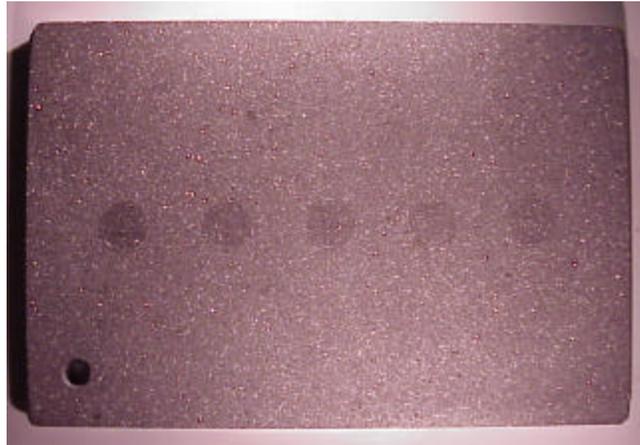
**Figure A-6. Overall view of a steel test plate illustrating placement of 12mm glass disks in machined recesses on the surface. Note: The plate has been prepared for coating by grit blasting.**

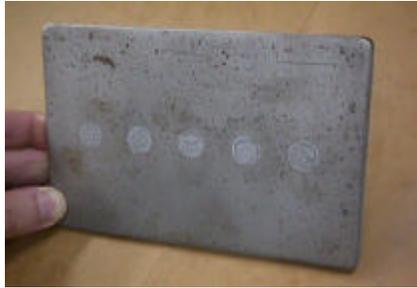
**Figure A-7. Photographic sequence illustrating alternative method of creating Type I zero-adhesion defects by applying PTFE spray onto the surface of the steel test specimen**

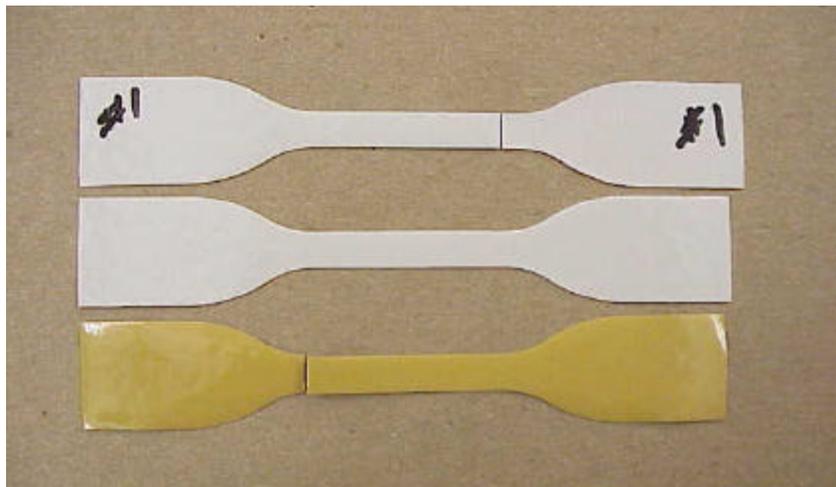
**Figure A-8. Tensile specimens of Phenoline 305<sup>0</sup>, as cured (above) and irradiated and tested to failure (below). Note minor changes in specimen length observed as a consequence of test conditions.**

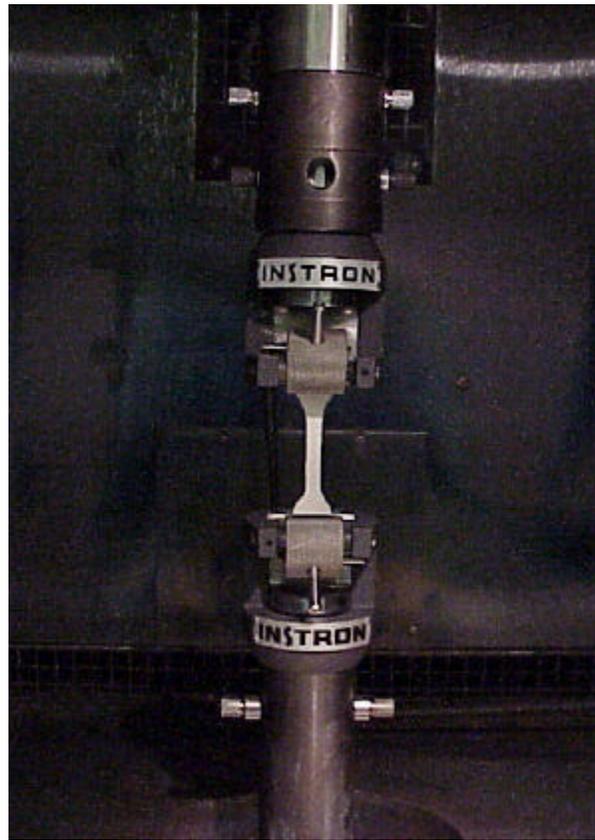
**Figure A-9. Tensile specimen fixed in knurled grips**

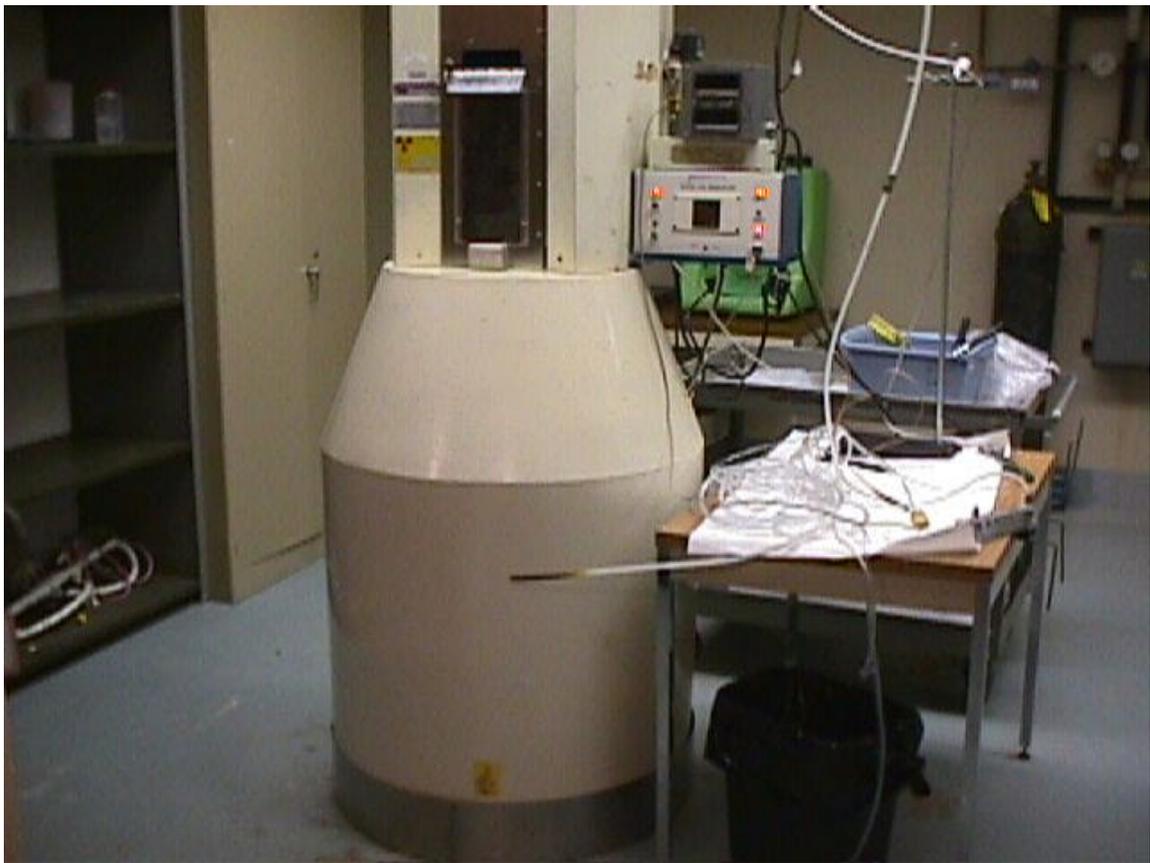
**Figure B-1. GammaCell 220**

There are two sources available for irradiation exposure. One is a Gammacell 220 (Figure B-1) with a current dose rate of  $2.32 \times 10^4$  R/hr. The second source is a J.L. Shepherd Model 109 Irradiator, with a current dose rate of  $1.27 \times 10^6$  R/hr. Both of these are gamma irradiators with Co-60 as the isotope. The chamber size of both sources is 6" diameter by 7.5" high. Auxiliary systems to raise or lower ambient temp and to introduce air or gas or chemicals to the system can be added.

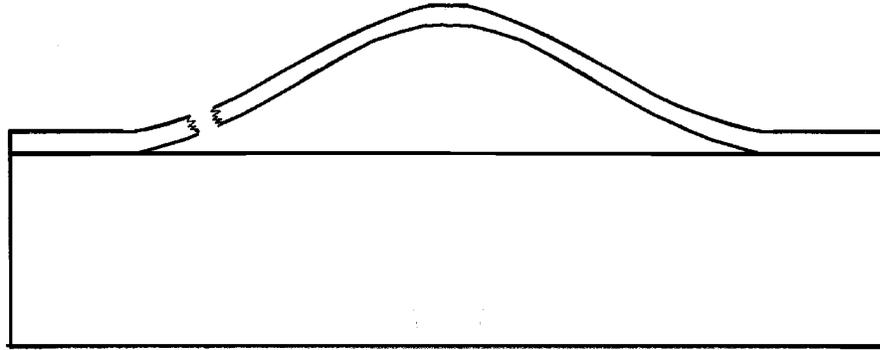
Figure C-2. Mode 1 Coating Failure

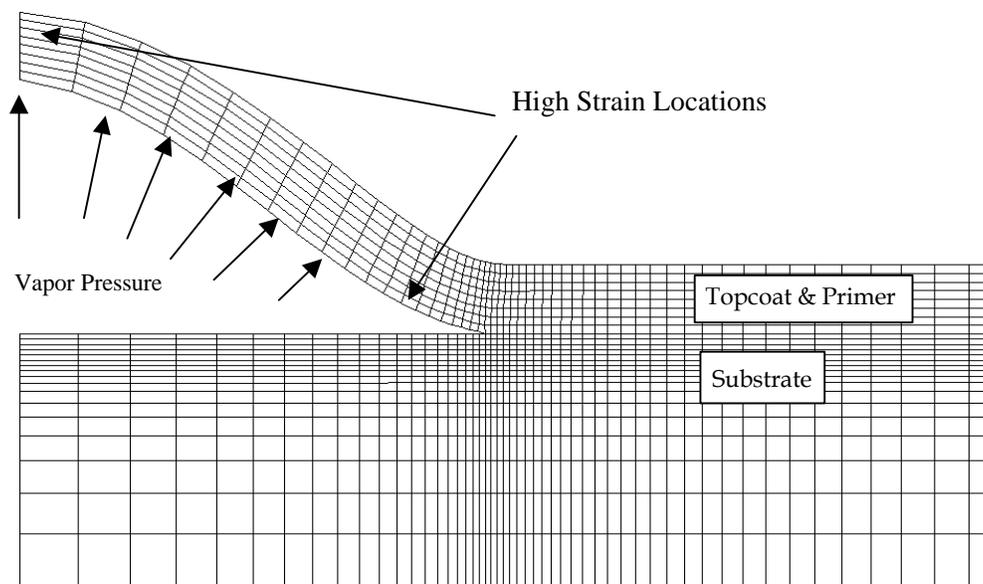
Figure C-3. Blistering due to buckling and/or vapor pressure loading

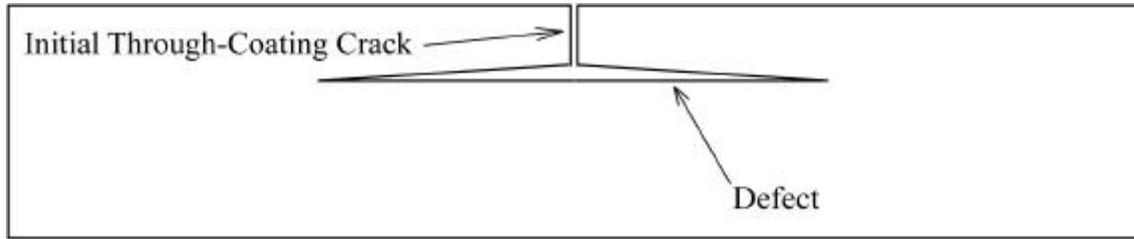
Figure C-4. Model for Mode 2 Coating Defect Analysis

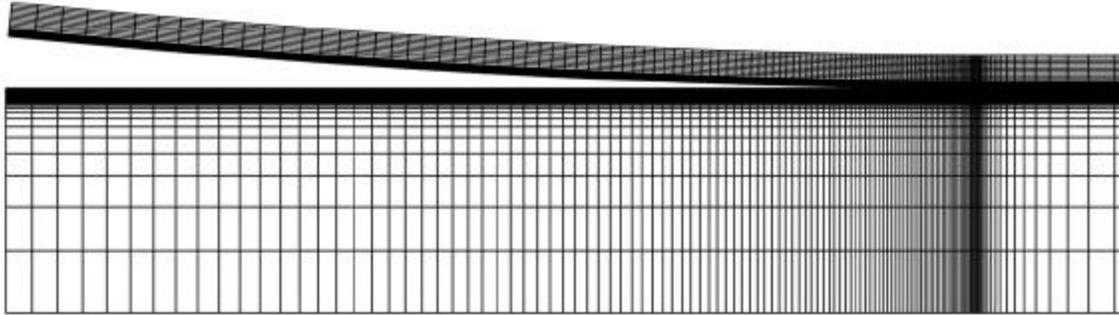
Figure C-5. Peel-Back due to thermal expansion mismatch ( $\alpha_{\text{topcoat}} < \alpha_{\text{primer}}$ )

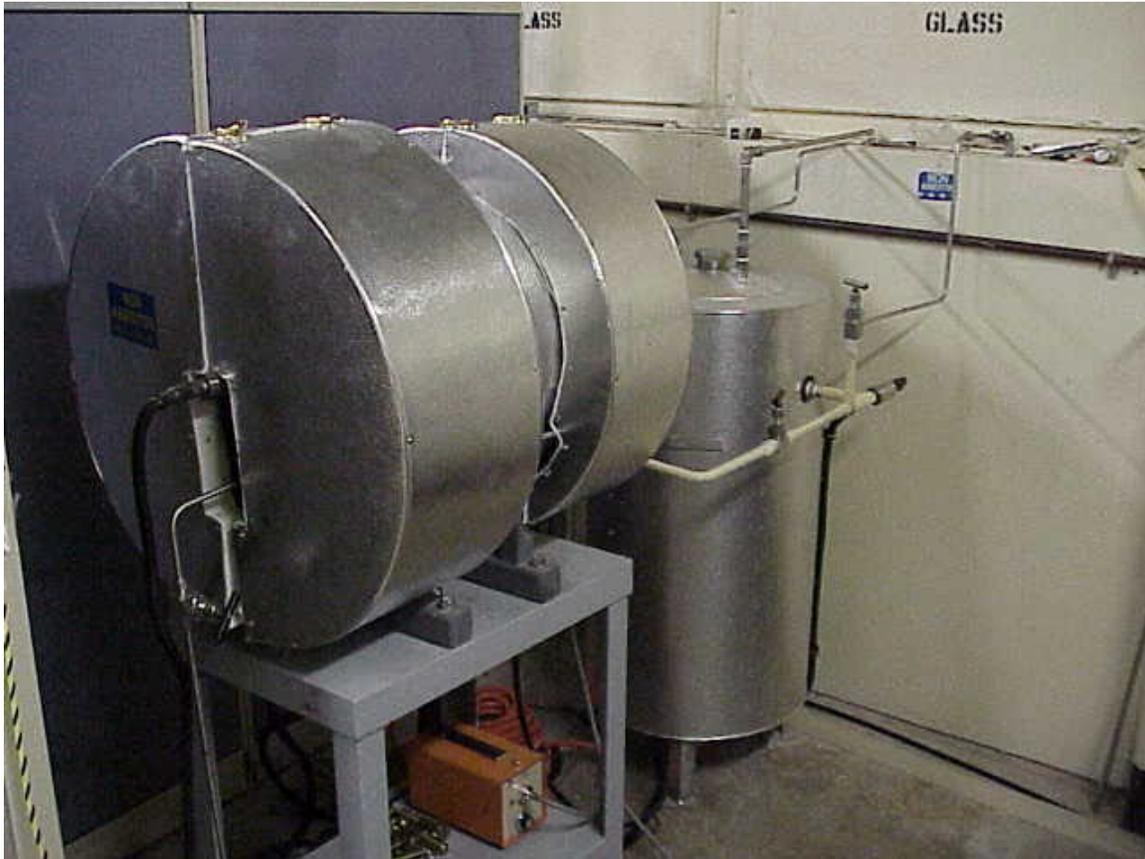
**Figure D-1. SRTC Coatings Performance Evaluation System. Insulated environmental test chamber is shown on the left, the 10 gallon steam generator is on the right.**

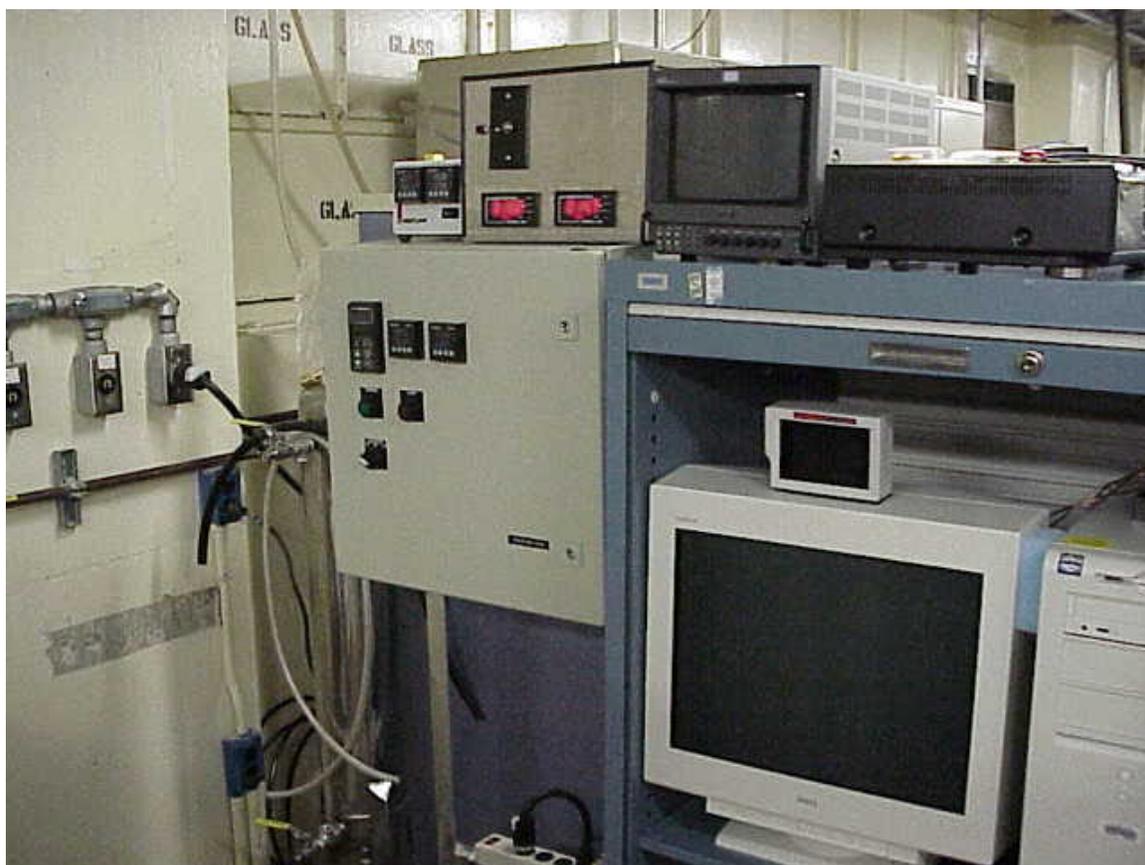
**Figure D-2. Overall view of the heater control console and the video monitoring and data acquisition systems for the SRTC Coatings Performance Evaluation System**

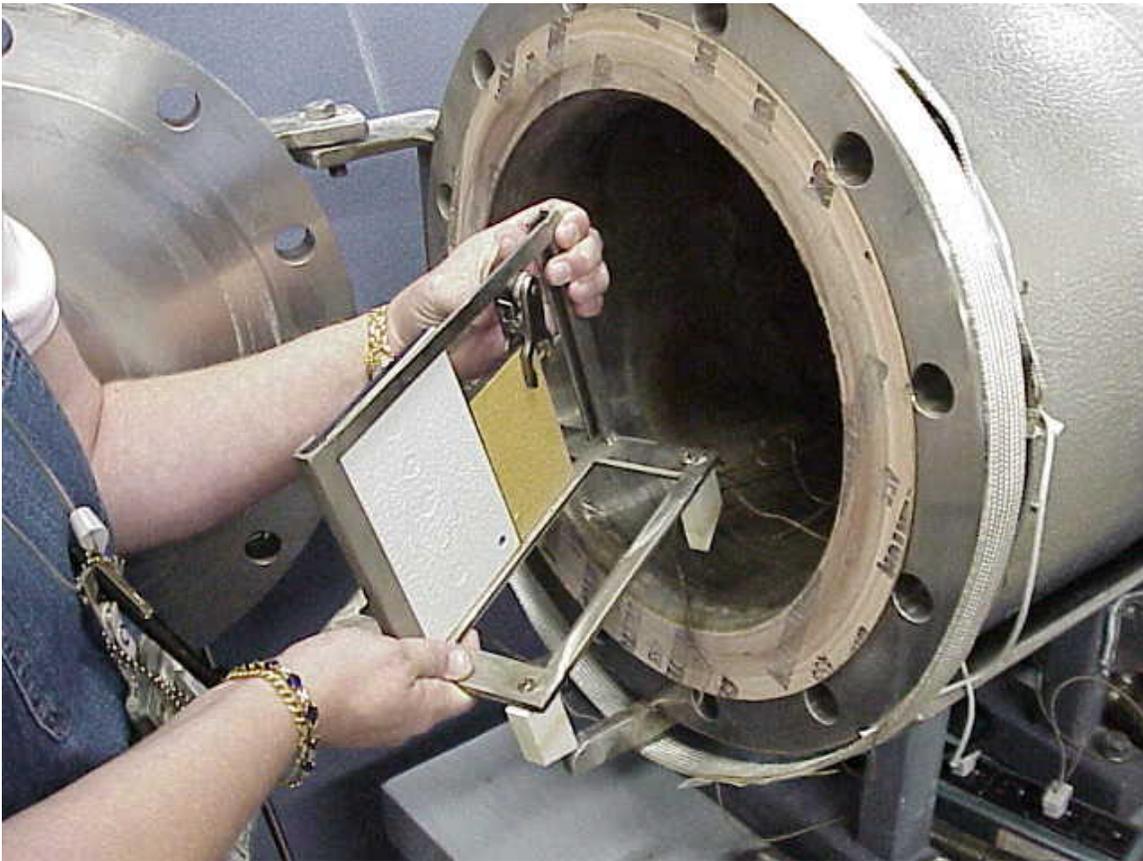
Figure D-3. Test Specimen being placed into the Coatings Performance Evaluation System

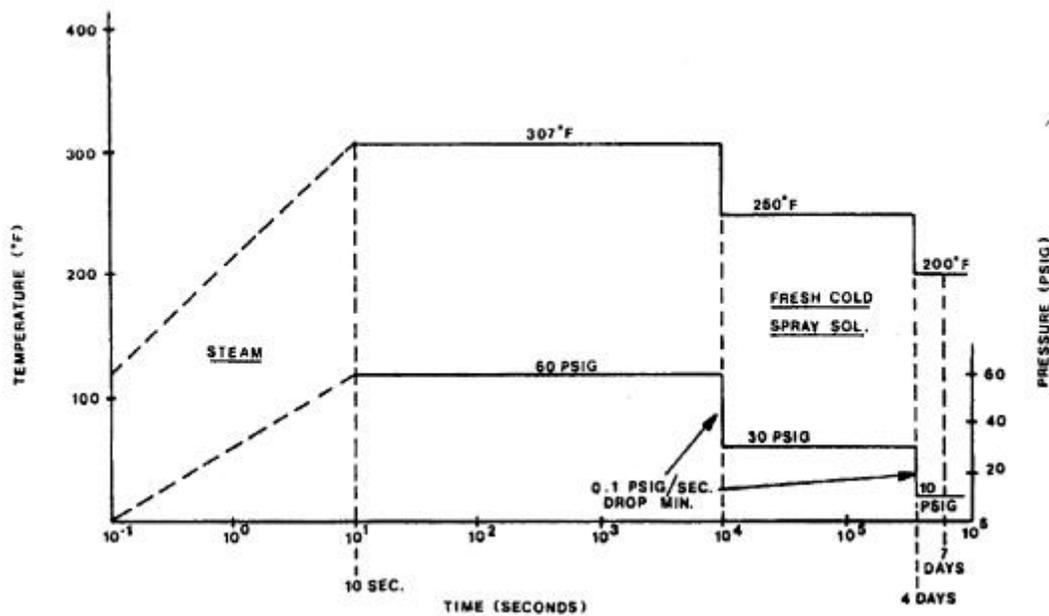
Figure D-4. Typical Pressurized Water Reactor Design Basis Accident (DBA) Testing Parameters (from ASTM D3911-95). (Note: The ASTM figure contains an error: 30 psig should be 15 psig, which is equivalent to 30 psia).

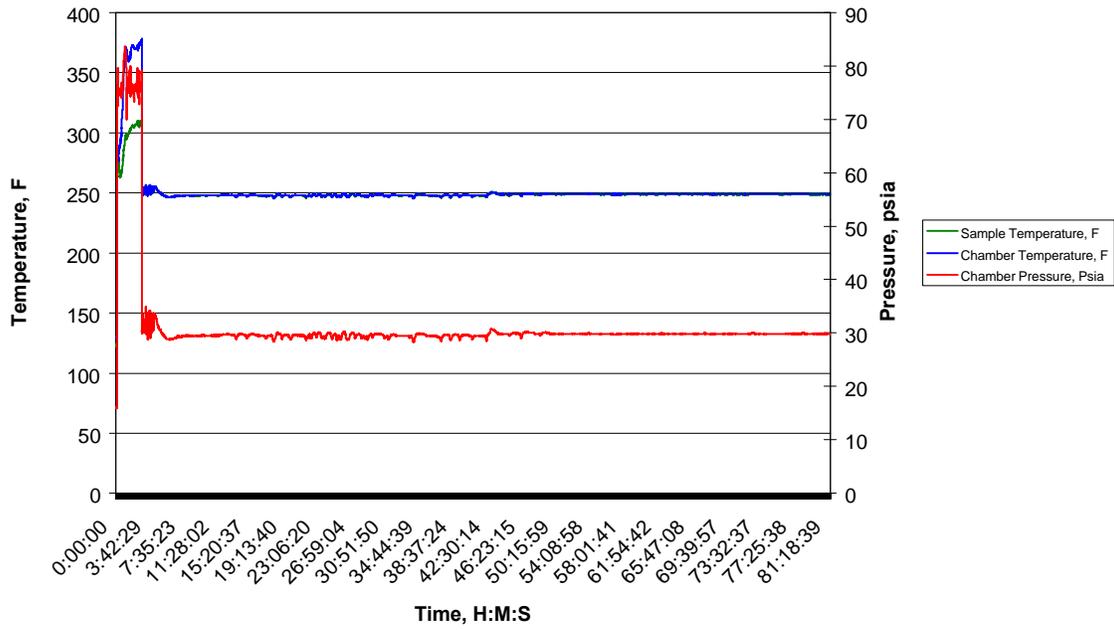
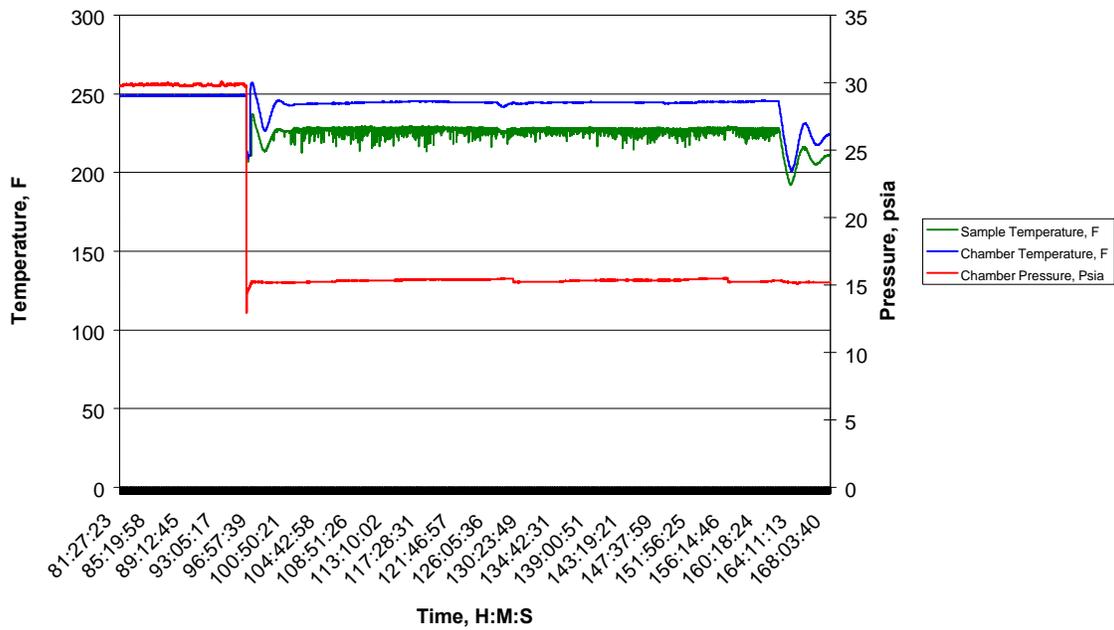
**Figure D-5. Typical SRS DBA Test Cycle**

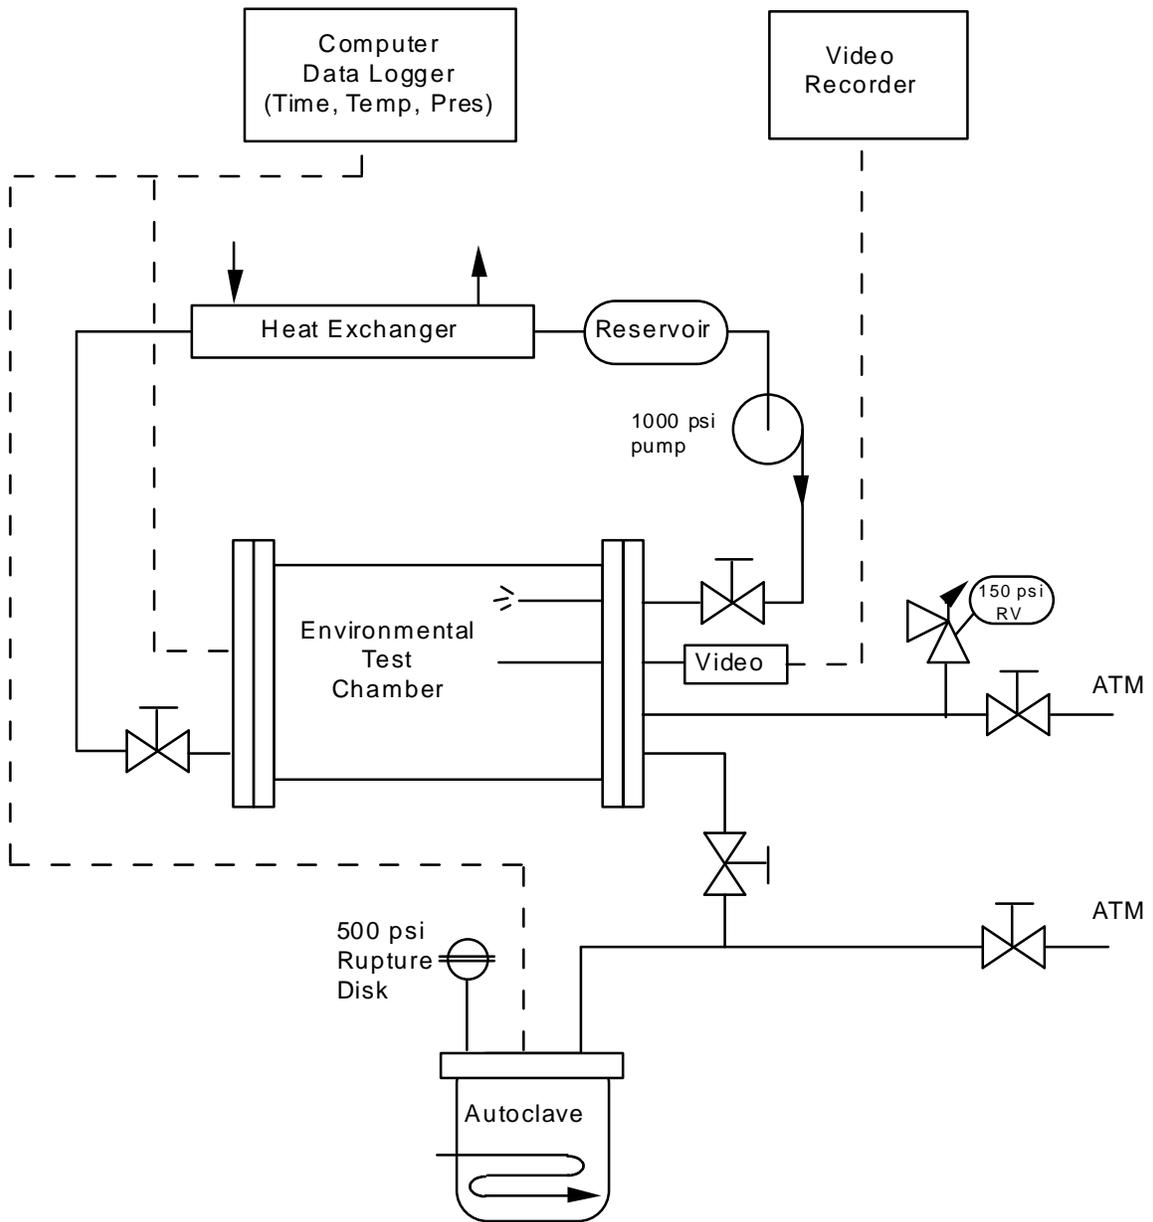
Figure D-6. Process schematic of coatings performance evaluation system

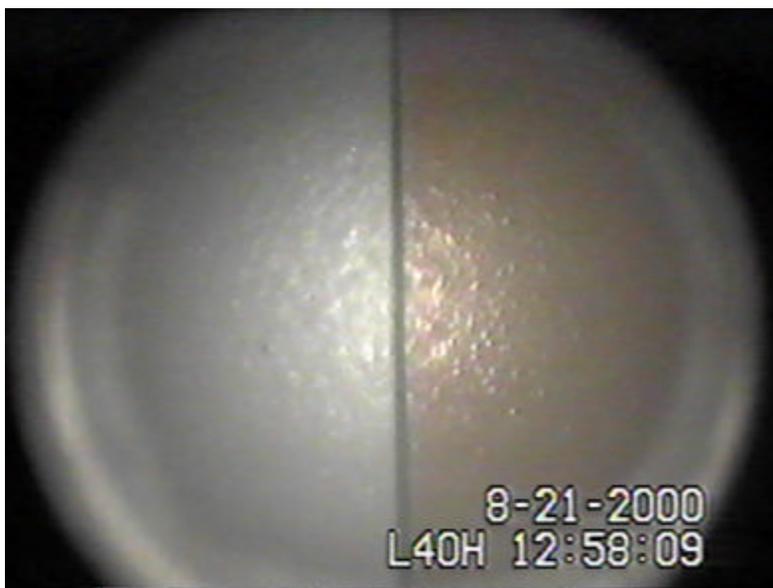
**Figure D-7. Video Borescope Image of Non-Aged (left) and Aged (right) System 1 Specimens**

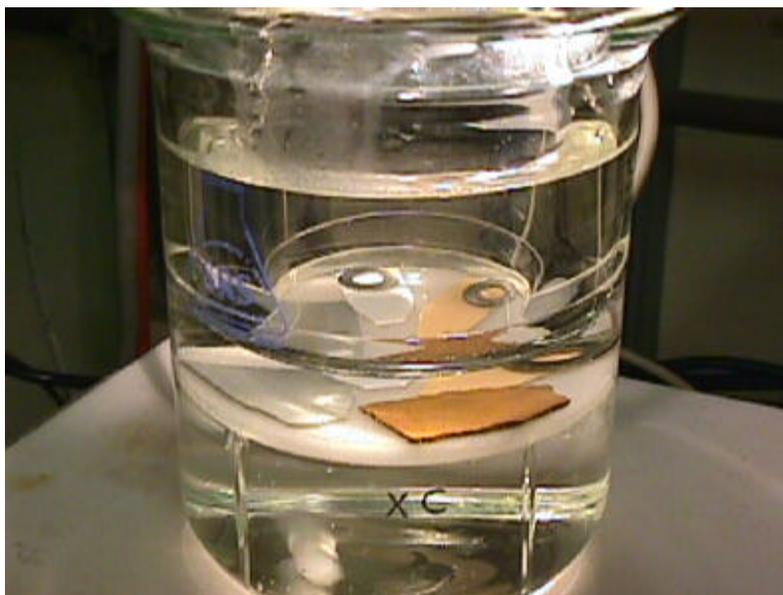
**Figure D-8. Overall view of soak test vessel. The vessel is placed on a thermostatically controlled hotplate. Note coating specimens placed on permeable glass frit stage. A magnetic stirring bar is visible on the bottom of the vessel.**

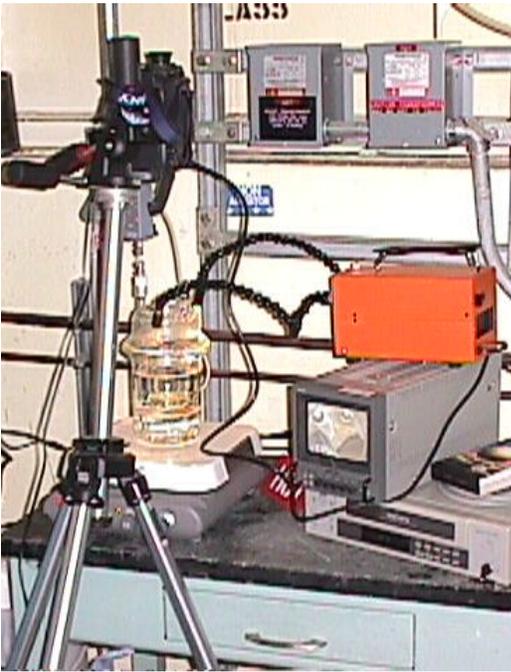
**Figure D-9. Overall view of soak test system, illustrating video camera (on tripod), fiberoptic lighting system (orange box), time-lapse video recorder, and video monitor**

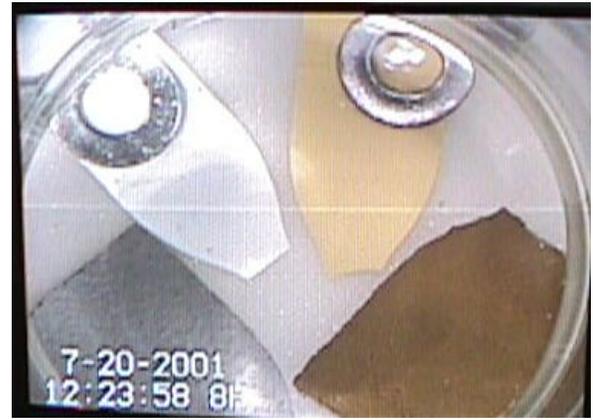
**Figure D-10. Video image of specimens at the beginning of testing, as recorded**

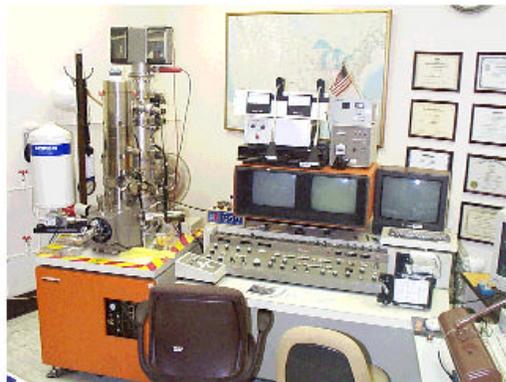
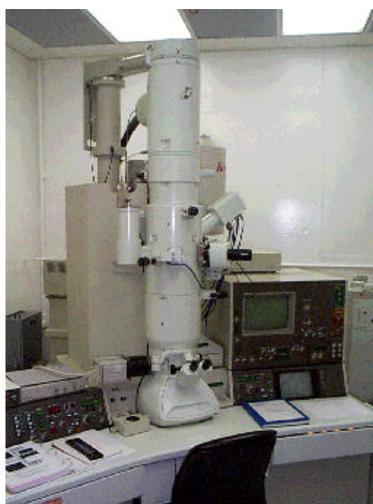
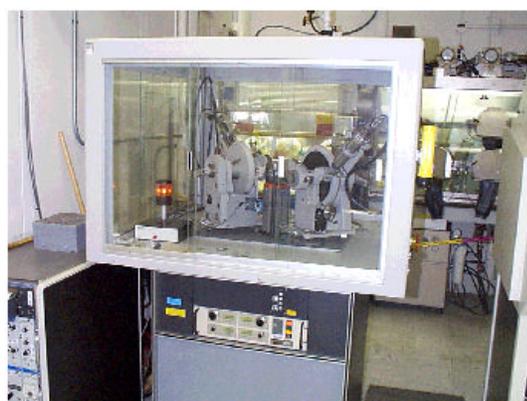
**Figure F-1. SRTC Analytical Capabilities: Scanning Electron Microscope (top), Transmission Electron Microscope (middle), and X-ray Diffraction Unit (bottom)**

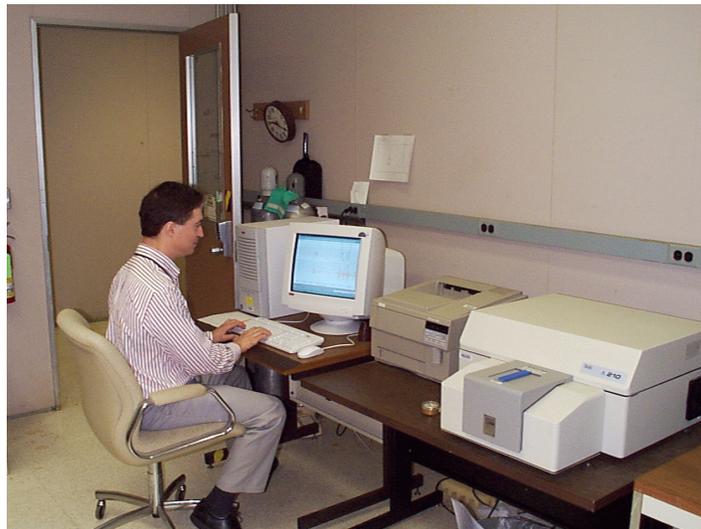
**Figure F-2. FT-IR Spectrophotometry Equipment**

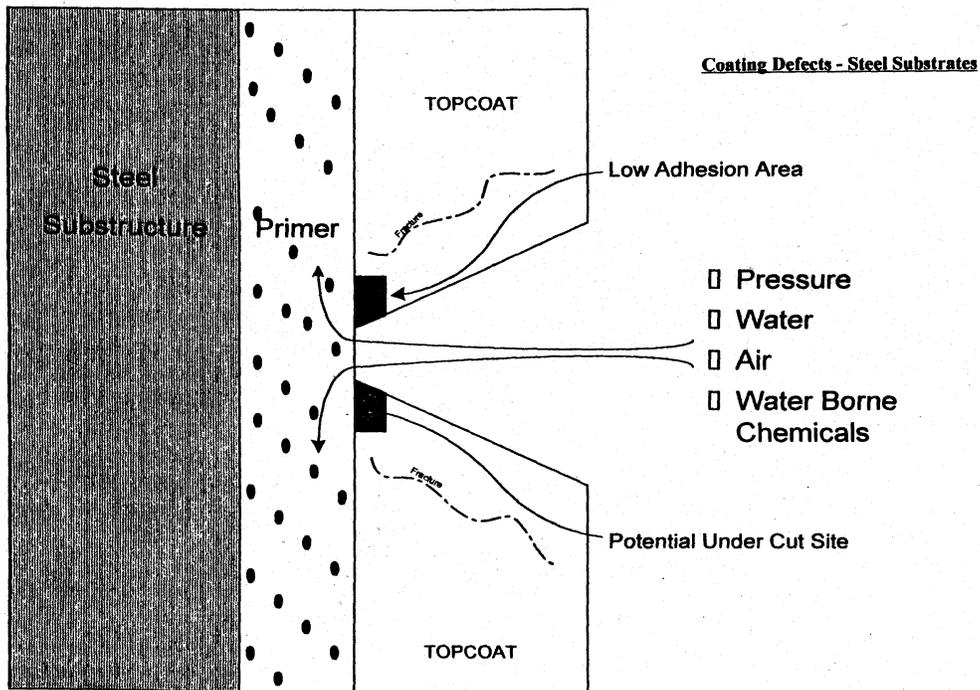
Figure G-2. Coating Defects and Phenomena of Importance
