Re: Kaiser Tulsa Adjacent Land Remediation Modification of Approved Adjacent Land Remediation Plan

February 16, 2001  
Project No. 5427F-01

### Buried Spillway

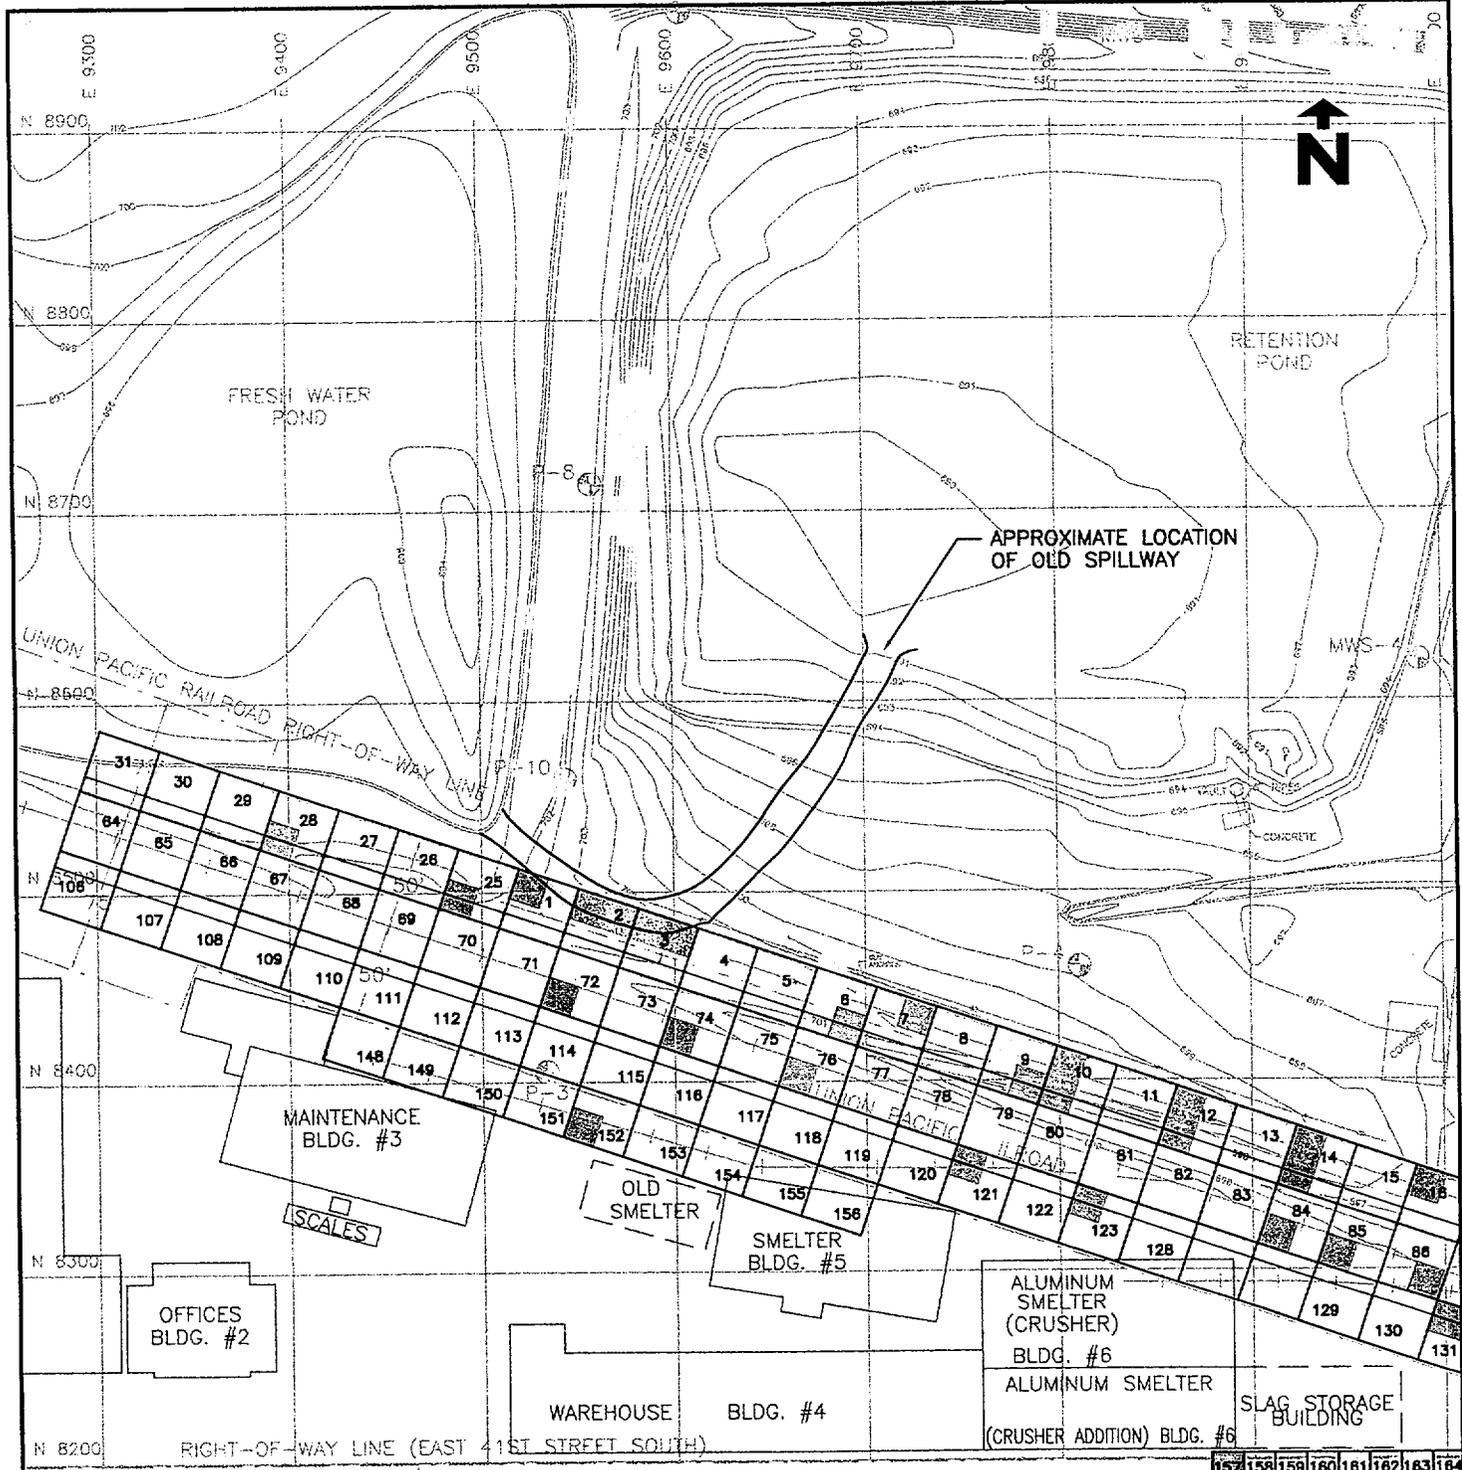
FIGURE 1  
INTERPRETED SPILLWAY LOCATION

Earth Sciences Consultants, Inc.'s interpretation of the approximate location of the buried spillway was overlaid on the site characterization map. The area in question is shown in the enclosed Figure 1. As shown in this figure, the spillway lies primarily on Kaiser Aluminum & Chemical Corporation (Kaiser) property but does intersect adjacent area Grids 1, 2, 3, and 4.

Specifically, we recommend that remediation proceed in the southern two quadrants of Characterization Grids 1 through 4. The remaining northern quadrants of Characterization Grids 1 through 4, which are located within the spillway, will be addressed during the on-site remediation activities. This approach is more realistic since water levels in the two on-site ponds may be lowered by closure of the Fresh Water Pond and/or other methods as part of the on-site decommissioning effort. We expect that this will alleviate the current difficulties associated with this area.
