Experiments With VVER Fuels to Confirm Safety Criteria

Zoltán Hózer, László Maróti, Lajos Matus, Péter Windberg
KFKI Atomic Energy Research Institute
H-1525 Budapest, P.O.Box 49, Hungary

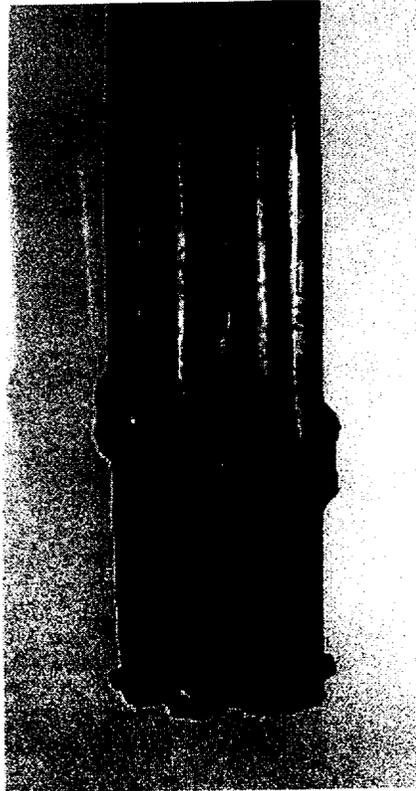
Fig.7.a
7-rod ballooning test in argon, 20 bar
initial pressure

After the tests the bundles were filled up with epoxy and several cross sections were prepared from each bundle for post-test examination (Fig. 8.a and 8.b). The axial distribution of deformation of each rod of each bundle was measured. The typical blockage rate (which shows the cross section reduction compared to the nominal value) was between 40-50% and the maximum was below 80%. The ballooning took place on the hottest 4-5 cm long part of the bundle (Fig. 7.a and 7.b).
