TABLE OF CONTENTS

1. PURPOSE

This report describes the Type B test results for the Model 702 transport package. These tests were performed in accordance with Test Plan 81 and were conducted April 9 through 15, 1999. The Test Plan specified testing necessary to demonstrate compliance with the requirements in 10 CFR Part 71 and IAEA Safety Series No. 6 (1985 as amended 1990) for "Normal Conditions of Transport" and "Hypothetical Accident Conditions." Evaluation of the compliance of the Model 702 with these requirements is provided in the Safety Analysis Report (SAR).

Three copies of the final Test Plan 81 Report, Model 702, Type B(U) Transport Package are enclosed. This version of the report incorporates the documentation missing from our May 14 draft report.

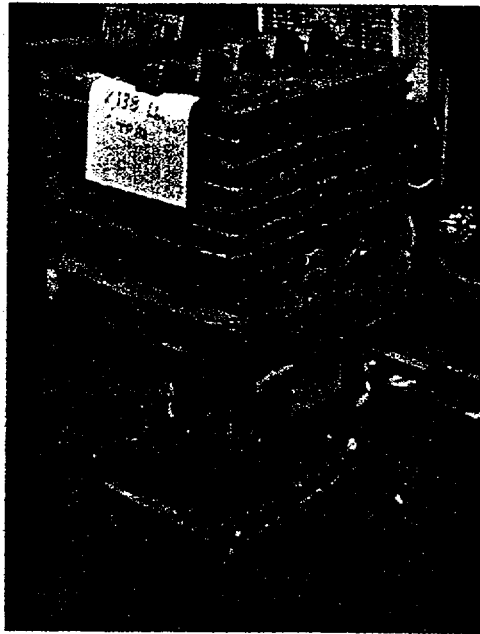
TP81(A) Compression Test Setup

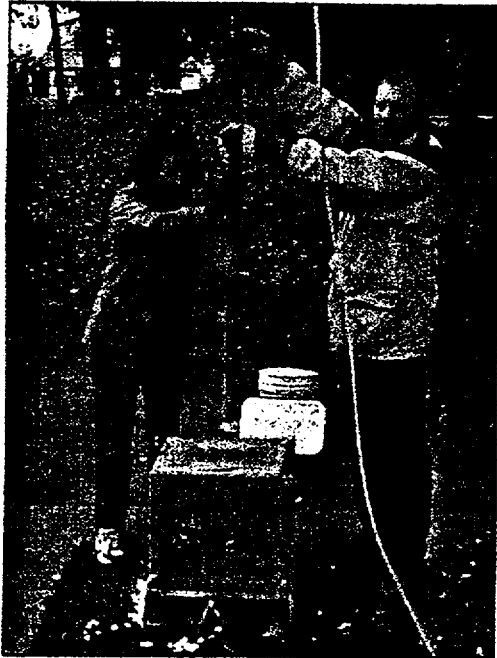
TP81(A) Penetration Test Setup

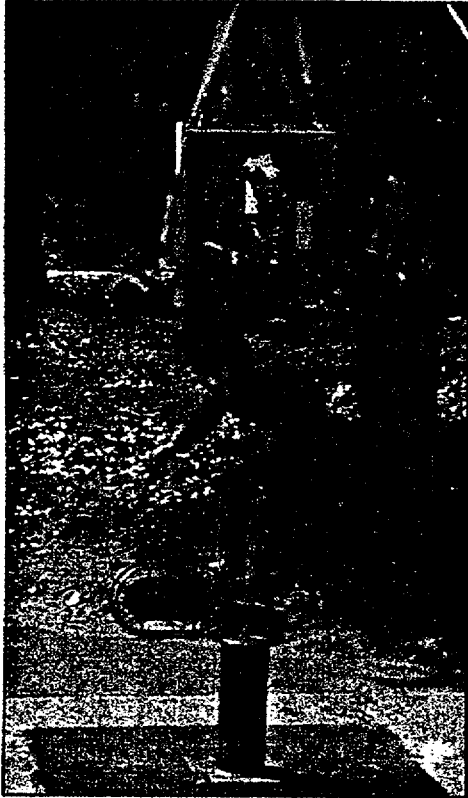
TP81(C) Puncture Test Setup
