H. B. ROBINSON STEAM ELECTRIC PLANT, UNIT NO. 2
DOCKET NO. 50-261/LICENSE NO. DPR-23

SUPPLEMENTAL INFORMATION REGARDING
NRC BULLETIN 2001-01, "CIRCUMFERENTIAL CRACKING OF
REACTOR PRESSURE VESSEL HEAD PENETRATION NOZZLES"

SUPPLEMENTAL INFORMATION REGARDING
NRC BULLETIN 2001-01, "CIRCUMFERENTIAL CRACKING
OF REACTOR PRESSURE VESSEL HEAD PENETRATION NOZZLES"

DETAILED CHRONOLOGY OF REACTOR PRESSURE VESSEL
HEAD EXAMINATIONS PERFORMED DURING REFUELING OUTAGE 20

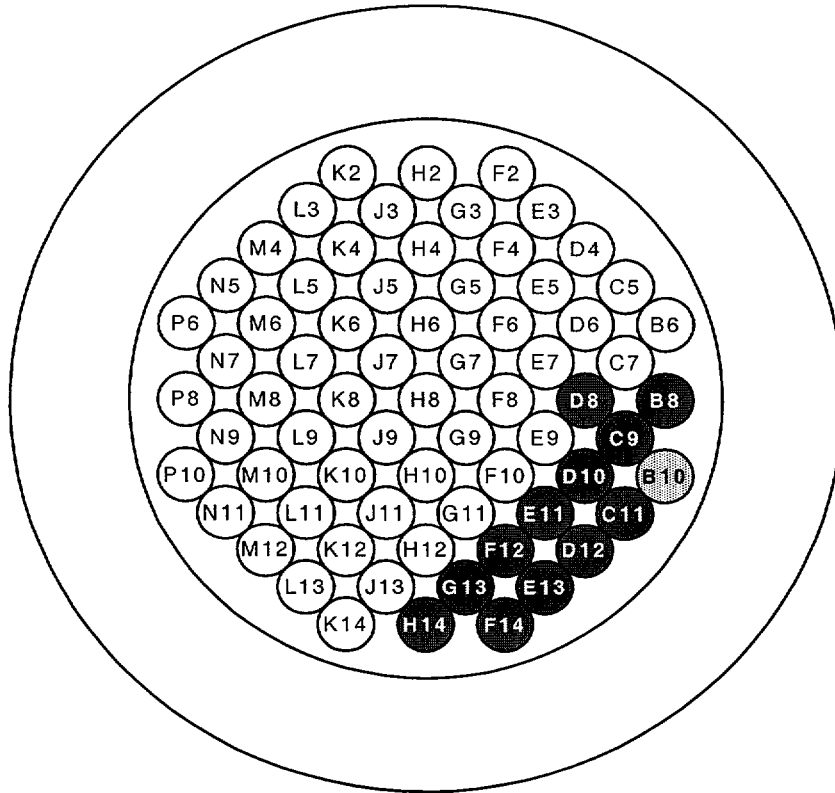
Figure 3

The shaded locations designate the area of VT-2 visual examination on April 15, 2001, where mapping of boric acid deposition was performed. This mapping included examination for evidence of leakage attributable to VHP nozzles. Examination activities were performed with RPV insulation removed from the affected area and were performed prior to cleaning or decontamination activities.

- April 15, 2001 The RPV head lower shroud was partially removed and metallic thermal insulation was removed from areas exposed to boric acid. This included an area approximately two feet wide by seven feet long. As shown on Figure 3, this included CRDM locations D8, B8, C9, D10, E11, F12, G13, H14, B10, C11, D12, E13, and F14. Subsequently, a VT-2 visual examination was completed by QC personnel to map the boric acid deposition on the RPV head. Specific orientation, related to the type of boric acid deposition associated with vessel head penetration (VHP) nozzle leakage identified at Oconee Nuclear Station Unit 3 (ONS3), was given to these personnel prior to the examination. The observed boric acid deposition on the RPV was recorded and attributed to leakage flowing onto the RPV head from the CRDM location B10 canopy seal weld above. No deposition or evidence of leakage was identified that could be attributed to leakage or degradation of the VHP nozzle welds or Alloy 600 material. Following completion of this examination, actions were initiated to clean the affected area (Figure 3) in preparation for base metal examinations to determine whether the boric acid deposition had resulted in corrosion or wastage.

- April 16, 2001 Cleaning of the affected RPV head areas (Figure 3) was completed without removal of additional insulation. Additionally, a VT-2 visual examination was completed by QC personnel to examine the affected area. This examination was focused on determining if corrosion damage was present on the RPV head or other components that may have been subjected to boric acid deposition. Scattered areas of light to medium rust were noted, with no evidence of metal loss or pitting detected. The area of interface between the reactor vessel head and CRDM nozzles was inspected with no distorted metal or discoloration noted.

- The area depicted in Figure 3, which was inspected on April 15, 2001, prior to cleaning or decontamination activities, was again examined. Each VHP nozzle was inspected to the extent necessary to ascertain that no upward boron leakage pattern existed as seen within the ONS3 videotape. No metal discoloration or new boron deposition was identified.

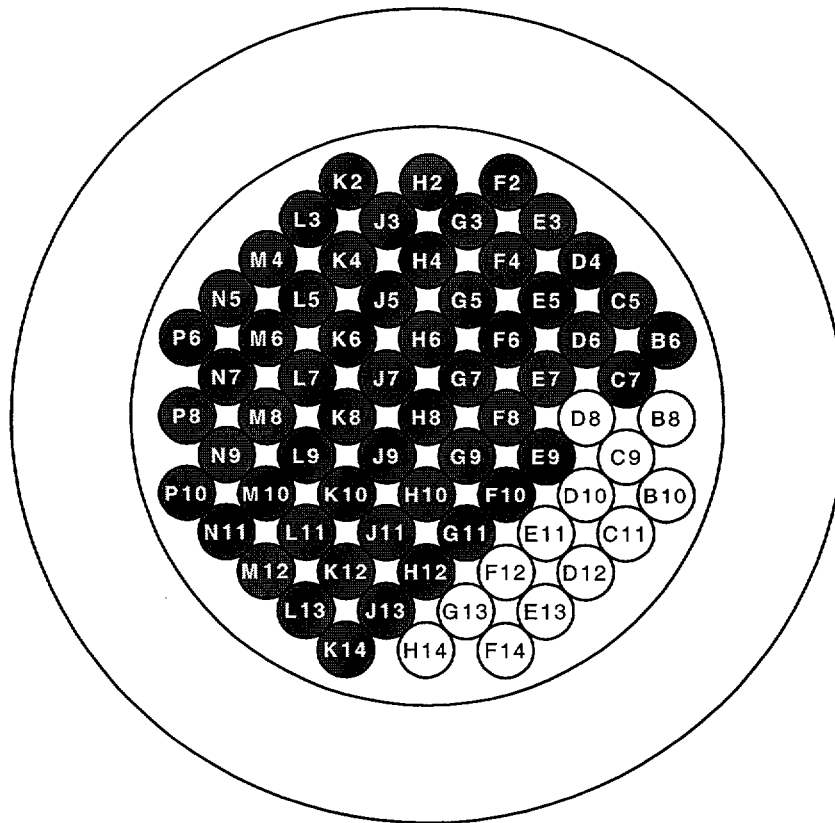
Figure 4

The shaded locations designate the area of VT-2 visual examination performed on April 19, 2001, to address concerns regarding VHP nozzle cracking. Examinations were performed with RPV head insulation removed and prior to cleaning or decontamination activities. These examinations were effective in distinguishing sources of boric acid deposition and confirmed that no evidence of VHP nozzle leakage or reactor coolant system pressure boundary leakage existed.

- April 18, 2001 Based on information received from NRC and the Nuclear Energy Institute (NEI) regarding VHP nozzle cracking, the decision was made to remove the remaining RPV head insulation (Figure 4) and perform a VT-2 visual examination of the entire RPV head. This examination was focused on identifying evidence of leakage or degradation of the VHP nozzles or Alloy 600 material.

- April 19, 2001 The remaining RPV head insulation was removed. Subsequently, QC personnel completed a VT-2 visual examination of the CRDMs and RPV head. Specific orientation, related to the type of boric acid deposition associated with VHP nozzle leakage identified at ONS3, was given to these personnel prior to the examination. This examination was performed prior to cleaning or decontamination activities for the area depicted in Figure 4. No evidence of VHP nozzle leakage or reactor coolant system pressure boundary leakage was identified.
