Attachment 3
Site Inspection Roster for Site Inspection Conducted August 16, 2001
Homestake Mining Company Superfund Site

Attachment 4
Site Inspection Photographs

Homestake Mining Company Five-Year Review, Site Inspection Photograph Log

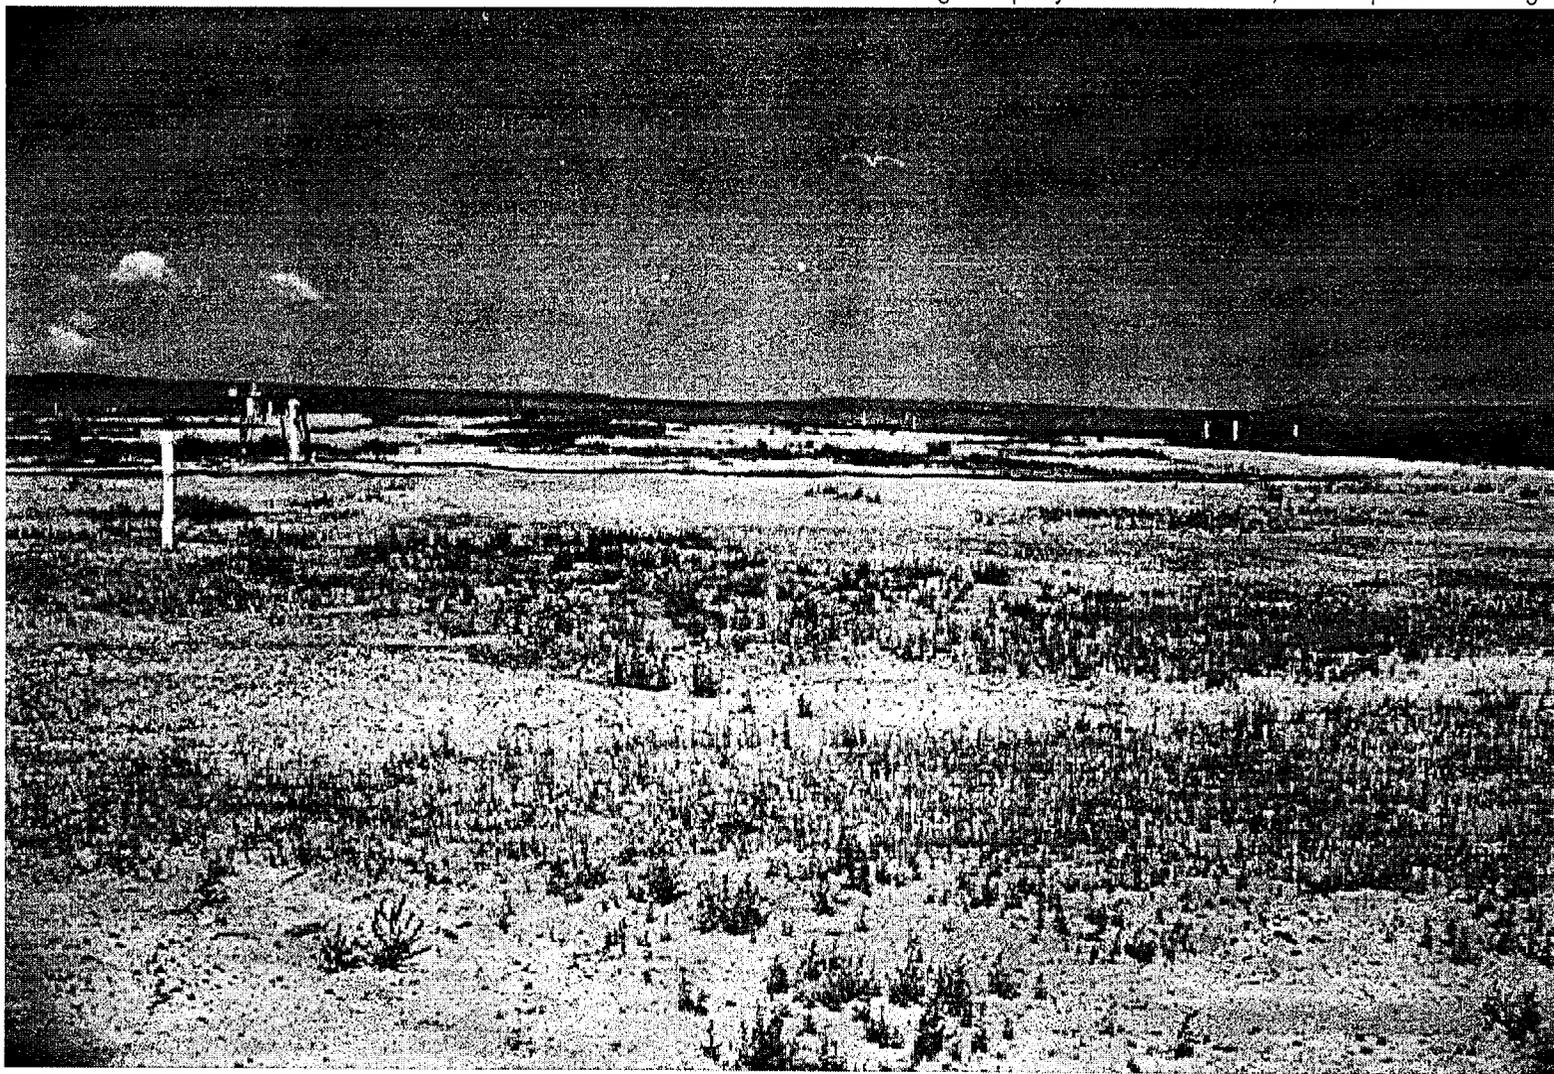
View across top of large tailing pile temporary cover, facing west.

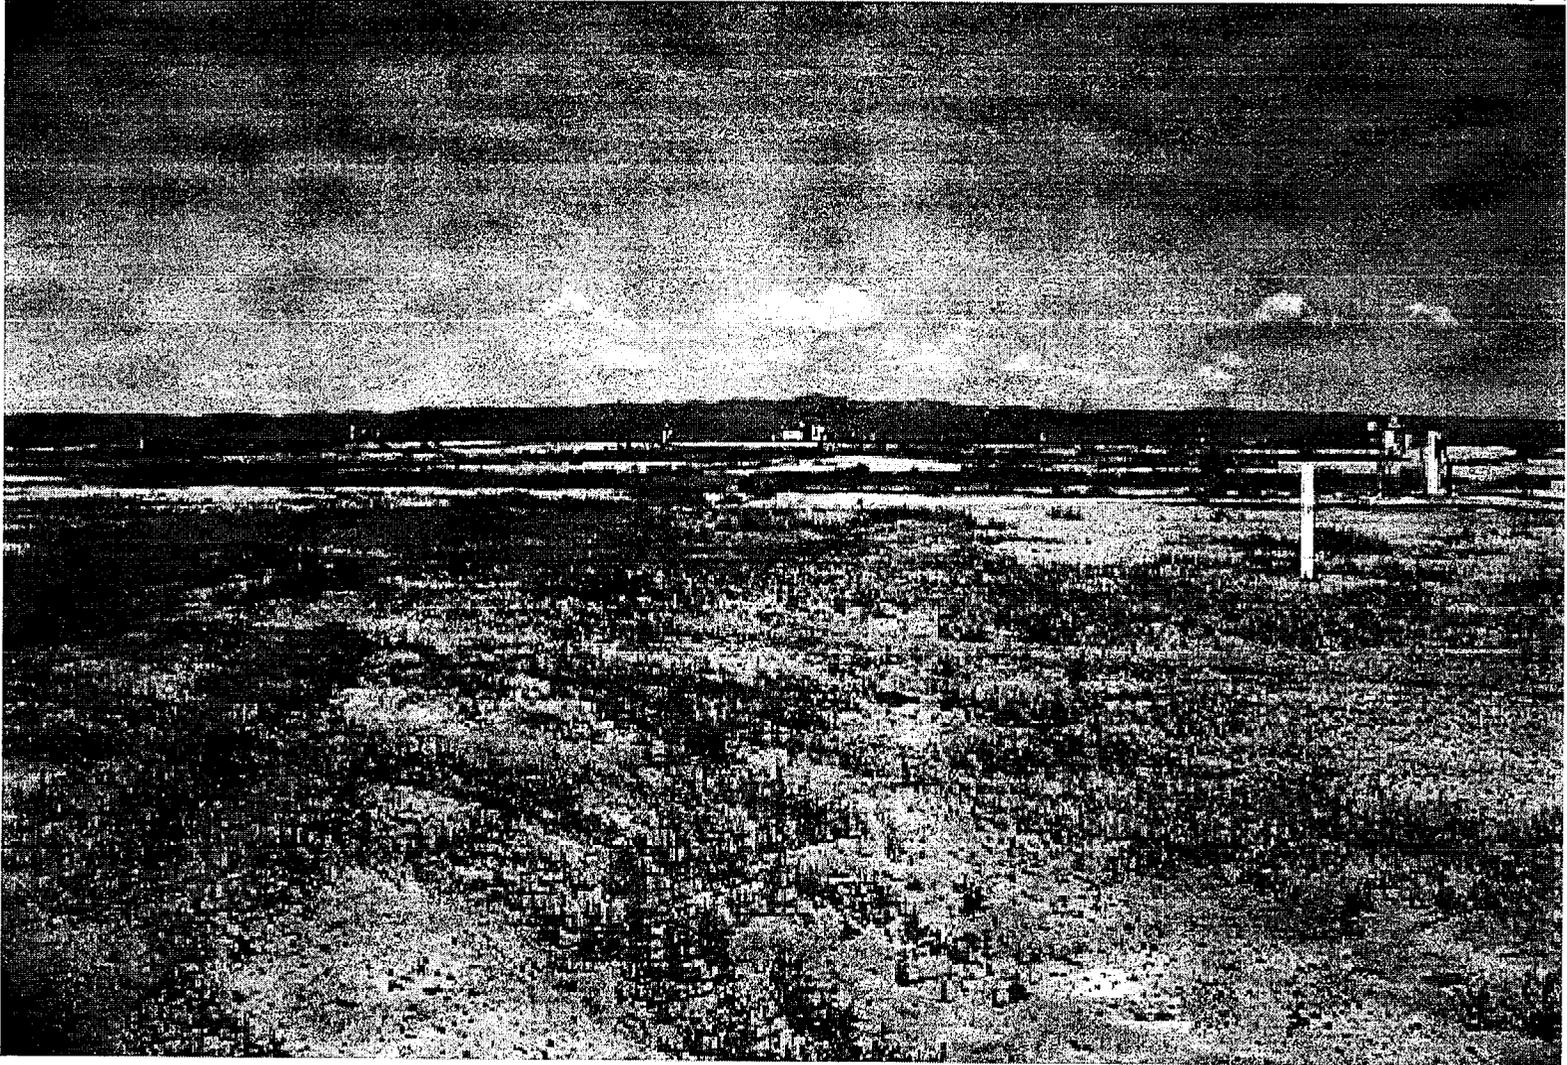
View across top of large tailing pile temporary cover, facing west-southwest (slightly left of view in previous photograph; wells at right are same wells at left in previous photograph).

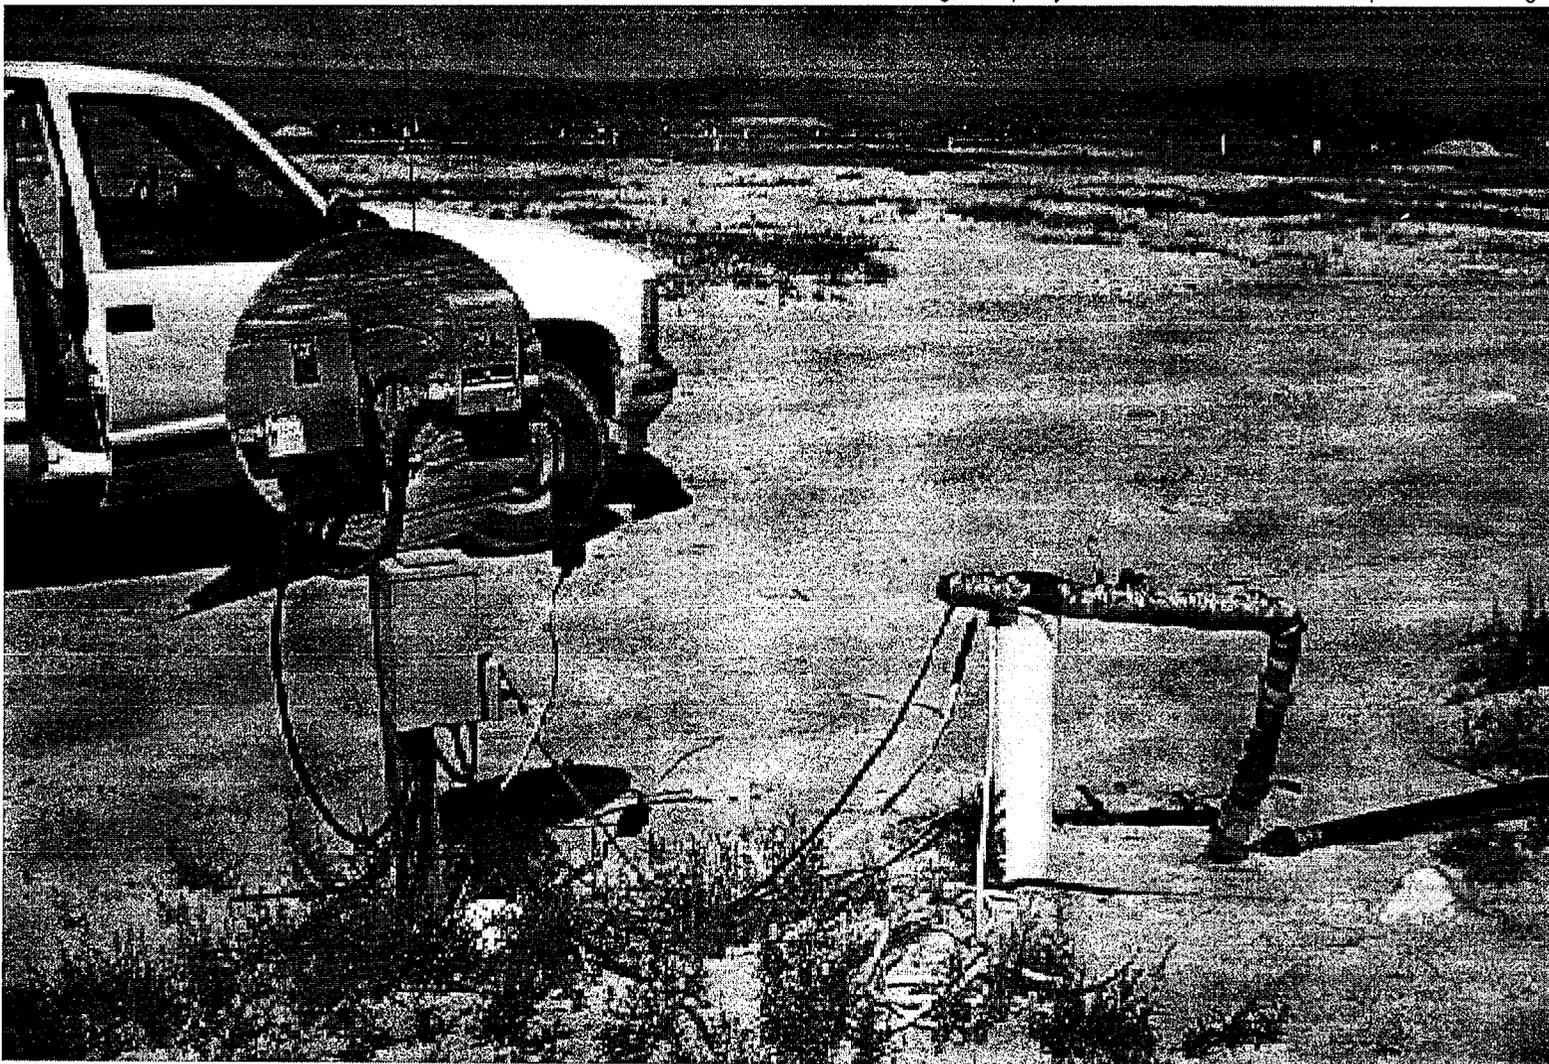
Facing west on top of large tailings pile, dewatering well CN6.

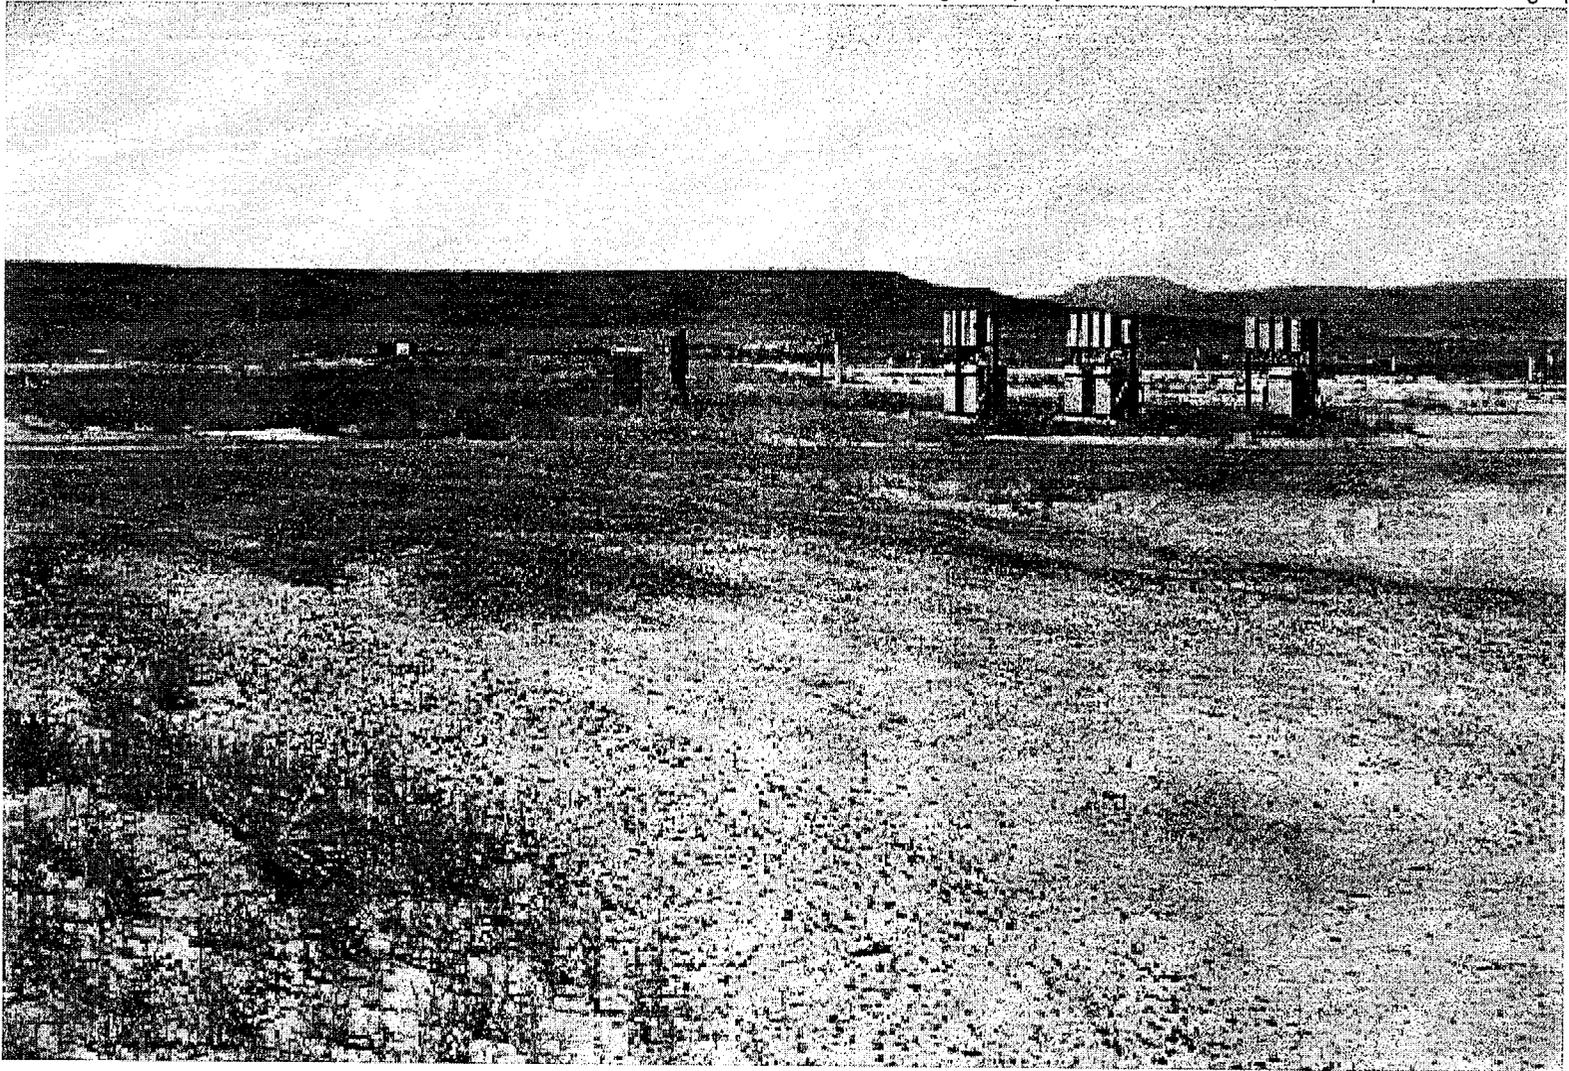
Facing south across large tailings pile temporary cover. Structures visible are the electrical boxes for the tailings pile dewatering well system.

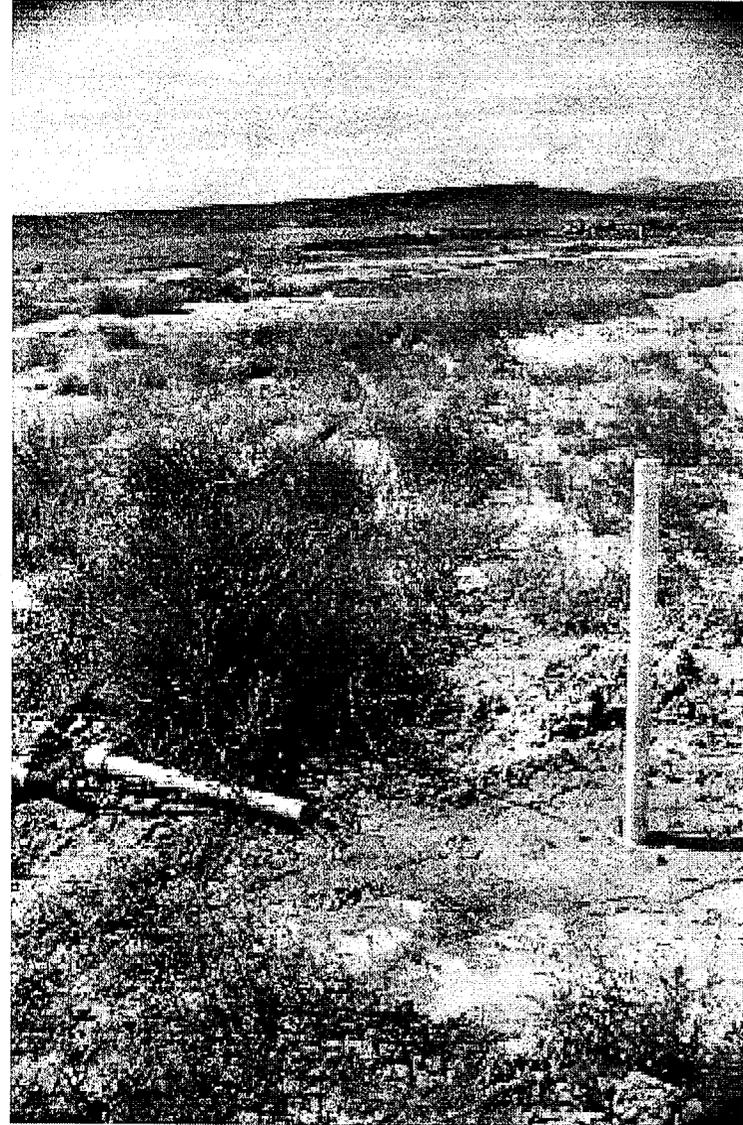
01_24_23A.JPG

Test injection well EK-7, on top of large tailing pile temporary cover. Using gravity drainage of fresh water.

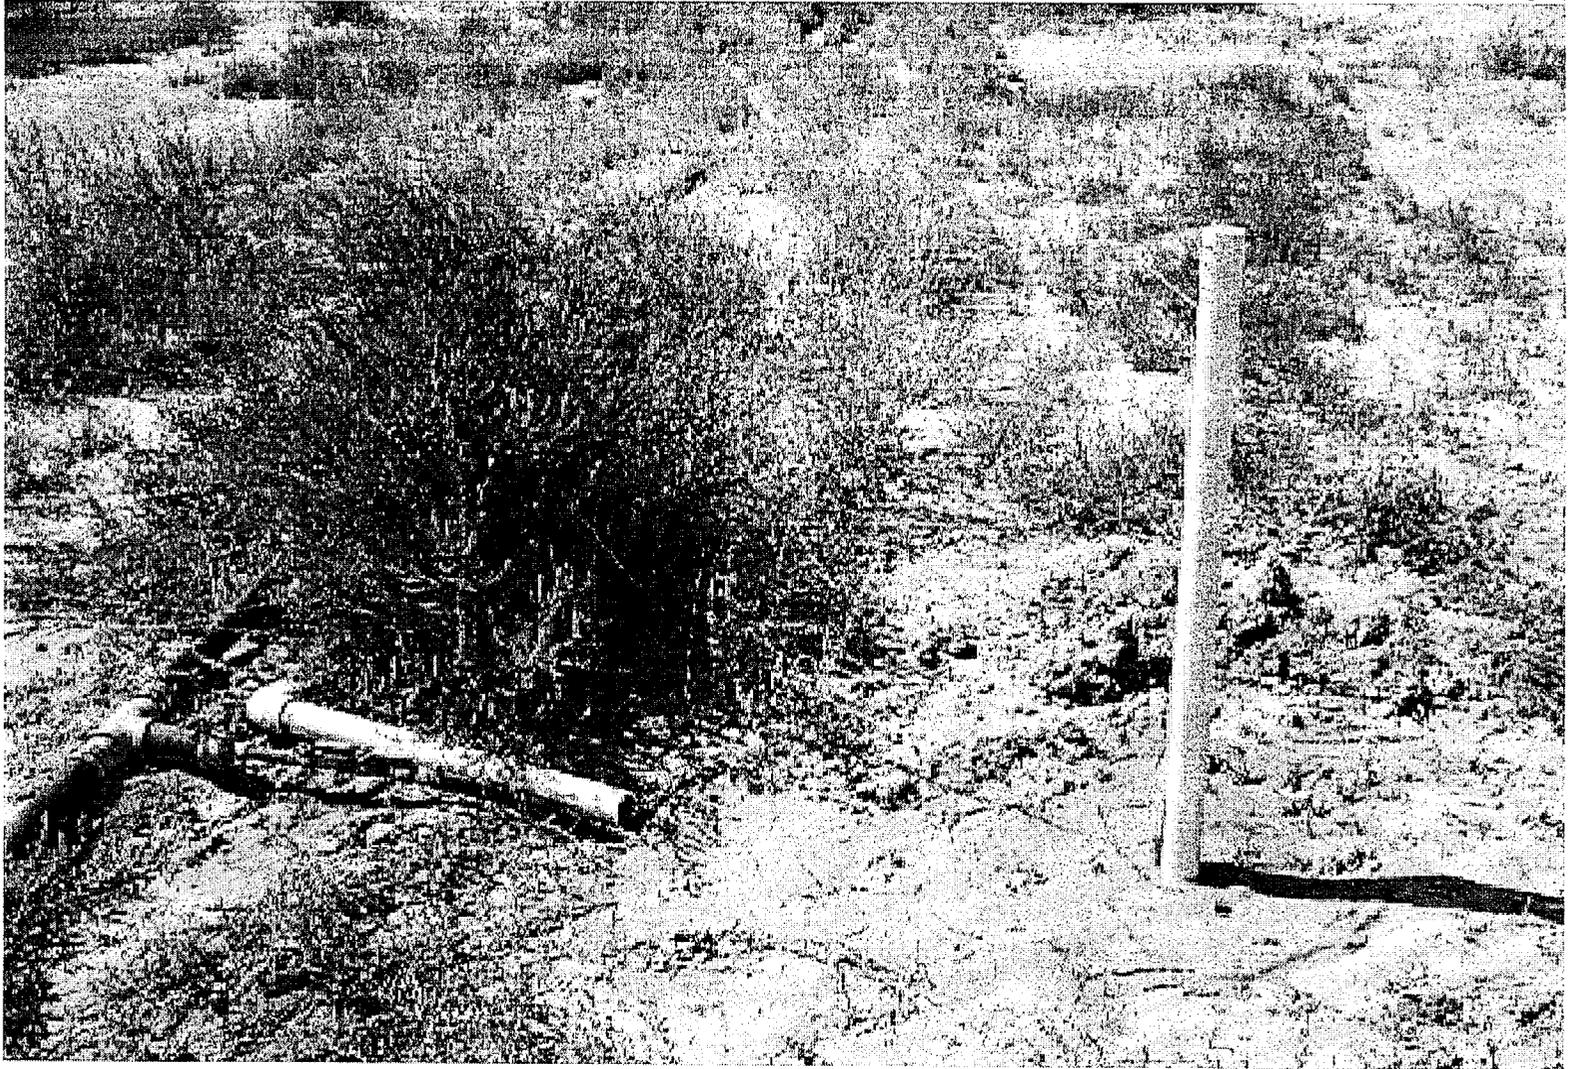
Closer view of injection well EK-7, seen in previous photograph.

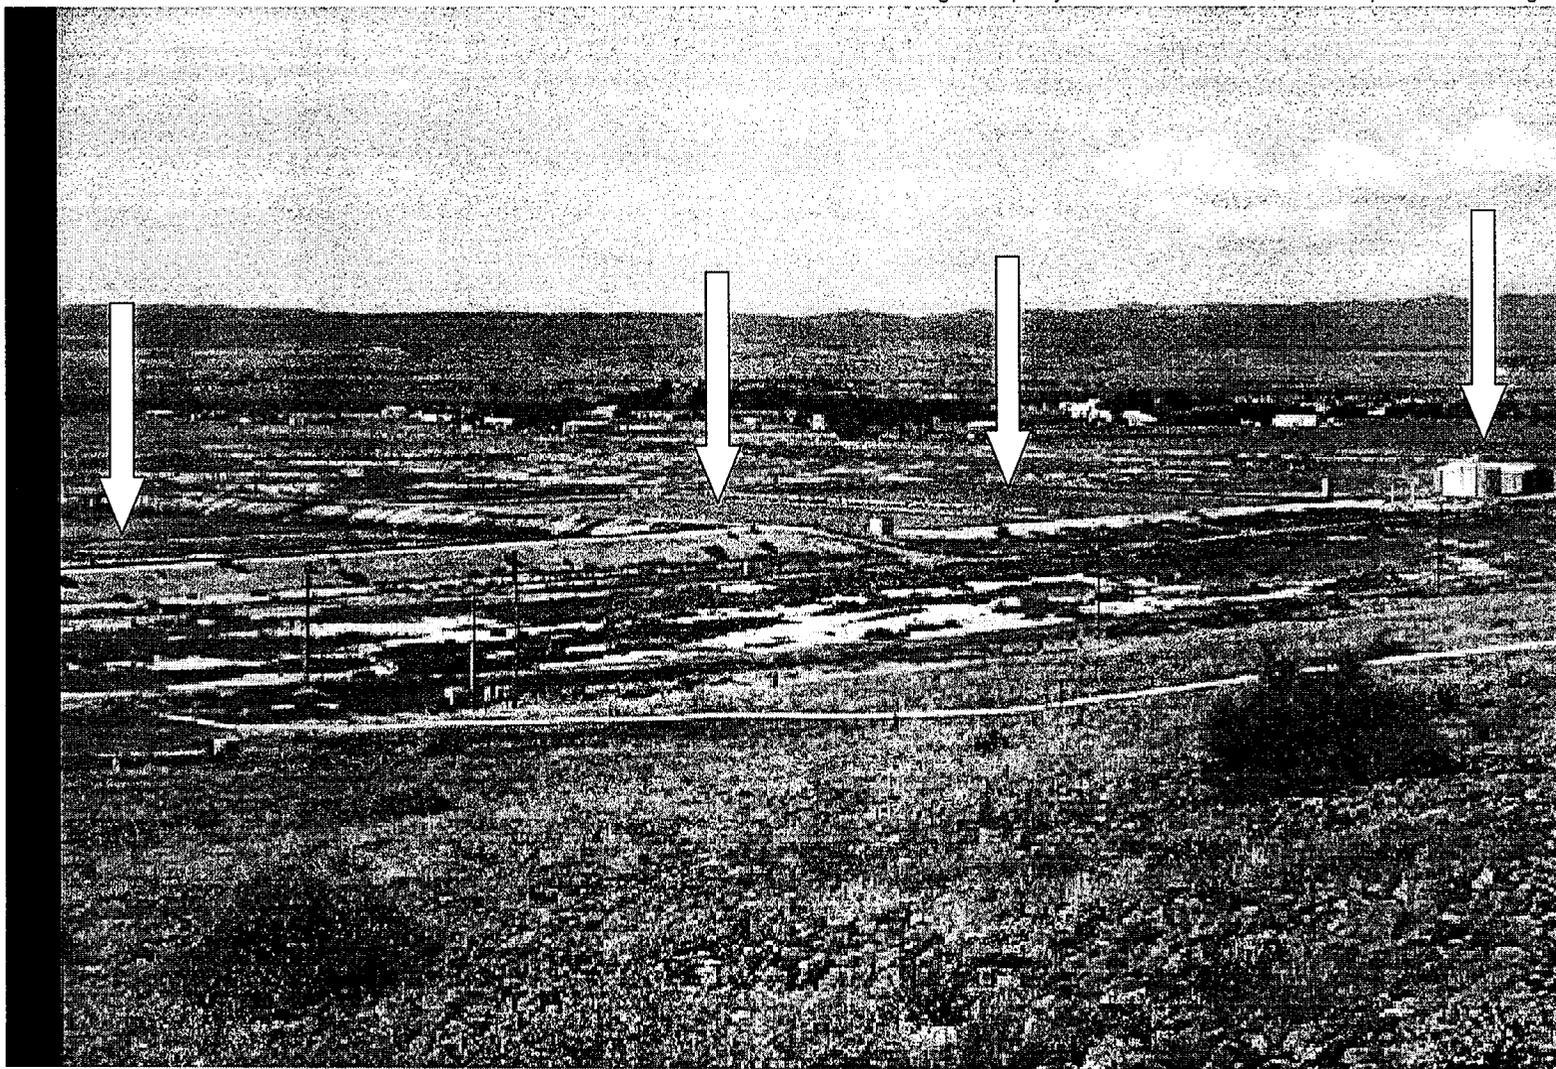
View south-southeast from southern edge of top of large tailing pile temporary cover, toward small lined evaporation pond (left white arrow), east-west collection ponds (two middle arrows) and reverse osmosis plant (right arrow). Residential community visible in background.

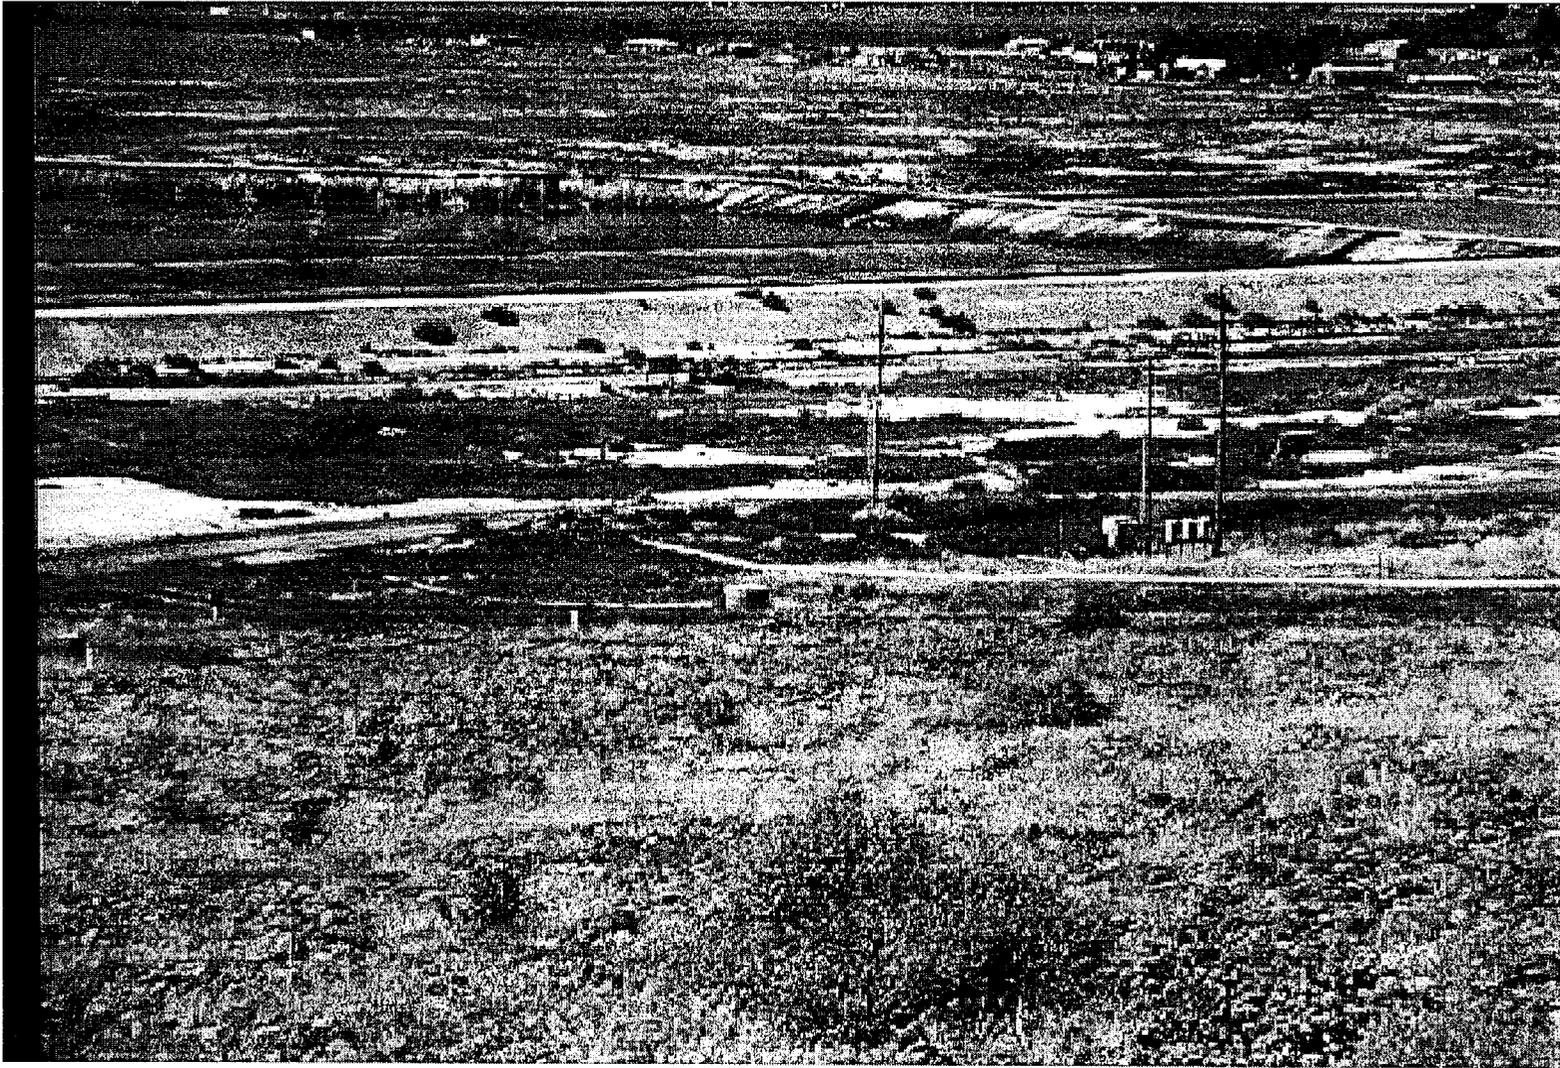
Closer view toward small lined evaporation pond (see previous photograph).

water for spray evaporation in the other pond. However, a spray system is installed in this pond, but due to design limitations, the system can only be used when weather conditions are optimal. Also, two brine ponds are located adjacent to and west of the second evaporation pond. All ponds are lined, and the dikes are inspected regularly. The plan is to reclaim these areas and install the final cover and radon barrier on the small tailings pile when the groundwater restoration program is complete.

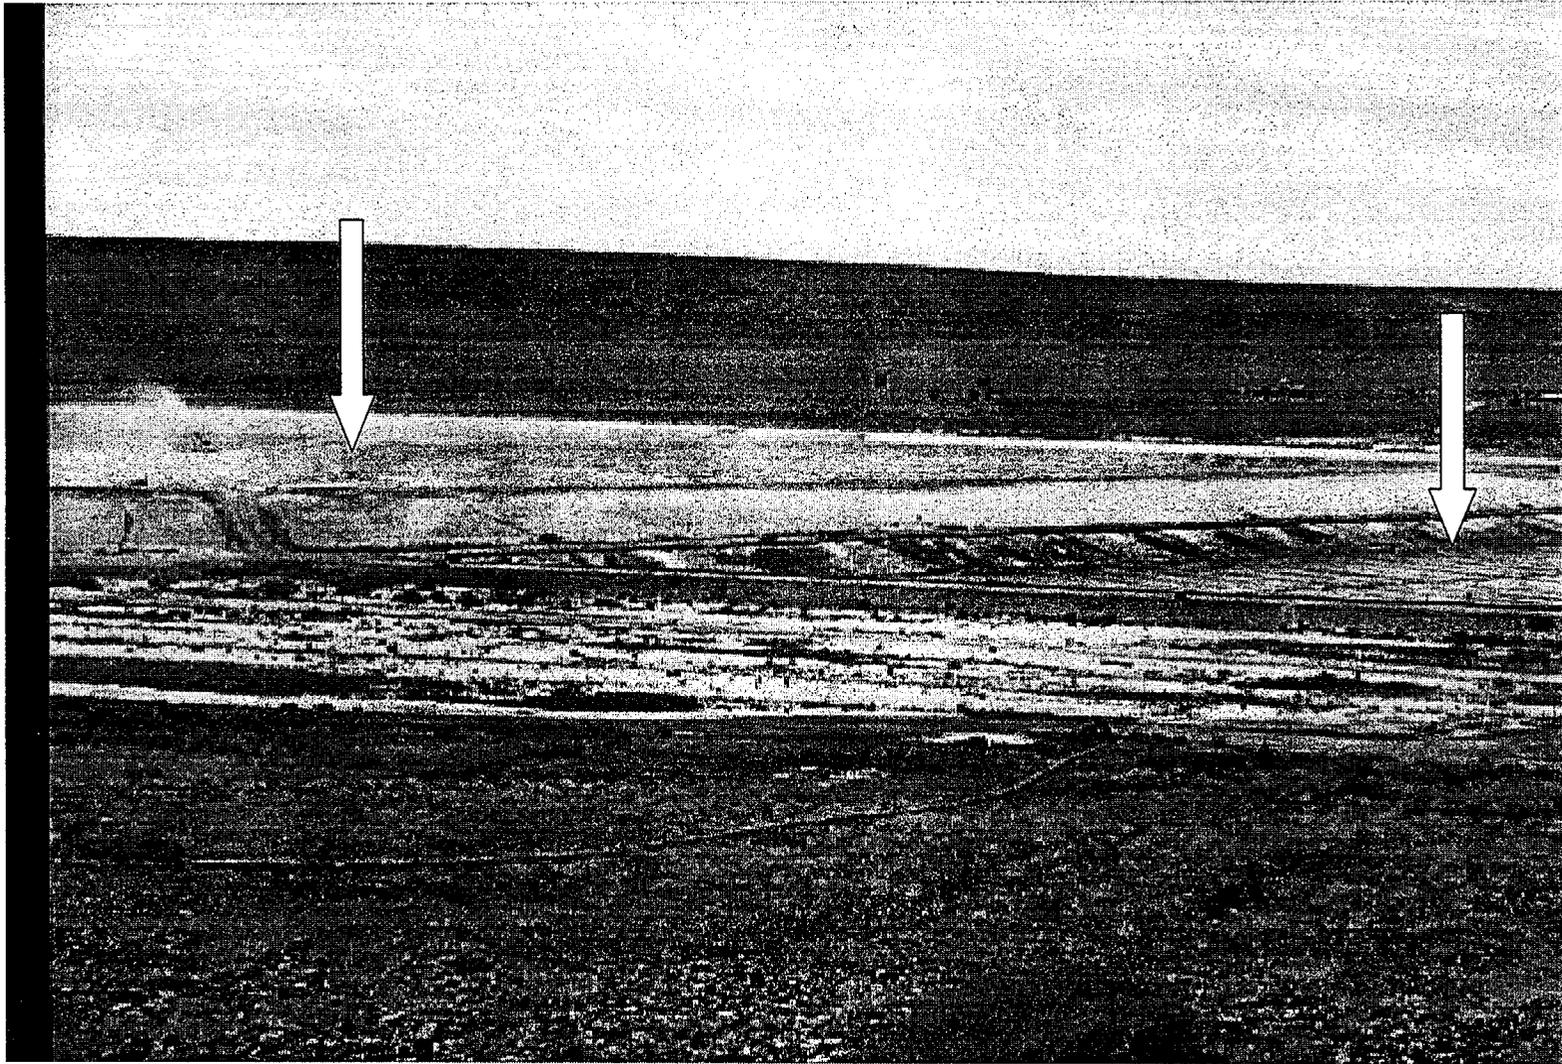
View south from southern edge of top of large tailing pile temporary cover, toward largelined evaporation pond (left arrow) and small lined evaporation pond (right arrow). Foreground is southern slope of largetailings pile. Note spray blower in large pond.

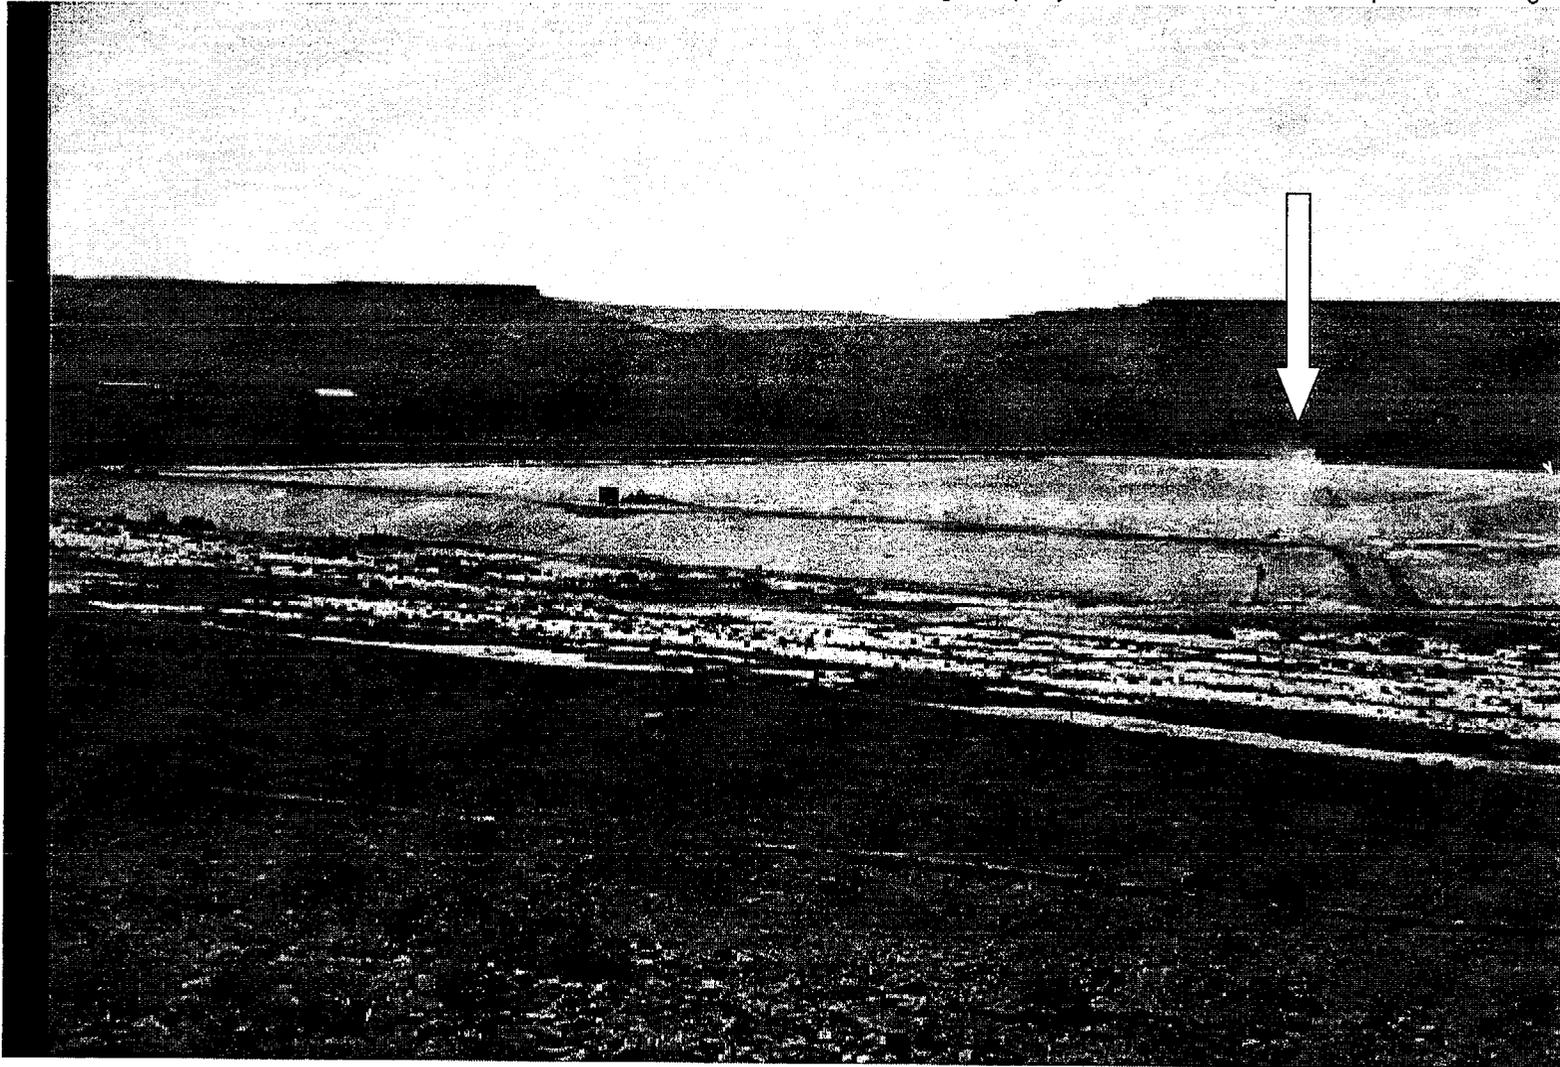
View south from southern edge of top of large tailing pile temporary cover, toward largelined evaporation pond. Foreground is southern slope of large tailings pile. Note spray blower in large pond (white arrow).

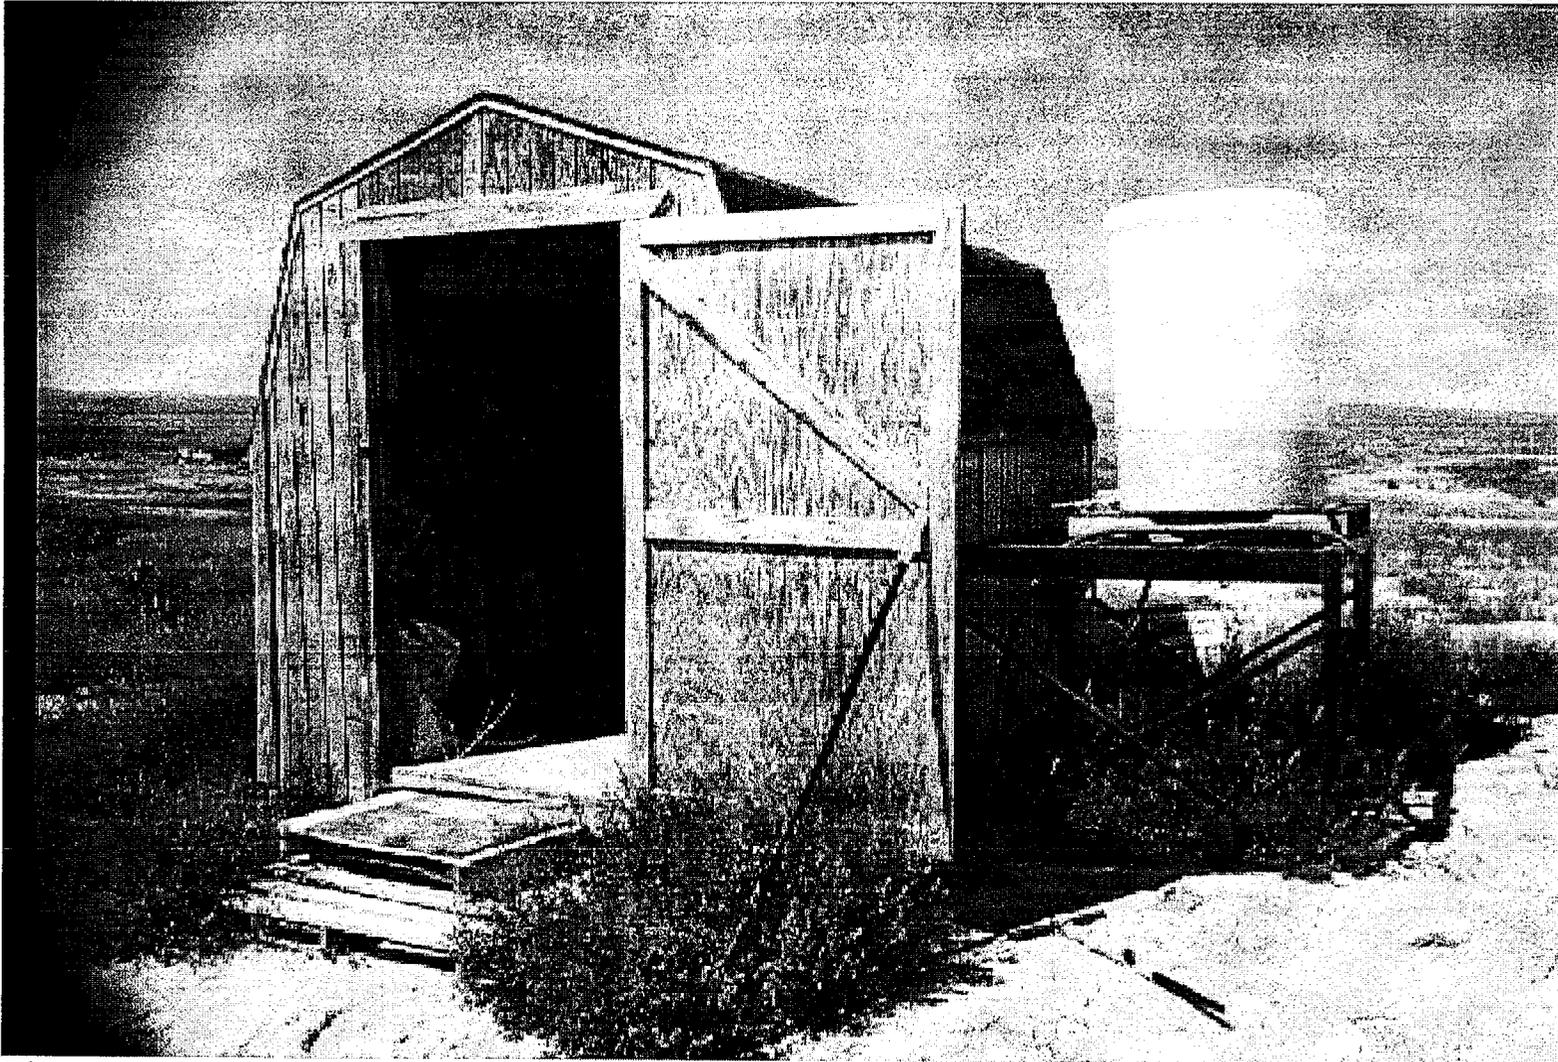
Bioremediation experiment station on top of large tailings pile (location visible in previous photograph). Injection well is located inside structure; molasses additive is in white tank. Associated monitoring wells are left of the structure.

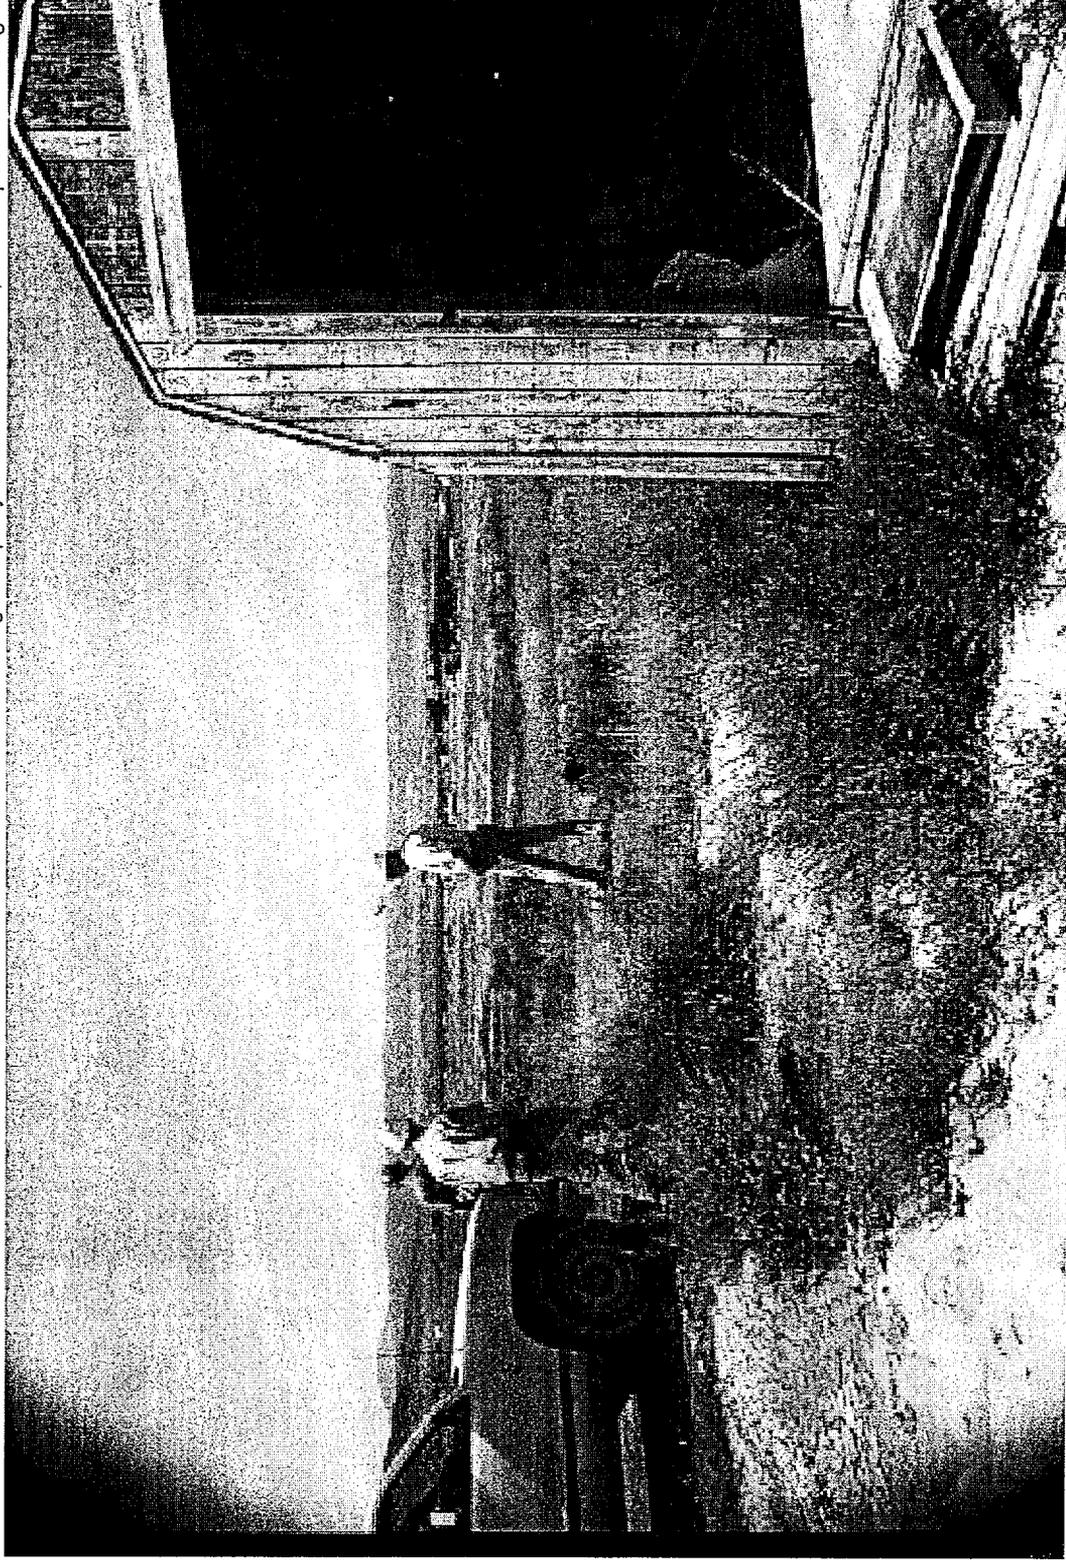
02_011_11.JPG

Bioremediation experiment station on top of large tailings pile, slightly south of previous view. Note evaporation ponds and residential community visible in background.

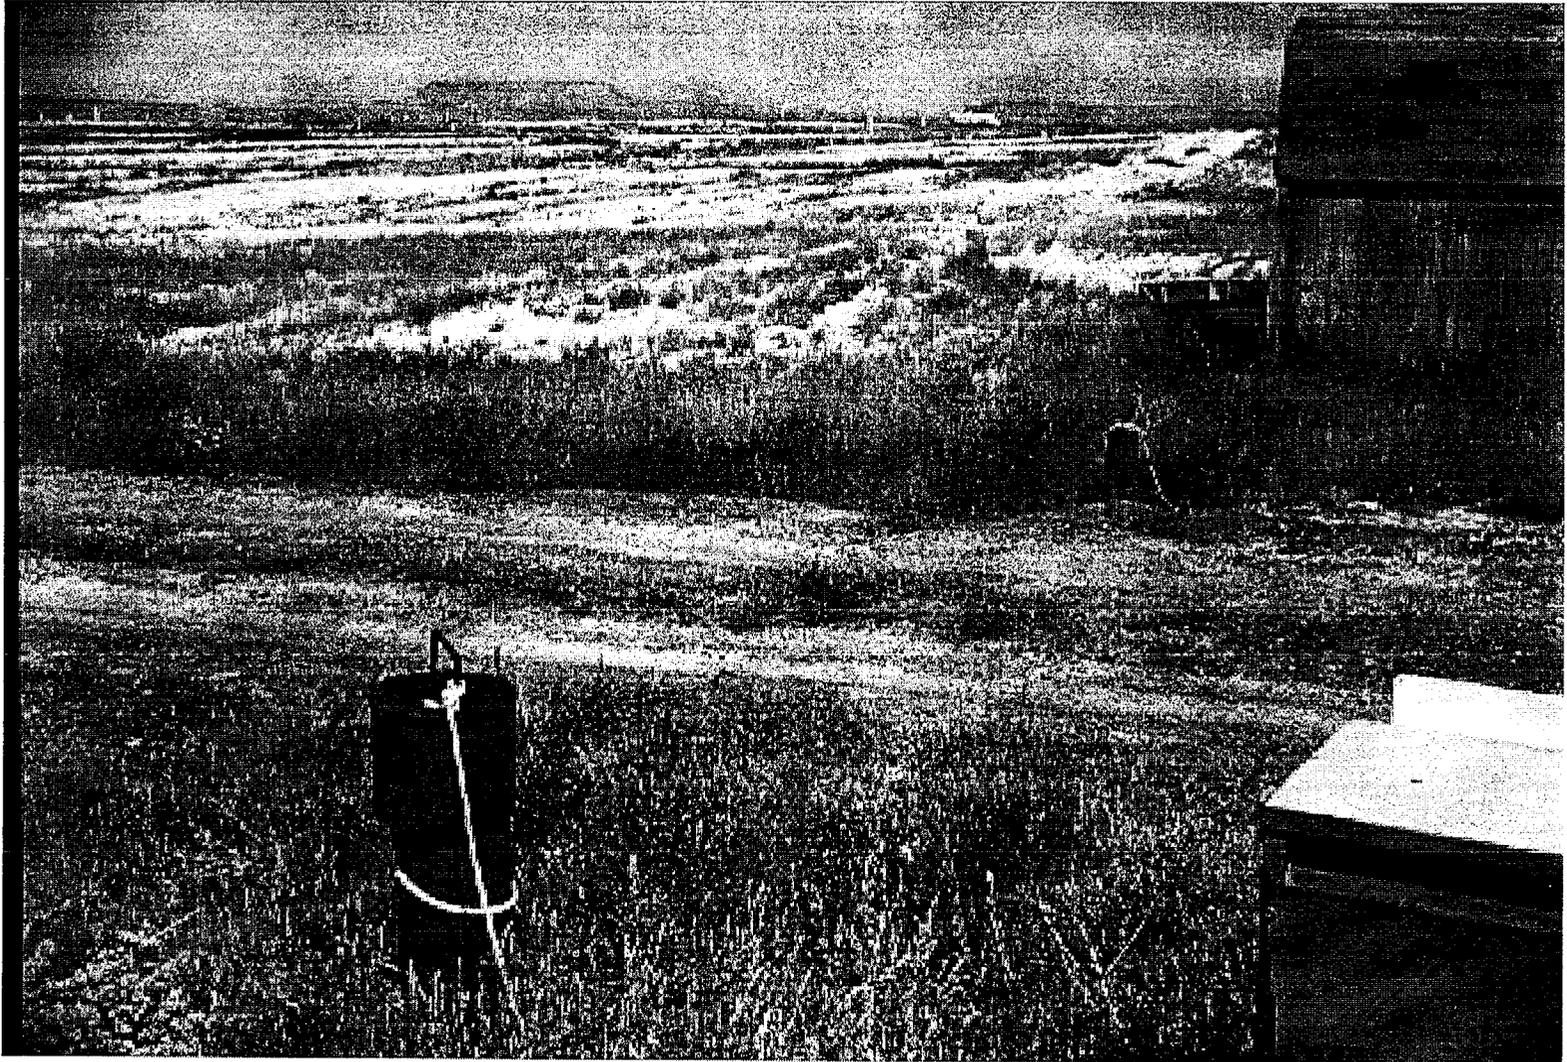
Monitoring wells associated with bioremediation experiment station, facing north-northwest.

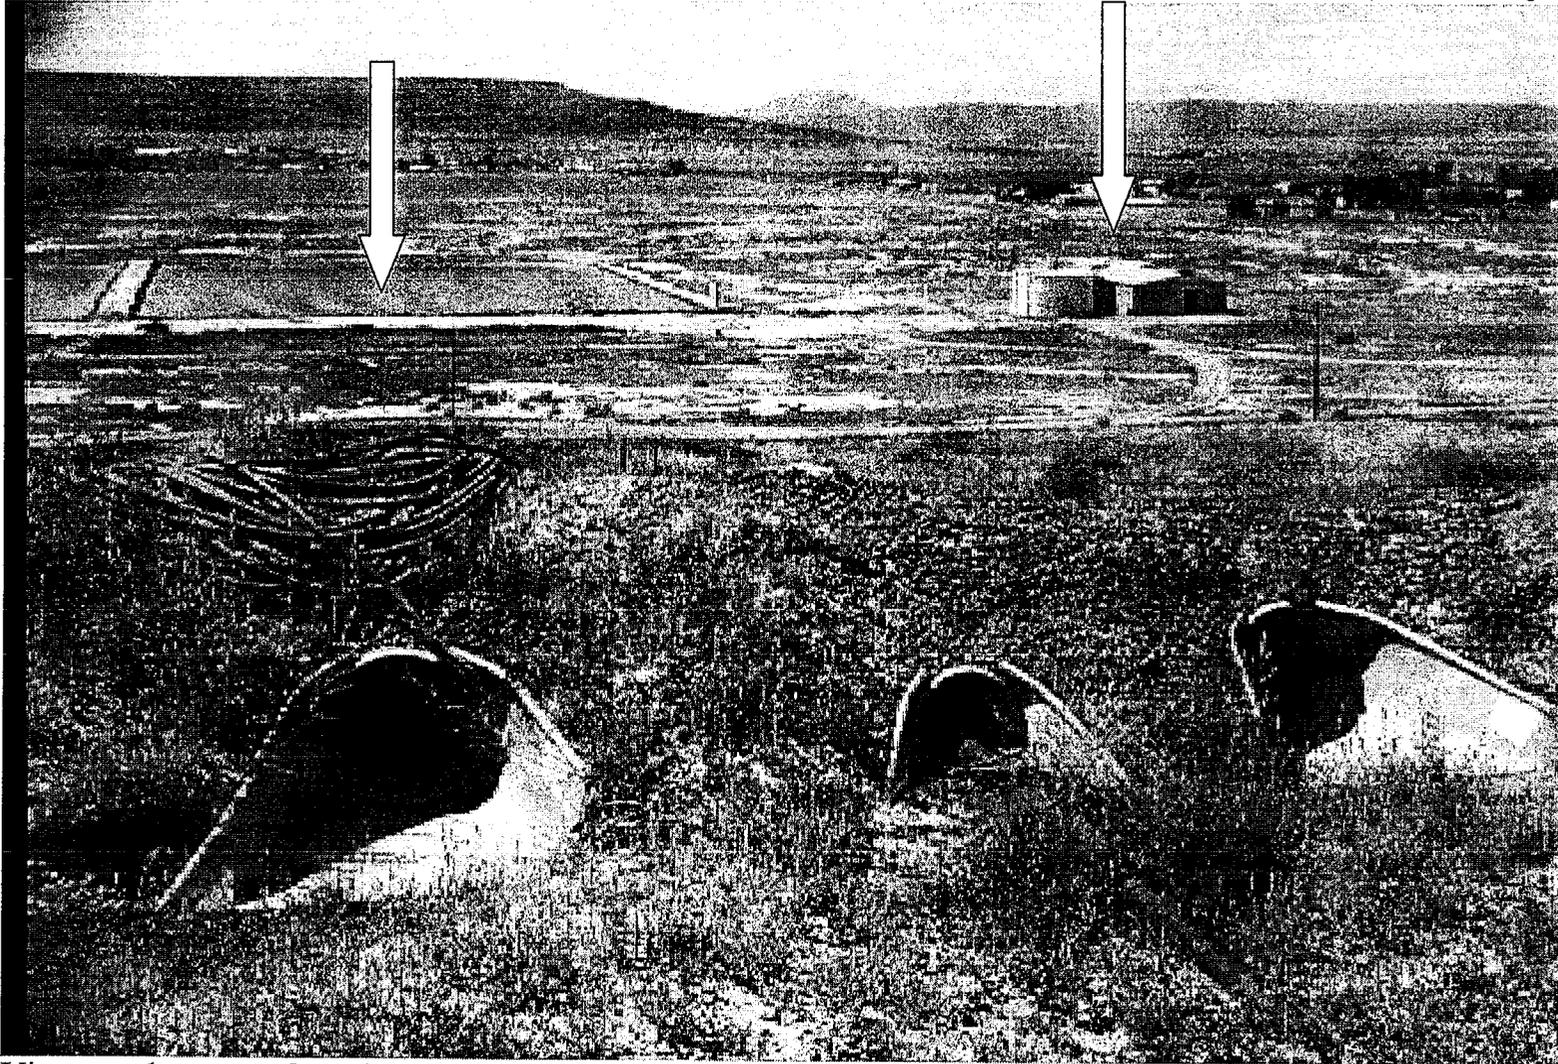
View south at top of southern slope of large tailings pile, showing runoff drainage pipes. Note west collection ponds and reverse osmosis plant (left and right arrows, respectively) Residential community is visible in background.
