Attachment 3
Site Inspection Roster for Site Inspection Conducted August 16, 2001
Homestake Mining Company Superfund Site

Attachment 4
Site Inspection Photographs

Homestake Mining Company Five-Year Review, Site Inspection Photograph Log

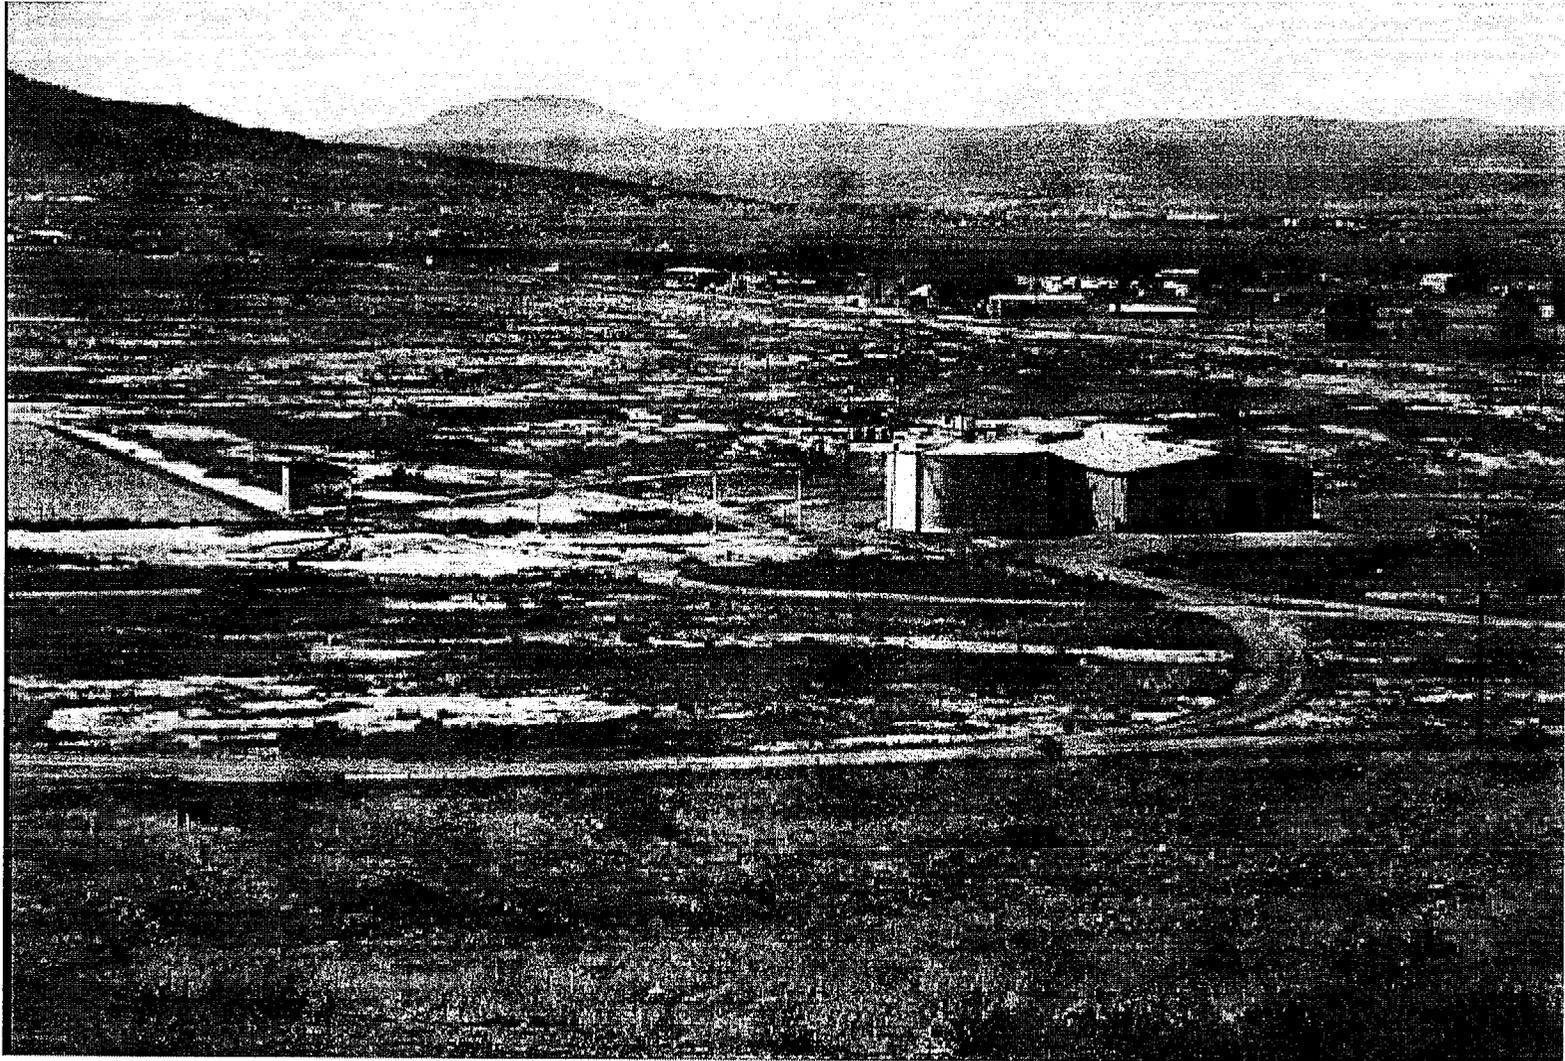
Closer view of reverse osmosis plant, as seen from top of southern slope of large tailings pile.

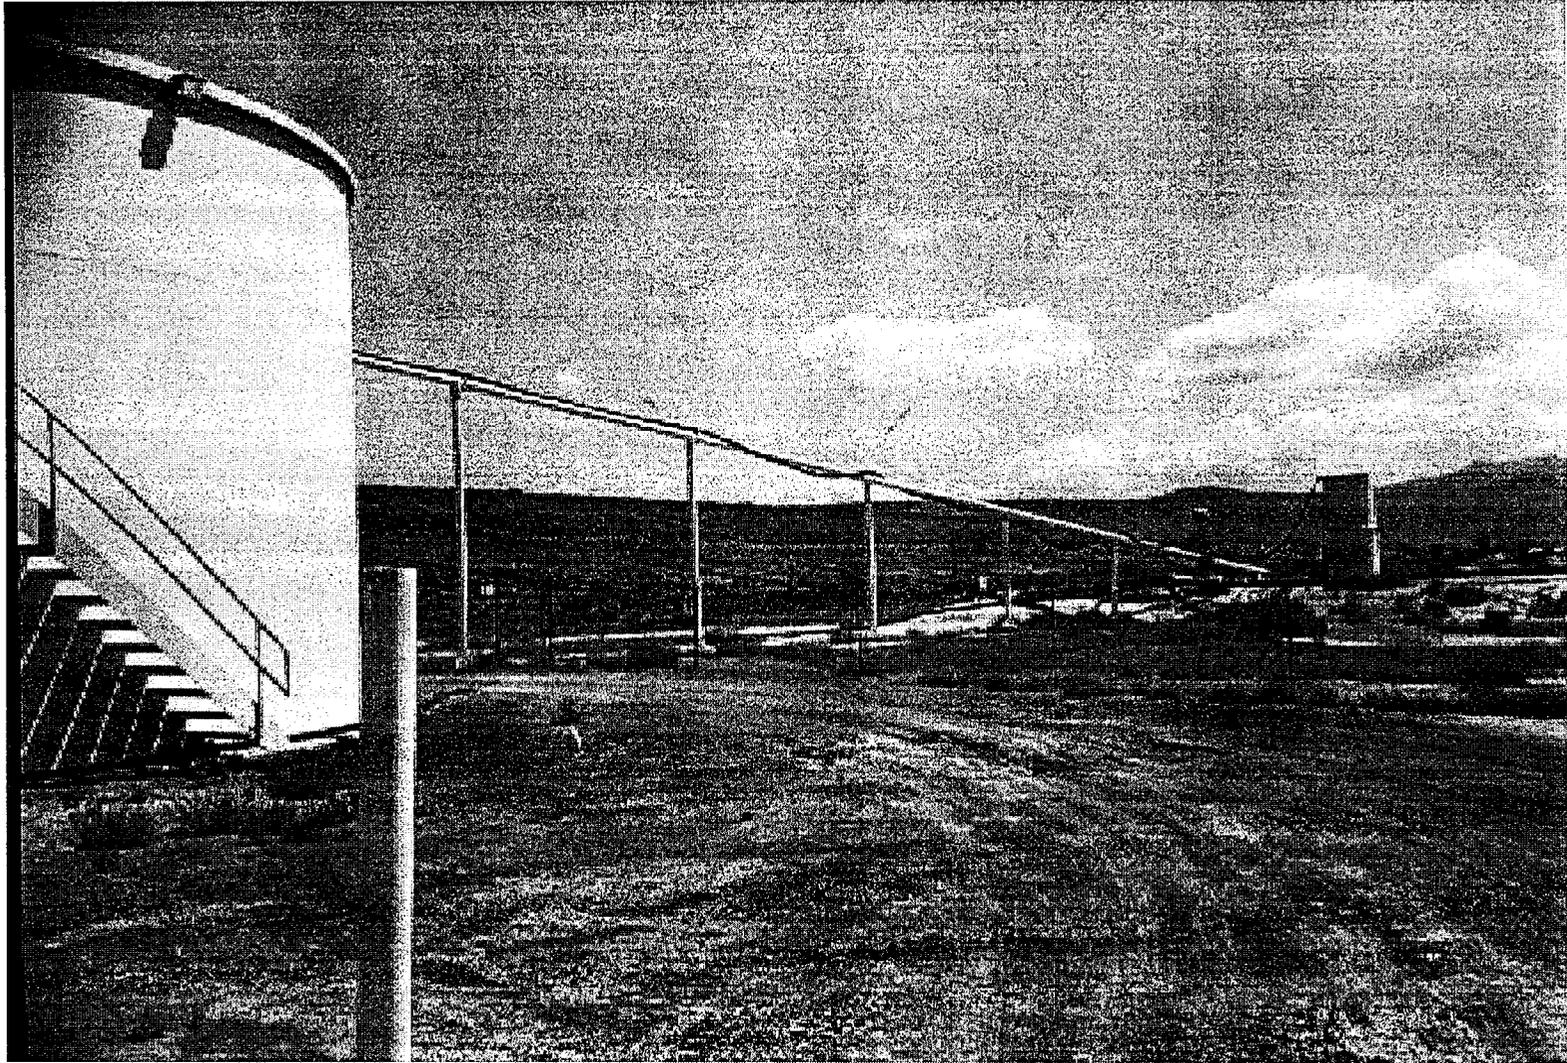
Exterior of reverse osmosis plant, showing conveyance between plant and evaporation ponds to right of view.
Facing north-northwest.

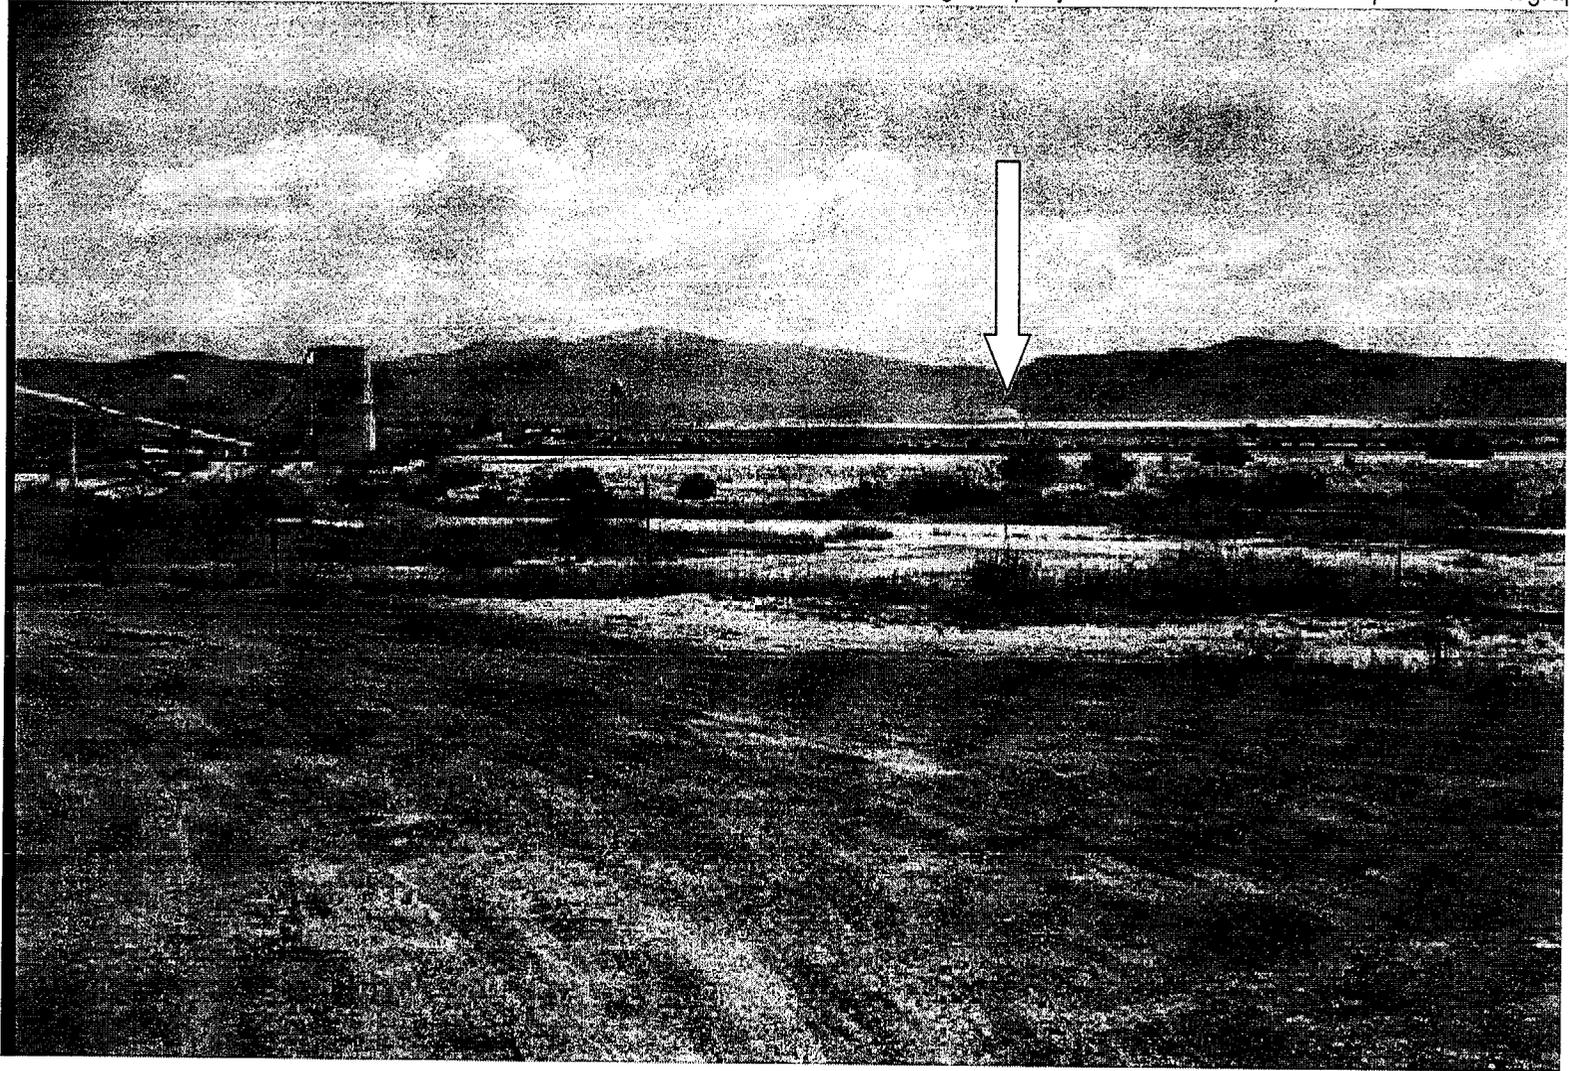
Facing east from south of reverse osmosis plant across evaporation ponds. Note spray blower in far pond at white arrow (the large lined evaporation pond).

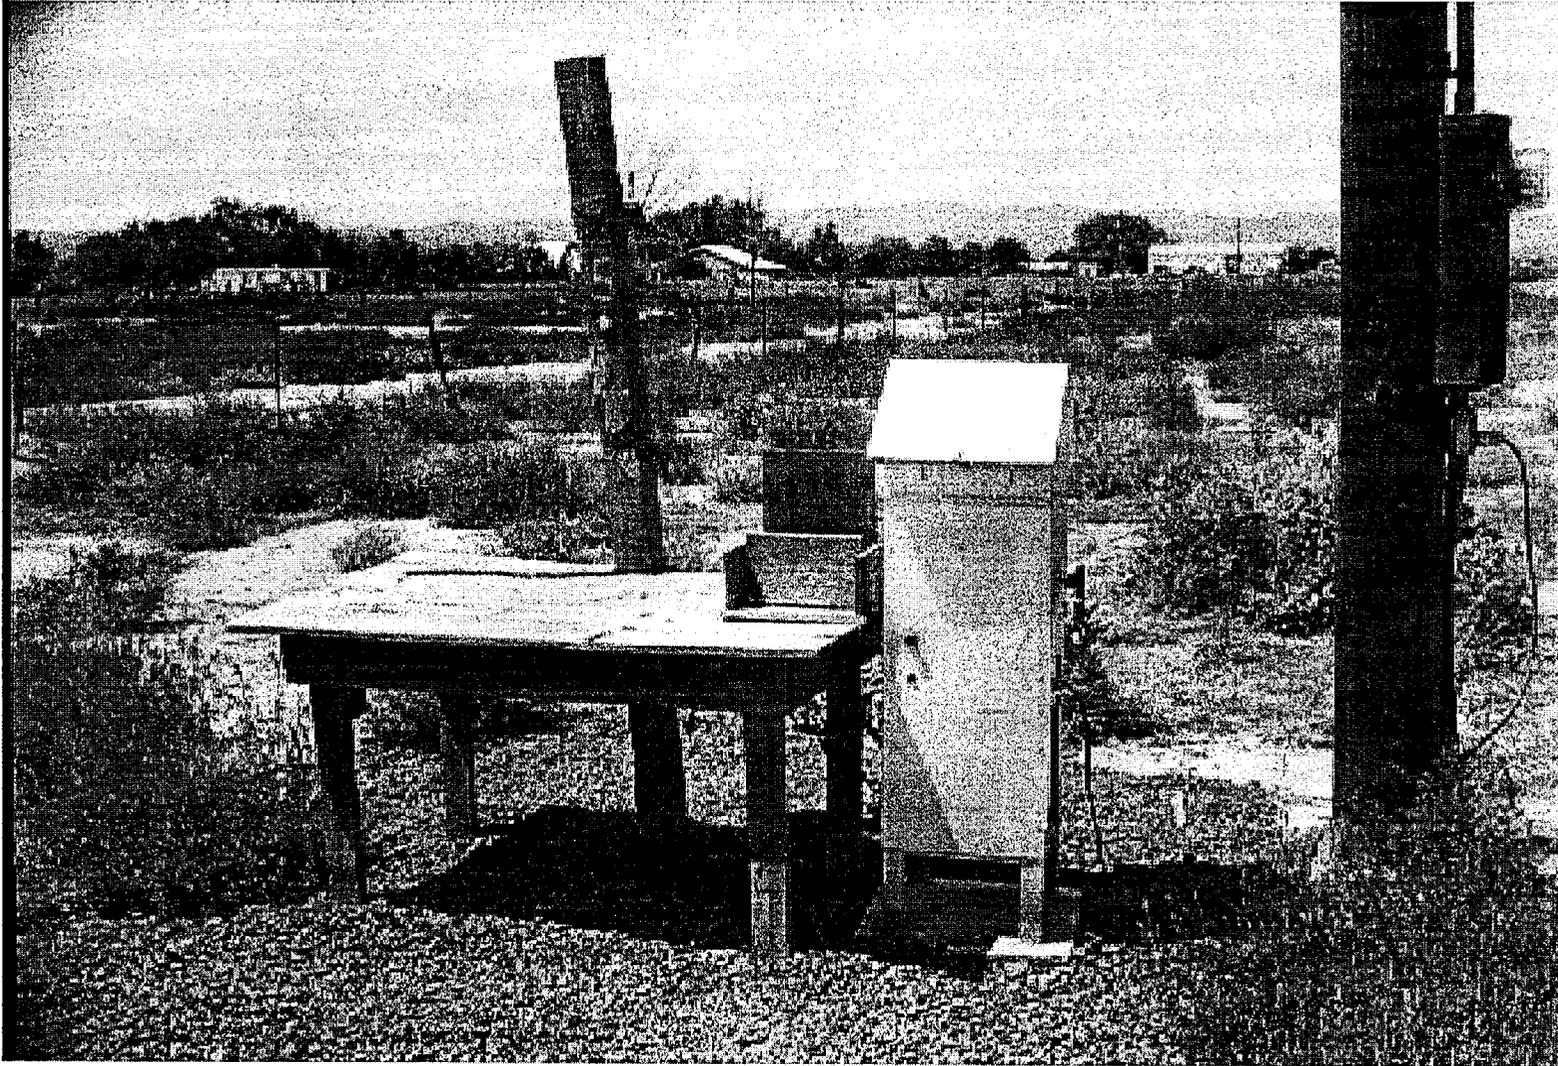
Facing west, air monitoring station near north end of Murray Acres subdivision.

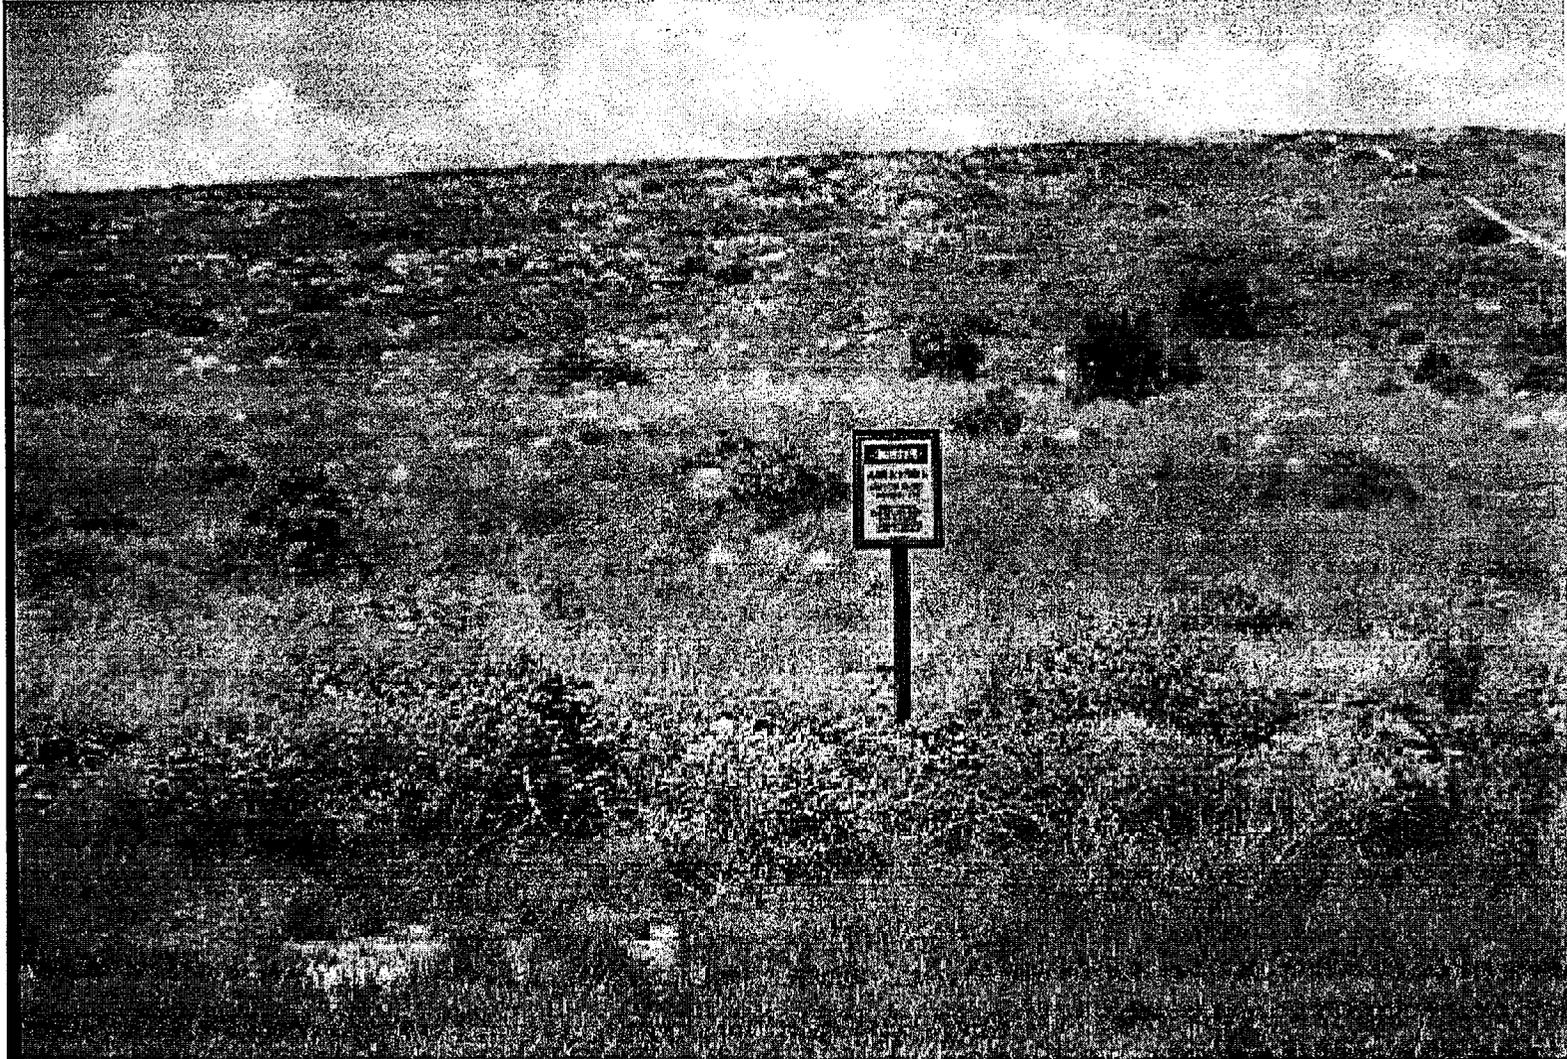
Facing south toward northern slope of large tailings pile, toward eastern end of the pile, closer view of asbestos disposal area seen in previous photographs. Sign states "Danger, Asbestos Waste Disposal Site, Breathing Asbestos Dust May Cause Lung Disease and Cancer".

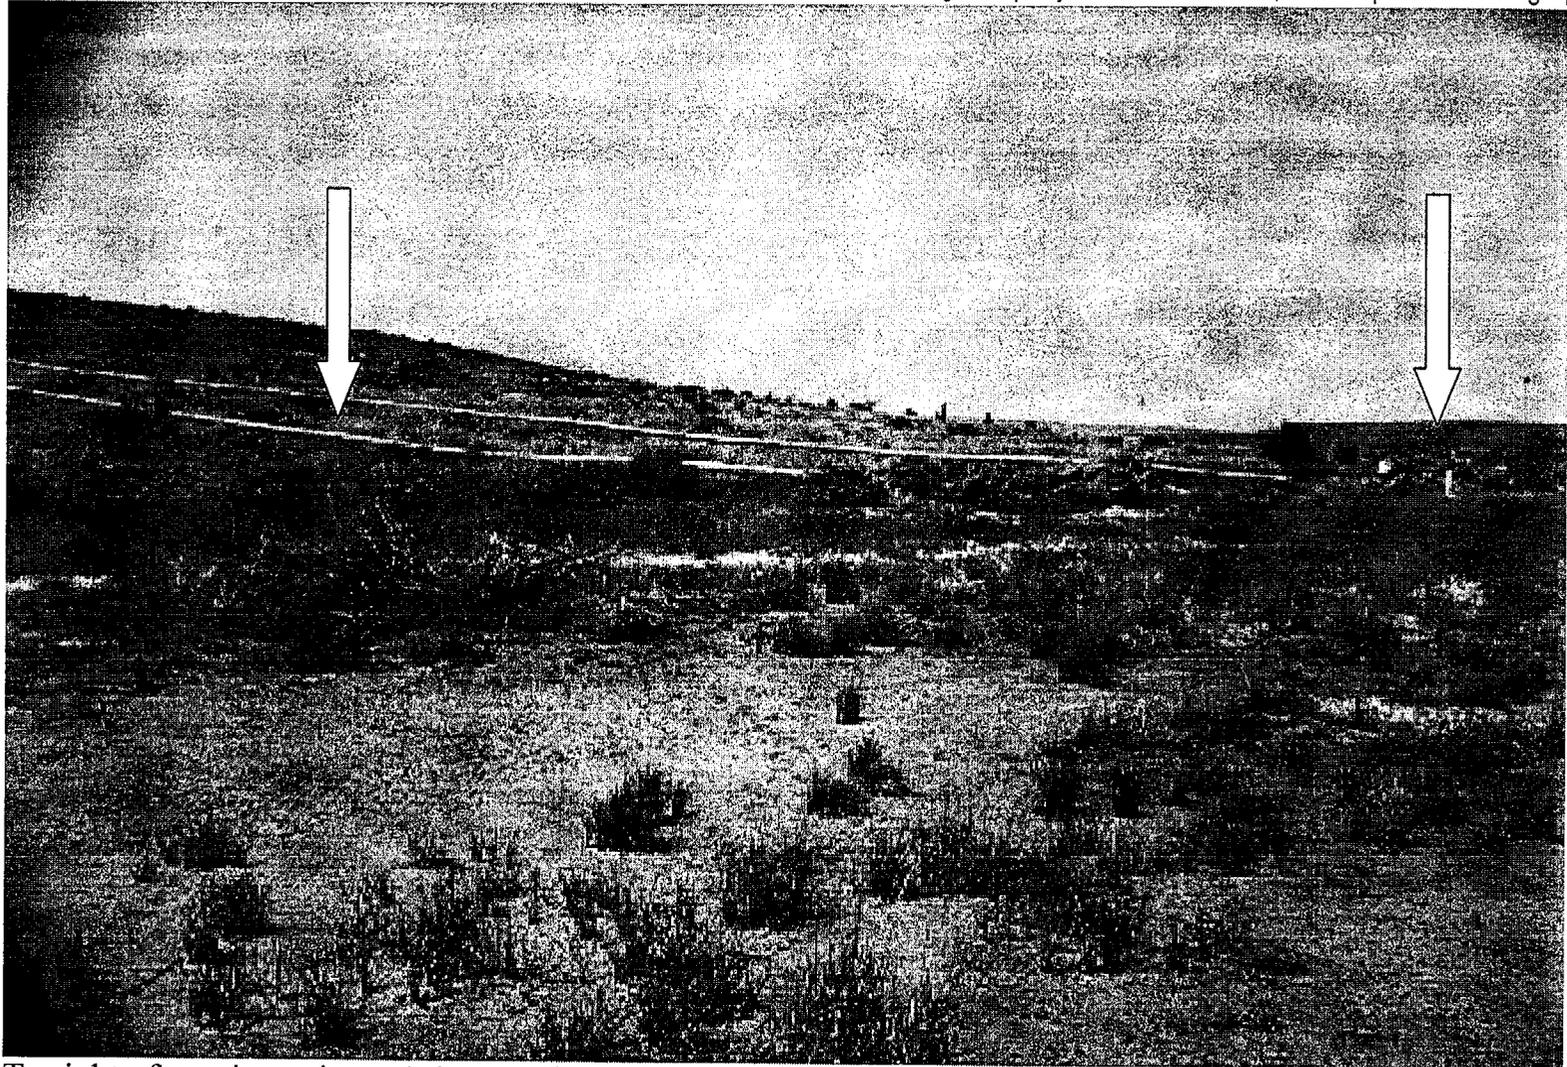
To right of previous view. Asbestos disposal area is left of view; runoff conveyance from top of large tailings pile is visible at left white arrow. Right white arrow shows runoff discharge point, which uses boulders to break flow.

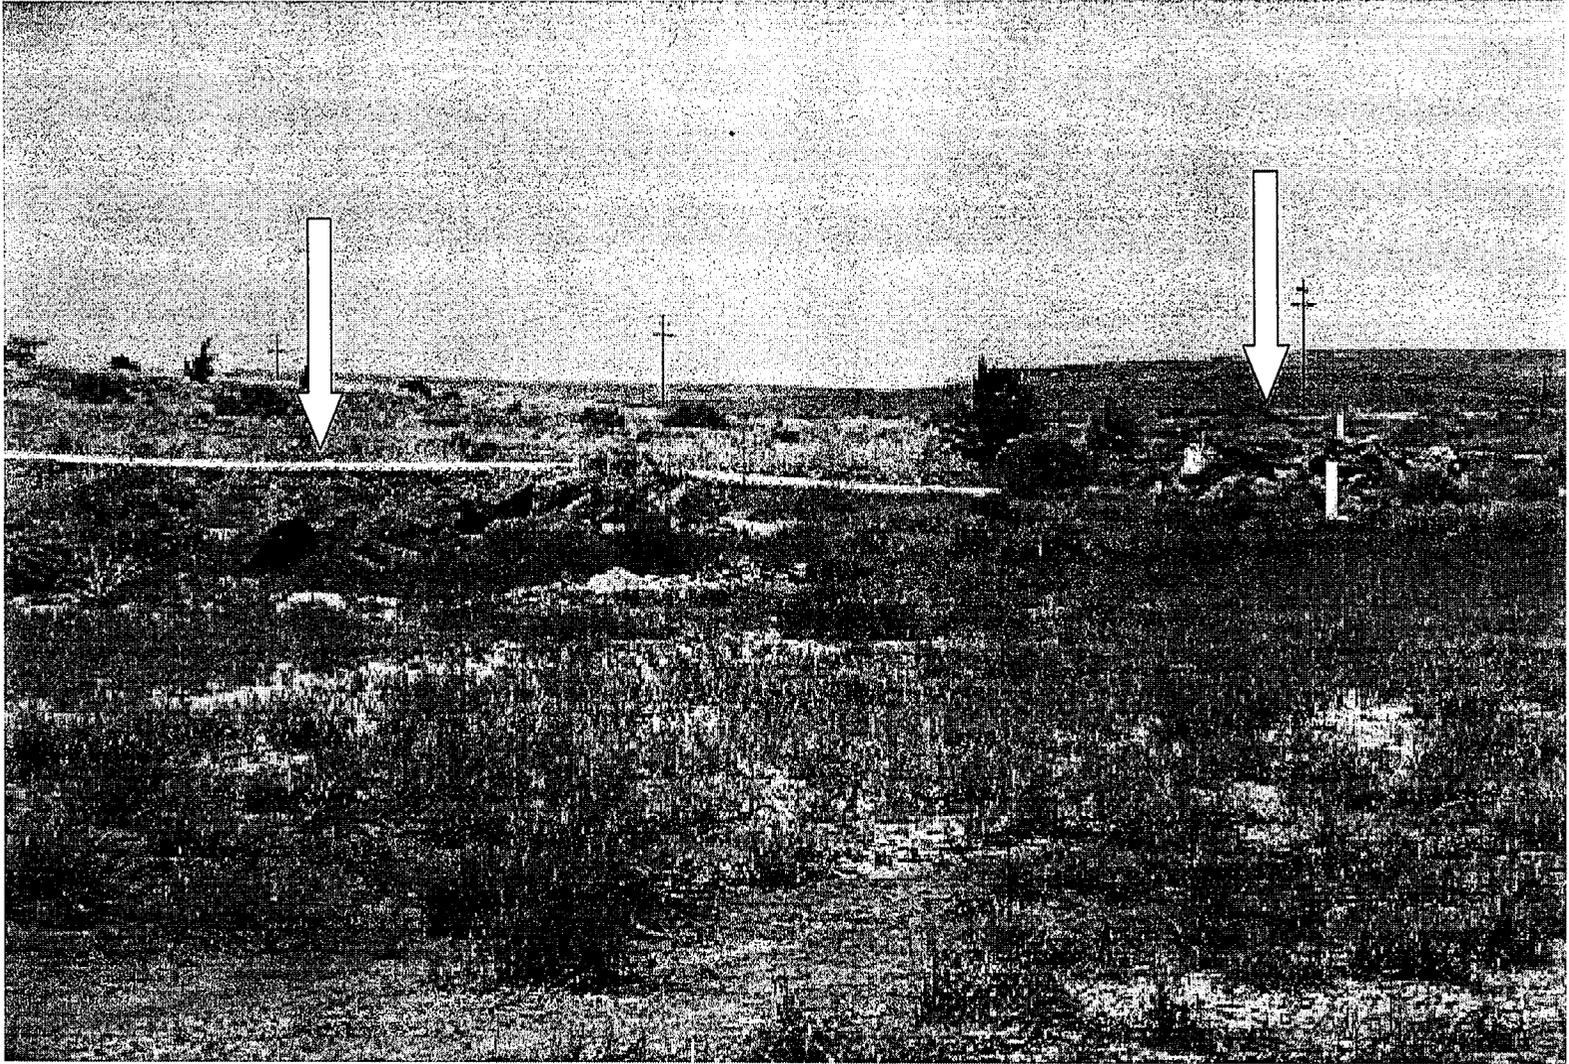
Closer view of previous photograph. Asbestos disposal area is left of view; runoff conveyance from top of large tailings pile is visible at left white arrow. Right white arrow shows runoff discharge point, which uses boulders to break flow.

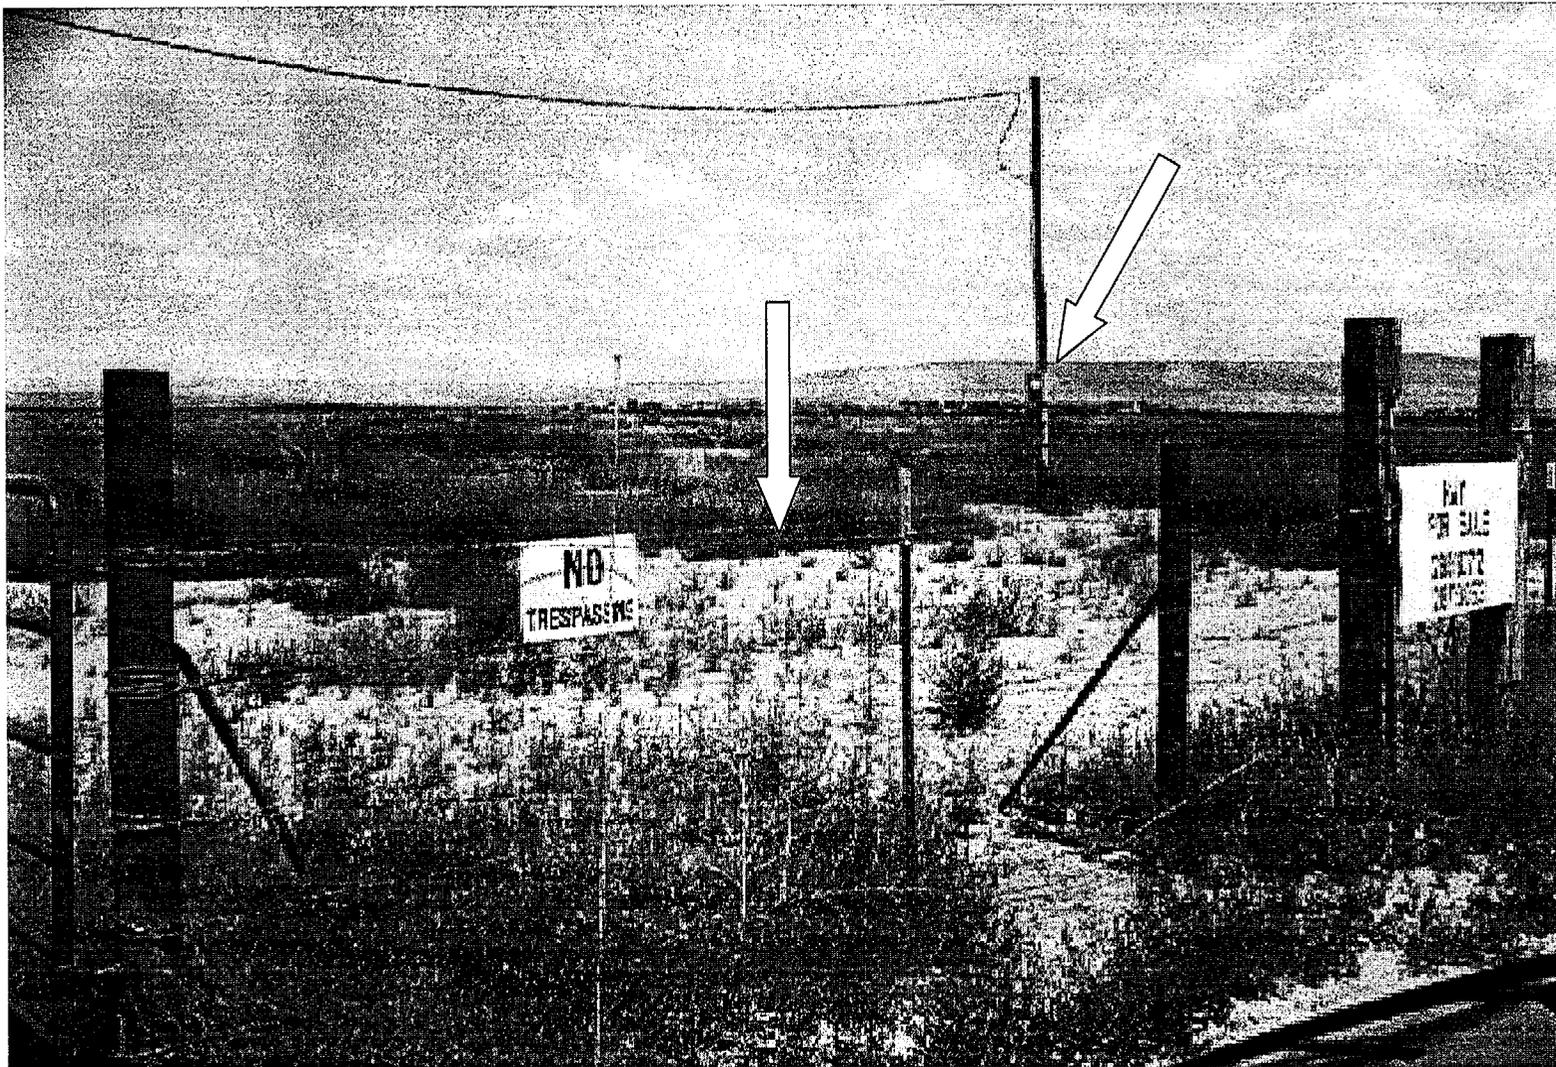
Facing north toward irrigation area west of Pleasant Valley Estates, at southwest corner of the irrigation area property. Note water conveyance pipe and power pole with electrical box (left and right arrows, respectively).
