DATA REPORT D
TRENCHES IN THE ISFSI STUDY AREA
DIABLO CANYON ISFSI

DCPP ISFSI SAR
Data Report D
Trenches in the ISFSI Study Area

Twenty-two shallow (1- to 8- feet-deep) trenches (designated T-1 to T-22) with cumulative length of about 1,510 feet, were excavated and logged at the Diablo Canyon ISFSI study area to obtain information on bedrock stratigraphy and rock mass properties (Figures D-1 and D-2). The trenches expose marine sedimentary rocks of unit Tof₆ of the Tertiary Obispo Formation and Holocene colluvium. Discontinuity surveys of joints, fractures and bedding (William Lettis & Associates, Inc., 2001, Diablo Canyon ISFSI Data Report F), as well as rock mass evaluations (William Lettis & Associates, Inc., 2001, Diablo Canyon ISFSI Data Report H) were performed in the trenches to obtain information to assess slope stability and in situ rock strength. The preparation of this data report was performed under the 2000 WLA Work Plan (William Lettis & Associates, Inc., Work Plan, 2000) using data collected under that Work Plan and the 2001 WLA Work Plan (William Lettis & Associates, Inc., Work Plan, 2001) .

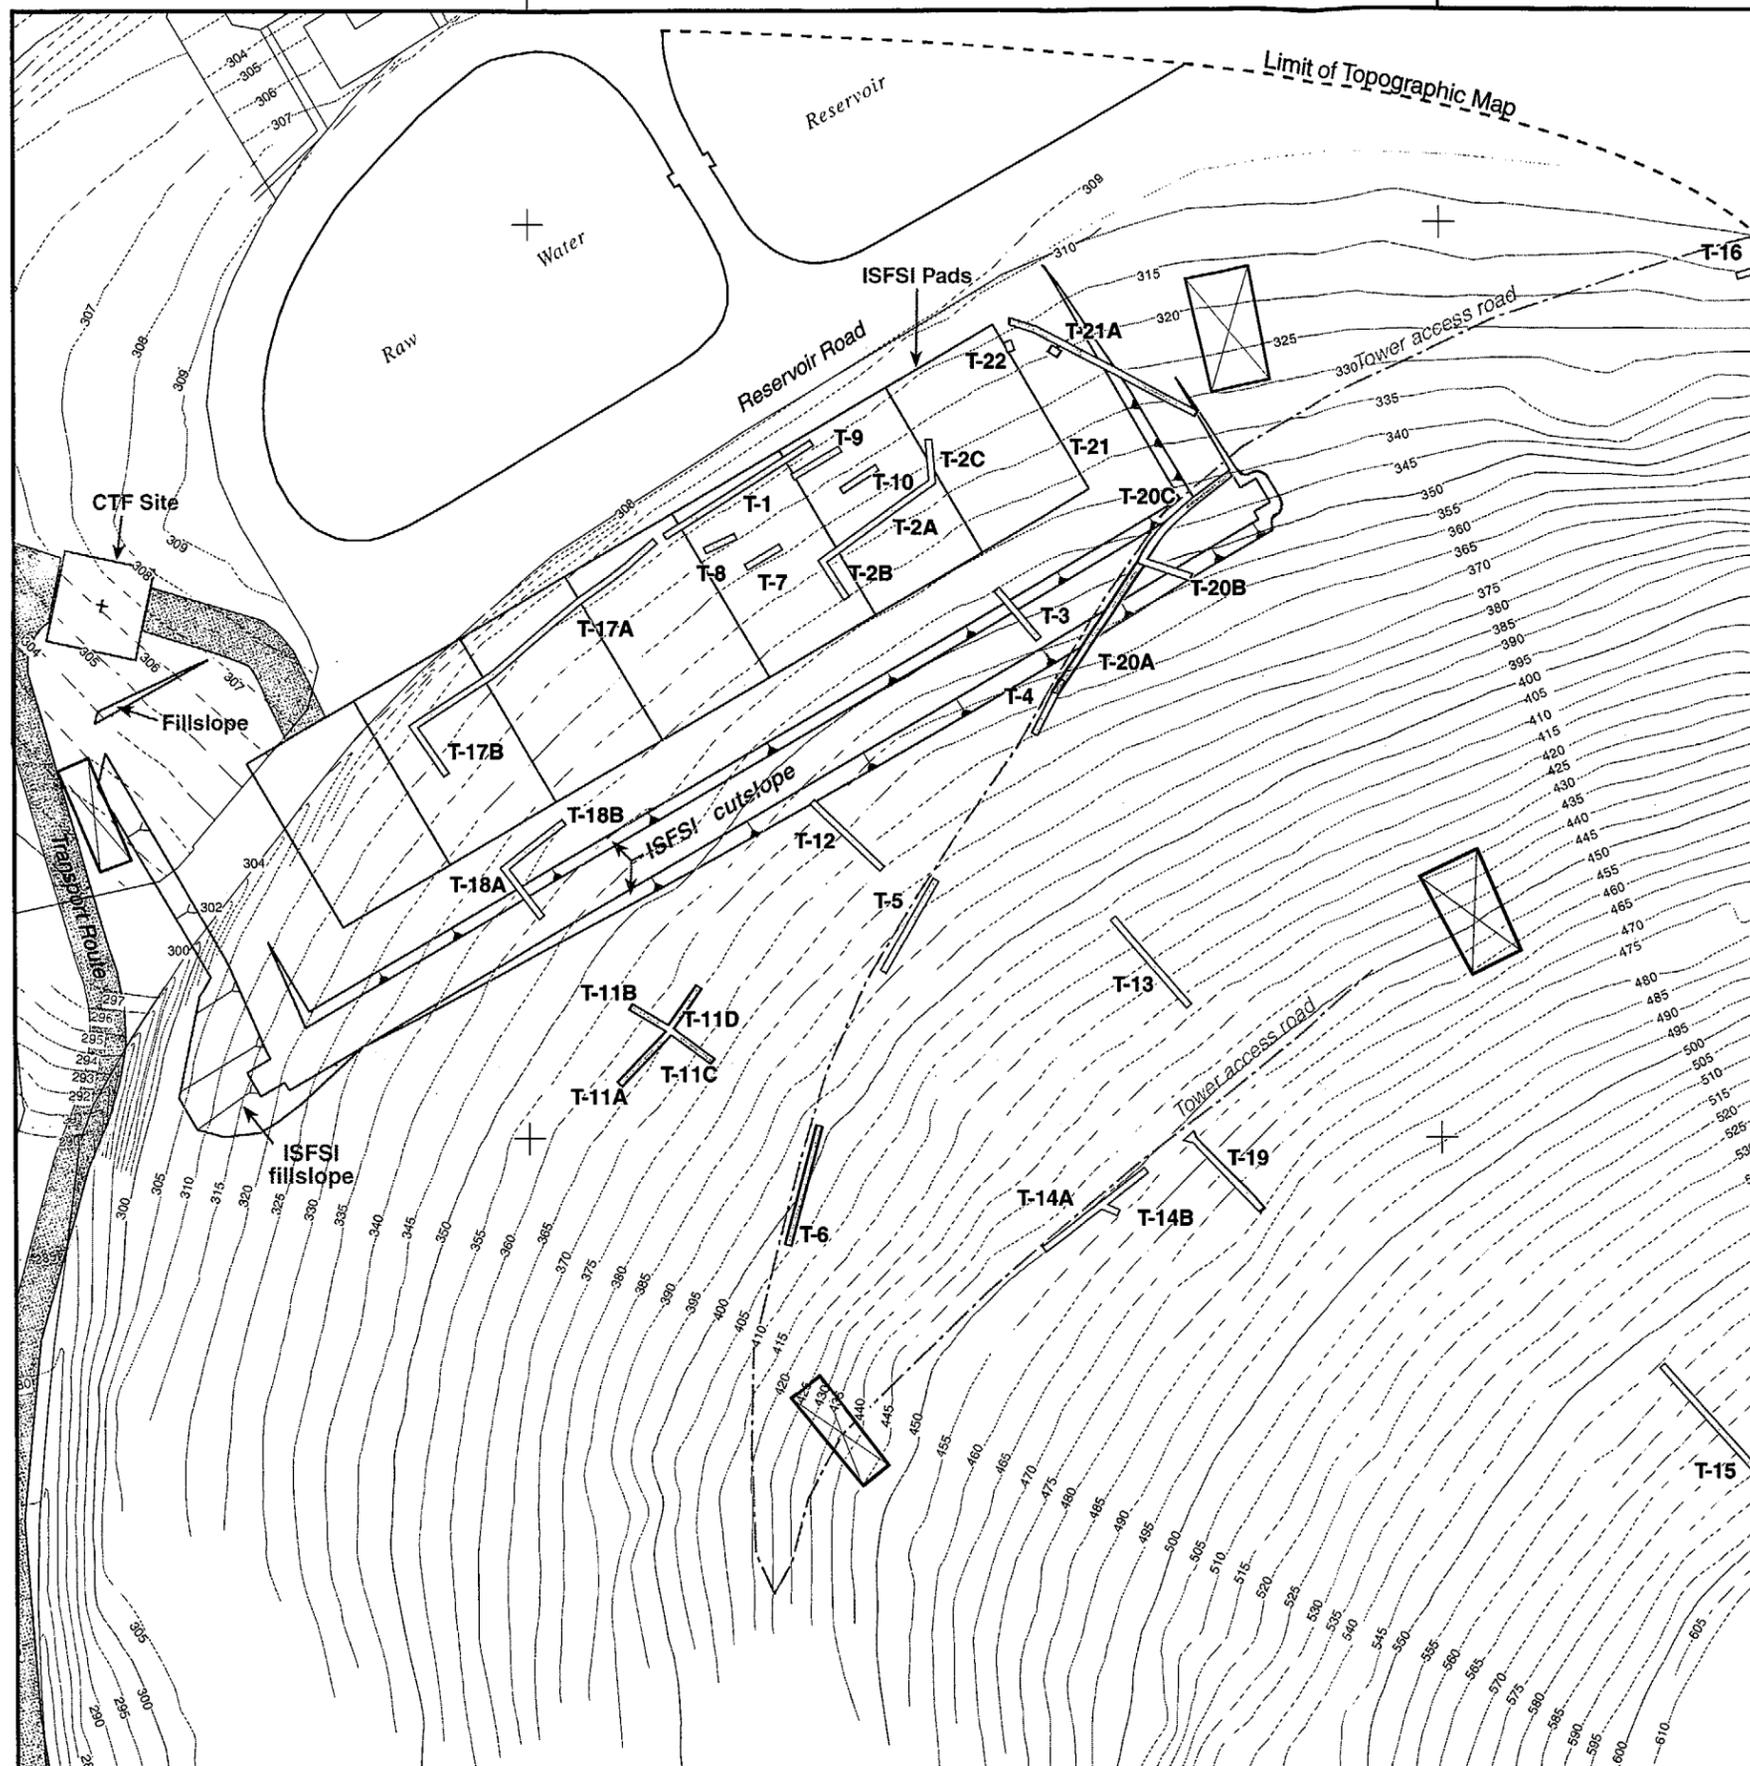
**FIGURE D-1
LOCATION OF EXPLORATION TRENCHES**

Five minor bedrock faults were encountered in trenches along the northern (downhill) margin of the site (e.g., trenches T-1, T-17). The faults strike west-northwest, are steeply dipping to vertical, and juxtapose rocks of different lithologies (Figure D-1). The sense of vertical separation generally is down to the northeast. Slickensides generally are subhorizontal. Combined, the sense of vertical separation and slickensides data indicate primarily right lateral strike slip on the minor faults.

T-3 Exploratory trench, number indicated
-

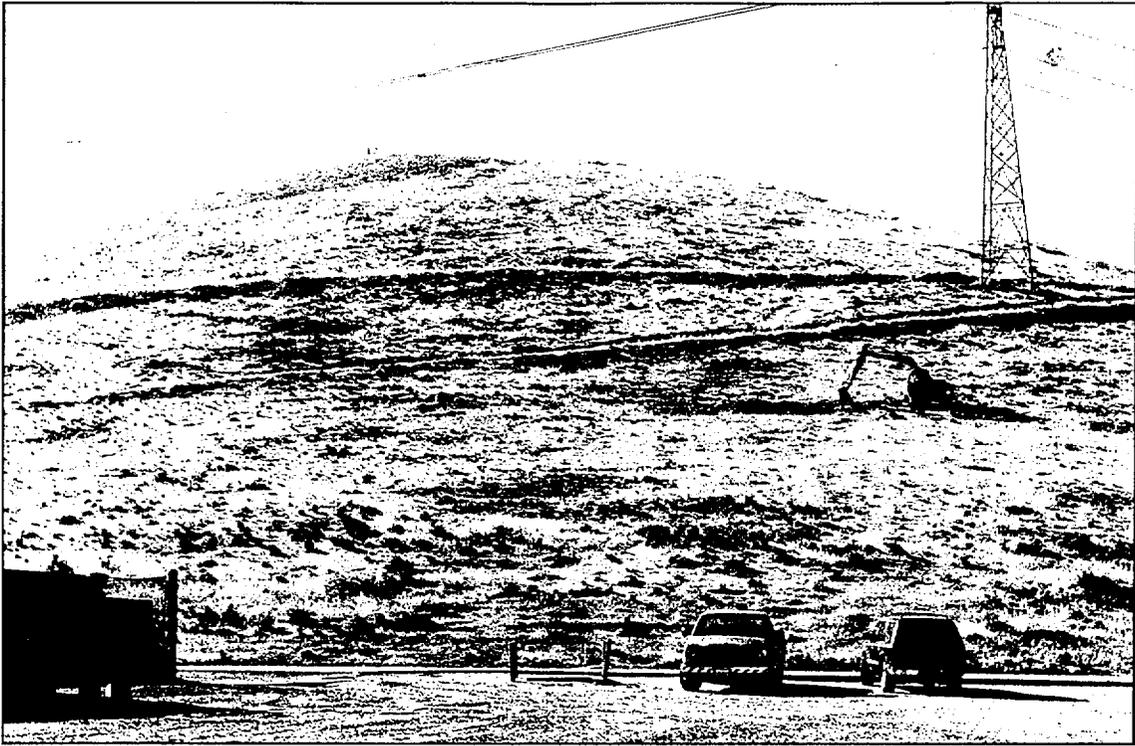
**FIGURE D-3
EXCAVATION OF TRENCH T-11, VIEW TO SOUTH**

Trenches were excavated with a rubber-tire backhoe or track-mounted excavator (Figure D-3), depending on the competence of the rock encountered. Excavation was easy and rapid in zones of friable, weathered, or closely jointed rock. In more massive rock, excavation was moderately difficult to difficult, and some trenches could not be extended more than 6 inches to 2 feet before meeting refusal. Site geologists supervised the trench excavations, cleaned the trench sidewalls with picks, shovels, and brooms, and logged the exposures. The geologists were Jeff Bachhuber, Charles Brankman, John Helms, John Baldwin and Rich Koehler of William Lettis & Associates, Inc. (WLA). Sedimentary beds and fault contacts, including structural features, were flagged with nails and colored plastic survey tape. Logs of the trench exposures were prepared at scales ranging from 1:40 to 1:160 to document rock lithology, structure, and lithologic contacts and are included in this Data Report. Measurements of bedding, joint, and fault orientations were made with a Brunton compass. Discontinuity surveys were performed in selected trenches by extending a fiberglass survey tape across the trench floor or sidewall, and

Excavation of trench T-11, view to the south.

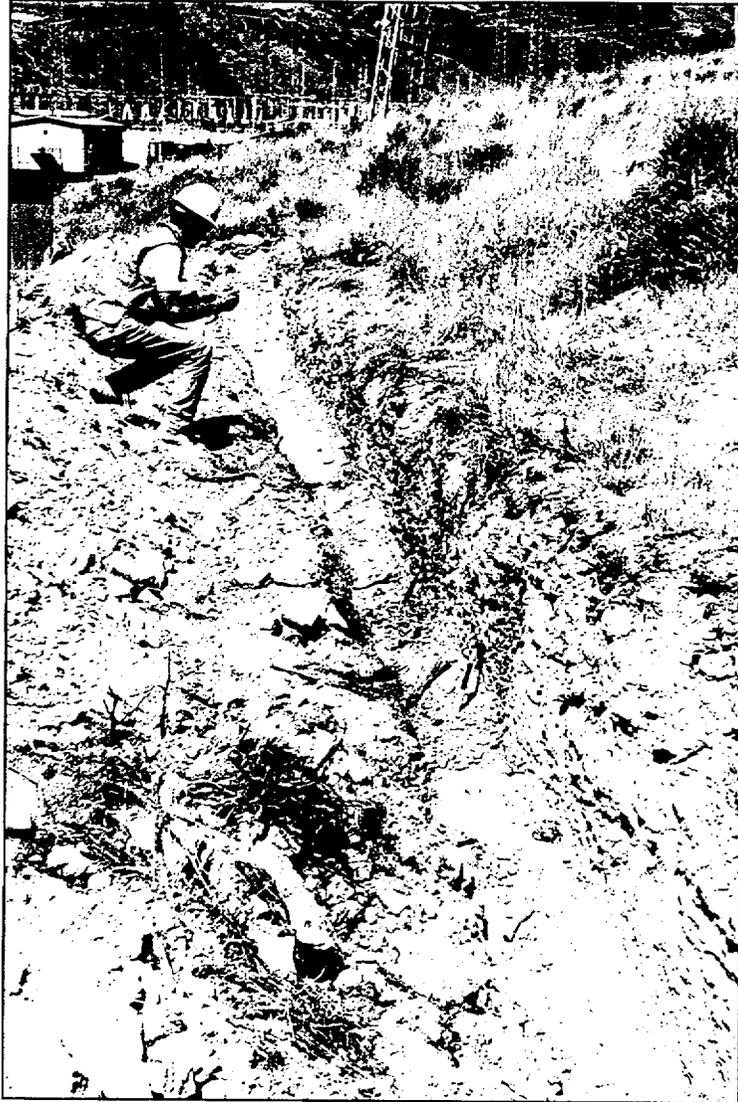
**FIGURE D-4
TRENCH T-1, VIEW TO NORTHEAST**

Altered sandstone (blue-gray color) and dolomite (tan color at far end of trench) in trench T-1. Hammer and orange stake at top of trench across from geologist mark location of a small fault.

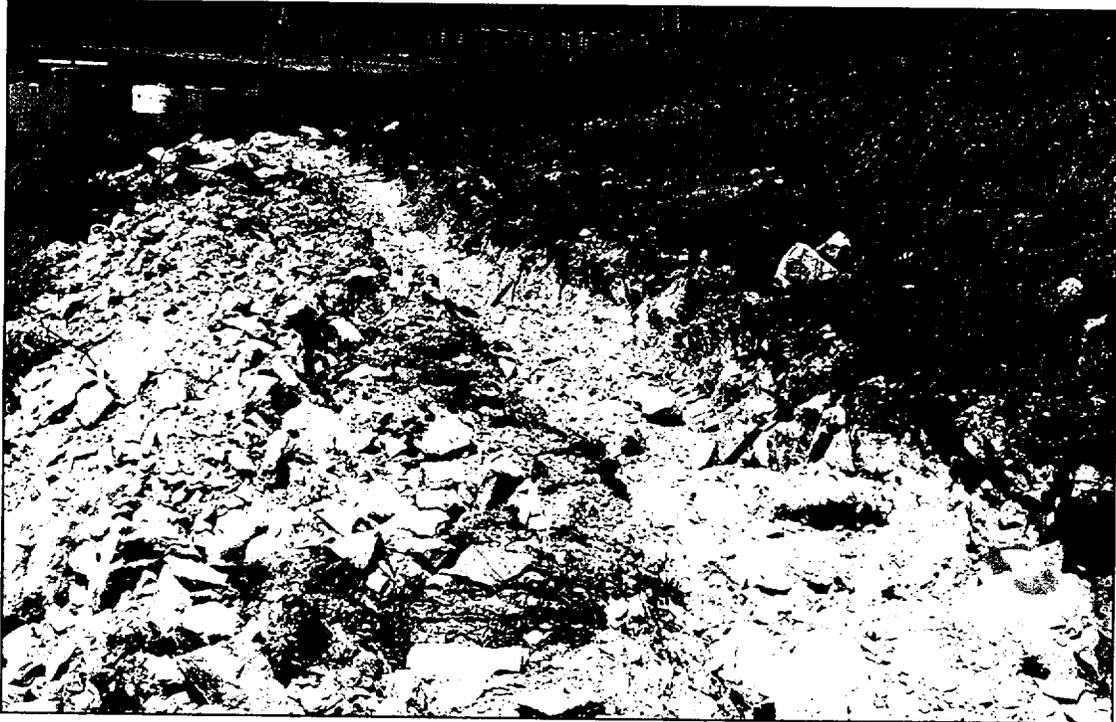
**FIGURE D-5
TRENCH T-2, VIEW TO NORTHEAST**

Typical blocky dolomite exposed in trench T-2.

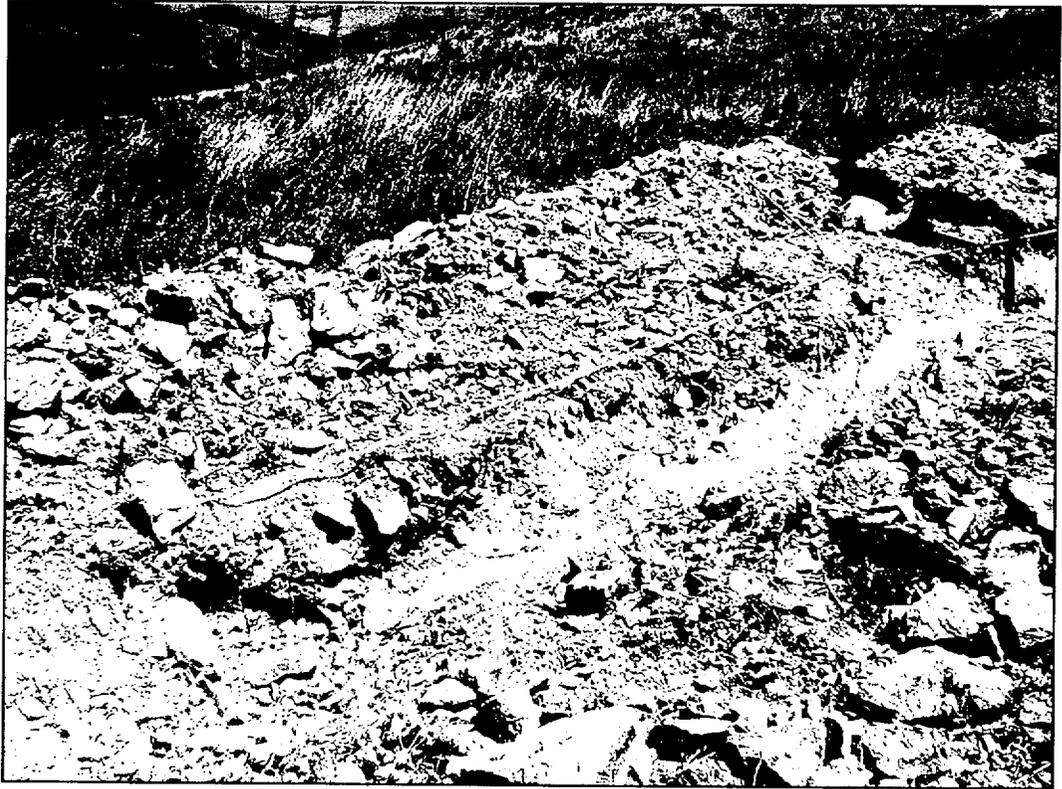
**FIGURE D-6
TRENCH T-3, VIEW TO THE NORTHEAST**

Typical blocky dolomite in trench T-3. Excavator could not rip hard rock in trench bottom, and met practical refusal.

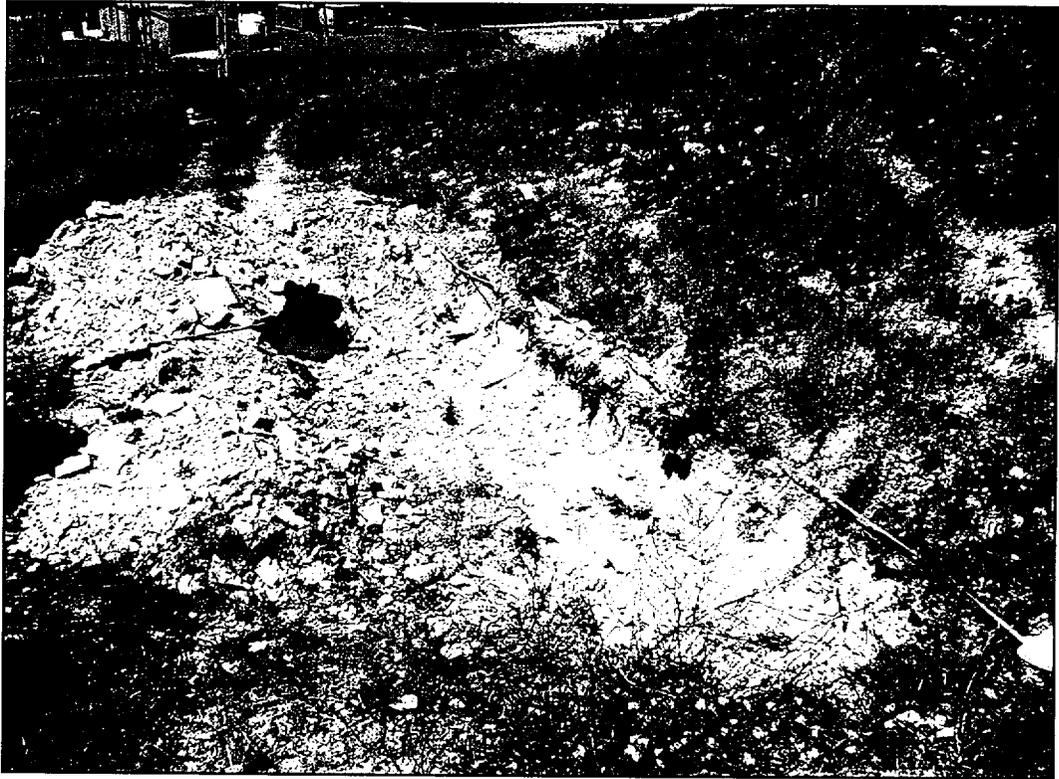
**FIGURE D-7
TRENCH T-4, VIEW TO THE NORTHEAST**

Blocky dolomite in trench T-4 along tower across road.

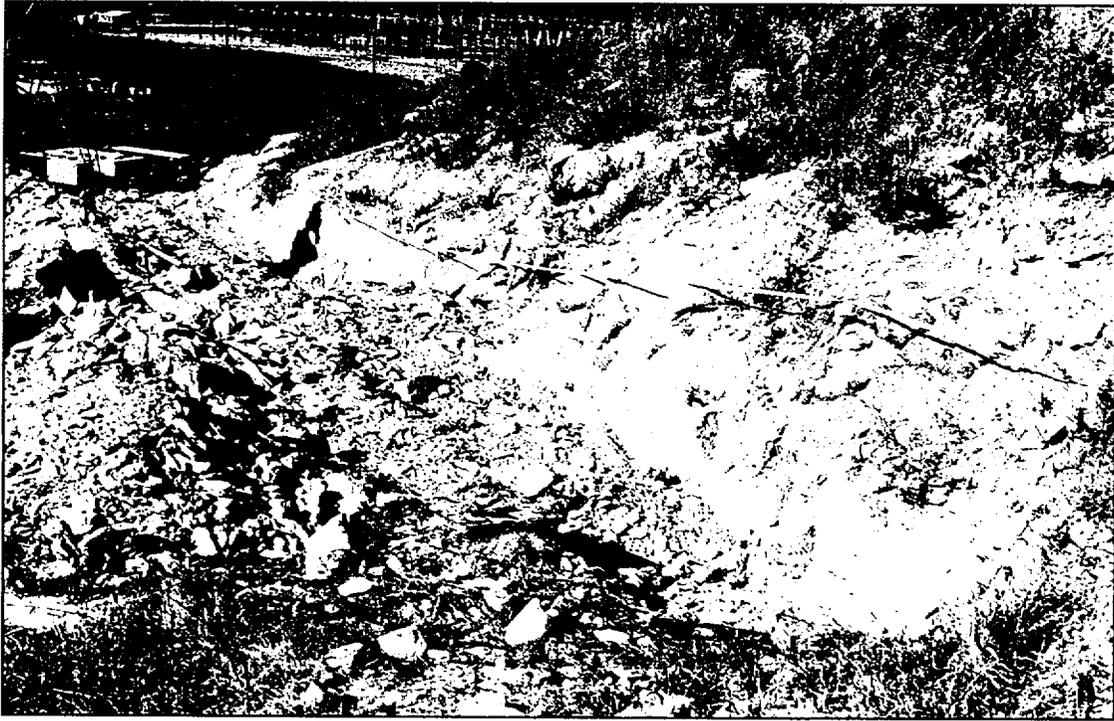
**FIGURE D-8
TRENCH T-5, VIEW TO NORTH**

Blocky to massive dolomite in trench T-5.

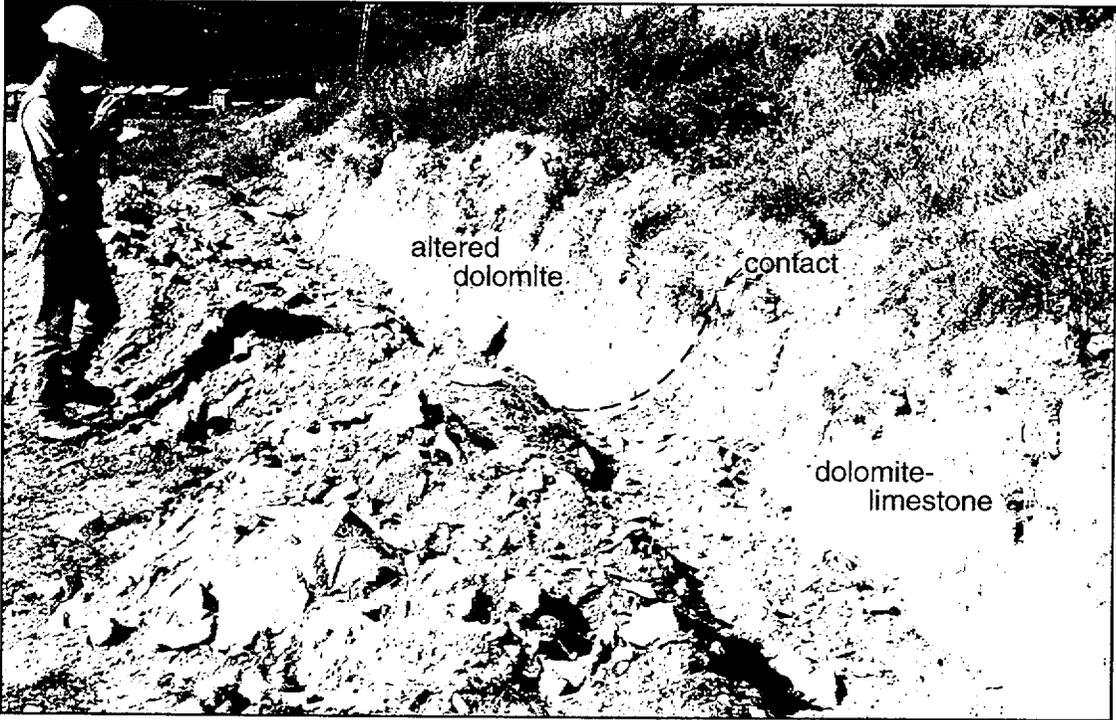
**FIGURE D-9
TRENCH T-6, VIEW TO THE NORTH**

Massive altered dolomite and blocky dolomite-limestone in trench T-6.

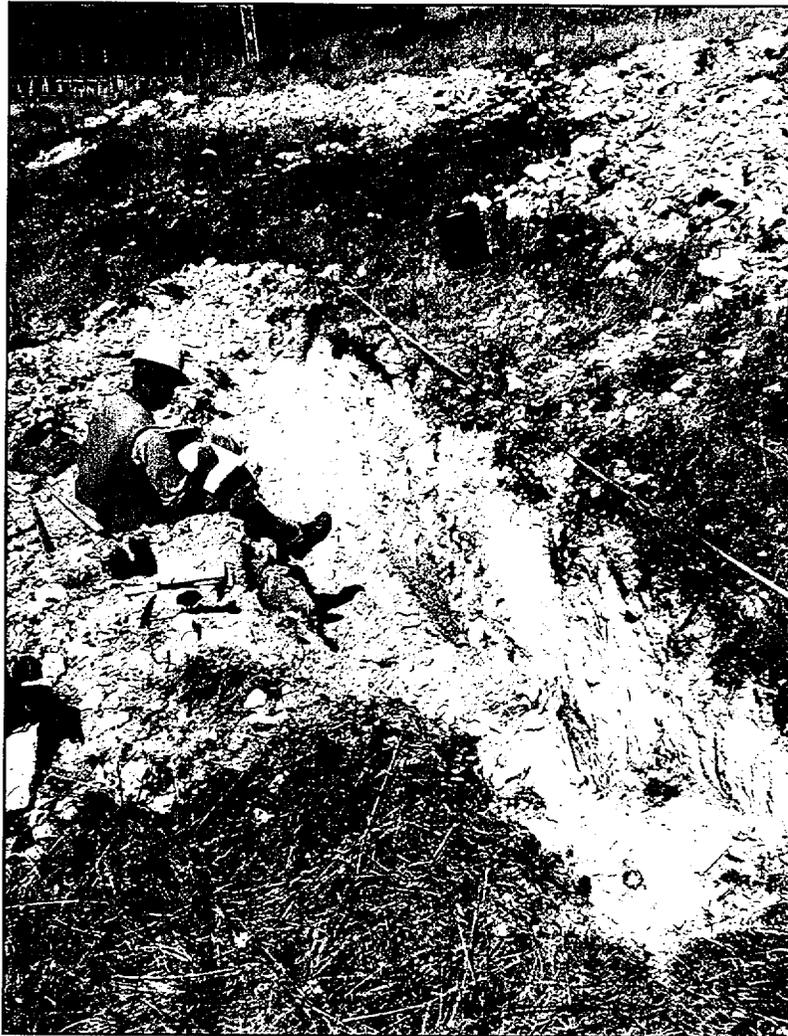
FIGURE D-10 TRENCH T-7, VIEW TO THE NORTHEAST

Blocky dolomite (tan) and altered sandstone (blue-gray) in trench T-7.
Several small secondary faults are marked by red survey flagging.

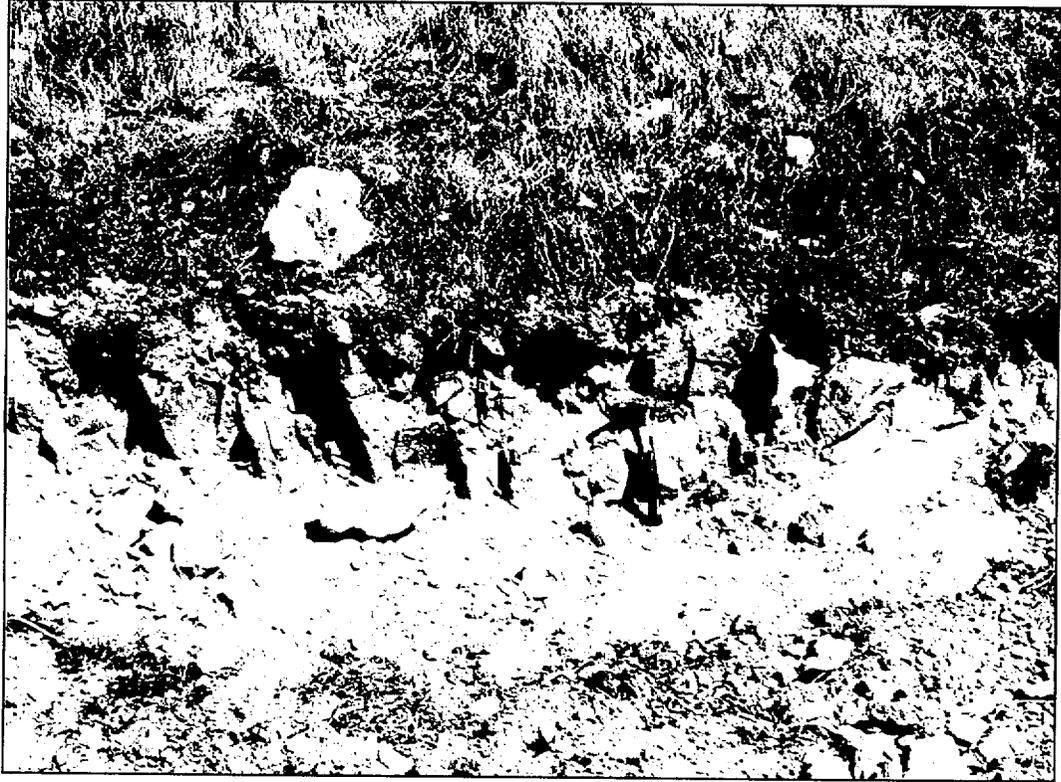
**FIGURE D-13
TRENCH T-10, VIEW TO THE SOUTHEAST**

Blocky dolomite in trench T-10.

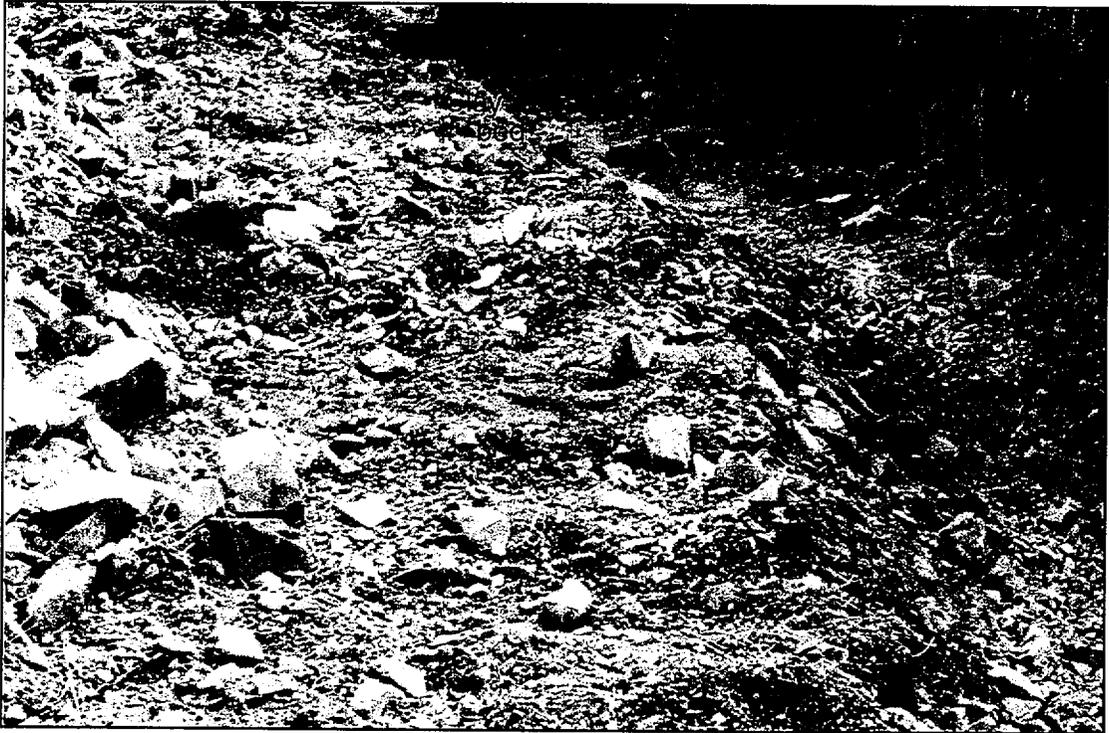
**FIGURE D-17
TRENCH T-14, VIEW TO NORTHEAST**

Blocky dolomite and clay bed in trench T-14.

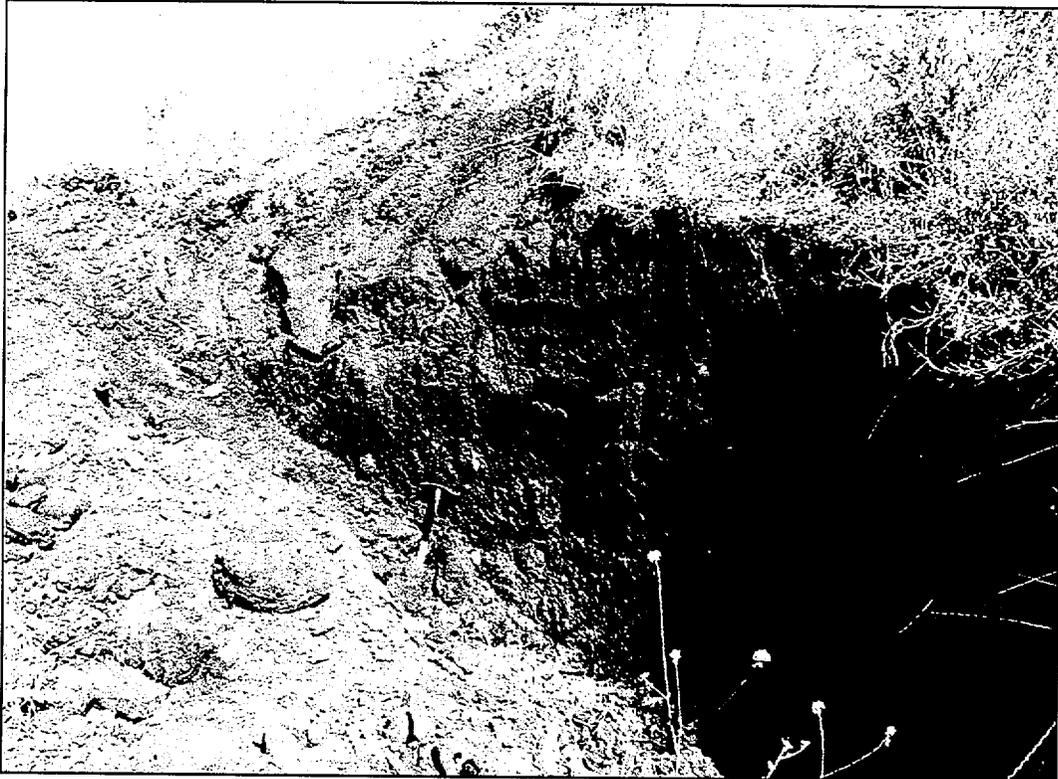
**FIGURE D-19
TRENCH T-16, VIEW TO THE SOUTH**

Thick clay colluvium in trench T-16.

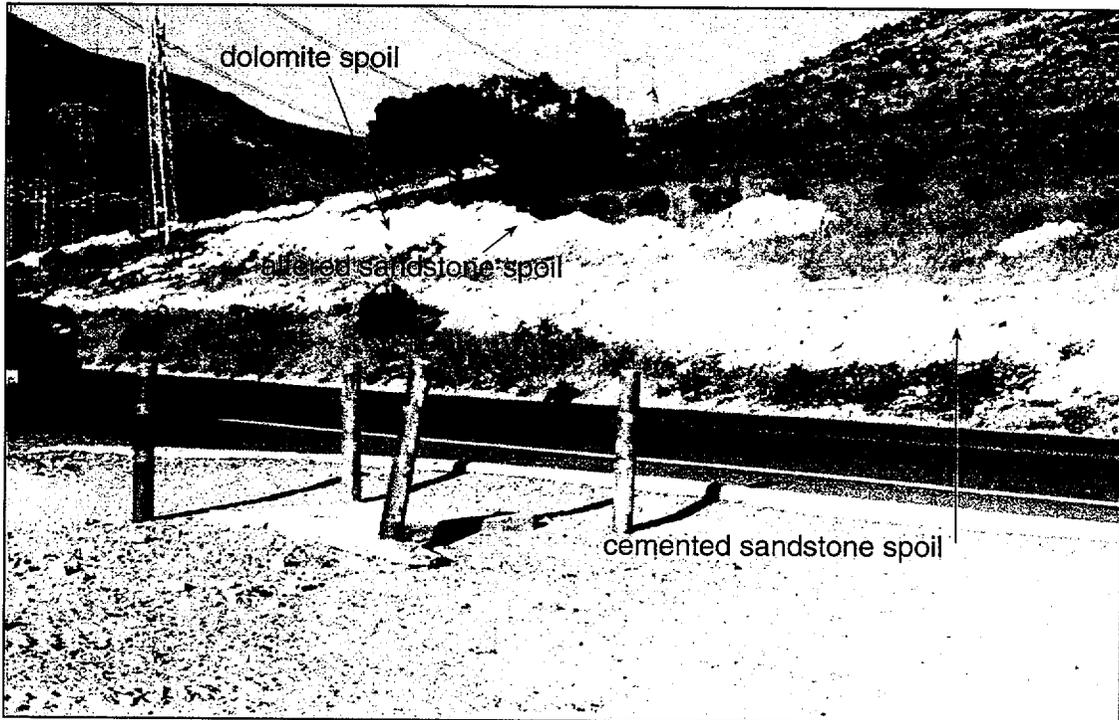
FIGURE D-20
TRENCH T-17 (FOREGROUND ALONG RESERVOIR
ROAD) VIEW TO THE SOUTHEAST

Distant view of trench T-17. Trench spoil piles show general locations of different rock types encountered at equivalent locations in the trench. Tan rock spoil along the right (near) part of the trench is derived from cemented sandstone. Blue-gray spoil in the middle and distant part of the trench is from altered sandstone. Tan spoil at the far end of the trench is from dolomite.

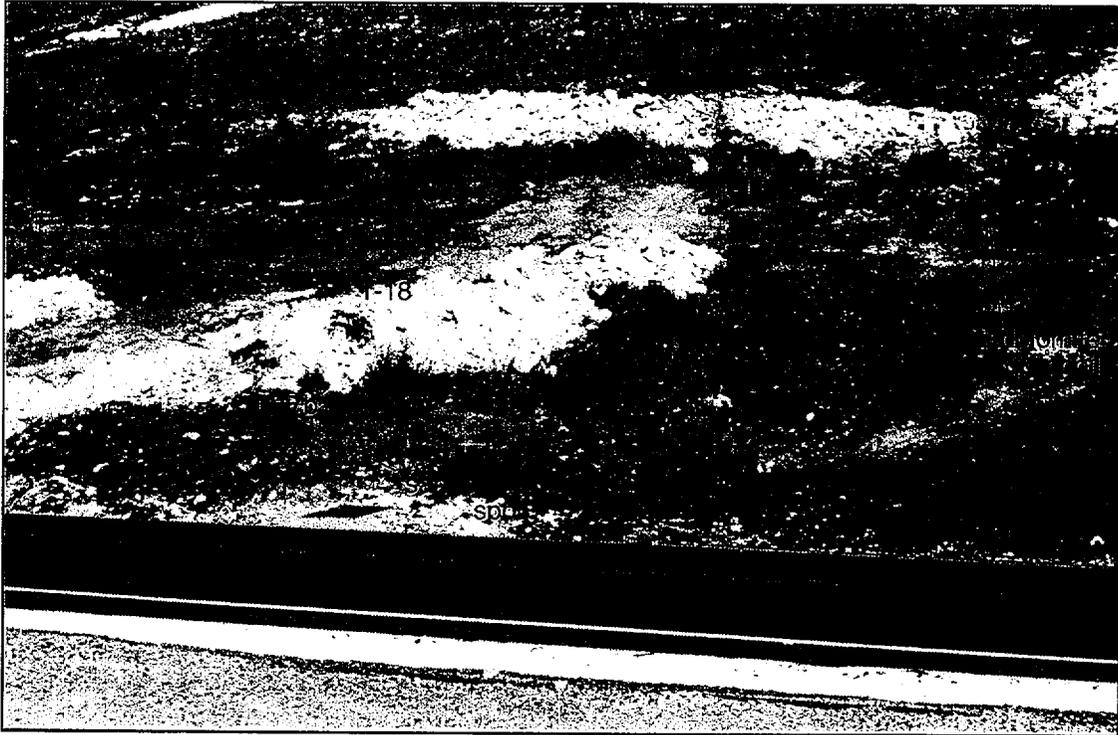
FIGURE D-21
TRENCH T-18 (CENTER OF PHOTO)
VIEW TO SOUTHEAST

Trenches T-17b, and T-18, and T-11, and associated spoil piles. Trench T-17b exposed cemented sandstone of unit Tof_{b-2} , and trenches T-11 and T-18 encountered dolomite of unit Tof_{b-2} . The contact between Tof_{b-2} and Tof_{b-1} trends subparallel to the slope contours between trenches T-17b and T-18.

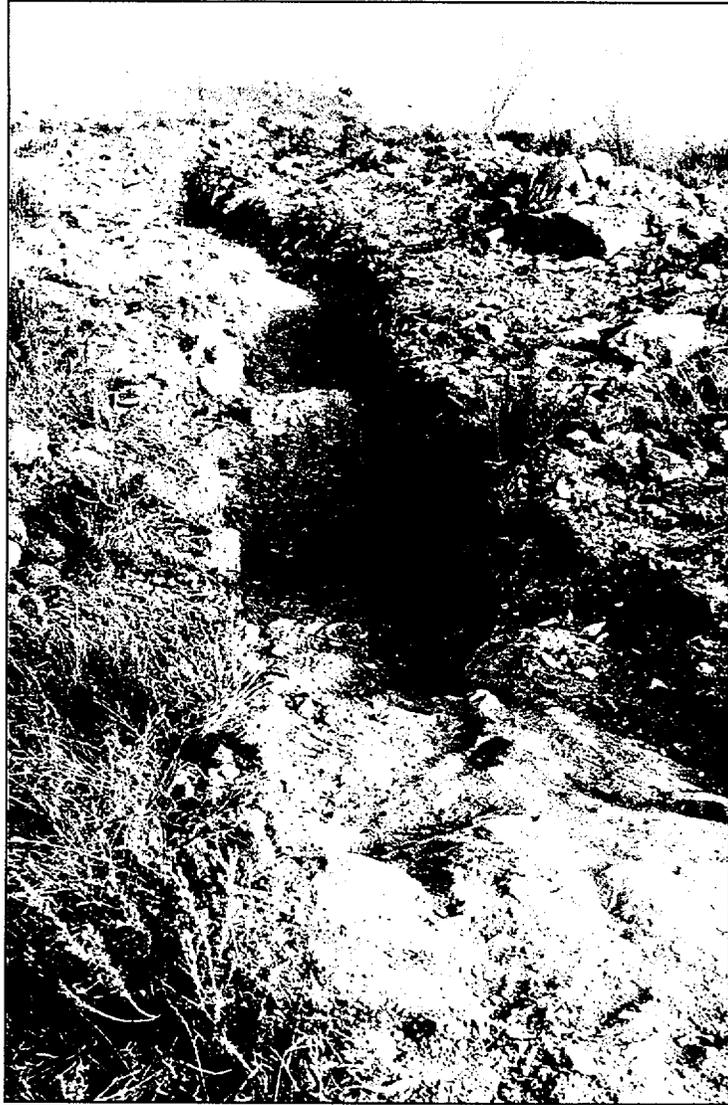
**FIGURE D-22
TRENCH T-19, VIEW TO NORTHWEST**

Blocky to massive dolomite in trench T-19.

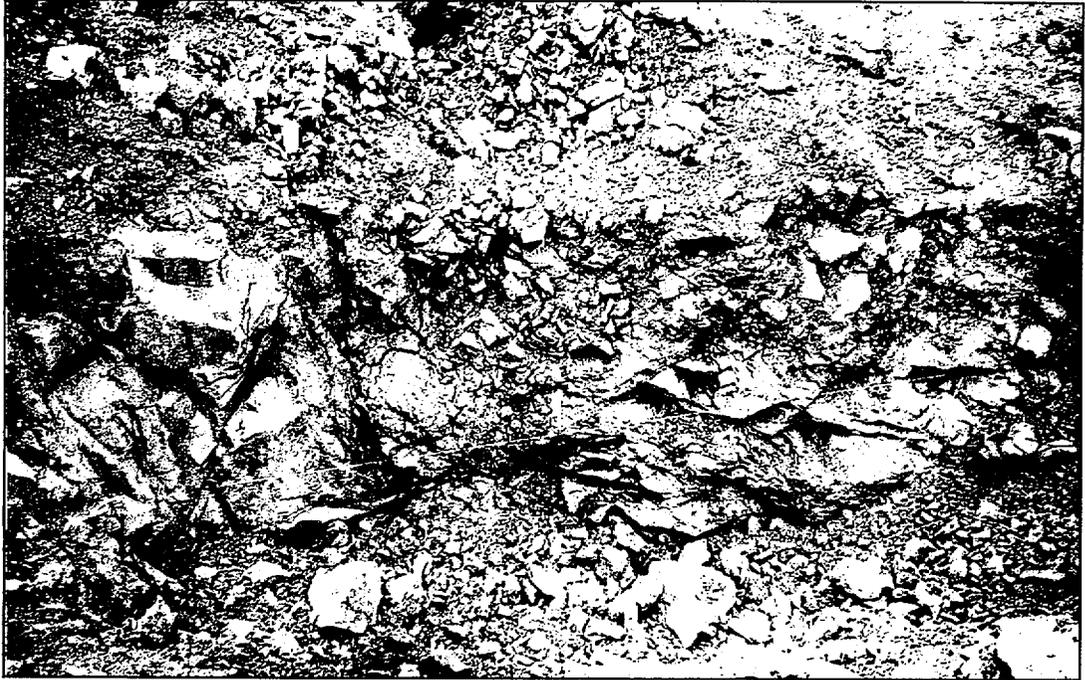
**FIGURE D-25
TRENCH T-22**

Dolomite in trench T-22.

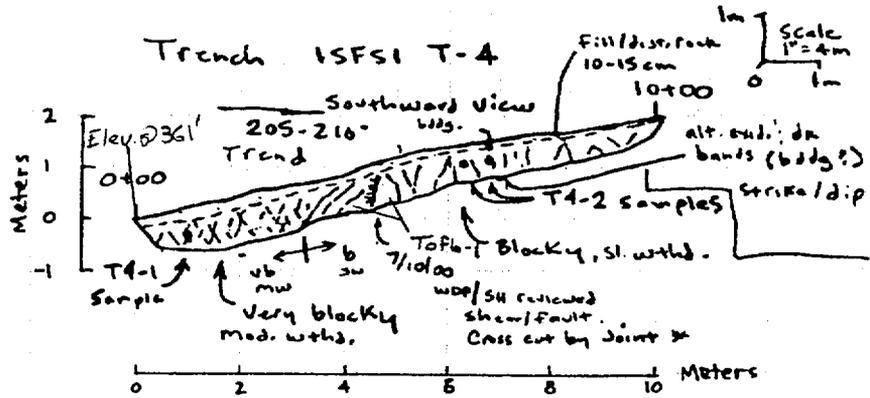
TRENCH T-4
 SOUTHEAST WALL

Entire trench exposes same dolomitic sandstone, relatively hard. Topb-1

Bedding E-W 270, 6° St. 6+80

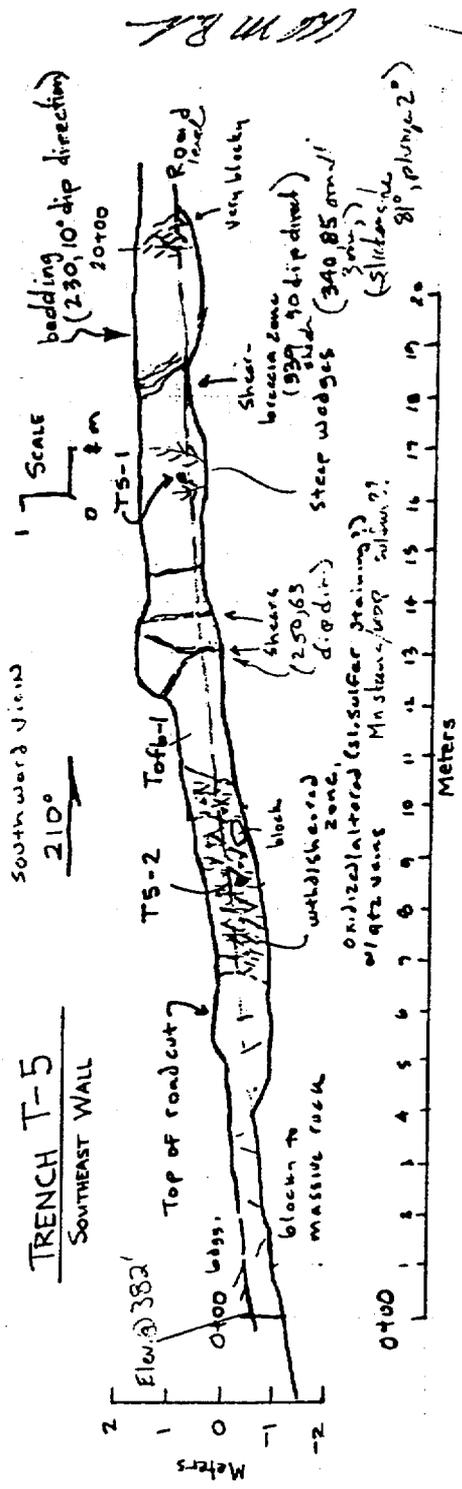
Trench 15FS1 T-5
 Tan dolomitic sandstone
 exposed throughout
 trench / road cut, (Tofb-1)
 Some zones of increased
 wthg. end faulted
 brecciation.
 Bedding laminations and
 surfaces.
 Bag. is tightly-banded
 w/ discontinuous beds
 Joints 0.25-0.5m long.
 Significant cohesion - found
 along bedding surfaces

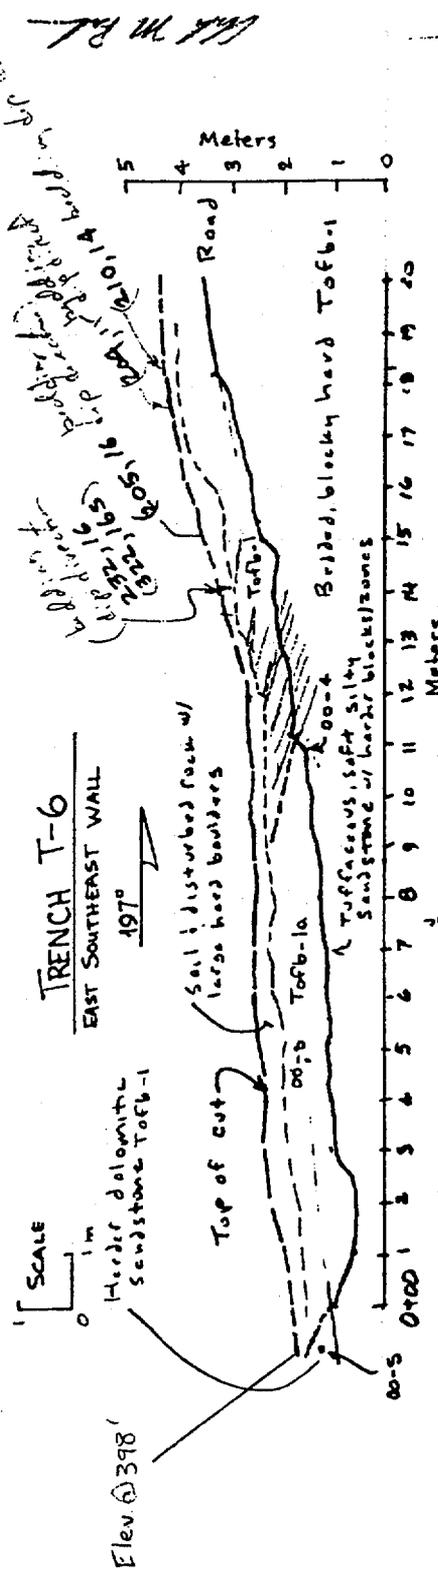
Trench ISFSI T-6
Rock type changes
across trench -
Beds described as
TOFb-1 and TOFb-1 were better grouped into
unit TOFb-1 - (M.B. 1012300)

TOFb-1a Turfaceous,
yellow-tan orange
Sandstone w/ harder
blocks can give Diwack
but pervasive Hel reaction
TOFb-1 light tan-
sandy
fine-grained almost
hard, laminated strong
Hel reaction
Tuff to nodded
beds.

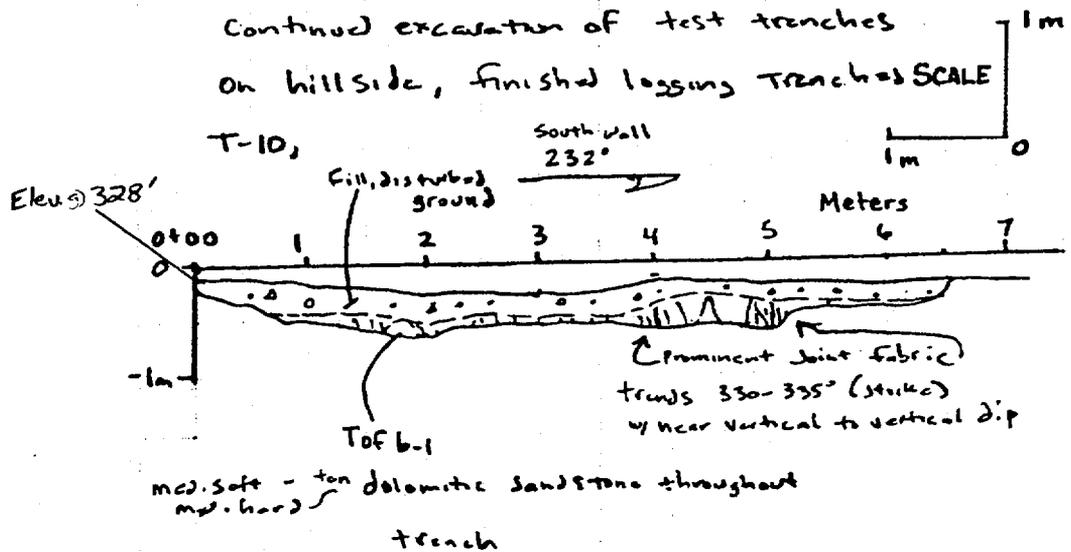
TRENCH T-10

Bedrock exposed continuously across trench
floor. Rock mass is tight w/ close to widely
spaced joints (blocky to very blocky).
Some slight slickensides and manganese on
tight joint surfaces, but no gouge or crushed zones.

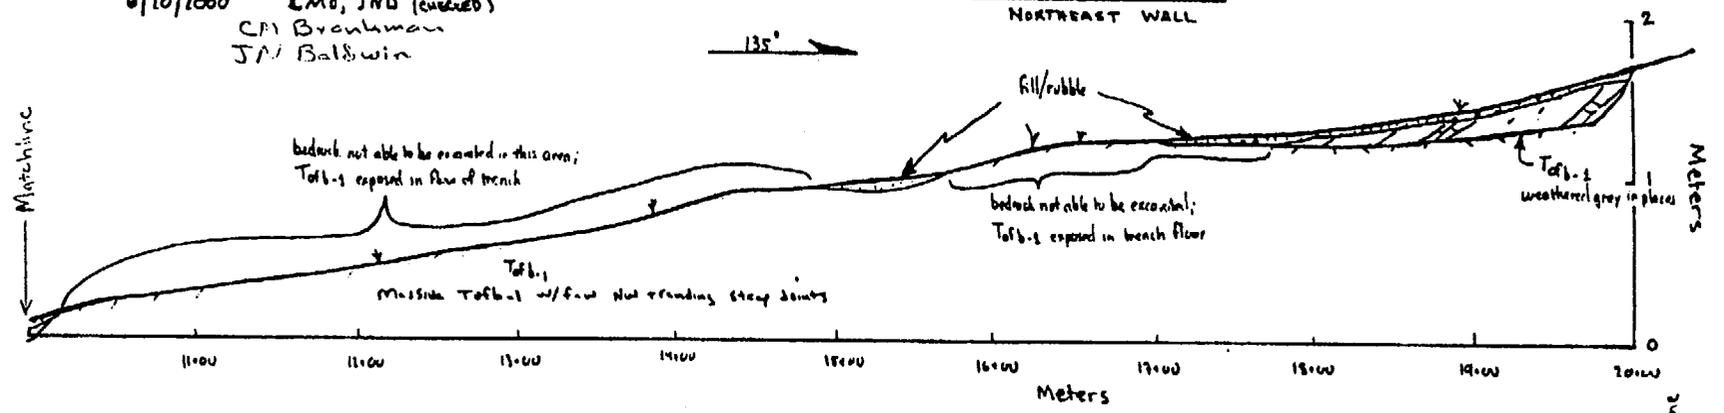
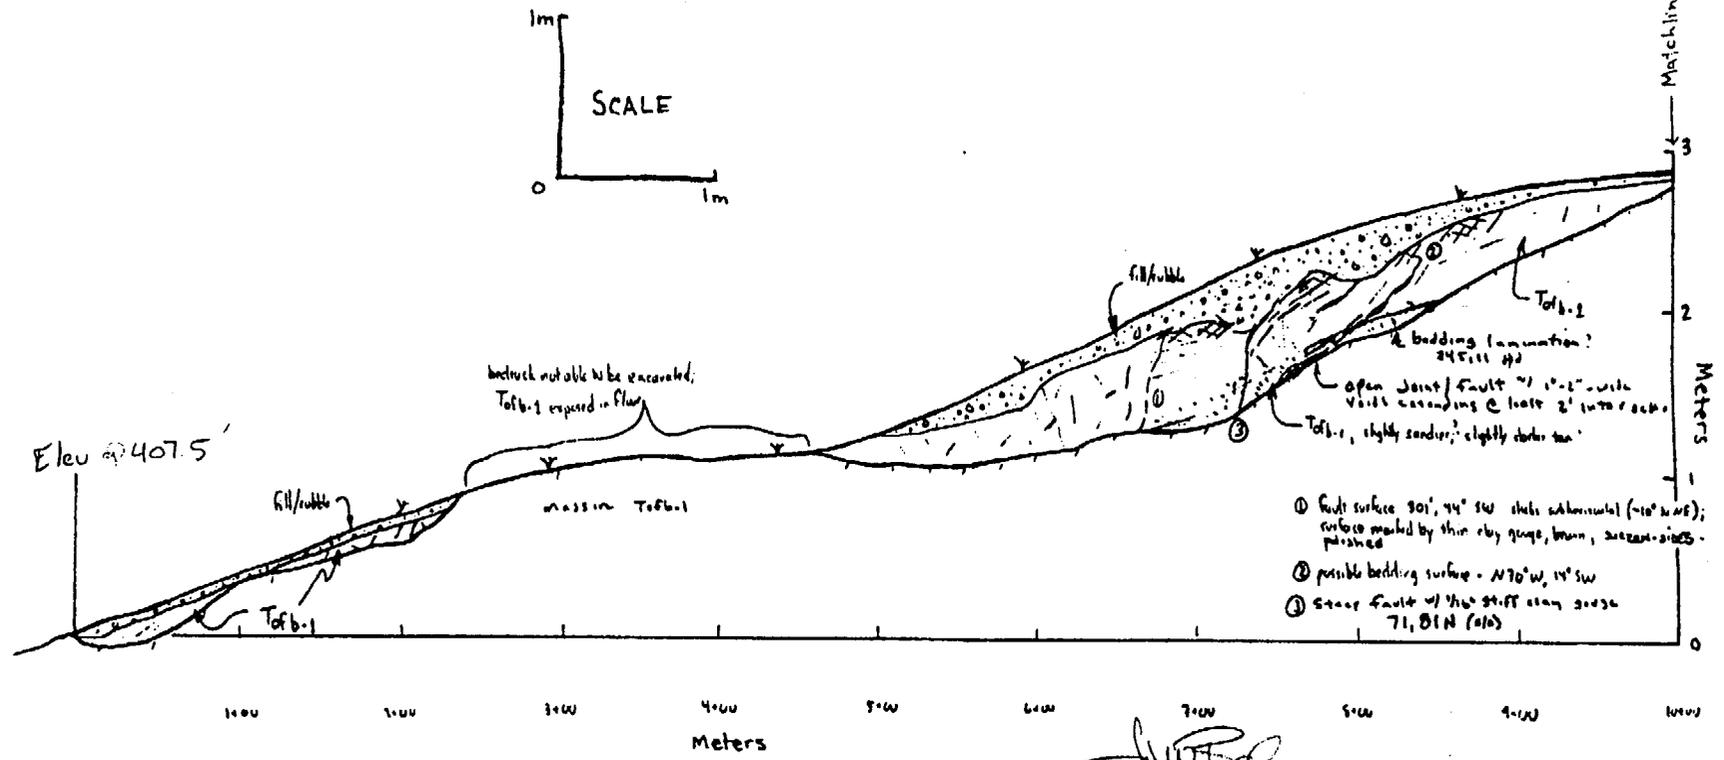
TRENCH T-13
NORTHEAST WALL

- ① fault surface 301, 74° SW steep subhorizontal (~10° NNE); surface marked by thin clay gouge, brown, calcareous, slickensided
- ② possible bedding surface - N70°W, 14° SW
- ③ steep fault w/ thin stiff clay gouge 71, 81 N (10)
