DATA REPORT D
TRENCHES IN THE ISFSI STUDY AREA
DIABLO CANYON ISFSI

DCPP ISFSI SAR
Data Report D
Trenches in the ISFSI Study Area

Twenty-two shallow (1- to 8- feet-deep) trenches (designated T-1 to T-22) with cumulative length of about 1,510 feet, were excavated and logged at the Diablo Canyon ISFSI study area to obtain information on bedrock stratigraphy and rock mass properties (Figures D-1 and D-2). The trenches expose marine sedimentary rocks of unit Tof₆ of the Tertiary Obispo Formation and Holocene colluvium. Discontinuity surveys of joints, fractures and bedding (William Lettis & Associates, Inc., 2001, Diablo Canyon ISFSI Data Report F), as well as rock mass evaluations (William Lettis & Associates, Inc., 2001, Diablo Canyon ISFSI Data Report H) were performed in the trenches to obtain information to assess slope stability and in situ rock strength. The preparation of this data report was performed under the 2000 WLA Work Plan (William Lettis & Associates, Inc., Work Plan, 2000) using data collected under that Work Plan and the 2001 WLA Work Plan (William Lettis & Associates, Inc., Work Plan, 2001) .

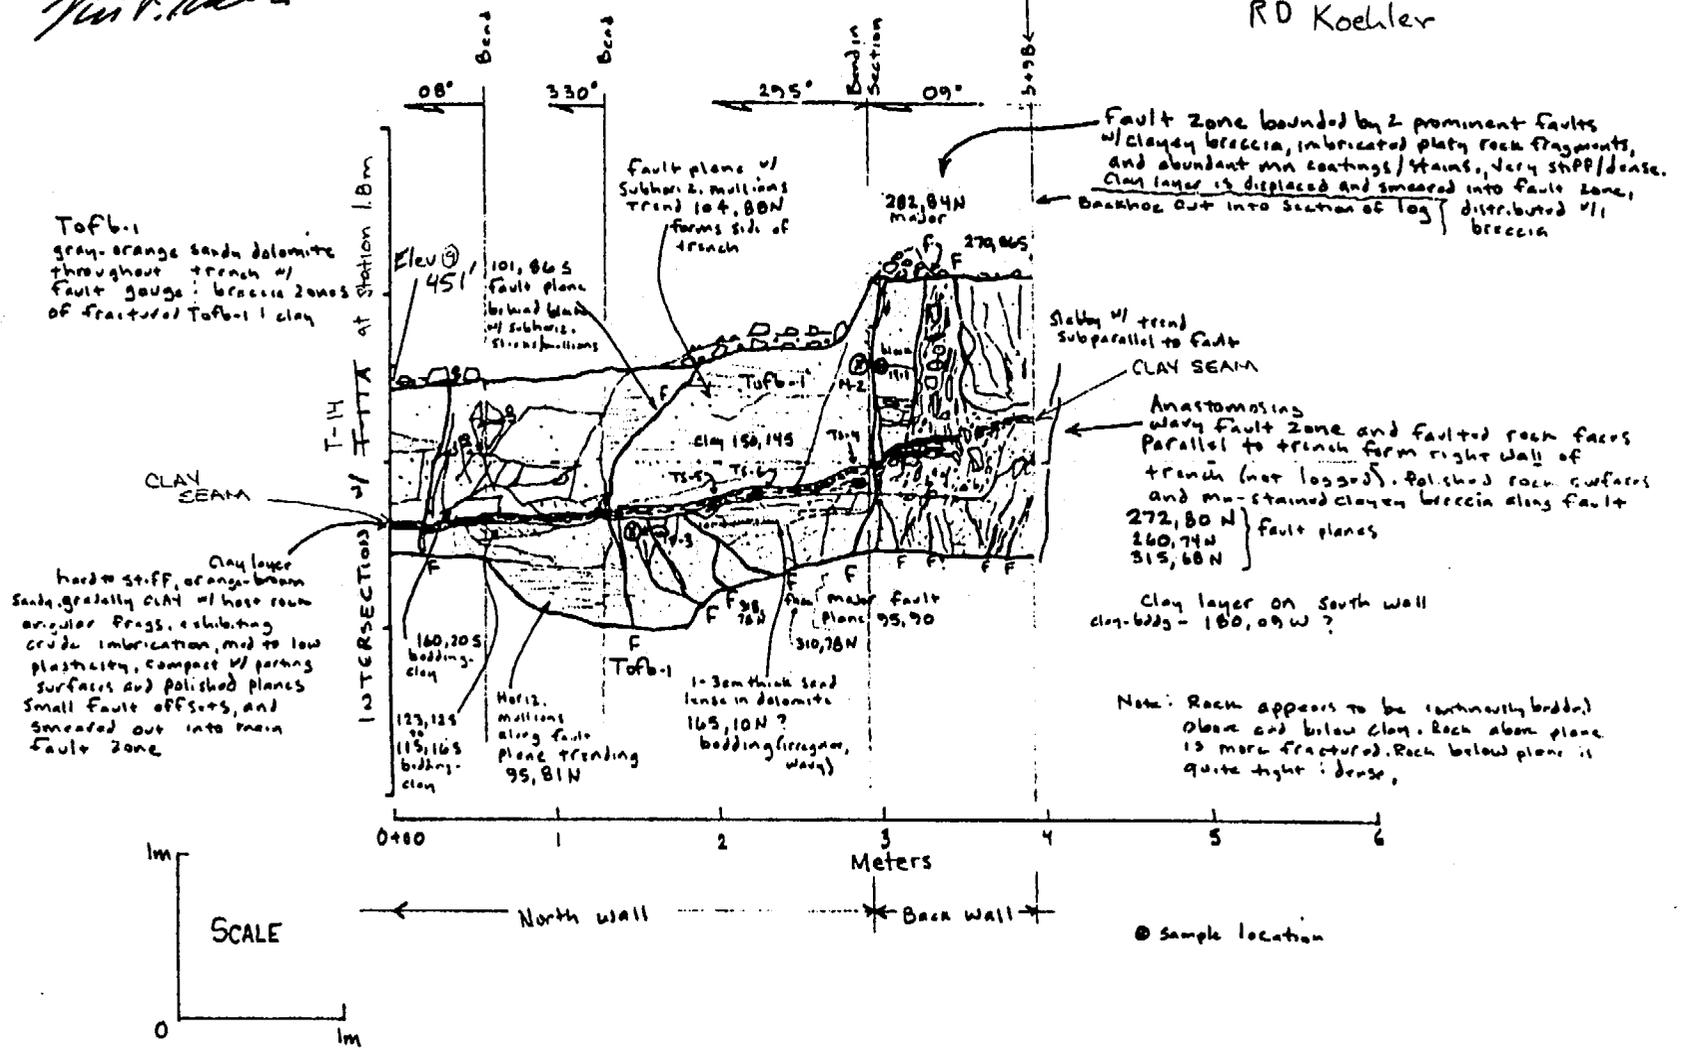
TRENCH T-14B
NORTH WALL

Tufb-1
gray-orange sand dolomite
throughout trench w/
Fault gouge: breccia zones
of fractured Tufb-1 clay

Clay layer
hard to stiff, orange-brown
sandy, generally clay w/ loose rock
angular frags. exhibiting
crude imbrication, mid to low
plasticity, compact w/ parting
surfaces and polished planes
Small fault offsets, and
smeared out into main
Fault zone

Fault zone bounded by 2 prominent faults
w/ clayey breccia, imbricated platy rock fragments,
and abundant mn coatings / stains, very stiff/dense.
Clay layer is displaced and smeared into fault zone,
Backlog out into section of log distributed w/
breccia

Anastomosing
wavy fault zone and faulted rock faces
Parallel to trench form right wall of
trench (not logged). Polished rock surfaces
and mn-stained clayey breccia along fault
272, 80 N } Fault planes
260, 74 N
315, 68 N

Note: Rock appears to be (uniformly bedded)
above and below clay. Rock above plane
is more fractured. Rock below plane is
quite tight & dense.

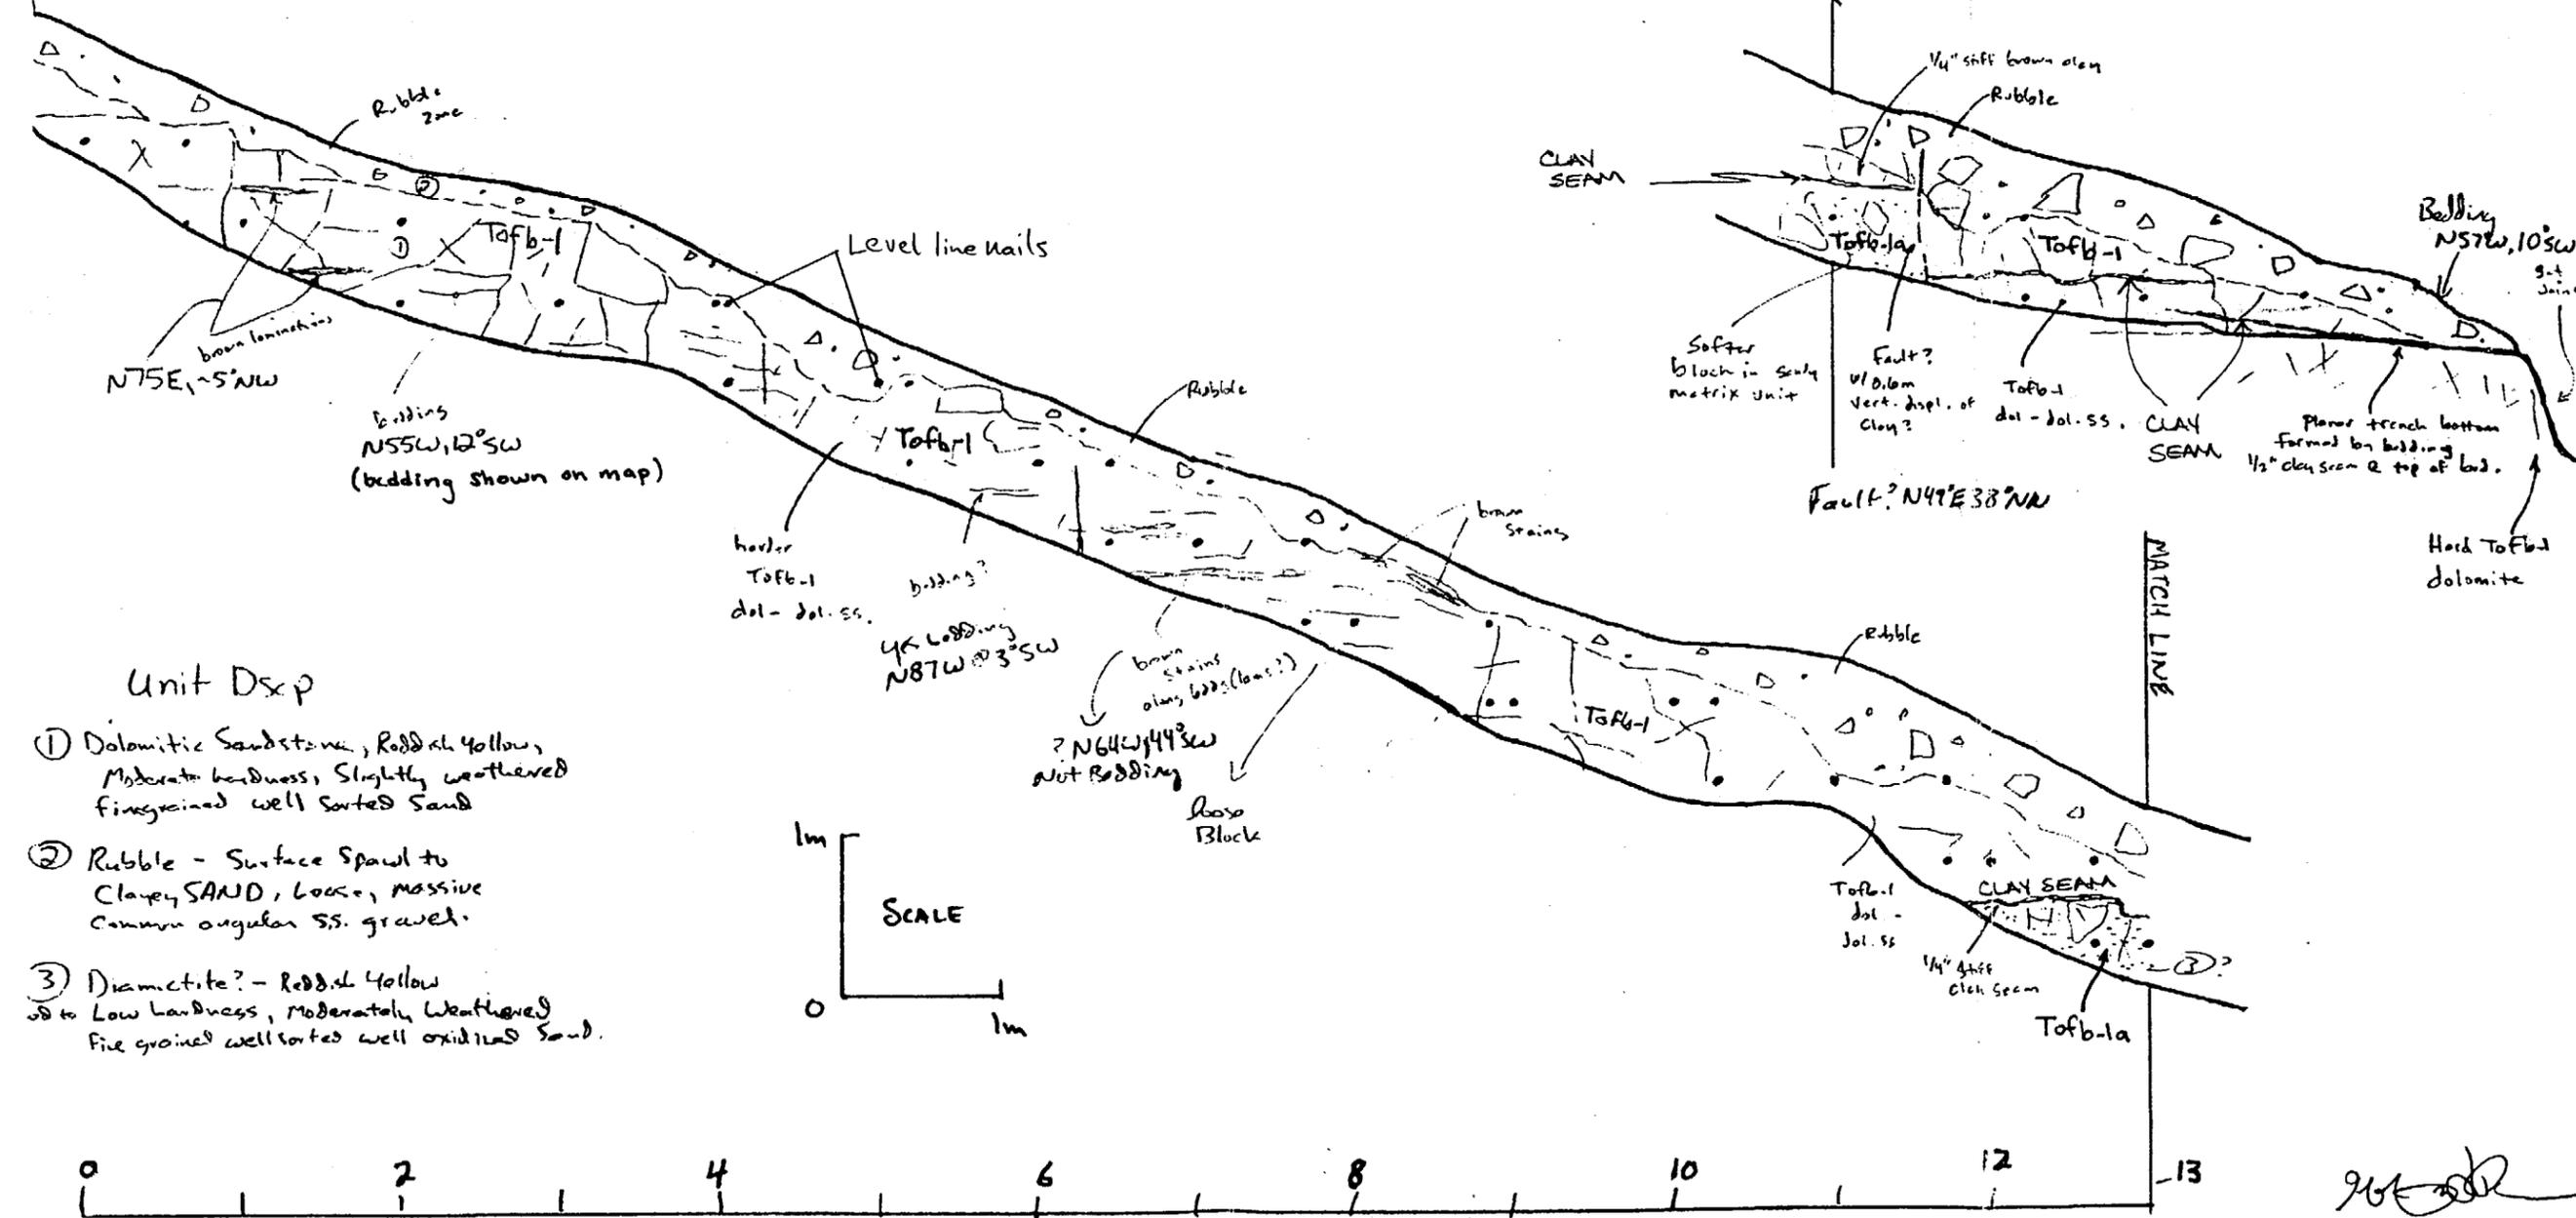
TRENCH T-19 (Slope)
 SOUTHWEST WALL

- ① Dolomitic Sandstone, Reddish yellow, Moderate hardness, Slightly weathered fine grained well sorted Sand
- ② Rubble - Surface Spawl to Clayey SAND, Loose, massive common angular ss. gravel.
- ③ Diamictite? - Reddish yellow to Low hardness, Moderately weathered fine grained well sorted well oxidized Sand.

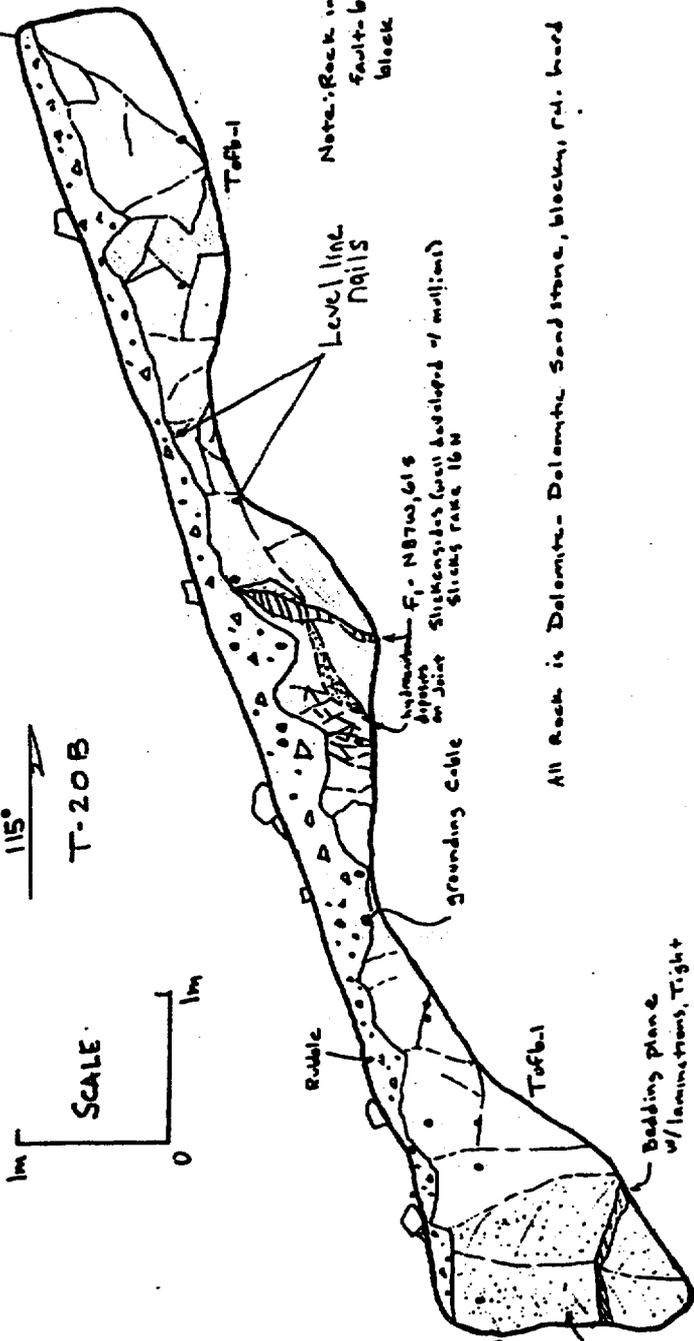
TRENCH T-20B
Northeast Wall

All Rock is Dolomite - Dolomitic Sand stone, blocky, f.d. hard

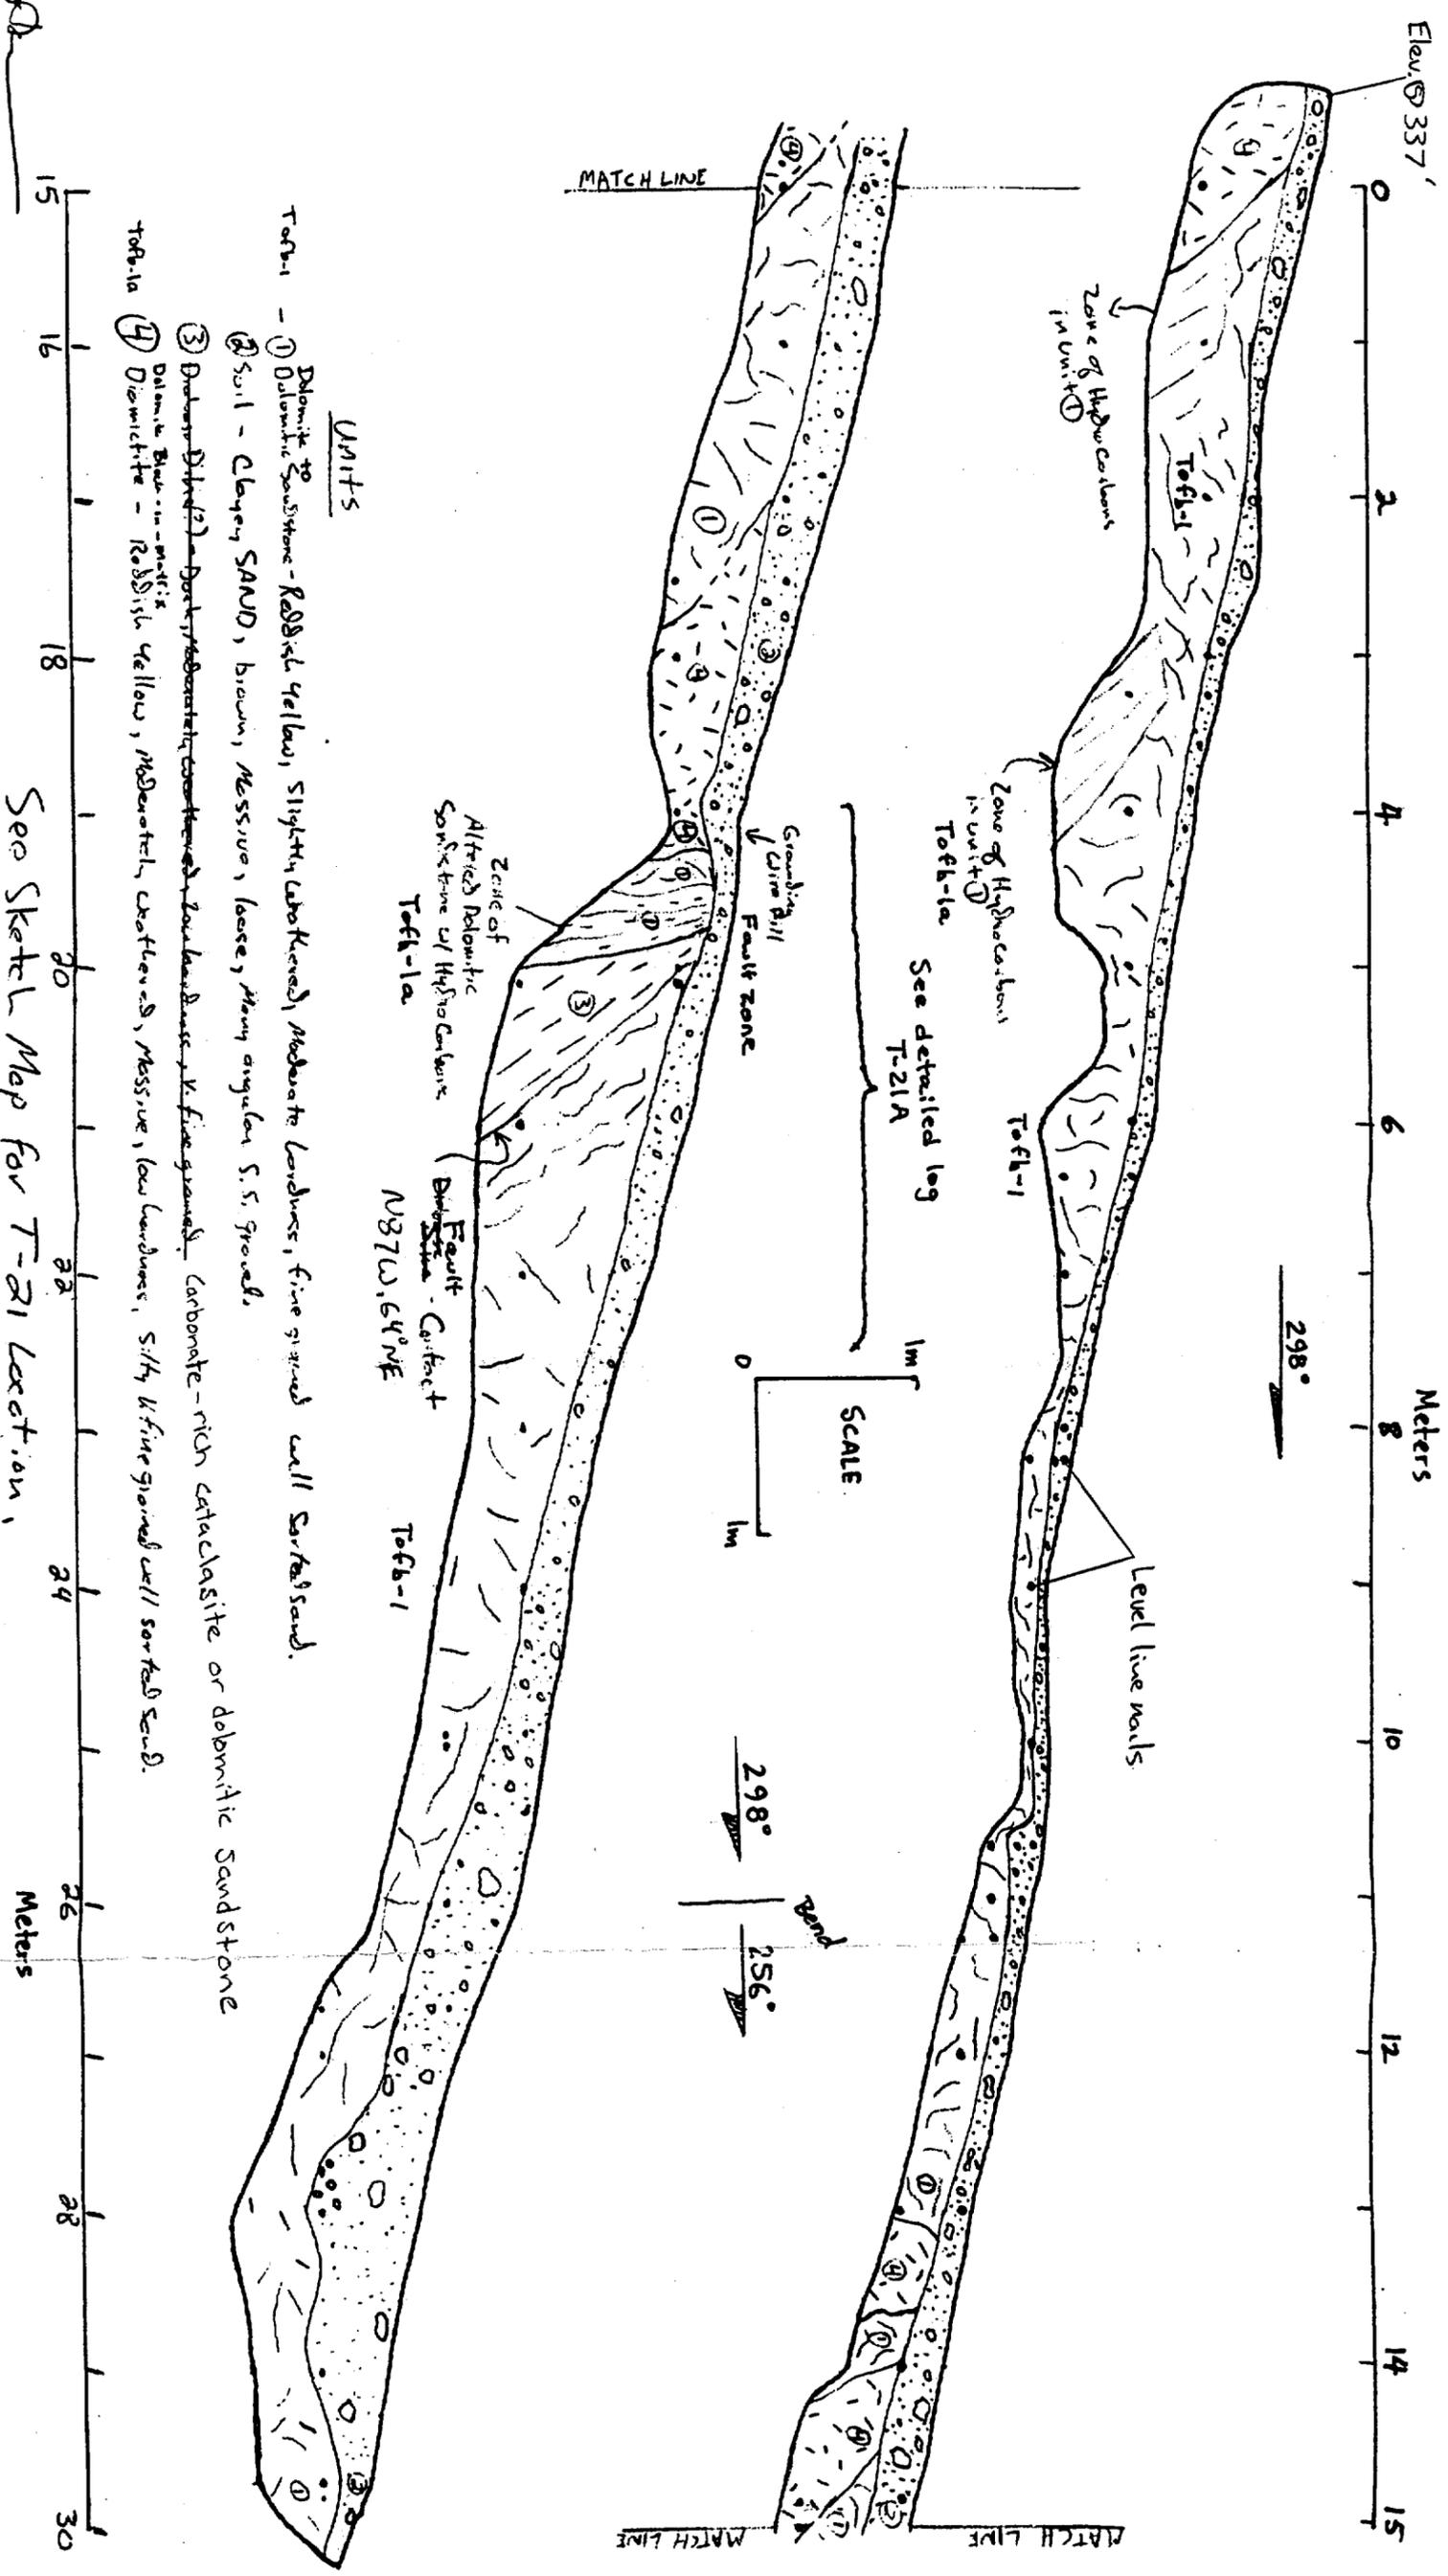
TRENCH T-21
 SOUTHWEST WALL

- Tofl-1 - Dolomite to Sandstone - Reddish yellow, slightly carbonaceous, moderate coarseness, fine grained well sorted sand.
 ② Soil - Clayey SAND, brown, massive, loose, many angular S.S. gravel.
 ③ Dolomite - Dark to black, carbonaceous, moderate to coarse, fine grained, carbonate-rich cataclastic or dolomitic sandstone
 Tofl-1a ④ Dolomitic Breccia - matrix of Dolomite - Reddish yellow, moderate, fractured, massive, low coarseness, silty & fine grained well sorted sand.

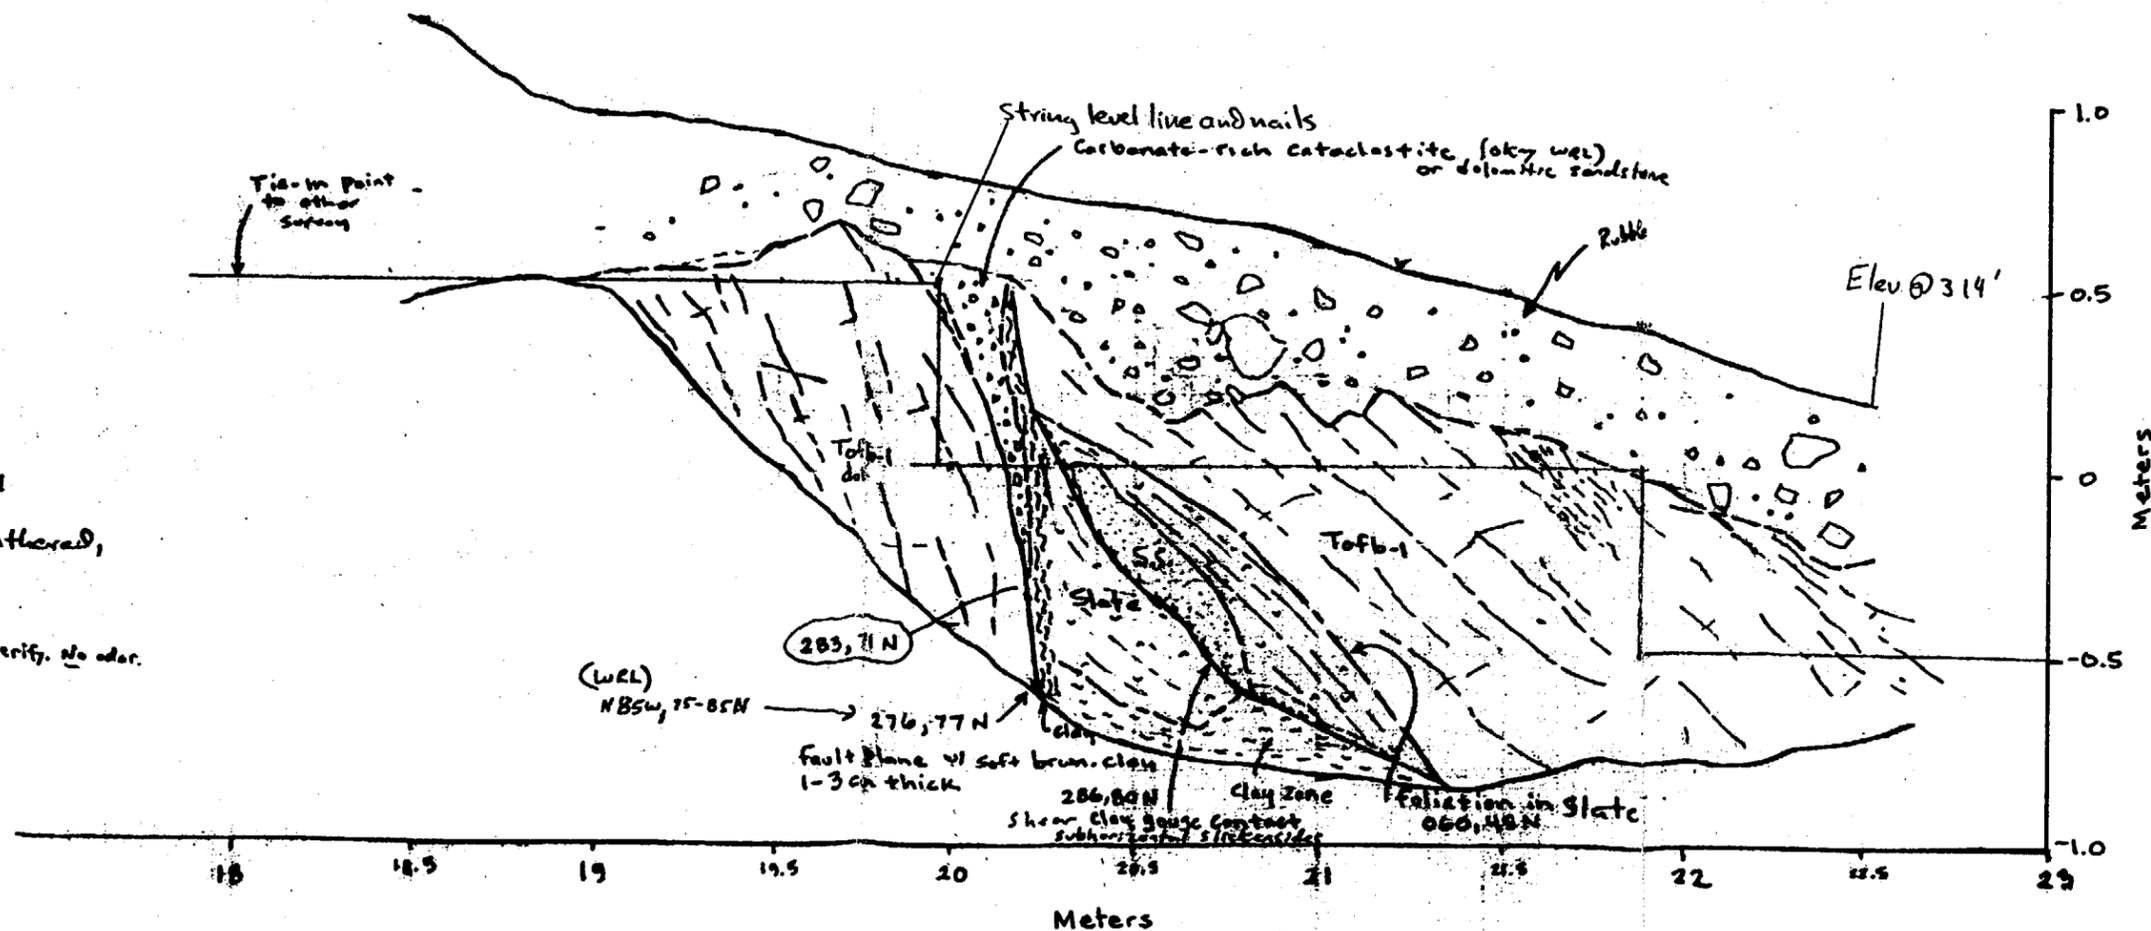
Tofb-1 - dolomite, buff tan to tan orange, fine grained.

S.S. = SANDSTONE, greywacke, grey
 Medium grained, well-sorted,
 friable, massive, slightly weathered,
 Strength = R1., Petro rich(?).
 I could not verify. No odor.
 (WRL)
