**DOCKET NUMBER 50-483
UNION ELECTRIC COMPANY
CALLAWAY PLANT
FACILITY OPERATING LICENSE NPF-30
2001 ANNUAL ENVIRONMENTAL OPERATING REPORT**

2001 Callaway Plant

Annual Radiological Environmental Operating Report

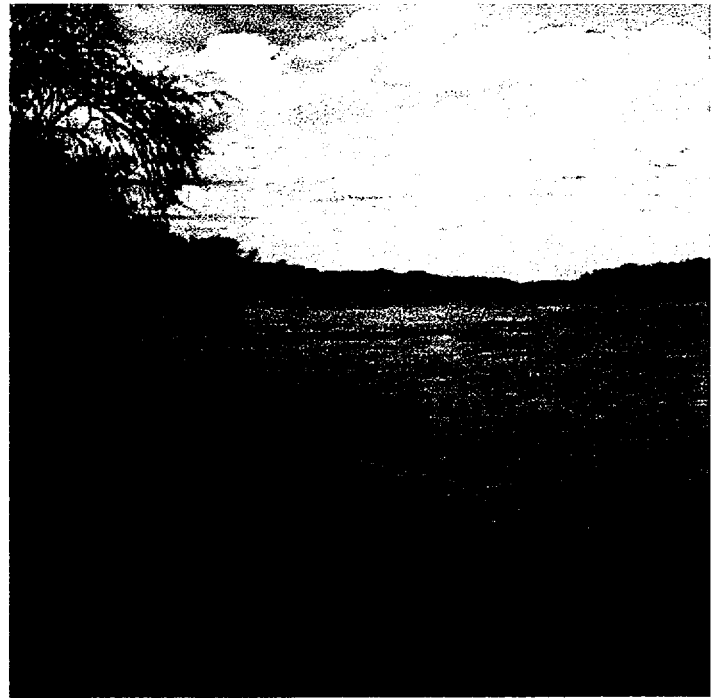
Shoreline sediment samples are collected two feet from the edge of the water in the same location as the bottom sediment samples. Sediment samples indicate there has been no impact on the environment from the Callaway Plant liquid discharge.
