DOCKET <u>50-255</u> - LICENSE <u>DPR-20</u> - PALISADES NUCLEAR PLANT PRIMARY COOLANT PUMP CASING STUD EVALUATION – CODE CASE N-566-1

Primary Coolant Pump Casing Stud Evaluation

SYSTEM:	Primary Coolant System
COMPONENT:	Primary Coolant Pump P-50C
CLASS:	ASME Class 1

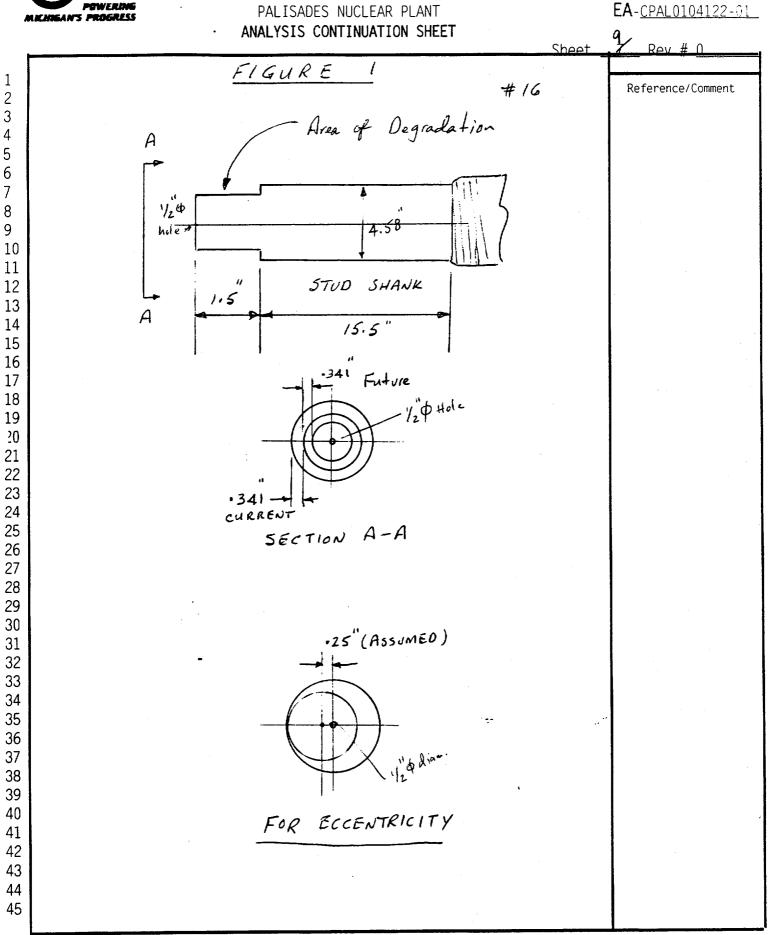
PRELOAD_STUD_STRESS	
View AA on page 9 shows the stud configuration used to calculate the effective stiffness of the corroded stud with respect to the non-corroded stud.	
Preload Force, F = K x 🛆	
Where, △ = stud elongation in inches K = Stiffness = EA/L E = modulus of elasticity L = length A = Cross-section Area	
The corroded stud cross section is considered as shown on page 9. Because the wastage is uniform all around the stud, there are now two cross sections that need to be considered. Also, there is a 0.5" diameter hole in the stud. (See Attach 3)

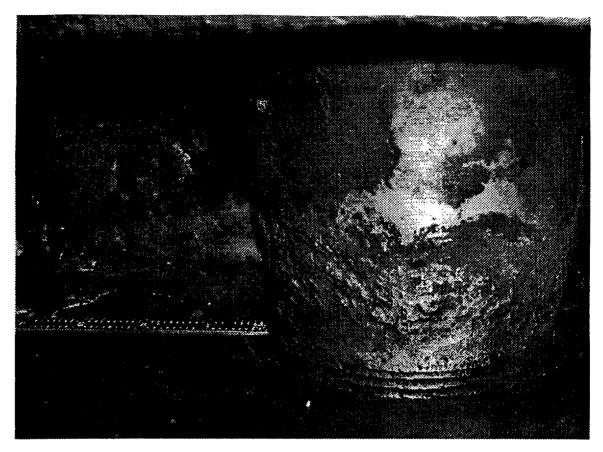
Attank # 1 sh 4 of 5 EA-CPAL0104122-01

5.5	In the current corroded condition, Stud $\#$ 16 measures 4.238 inches and $\#$ 1 measures 4.482 inches in minimum diameter.	
5.6	Time line regarding casing leak for Pump 50C is shown on Attach 10. Wastage is assumed to begin after start- up from REFOUT 14 in 12/1999, which is the last time pump 50C is known to have been free from significant boron accumulation. Calculations are based on the 18 months from the end of the REFOUT 14 to the beginning of force outage 01-5001 in June 2001. From these 18 months, 3 months were subtracted for forced and refueling outage time with the PCS below 210 degrees F. A review of Reactor Engineering records for this period of time indicates the PCS was below 210 degrees F for approximately 59 days. An additional 30 days is subtracted to add a level of conservatism.

Stud #16 taken on December 22, 2001

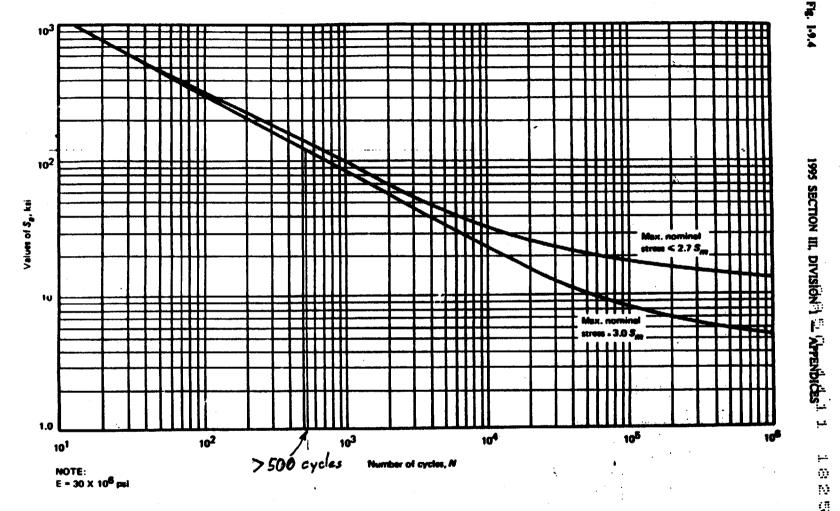
- I ftail 13 sh 1 f 2 EA-CPAL 0104122-01

FIG. I-9.4 DESIGN FATIGUE CURVES FOR HIGH STRENGTH STEEL BOLTING FOR TEMPERATURES NOT EXCEEDING 700°F Table I-9.1 Contains Tabulated Values and a Formula for Accurate Interpolation of These Curves

Number of cycles, experienced by the studs in the corroded condition is less than 10. Therefore, usage factor = 10/1000 = 0.01 which is extremely small as compared to 0.1 allowed in the industry practice.
