# Steam Generator Tube Integrity Program

## Semiannual Report October 1999 — March 2000

Argonne National Laboratory

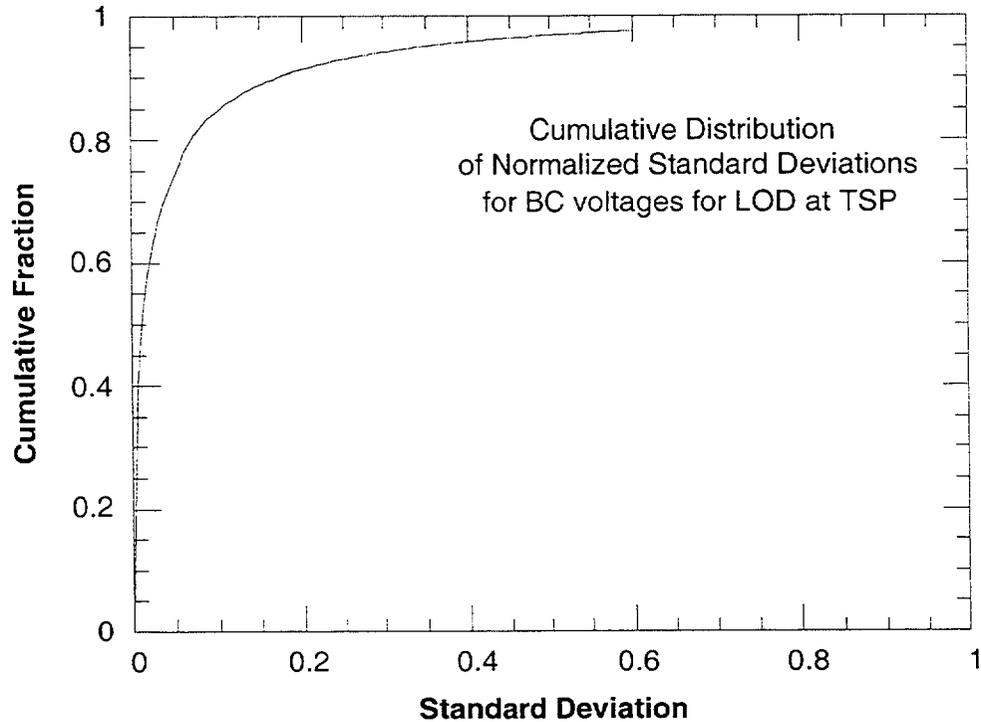
Fig. 2.2. Cumulative distribution of normalized standard deviations for bobbin coil voltages for LODSCC at tube support plates.

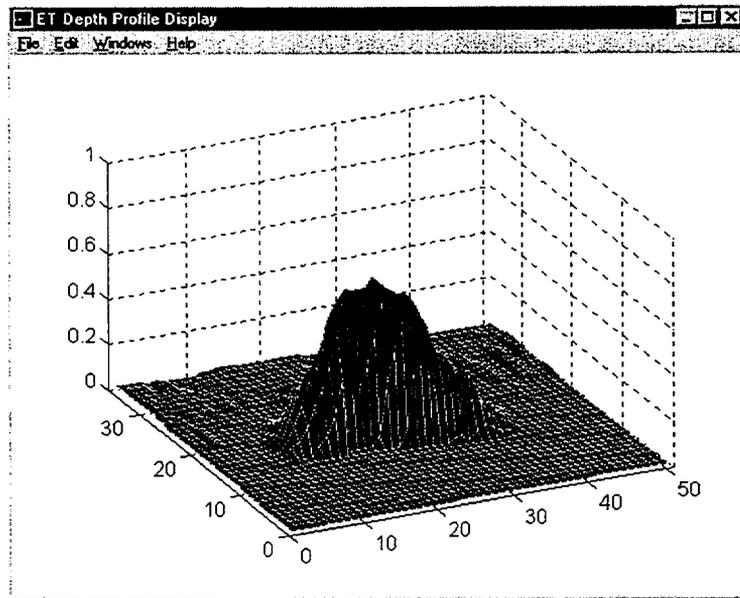
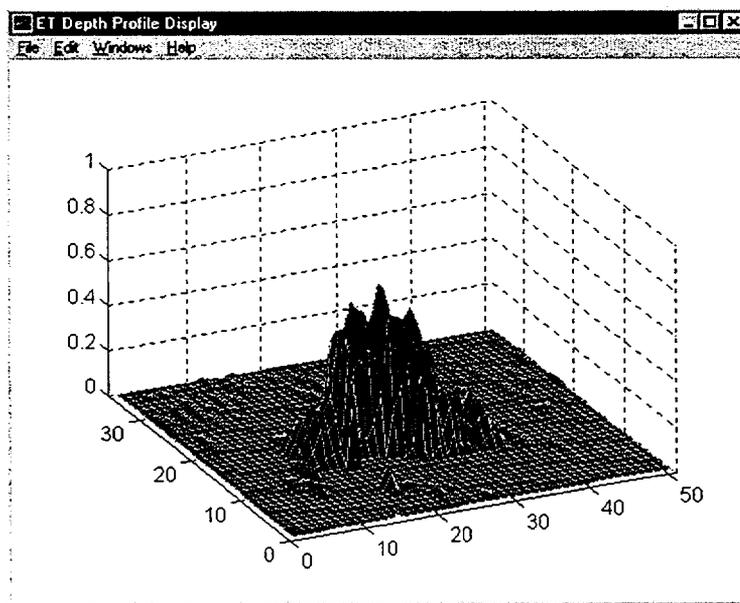
Fig. 3.1. Data analysis results for specimen with laboratory-grown longitudinal ODSCC showing (a) terrain plot of relative depth profile for cracked zone and (b) restored profile by inverse filtering. Maximum crack depth is estimated to be >80% TW. Isometric display of results shows finer details in restored profile.

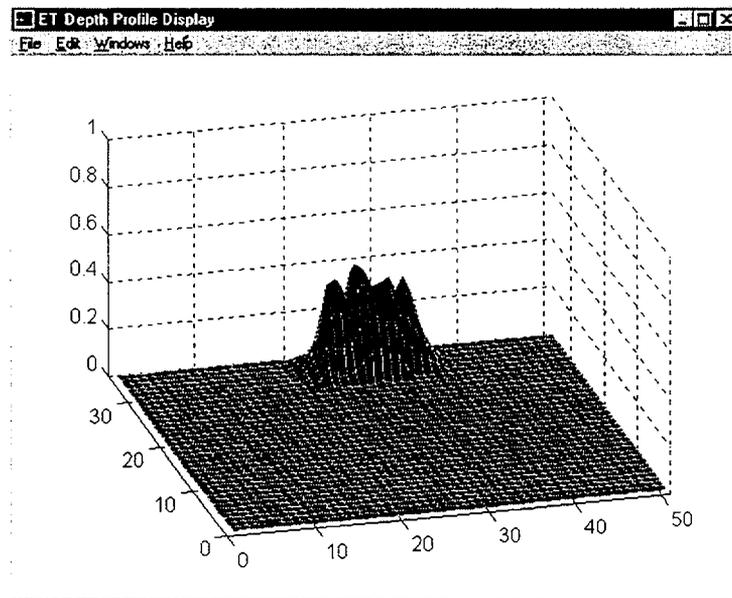
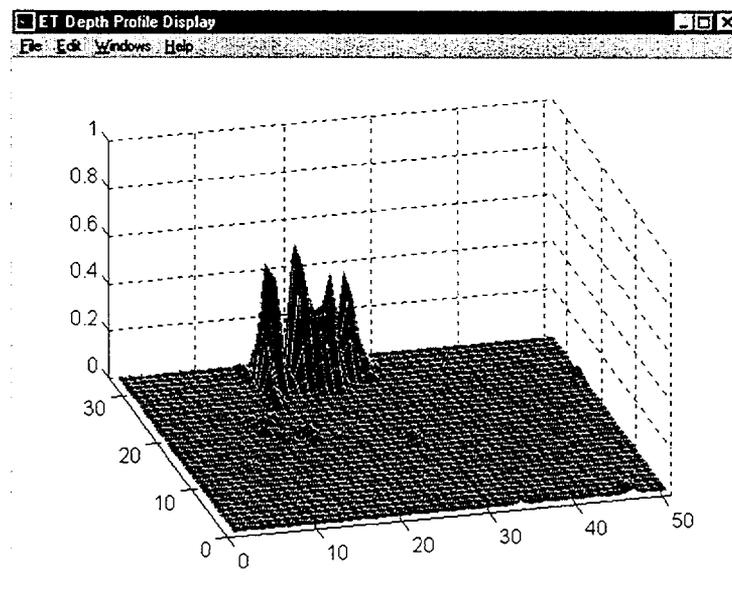
Fig. 3.2. Data analysis results for specimen with laboratory-grown longitudinal ODSCC showing (a) terrain plot of relative depth profile for cracked zone and (b) restored profile by inverse filtering. Maximum crack depth is estimated to be  $\approx 80\%$  TW. Isometric display of results shows finer details in restored profile.

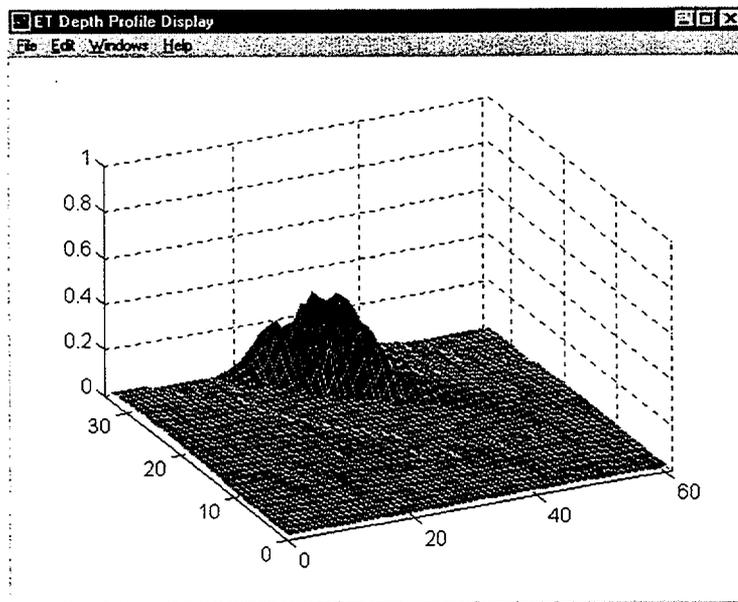
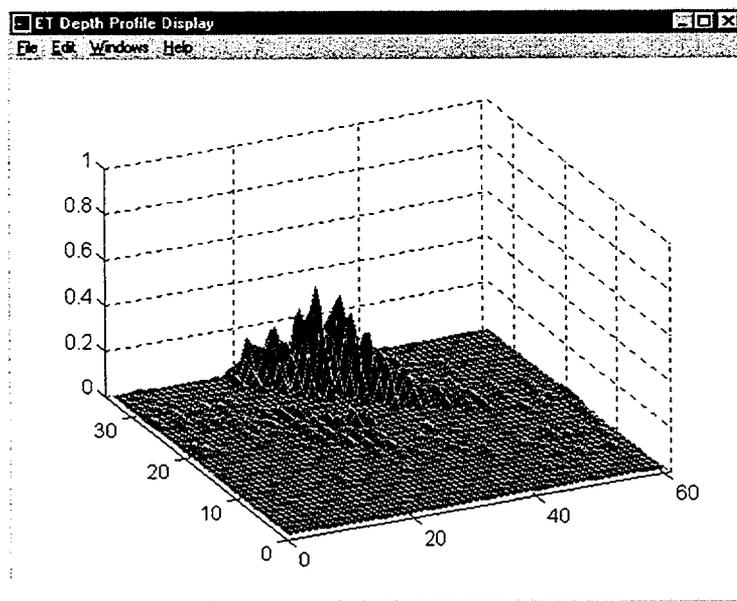
Fig. 3.3. Data analysis results for specimen with laboratory-grown skewed ODSCC showing (a) terrain plot of relative depth profile for cracked zone and (b) restored profile by inverse filtering. Maximum crack depth is estimated to be  $\approx 80\%$  TW. Isometric display of results shows finer details in restored profile.

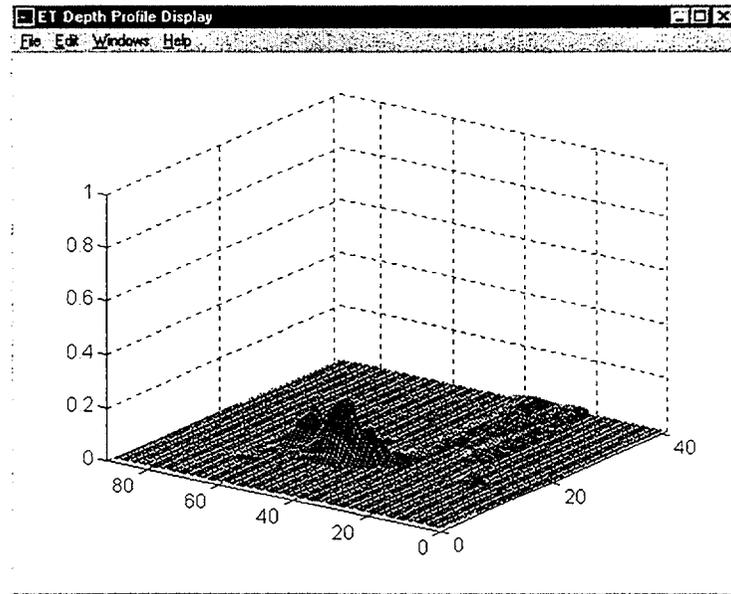
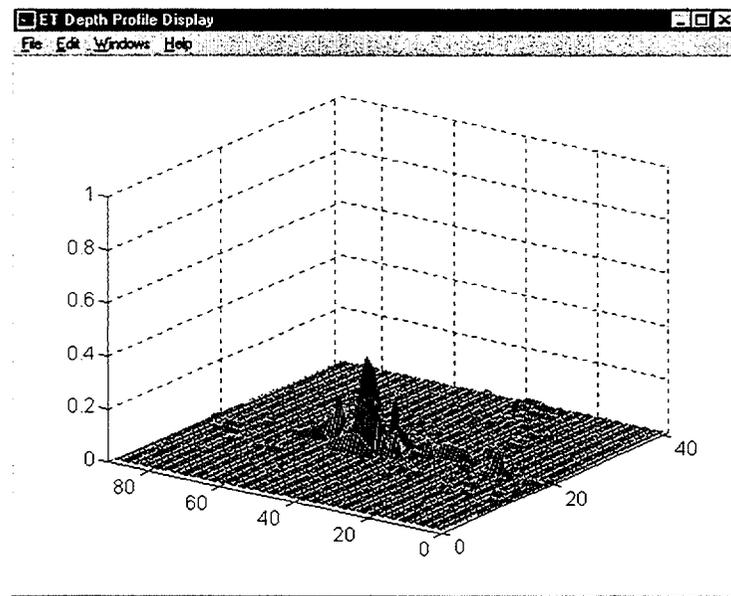
Fig. 3.4. Data analysis results for specimen with laboratory-grown circumferential ODSCC showing (a) terrain plot of relative depth profile for cracked zone and (b) restored profile by inverse filtering. Maximum crack depth is estimated to be  $\approx 60\%$  TW. Isometric display of results shows finer details in restored profile.

Figures 3.4 and 3.5 show the results of analyses for two specimens with circumferential ODSCC at the roll transition region of tube. The processed data clearly indicates complete suppression of the roll transition that is the primary signal feature in the amplitude trace. The maximum flaw depths were estimated to be  $\approx 60\%$  and  $\approx 80\%$  TW, respectively. Based on the terrain plots in Figs. 3.4(a) and 3.5(a), both cracks extend nearly  $120^\circ$  around the

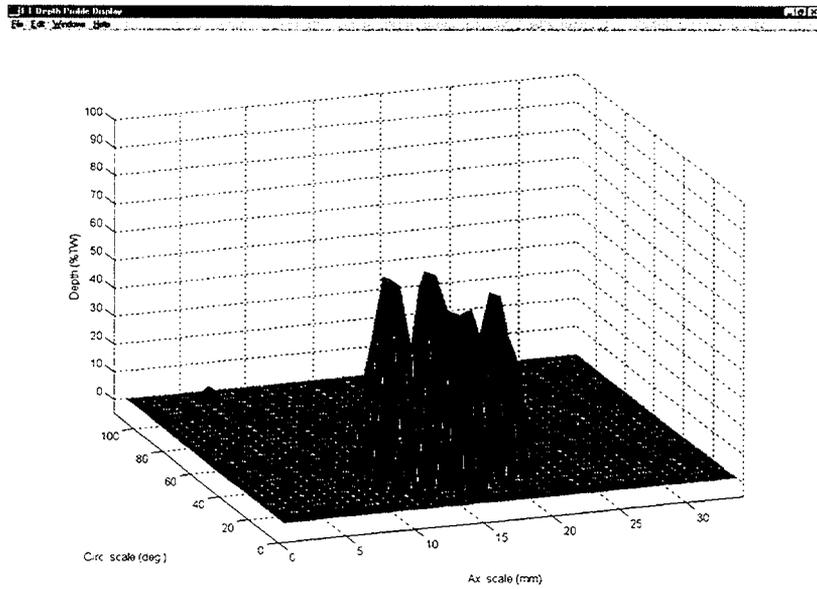
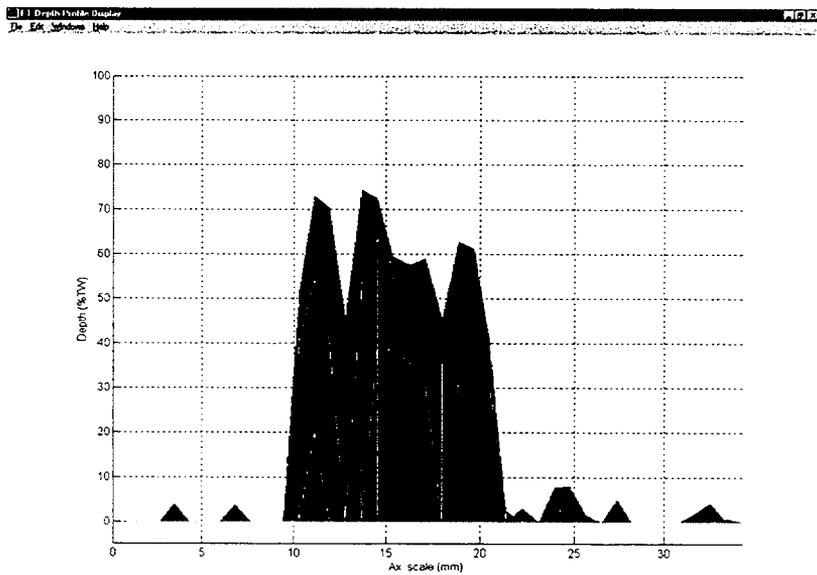
Fig. 3.10. Representative display of data analysis results for a specimen with laboratory-grown longitudinal ODSCC showing two views of estimated depth profile of cracked region. Figure 3.10(b) is a cross-sectional view of the terrain plot in Fig. 3.10(a). The profile indicates a total flaw length of  $\approx 12$  mm (0.5 in.), with maximum depth  $>70\%$  TW. Close observation of graphics from various view angles reveals the axial crack to be composed of multiple segments.

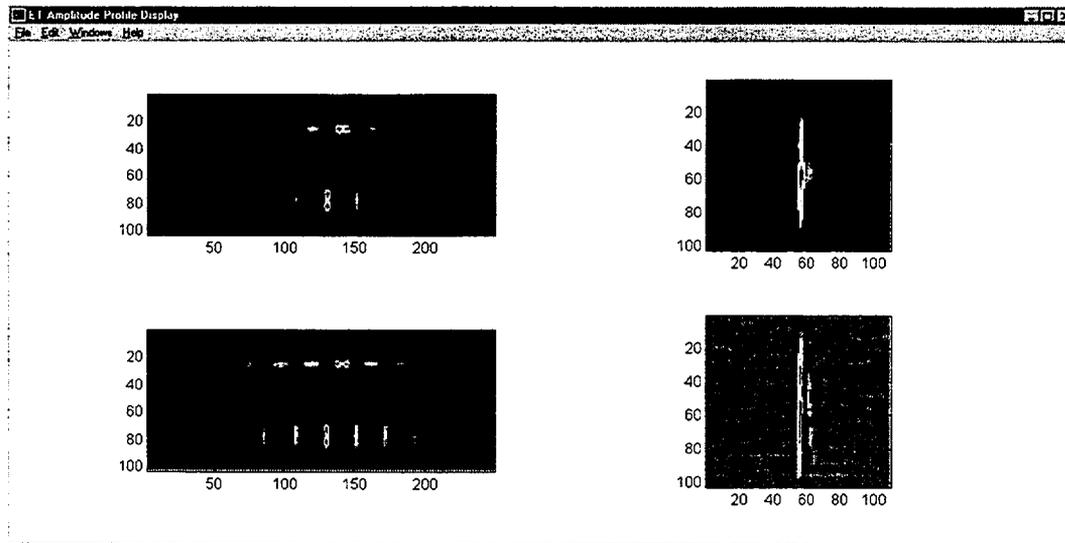
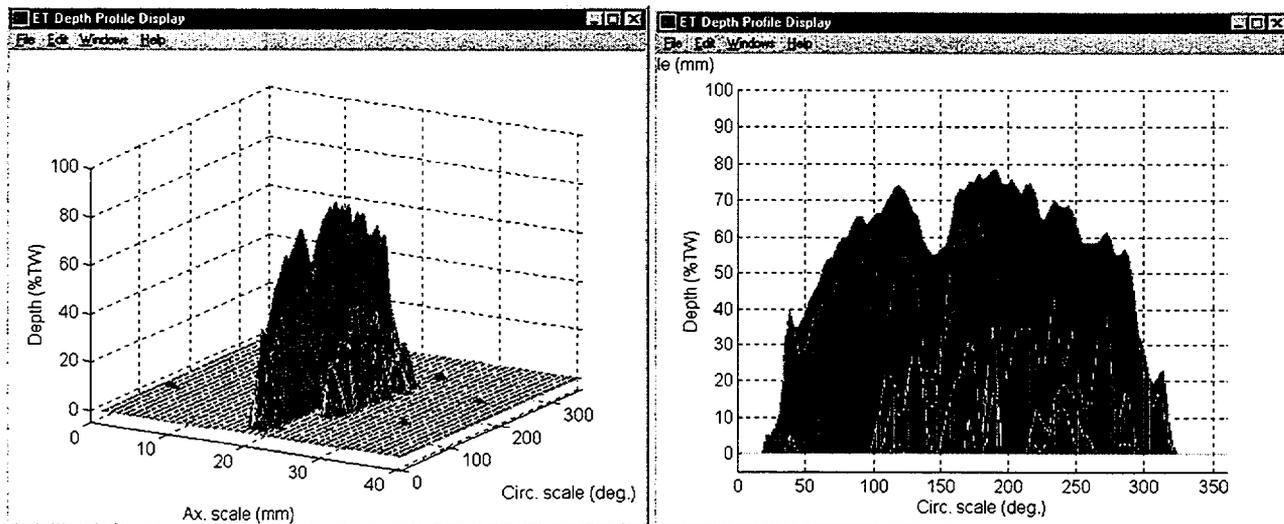
Fig. 3.11. Representative display of data analysis results for specimen with laboratory-grown circumferential ODSCC showing (a) pre- (top) and post-processed (bottom) images of normalized data and (b) terrain and cross sectional plots of estimated flaw profile. Results indicate  $\approx 360^\circ$  circumferential cracking, with maximum depth of  $\approx 80\%$  TW.

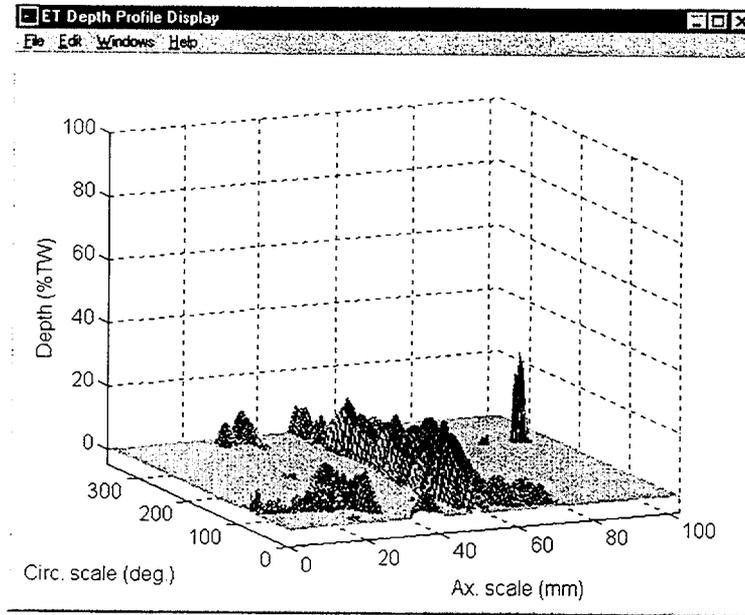
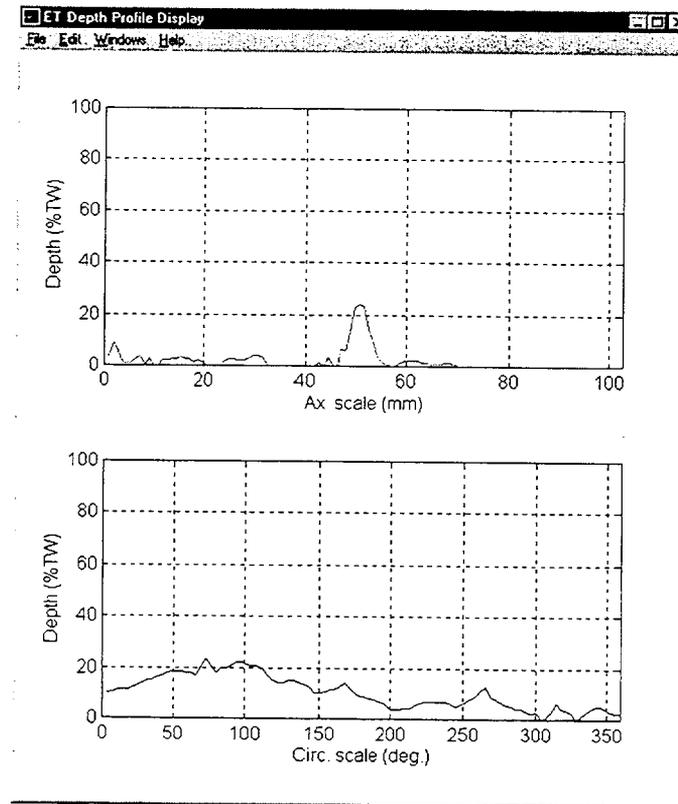
Fig. 3.12. Representative display of data analysis results for specimen with laboratory-grown shallow circumferential IDSCC showing (a) terrain and (b) cross-sectional plots of estimated flaw profile. Results indicate  $\approx 360^\circ$  circumferential cracking with maximum depth of  $>20\%$  TW.

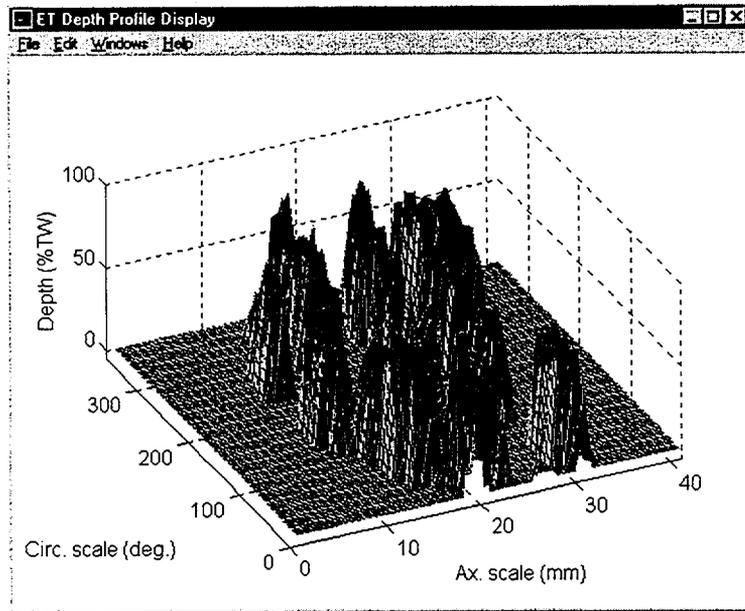
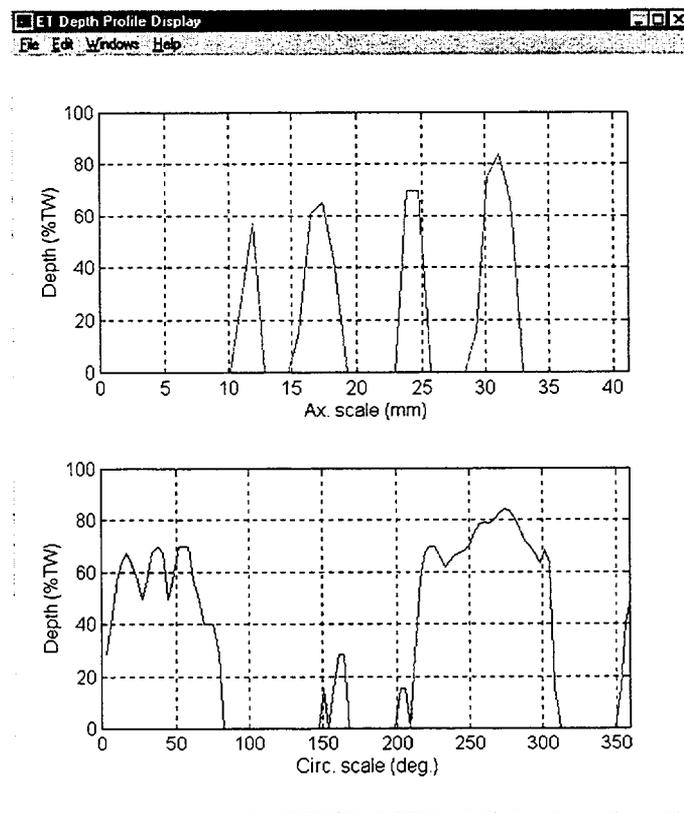
Fig. 3.13. Representative display of data analysis results for specimen with laboratory-grown circumferential ODSCC showing (a) terrain and (b) cross-sectional plots of estimated flaw profile. Results indicate  $\approx 360^\circ$  staggered circumferential cracking with maximum depth of  $>80\%$  TW.

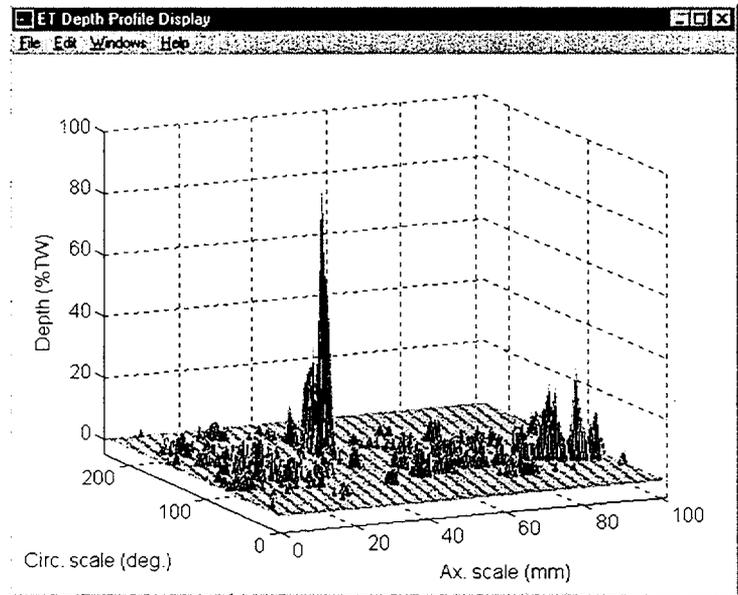
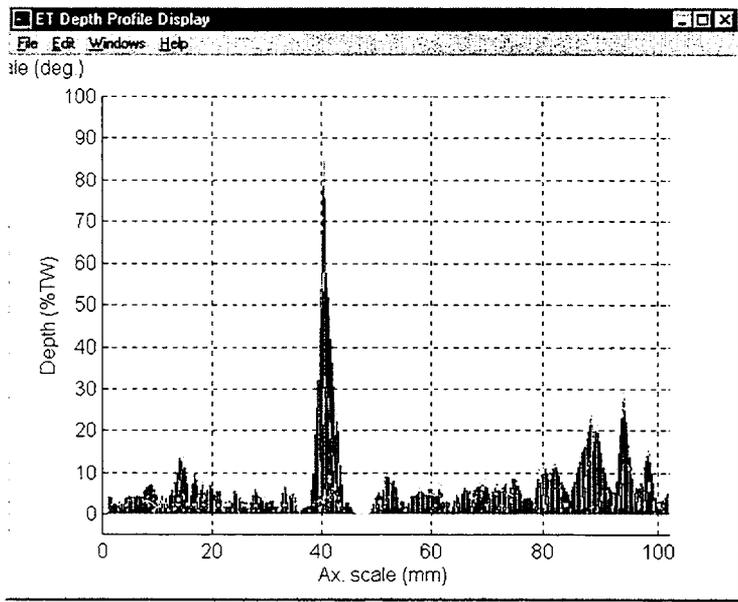
Fig. 3.14. Representative display of data analysis results for specimen with laboratory-grown axial IDSCC showing (a) terrain plot and (b) cross-sectional view of estimated flaw profile. Results indicate dominant single axial crack with maximum depth of >80% TW.

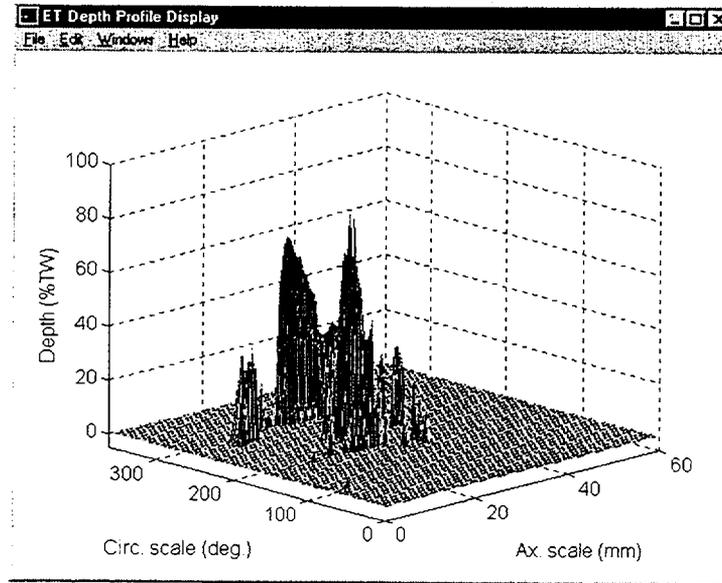
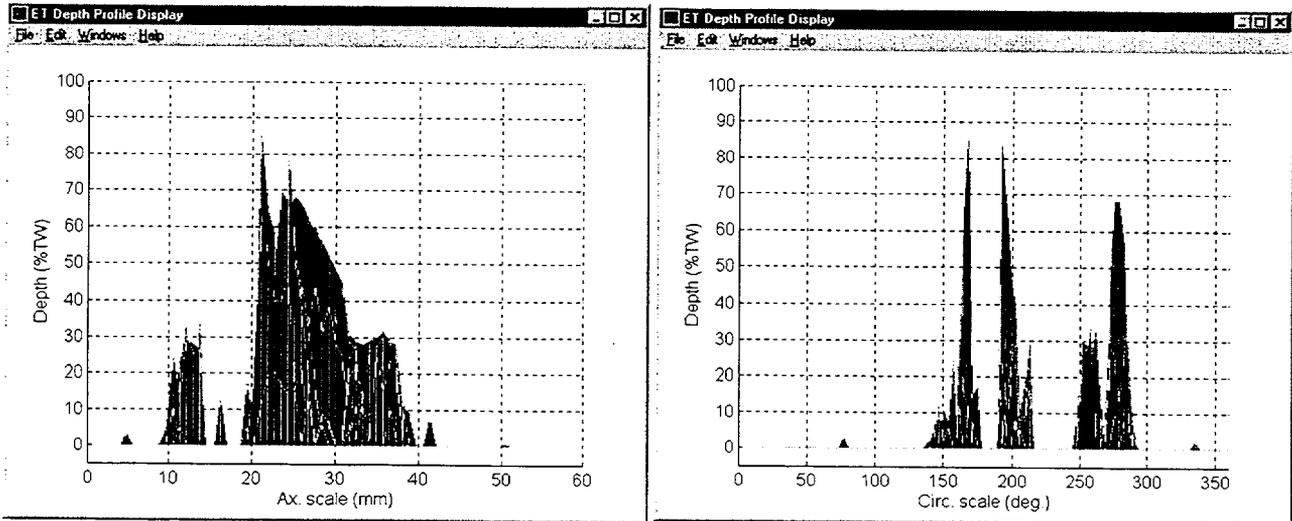
Fig. 3.19. Representative display of data analysis results for specimen with laboratory-grown axial ODSCC showing (a) terrain and (b) cross-sectional views of estimated flaw profile. Results indicate multiple axial cracks with maximum depths >80% TW.

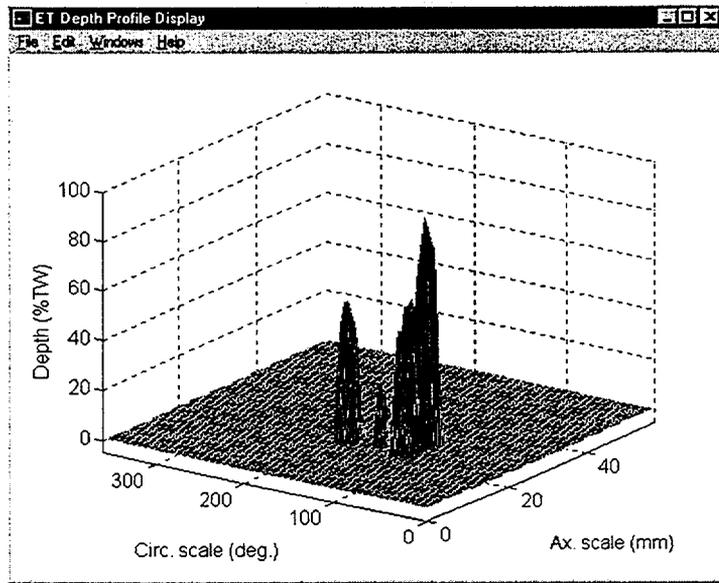
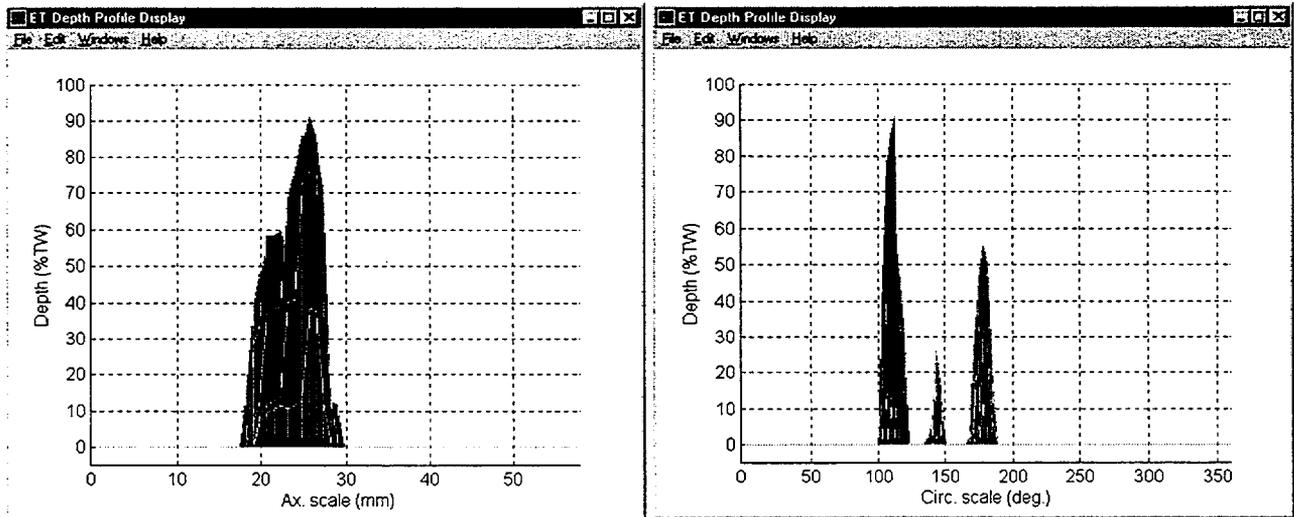
Fig. 3.20. Representative display of data analysis results for specimen with laboratory-grown axial ODSCC showing (a) terrain and (b) cross-sectional views of estimated flaw profile. Results indicate multiple axial cracks with maximum depths >80% TW.

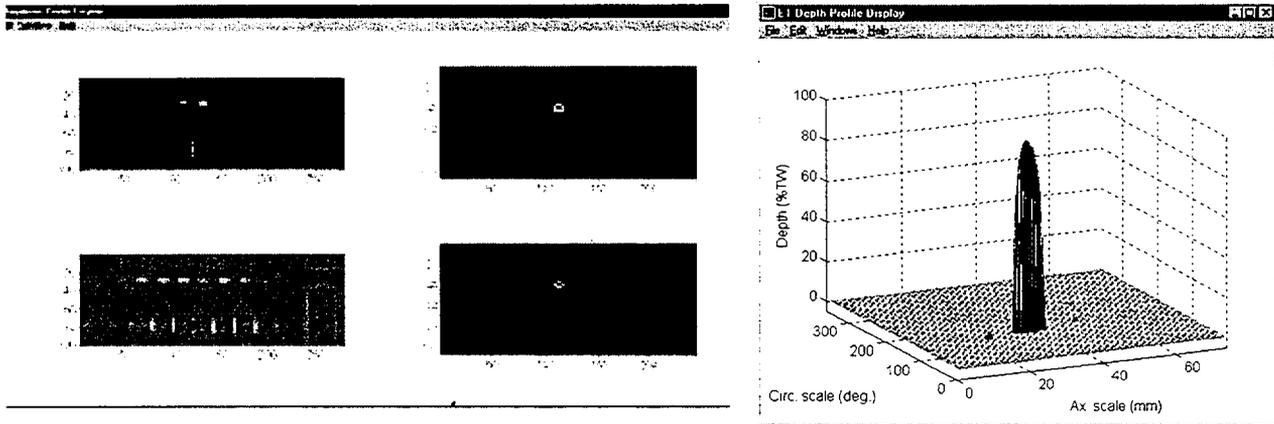
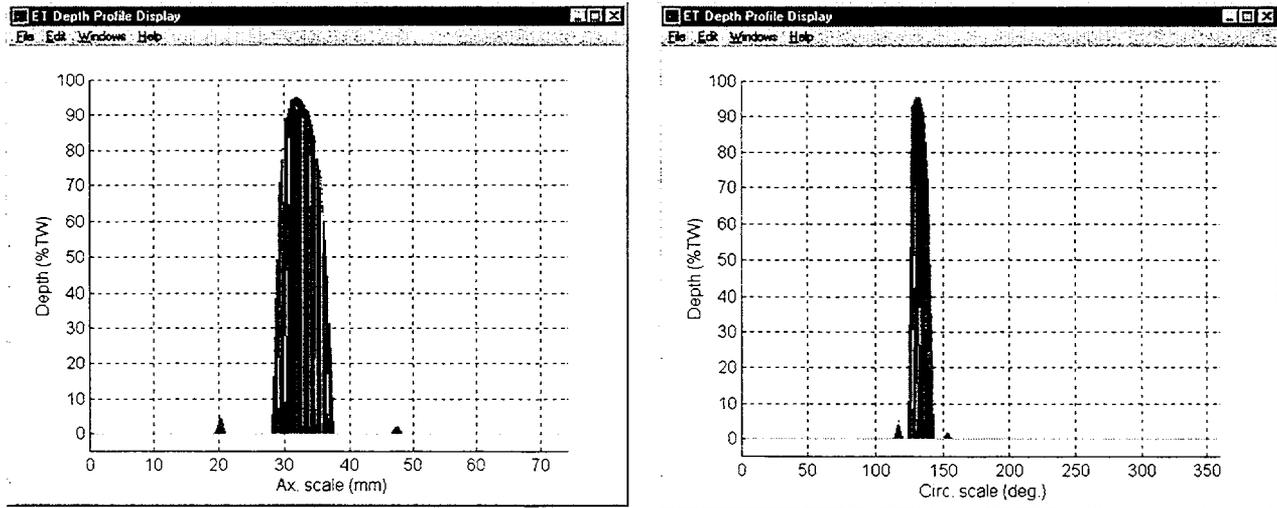
Fig. 3.21. Representative display of data analysis results for specimen with laboratory-grown ODSCC degradation showing (a) image display, (b) terrain profile, and (c) cross-sectional views of estimated flaw size. Results indicate single crack with maximum depth >90% TW.

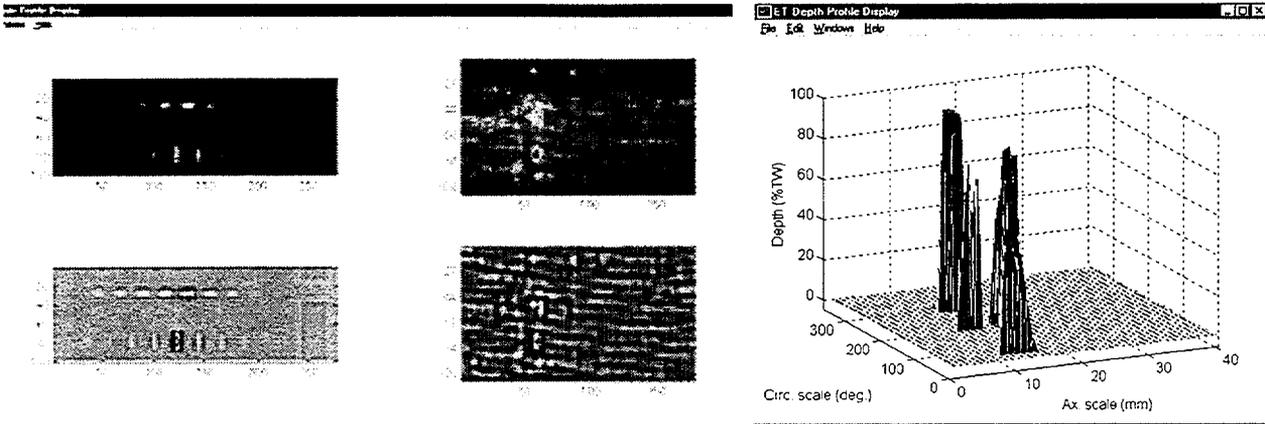
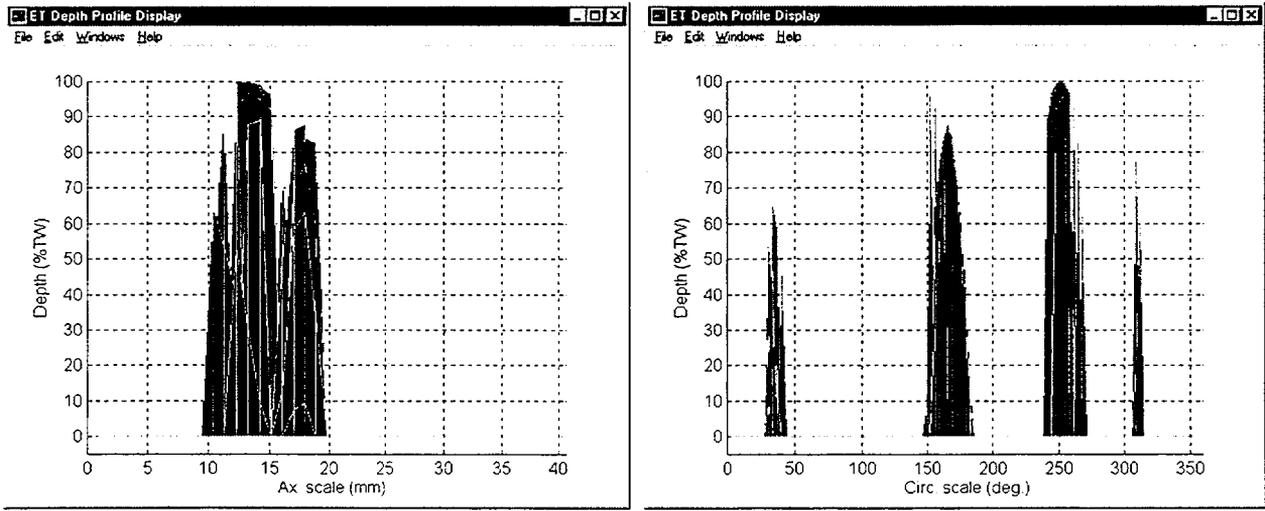
Fig. 3.22. Representative display of data analysis results for specimen with laboratory-grown ODSCC degradation showing (a) image display, (b) terrain profile, and (c) cross sectional views of estimated flaw size. Results indicate multiple cracks around circumference, with maximum depth of dominant flaw reaching 100% TW.

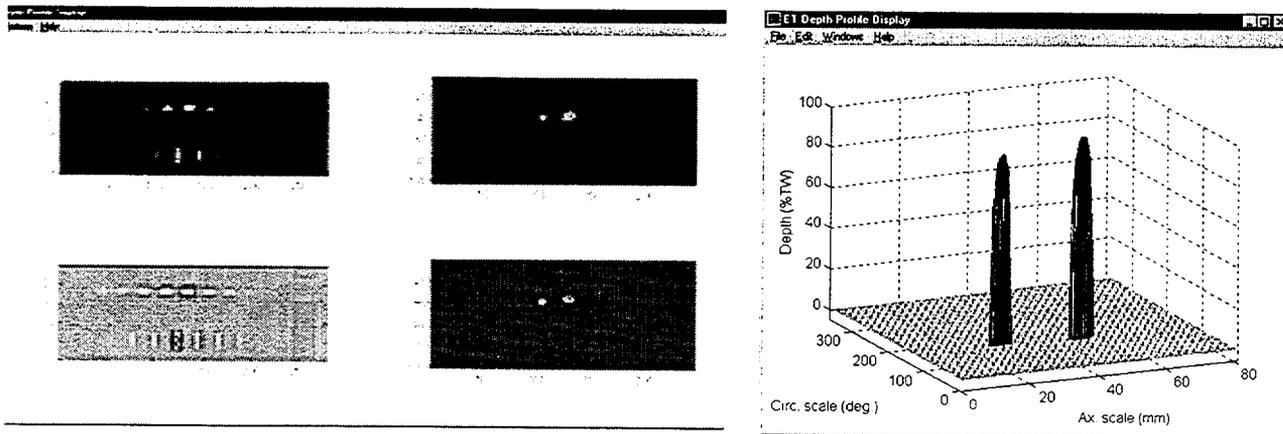
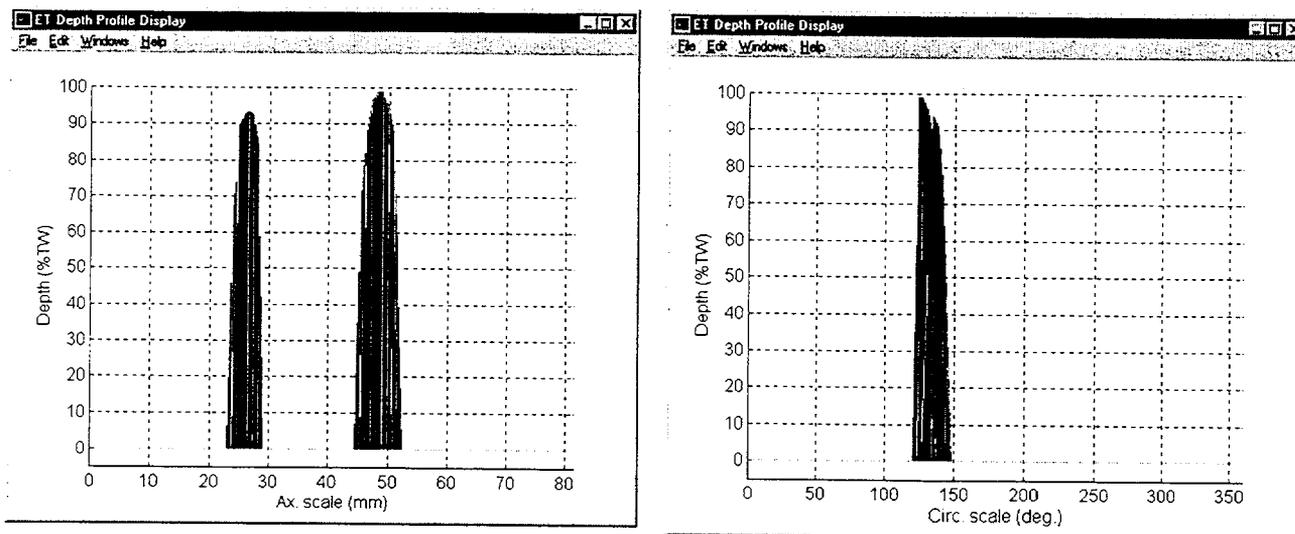
Fig. 3.23. Representative display of data analysis results for specimen with laboratory-grown ODSCC degradation showing (a) image display, (b) terrain profile, and (c) cross-sectional views of estimated flaw size. Results indicate two circumferentially offset cracks, with maximum depth reaching  $\approx 100\%$  TW.

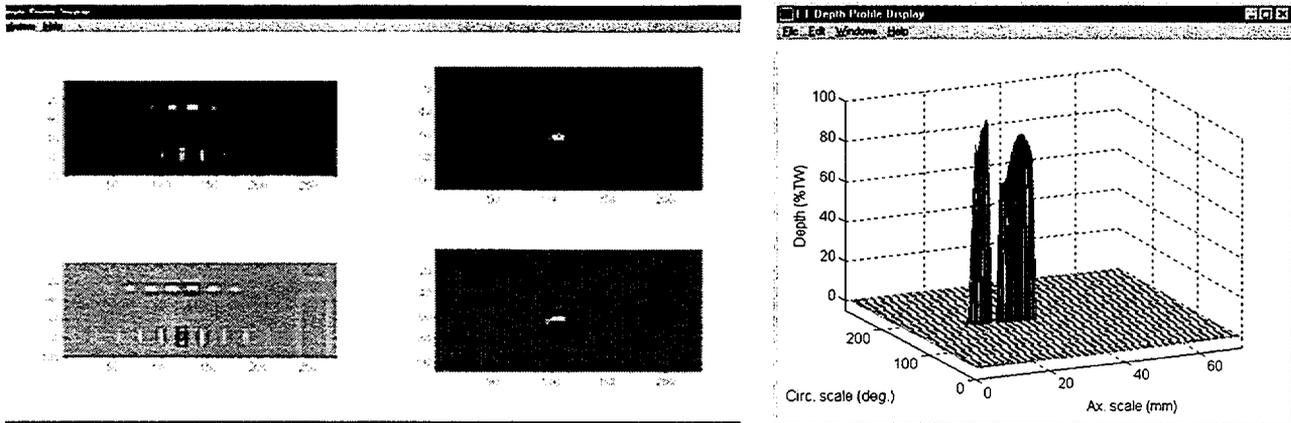
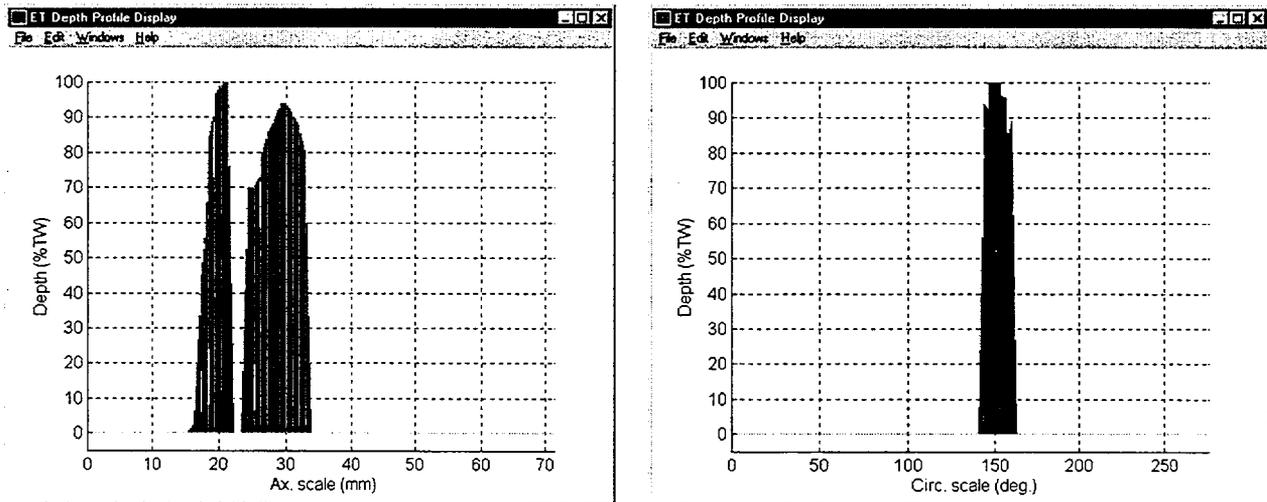
Fig. 3.24. Representative display of data analysis results for specimen with laboratory-grown ODSCC degradation showing (a) image display, (b) terrain profile, and (c) cross-sectional views of estimated flaw size. Results indicate segmented crack with maximum depth of  $\approx 100\%$  TW.

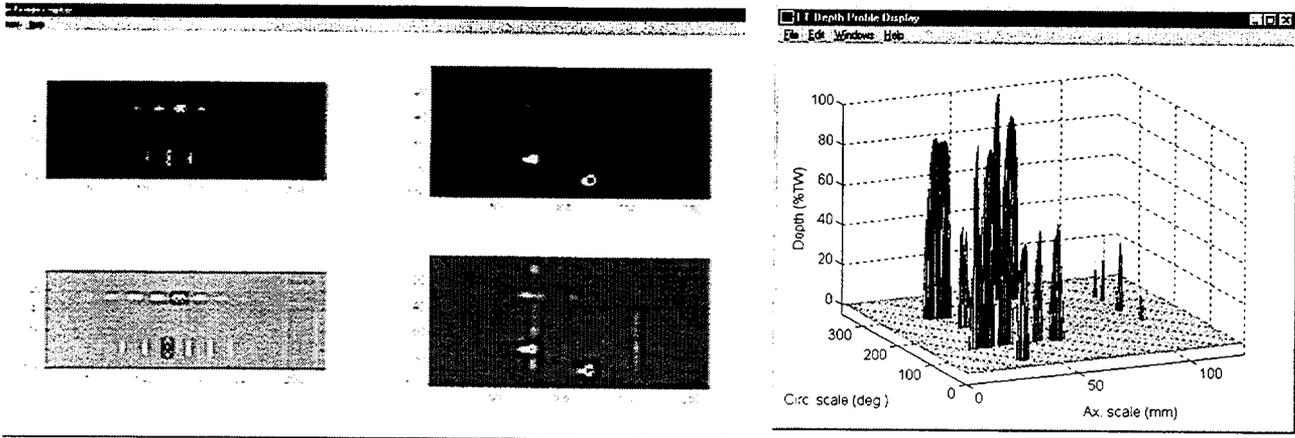
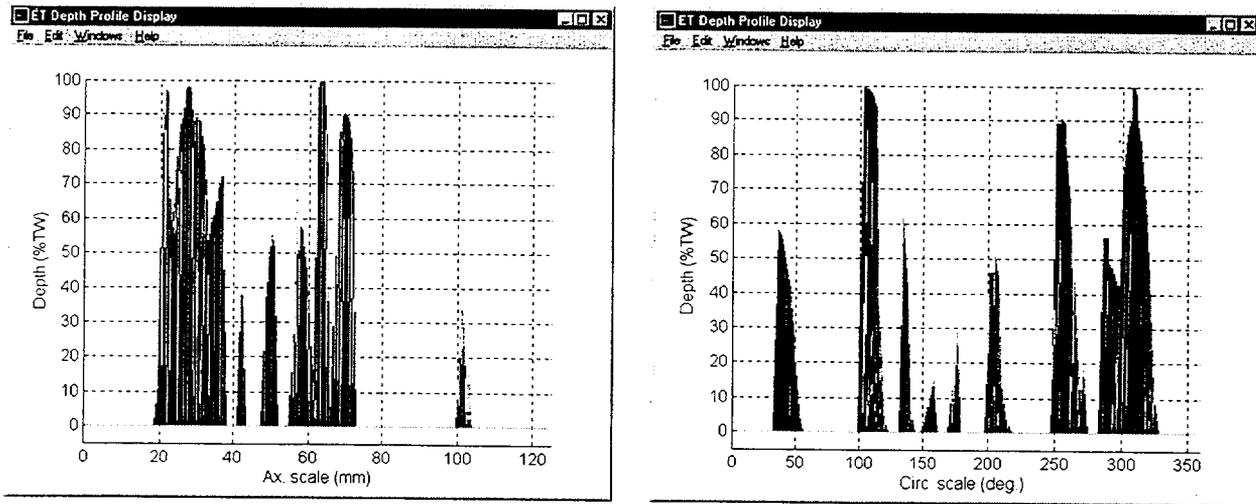
Fig. 3.27. Representative display of data analysis results for specimen with laboratory-grown ODSCC degradation showing (a) image display, (b) terrain profile, and (c) cross-sectional views of estimated flaw size. Results indicate multiple cracks around circumference, with maximum depth of dominant flaws reaching  $\approx 100\%$  TW.

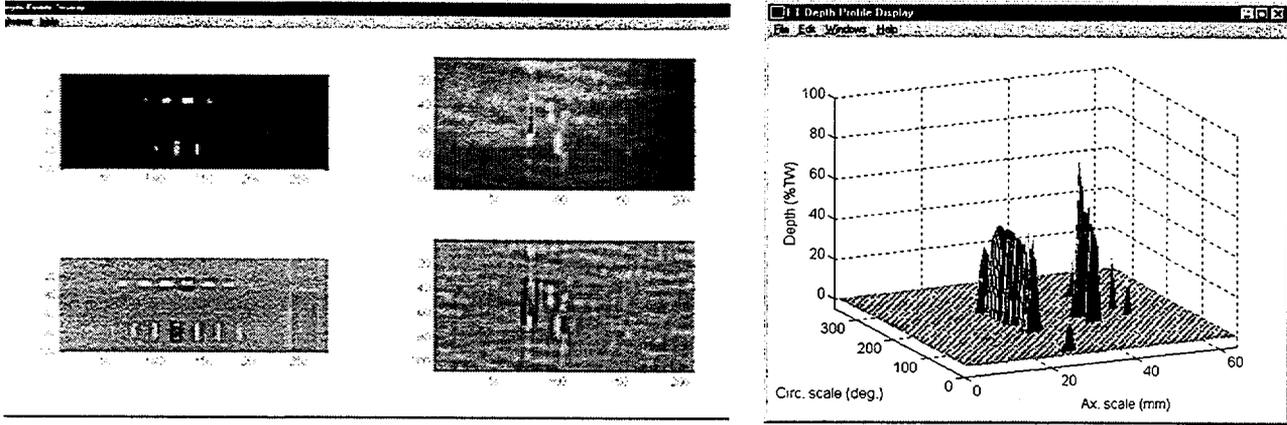
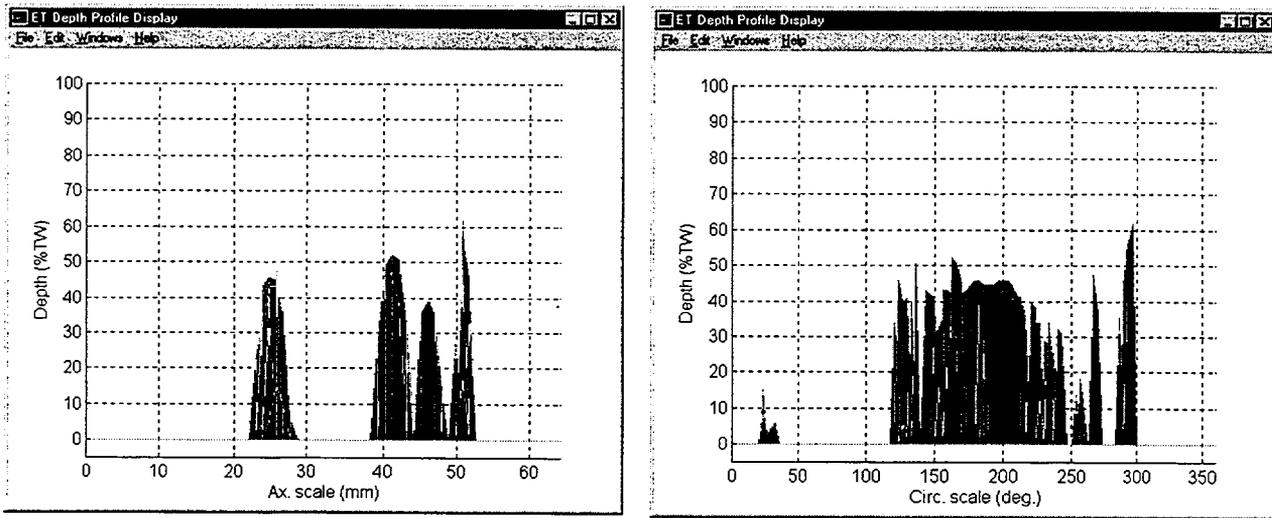
Fig. 3.28. Representative display of data analysis results for specimen with laboratory-grown ODSCC degradation showing (a) image display, (b) terrain profile, and (c) cross-sectional views of estimated flaw size. Results indicate multiple cracks at several axial locations around circumference, with maximum depth >60% TW.

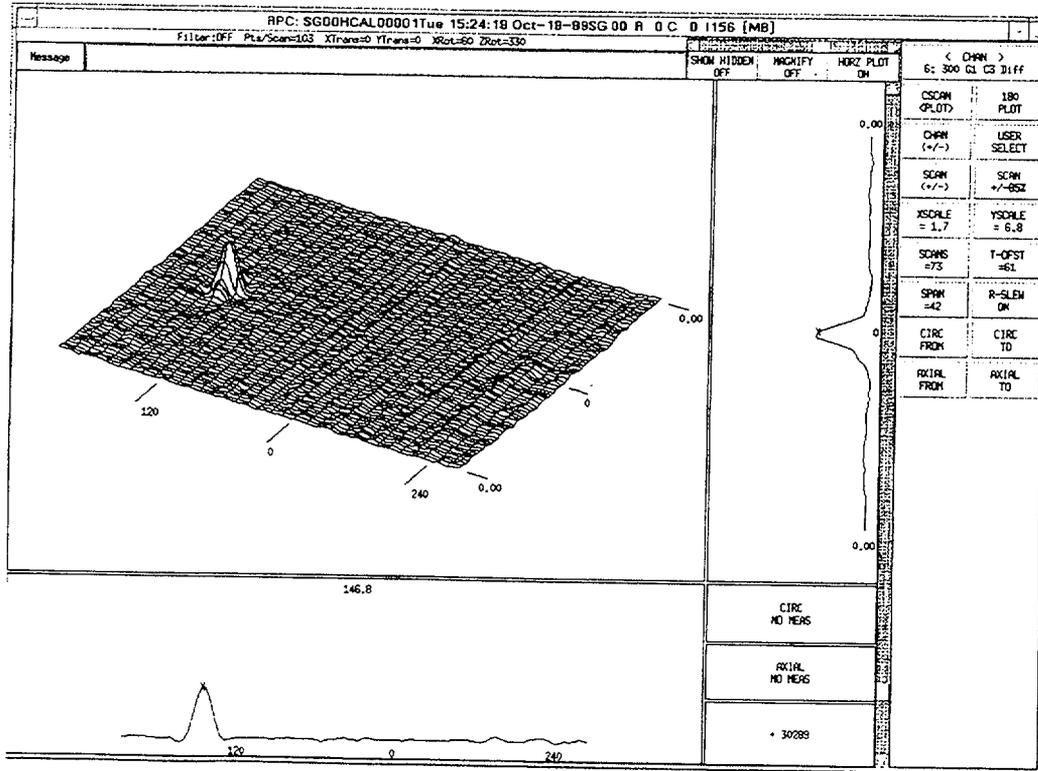
Fig. 4.1. EC NDE test results for Specimen SGL717 with 90% TW axial ODSCC indication.

The cracked tubes were examined by eddy current NDE. Figure 4.1 shows the eddy current NDE result for Specimen SGL717 with an axial ODSCC indication having an estimated depth of 90% TW. Figures 4.2 and 4.3 show EC results for Specimens SGL473 and SGL492 with axial ODSCC indications ≈95% TW. Figure 4.3 also indicates that the axial ODSCC in Specimen SGL492 has a segmented secondary crack. Figures 4.4 and 4.5 show EC results for Specimens SGL748 and SGL757 with axial ODSCC indications estimated to be 60 and 85% TW, respectively. Multiple segmented cracks are indicated for both specimens. Figures 4.6 and 4.7 show eddy current NDE results for Specimens SGL737 and SGL776. A segmented OD axial indication ≈85% TW is seen in Specimen SGL737 and a complicated OD axial and circumferential indication ≈60% TW is seen in Specimen SGL776. Specimens SGL741, SGL786 and SGL795 (Figs. 4.8, 4.9, and 4.10) show circumferential ODSCC (≈90% TW), circumferential IDSCC (≈20% TW), and axial IDSCC (≈80% TW) indications, respectively. Specimen SGL795 shows multiple axial IDSCCs. Figures 4.11-4.14 show EC results for Specimens SGL808, SGL809, SGL816, and SGL817. Axial IDSCC indications are seen for Specimens SGL808 and SGL809 (Figs. 4.11 and 4.12), with two axial SCCs in each specimen. The depth of the SCC is estimated to be ≈60% TW for Specimen SGL808 and 100% TW for Specimen SGL809. Figures 4.13 and 4.14 show axial ODSCC indications for Specimens SGL816 and SGL817 with estimated depths of ≈85 and 95% TW, respectively.

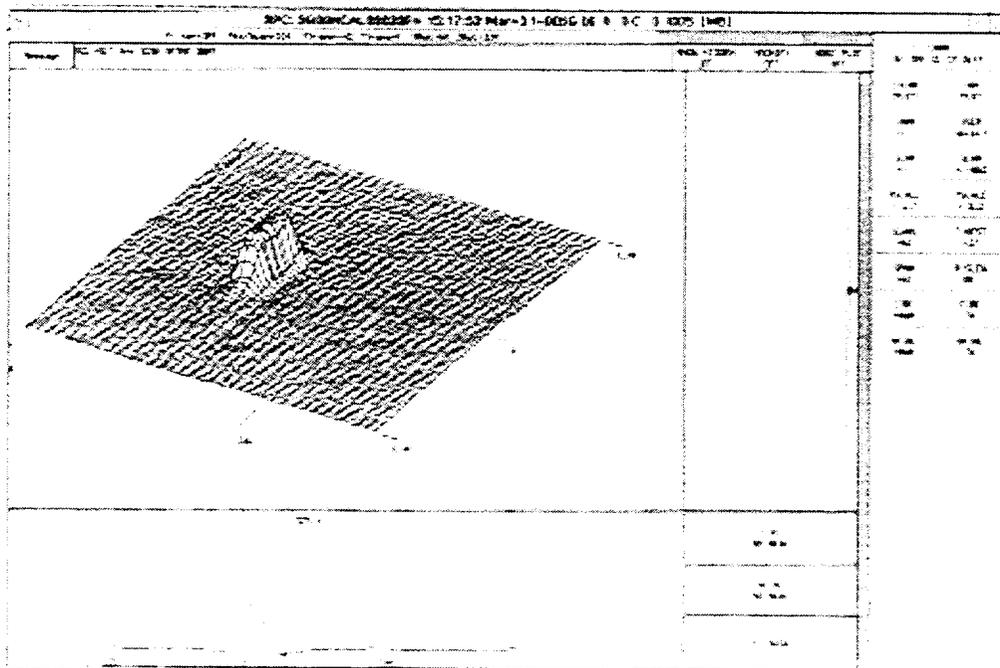
Fig. 4.14. EC NDE test results for Specimen SGL817 with 95% TW axial ODSCC indication.

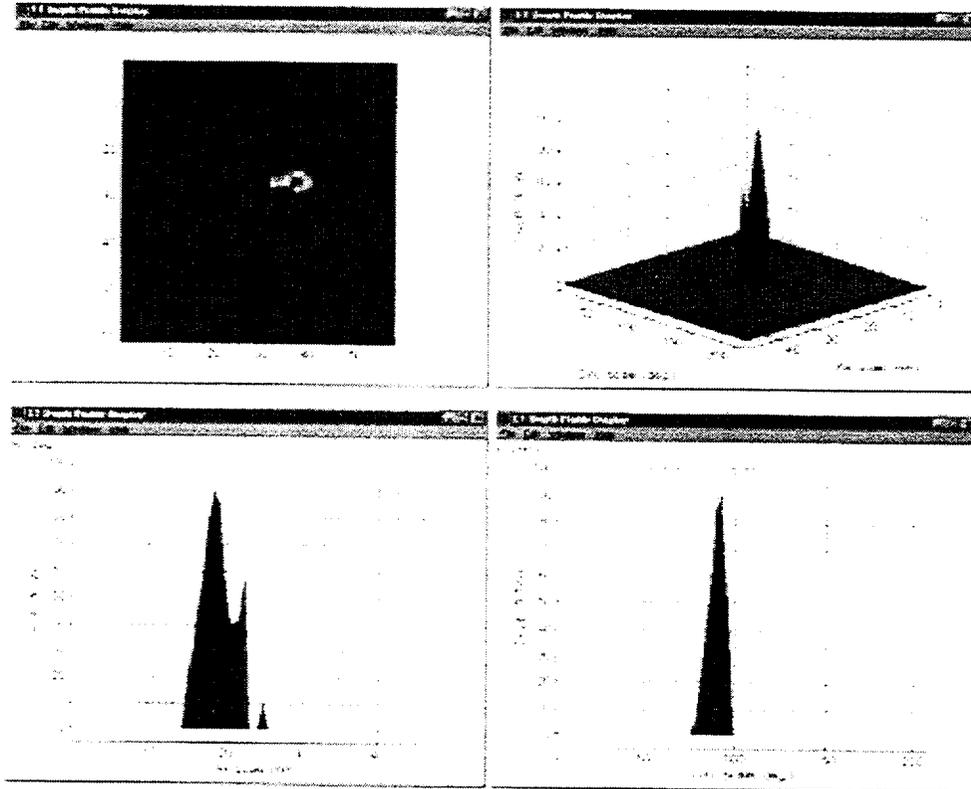
Fig. 4.26. Eddy current NDE of Specimen SGL494.
