# Steam Generator Tube Integrity Program

## Semiannual Report October 1999 — March 2000

Argonne National Laboratory

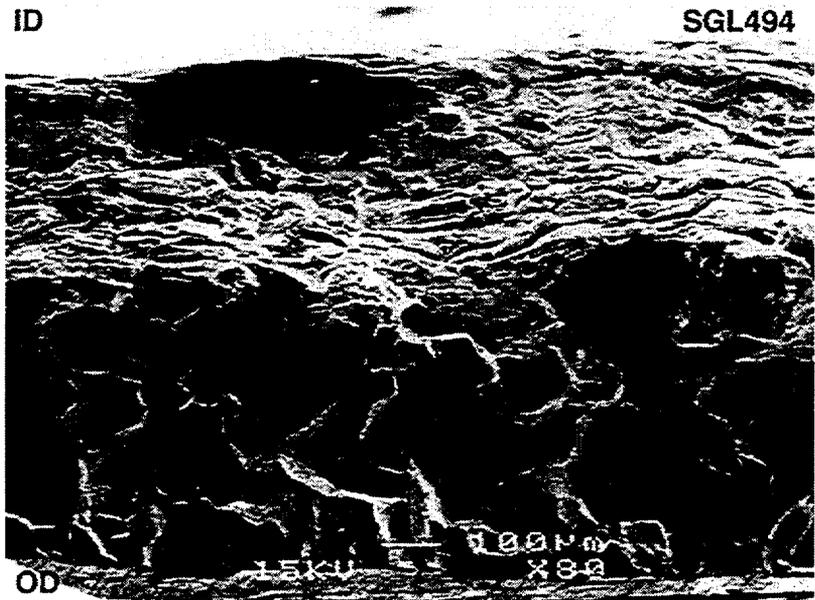
Fig. 4.28. Scanning electron photomicrograph of fracture surface of Specimen SGL494.

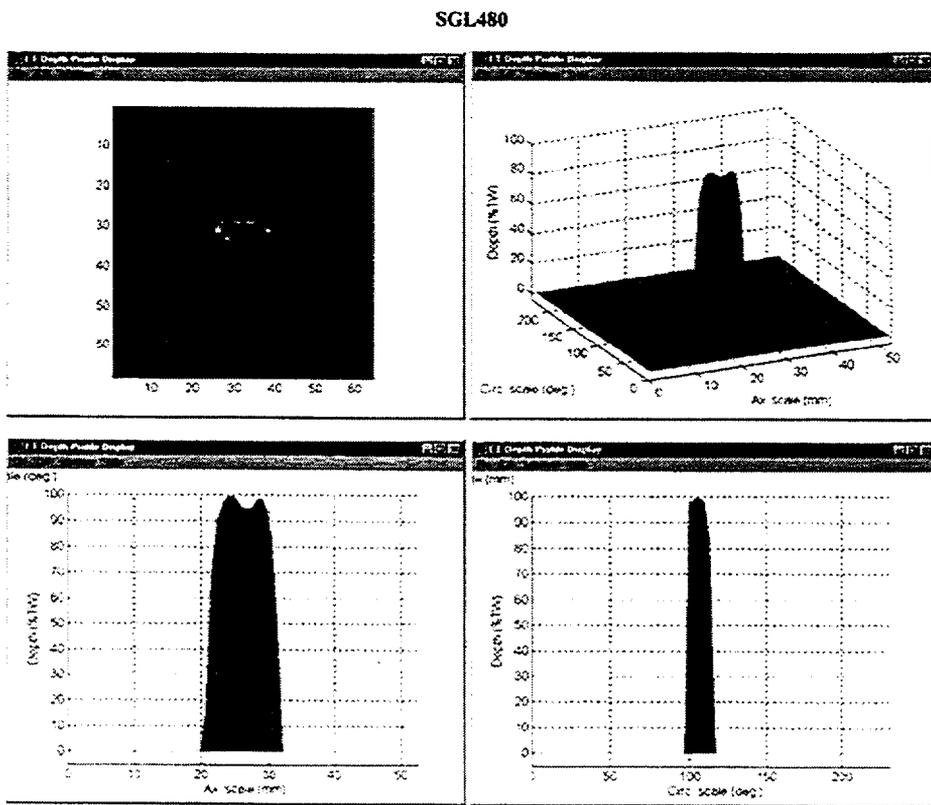
Fig. 4.29. Eddy current NDE of Specimen SGL480.

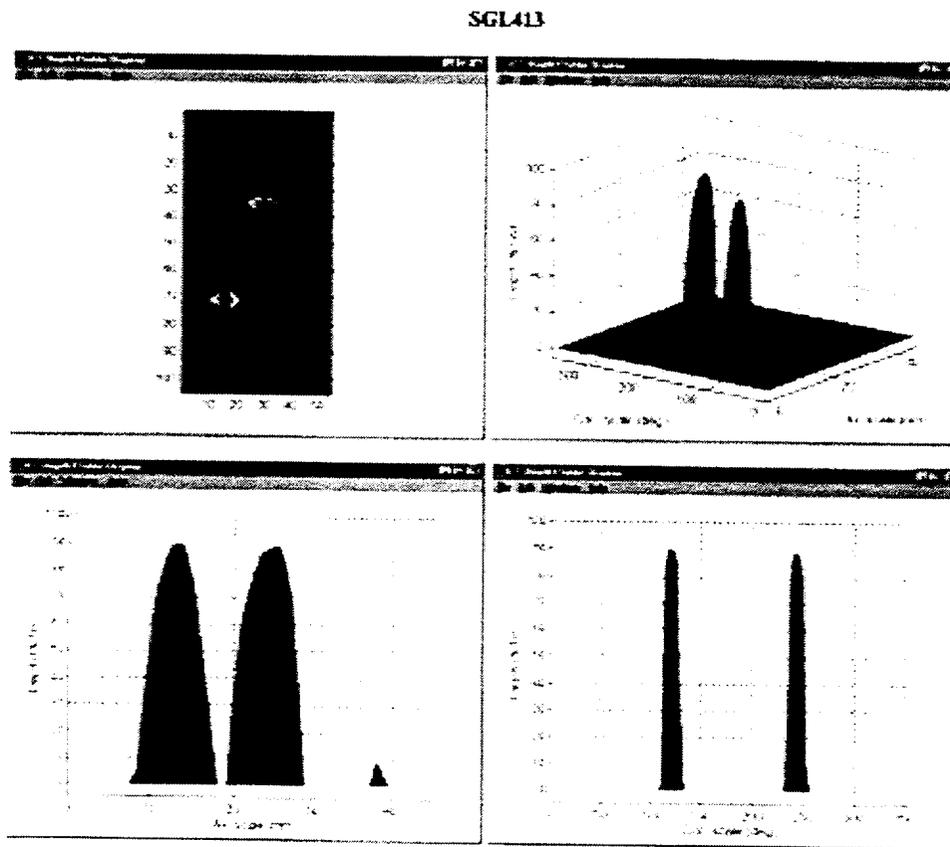
Fig. 4.31. Eddy current NDE of Specimen SGL413.

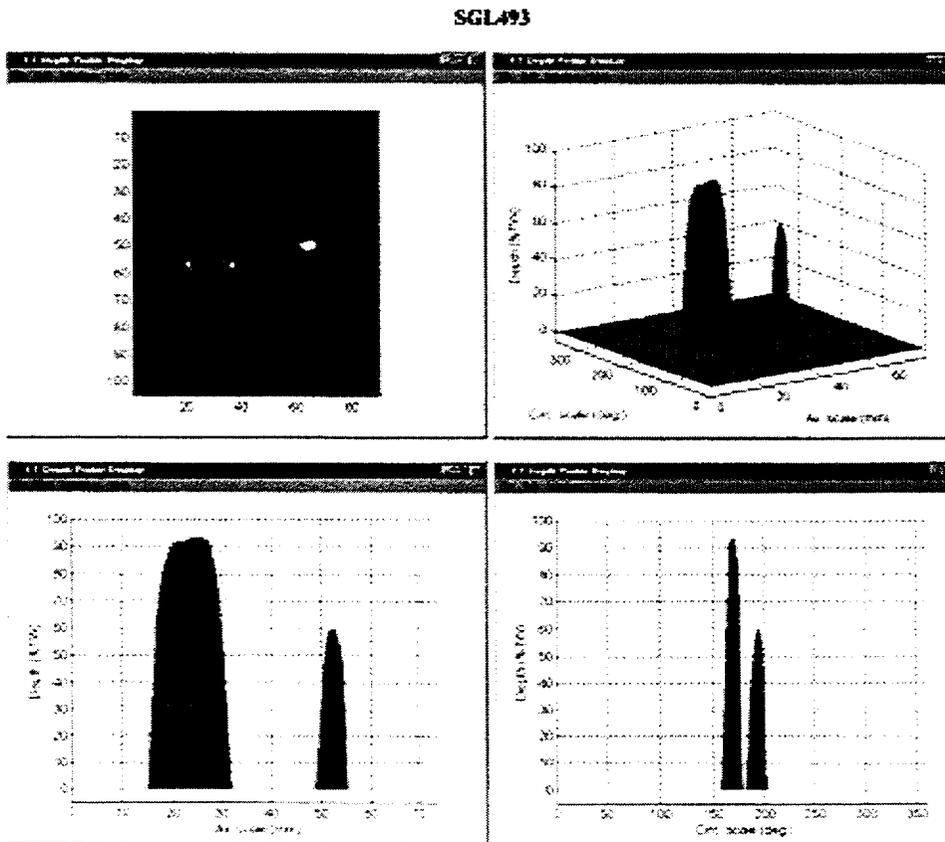
Fig. 4.33. Eddy current NDE of Specimen SGL493.

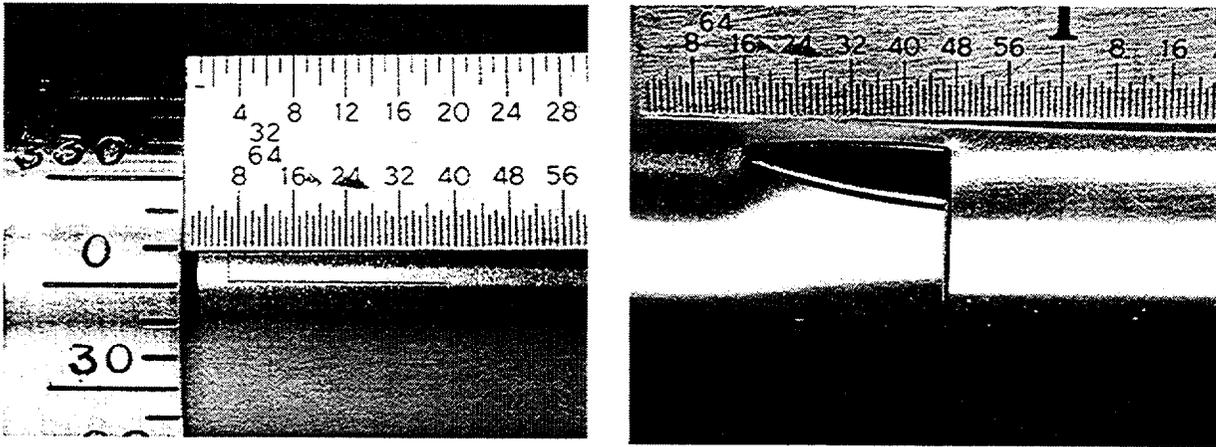
Fig. 4.61. Appearance of Specimen 5469-4-4 with Type 10 flaw before (left) and after (right) Stage 1 testing.

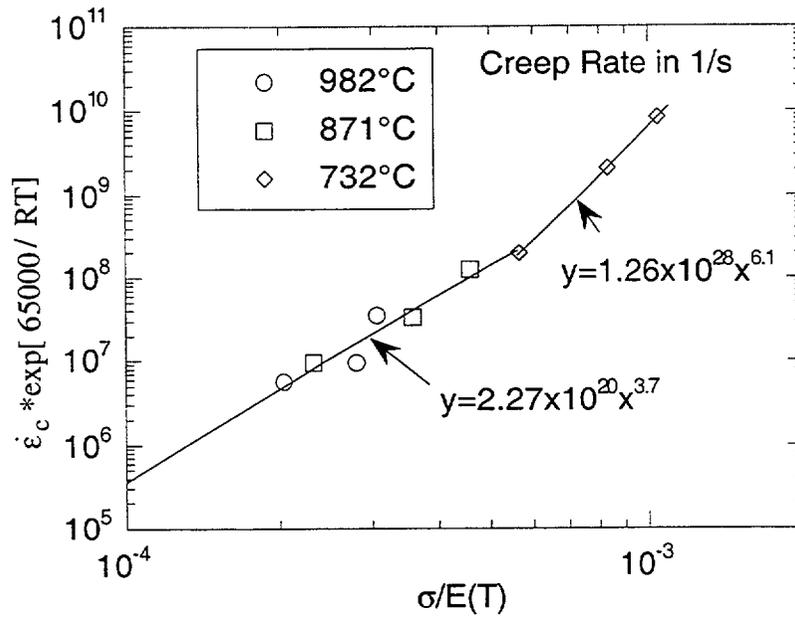
Fig. 4.71. INEEL data on creep rate of Alloy 600 vs. stress plotted using activation energy of 65 kcal/mole and stress normalized by Young's modulus at temperature.

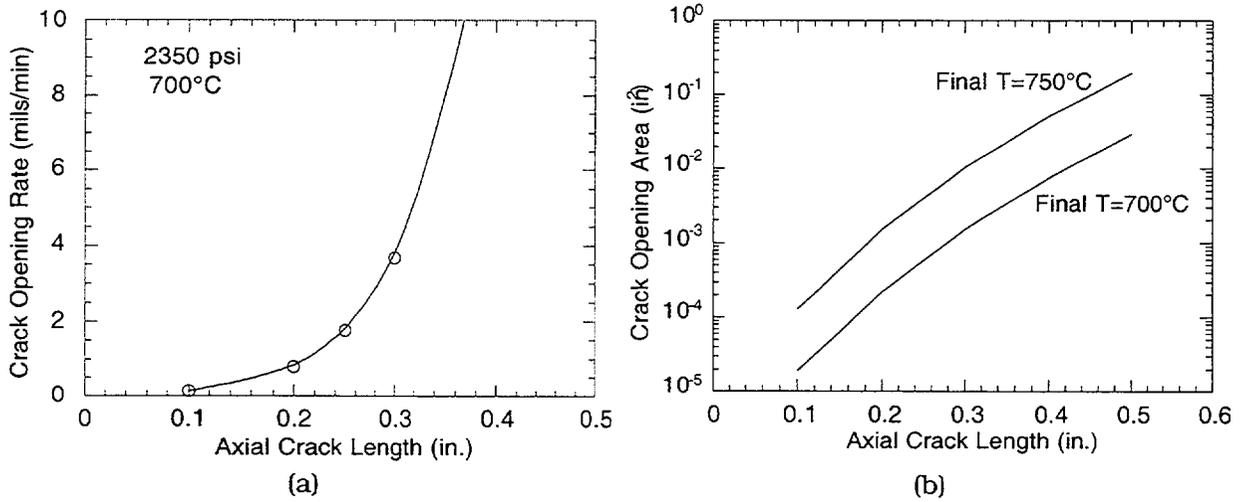
Fig. 4.73. Variations of (a) crack opening displacement rate with throughwall axial crack length for tube subjected to internal pressure of 16.2 MPa (2350 psi) at 700°C and (b) crack opening area with crack length at final temperatures 700 and 750°C for tube subjected to Case 6RU transient.

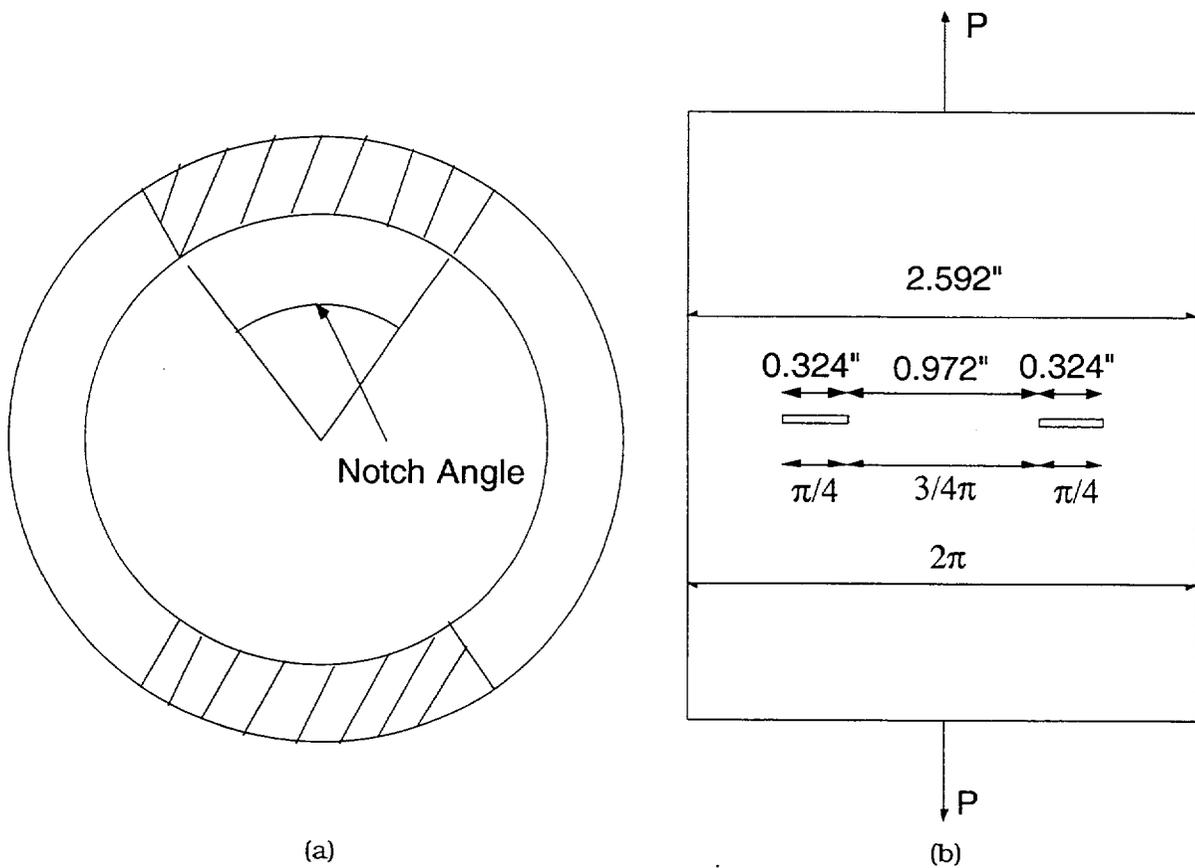
Fig. 4.74. (a) Tube with two symmetrical throughwall circumferential notches and (b) axial loading on tube with two symmetrical 45° notches plotted after making axial cut and unfolding the tube circumference into a plane.

It is extremely difficult to carry out creep tests on tubular specimens with throughwall axial notches subjected to internal pressure. Because the approach followed in this report depends critically on our ability to predict crack opening displacement rates in rectangular plates, validation tests should ideally be conducted on rectangular plates with notches at high temperature. However, validation tests can also be conducted on axially loaded tube specimens with two symmetrical throughwall circumferential EDM notches (Fig. 4.74a) if the

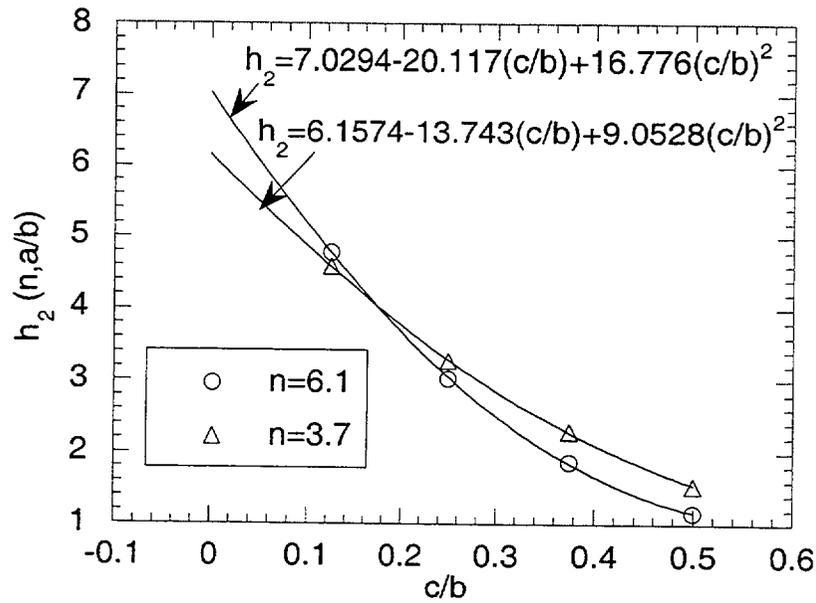
Fig. 4.75. Variation of  $h_2$  with  $c/b$  for creep rate exponents  $n = 3.7$  and  $6.1$ .

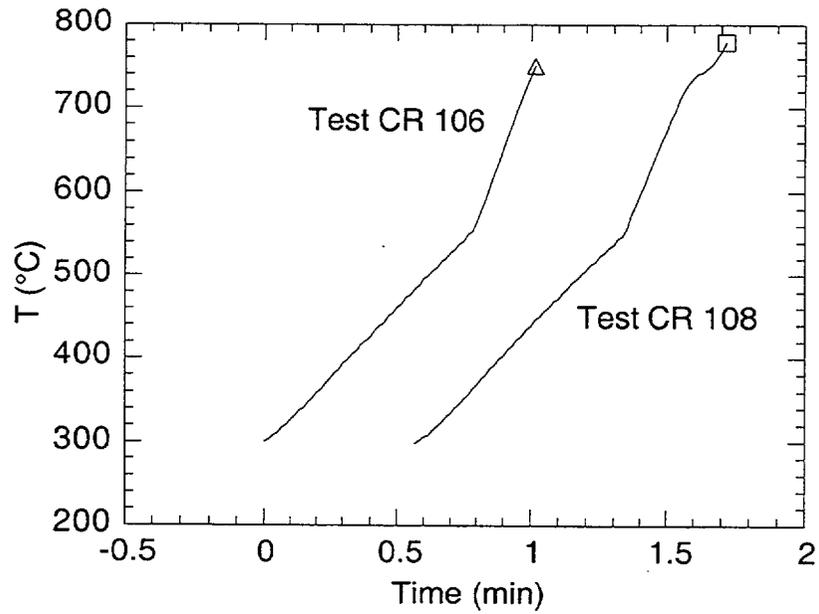
Fig. 4.78. Time vs. temperature plot for tests CR 106 and CR 108. Curve for CR 108 has been displaced in the horizontal direction for clarity.

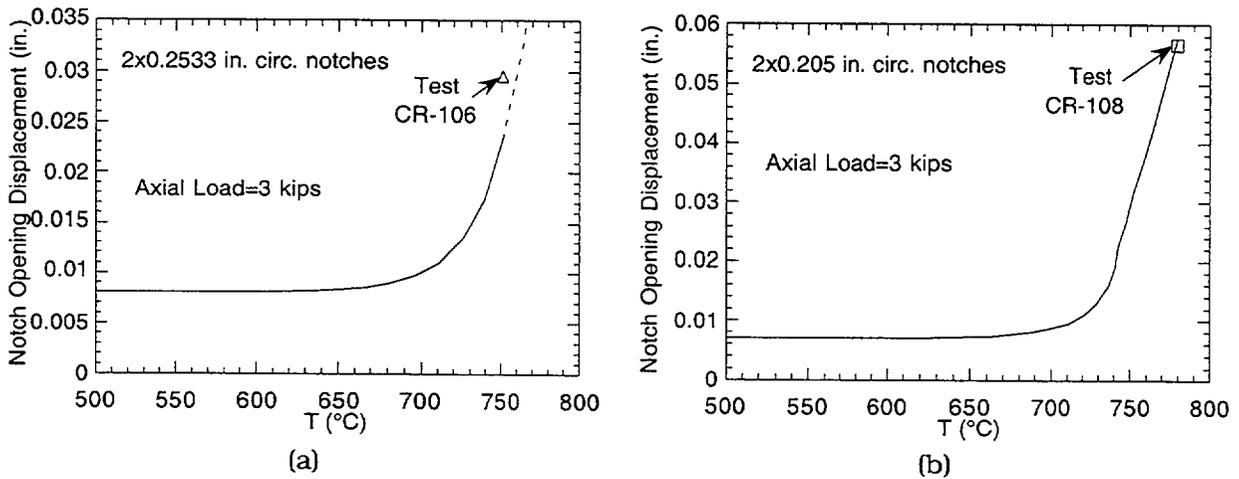
Fig. 4.79. Comparison of predicted (solid line) and experimentally measured (symbols) notch opening displacements for (a) Test CR 106 and (b) Test CR 108.

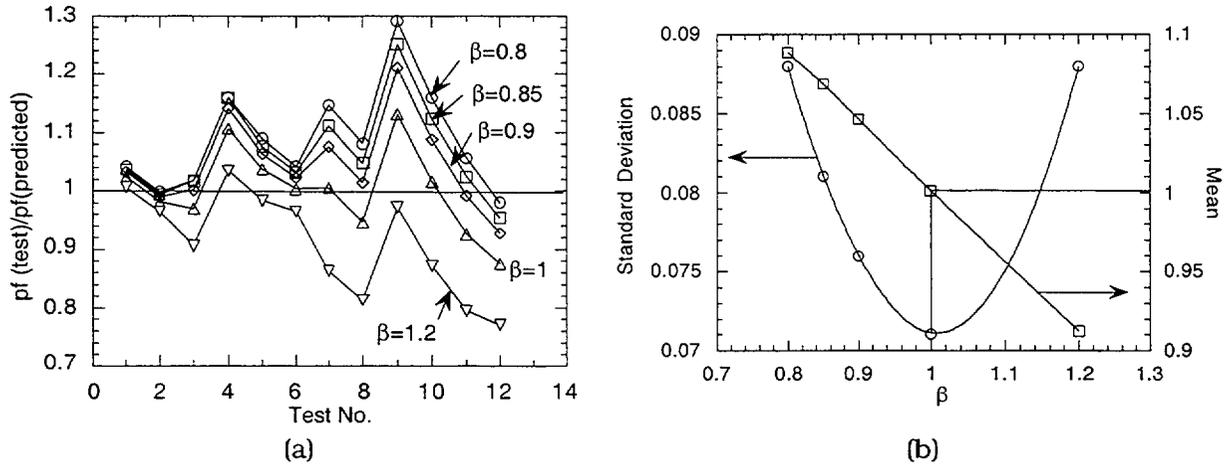
Fig. 4.80. (a) Variation of test failure pressures divided by predicted failure pressures corresponding to various values of  $\beta$  for the ANL tests and (b) variation of mean value and standard deviation of test failure pressure divided by predicted failure pressure with  $\beta$ .

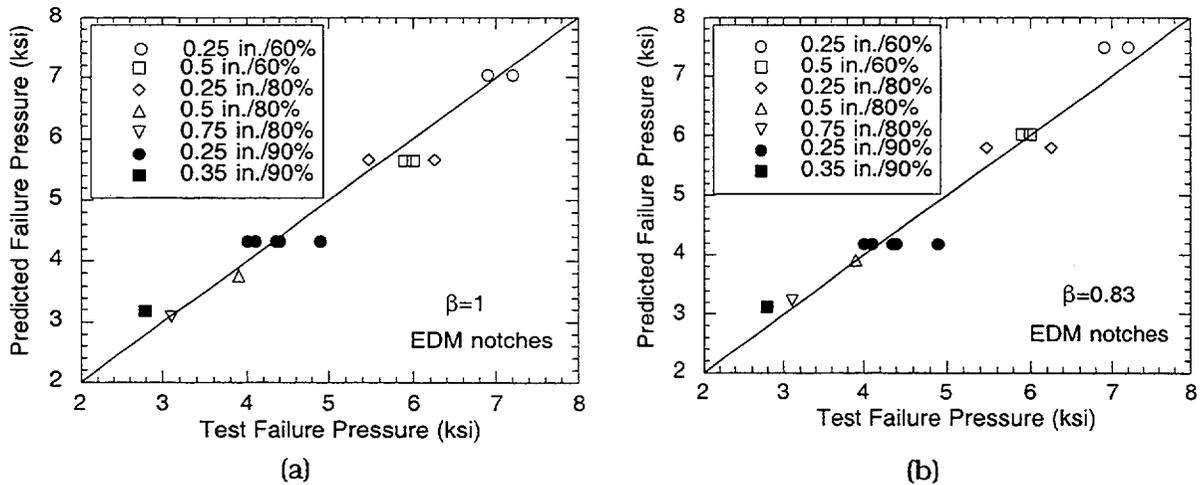
Fig. 4.81. Observed vs. predicted ligament rupture pressures for tubes with EDM notches using (a)  $k = 0.55$  and  $\beta = 1$  and (b)  $k = 0.595$  and  $\beta = 0.83$ .

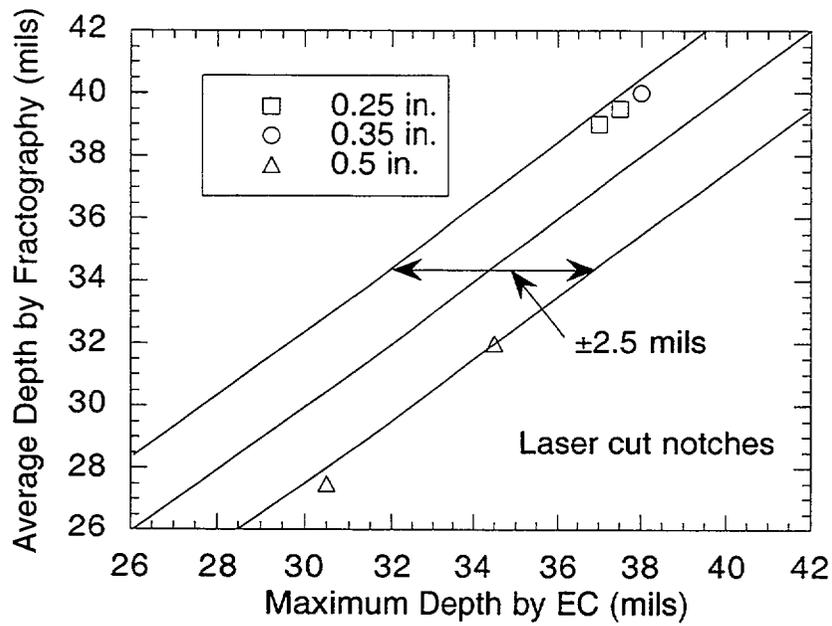
Fig. 4.82. Comparison of notch depths of laser-cut notches as measured by EC with those by fractography.

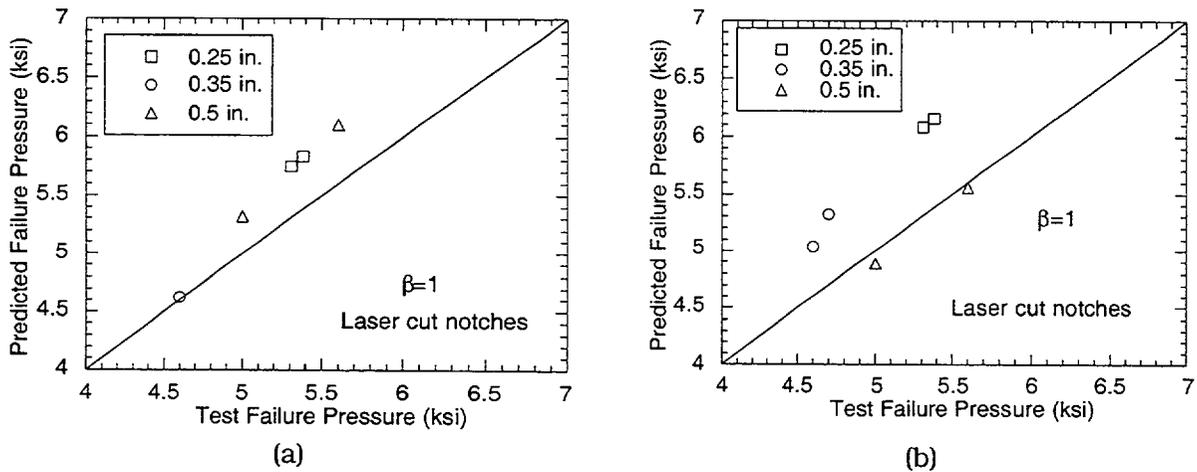
Fig. 4.83. Observed versus predicted ligament rupture pressures (with  $\beta = 1$  and  $k = 0.55$ ) for tubes with laser-cut notches using notch depths from (a) fractography and (b) EC measurements.

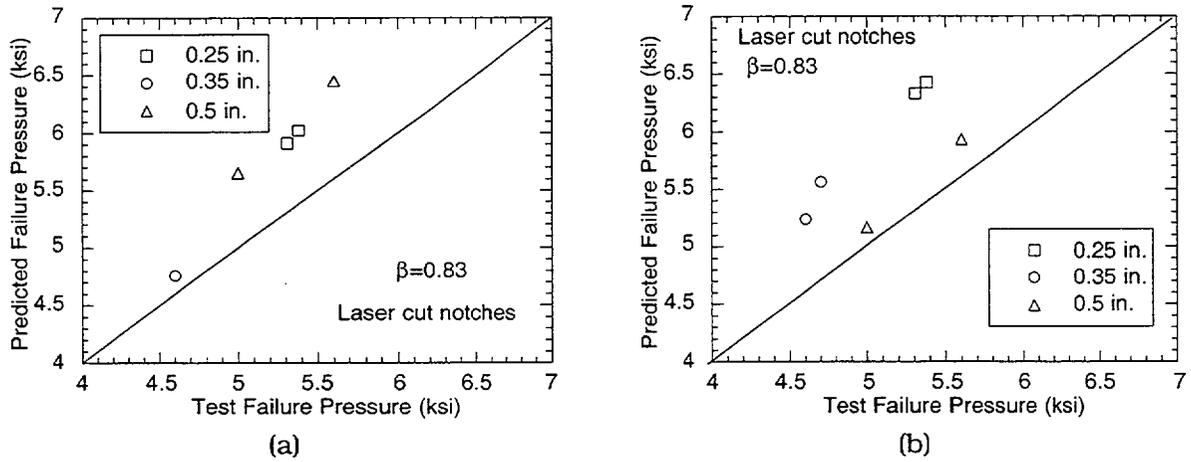
Fig. 4.84. Observed versus predicted ligament rupture pressures (with  $\beta = 0.83$  and  $k = 0.595$ ) for tubes with laser-cut notches using notch depths from (a) fractography and (b) EC measurements.

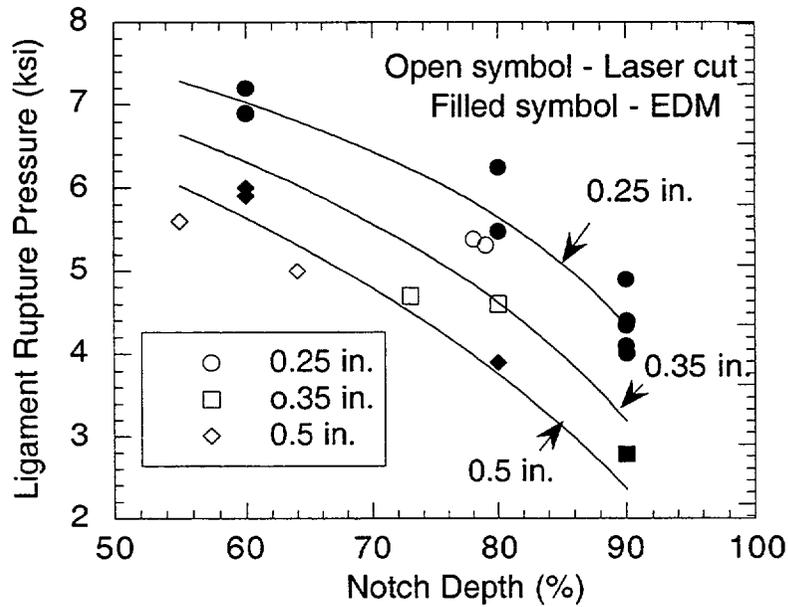
Fig. 4.85. Comparison of ligament rupture pressures for EDM and laser-cut notches of various lengths and depths with predicted values (solid lines).

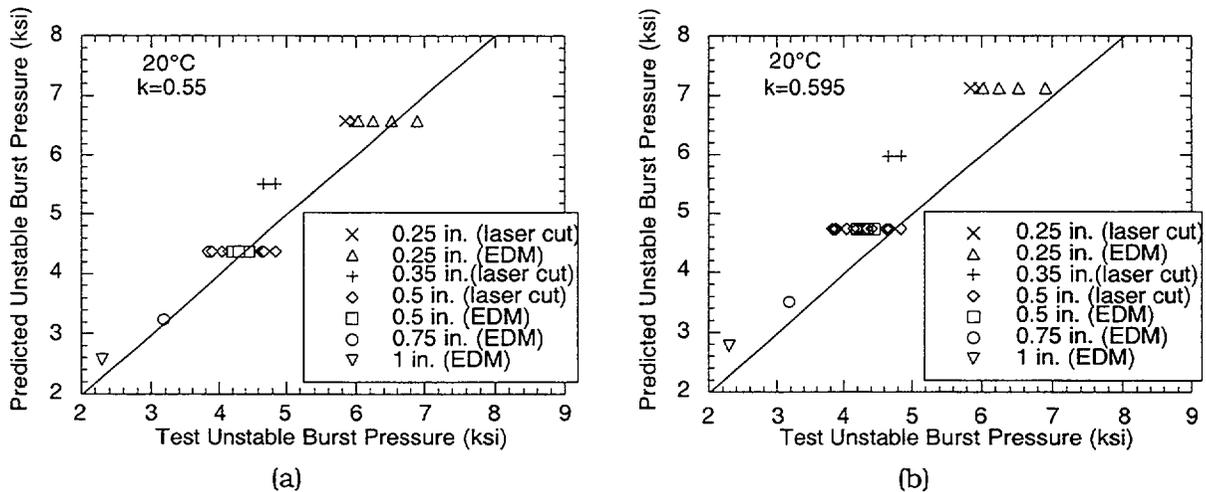
Fig. 4.86. Observed vs. predicted unstable burst pressures for tubes with throughwall EDM and laser-cut notches using (a)  $k = 0.55$  and (b)  $k = 0.595$ .

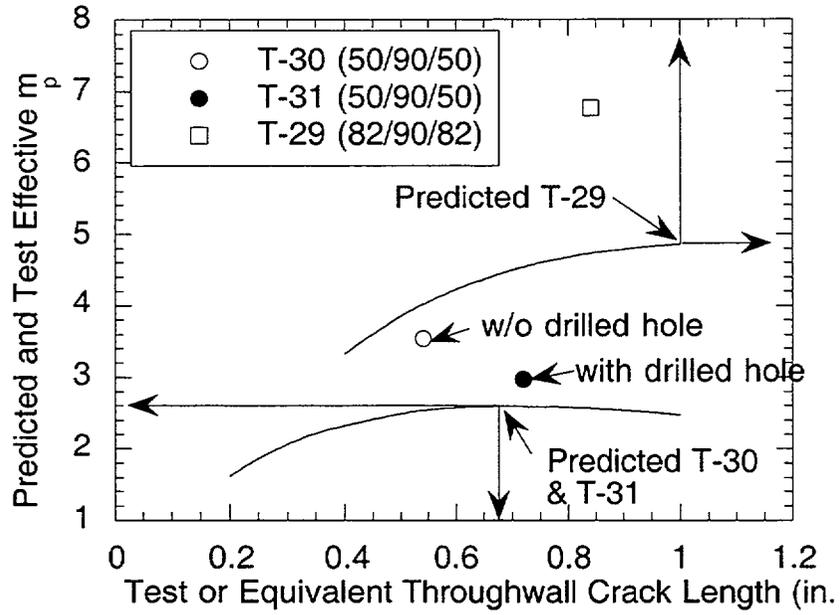
Fig. 4.88. Comparison of predicted vs. observed effective  $m_p$  for tests with trapezoidal notches.
