Probability of Detecting Leaks in RPV Upper Head Nozzles
by Visual Inspections

**Revision 1
June 17, 2002**

Prepared for:
MRP PWR Alloy 600 Assessment Committee

Prepared by:
Steve Hunt and Mark Fleming
Dominion Engineering, Inc.

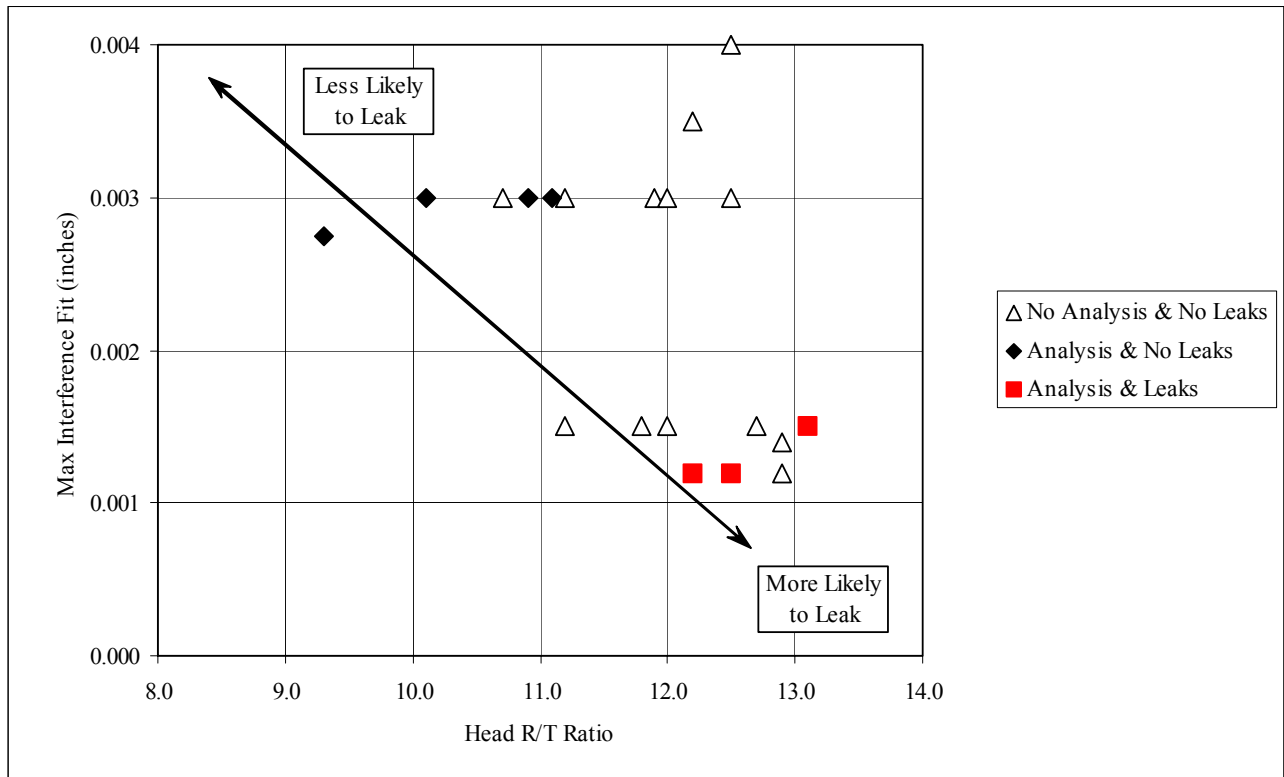
Figure 1
Reactor Vessel Head Designs for Which Leak Path Has Been Confirmed

Figure 1 shows the specified interference fits relative to the vessel head radius to thickness ratio (R/T), and the status of cases analyzed and confirmed leakage. These results show that calculations have demonstrated a leak path for nozzles with up to 0.003" specified maximum interference fit with the smallest R/T ratios. Designs with small R/T ratios will have smaller gap opening displacement than heads with large R/T ratios since they will have lower membrane stresses in the head and less pressure dilation of the vessel shell.
