Steam Generator Tube Integrity Program

Annual Report
October 1998 — September 1999

Argonne National Laboratory

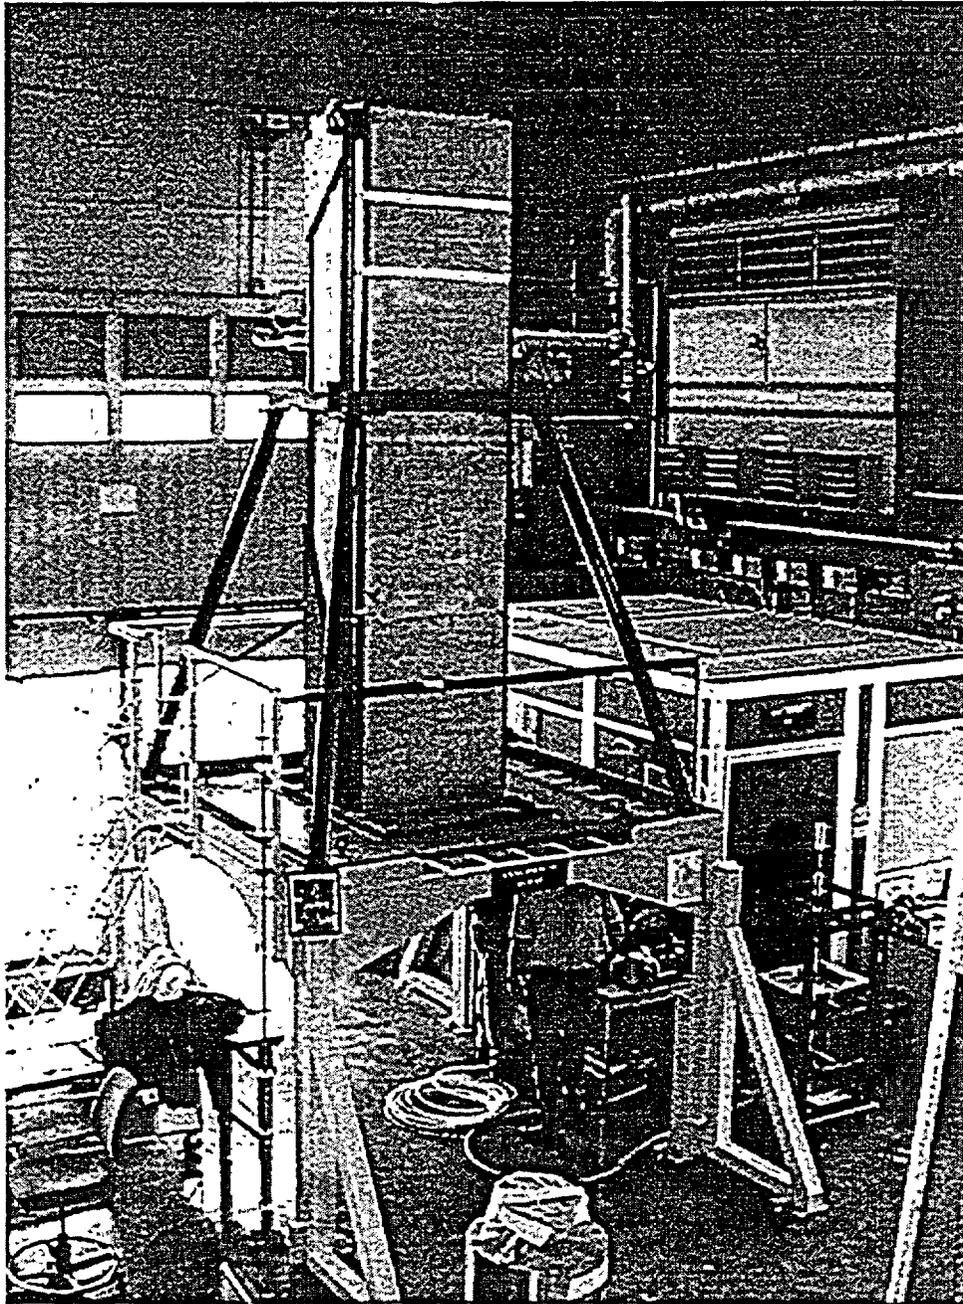
Fig. 2.4. Photograph of activity during acquisition of eddy current data by Zetec team.

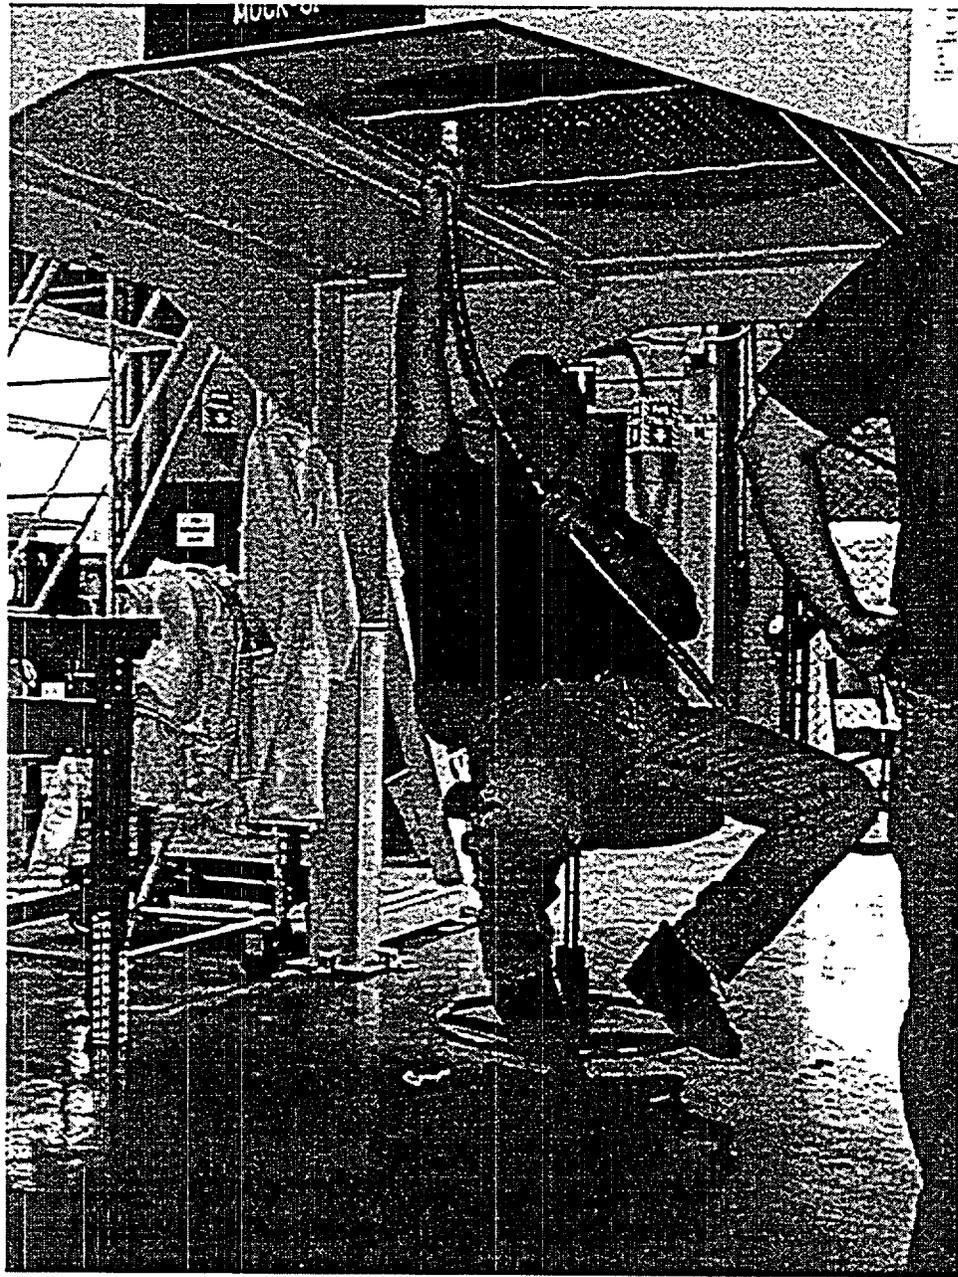
Fig. 2.5. Photograph of underside of tube bundle. Conduit carrying the EC probe is shown being positioned under a tube.

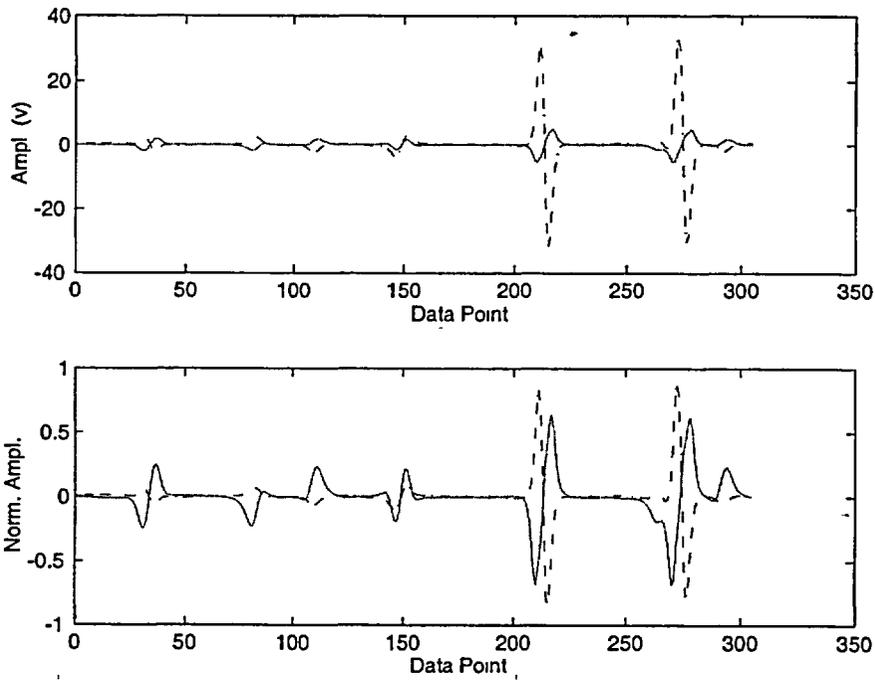
Fig. 3.1. Differential BC horizontal and vertical signal components of calibrated original (top) and renormalized (bottom) traces at $f = 400$ kHz. Simulated indications from left to right consist of throughwall drilled hole, TSP ring, 10% OD and 20% ID circumferential grooves, and composite (of last three indications) signal.

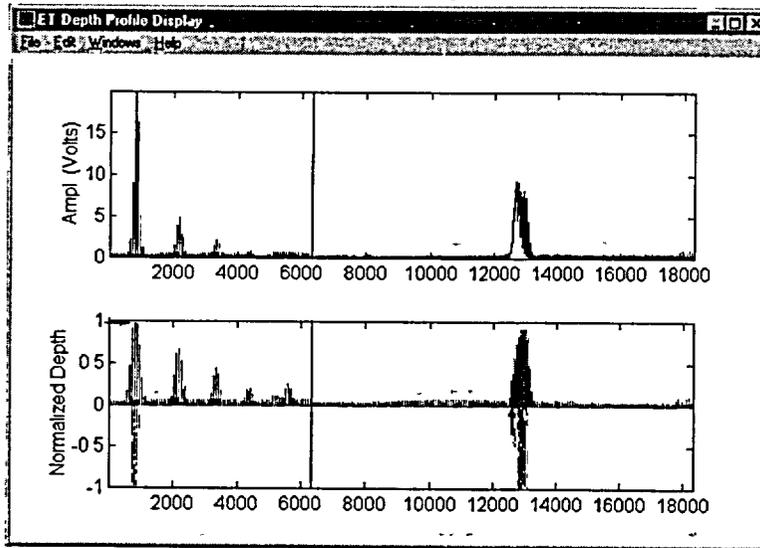
Fig. 3.8. Output of data analysis tool for roll-expanded specimen #1-11 that was destructively identified as having 100% (max. depth) LIDSCC degradation. Traces show calibrated amplitude in volts (top), and normalized multifrequency depth profile (bottom) of notch standard (left) followed by sample tube, suggesting >80% degradation depth around scan location 1.3×10^4 . Eddy current readings are from 2.92 mm (0.115 in.) pancake of three-coil rotating probe.

3.8.	Output of data analysis tool for roll-expanded specimen #1-11 that was destructively identified as having 100% LIDSCC degradation.....	27

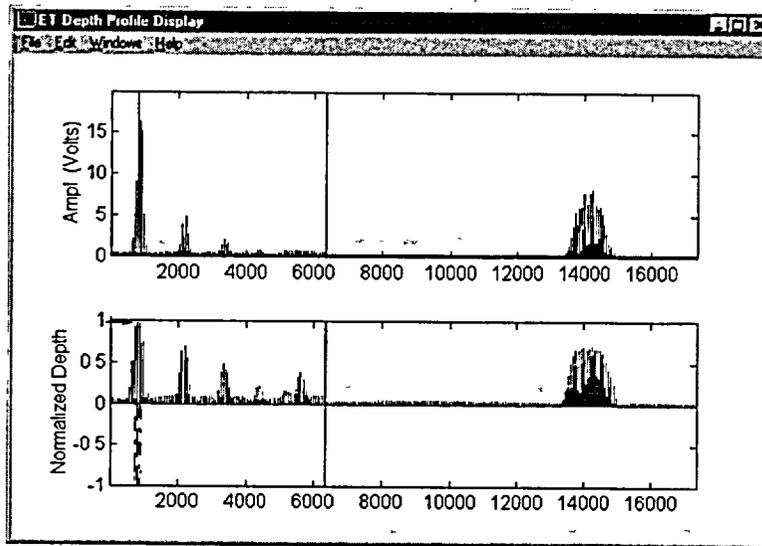
Fig. 3.9. Output of data analysis tool for roll-expanded specimen #2-06 that was destructively identified as having 100% (max. depth) LODSCC degradation. Traces show calibrated amplitude in volts (top), and normalized multifrequency depth profile (bottom) of notch standard (left) followed by sample tube, suggesting >80% degradation depth around scan location 1.4×10^4 . Eddy current readings are from 2.92 mm (0.115 in.) pancake of three-coil rotating probe.

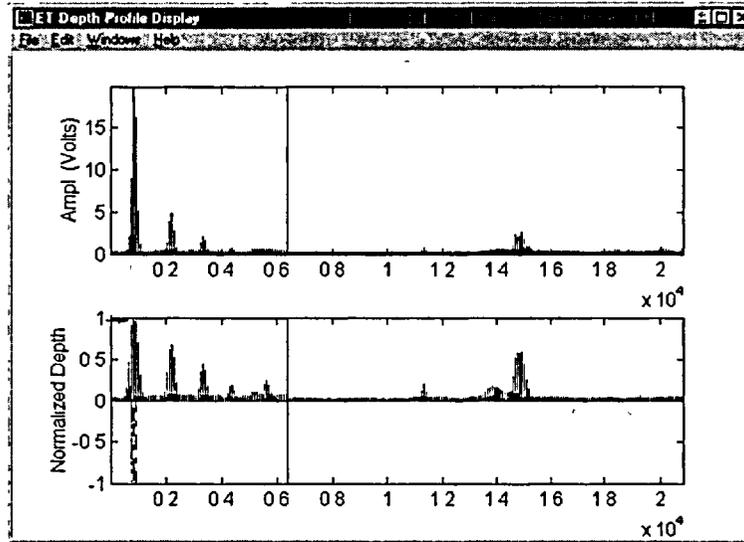
Fig. 3.10. Output of data analysis tool for specimen #2-11 that was destructively identified as having 95% (max. depth at a single point with all other indications marked <38%) LODSCC degradation. Traces show calibrated amplitude in volts (top), and normalized multifrequency depth profile (bottom) of notch standard (left) followed by sample tube, suggesting 60-80% degradation depth around scan location 1.5×10^4 . Eddy current readings are from 2.92 mm (0.115 in.) pancake of three-coil rotating probe.

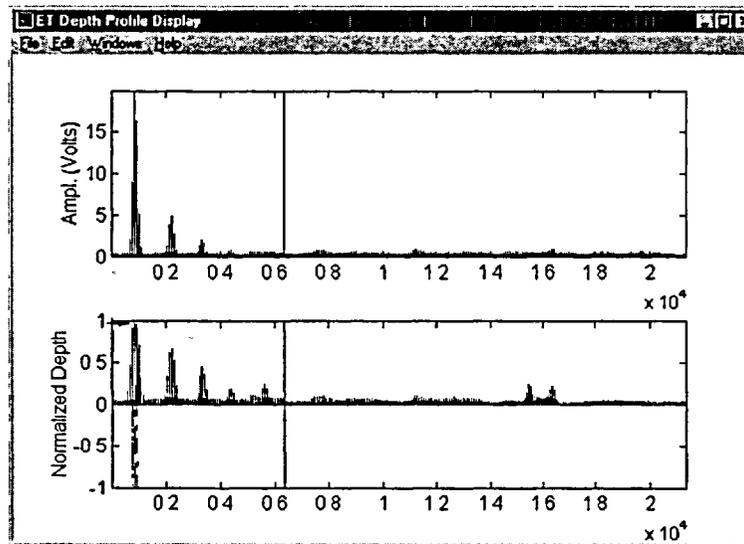
Fig. 3.11. Output of data analysis tool for specimen #2-19 that was destructively identified as having 46% (max. depth) LODSCC degradation. Traces show calibrated amplitude in volts (top), and normalized multifrequency depth profile (bottom) of notch standard (left) followed by sample tube, suggesting 20-40% degradation depth around scan location 1.6×10^4 . Eddy current readings are from 2.92 mm (0.115 in.) pancake of three-coil rotating probe.

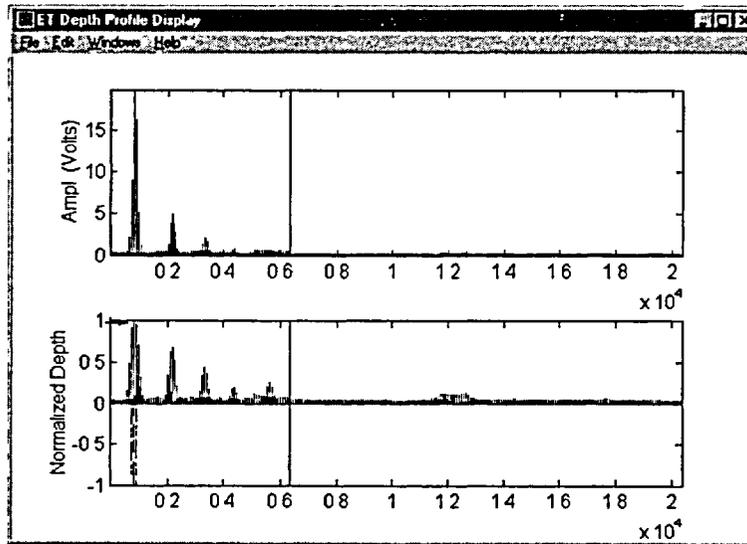
Fig. 3.12. Output of data analysis tool for specimen #2-20 that was destructively identified as having 16% (max. depth) LODSCC degradation. Traces show calibrated amplitude in volts (top), and normalized multifrequency depth profile (bottom) of notch standard (left) followed by sample tube, suggesting <20% degradation depth around scan location 1.2×10^4 . Eddy current readings are from 2.92 mm (0.115 in.) pancake of three-coil rotating probe.

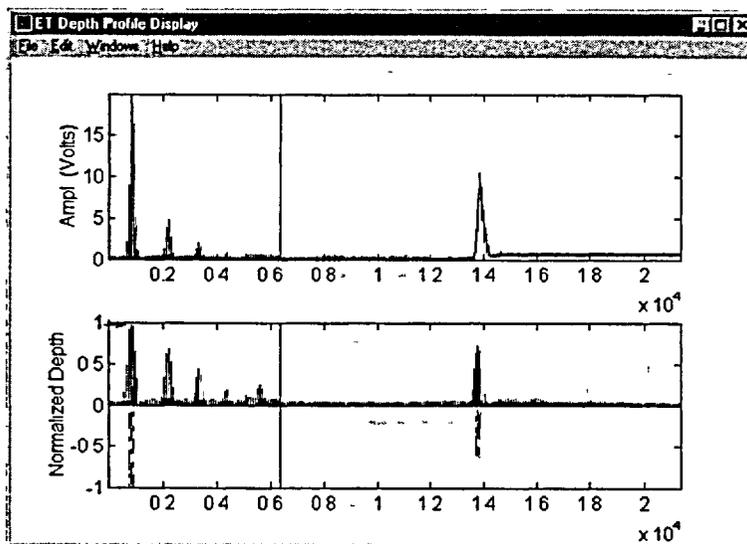
Fig. 3.13. Output of data analysis tool for roll-expanded specimen #3-14 LIDSCC degradation (no DE results available; target value 30%-60%). Traces show calibrated amplitude in volts (top), and normalized multifrequency depth profile (bottom) of notch standard (left) followed by sample tube, suggesting 40%-60% degradation depth around scan location 1.4×10^4 . Eddy current readings are from 2.92 mm (0.115 in.) pancake of three-coil rotating probe.

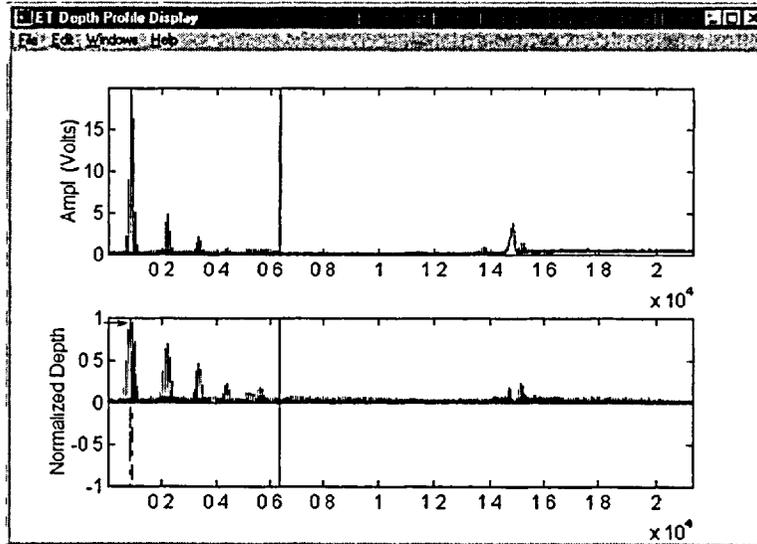
Fig. 3.14. Output of data analysis tool for roll-expanded specimen #4-04 that was destructively identified as having 64% (max. depth) CODSCC degradation. Traces show calibrated amplitude in volts (top), and normalized multifrequency depth profile (bottom) of notch standard (left) followed by sample tube, suggesting >40% degradation depth around scan location 1.5×10^4 . Eddy current readings are from 2.92 mm (0.115 in.) pancake of three-coil rotating probe.

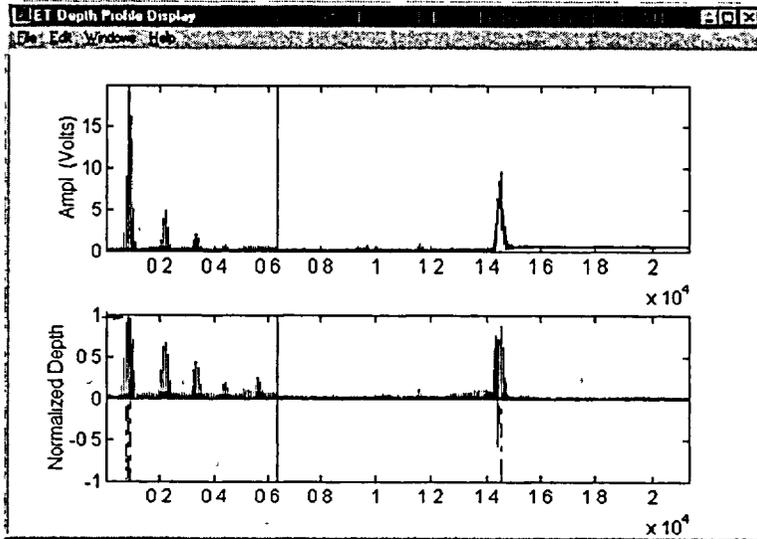
Fig. 3.15. Output of data analysis tool for roll-expanded specimen #4-10 that was destructively identified as having 100% (max. depth) CODSCC degradation. Traces show calibrated amplitude in volts (top), and normalized multifrequency depth profile (bottom) of notch standard (left) followed by sample tube, suggesting >80% degradation depth around scan location 1.4×10^4 . Eddy current readings are from 2.92 mm (0.115 in.) pancake of three-coil rotating probe.

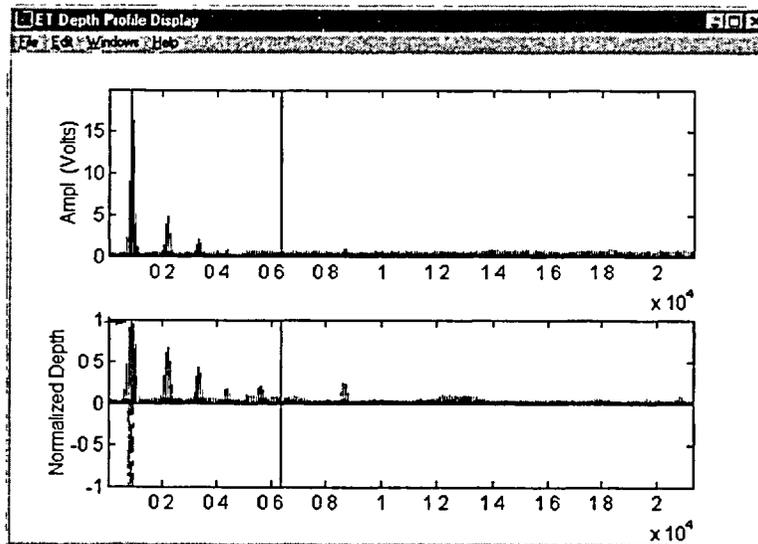
Fig. 3.16. Output of data analysis tool for roll-expanded specimen #B10-07 that was destructively identified as having 28% (max. depth) LODSCC degradation. Traces show calibrated amplitude in volts (top), and normalized multifrequency depth profile (bottom) of notch standard (left) followed by sample tube, suggesting 20-40% degradation depth around scan locations 0.9×10^4 and 1.3×10^4 . Eddy current readings are from 2.92 mm (0.115 in.) pancake of three-coil rotating probe.

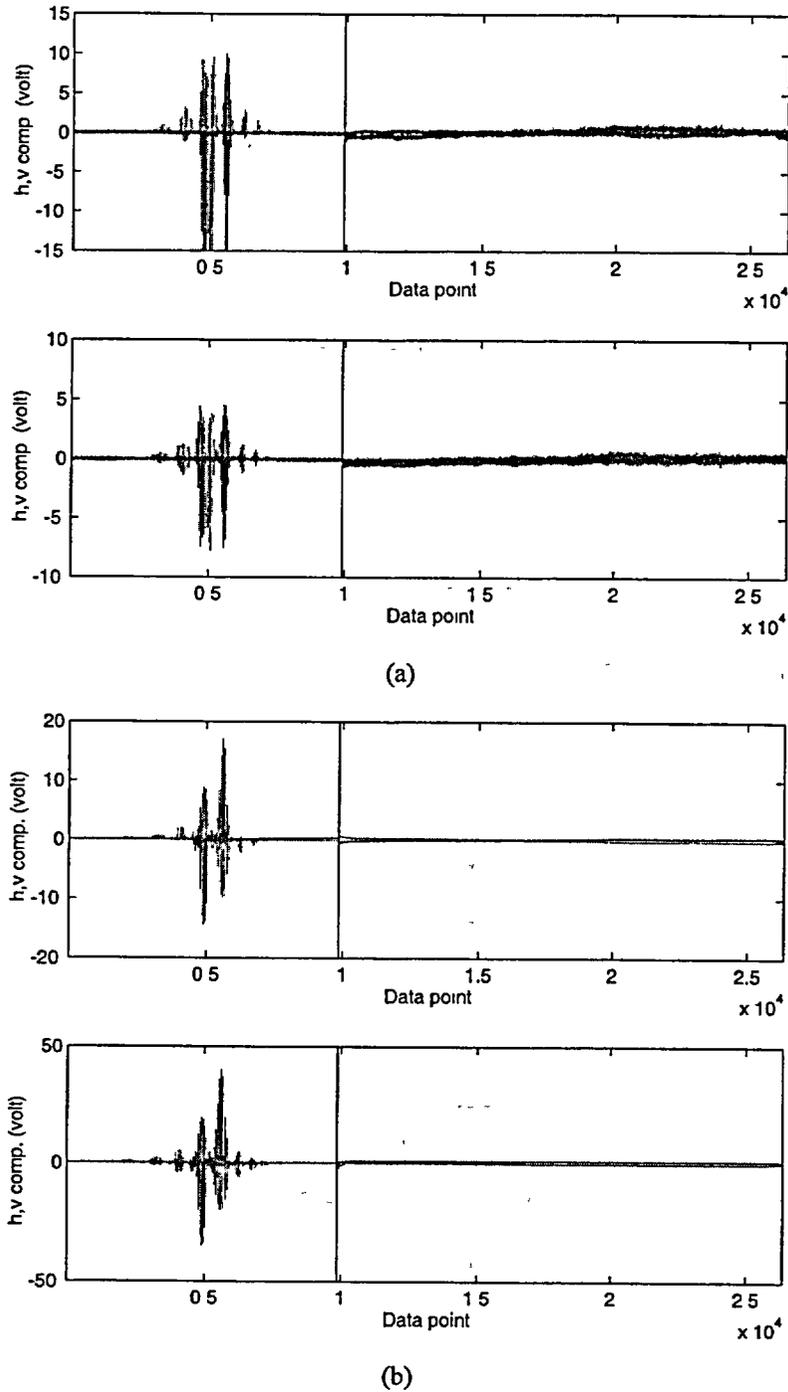
Fig. 3.18. Calibrated readings with (a) 2.92 mm (2.92-mm [0.115-in.]) pancake and (b) midrange +Point coils of three-coil rotating probe at 400 kHz (top) and 100 kHz (bottom) frequencies on 22.2-mm (0.875-in.)-diameter Alloy 600 tube. Response from 20-100% OD, 6.35-mm (0.25-in.)-long axial/circumferential EDM notches from in-line standard is shown on left; signal from test specimen SGL-432 is on right. No discernible indications are present in these traces, although a BC indication is present, as shown in Fig. 3.17.

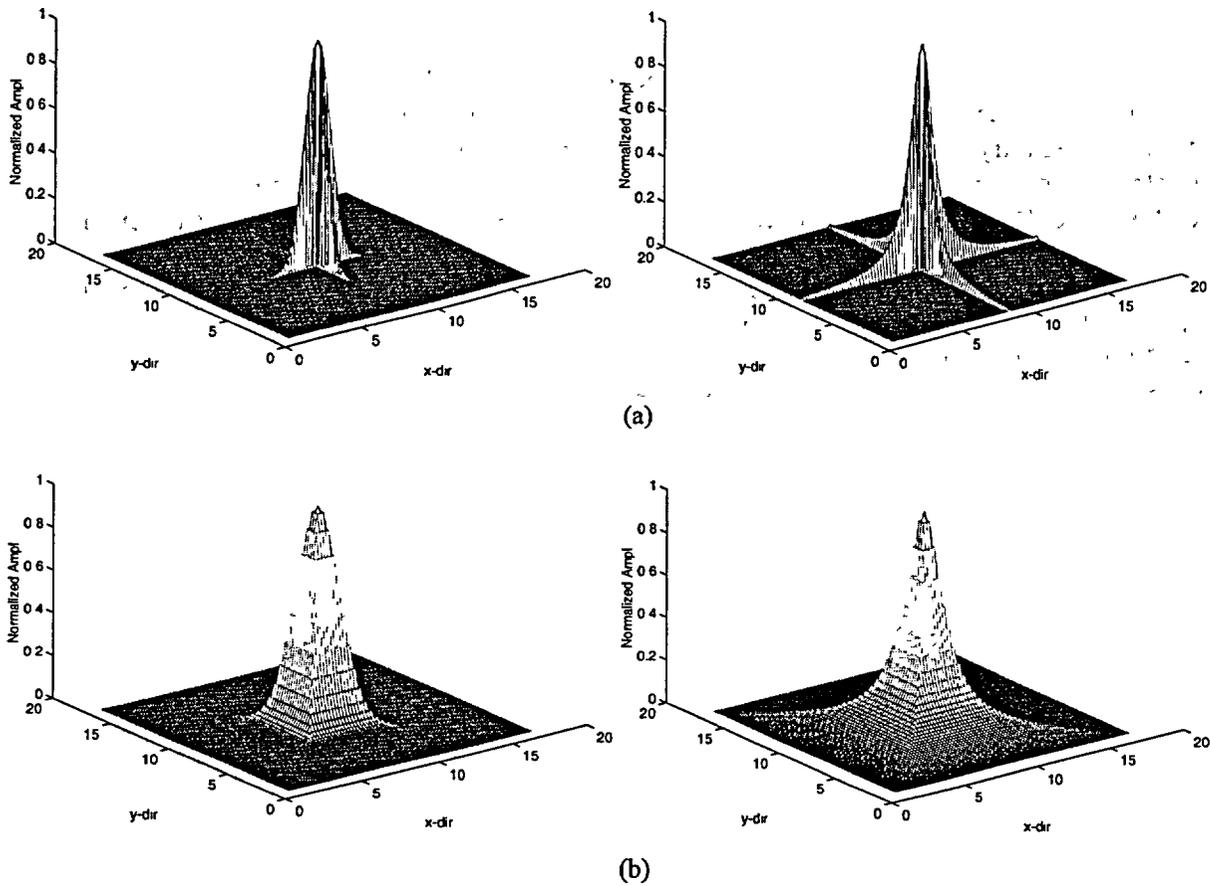
Fig. 3.33. Spatial domain 2-D kernels for Gaussian (left) and Lorentzian (right) impulse responses constructed by (a) two orthogonal 1-D functions and (b) rotation of 1-D function about vertical axis.

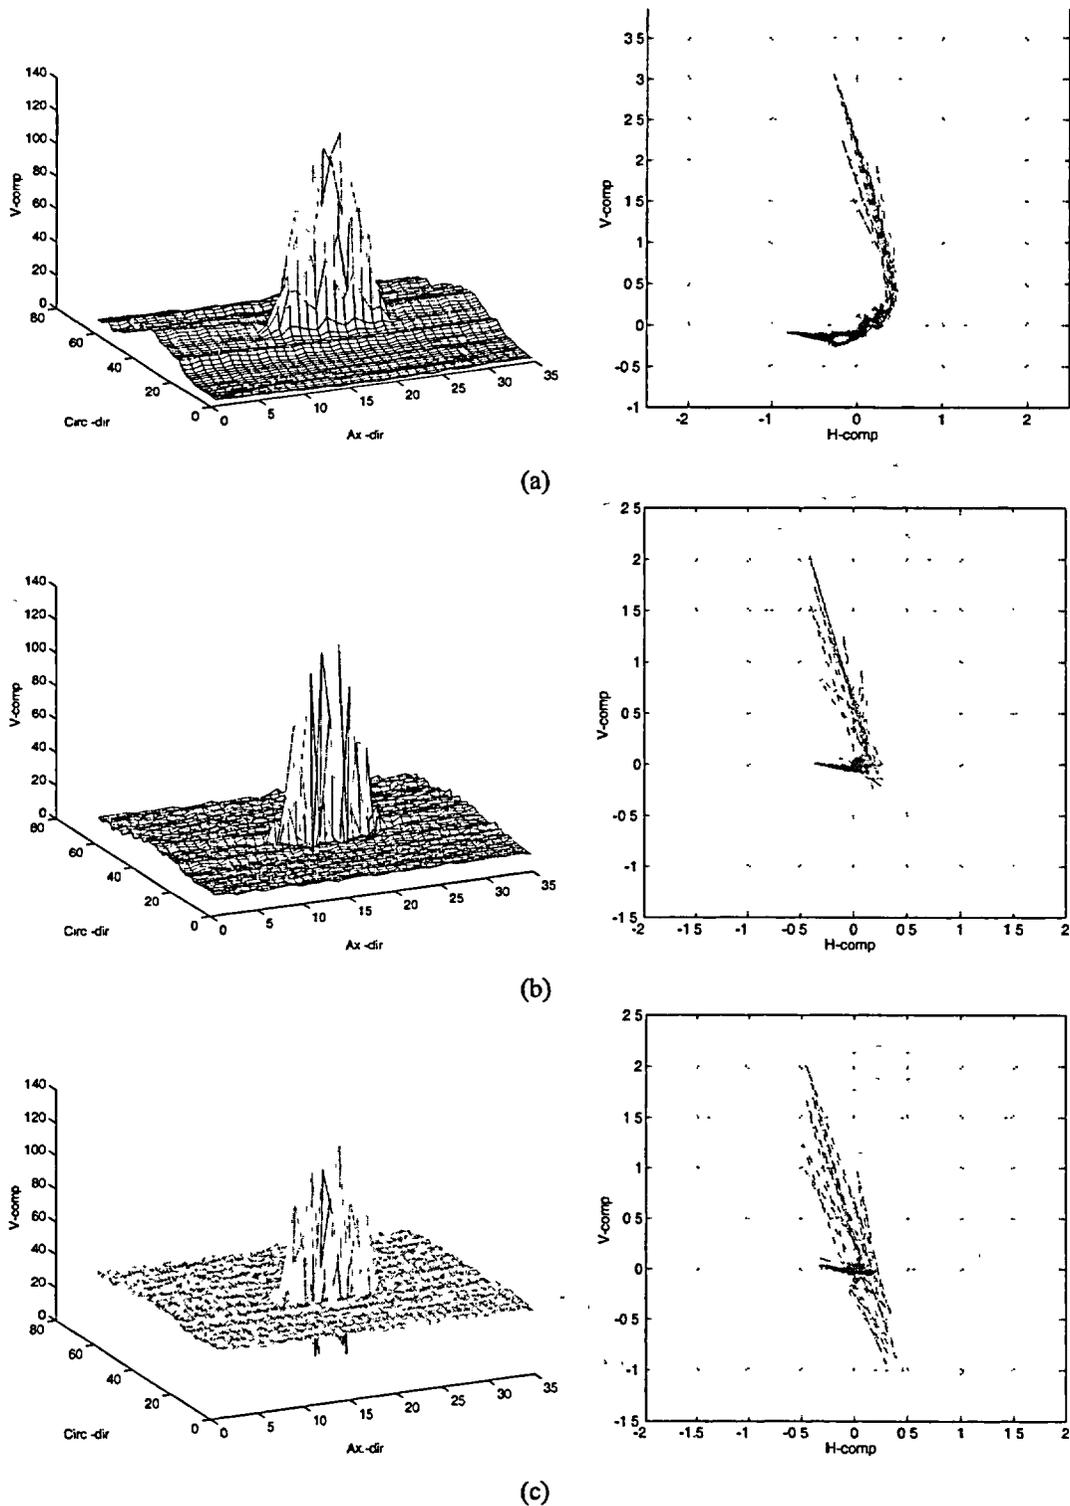
Fig. 3.34. (a) Original and (b)-(c) restored signals with 2-D Lorentzian kernels of Fig. 3.34 for Type-1 laser-cut specimen #5528-1-1 with nominal OD flaw depth of 80% TW. In both cases, the deconvolved signal displays higher spatial resolution and lower baseline variation. NDE maximum depth estimates were 58% by bobbin coil (phase-angle) and 75% by multiparameter analysis of RPC (2.92-mm [0.115-in.] pancake) data.

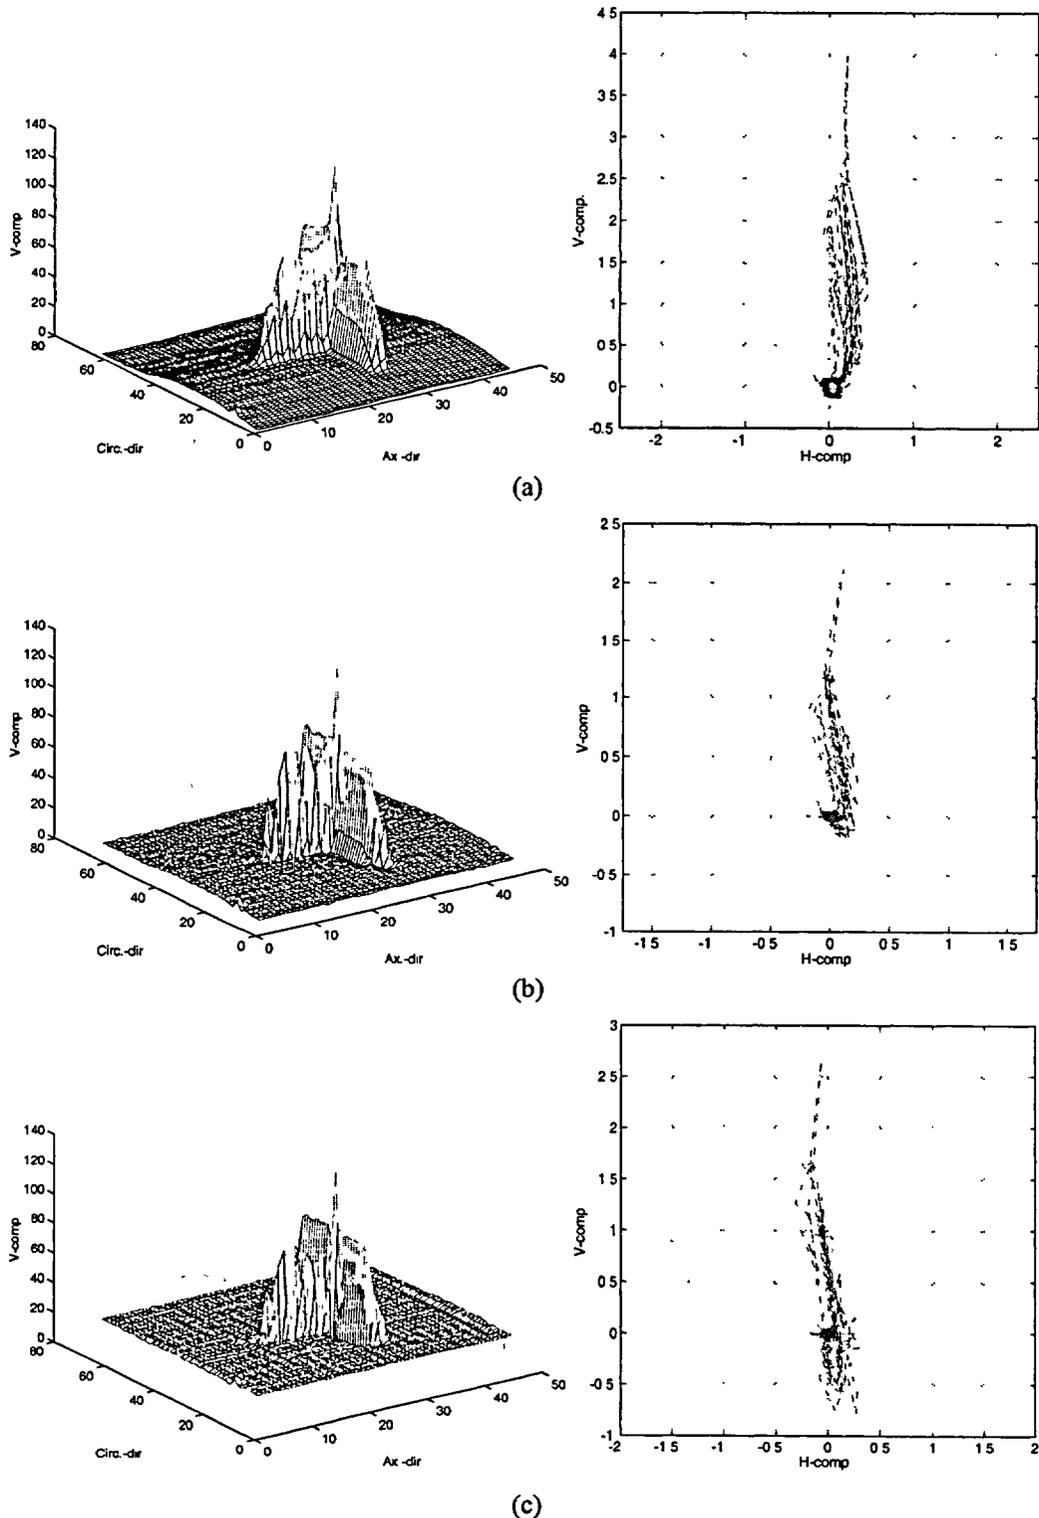
Fig. 3.41. (a) Original and (b)-(c) restored signals with 2-D Lorentzian kernels for Type-9 laser-cut specimen #5469-4-3 with nominal OD flaw depth of 80% TW. NDE maximum depth estimates were 48% by bobbin coil (phase-angle) and 69% by multiparameter analysis of RPC (2.92-mm [0.115-in.] pancake) data.

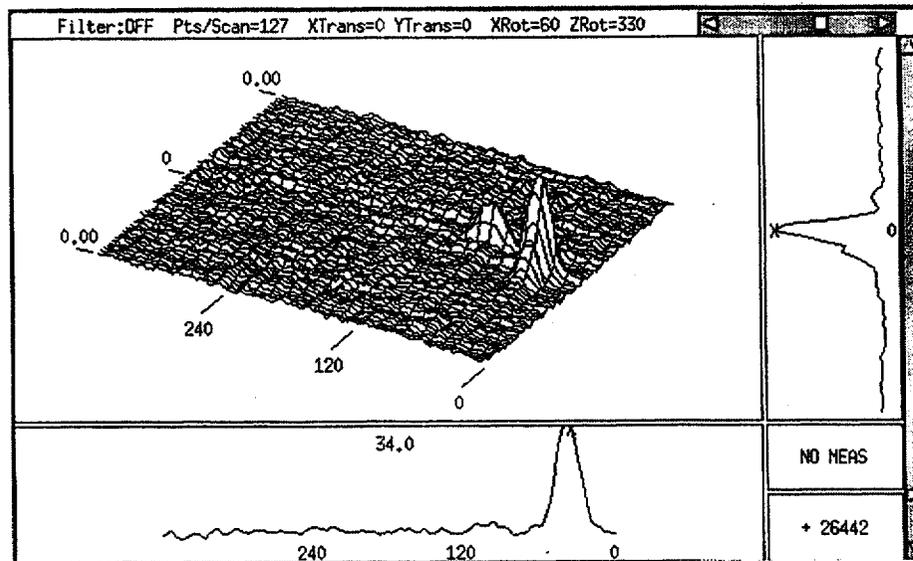
Fig. 4.5. Eddy current NDE test results from Specimen SGL-288 showing an axial ODSCC indication.

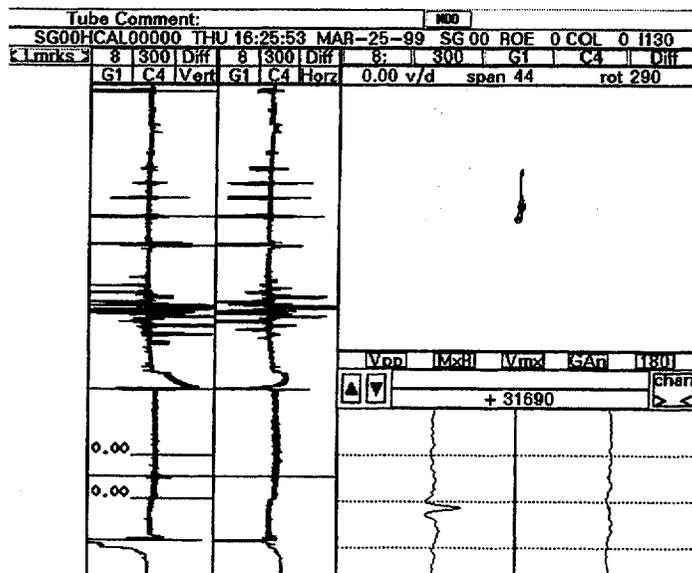
Fig. 4.21. Eddy current NDE test results from specimen SGL-397 after degradation.

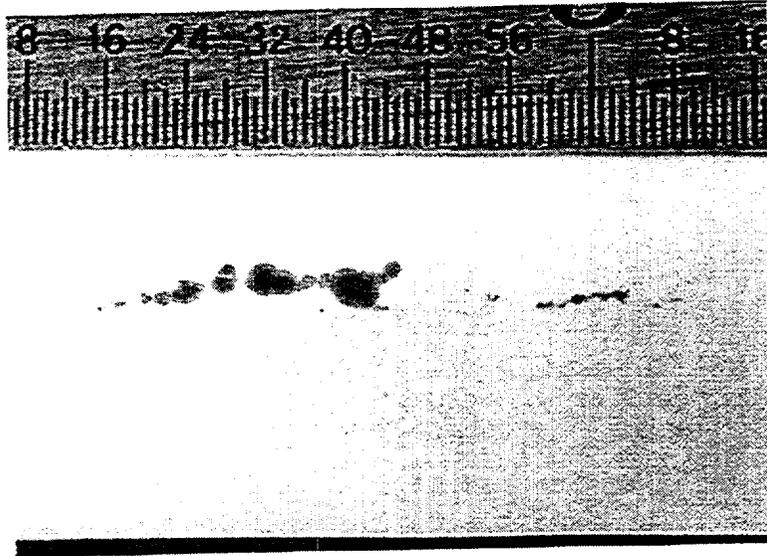
Fig. 4.22. Dye penetrant examination of dented Alloy 600 tube SGL-527 showing segmented axial ODSCC indication.

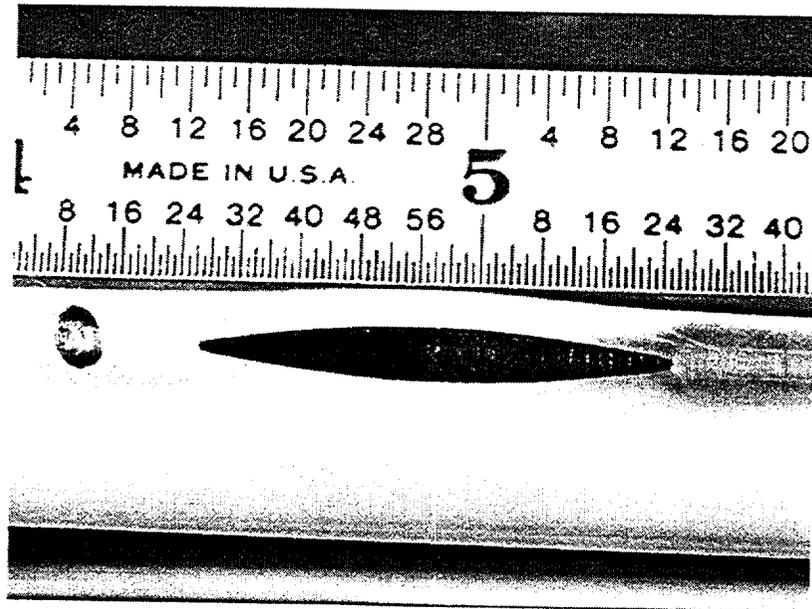
Fig. 4.25. Opening of 25.4-mm (1-in.)-long axial 100% TW EDM notch (tube T14EATWX1) after test was interrupted at 13.8 MPa (2000 psi) to measure flaw area.

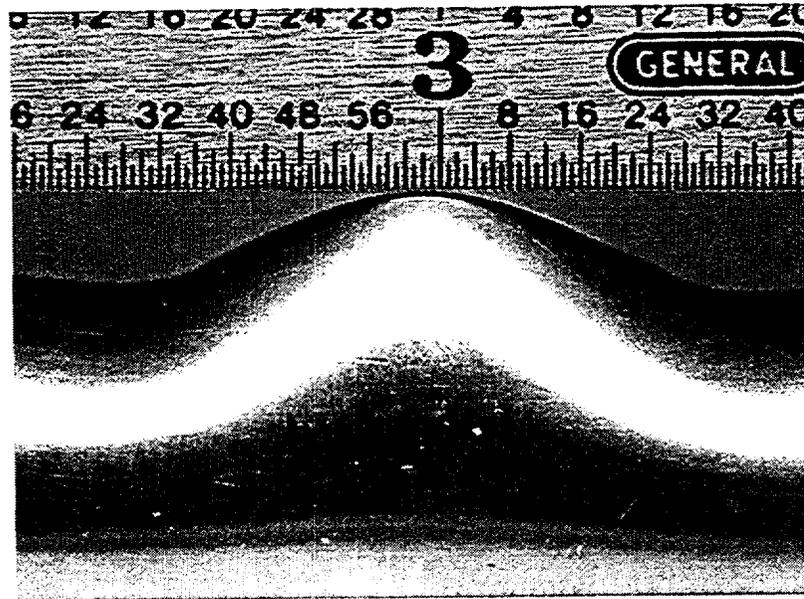
Fig. 4.27. Side view of tube specimen shown in Fig. 4.26, showing three-dimensional bulging at failure site.

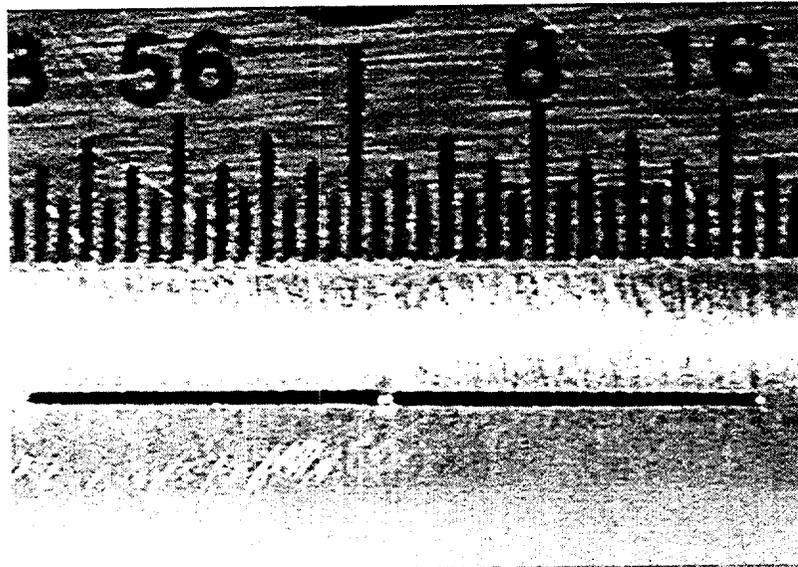
Fig. 4.28. Posttest photograph of tube T24EATWX.5 LIG tested at room temperature at up to 17.2 MPa (2500 psi), showing little flaw distortion and intact ligament.

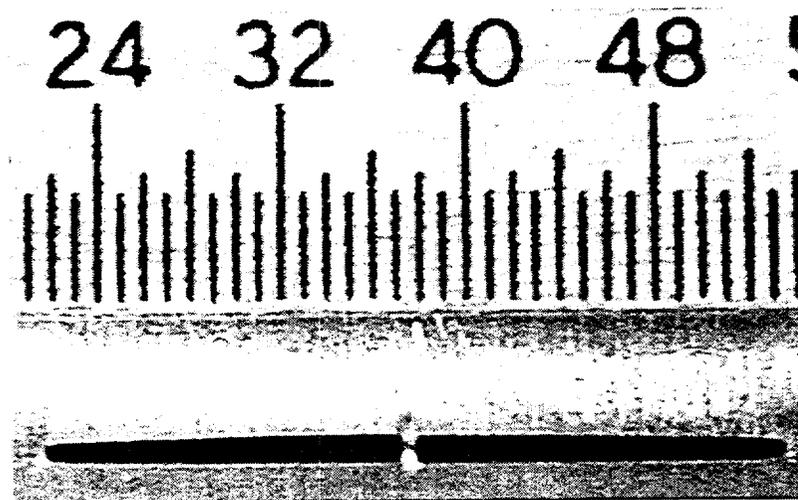
Fig. 4.29. Posttest photograph of tube T25EATWX.5 LIG tested at 282°C (540°F) at up to 17.9 MPa (2600 psi), showing appreciable flaw notch widening and torn ligament.

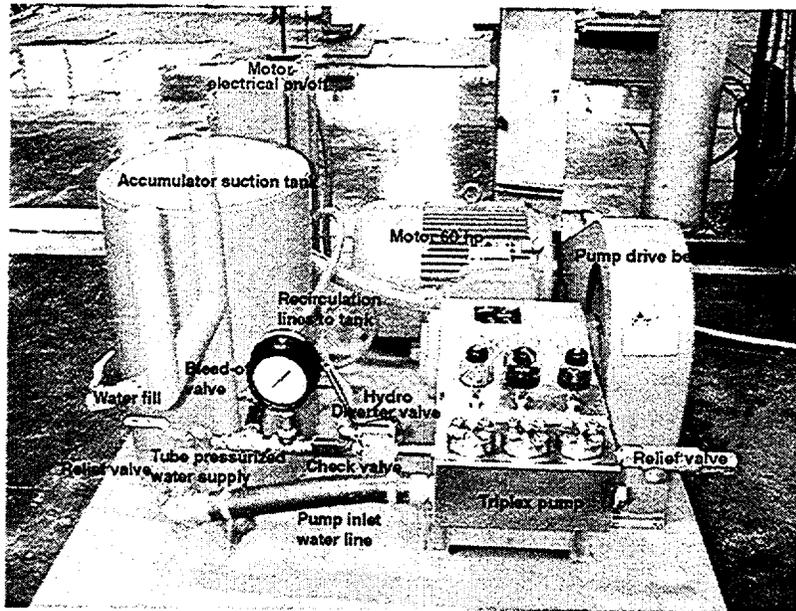
Fig. 4.33. Water pump pressurizer

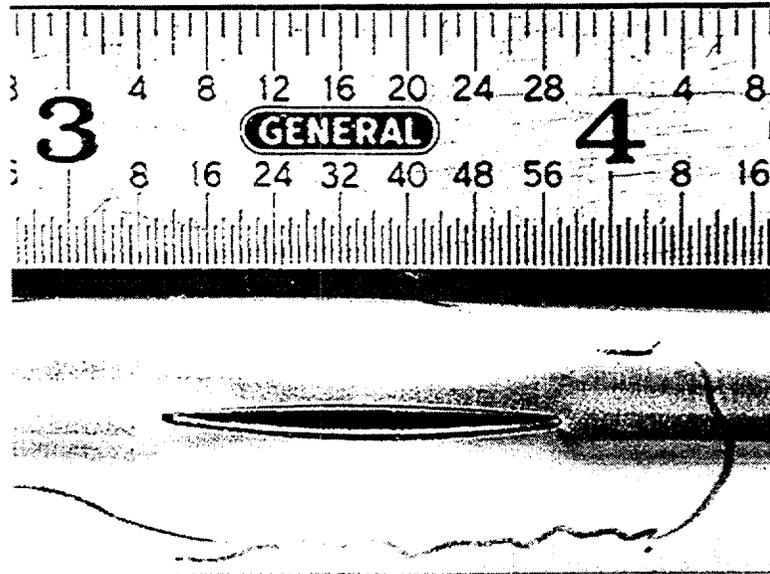
Fig. 4.36. Posttest appearance of specimen OM107 (19.1-mm [0.75-in.] long 80% TW axial EDM notch), tested without bladder at a quasi-steady-state pressurization rate. Ligament tearing occurred at 21.4 MPa (3100 psi).

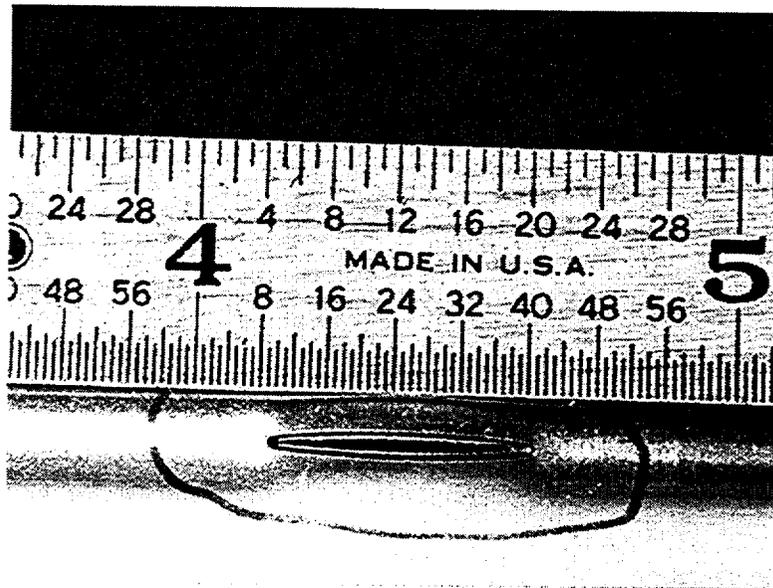
Fig. 4.39. Posttest appearance of specimen OM120 (12.7-mm [0.5-in.]-long 80% TW axial EDM notch), tested without bladder at a quasi-steady-state pressurization. Ligament tearing occurred at 26.9 MPa (3900 psi), as compared to the predicted failure pressure of 25.5 MPa (3700 psi).

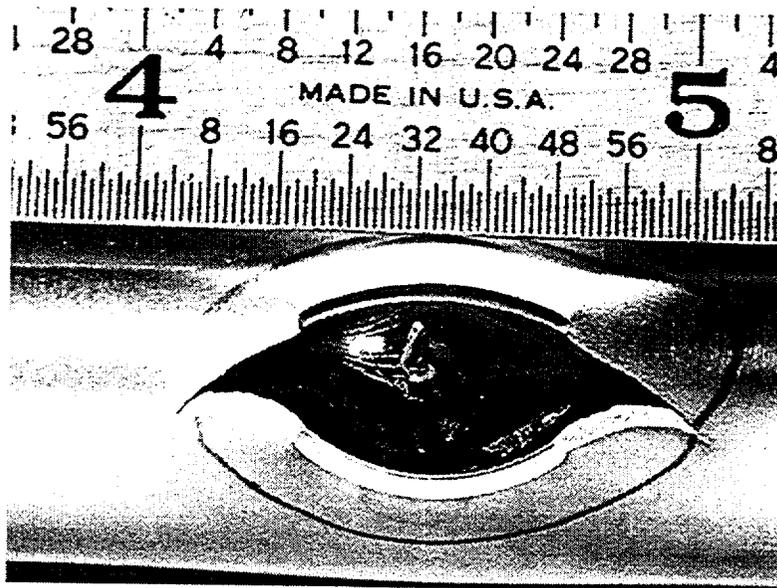
Fig. 4.42. Posttest appearance of specimen OM121 (12.7-mm [0.5-in.] long 80% TW axial EDM notch), tested with bladder at a pressurization rate of 13.8 MPa/s (2000 psi/s). Flaw burst occurred at 29.0 MPa (4200 psi), as compared to the predicted failure pressure of 30.3 MPa (4400 psi).

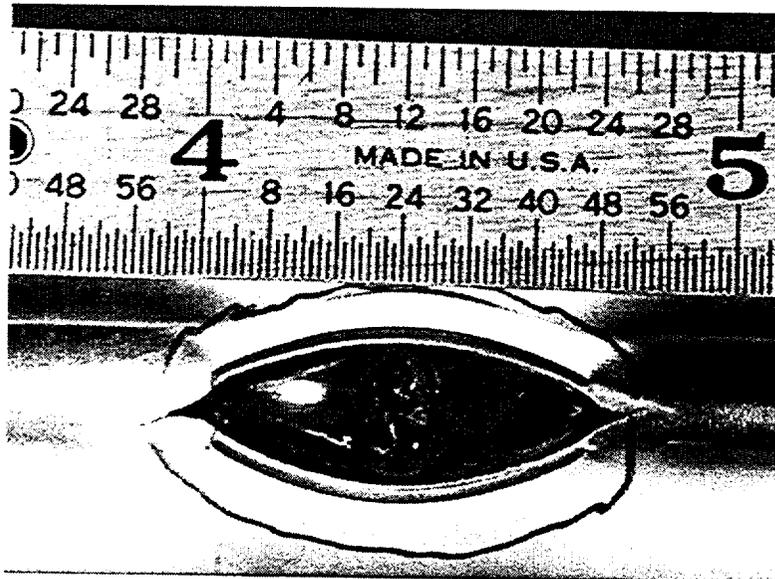
Fig. 4.43. Posttest appearance of specimen OM123 (19.1-mm [0.75-in.] long 80% TW axial EDM notch), tested with bladder at a pressurization rate of 13.8 MPa/s (2000 psi/s). Flaw burst occurred at 21.9 MPa (3180 psi), as compared to the predicted failure pressure of 22.8 MPa (3300 psi).

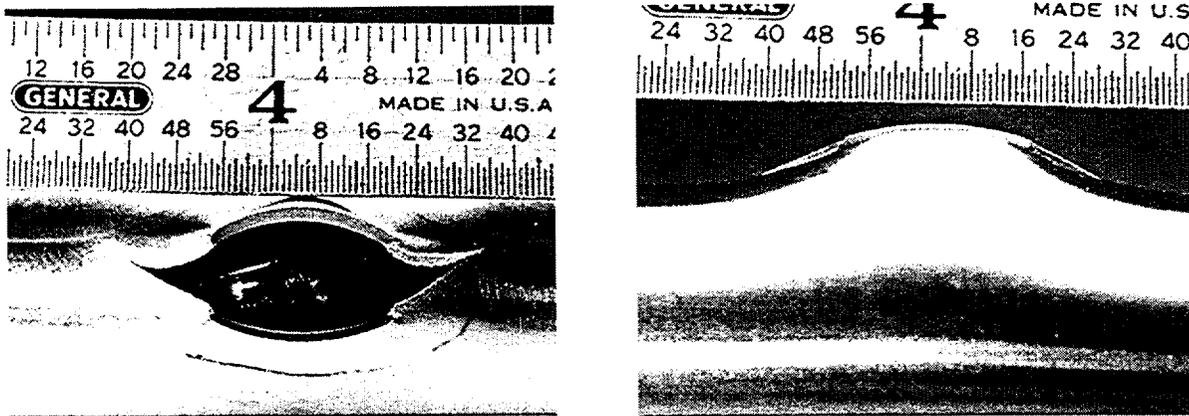
Fig. 4.47. Top (left) and side (right) views of tube OM101 with a 12.7-mm (0.5-in.)-long 100% TW EDM axial OD notch, tested with a 2-4-mm (18-in.)-thick bladder at a pressurization rate of 13.8 MPa/s (2000 psi/s).

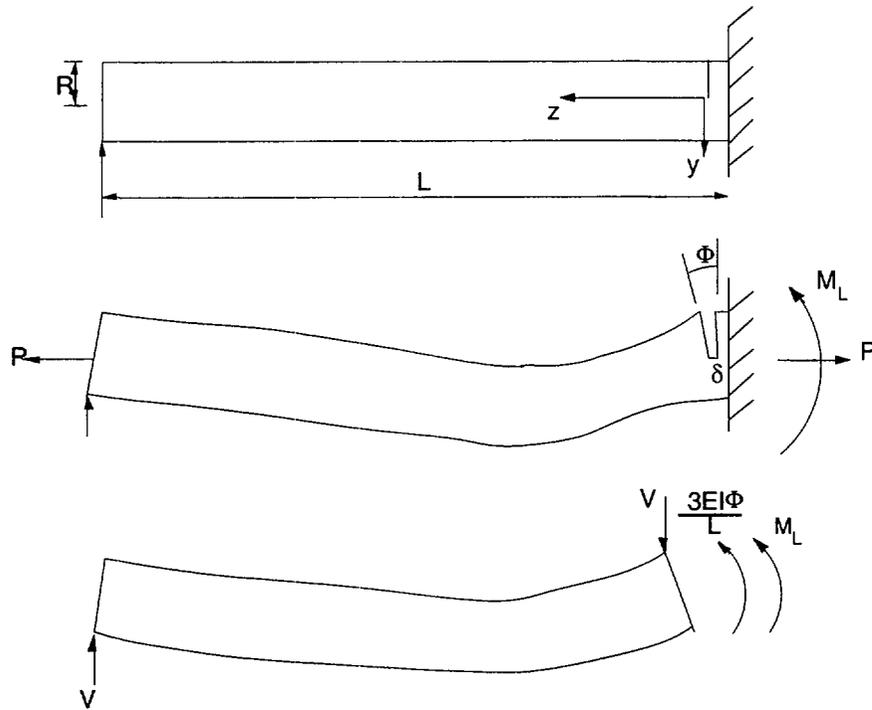
Fig. 4.48. Geometry, loading, and idealized deformation of tube with single TW circumferential crack.

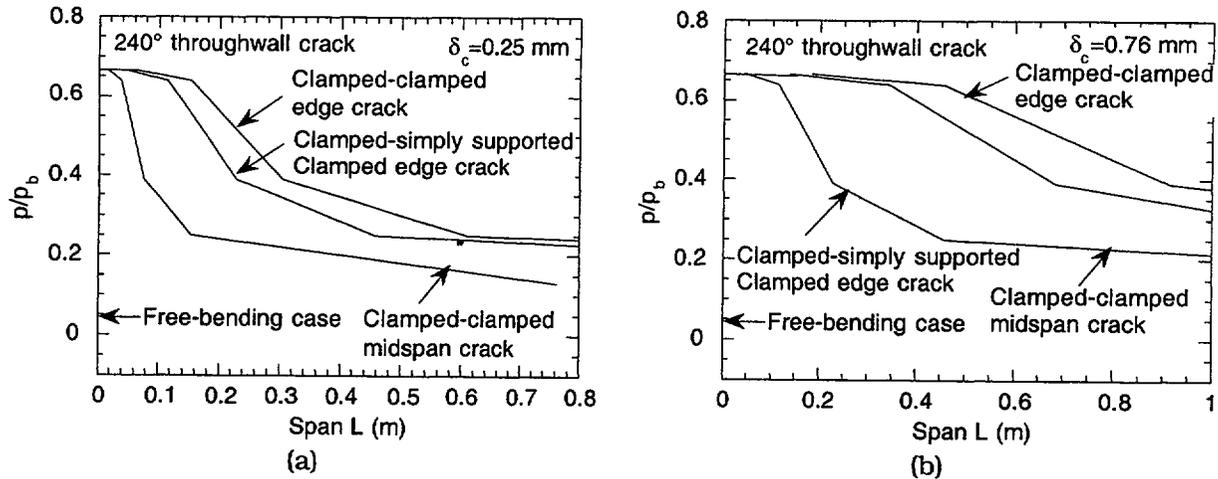
Fig. 4.54. Variation of failure pressure, normalized by unflawed burst pressure, of tube with 240° TW crack with span for several edge conditions, crack locations, and δ_c values of (a) 0.25 mm (0.01 in.) and (b) 0.76 mm (0.03 in.).

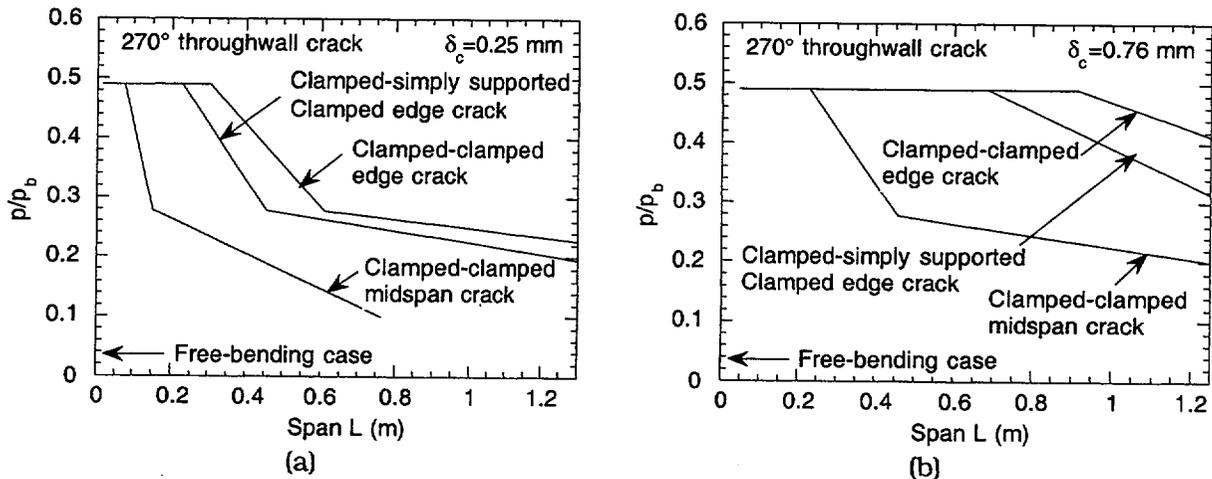
Fig. 4.55. Variation of failure pressure, normalized by unflawed burst pressure, of tube with 270° TW crack with span for several edge conditions, crack locations and δ_c values of (a) 0.25 mm (0.01 in.) and (b) 0.76 mm (0.03 in.).

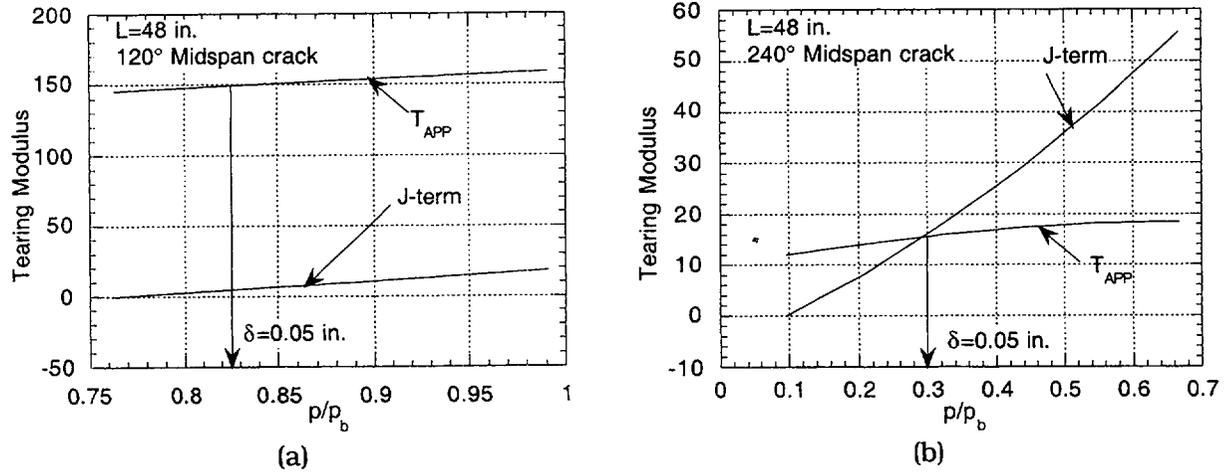
Fig. 4.56. Variation of applied tearing modulus and J-term in Eq. 4.13 with pressure (normalized by the unflawed burst pressure) of clamped edge tube with midspan cracks of angular length (a) 120° and (b) 240°.
