Steam Generator Tube Integrity Program

Annual Report
October 1998 — September 1999

Argonne National Laboratory

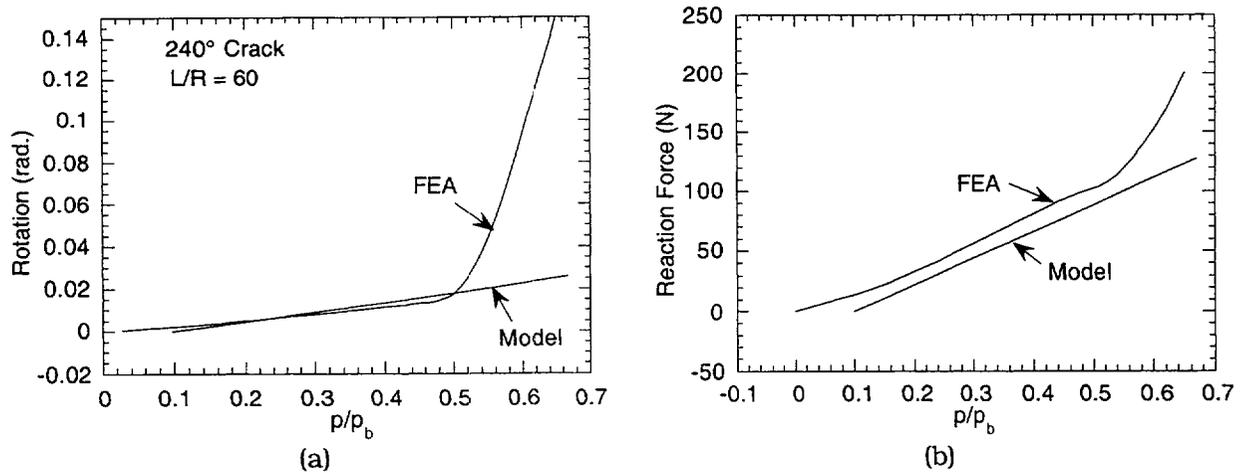
Fig. 4.59. Comparison of model prediction and elastic-plastic FEA results ($\sigma_y / \bar{\sigma} = 0.5$) for (a) crack section rotation and (b) support reaction force of tube simply supported at one end and clamped at the other (as in Fig. 4.53) at various normalized pressures.

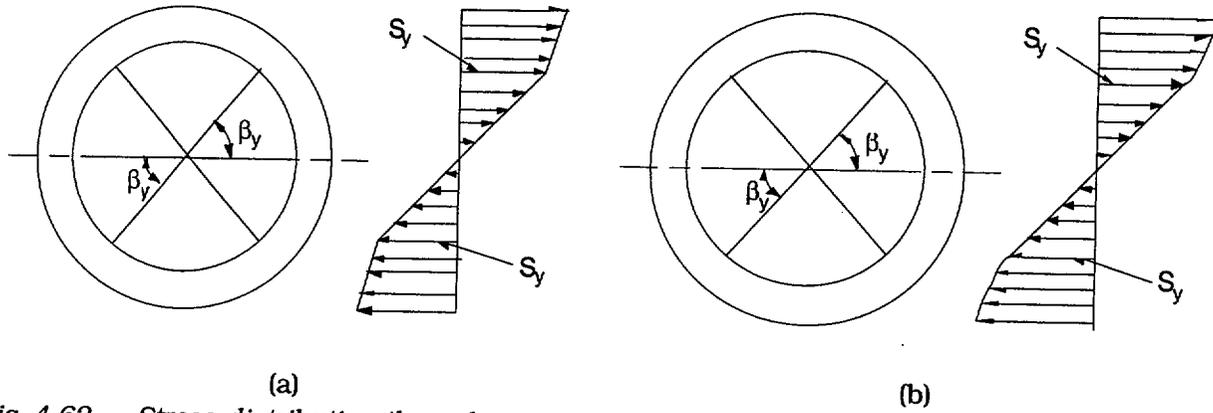
Fig. 4.62. Stress distribution through section away from crack section after yield: (a) bilinear for bilinear stress-strain curve and (b) nonlinear for power-law hardening curve.

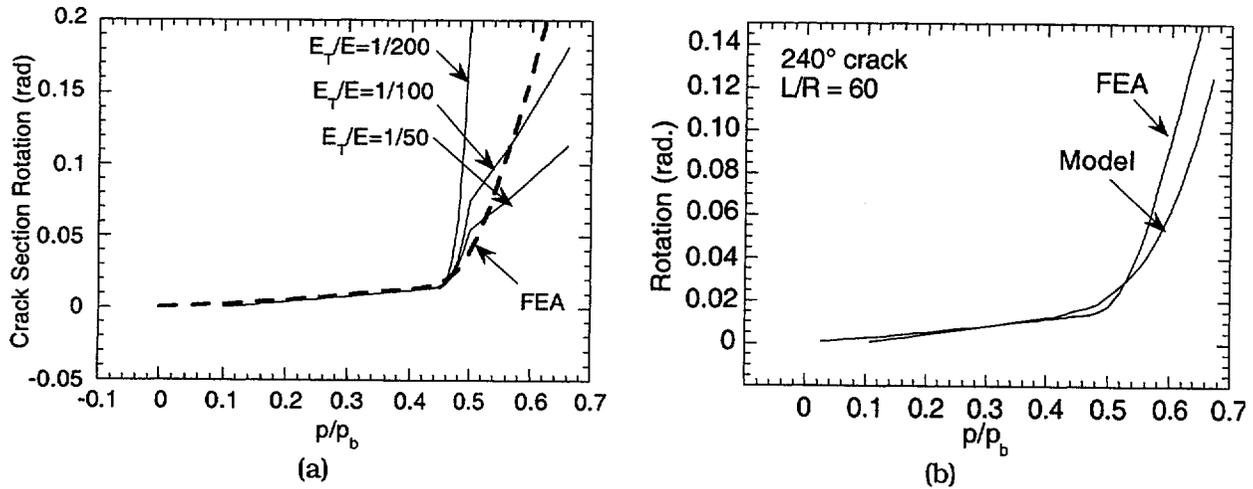
Fig. 4.65. Variation of crack section rotation with normalized pressure as calculated by FEA ($\sigma_y / \bar{\sigma} = 0.5$) and those calculated by a model that allows for plastic yielding away from crack plane using (a) bilinear stress-strain curve and (b) power-law hardening stress-strain curve.

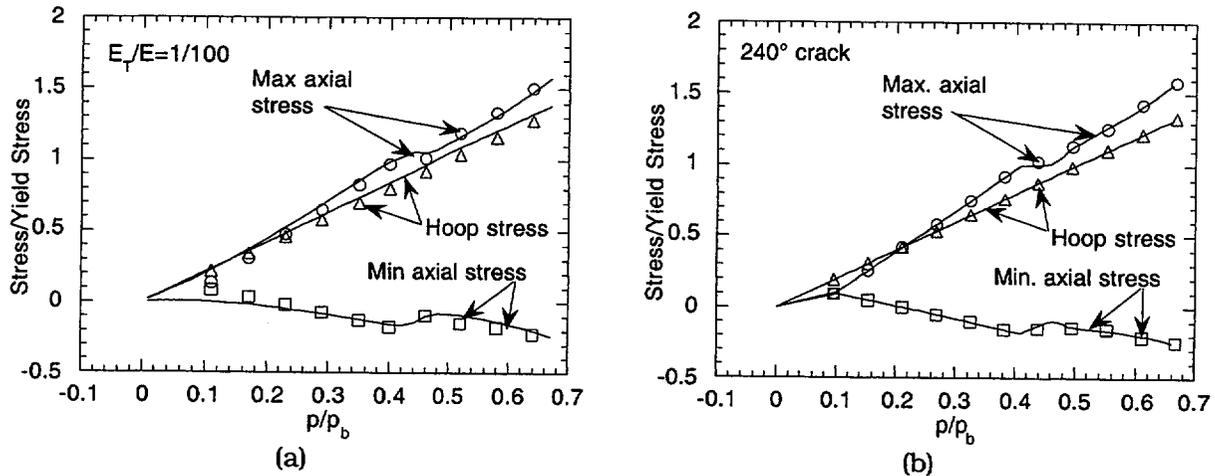
Fig. 4.66. Model predictions for stresses, allowing for plastic deformation ($\sigma_y / \bar{\sigma} = 0.5$) away from crack plane, using (a) bilinear stress-strain curve and (b) power-law hardening stress-strain curve and elastic-plastic FEA results for stresses at section located at distance $4R$ from crack plane in tube ($L/R = 60$) simply supported at one end and clamped at the other (as in Fig. 4.49) at various pressures. Symbols, and lines without symbols, represent model calculations and FEA results, respectively.

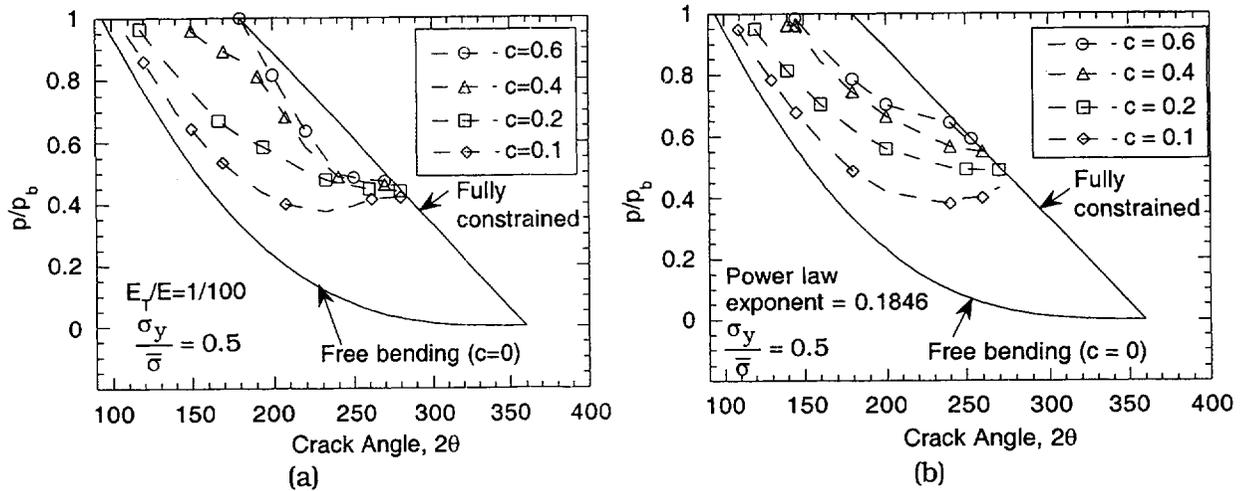
Fig. 4.67. Calculated variation of pressure, normalized by unflawed burst pressure, with crack angle for onset of crack growth in tube with single TW circumferential crack, using elastic-plastic model with (a) bilinear stress-strain curve and (b) power-law hardening stress-strain curve.

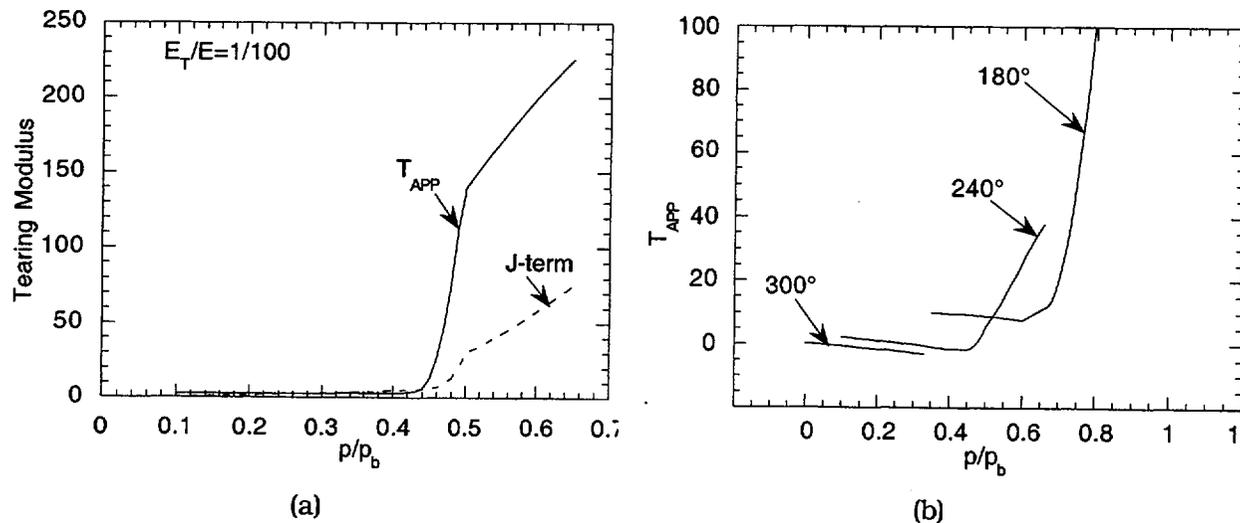
Fig. 4.69. Calculated variation of applied tearing modulus with pressure, normalized by unflawed burst pressure, for single TW circumferential crack in a tube, using elastic-plastic model with (a) bilinear stress-strain curve for 240° crack and (b) power-law hardening stress-strain curve for 180°, 240°, and 300° cracks.

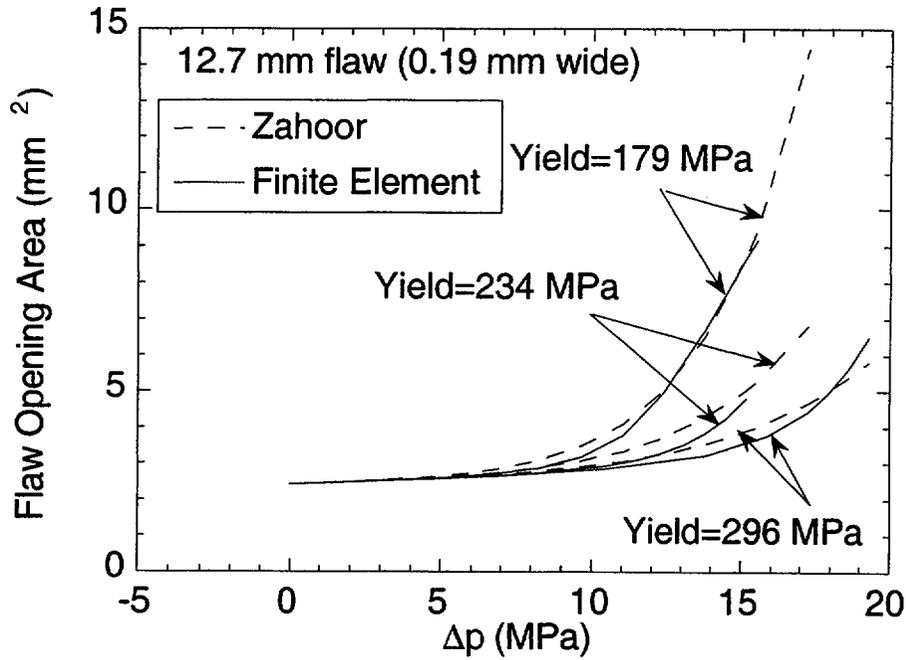
Fig. 4.70. Predicted crack opening area (by FEA and Zahoor model) of 12.7-mm (0.5-in.)-long TW crack (laboratory-grown) in heat-treated tube as functions of pressure.

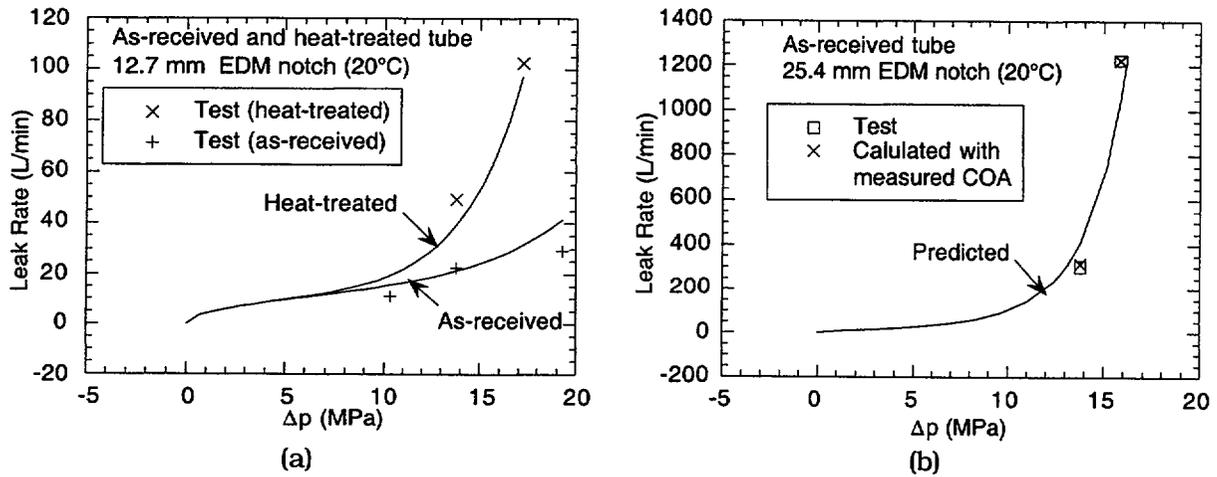
Fig. 4.71. Calculated (solid line) vs. experimentally measured (symbols) leak rates at 20°C for as-received and heat-treated 22.2-mm (7/8-in.)-diameter tubes with (a) 12.7-mm (0.5-in.) and (b) 25.4-mm (1-in.)-long TW axial EDM notches. Cross symbols in Fig. 4.71b denote calculated leak rates using posttest measured crack opening areas.

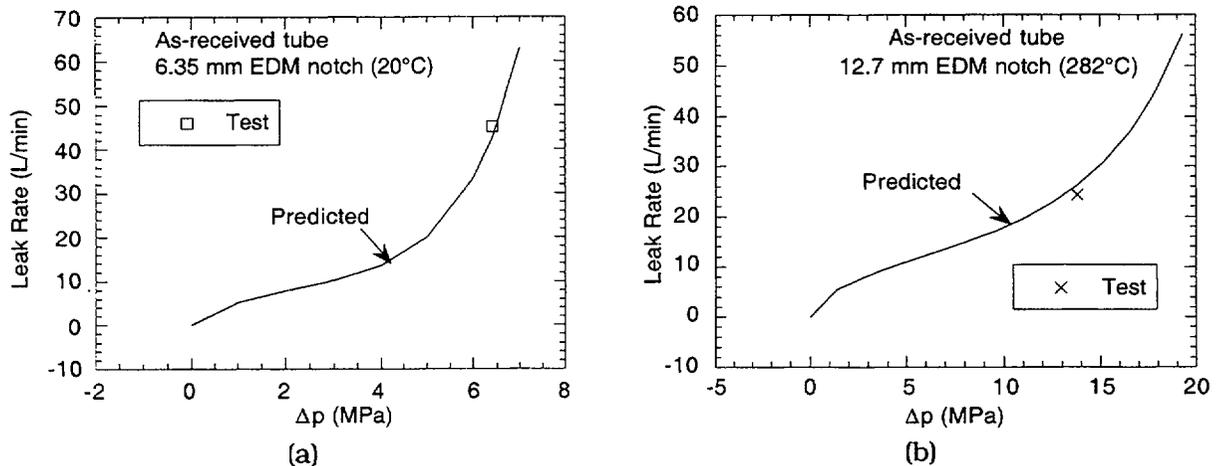
Fig. 4.72. Comparison of calculated (solid line) versus experimentally measured (symbol) leak rates in as-received 22-mm (7/8-in.)-diameter tubes with (a) 6.35-mm (0.25-in.)-long flaw at 20°C and (b) 12.7-mm (0.5-in.)-long flaw at 282°C.

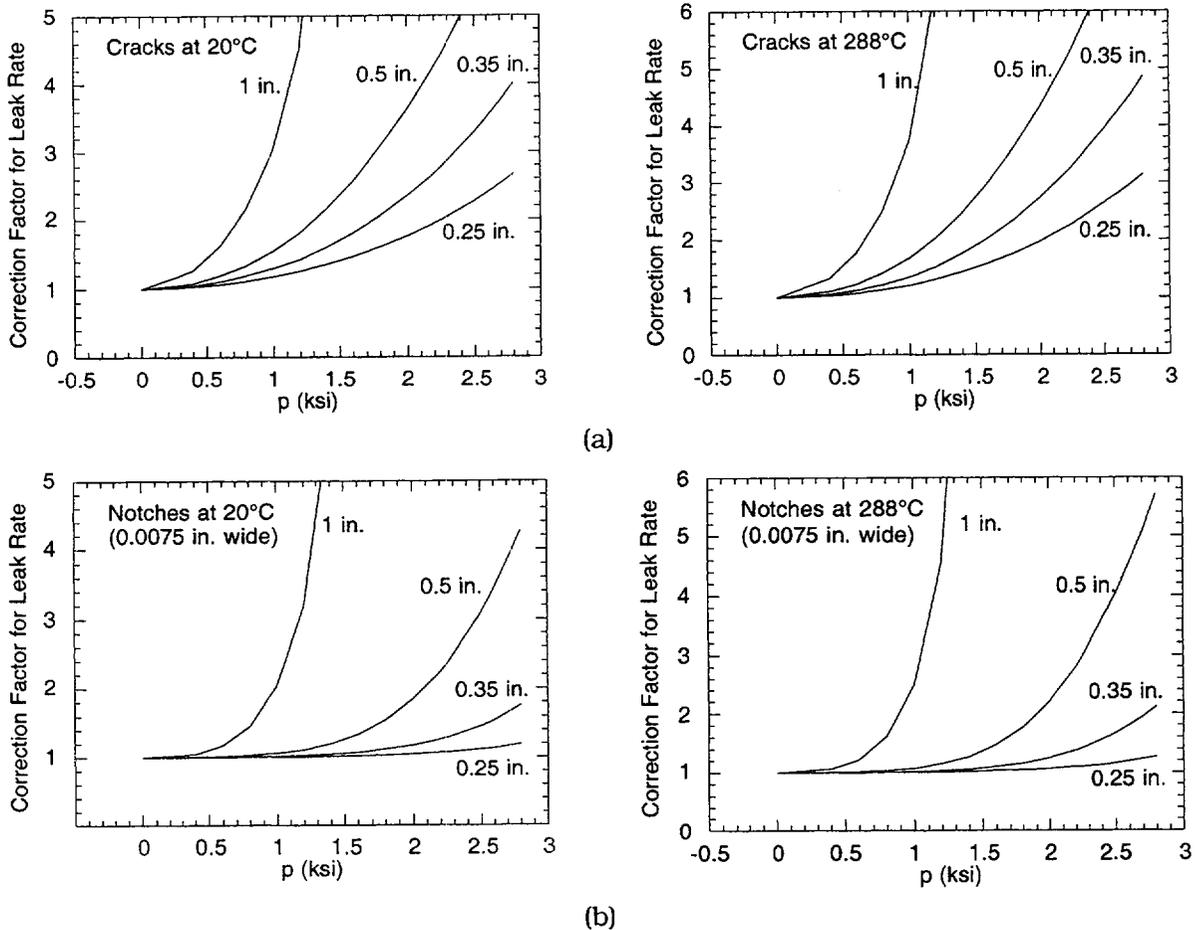
Fig. 4.73. Correction factors for obtaining leak rates in as-received Alloy 600 tubes from sensitized tube data at 20°C and 288°C for tubes containing (a) single TW axial cracks without axial segments and (b) initially 0.19-mm (0.0075-in.)-wide rectangular TW axial notches.

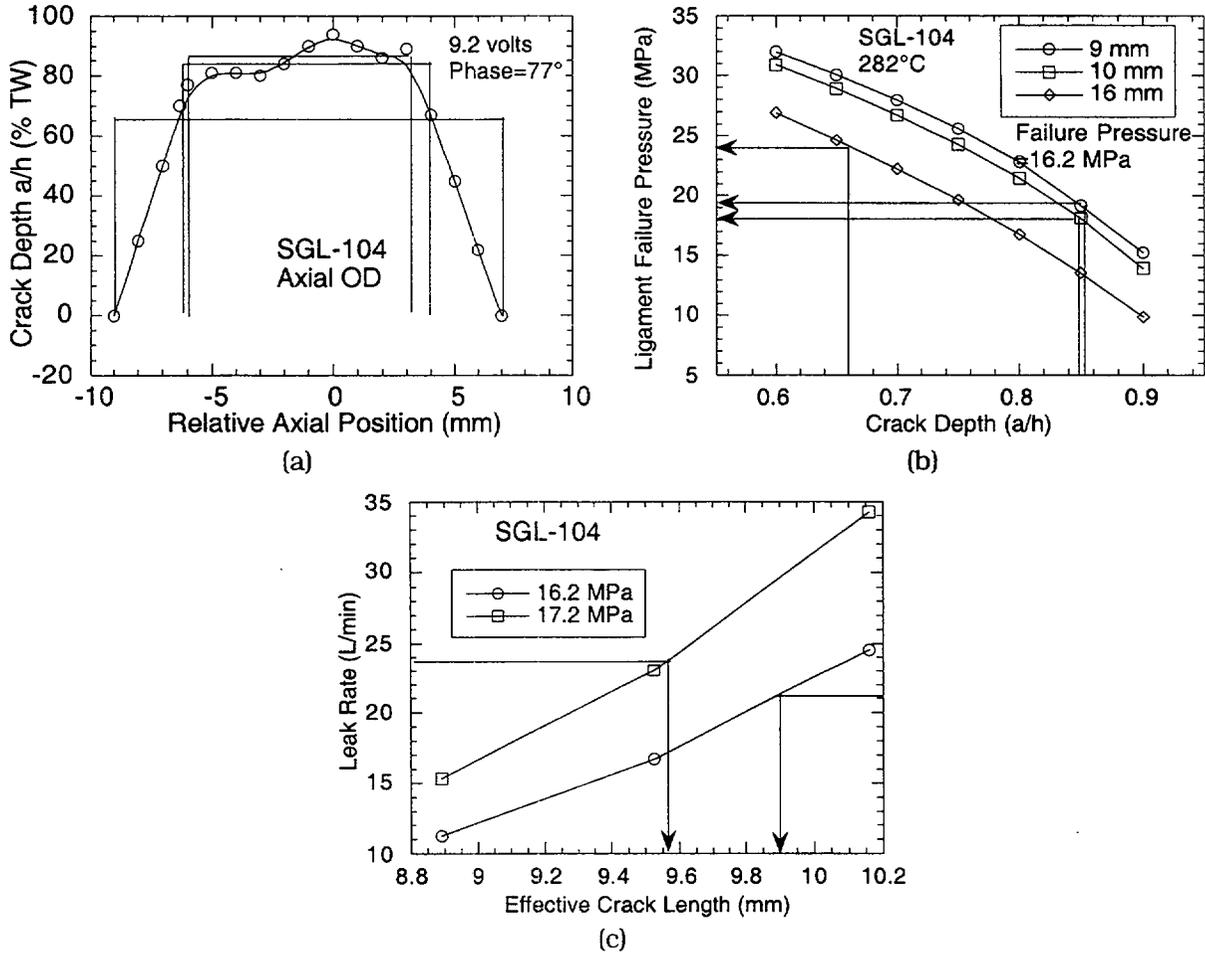
Fig. 4.74. (a) Estimated crack depth profile from EC +Point data, (b) calculated ligament failure pressures for two equivalent rectangular crack sizes, and (c) effective TW crack length estimated from leak-rate data for test SGL-104 conducted at 288°C.

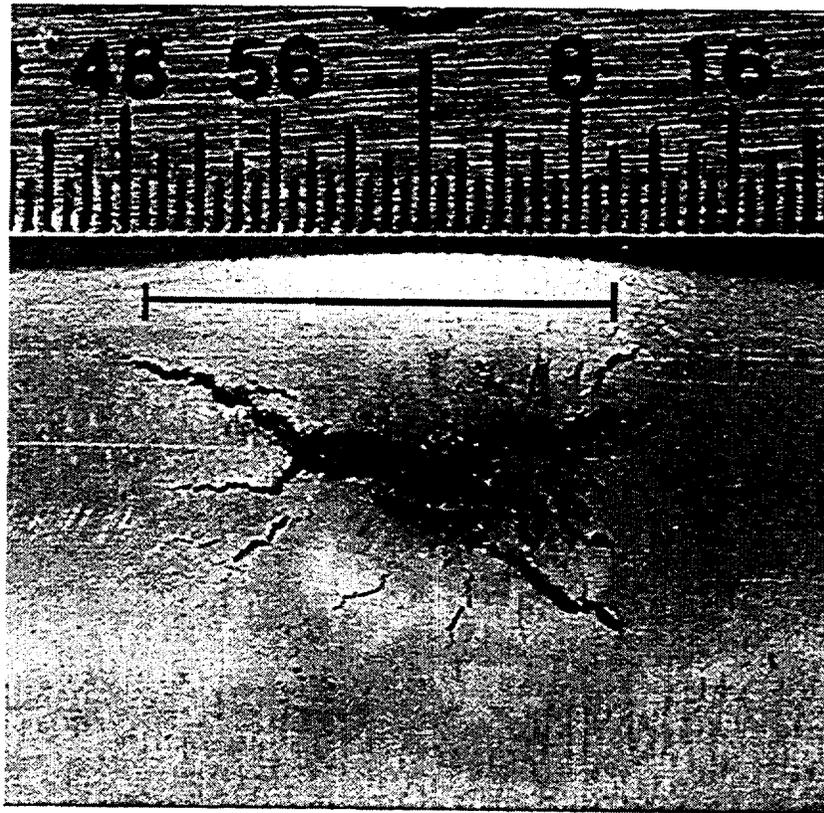
Fig. 4.75. Posttest view of OD crack of specimen SGL-104. Marker indicates effective TW crack length (10 mm or 0.39 in.) calculated from measured leak rate.

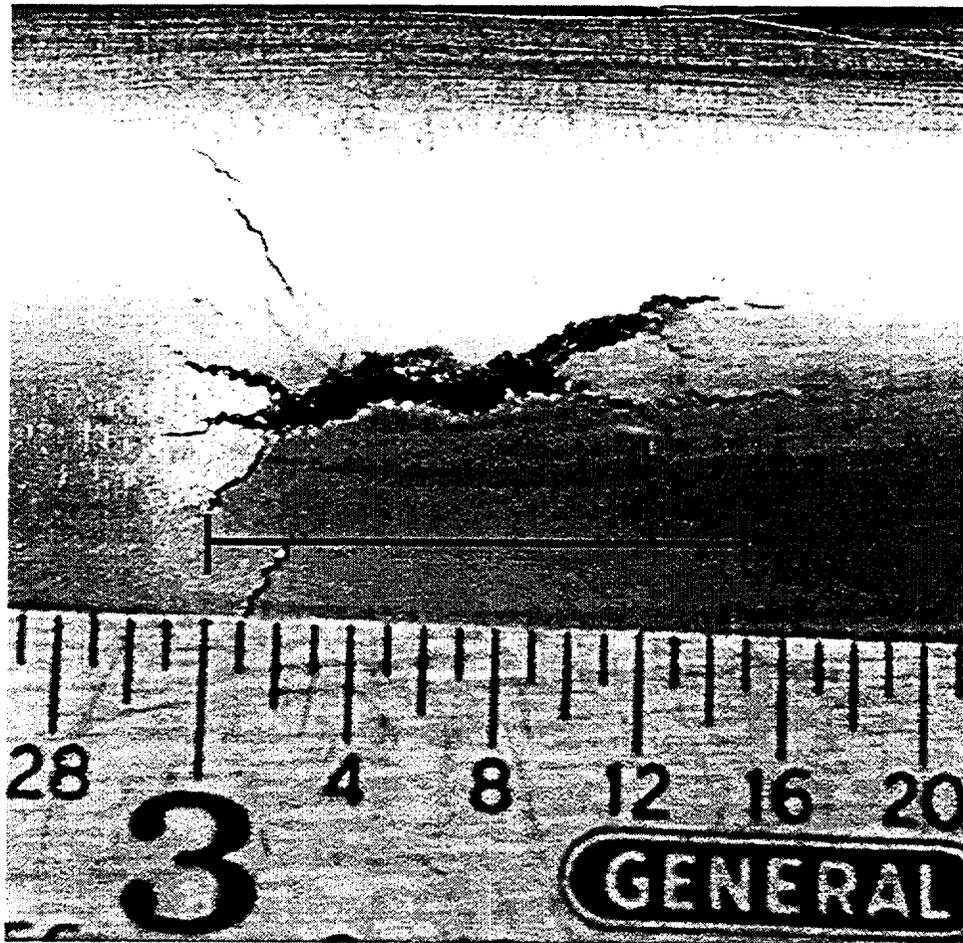
Fig. 4.77. Post-test view of OD crack of specimen SGL-195. Marker indicates effective TW crack length (12 mm or 0.47 in.) calculated from measured leak rate.

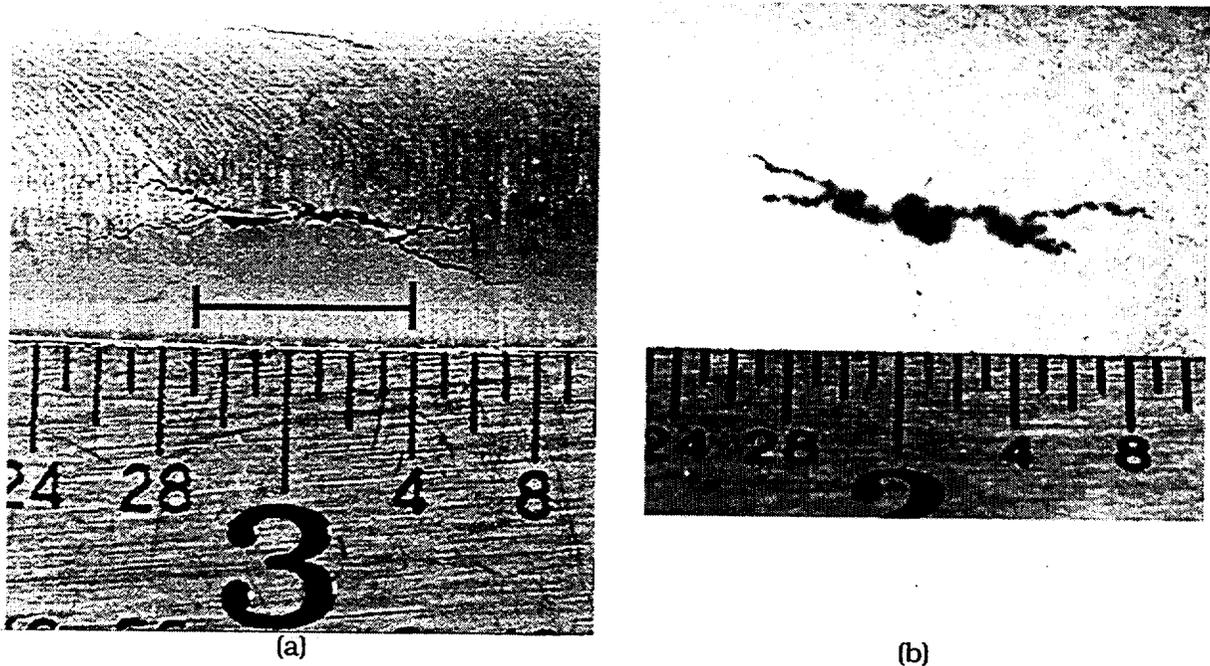
Fig. 4.79. (a) Post- and (b) pretest dye-penetrant-enhanced views of crack in test specimen SGL-177. Marker in (a) indicates effective TW crack length (5.5 mm or 0.22 in.) calculated from measured leak rate.

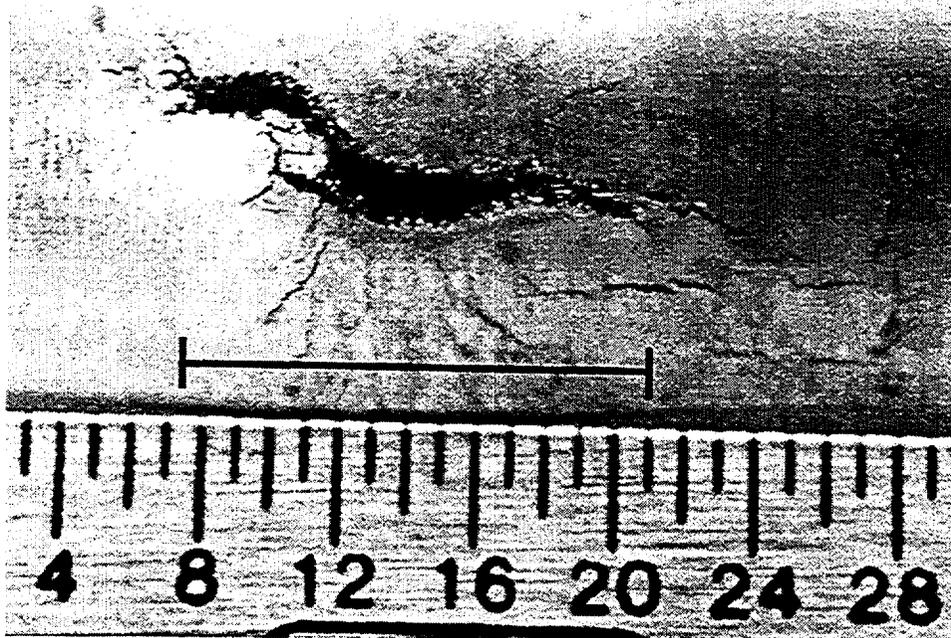
Fig. 4.81. Posttest view of OD crack of specimen SGL-219. Marker indicates effective TW crack length (11 mm or 0.43 in.) calculated from measured leak rate.

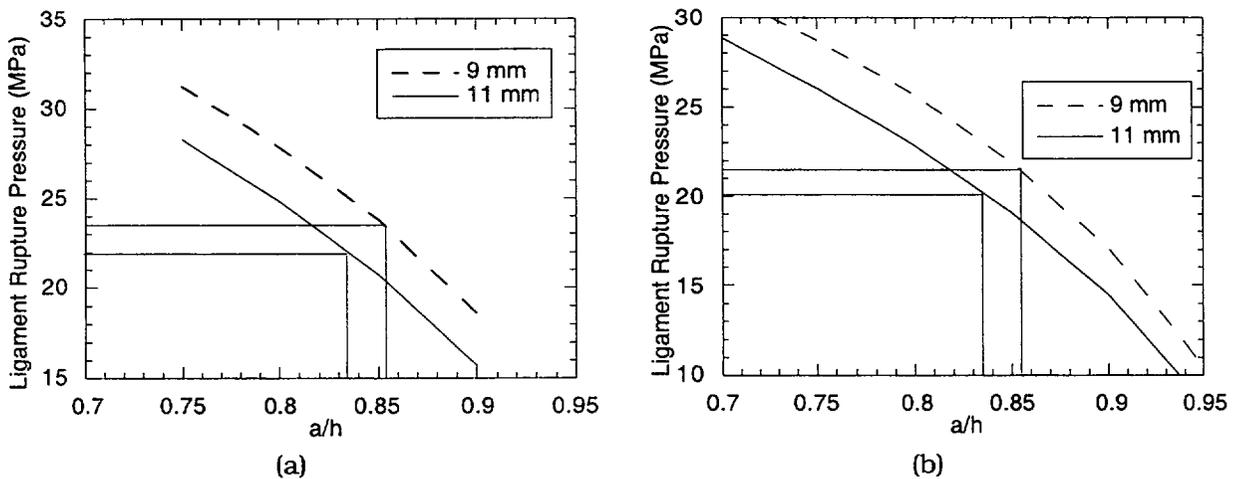
Fig. 4.83. Calculated ligament rupture pressure for two equivalent rectangular cracks in Westinghouse tube 2-10 at (a) room temperature and (b) 288°C.

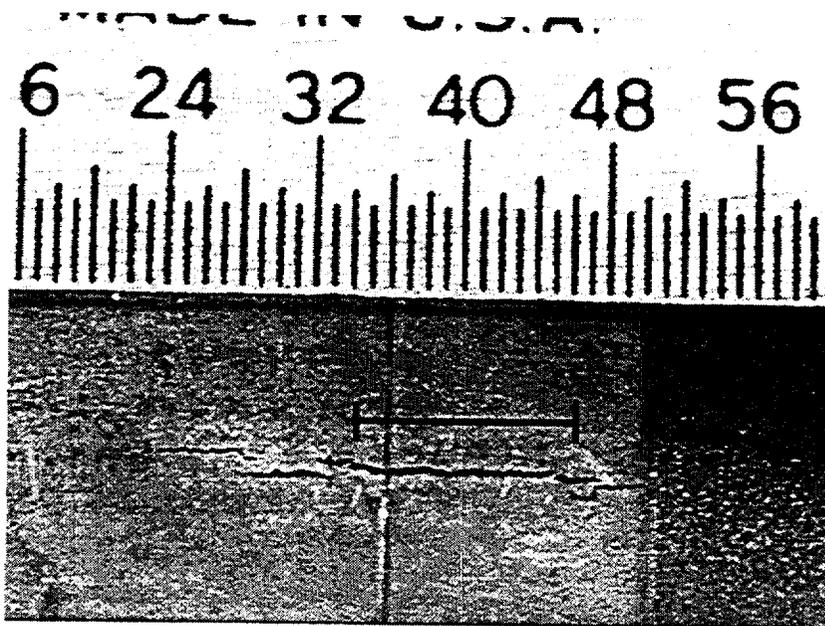
Fig. 4.85. Posttest view of OD crack of Westinghouse specimen 2-10. Marker indicates effective TW crack length (4.8 mm or 0.19 in.) calculated from measured leak rate.

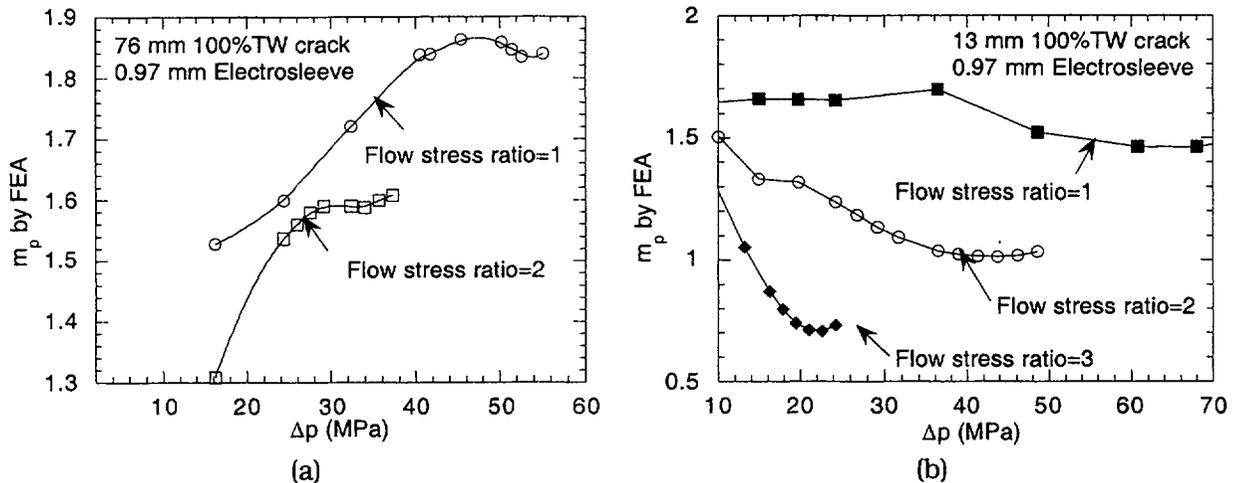
Fig. 4.87. Variation of m_p factor with pressure for (a) 76-mm (3-in.)-long and (b) 13-mm (0.5-in.)-long cracks for various values of flow stress ratios between tube and Electrosleeve.

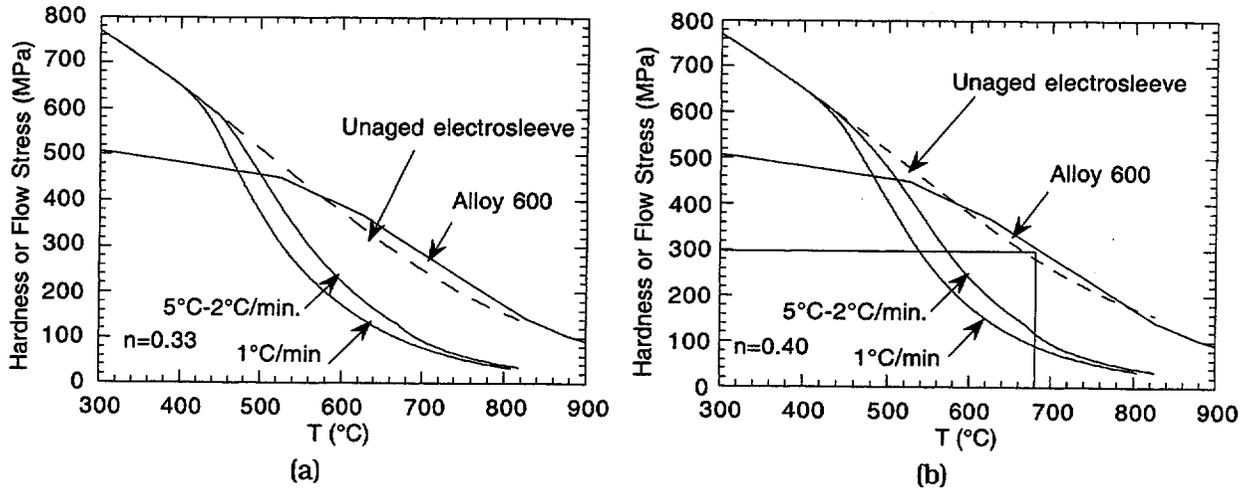
Fig. 4.99. Calculated reductions of flow stress of Electrosleeve material with temperature, using Hall-Petch exponent (a) $n = 0.33$ and (b) $n = 0.40$, for scoping ramp (Fig. 4.98) and constant ramp rate of 1°C/min.

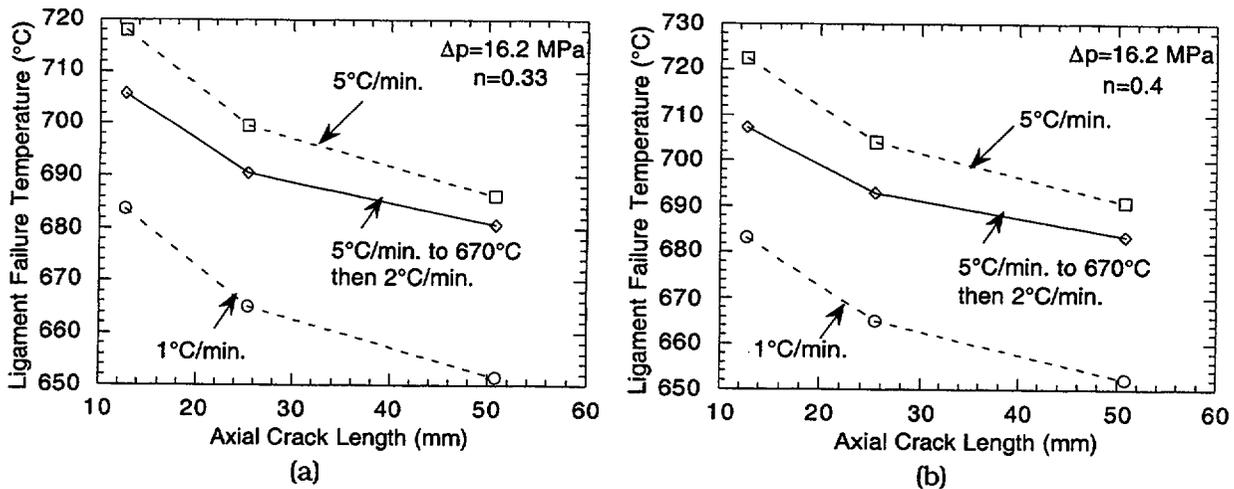
Fig. 4.100. Predicted ligament failure temperatures by Hall-Petch model for Electrosleeved tubes with throughwall axial cracks under scoping ramp (Fig. 4.98) and constant temperature ramp rates of 1 and 5°C/min and constant internal pressure of 16.2 MPa (2.35 ksi), using (a) $n = 0.33$ and (b) $n = 0.4$.

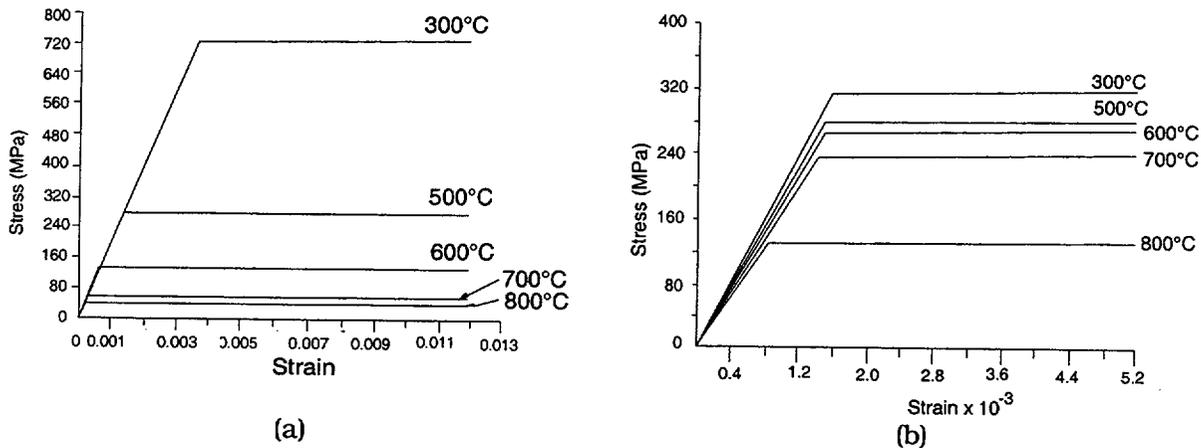
Fig. 4.107. Stress-strain curves used for (a) Electrosleeve (Case 6 ramp) and (b) Alloy 600.

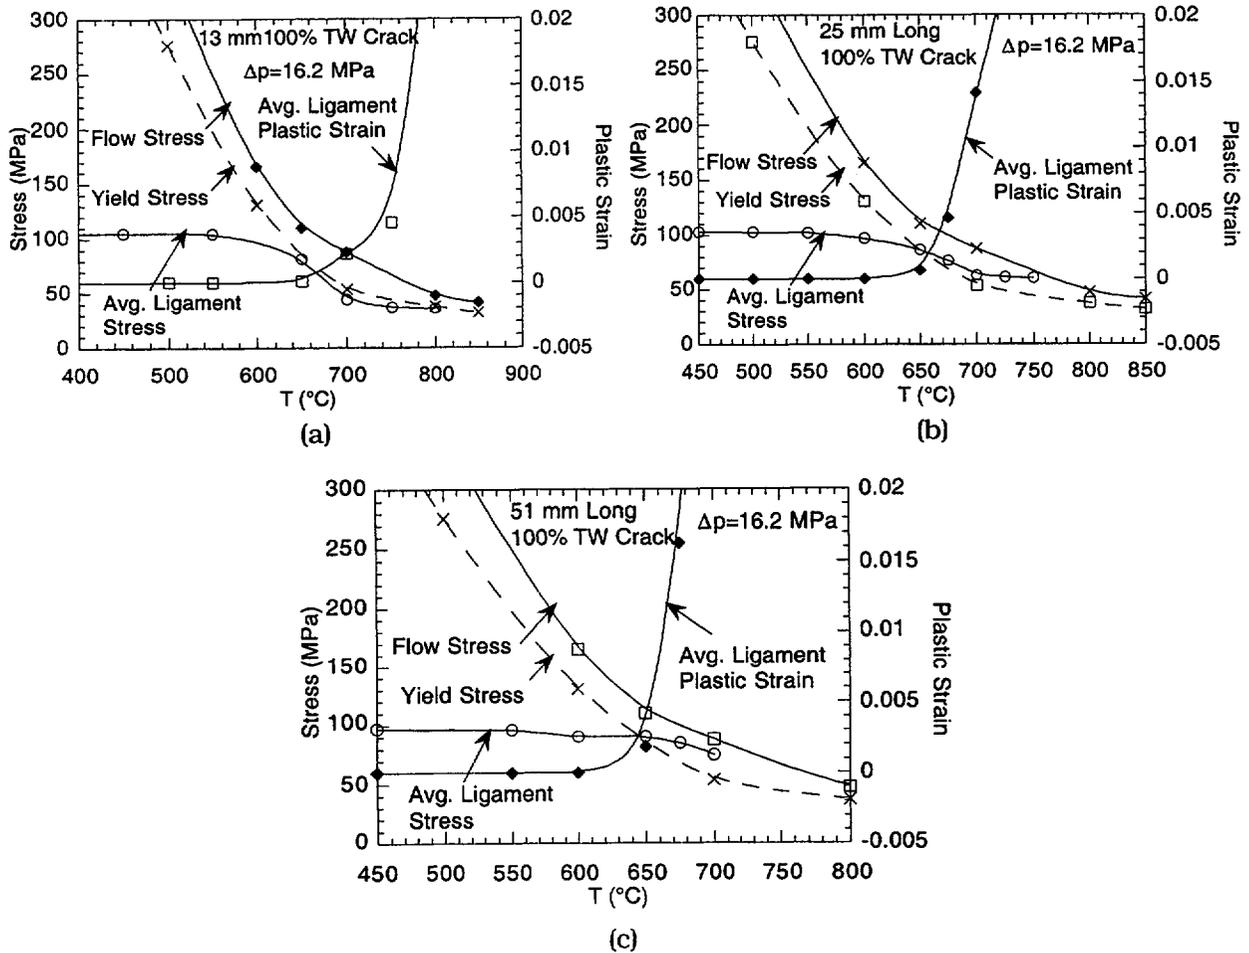
Fig. 4.108. Calculated variations of average ligament stress, average ligament plastic strain, yield stress and flow stress of Electrosleeve with temperature under Case 6 loading on tube with (a) 13-mm (0.5-in.), (b) 25-mm (1-in.), and (c) 51-mm (2-in.) long, 100% TW crack.

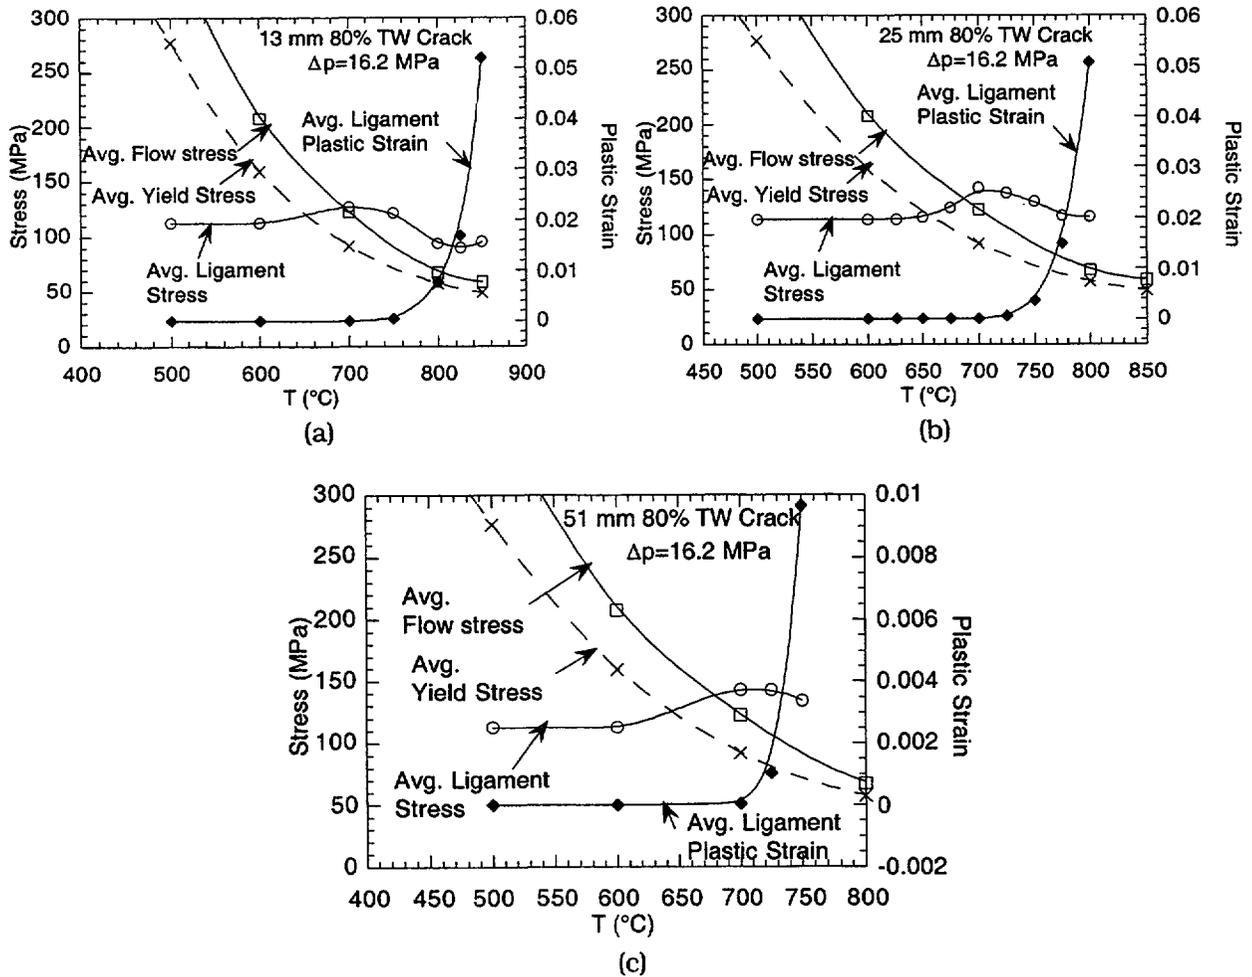
Fig. 4.112. Calculated variations of ligament-averaged stress, plastic strain, yield stress and flow stress with temperature under Case 6 loading of tube with (a) 13-mm (0.5-in.), (b) 25-mm (1-in.), and (c) 51-mm (2-in.)-long, 80% part-TW crack.
