Cable Insulation Resistance Measurements Made During Cable Fire Tests

Sandia National Laboratories

U.S. Nuclear Regulatory Commission
Office of Nuclear Regulatory Research
Washington, DC 20555-0001

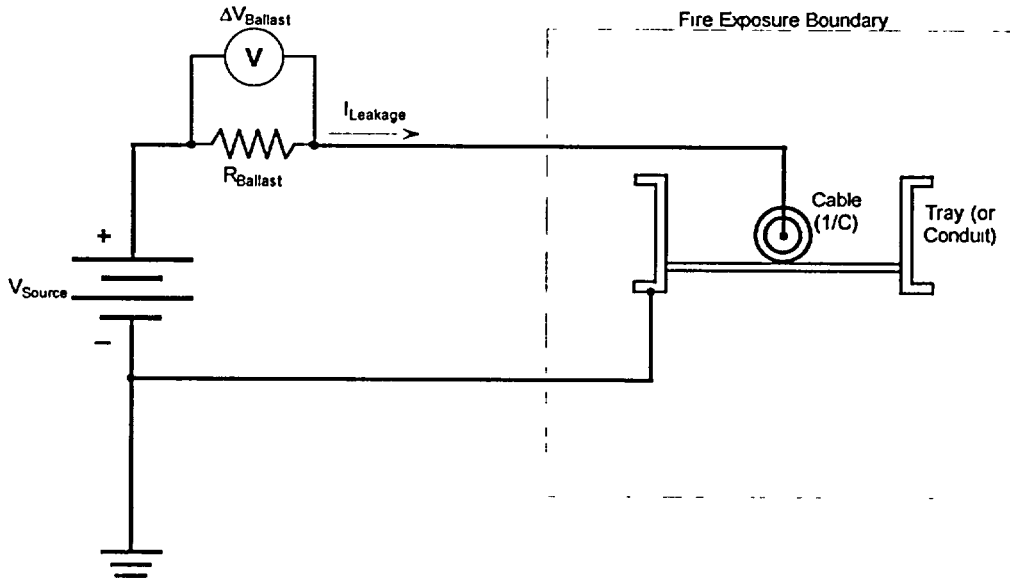
Figure 2-1. A simple cable functionality monitoring circuit using a single voltage potential applied to a single conductor cable. The circuit is capable of estimating the cable IR based on the measured voltage drop across the ballast resistor.

Ohm's law for the ballast resistor yields the leakage current ($I_{Leakage}$) based on the measured voltage drop ($\Delta V_{Ballast}$) and resistance ($R_{Ballast}$) as follows:

$$I_{Leakage} = \frac{\Delta V_{Ballast}}{R_{Ballast}}$$

Using Ohm's law a second time, based on the cable's voltage potential ($V_{Source} - \Delta V_{Ballast}$) and the determined leakage current, the IR ($IR_{Exposed}$) between a conductor and ground ($V_{Reference}$) can be calculated:

$$IR_{Exposed} = \frac{(V_{Source} - \Delta V_{Ballast}) - V_{Reference}}{I_{Leakage}}$$

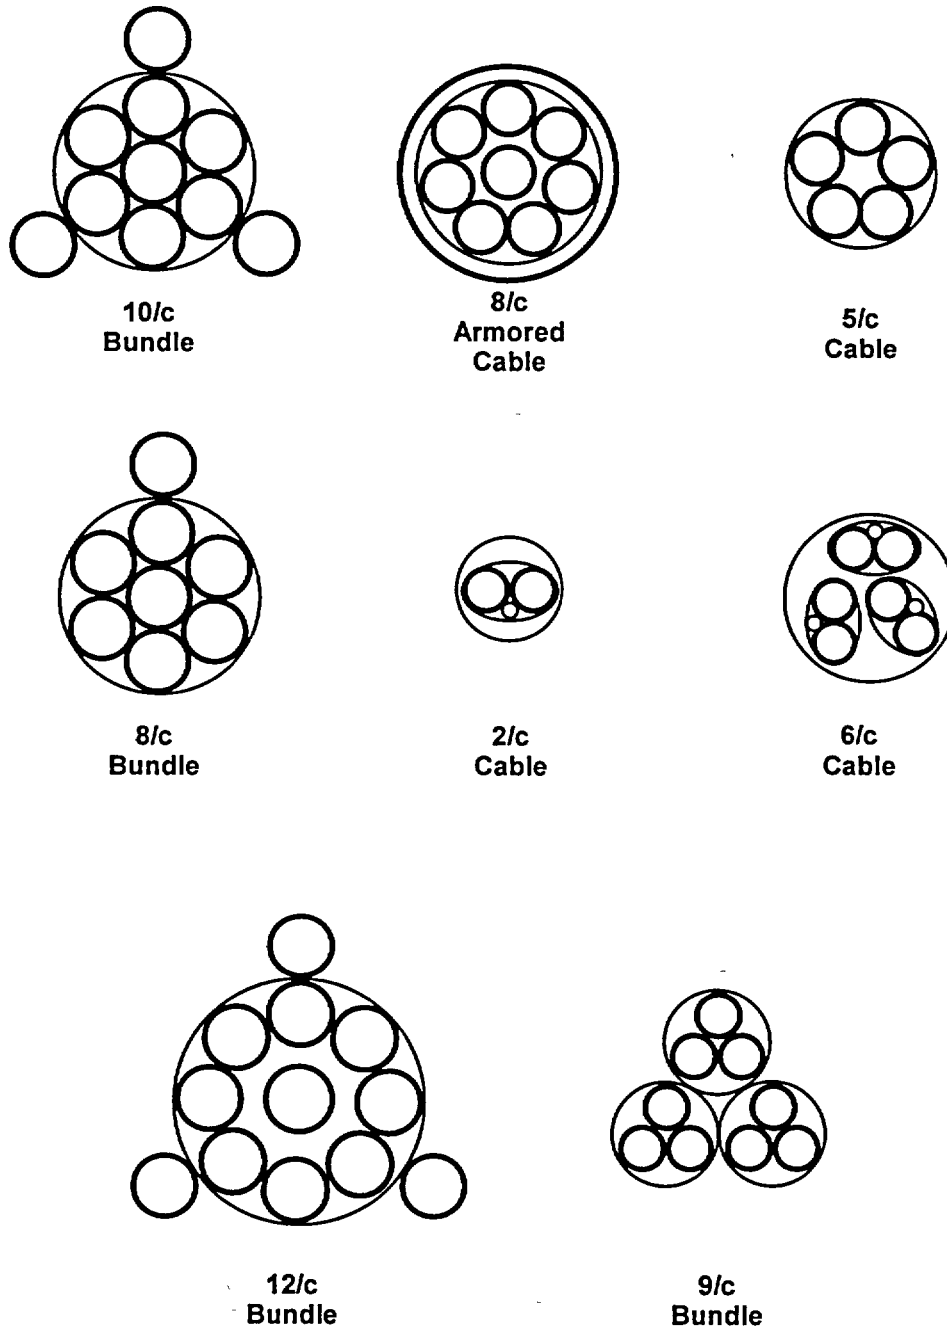
Figure 3-8. Cross-sectional views of the various cable bundle configurations tested using the IR measurement system.

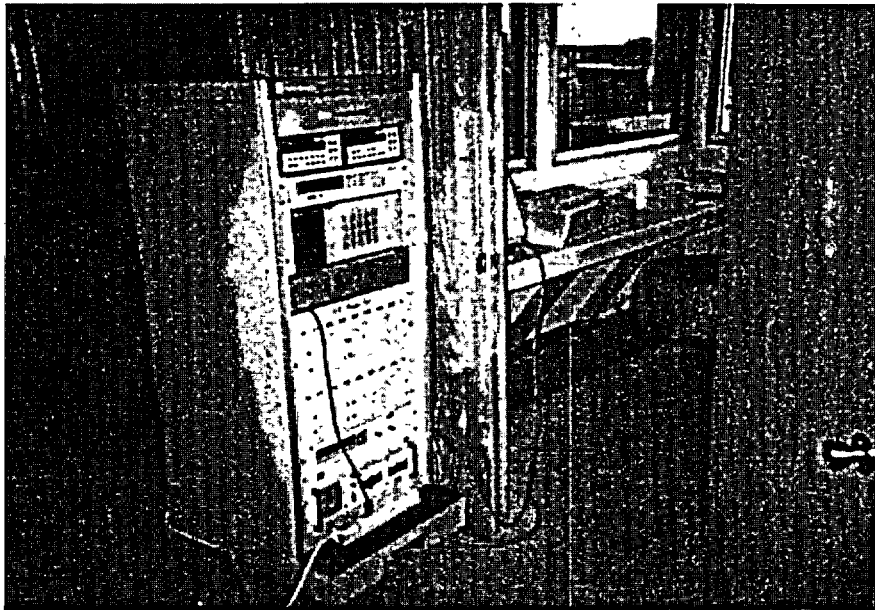
Figure 3-9. Front view of the IR measurement system instrument rack.

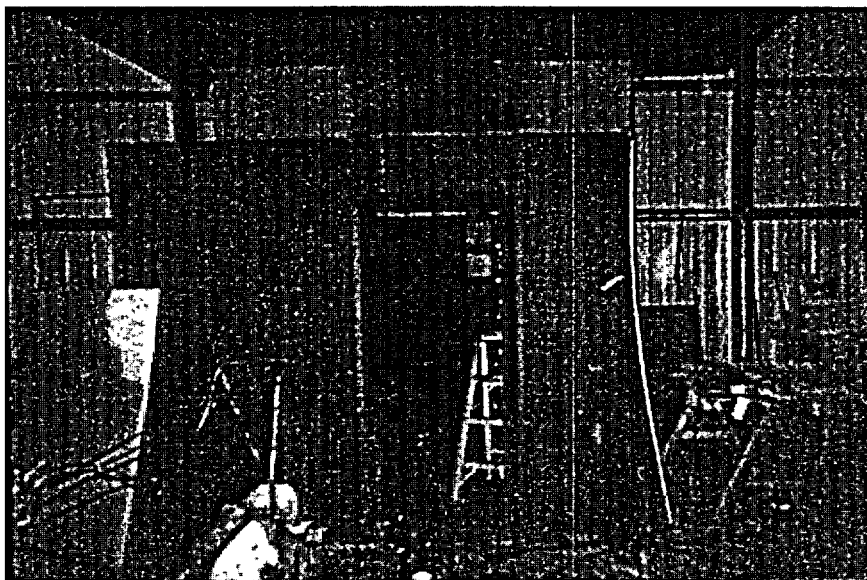
Figure 4-1. Fire test cell.

All of the 18 fire tests described here were conducted in a steel chamber measuring 3 m (10 ft) wide, 3 m (10 ft) deep, and 2.4 m (8 ft) high, shown in Figure 4-1. The chamber has an opening (door) ~76 cm (30 in.) wide by 2.1 m (7 ft) high in the center of one wall. The exposure fire was generated by flowing propane gas through a 30 cm (12 in.) × 30 cm (12 in.) diffusion burner (a "sand burner," see Figure 4-2). The fire intensity was controlled by the flow rate of the propane through the burner and ranged from 70 to 350 kW.

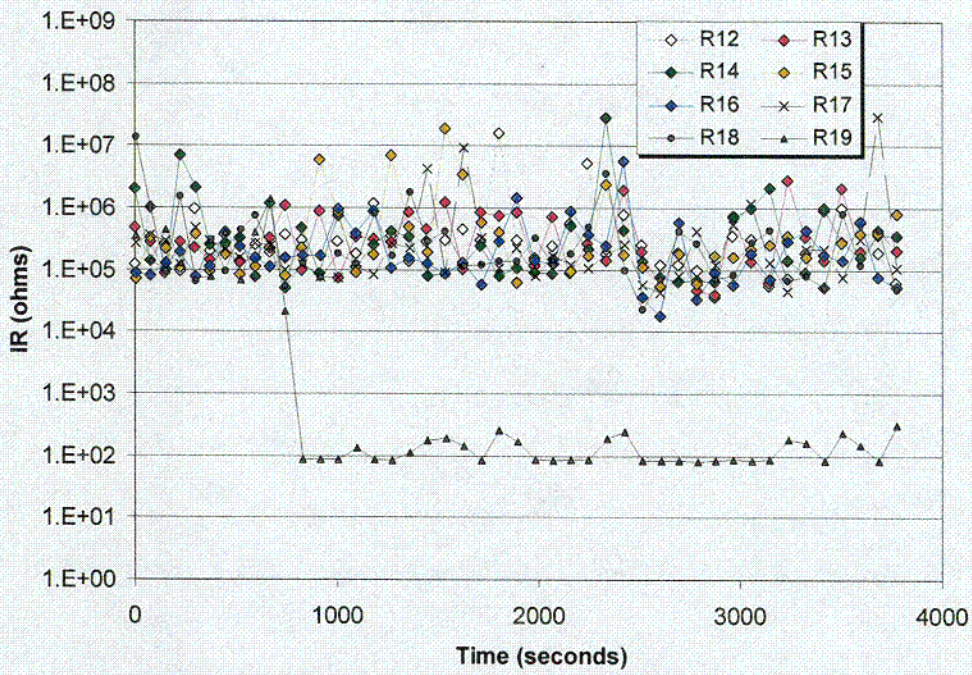
Figure 5-2. Representative conductor-to-conductor IRs obtained during Test 1. This plot shows the IRs between Conductor 1 and Conductors 2 through 9.

The reduction in IR between conductor pairs and each to ground indicates an increase in the leakage currents. However, in this case, the leakage currents remained small. Figure 5-4 shows a plot of how the leakage currents for Conductors 1 and 2 changed in their relationship to one another and to ground as the test progressed. Based solely on the results of the IR measurements made during Test 1, it does not appear that the IR cable experienced damage to the point of allowing leakage currents high enough to cause device actuation or blown fuses.

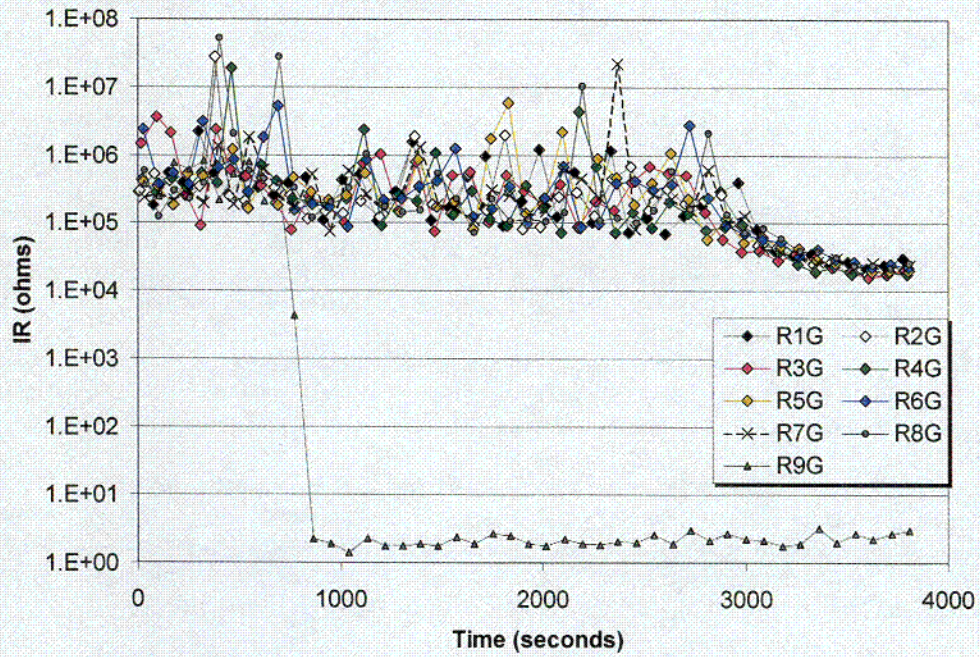
Figure 5-3. Conductor-to-ground IRs obtained during Test 1.

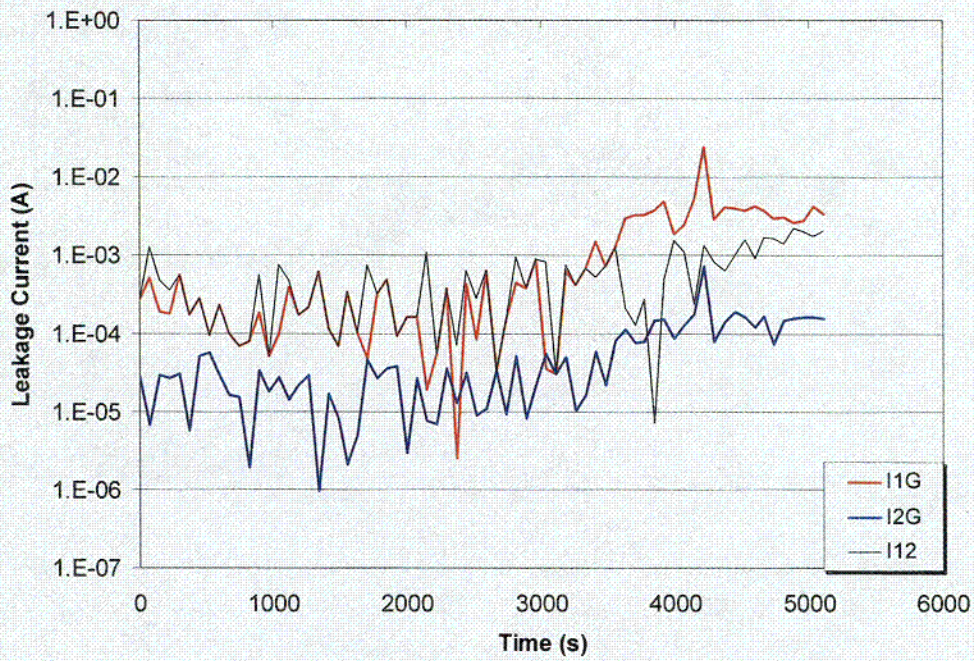
Figure 5-34. Leakage currents resulting from IR changes between Conductors 1 and 2 in the cable tray cable during Test 8.
