B&W FUEL COMPANY, COMMERCIAL NUCLEAR FUEL PLANT
MODEL B FRESH FUEL SHIPPING CONTAINER
PACKAGE ID USA/6206/AF | DOCKET 71-6206
SECTION: SAFETY ANALYSIS REPORT

REPORT ON TEST
OF
MODEL B FRESH FUEL SHIPPING CONTAINER

PART A - MINOR DROP TESTS, SHIPPING & HANDLING TESTS

PART B - 30' DROP TESTS AND PIN DROP

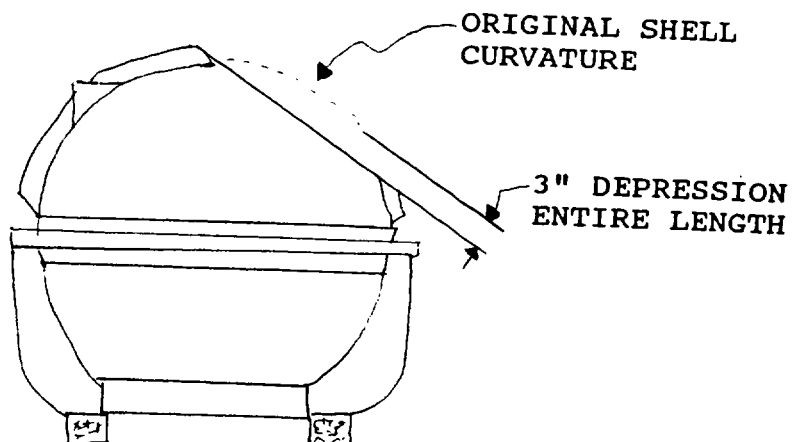
FIG I.

- 8.2.1 The ends of the cover received the full force of the impact directly on the two stacking brackets which were depressed to a greater degree than the cover shell itself. Actual measurement disclosed the cover shell had been uniformly depressed 3 inches throughout its length. (See Fig. I)

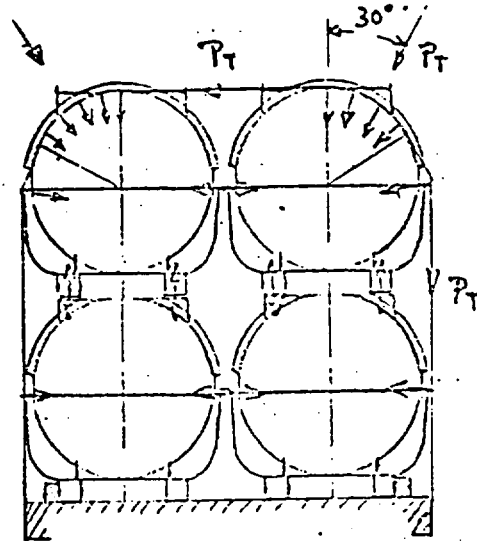
FIG. II-5.1

LOADING CONFIGURATION

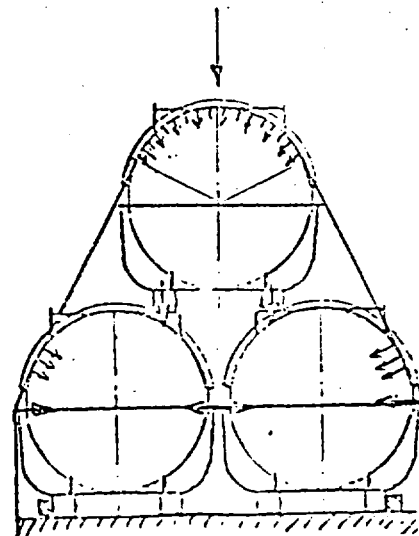
FIG. II-5.2

STRAPPING FORCE DISTRIBUTION

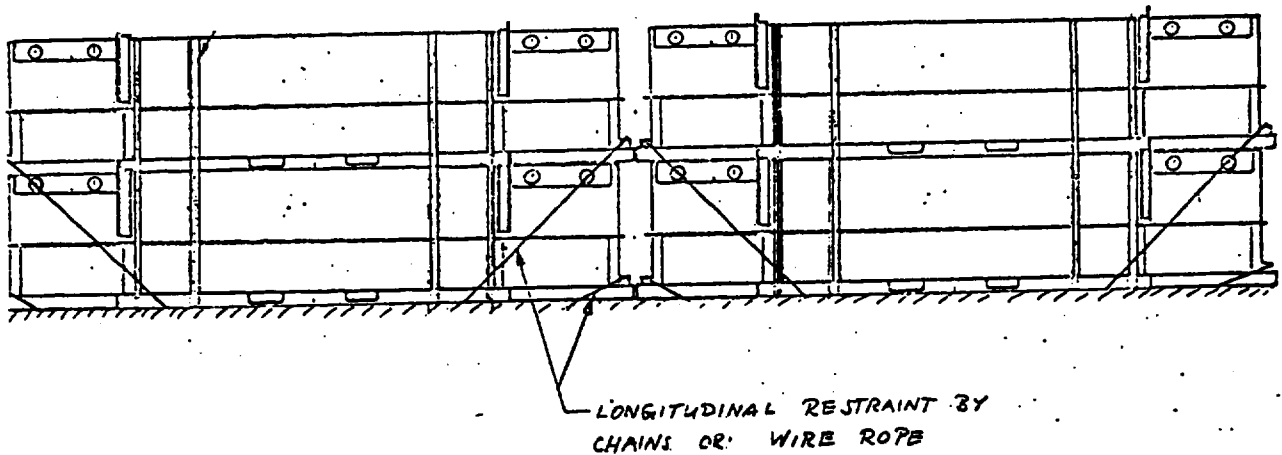
TRUCK LOADING CONFIGURATION

6 OR 8 CONTAINERS LOADED

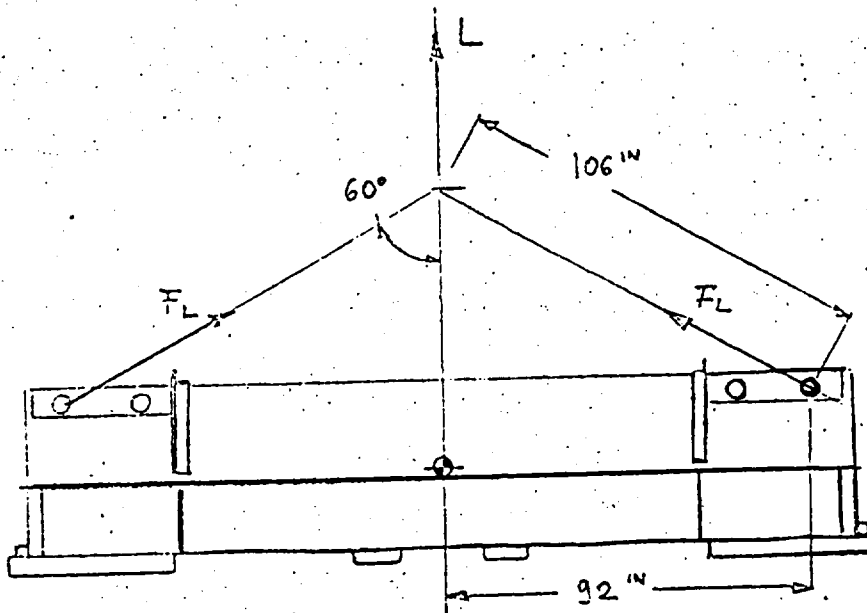
LIFTING FORCES AT 3G SHOCK

LIFTING FORCE
 $L = 3g \times 7300 =$
 $L = 21,900 \text{ LBS}$

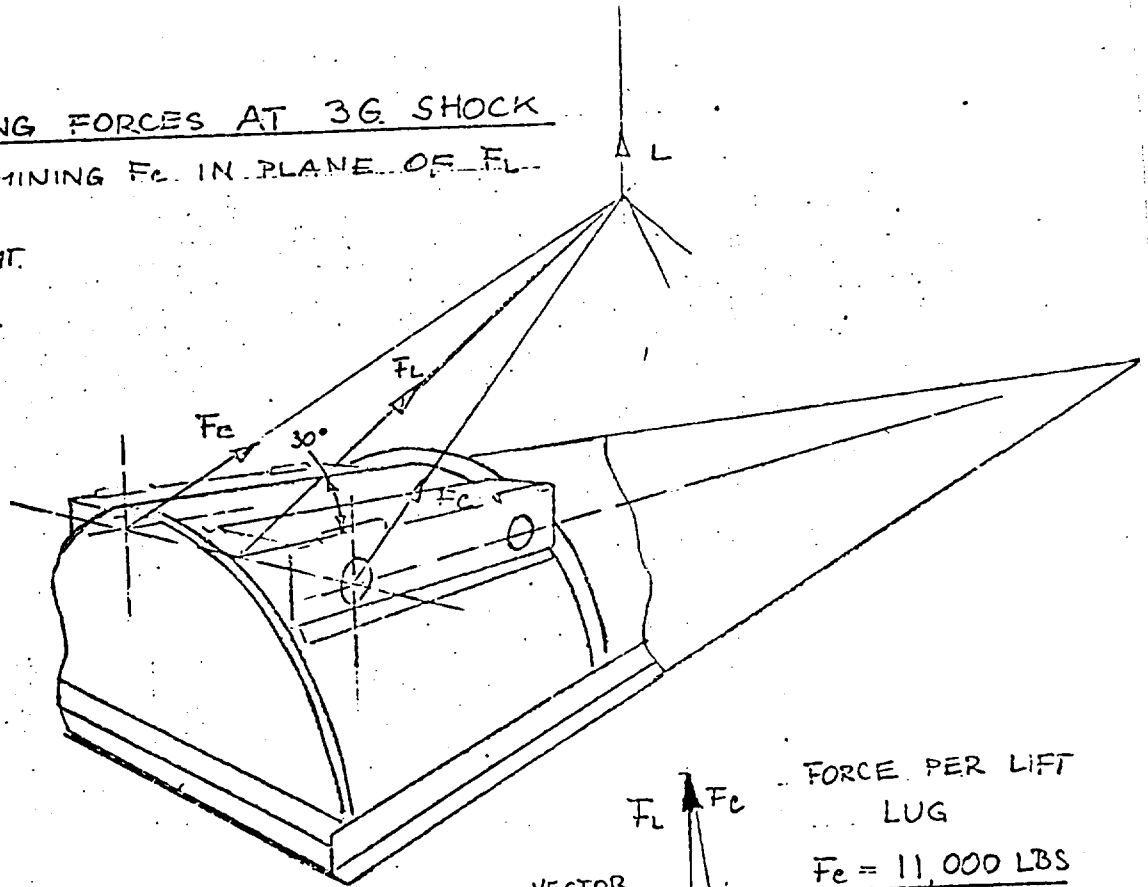
LIFTING FORCES AT 3G SHOCK
DETERMINING F_c IN PLANE OF F_L

GEOMETRIC ARRANGEMENT
SCALE: 1" \triangleq 40"

FORCE PER LIFT
LUG
 $F_c = 11,000 \text{ LBS}$

VECTOR
 $V_{LS} = 1700 \text{ LBS}$

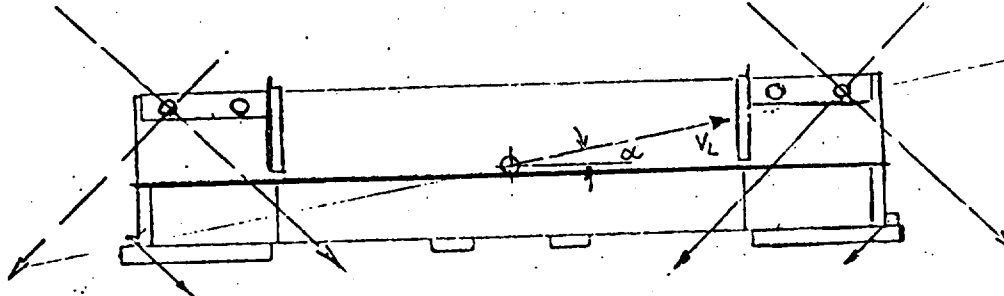
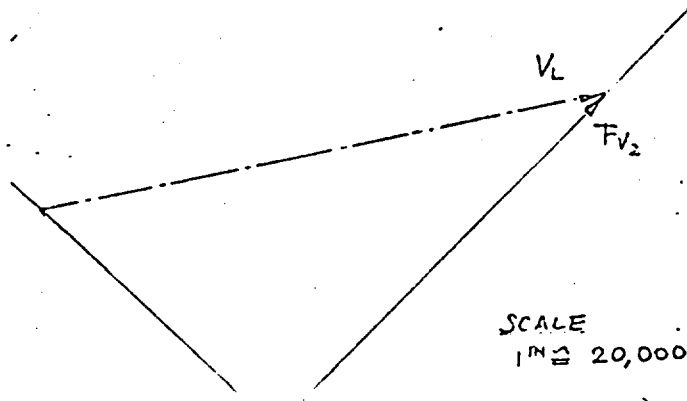
TIE DOWN FORCE VECTORS
 LONGITUD. PLANE - 45°

$$F_{V1} = 42,500 \text{ LBS}$$

$$F_{V2} = 61,000 \text{ LBS}$$

SCALE
 $1" \cong 20,000 \text{ LBS}$

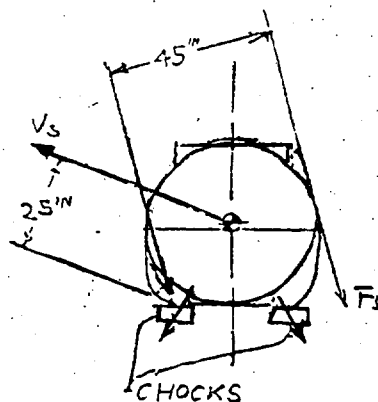
CHOCKS PROVIDED ALONG THE SKIDS —

IMPACT VECTORS

IMPACT FORCE VECTOR
 IN SIDEWISE PLANE

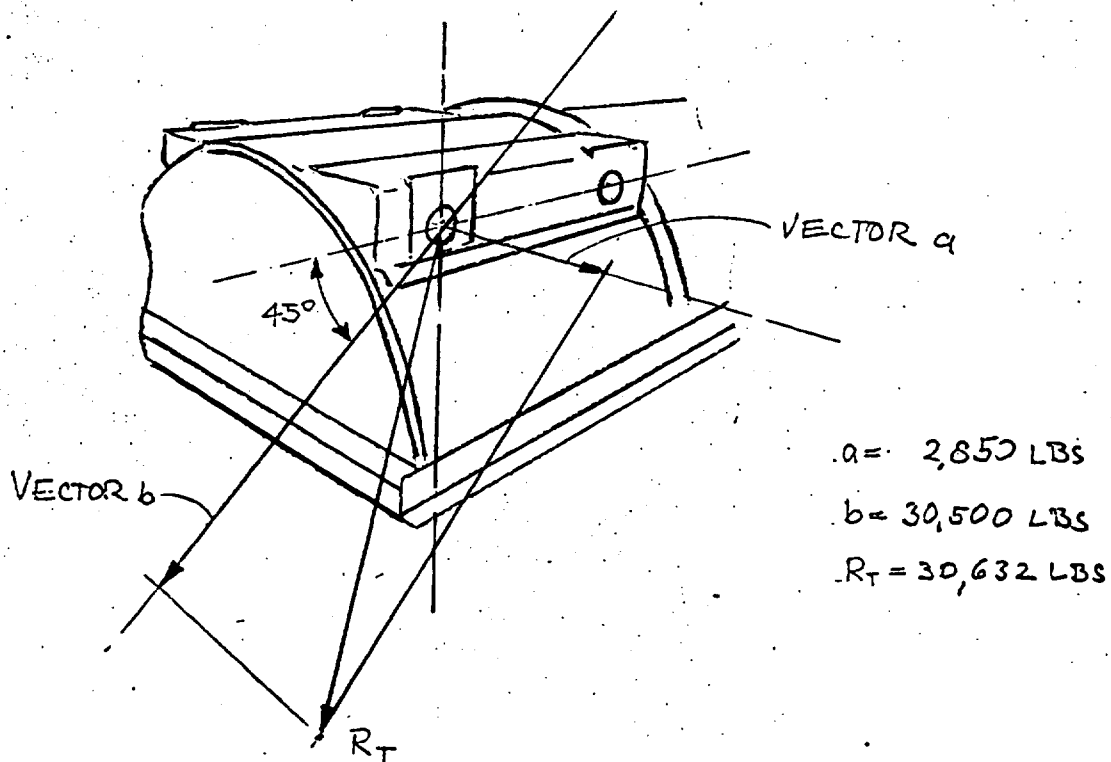
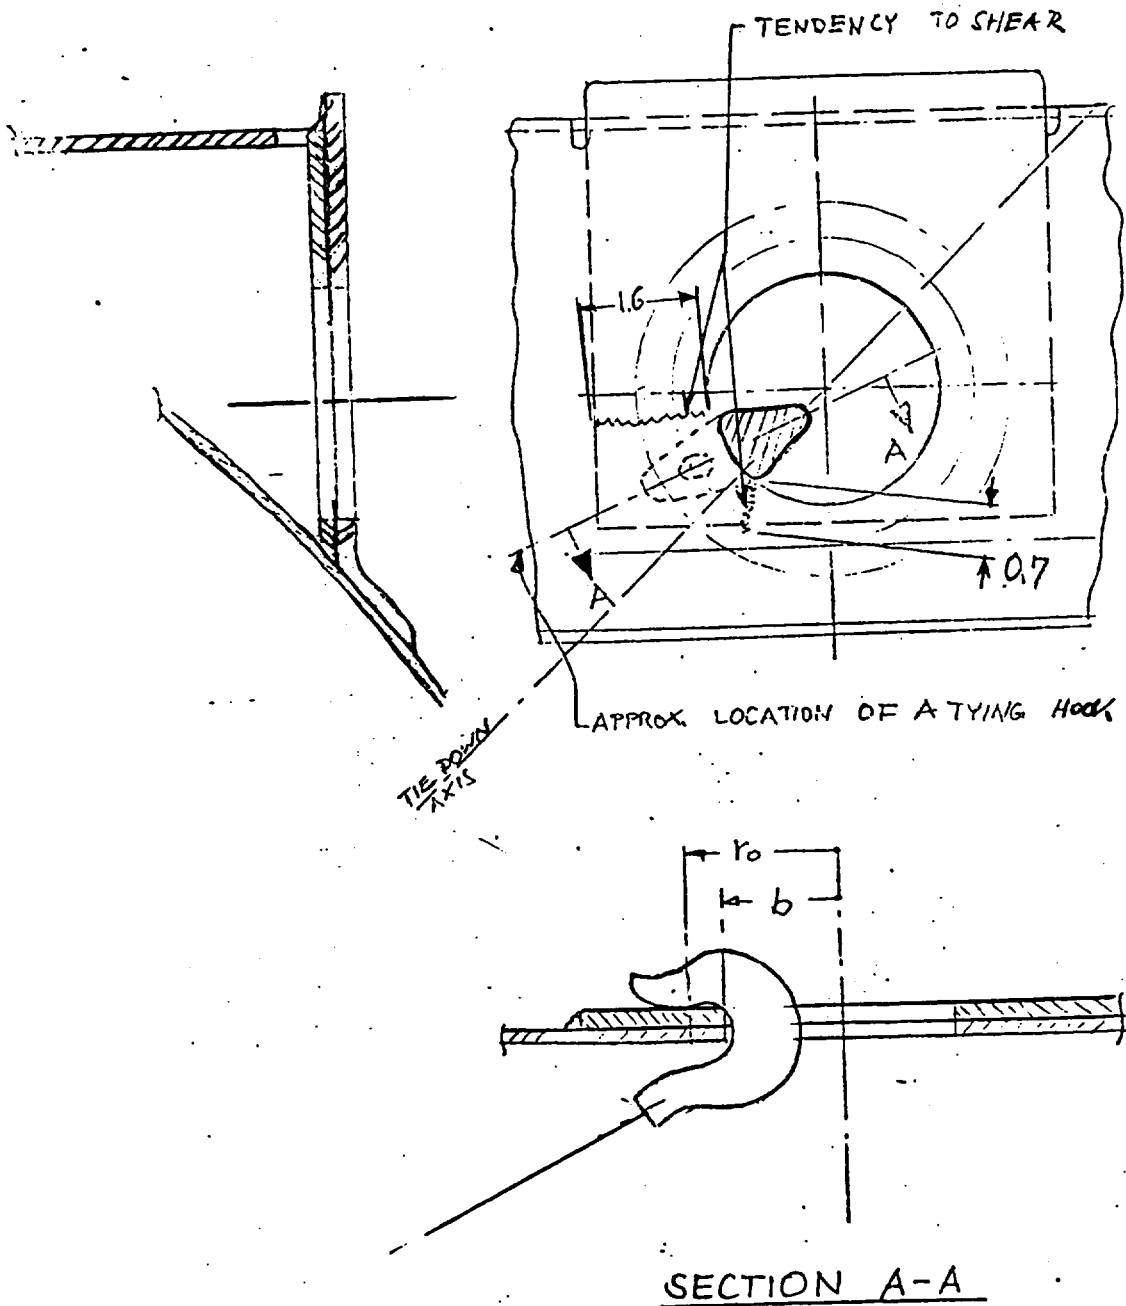
STRESS ON LIFT EYE

TENDENCY TO TEAR OUT HOLE

COMBINED STRESS BY:

- 1) VECTOR a. PULLING RECTANGULAR TO HOLE
- 2) VECTOR b. PULLING IN PLANE OF HOLE

LOCATION OF A TIE DOWN HOOK IN THE
LIFTING EYE

2.1 Vector "a" Pulling Rectangular to the Lift Hole

The hook will be located somewhat higher than at the 45 degree axis because of diminishing space behind the backup plate.

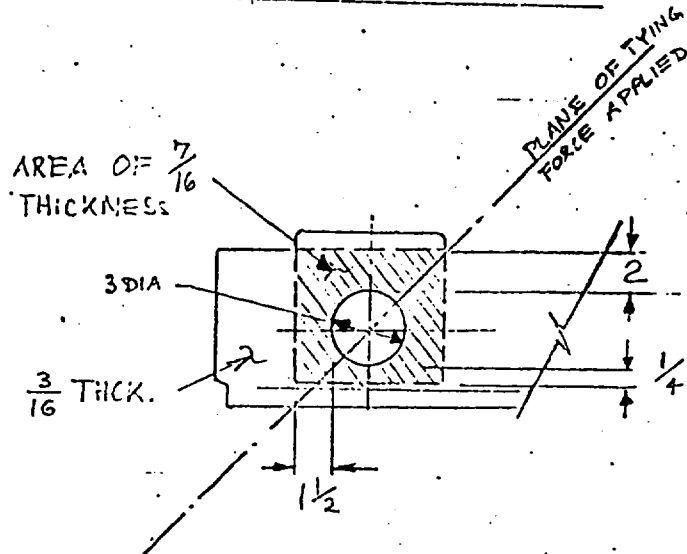
ACTUAL CONDITION

Actual conditions do not allow a standard calculation procedure. We adapt the dimensions to the case #60 of Formulas for Flat Plates, Table X, Page 232, in "Roark, Formulas for Stress and Strain, " McGraw-Hill Book Company.

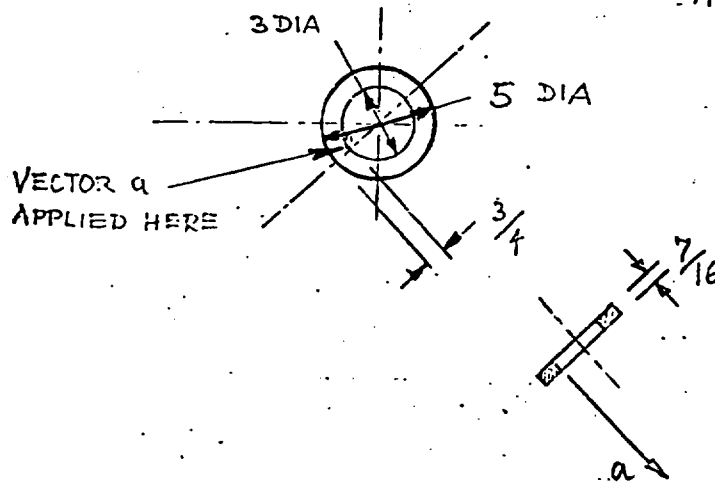
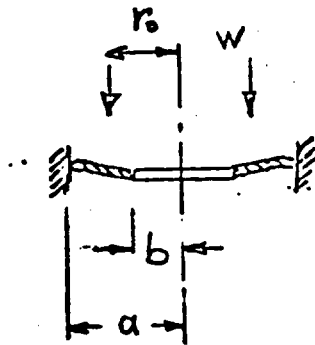
SIMULATED CONDITION

CIRCULAR PLATE WITH CONCENTRIC HOLE

Circular Plate
 With Concentric
 Hole
 Outer Edge Fixed
 Inner Edge Free

Uniform load on concentric circular ring of Radius r_o .

Our application shows only a local area where the hook touches the back-up plate. To about conform with the conditions of the formula, we multiply the force with 1.3.

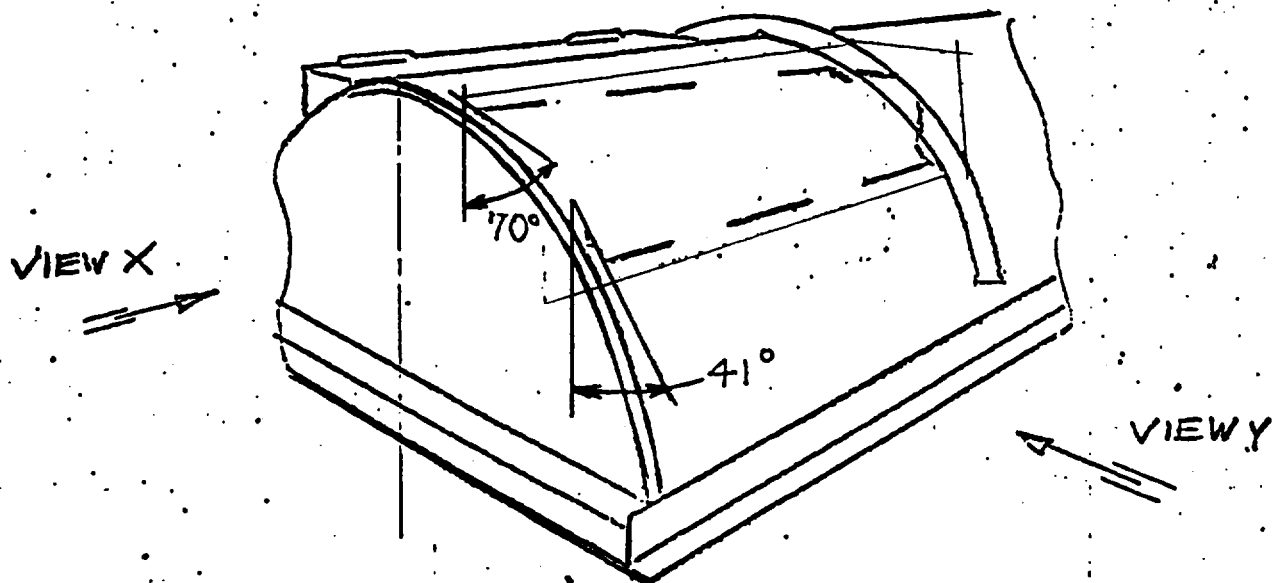
WELD PATTERN

LOCATION OF THE TWO PLANES

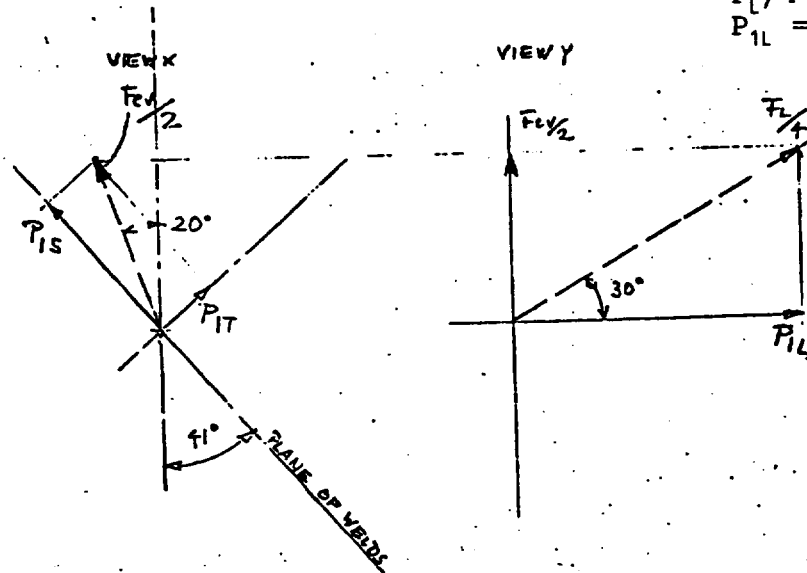
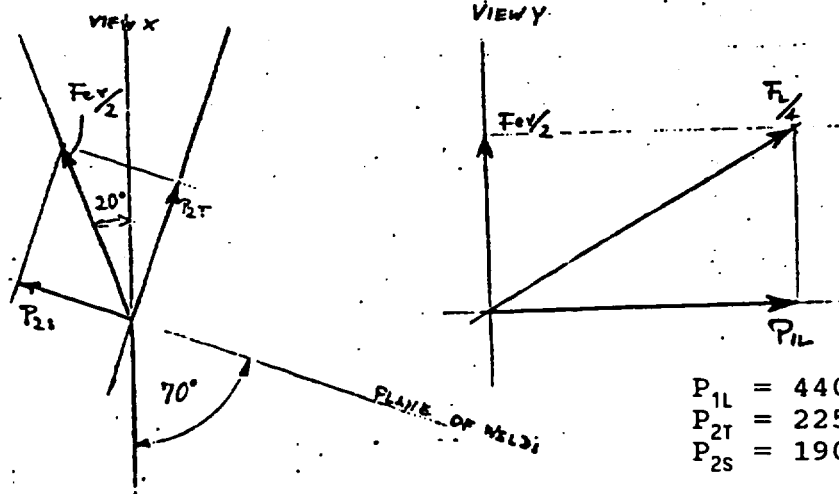
LIFTING FORCES ON WELDS

SCALE 1" 2000 lbs

$F_{cv}/2 = 2915 \text{ lbs.}$
 $P_{1s} = 2600 \text{ lbs.}$
 $P_{1T} = 1000 \text{ lbs.}$
 $F_L/4 = 5038 \text{ lbs.}$
 $P_{1L} = 4400 \text{ lbs.}$

$P_{1L} = 4400 \text{ lbs.}$
 $P_{2T} = 2250 \text{ lbs.}$
 $P_{2s} = 1900 \text{ lbs.}$

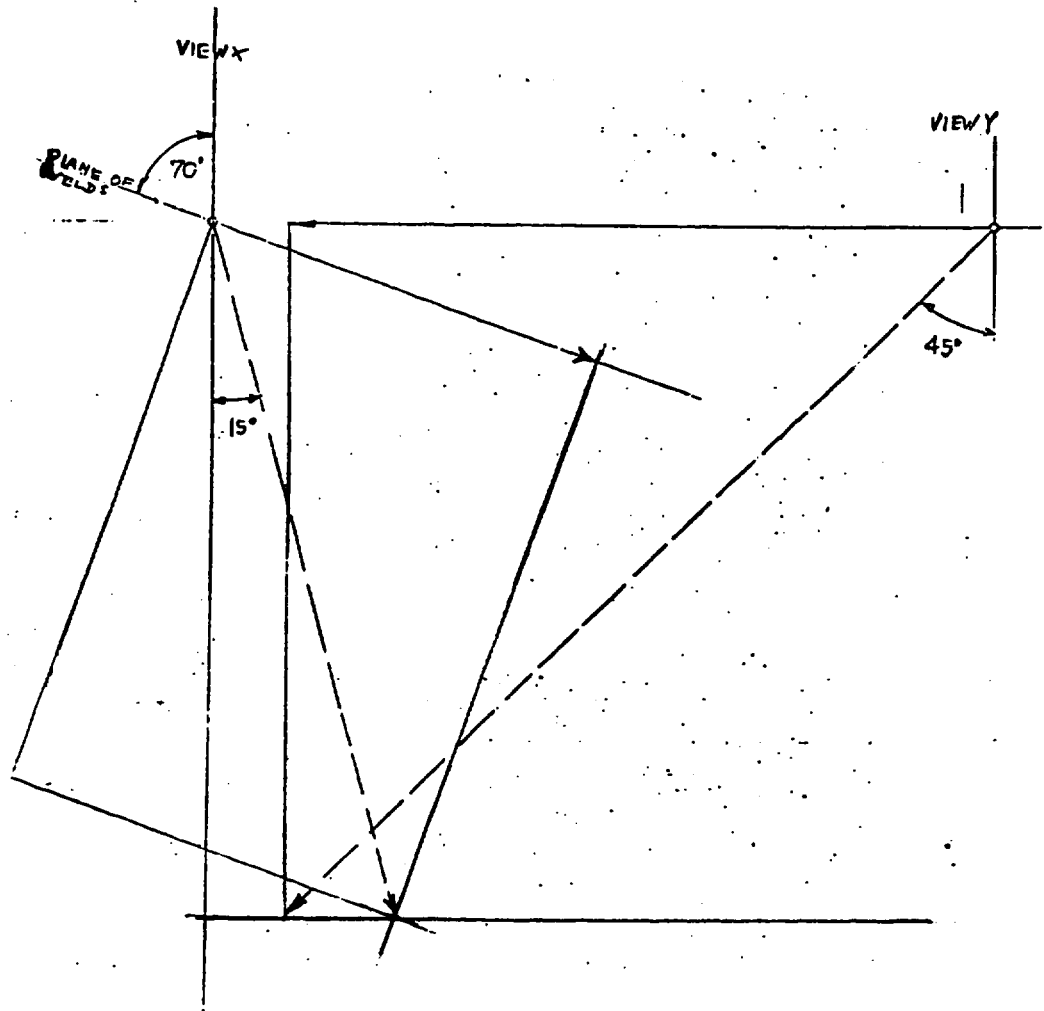
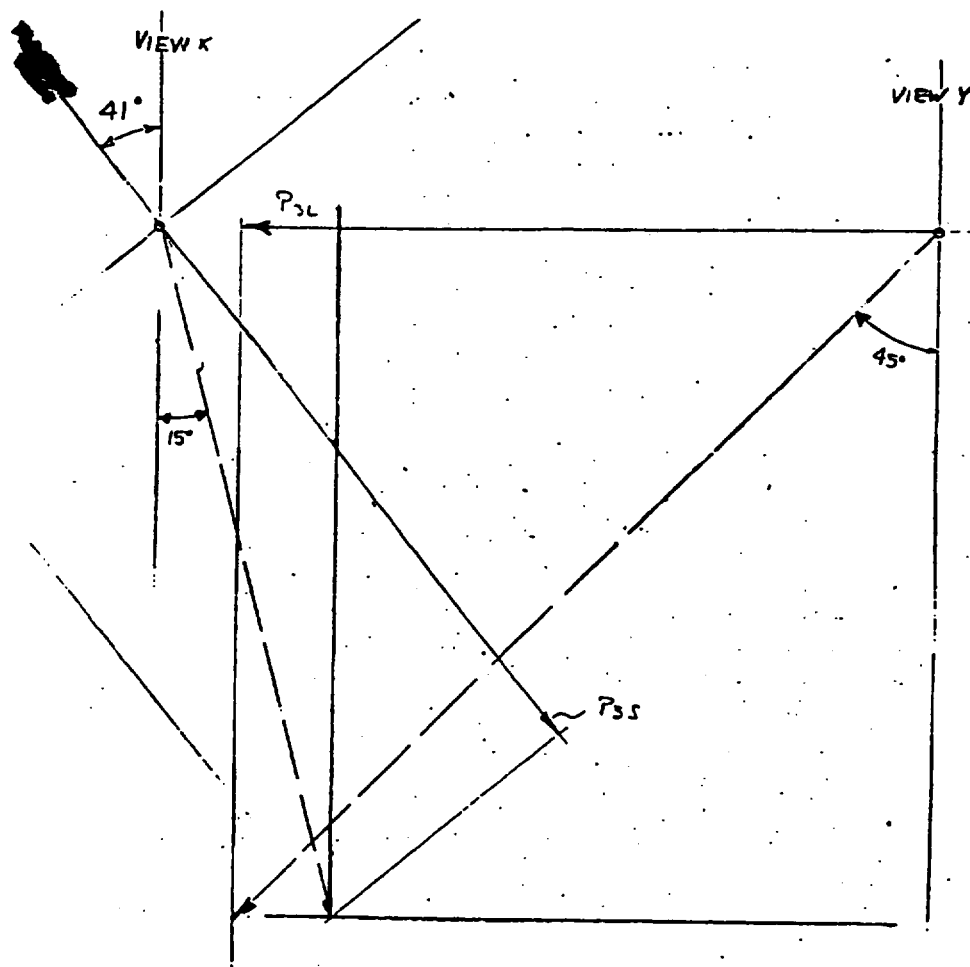
WELDS - TIE DOWN FORCES

$F_{s2}/4 = 5470 \text{ lbs.}$
 $F_{vl}/4 = 15200 \text{ lbs.}$
 $P_{3s} = 10000 \text{ lbs.}$
 $P_{3l} = 10700 \text{ lbs.}$
 $P_{3l} = 4400 \text{ lbs.}$

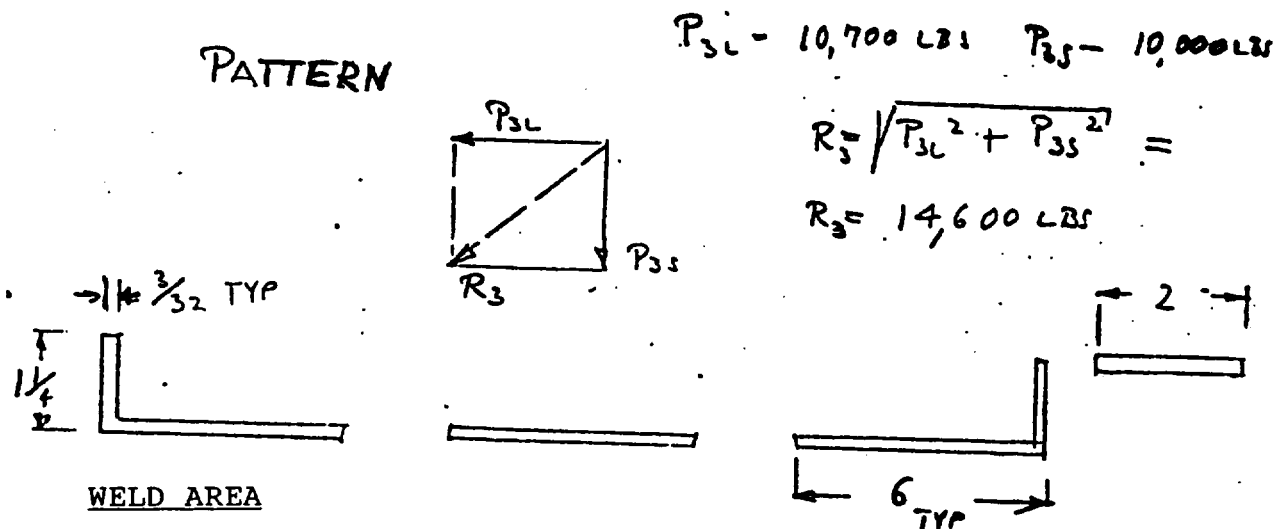
WORST CONDITION - TIE DOWN FORCE IN 41° PLANE WELDS

WELD AREA

$$A = (3 \times 6 + 2 \times 1.25 + 2) \times 0.094 = 2.115 \text{ in}^2$$

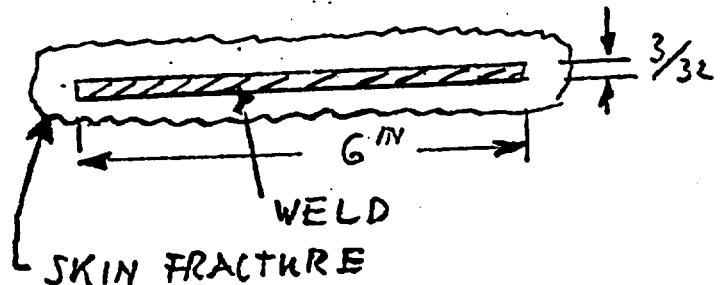
The stacking bracket connection welds would be peeled apart if any local excessive lifting force would bring damage. The containment of the shell would always be sustained as the skin could not be torn due to the following thesis:

The cross-sectional area of the skin is about twice the weld area.

$$\text{Ratio } \frac{A_s}{A_w} = \frac{12.5 \times 0.089}{6 \times 0.094} = \frac{1.97}{1} = 2:1$$
