LIC-02-0147

Subject: Licensee Event Report 90-28 for the Fort Calhoun
Station

TITLE (4) Leakage Through Control Element Drive Mechanism Housing

Fort Calhoun Station
 Discussion of Control Element Drive Mechanism Housing
 Reliability

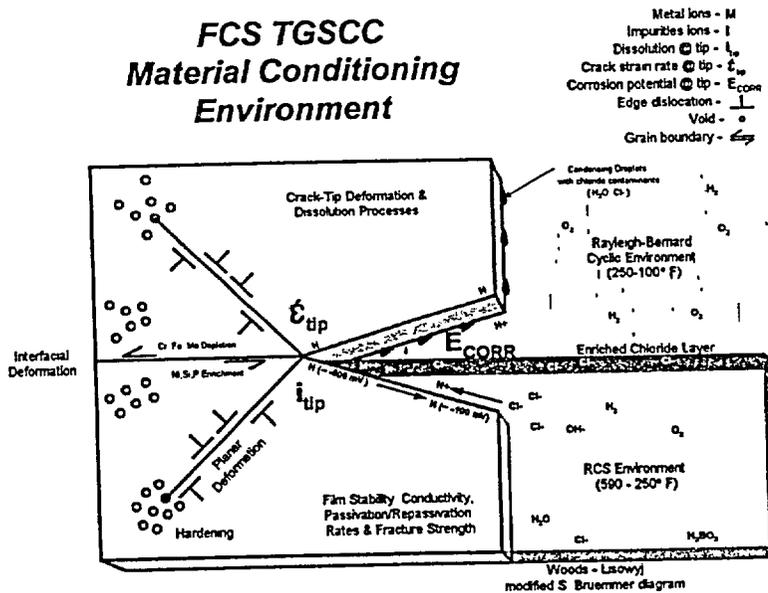
Crack Model
Figure No. 1

The evolution of TGSCC is started from a process in which an electrochemically oxidizing corrosion environment removes surface metal ions. This chemical reaction attacks the steel's surface structure if not arrested by passivation of material surface (protective film layer). However, repassivation does not occur when the surface is being washed by an acidic solution contaminated by chlorides (leached from: Graphitar, O-ring and Flexitallic gasket). Therefore, this condition tends to deplete iron (Fe), chromium (Cr) and molybdenum (Mo) ions from the crack tip, which in turn are replaced by impurities resulting in a corrosion potential that is referred to as transpassive region (E_{CORR}), see Figure

No. 1 showing the corrosion mechanism.

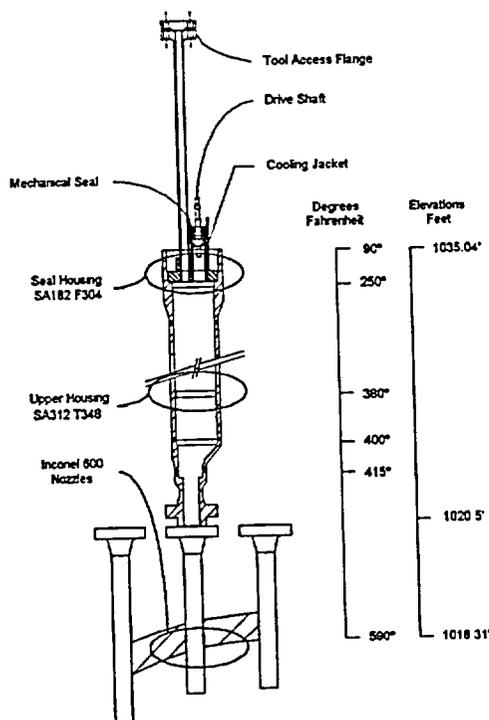
Broader View
Figure No. 2

At FCS as at other plants, the prime areas of concern are the reactor vessel head penetration (RVHP) nozzles. The nuclear industry has labeled these failures as primary water stress corrosion cracking (PWSCC), which has been generalized as a susceptible material under a tensile stress in an environment containing some oxygen and a chloride ion catalyst. A more specific corrosive model developed at FCS depicts the development of a low electrochemical potential (~500 mv) near a cold worked and/or tensile stressed area in contact with the primary system, which can initiate a Transgranular and/or Intergranular Stress Corrosion Crack (TGSCC/IGSCC). In this consideration, the focus of FCS has been to take a broader view of TGSCC versus reacting to single events. This broader view has included the RV head penetration nozzles, CEDM upper and seal housing assemblies (see Figure No. 2). Even though the CEDM upper and seal housing assemblies are made of stainless steel, the environmental conditioning that causes PWSCC is similar to the Inconel 600, head penetration nozzles. Understanding this conditioning or incubation period that is due to stagnancy is paramount to understanding SCC in the CEDM housings and RVHP nozzles.

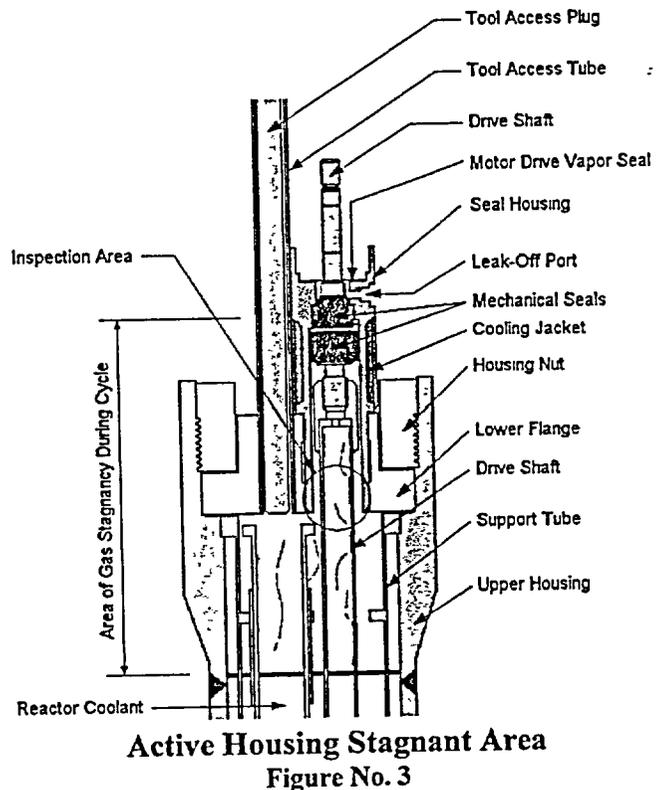
The CEDM Seal Housing Assembly is made of ASME SA 182 Type F304 material. The assembly consists of three principal elements: the drive housing, the tool access tube and the autoclave flange (see Figure No. 3). The drive housing has an inside diameter (ID) of 2.0625" with a wall thickness of 312 mils and functions as a boundary between the RCS and motor drive. The tool access tube has an ID of 1.240" with wall thickness of 120 mils and provides access for decoupling the control element assembly prior to removal of the reactor head. These two components are sleeve fitted and seal welded to the autoclave flange (outside diameter of 8.825") that is bolted to the upper CEDM housing assembly.

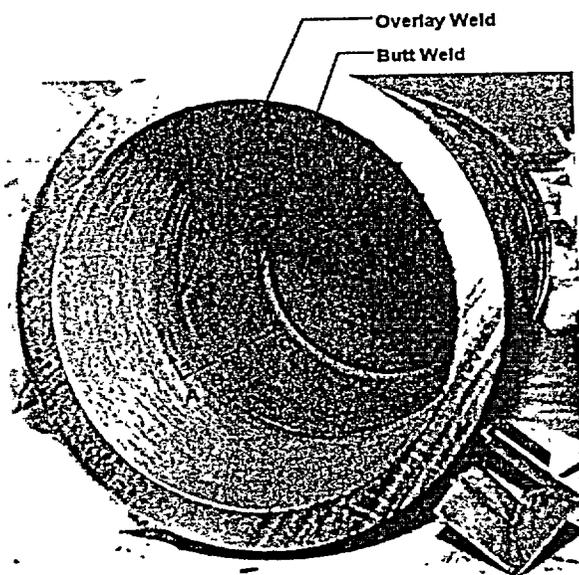
**Non-Active Housing
Stagnant Area**
Figure No. 4

The CEDM Upper Housing Assembly consists of an upper flange, lower flange and a modified eccentric reducer that is made of ASTM SA182 Type F348, and a pipe that is made of ASTM SA312 Type F348 material. This upper flange supports the seal housing assembly and is secured by a housing nut. The lower flange is secured to reactor vessel head penetration nozzle and is sealed by an omega seal. These flanges are attached to a 8", schedule 120 pipe and a 5"x8", schedule 120 eccentric reducer by butt welds and the internals support ring formed from an overlay weld. The assembly consists of five principal internals, which are: the support tube assembly, piston tube guide assembly, rack assembly, drive shaft, and bevel gear housing. The spare CEDM Upper Housing Assemblies were supplied with a spoiler to enhance circulation in these assemblies.

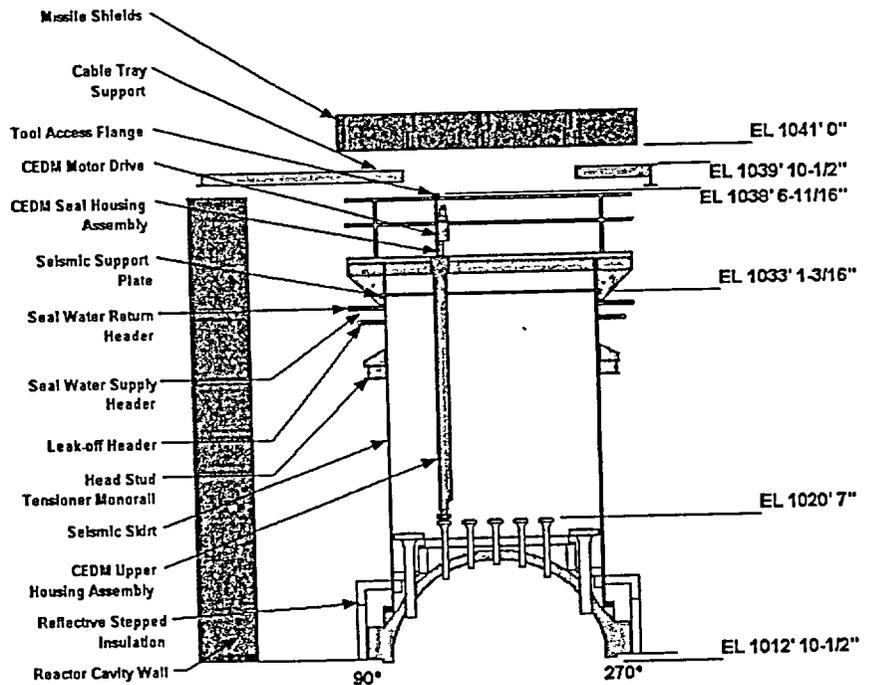
RVHP and Associated Equipment
 Figure No. 5

The NRC has issued Bulletin 2001-01 on RVHP nozzle cracking on August 3, 2001. The commission has grouped the primary water reactors into four categories based on the initial industry RV head time-at-temperature histogram in which FCS is assessed at 17.9 Effective Full Power Years (EFPY) from Oconee Unit 3 conditions. FCS has responded to this bulletin by demonstrating regulatory compliance, supplying requested information, and planning an effective visual examination of the reactor head surface during the 2002 refueling outage (see Figure No. 5).

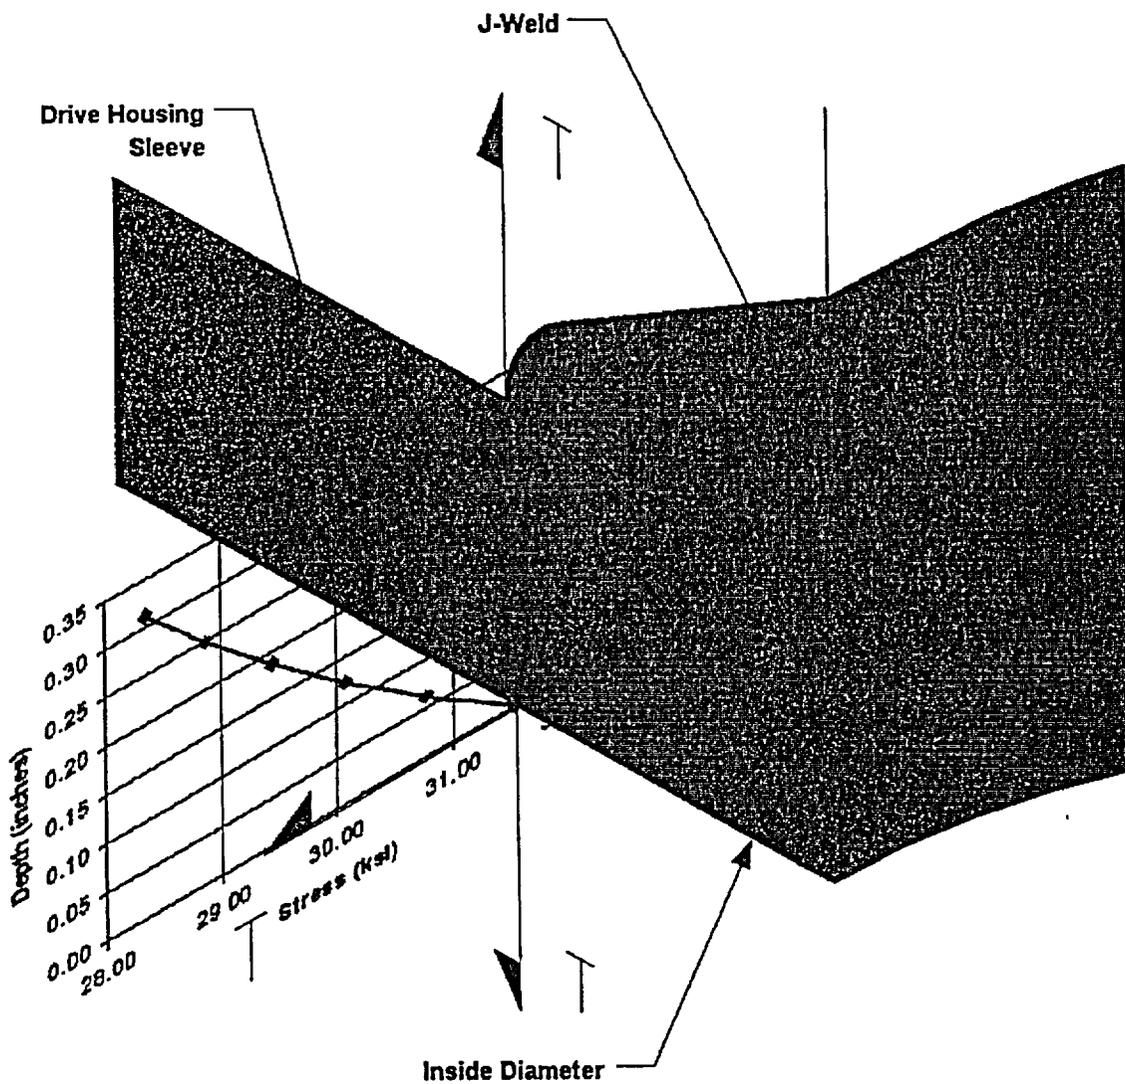
Control Element Drive Mechanism Seal Housing Assembly J-Weld Circumferential Stress		DWG NO
DRAWN	KIRBY D WOODS	Figure No 2
ISSUED	November 29, 2001	SCALE None

J-Weld Through-Wall Circumferential Residual Stress

Note: T - Tension

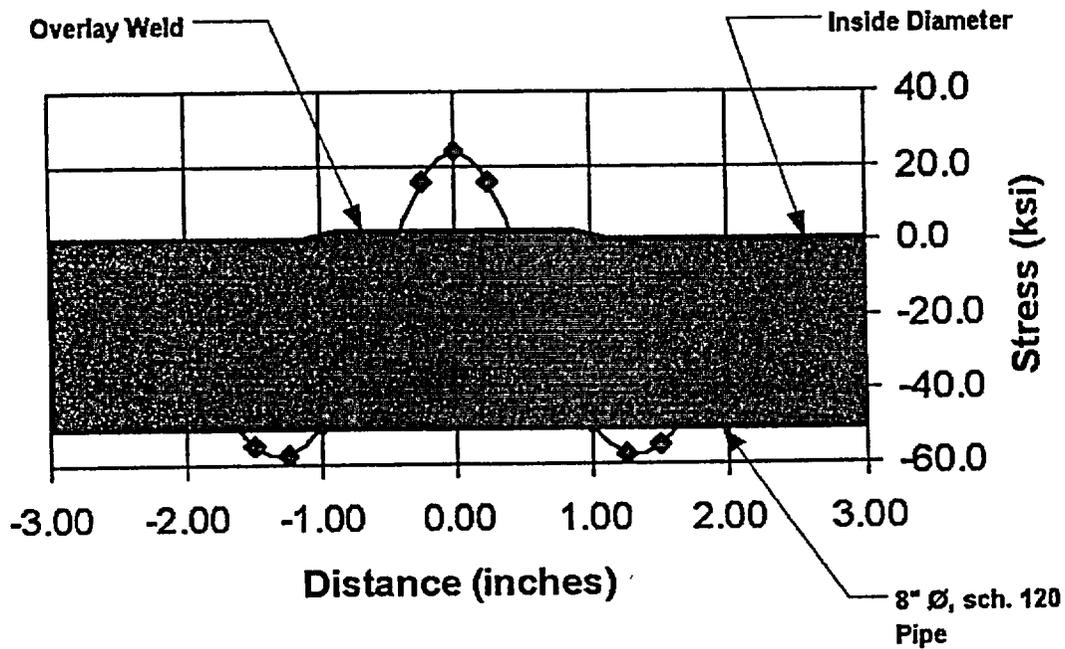
Control Element Drive Mechanism Upper Housing Assembly Overlay Weld Longitudinal Stress		DWG NO
DRAWN	KIRBY D. WOODS	Figure No 6
ISSUED	November 29, 2001	SCALE None

Inside Diameter Longitudinal Residual Stress

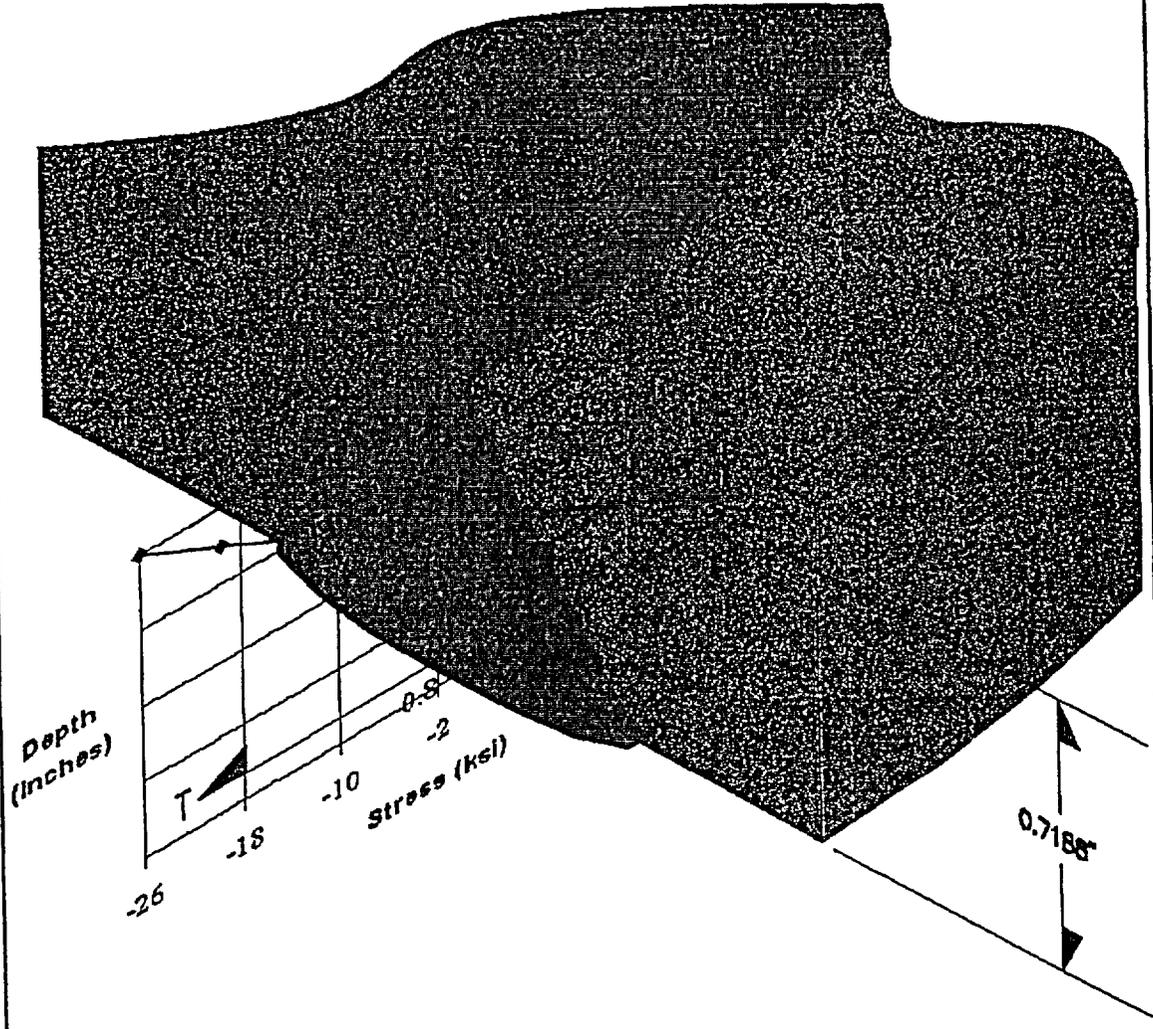
Control Element Drive Mechanism Upper Housing Assembly Butt Weld Through-Wall Stress		DWG NO
DRAWN	KIRBY D WOODS	Figure No 7
ISSUED	November 29, 2001	SCALE 1:1

Butt Weld Through-Wall
Circumferential Stress

Note: C - Compression
T - Tension

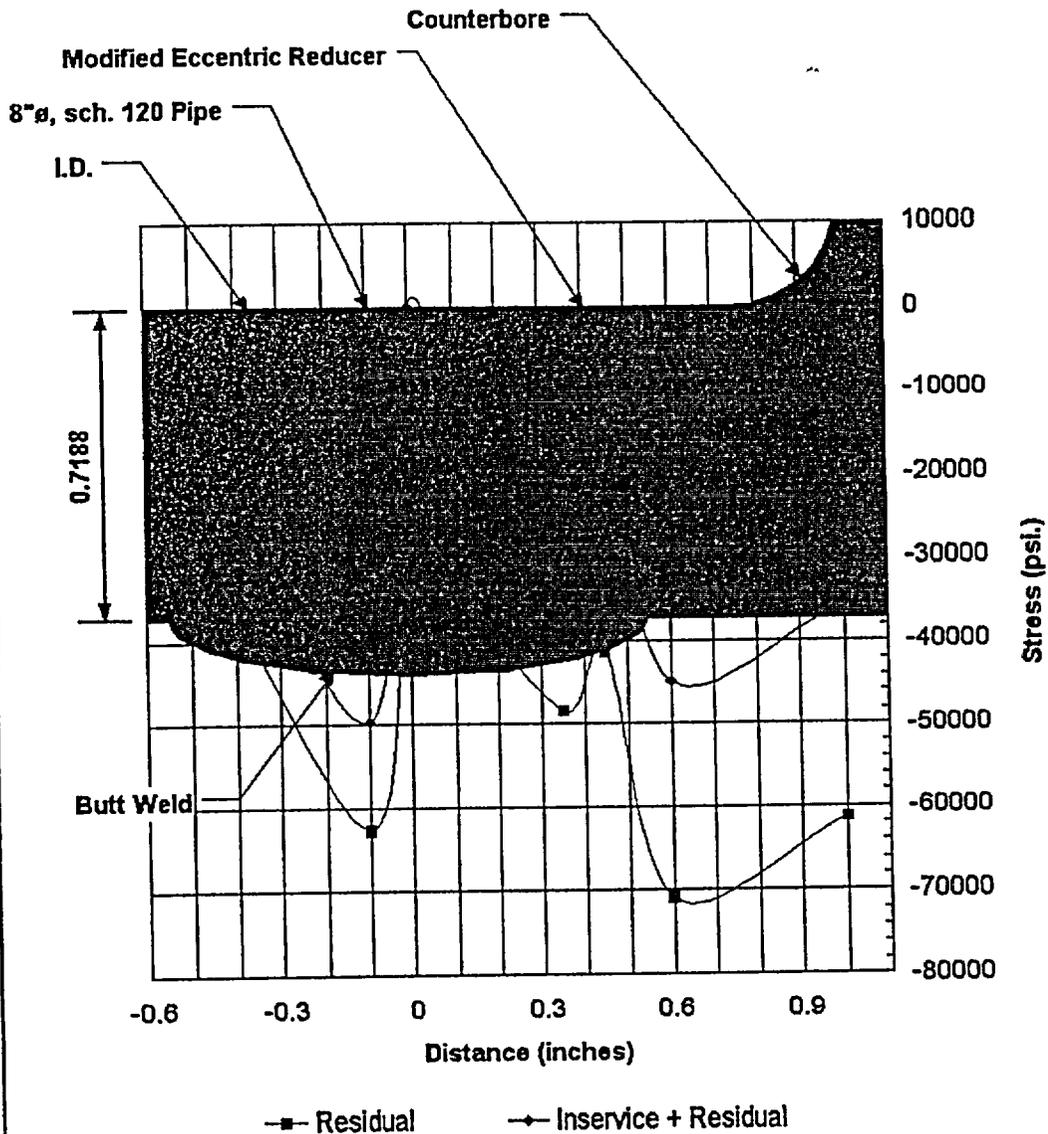
Control Element Drive Mechanism Upper Housing Assembly Circumferential Butt Weld Stress		DWG NO
DRAWN	KIRBY D WOODS	Figure No. B
ISSUED	November 29, 2001	SCALE None

Inside Diameter Circumferential Residual Stress

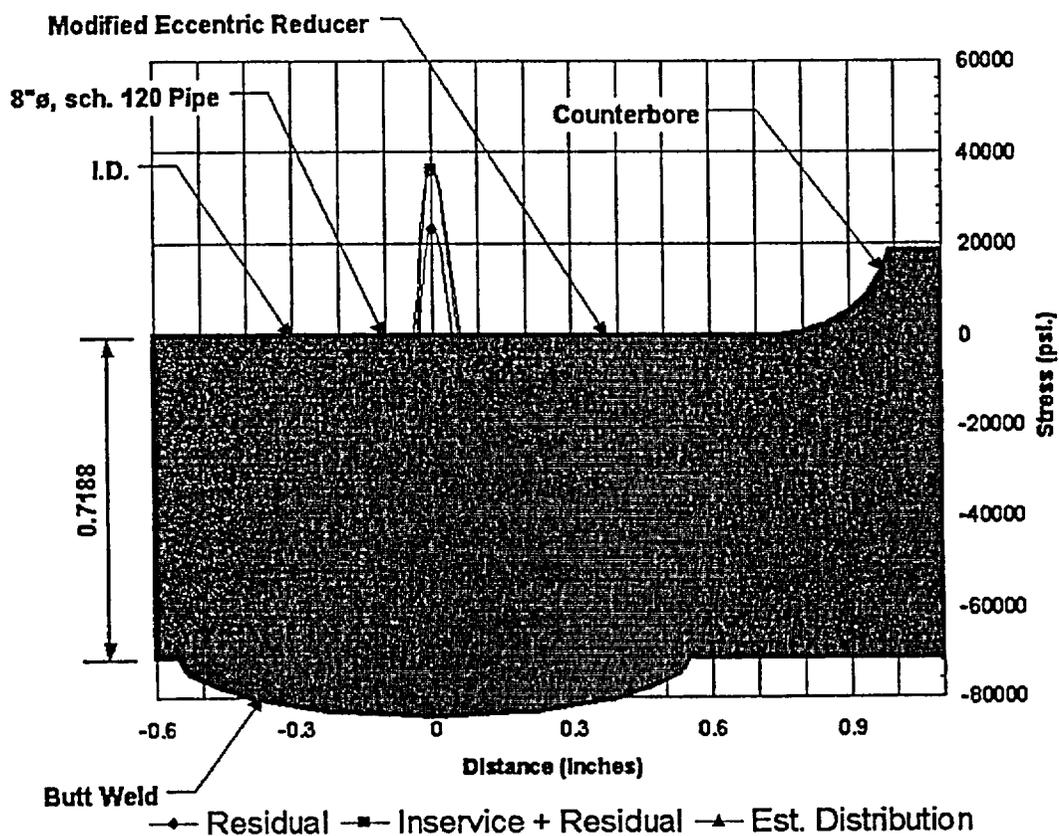
Control Element Drive Mechanism Upper Housing Assembly Longitudinal Butt Weld Stress		DWG NO Figure No 9
DRAWN	KIRBY D WOODS	SCALE None
ISSUED	November 29, 2001

Inside Diameter Longitudinal Residual Stress

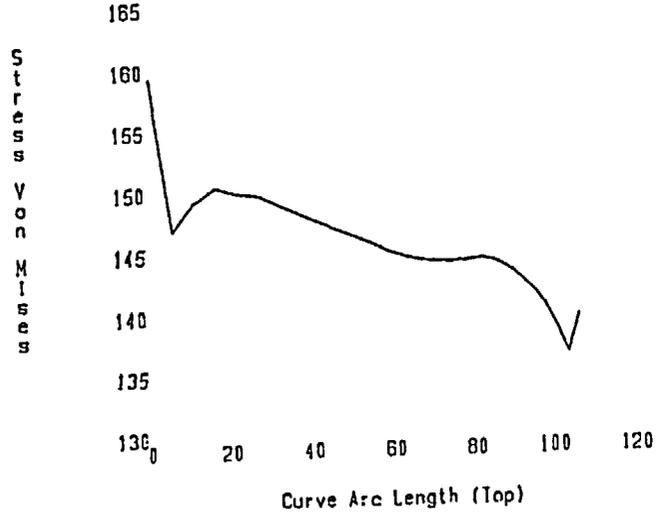
Von Mises stress, shrink fit 0.780 mm, 0 rpm

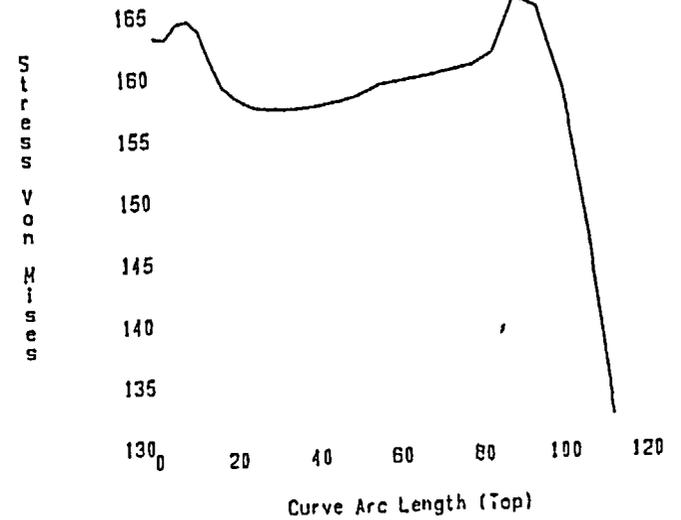
Von Mises stress, shrink fit 0.750 mm, 8 rpm

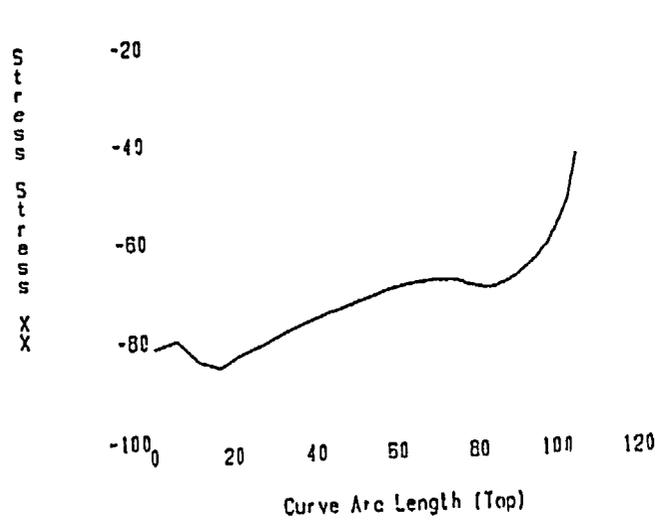
radial stress, shrink fit 0.780 mm, 0 rpm

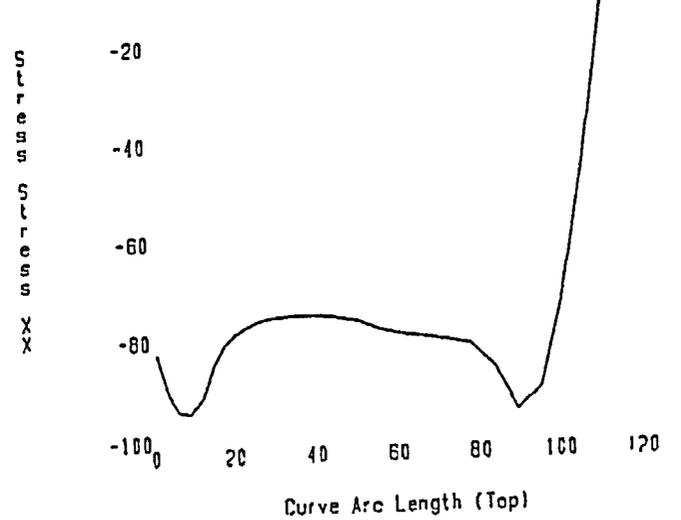
radial stress, shrink fit 0.750 mm, 8 rpm

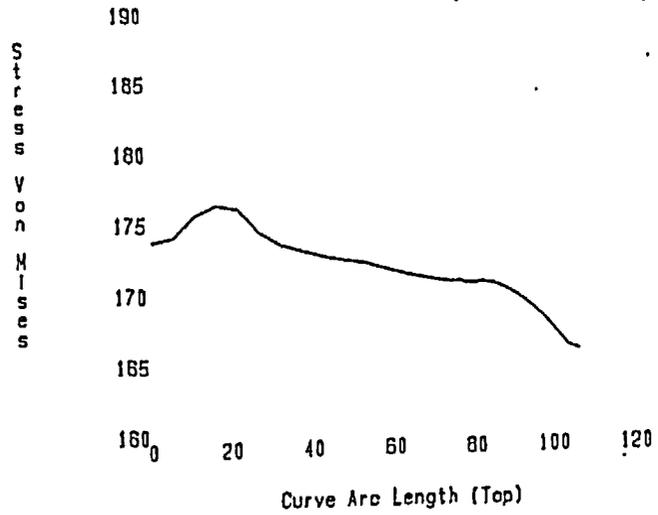
Von Mises stress, shrink fit Ø 790 mm, 1200 rpm

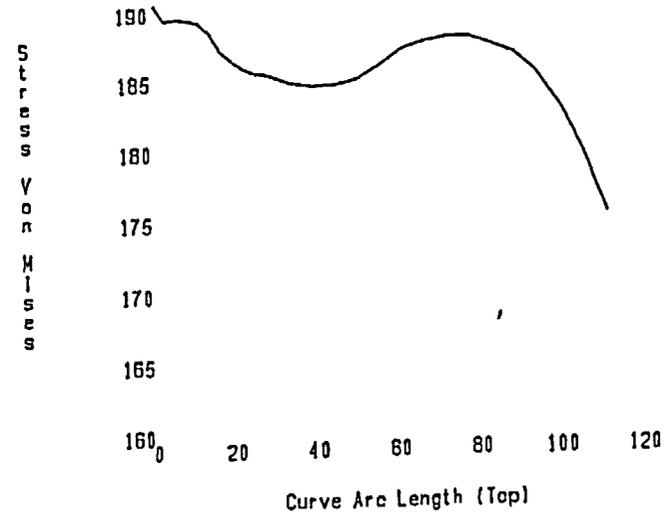
Von Mises stress, shrink fit Ø 750 mm, 1200 rpm

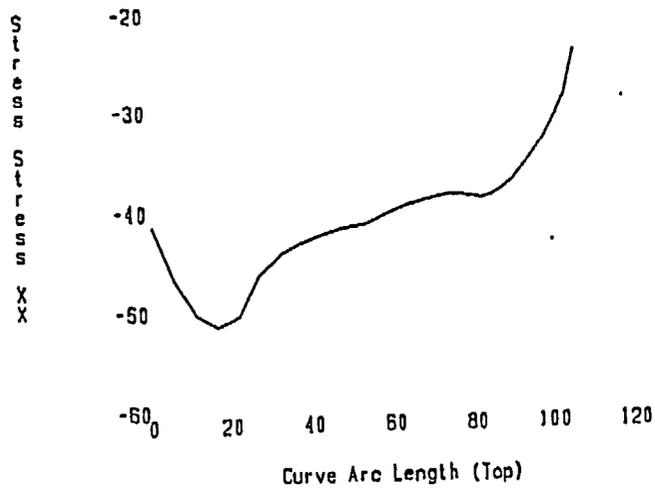
radial stress, shrink fit Ø 790 mm, 1200 rpm

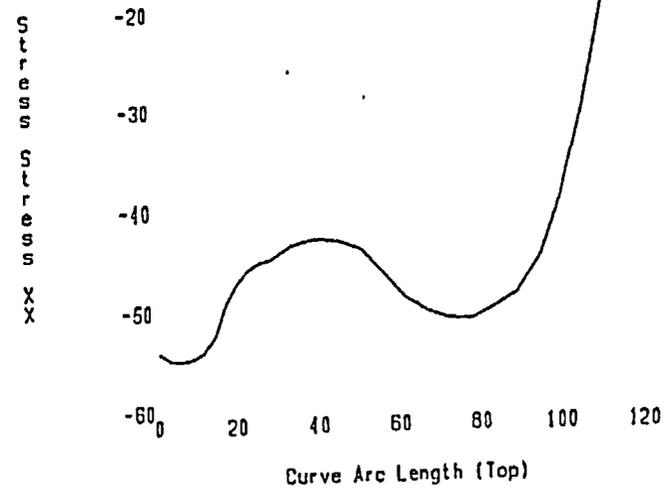
radial stress, shrink fit Ø 750 mm, 1200 rpm

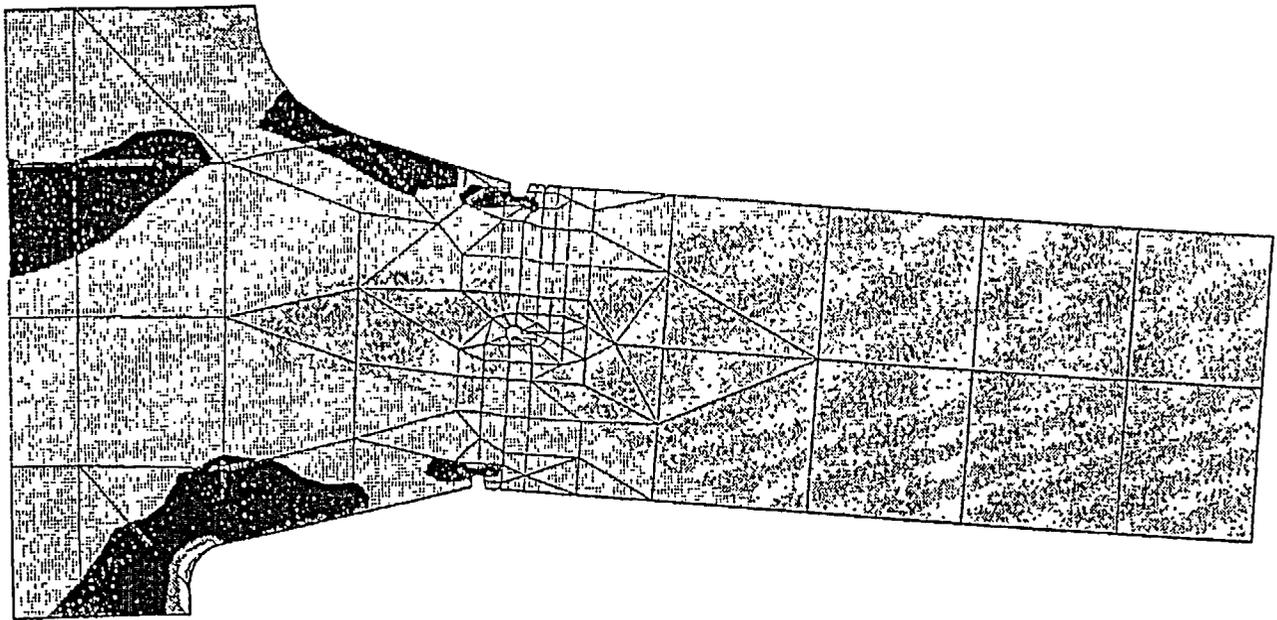
Von Mises stress, all, 0 rpm, 4g_vertical

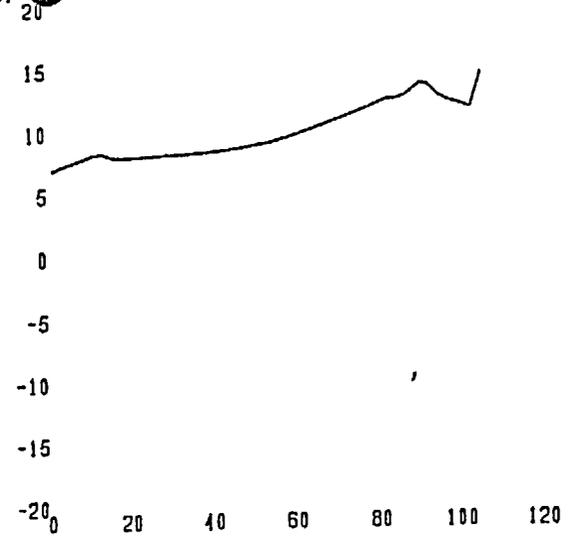
Von Mises stress, Ø 750 mm, 0 rpm, 4g_vertical

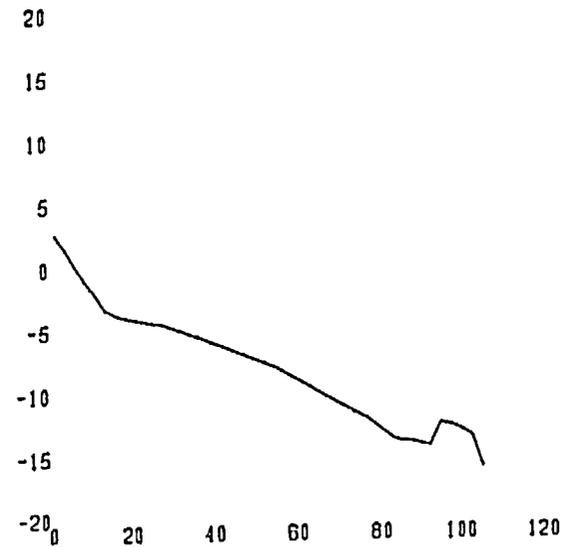
radial stress, Ø 750 mm, 0 rpm, 4g_vertical

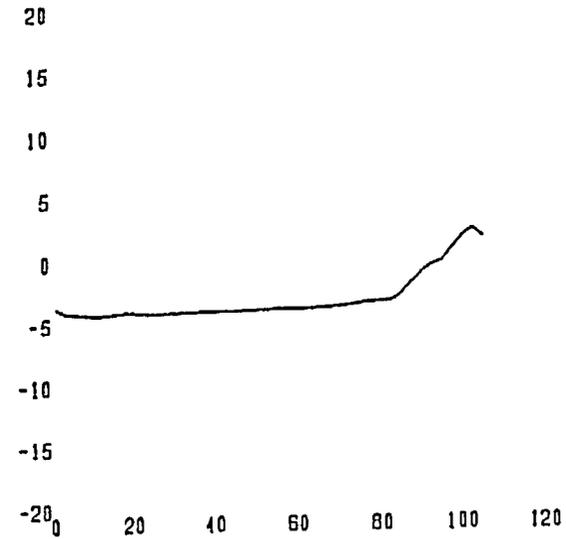
xy shear stress, Ø 750 mm, 0 rpm, 4g_vertical

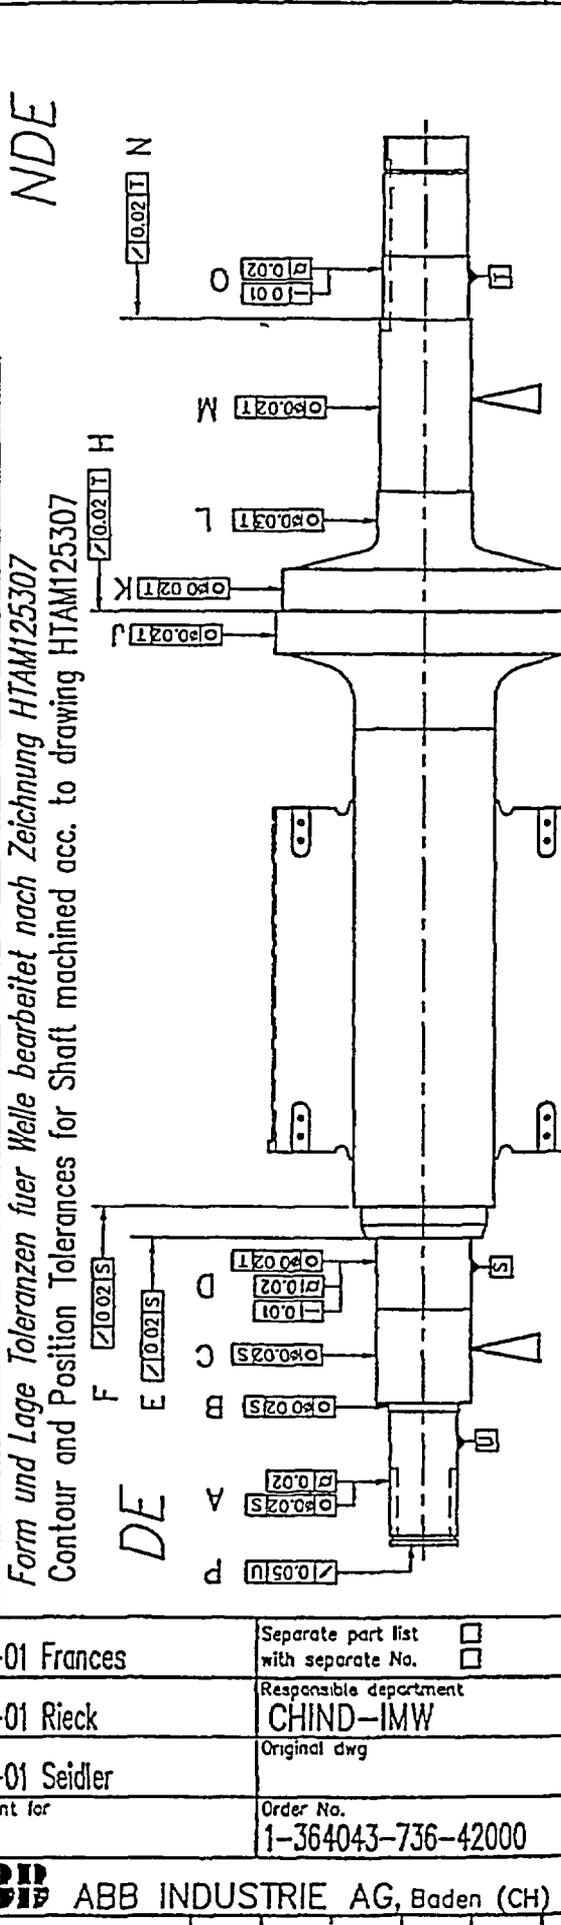
NDE
 Form und Lage Toleranzen fuer Welle bearbeitet nach Zeichnung HTAM125307
 Contour and Position Tolerances for Shaft machined acc. to drawing HTAM125307
