REPORT  
GEOLOGICAL AND GROUND-WATER INVESTIGATION  
PROPOSED SPENT FUEL STORAGE FACILITY  
NEAR MORRIS, ILLINOIS ·  
FOR  
THE GENERAL ELECTRIC COMPANY

Dames & Moore  
Job No. 1674-092-07  
September 3, 1975

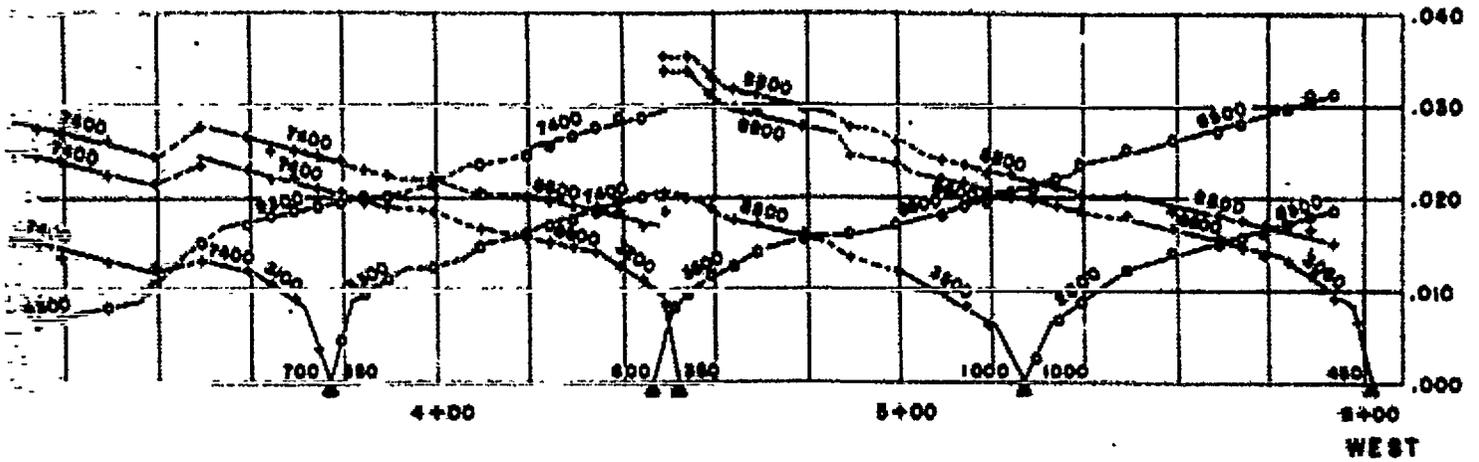
IN THE TIME - DISTANCE DATA SOME ANOMALOUS LATE ARRIVAL TIMES ARE DENOTED BY "SHOT DELAY". THIS MEANS THAT THESE LATE ARRIVAL TIMES HAVE BEEN CAUSED BY TRANSMISSION THROUGH PREVIOUSLY DISTURBED SOIL ZONES.

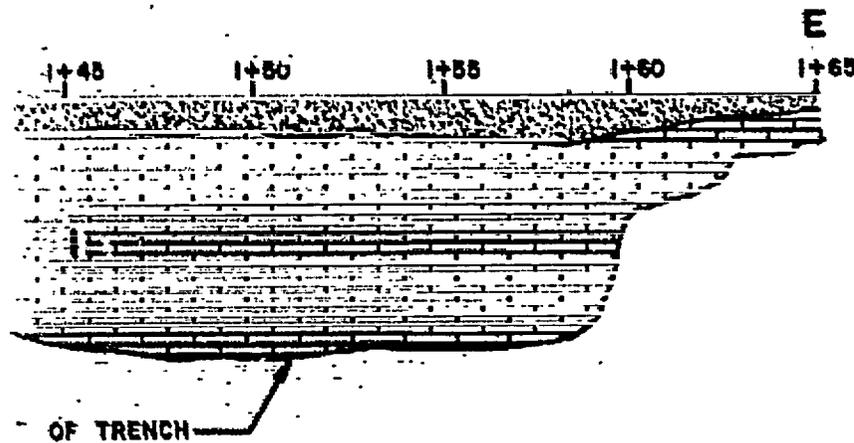
**TRENCH CROSS - SECTION  
NORTH WALL  
T-101**

REFUSAL WAS CAUSED BY THE IRREGULAR WALLS AND THE NARROW WIDTH OF JOINT

T-101: North wall; view, looking northwest: Joint fill material from 1+27 to 1+37. The major solutioned joint is curvilinear across the trench floor with a general trend of N65°W. The north wall cuts the joint and fill material at about a 30° angle.
