**Remediation of Mixed Waste Disposal Site
USDA National Animal Disease Center (NADC)
Ames, Iowa**

CLOSEOUT REPORT

FINAL

March 14, 2003

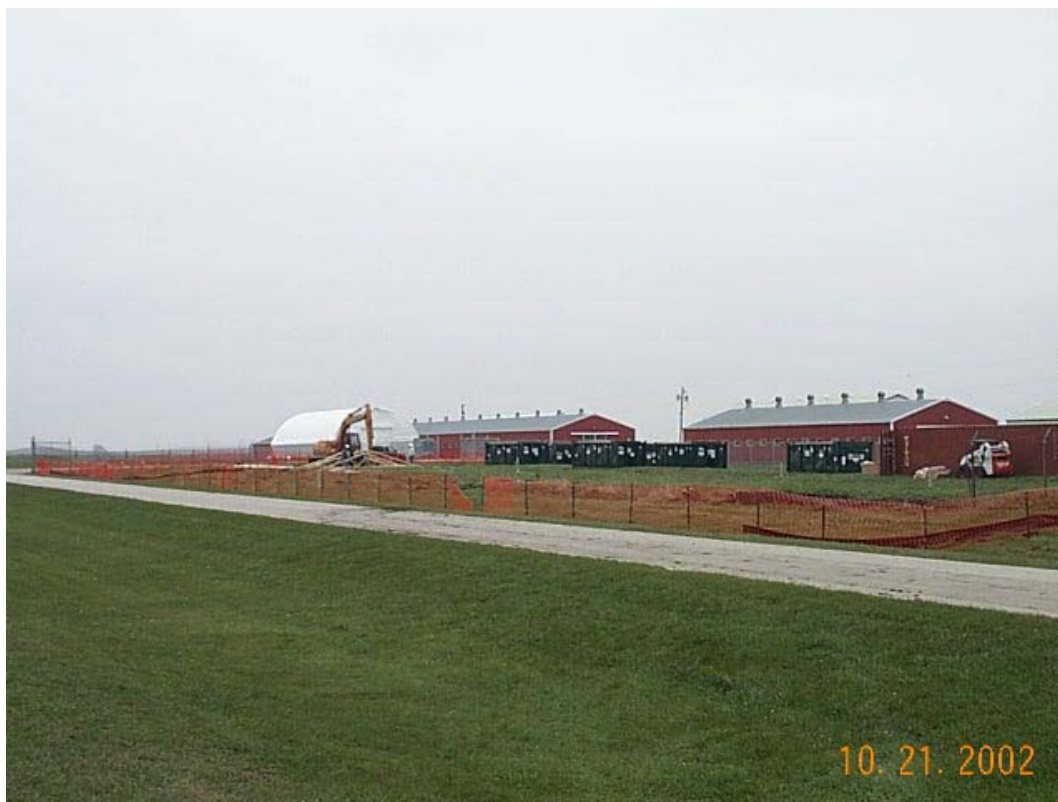
Figure 3-2: Temporary fencing around CZ

An outer CZ boundary was then erected to serve as the primary construction area during the remediation project. All remediation activities at the Site were performed within the CZ. The CZ was marked using steel fence posts and standard orange snow fencing for easy identification (see Figure 3-2). Temporary gates were also installed to control for vehicle ingress and egress.

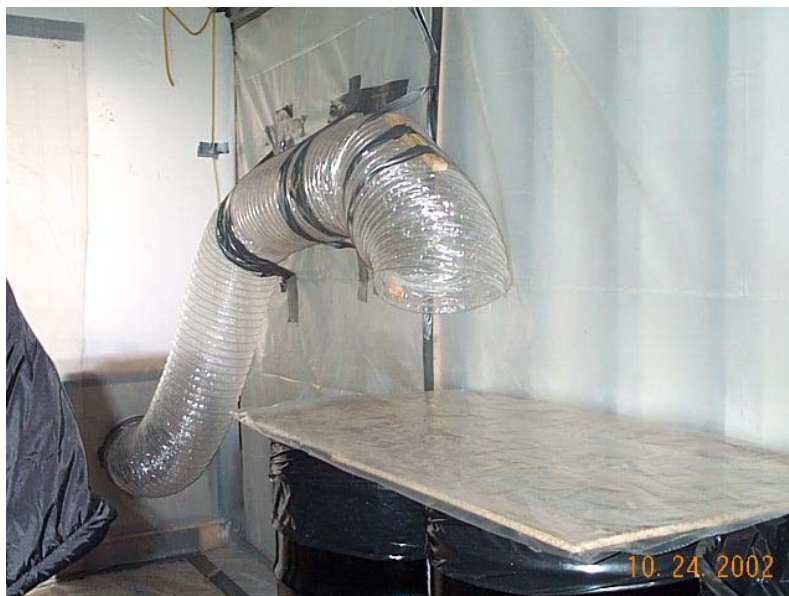
Figure 3-3: Sorting/segregation tent with exhaust system

A waste sorting and segregation area was constructed within a 40-ft 'Seavan' container as described in the WP (see Figure 3-3). A negative pressure enclosure was created using a HEPA-filtered air machine located outside the containment tent that continuously drew air from the enclosed area. The purpose of the negative-pressure enclosure was to prevent any airborne contaminants from escaping the boundaries of the tent during waste sorting and segregation activities. The containment tent was also continuously monitored for volatile organic compounds via a flame ionization detector (FID) and airborne tritium (H-3) by way of a vapor collection bubbler apparatus. The H-3 sampler hose is shown near the top left of Figure 3-3.

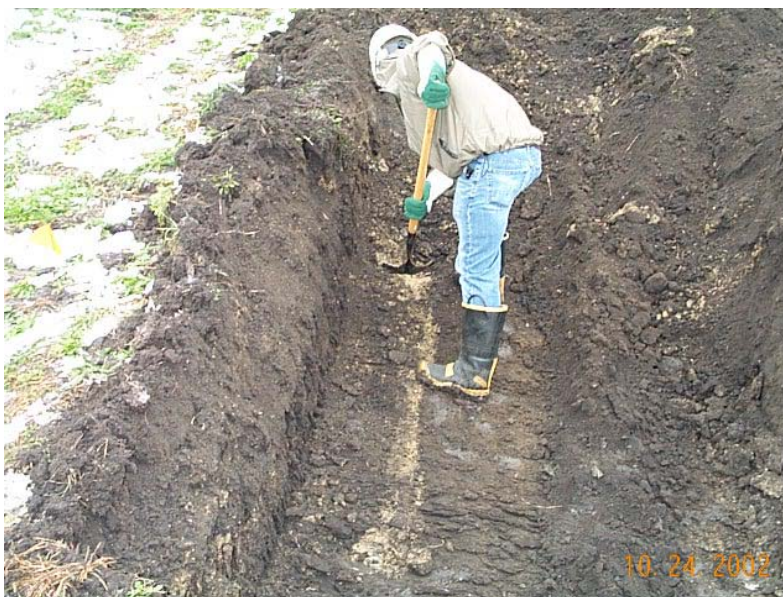
The approximate boundaries of the burial pits were known based on historical documentation and field markings installed by current and former NADC staff. The burial pits were excavated in ascending chronological order, starting at the eastern end of the trench (Pit 1) and proceeding to the west. Despite the fact that the waste materials had been removed from Pit 1 in 1989, investigation of this pit was necessary because no FSS had been performed. Uncovering the first pit was also viewed as a useful exercise to gauge physical characteristics of the soils that would aid the team in identifying other pit boundaries.

Figure 3-4: Photo showing backfill line in Pit 1. The soil to the right of the yellow line(clay) indicates the pit location.

The natural topsoil layer was observed to extend to an average depth 3.5 to 4 ft below ground surface (bgs). Outside the actual pit excavations, a sharp contact separates the above topsoil from native, hard yellow clay. The yellow clay is a glacial till deposit that contains very little silt, but does contain sparse pockets of reddish-yellow medium to coarse sand. Actual delineation of the burial pits was fairly simple due to the distinct color and texture change from the dark topsoil to the underlying yellow clay. Soils within the pit boundaries consisted of mixed topsoil and clay with sharp contacts distinguishing the edges of the pits.

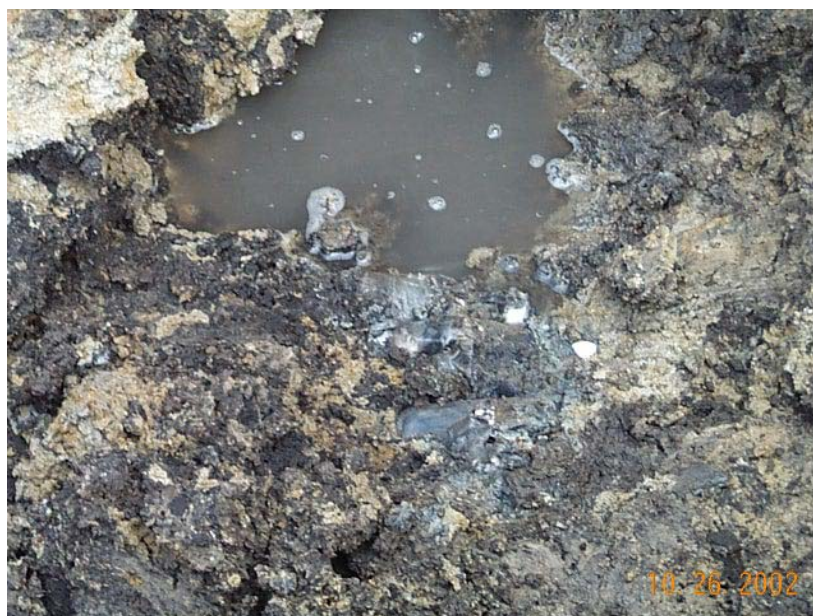
Excavation of existing buried wastes began with Pit 2. Preparation of the trench was accomplished in the same manner as described for Pit 1 above, with overburden soils removed and the center portion of the trench excavated gradually until evidence of the waste was observed. However, during removal of the center portion of the overburden soils, loose vials and other laboratory debris were observed prior to uncovering any intact bags. At this point, the remediation crew switched to manual excavation techniques to dig around the observed items to find the extent of the burial. The results of these efforts were largely unsuccessful as the bags were found to be degraded, torn, or shredded, leaving the buried wastes generally uncontained. Observed waste condition from Pit 2 is shown in Figure 3-5. The white objects in the photo are scintillation vial caps.

Figure 3-5: Close-up view of loose waste materials in Pit 2.

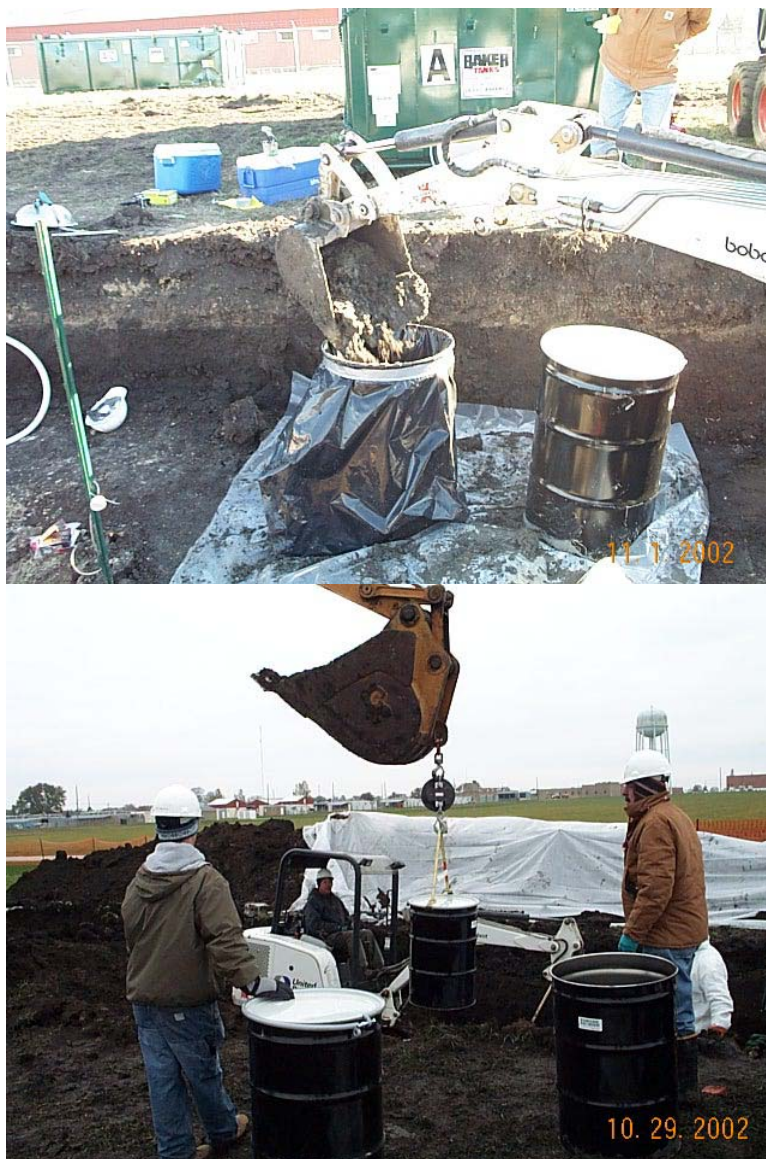
Waste removal proceeded using the bucket of the excavator. The excavator scooped the buried waste out of Pit 2 and placed it on 6-mil polyethylene sheeting adjacent to the trench for manual sorting and segregation. The volume of material, coupled with the gross amounts of soil incorporated, made use of the waste sorting and segregation tent impractical. Vials and other debris were removed by hand from the soil/waste mixtures as effectively as possible with all wastes loaded into drums, as shown in Figure 3-6.

The loading of excavated waste materials directly into drums, as shown in Figure 3-6, was used to remediate Pits 2 through 8. Plastic sheeting was placed underneath and behind the drums as a contamination control measure during drum loading and removal. Once the final drum for the pit was filled, the plastic was folded up and packed into the drum before it was sealed. The sealed drums were then wiped down with a large area (i.e. masselin) wipe and scanned with a GM survey meter for gross contamination. If no contamination was detected, the drum was lifted from the trench and placed in a staging area to the south of the trench for final weighing and labeling.

Figure 3-6: Photographs of drum loading and handling procedures during pit remediation

The condition of the waste in Pit 2 (i.e. bags not intact) required CABRERA to reevaluate the techniques and processes planned to accomplish the Site 1 remediation. The proposed field change involved mobilizing a mini-excavator and second heavy-equipment operator to the NADC. The mini-excavator is a scaled-down version of the large unit equipped with a much smaller bucket. This allowed excavation with greater precision (i.e. less soil waste) as well as direct loading into drums. Despite the fact that the use of heavy machinery had the potential to increase the total mixed waste volume, the overall process was determined to be the most efficient means for removing the buried wastes from the remainder of the pits. These field modifications were approved by NRC Region 1 and EPA Region VII prior to execution.

Although this waste removal process proved effective, the loading and handling of waste into 55-gallon drums proved too inefficient to attempt for the remaining burial pits. As an alternative, 96 cubic foot (ft³) 'B-25' boxes were

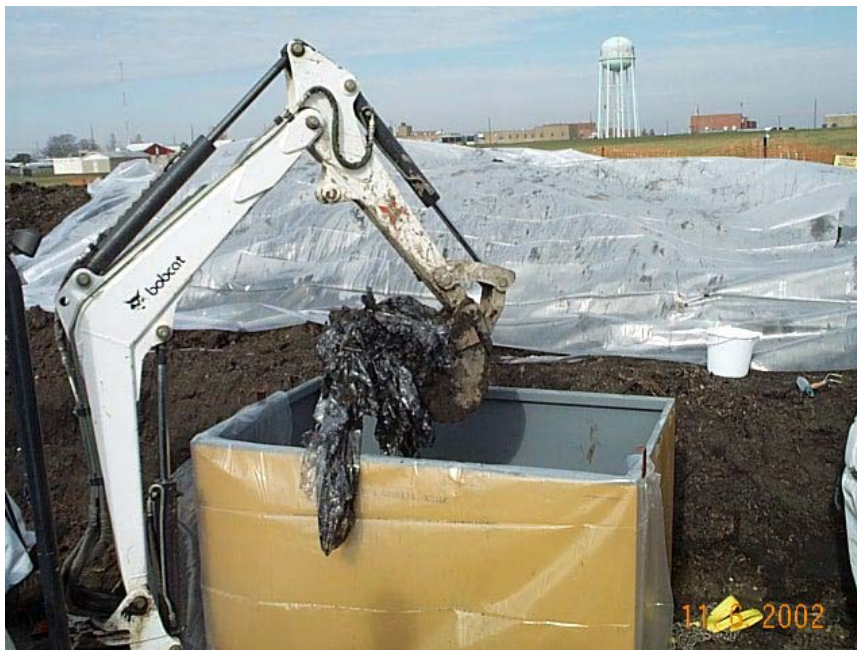
mobilized to expedite the removal and packaging of the mixed wastes. The B-25 boxes had industry standard dimensions of 6-ft long by 4-ft wide by 4-ft tall with a net weight capacity of approximately 6000 pounds. The use of B-25s was advantageous to the Site 1 remediation project as it allowed waste loading to proceed at a much faster pace (each B-25 will hold an equivalent volume of (10) 55-gallon drums).

Figure 3-7: Loading of excavated wastes into B-25 box.

The waste from Pits 9 through 16 was loaded into B-25 boxes. Loading and handling of the B25s was done in much the same way as the drums. The mini-excavator removed wastes from the pits and directly loaded them into the boxes. This process is shown in Figure 3-7. Each box was incrementally weighed using the large excavator, equipped with a 10,000-pound (lb) digital scale to avoid potential overfilling. It was observed that the boxes could only be filled to approximately 75% of their total volume before reaching weight capacity. Once the box was satisfactorily filled and weighed, the top was attached and the box was labeled and staged in the southwest corner of the CZ.

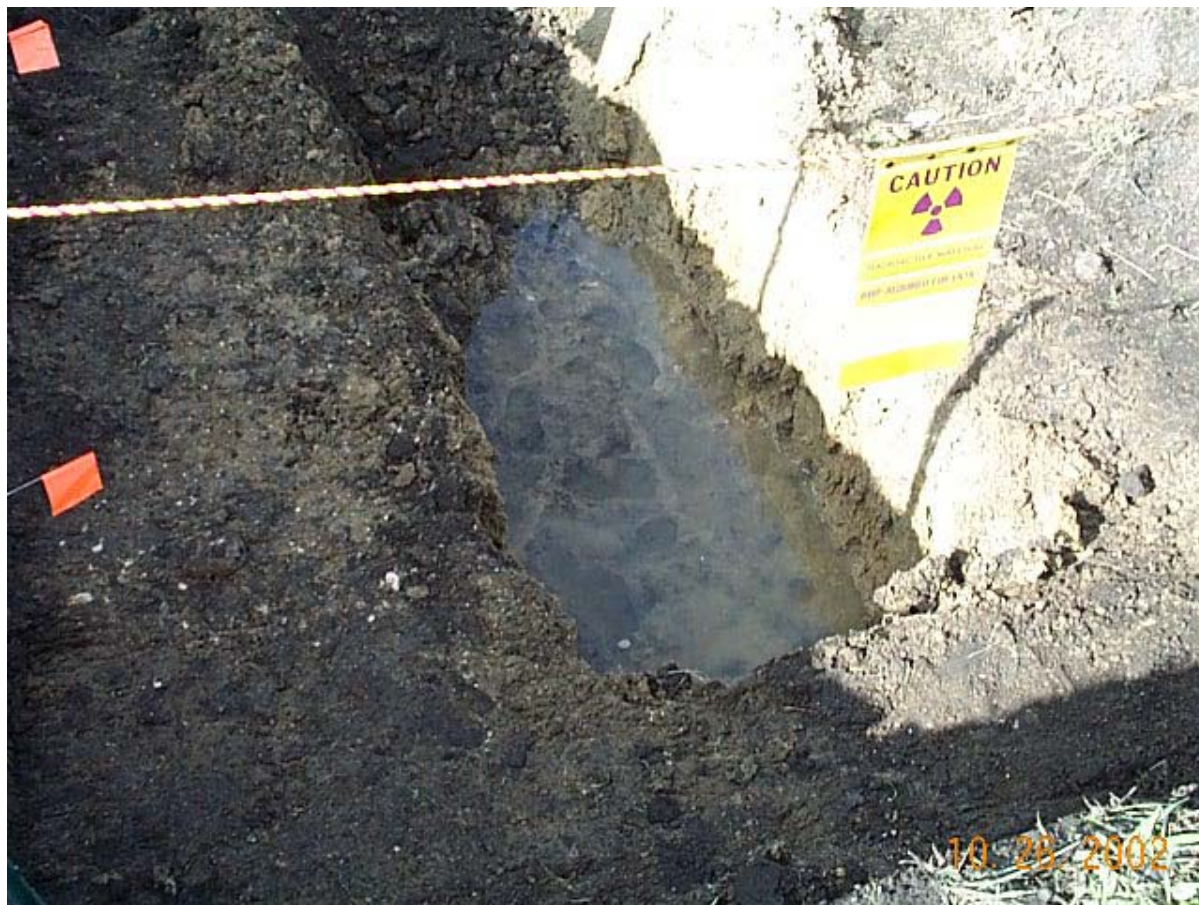
Based on historical groundwater monitoring data from nearby wells, and observations recorded during the 1989 remediation of Pit 1, it was not anticipated that groundwater would be encountered during pit remediation. This however, was not the case. Once excavation activities proceeded beyond 6 ft bgs, groundwater infiltration was readily observed through the surrounding clay into the pit. The level of the groundwater table encountered during the excavation was consistently observed at a depth of 6 ft. The recharge rates were relatively slow due to the dense nature of the clays, so the remediation crew generally had 30-45 minutes to remove and containerize the excavated bags and vials until standing water was

again observed on the pit floor. Figure 3-8 is a photograph of the typical standing groundwater level seen once waste materials were removed from the pits.

Figure 3-8: View of standing groundwater level in finished pit

The presence of groundwater at shallow depths had a profound impact on the remediation activities. All standing water was pumped from the excavation to a holding tank, with any residual water solidified using SP-400 polymer absorbent. The use of polymer absorbent had the added effect of trapping any loose vials and other debris from the pit floor for easier removal.

Once all loose materials had been removed, groundwater was allowed to recharge into the pits until the buffer soils were to be removed. At this time, all standing water was pumped to the holding tank such that buffer soils could be removed without having to add a significant amount of SP-400. Approximately 1000 gallons of groundwater was pumped to the holding tank during the remediation.

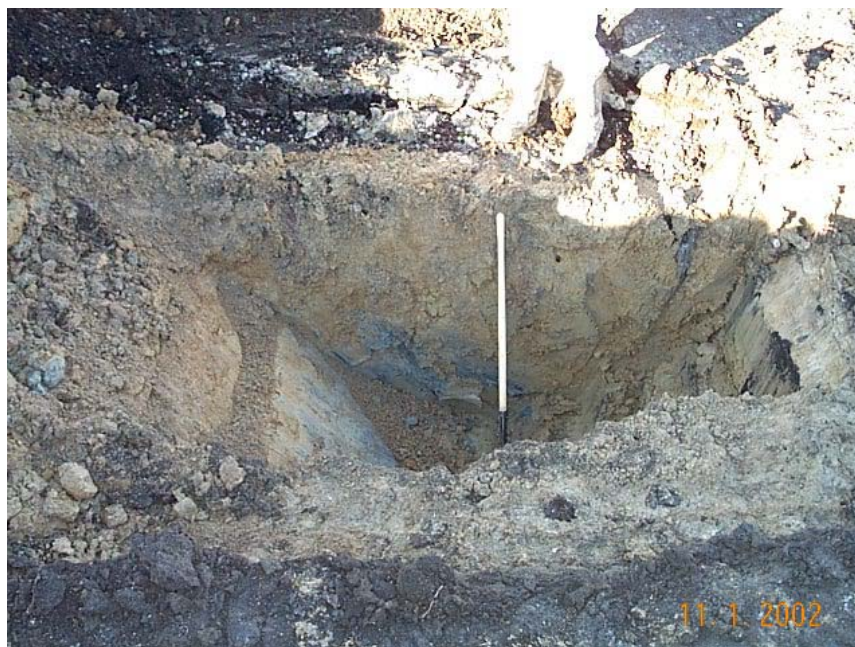
The WP prescribed removal of approximately one foot of surrounding soil from all sides of each pit once all waste materials had been removed. During remediation of the first few pits (i.e. Pits 1-5), buffer soil removal immediately followed the mixed waste removal. This procedure allowed for prompt sampling of the excavated pits prior to moving on to the next burial. However, this procedure was abandoned after Pit 5 due to discoloration of soil observed beyond one foot on the northern face of the excavation (see Figure 3-9). Additional soils were removed from the north wall and floor until the remaining soils appeared normal in color. This over-excavation was done as a conservative measure to ensure that remaining soils would be below cleanup criteria. Due to the increased volume removed from Pit 5, all buffer soil removal was suspended until all of the burial pits were remediated in order to better manage the overall waste volumes.

Figure 3-9: Pit 5 post-buffer soil removal. Discolored soil on north wall is seen to the left of shovel handle.

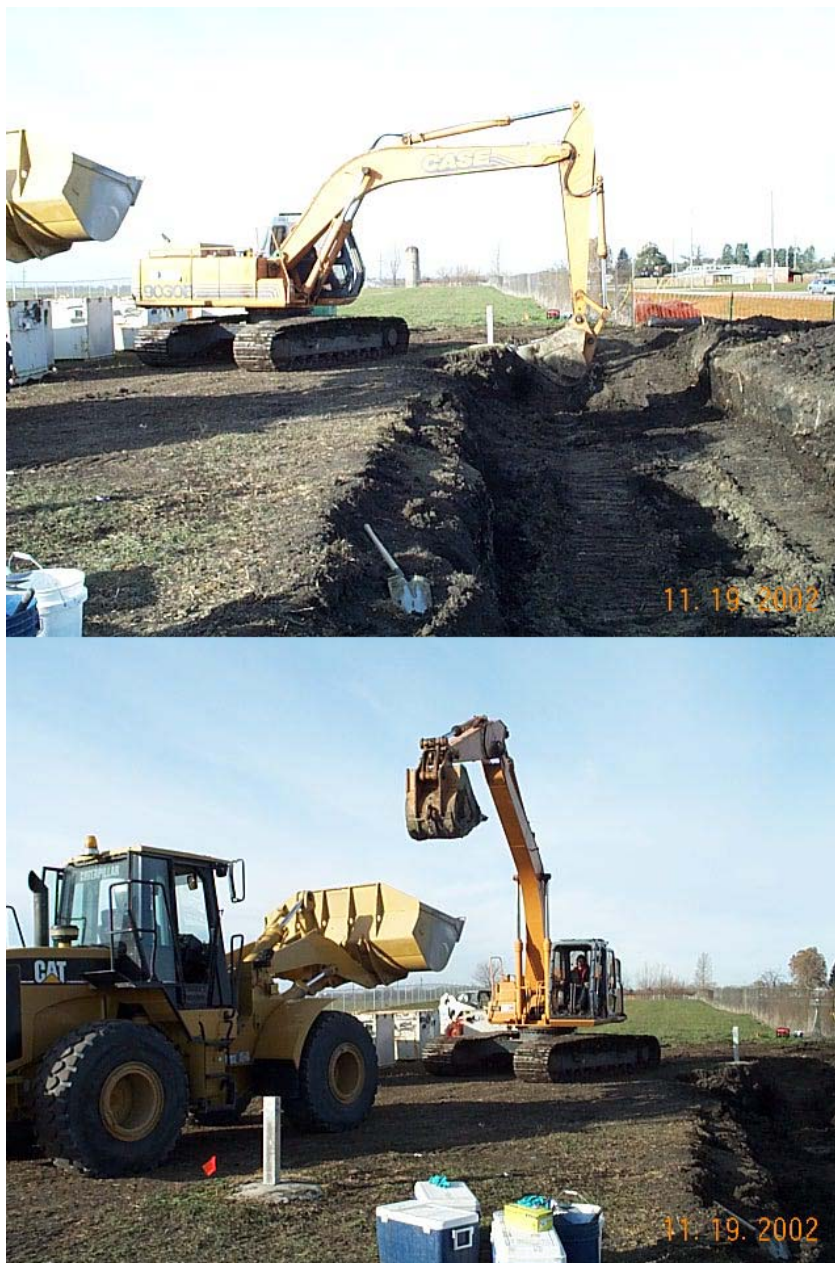
Figure 3-10: Buffer Soil Removal Process

Buffer soil removal began again on November 15, 2002, starting at the western edge of Site 1 and working to the east. In addition to the soils within the pits, a thin layer of soil from the benched portions of the trench was also removed to account for any residual wastes that may have fallen or splashed during loading and packaging prior to beginning the FSS. Since removal of the buffer soils was being performed last, the excavator had to be located within the trench. This placement limited the reach of the bucket, precluding direct loading into the 25-yd³ hard-top roll-off dumpsters called 'intermodal containers.' Therefore, a 4 cubic-yard (yd³) capacity payloader was brought in to serve as a transport vehicle between the excavator and the intermodals. Figure 3-10 shows this process in action. Approximately 72 yd³ of buffer soils were removed during the Site 1 remediation project.

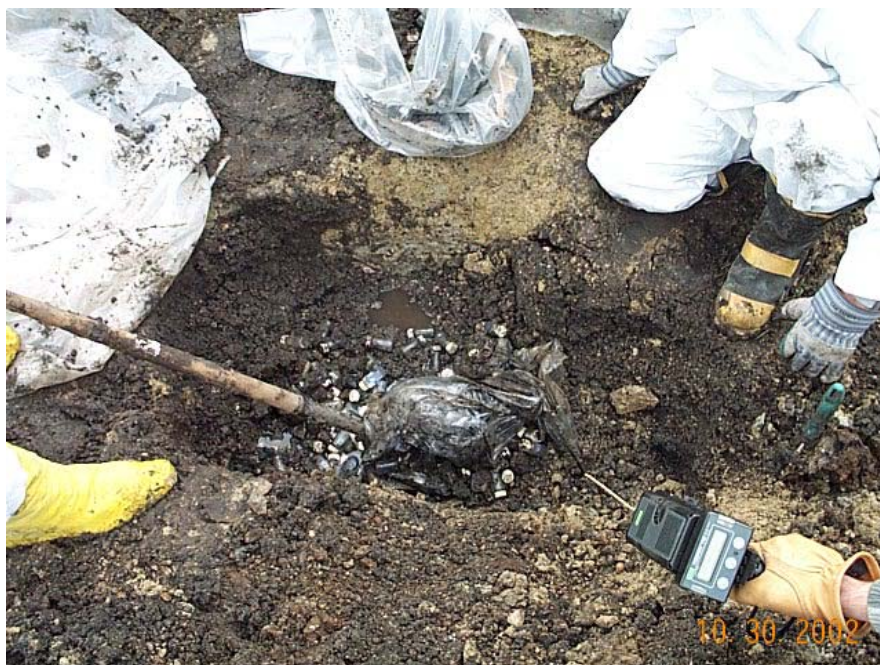
During remediation of Pit 2, VOC measurements taken in close proximity to waste material were observed to be greater than or equal to 1 part per million (ppm) using the photoionization detector (PID). A typical field scan during remediation is shown in Figure 3-11.

Figure 3-11: Use of a Photoionization Detector (PID) During Waste Removal

This data, in conjunction with the guidance in Table 8-1 of the SSHP triggered an upgrade in personnel protective equipment (PPE) level to a modified Level C, requiring the use of half-face air purifying respirators with combination cartridges whenever PID measurements exceeded stated action levels. Respirators were typically worn only during direct excavation and packaging of waste materials. It should be noted that this upgrade was conservative, as all PID measurements taken within the breathing zone of the workers were below stated action limits.

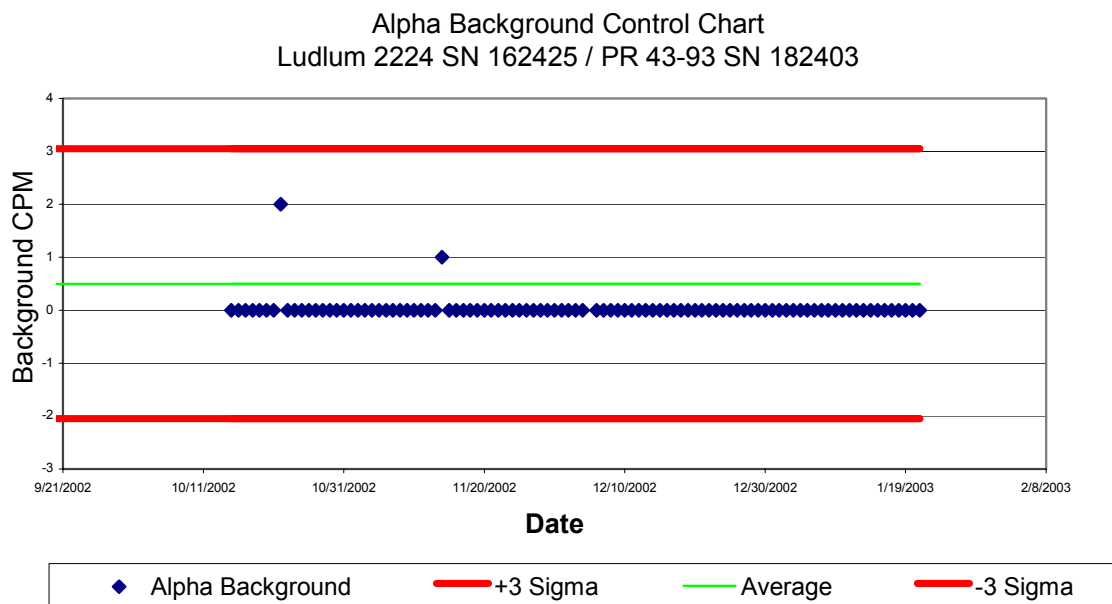
Administration of QC for the Ludlum 2929 was handled in the following manner. Each daily background and source measurement was recorded and the resulting counts plotted on the control chart. The 2σ and 3σ tolerance bands on each control chart were determined from repeated baseline measurements taken at the beginning of the survey effort. If any point was found to reside outside of 2σ , the instrument could still be used provided that the condition did not occur on two consecutive days. The policy is supported by the statistical fact that 2 failures are expected per every 100 measurements at the 95% confidence level ($\pm 1.96\sigma$). However, if any single QC measurement was found to be outside of $\pm 3\sigma$, the situation was instantly investigated. Control charts for each instrument are shown in Figures E-1 through E-8.

Figure E-1: Alpha background control chart for Ludlum model 2929

Figure E- 2: Beta background control chart for Ludlum model 2929

Figure E- 3: Tc-99 beta source control chart for Ludlum model 2929

Figure E- 4: Th-230 alpha source control chart for Ludlum model 2929

Figure E- 5: Alpha background control chart for Ludlum model 2224

Figure E- 6: Beta background control chart for Ludlum model 2224

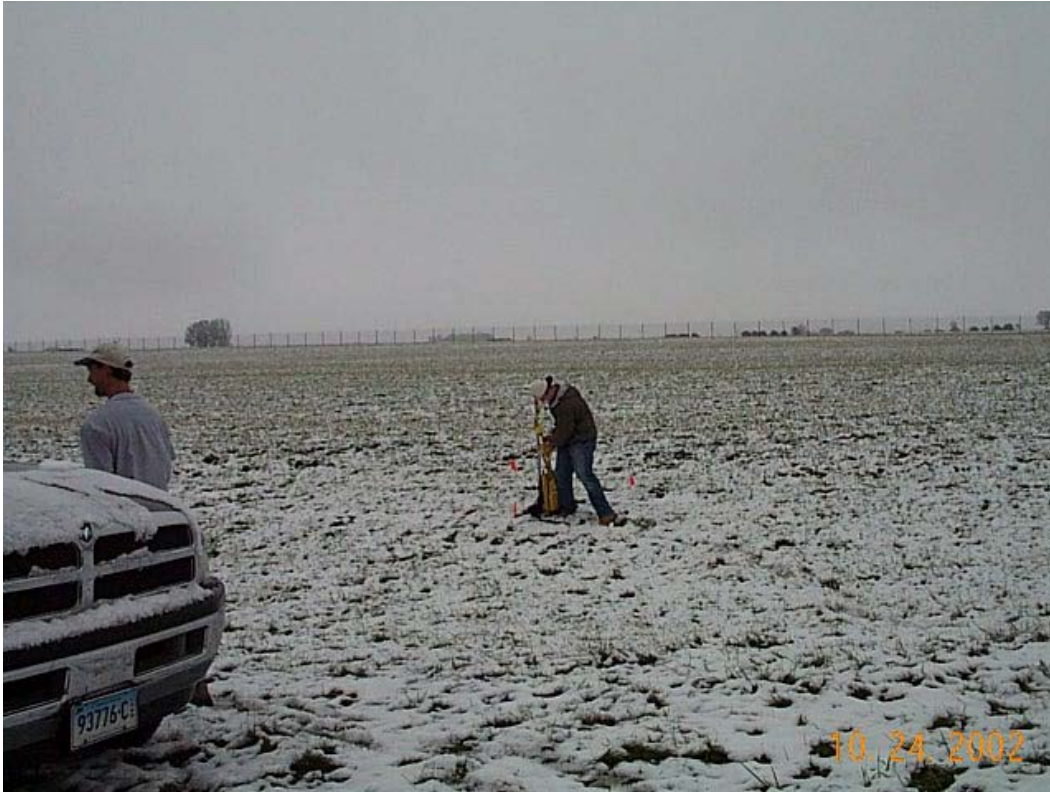
Figure 1: GPS QC location

The GPS unit used at Site 1 was checked daily for positional accuracy. A static count was taken at a common location for a minimum of 60 seconds every morning prior to the start of work. The QC location was located to the east of the field trailer outside of any line of sight obstructions (shown in the Figure 1 below).
