VERIFICATION AND ENHANCEMENT OF BEDROCK GEOLOGIC MAPS FOR YUCCA
MOUNTAIN, NEVADA

Edited by Warren C. Day and Cynthia D.M. Corbett

United States Geological Survey
Administrative Report

Denver, Colorado
1995

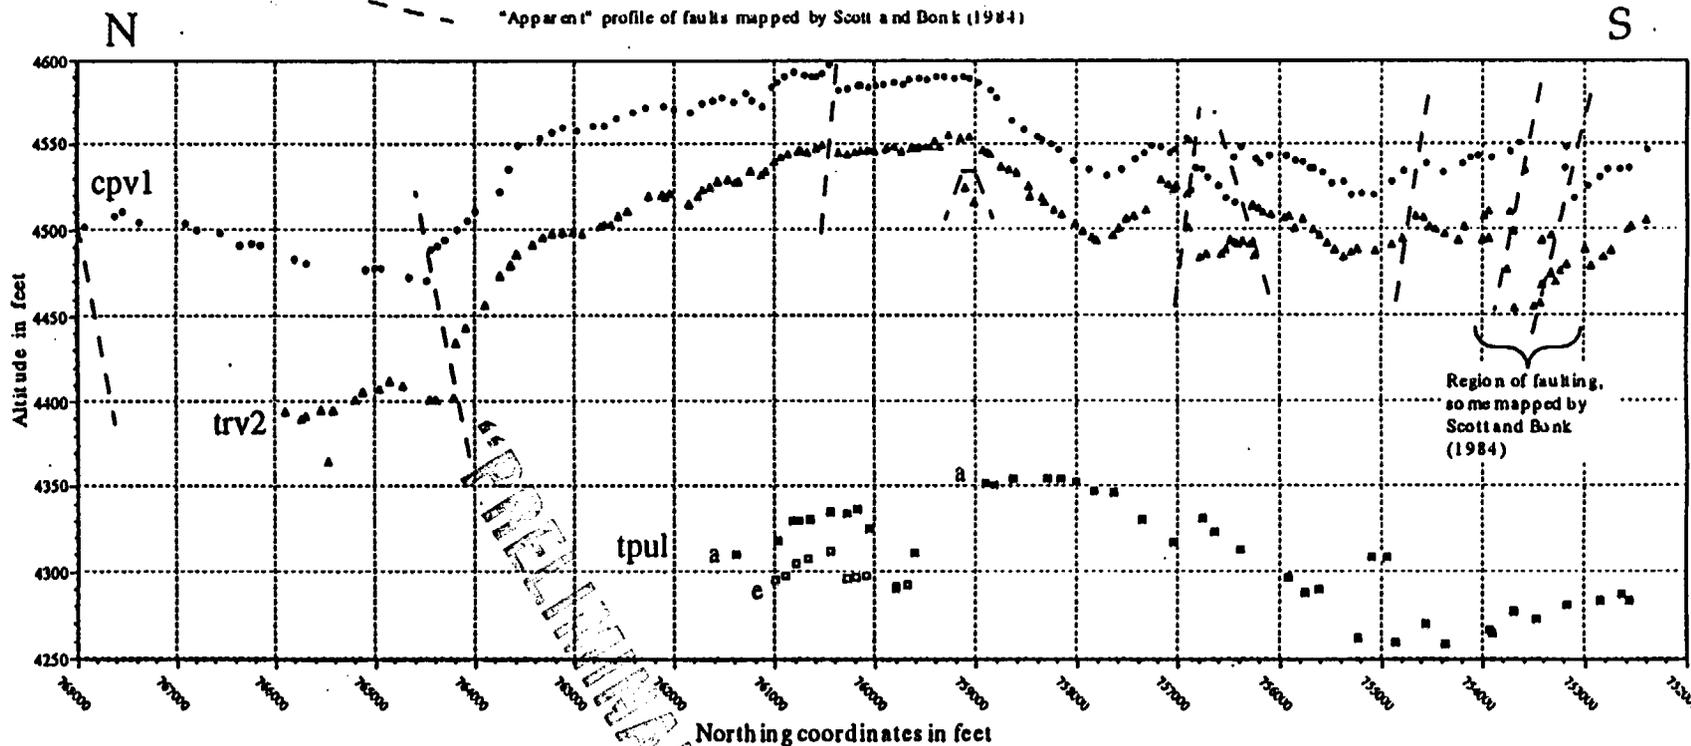
Figure 1. North-South profile of survey and altitude data for three lithostratigraphic contacts on west flank of Yucca Mountain.

There are a total of 353 stations on survey lines along the three lithostratigraphic contacts. Stations along the contacts are located (1) in drainages where contacts are typically better exposed than on interfluves, (2) at locations of measured sections, reference locations for strip maps of the fracture studies in the PTn, and sample transects of boreholes for hydrologic properties, and (3) approximately every 50 to 200 ft along the base of Tpcpv1 and Tptr2, and 75 to 100 ft along the base of Tptpul.
