## 9.0 GLOBAL SFMT POSTTEST ANALYSIS

### 9.1 The Structural Failure Mode Test and SFMT Analysis Objectives

### 9.2 Posttest SFMT Global Model

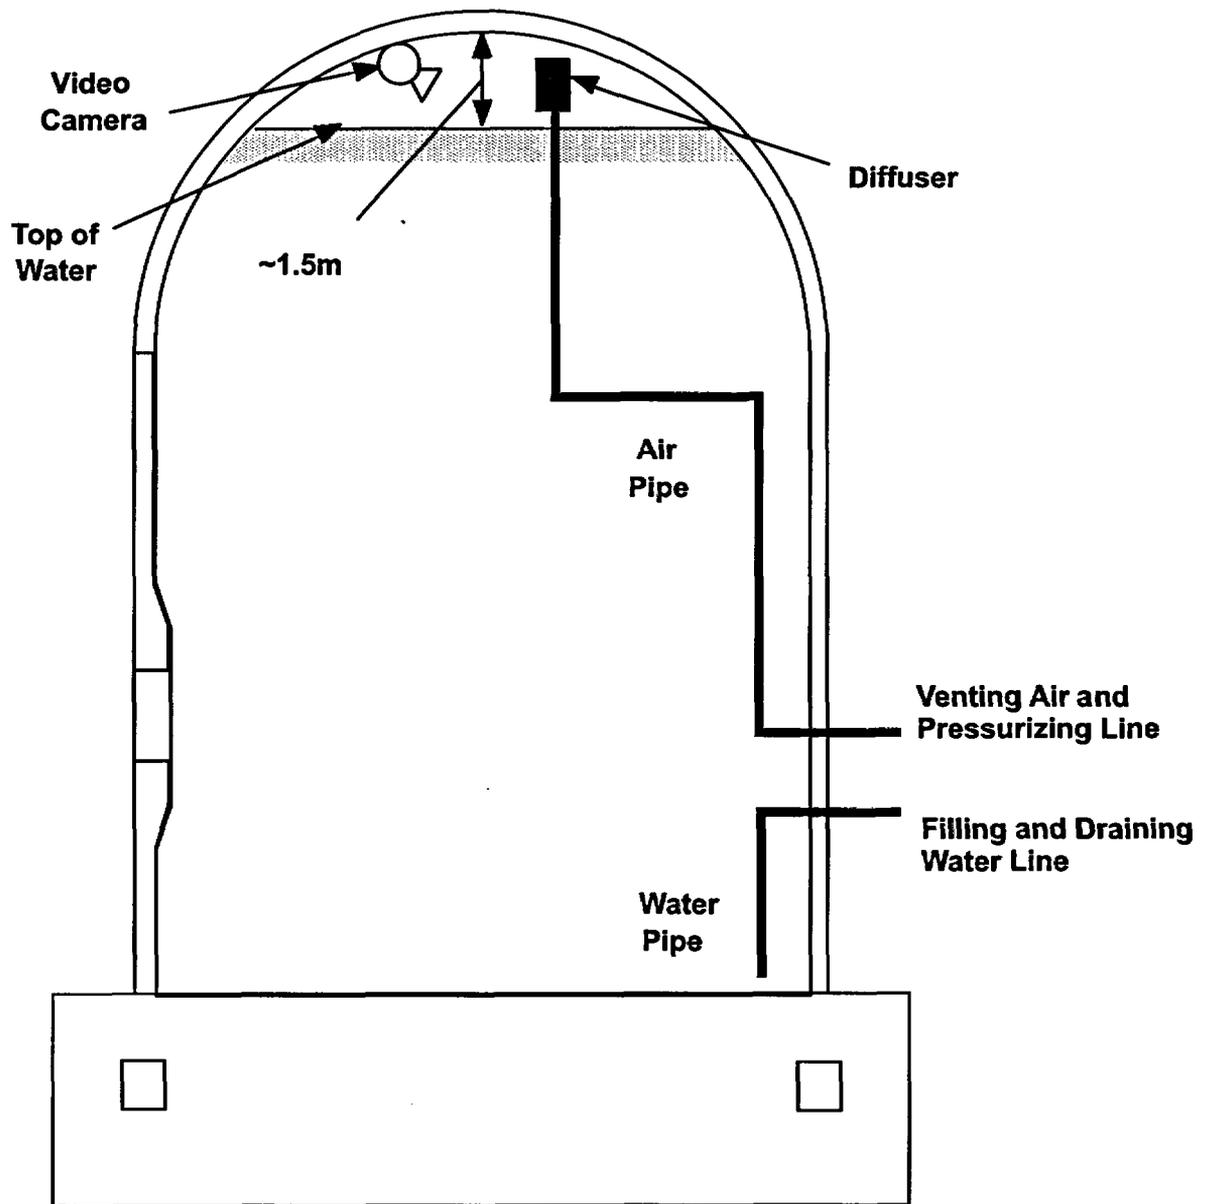
Figure 9-1. PCCV SFMT Pressurization Configuration

The work described in this report provided detailed documentation of comparisons of the pretest analyses to the test measurements, made adjustments to analytical models for measured material properties or material conditions, and explained and quantified behaviors and failure modes observed in the test. The overall goal of documenting analysis improvements and lessons learned, however, was limited to the context of what was learned from the LST; namely, that associated with PCCV pressure response out to global hoop strains was only about 0.5%, and liner tearing failure modes may have occurred prematurely due to welding irregularities. To obtain further information from the PCCV model, a SFMT was conducted in November 2001. In this test, the existing steel liner was relined with a heavy plastic liner and the testing medium was changed to hydrostatic, driven by nitrogen, which was pumped into a much smaller gas volume, as shown in Figure 9-1.

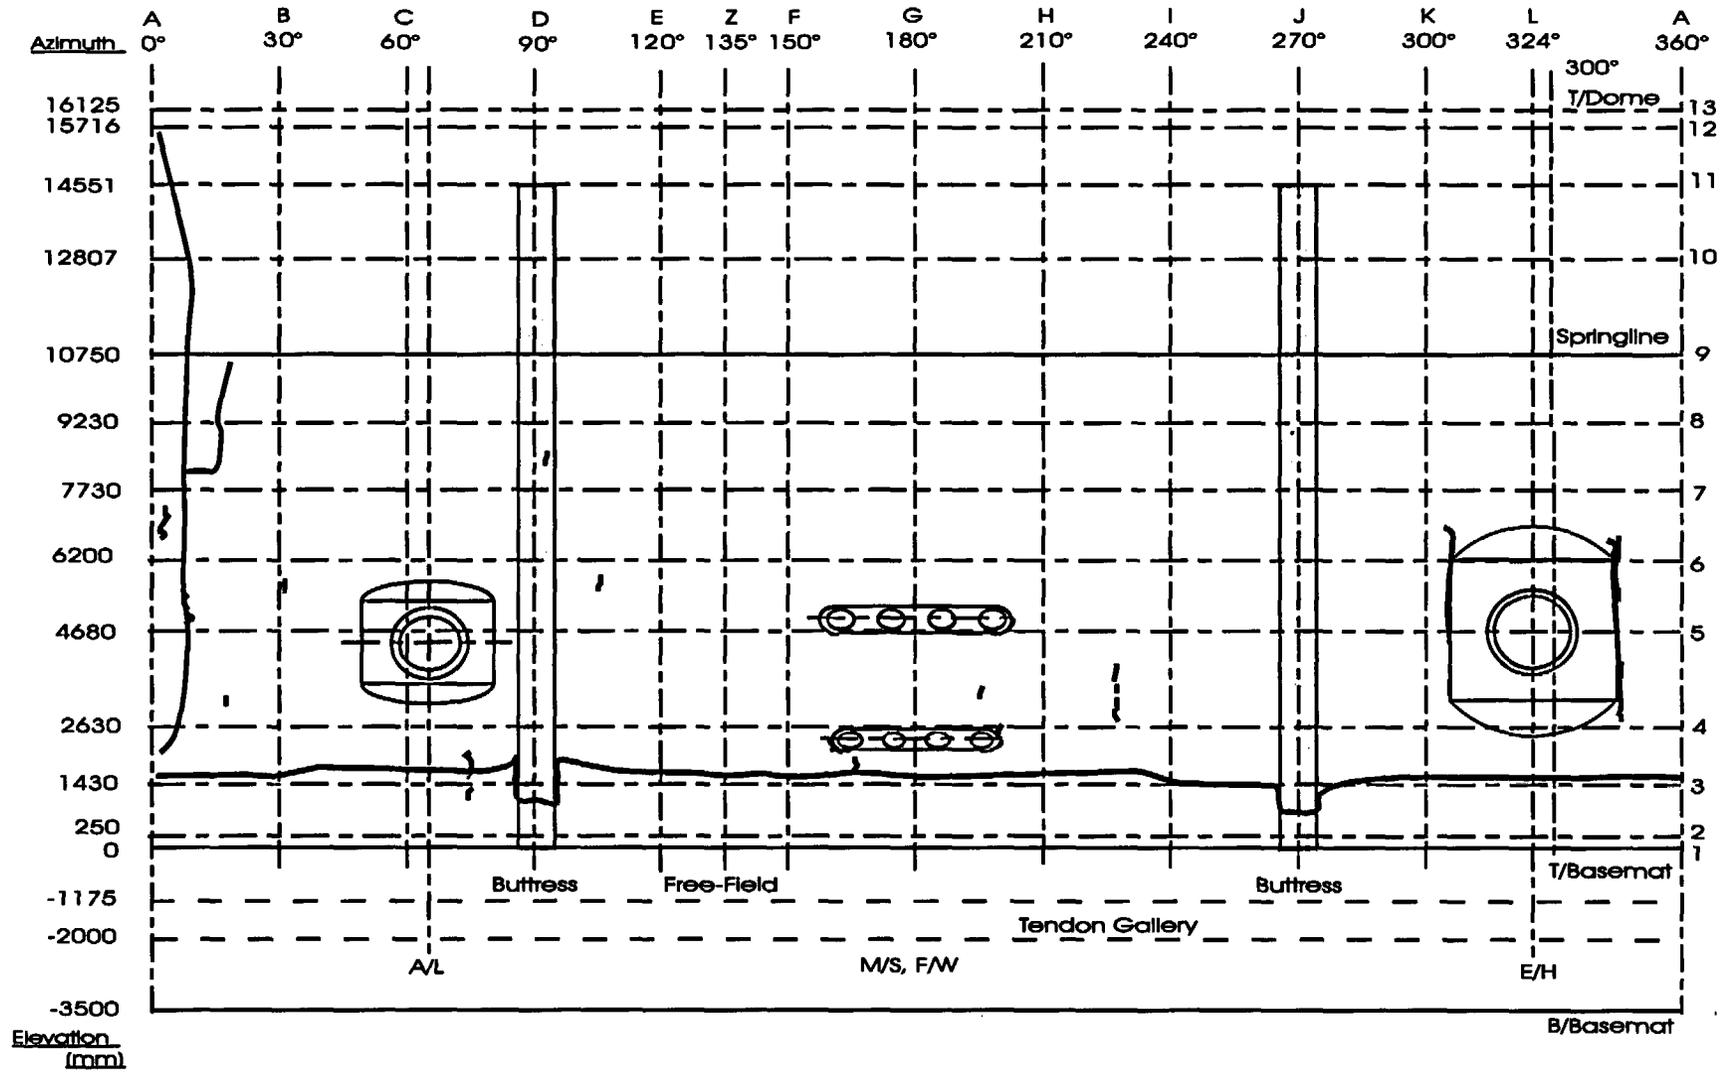
Figure 9-4. PCCV SFMT Rupture Map

The SFMT resulted in a completely different failure mode: a catastrophic burst of the vessel. Additional measurement data was obtained much further into the nonlinear response range of the structure than in the LST, i.e., up to global hoop strains of nearly 2%. The rapid failure mode that followed was also captured on video. Some still photos from this video are shown in Figures 9-2 and 9-3, and the rupture pattern that occurred is shown in Figure 9-4. SNL provided some posttest observations of the SFMT.

- Rupture initiated at approximately midheight of the cylinder near azimuth 6 degrees, then radiated vertically in both directions; a subsequent rupture line radiated circumferentially approximately 1.5 m above the top of the basemat.

It is clear from the video coverage of the test that the rupture occurred near cylinder midheight and near 6 degrees azimuth. The SFMT analysis model provides additional insight as to how this failure likely developed. Prior to  $P = 3$  Pd the 0 to 6 degrees azimuth location, elev. 5 m was behaving similarly to other azimuths away from penetrations. After 3.2 Pd, a few hot spots emerged around this elevation: a) edge of E/H wall embossment, b) edges of M/S penetration, and c) this  $\sim 0$  degree location. In each case, the cause of the hot spot appears to be the location's position relative to a stiffness discontinuity. In the case of the 0 degree location, the discontinuity is a step down in inner and outer hoop rebar area totaling 38% (step-down from alternating D19, D16 bars to a pattern of 1D16/3D13 bars). Then at 3.49 Pd, while the other locations also showed elevated strain, the wall and tendon strain at the 0 to 6 degree location was the highest, and a tendon ruptures. Once this occurs, the analysis shows the neighboring tendons rupturing and the deformations spread quickly at this azimuth. It is interesting to note that the analysis predicts the secondary tendon ruptures spread upward. Shortly after the first rupture at 5.4 m, analysis predicts the tendon ruptures to spread up through 6.5 m. From review of the test video, this appears to also agree with observations. By 3.65 Pd, the analysis shows rupture to have spread over a vertical line spanning up to 6 m. This also agrees with observations.

After wall rupture, a secondary event occurred in the SFMT; the through-wall failure around the circumference of the wall at about 1.5 m elevation. While it is difficult to say at what azimuth this failure initiated, it seems clear that this was a shear or combined shear/flexural failure of the wall. The plotting of analysis shear results (force and stress) in Figures 6-42 and 6-43 show that such failure may have initiated at the buttresses (evidenced by the high shear stresses predicted there) and then "unzipped." Upon reviewing the plans again, it can be noted that at elev. 1.60 m there is a step-down in vertical rebar from D19 to D16, which may have focused this shear failure plane. Moreover, at the buttresses, the outer vertical rebar step down occurs slightly lower: at 1.22 m there is a change from a total of 19D19 bars down to a total of 10D19 bars placed within the buttress. This may explain why the circumferential failure (see Figure 9-4) ran through the buttresses at a lower elevation than the rest of the wall. As a point of comparison, the shear failure threshold calculation performed in the pretest work [1] is compared to the demand (both pretest axisymmetric and posttest SFMT) in Figure 9-44. This figure shows that without the trigger of rupture of the vessel, the capacity (a modified compression

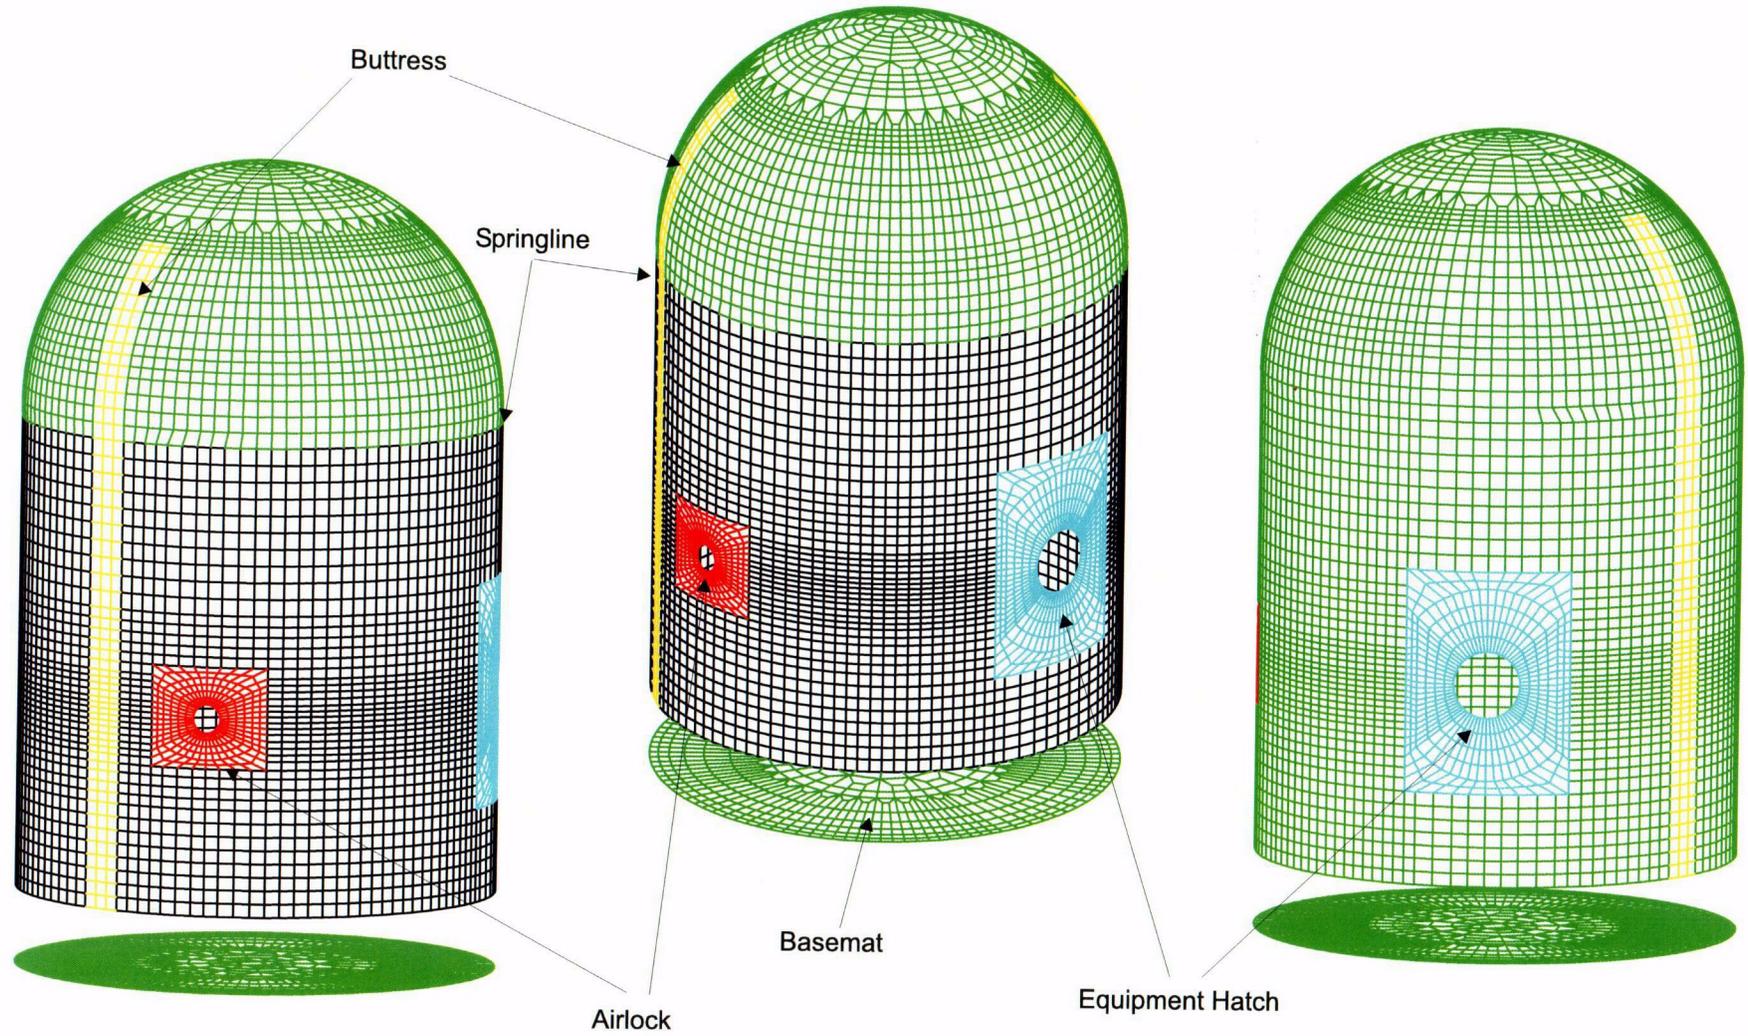
Figure 9-5. PCCV SFMT, 3D Global Shell Model

The SFMT posttest analysis model is a fully 3D model of the entire containment cylinder, dome, and basemat, which focuses on capturing the global behavior versus pressure up to the tendon rupture observed in the SFMT. The containment was modeled with shell elements, which required a bonded tendon assumption for the post-tensioned tendons and was simpler to model than the pretest 3DCM model. The ABAQUS general-purpose finite element program Version 5.8-18, along with the ANACAP-U concrete and steel constitutive modeling program, was used for the SFMT analysis, just as for the other posttest work.

A layered shell model was developed that included the liner and concrete as separate layers; rebar subelements were used to model the reinforcement and tendons. The E/H and A/L penetrations of the PCCV were explicitly modeled, with emphasis on their associated perturbations in rebar and tendon patterns and increased wall thickness. The M/S and

F/W penetrations were not modeled explicitly, since these penetrations cause negligible perturbation of the tendon pattern. However, the additional reinforcement associated with these penetrations and the thickening of the liner was included. The model consisted of 4-node composite (layered) shell elements. The inner layer simulated the 1.6 mm thick steel liner and the outer layer was given properties consistent with the concrete wall, including the differing thickness of the wall at the buttress, springline, dome, and E/H and A/L penetration regions. Both the liner and concrete layers were each assigned three integration points through the thickness. The basemat was also modeled with composite shell elements and rebar subelements, but the tendon gallery was not explicitly modeled. The horizontal plane of nodes making up the basemat was located at the geometric centerline of the region, approximately 180 cm (70 inches) below the base of the containment wall. The nodes at the base of the cylinder wall were tied to corresponding nodes in the horizontal plane of the basemat with multipoint constraint equations. The bottom of the basemat was modeled with nonlinear spring elements with an average spring constant of 150.5 kips per square inch in compression; the tensile/uplift stiffness was very small. The finite element mesh is shown in Figure 9-5.

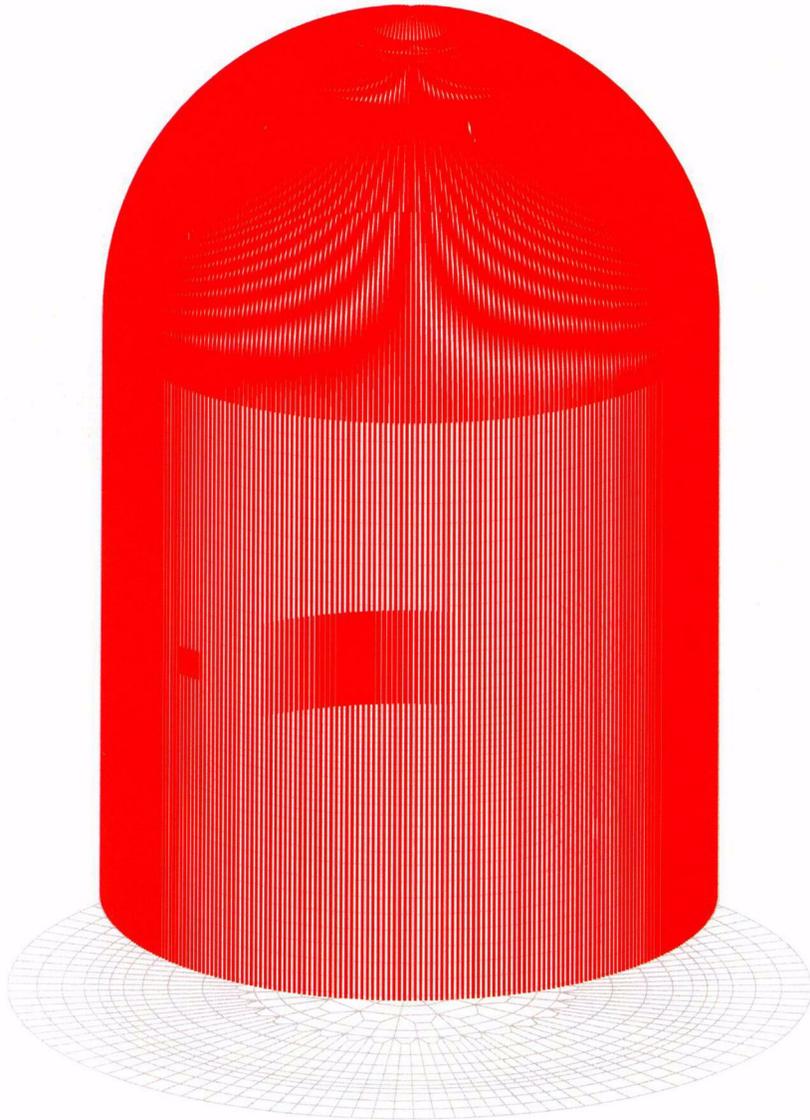
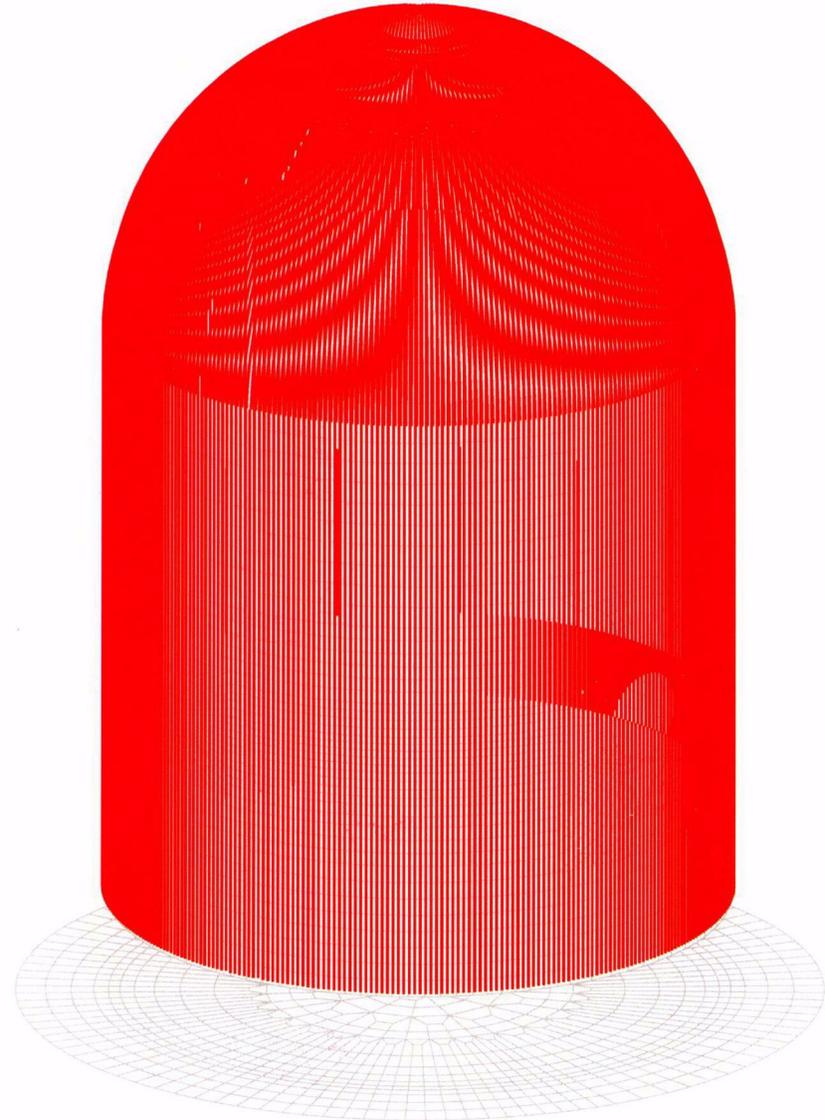
Figure 9-6. PCCV SFMT 3D Global Shell Model, Reinforcement Subelements  
Vertical Reinforcement in Cylinder and Dome

The reinforcement was modeled as subelements within the shell elements at the correct section depth. Figure 9-6 shows the inner and outer layers of vertical reinforcement in the cylinder and the dome regions. The two layers of hoop reinforcement are shown in Figure 9-7. The bonded post-tensioned tendons are also modeled as rebar subelements within the shell elements, as shown in Figure 9-8. The perturbation of the meridional and hoop tendons around the A/L is accurately simulated. In the local region of the E/H where the hoop tendons overlap through the thickness, they were combined in groups of two with the total properties of the pair located at the geometric centroid of the two tendons. The tendons were post-tensioned by applying an initial stress to the specific tendon subelements. To address the issue of tendon friction, which was studied in detail in the 3DCM analysis, two versions of tendon initial stress were analyzed: one with variable stress around the circumference, as a function of friction and setting losses, and the other uniform tendon prestress, set to the average value of tendon stress.

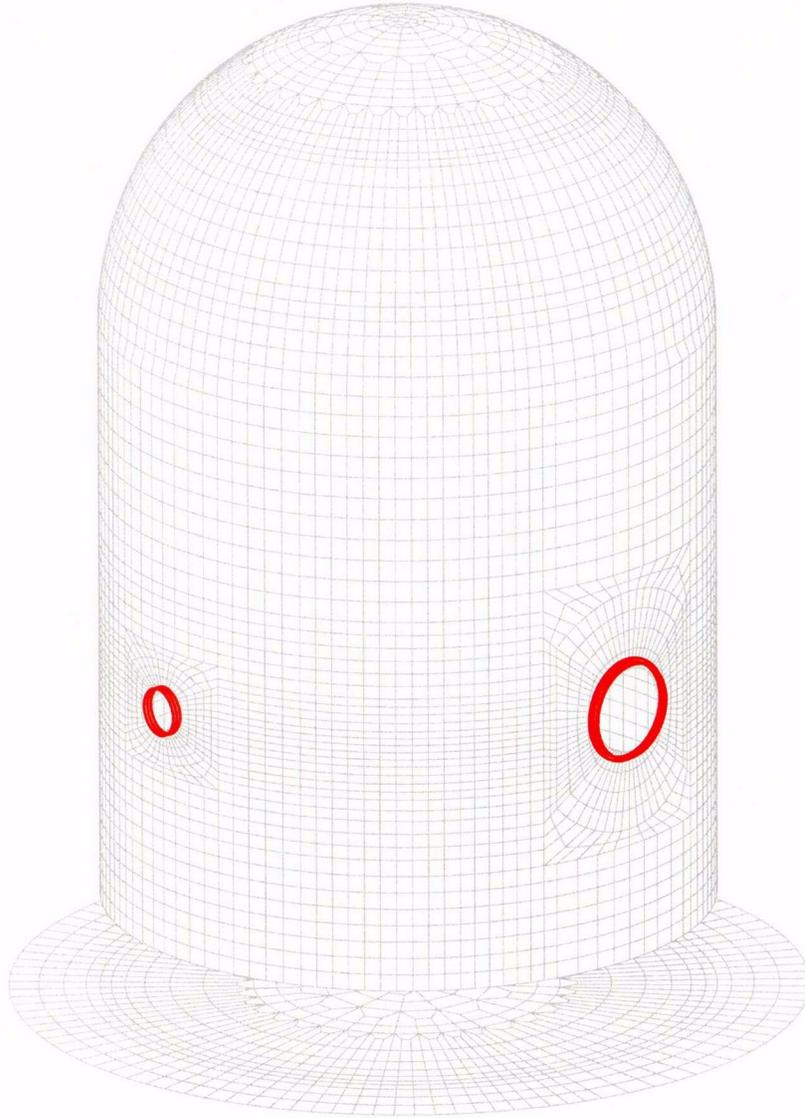
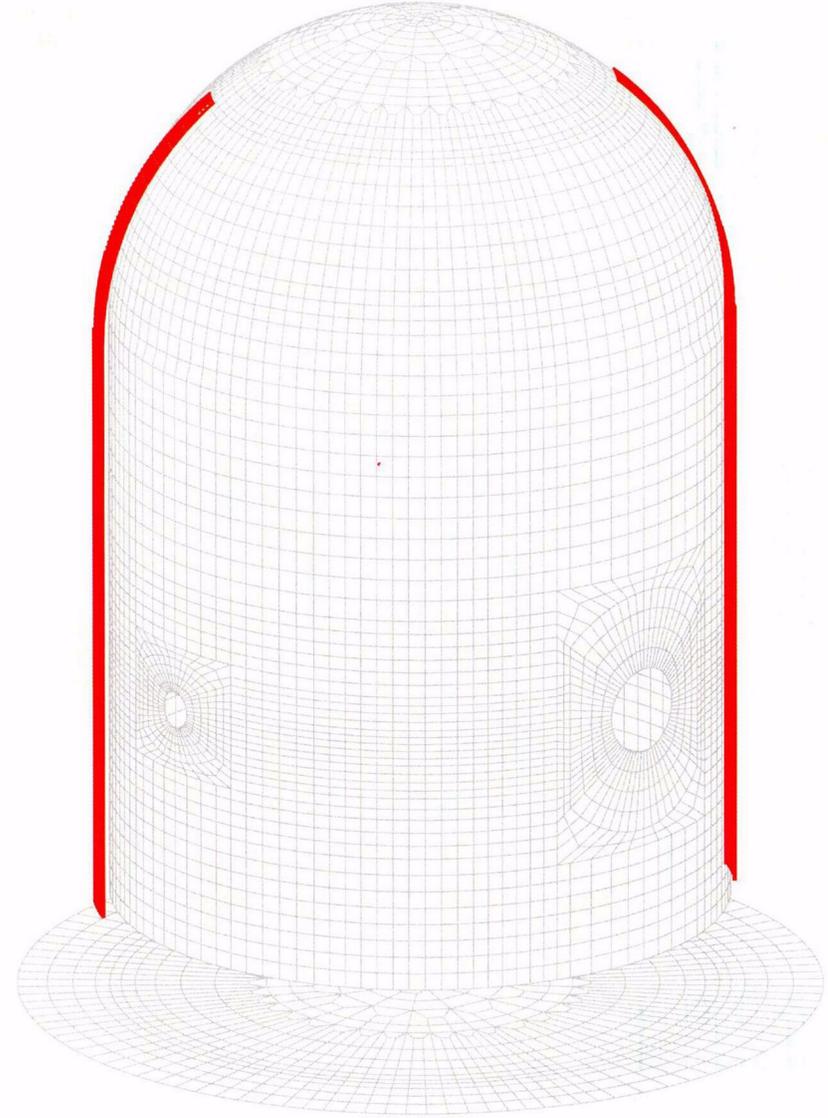
Figure 9-9. PCCV SFMT 3D Global Shell Model, Reinforcement Subelements  
Buttress and Local Penetration Reinforcement

Figure 9-9 shows additional local reinforcement in the buttresses at 90 and 270 degrees and the ring hoops at the E/H and A/L openings.

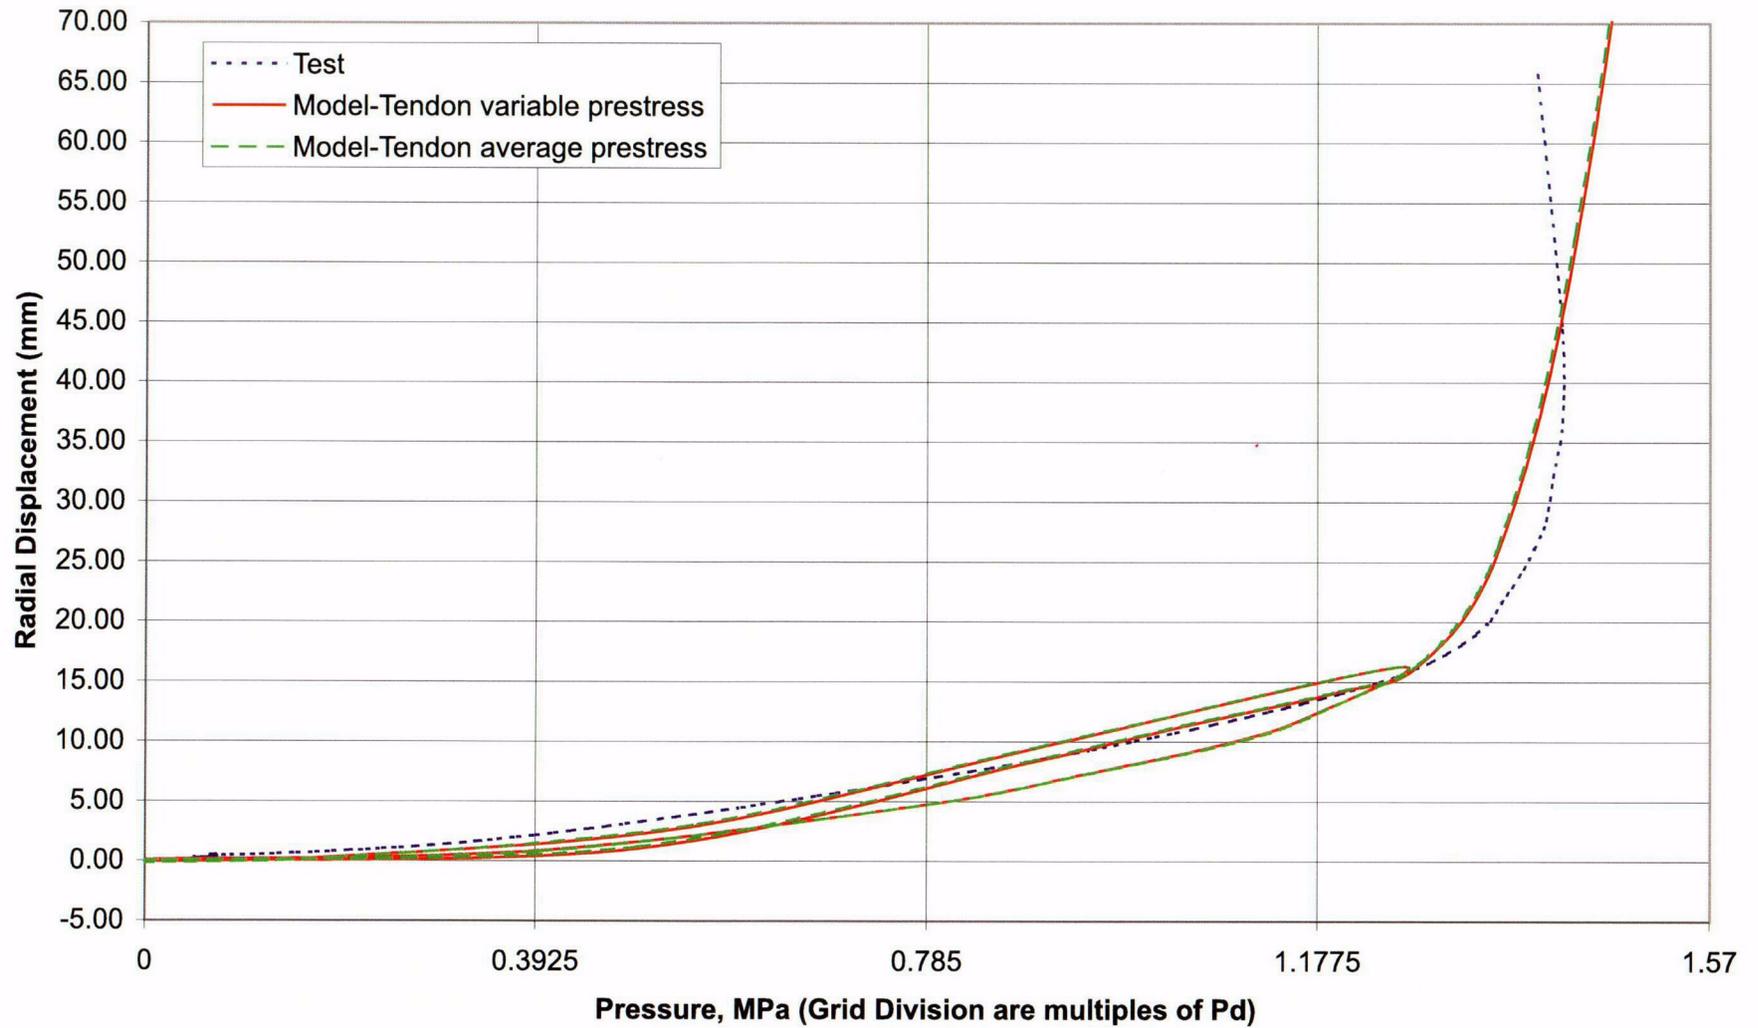
Figure 9-10. PCCV SFMT, 3D Global Shell Model - Gage R-Z4-05 Comparison  
Radial Displacement, 135 Degrees, Elevation 2.63 m

Displacement versus pressure histories at various locations are compared to the SFMT in Figures 9-10 through 9-15. The displacement data from the test is plotted along with posttest analysis data from the model with uniform average tendon stress, and from the analysis with variable tendon post-tensioning stresses. The displacements are plotted versus the total internal pressure, including the hydrostatic component. The average pressure is the gas pressure plus the hydrostatic pressure that exists near the midheight of the cylinder (i.e., at an elevation of approximately 5.0 m). Table 9-1 summarizes the figure number, gage location, azimuth, elevation, and displacement component used for these comparisons.

At azimuth 135 degrees, elevations 2.63 and 6.2 m, the pretest analysis results were also added to the plots.

The plots in this section generally show a good correlation between the analysis and the PCCV SFMT response. The displacement behavior predicts the actual displacement well (to within a few percent over most of the pressure response range), and the strain contour plots indicate that failure is predicted between 0 degrees azimuth and 6 degrees azimuth, which agrees well with observations from the SFMT. The pretest axisymmetric analysis also agrees well with the SFMT response, at least for midheight of cylinder radial displacement. It is interesting to note the effects of running LST pressurization first. The LST pressure response of the vessel shows a little larger stiffness (slope of displacement versus pressure curve) than the SFMT reload. The tendon behavior plots indicate that for the baseline analysis, the first tendons rupture at elevation 5.5 m at a pressure load of 3.51 Pd (1.381 MPa).
