# ***Thermal Creep of Dry-Cask- Stored PWR Cladding and High-Burnup PWR Cladding***

***Review of  
ANL Cladding Performance Program  
July 17, 2003***

***Argonne National Laboratory***

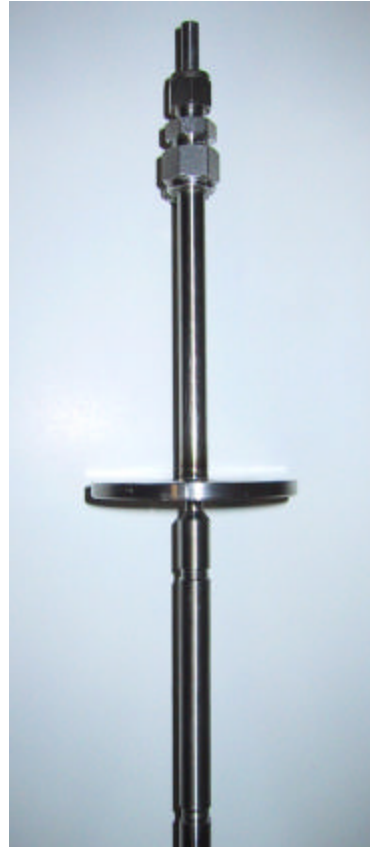
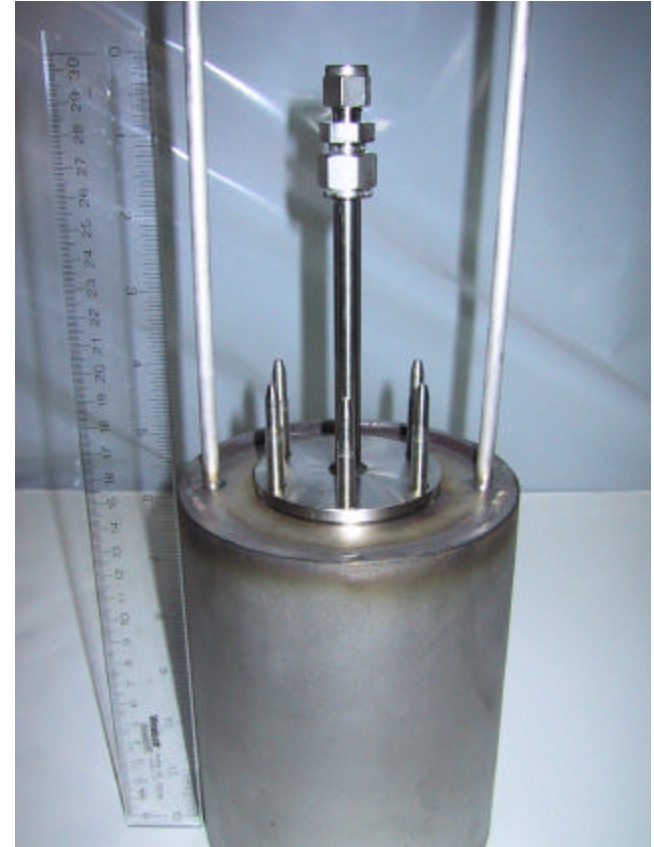
- Test Chamber
  - Inert-gas purged to preclude sample oxidation during test

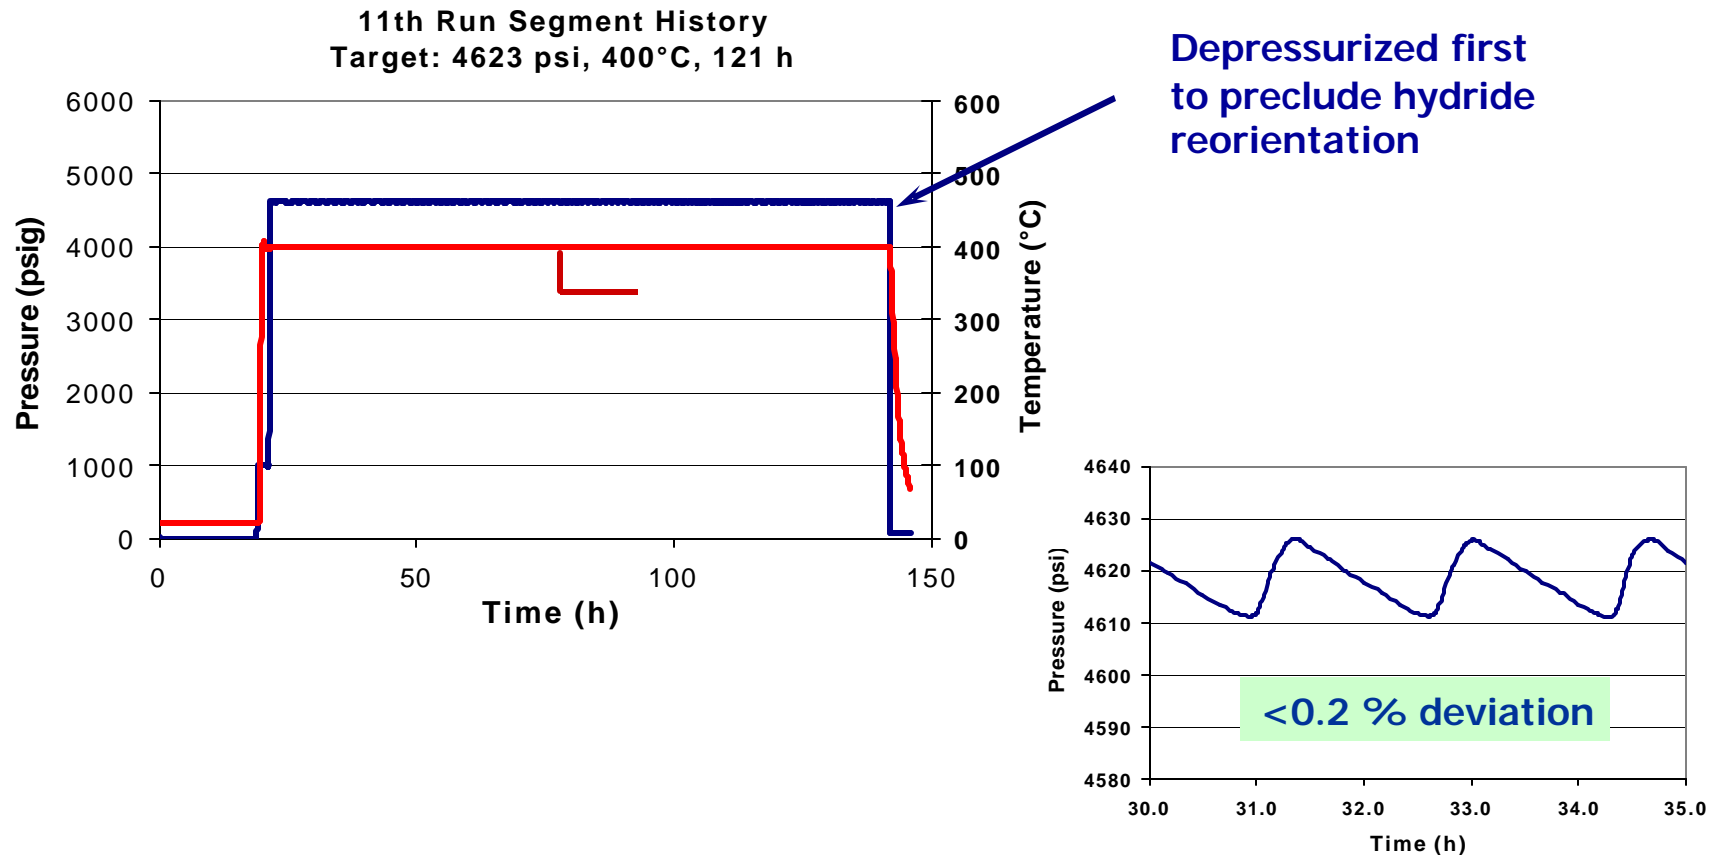
# Thermal Creep Tests – Typical Performance

- Good pressure and temperature control
- Periodic shutdowns for dimensional measurements

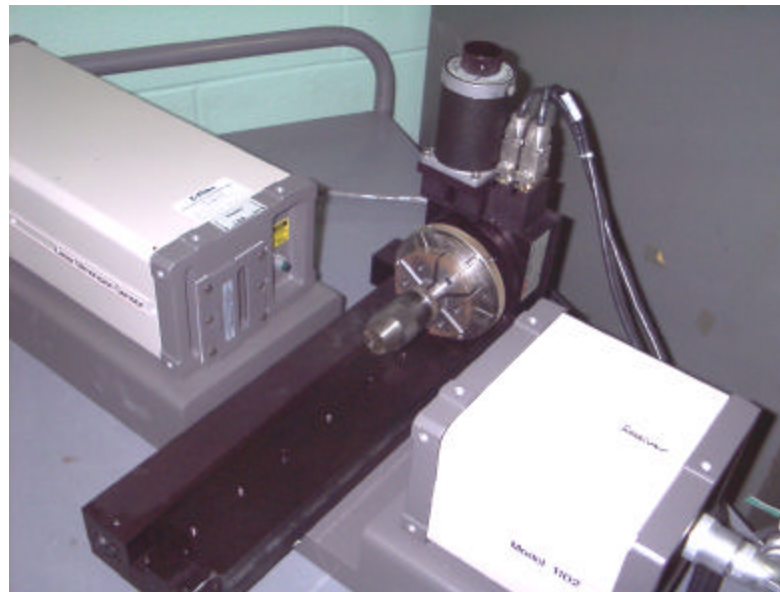
- **Laser Profilometry**

- Measurements made off-line at room temperature
- Diameters measured at multiple axial and azimuthal locations to within  $\pm 2 \times 10^{-5}$  in. (0.005% strain)
- Length measured to  $\pm 10^{-3}$  in. to evaluate creep anisotropy.

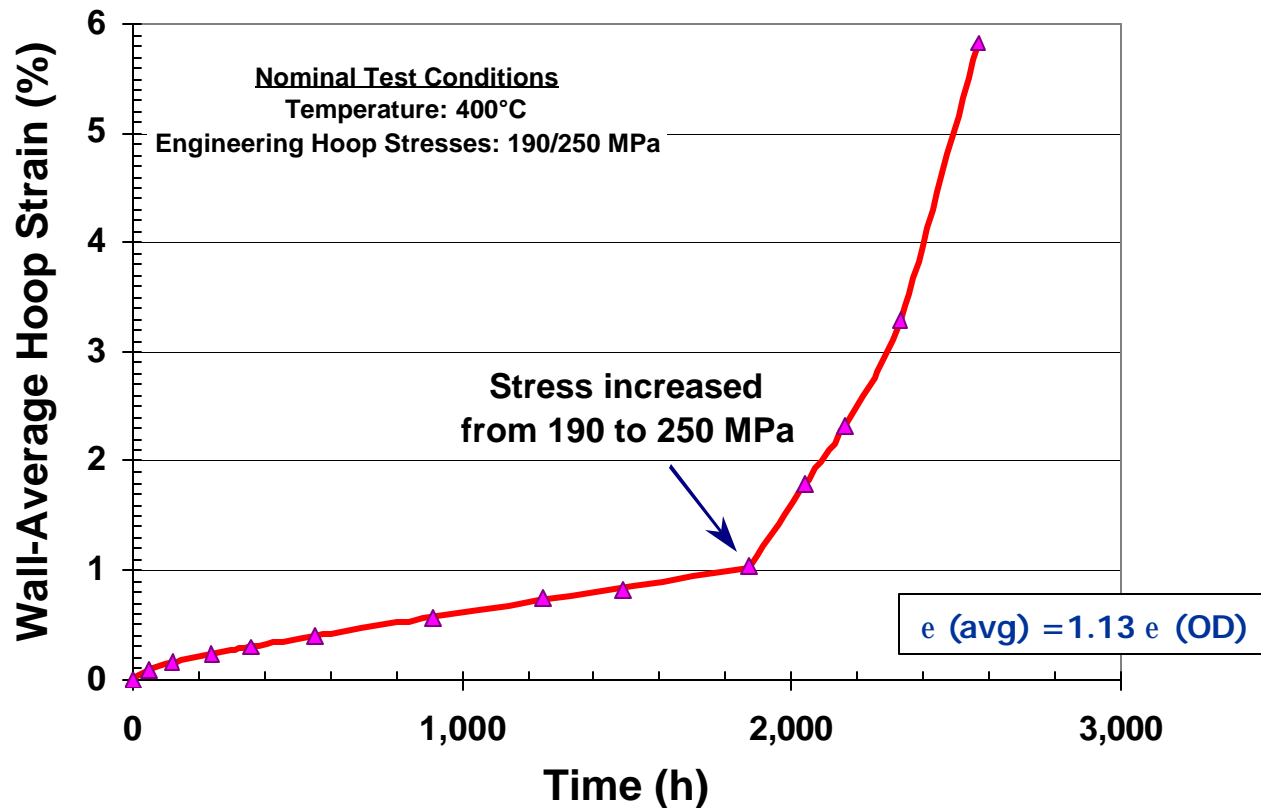
# Thermal Creep Tests – Surry C9

- 400°C, 190/250 MPa engineering hoop stress, 2566 h
- 5.8% average hoop strain, no rupture

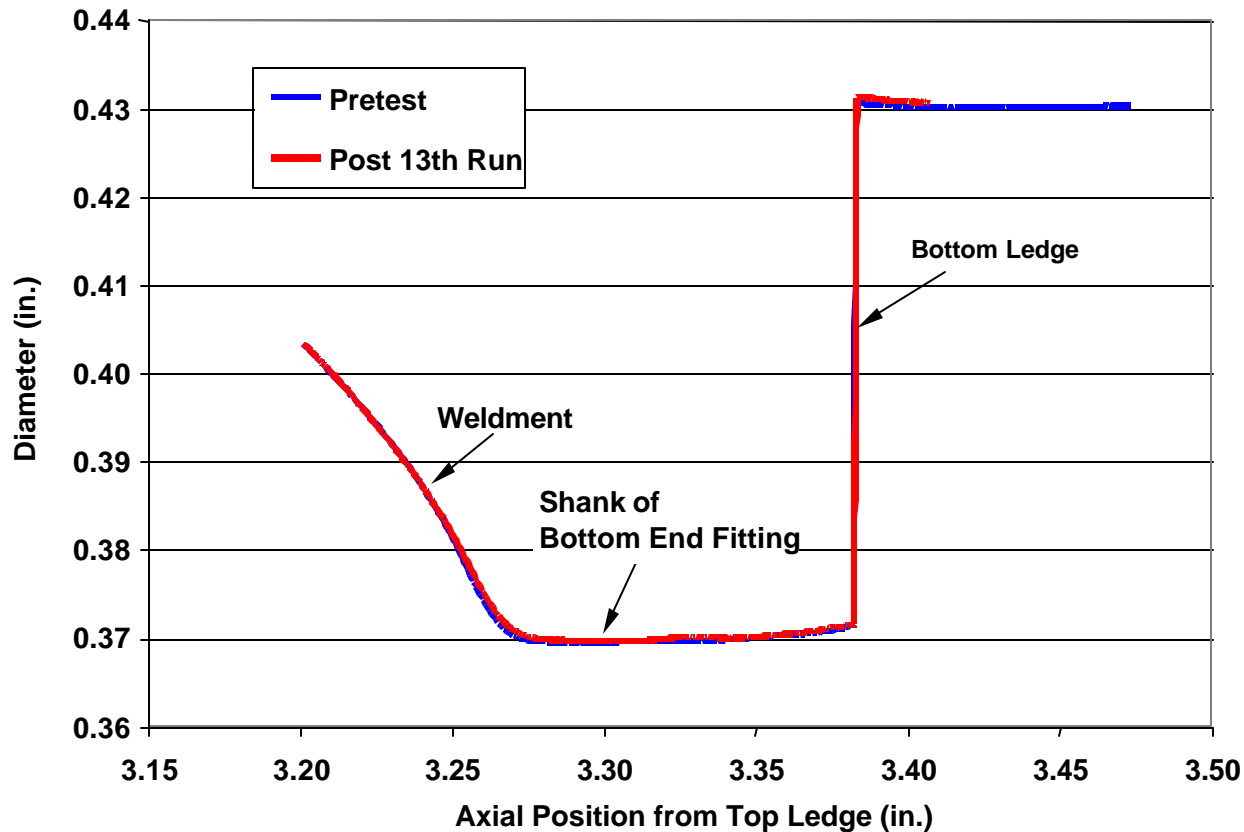
- No apparent creep anisotropy based on sample length measurements

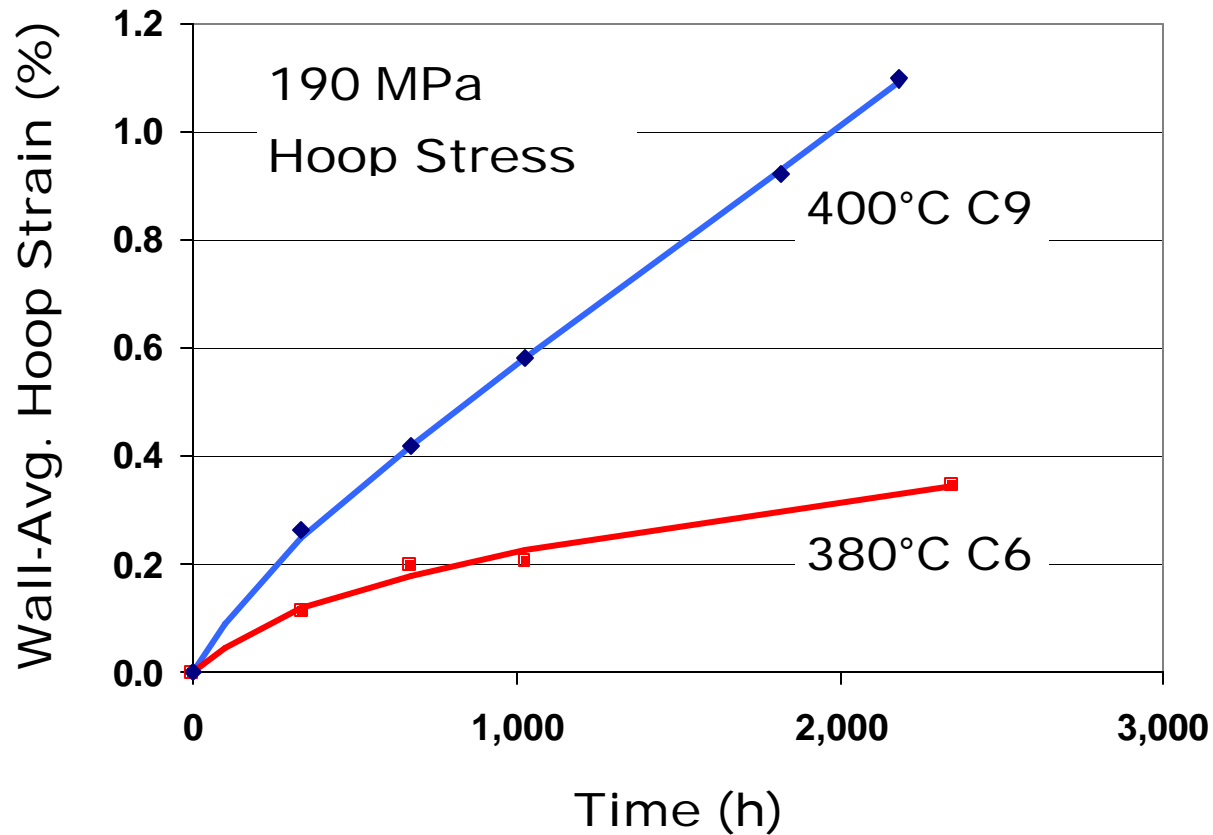
## - Temperature Dependency

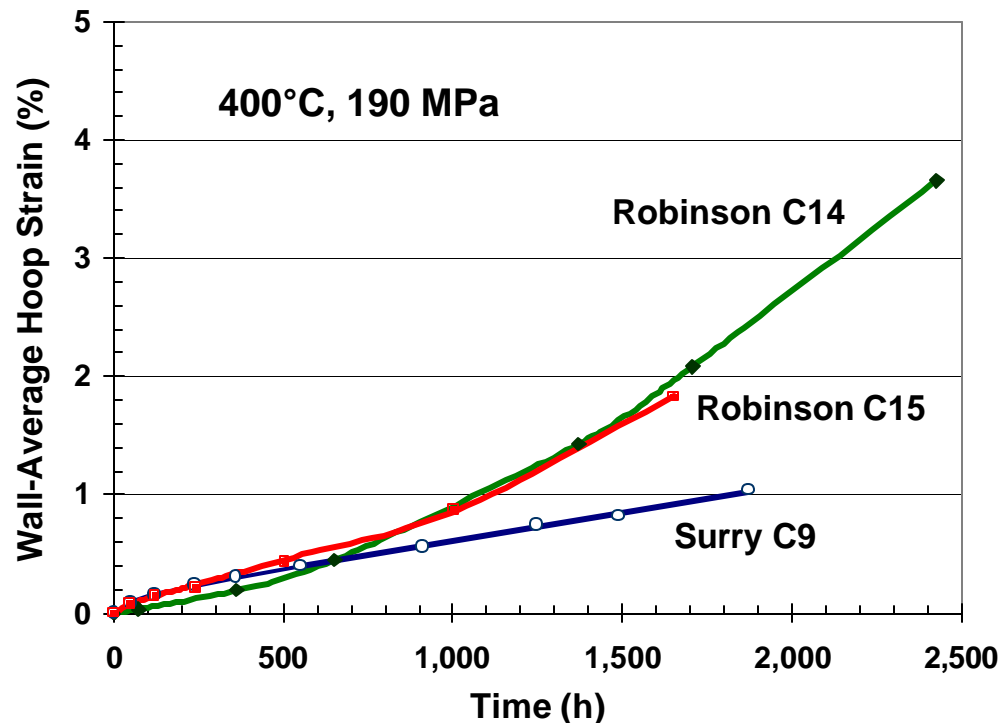
- At 400°C, secondary creep rate of H. B. Robinson appears to be comparable to that of Surry at the onset of test. Rate appears to be greater afterwards.
- C14 was terminated at 2450 h at 3.6% e.

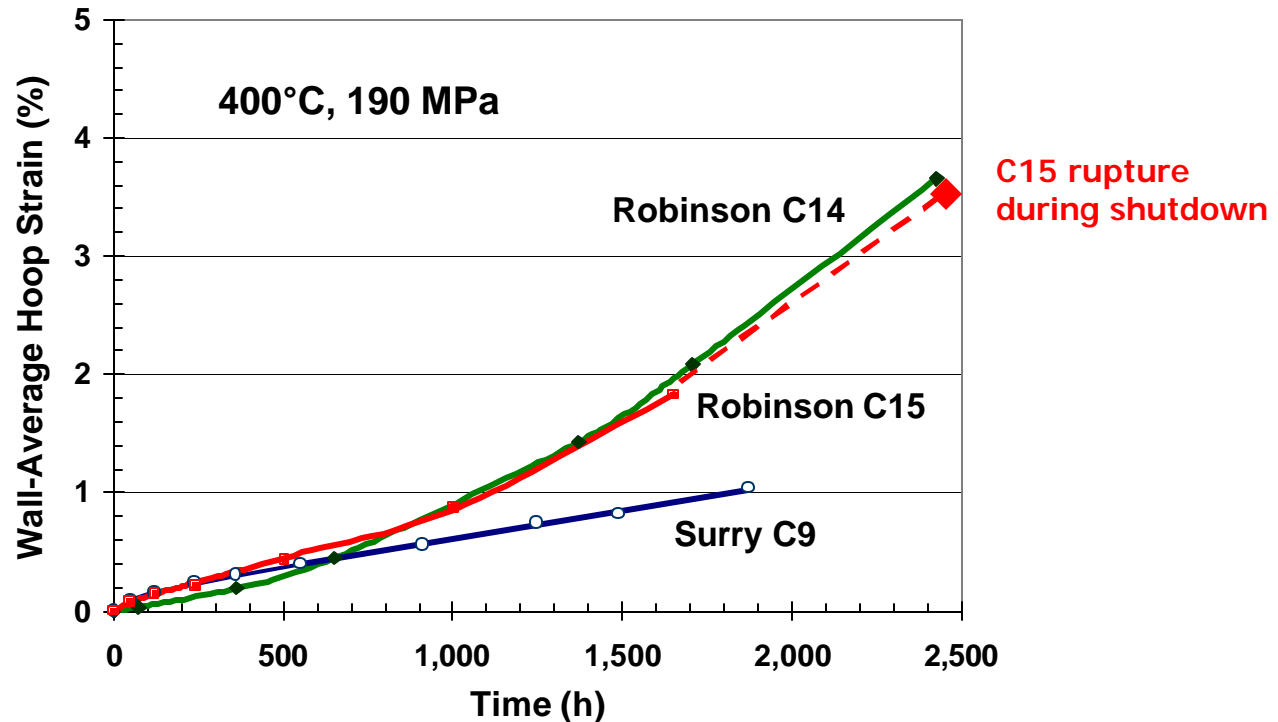
- C15 developed a rupture during the final shutdown, which stipulated cool-down first before depressurization to study hydride reorientation. (In comparison, C14 was depressurized first in the final shutdown.)

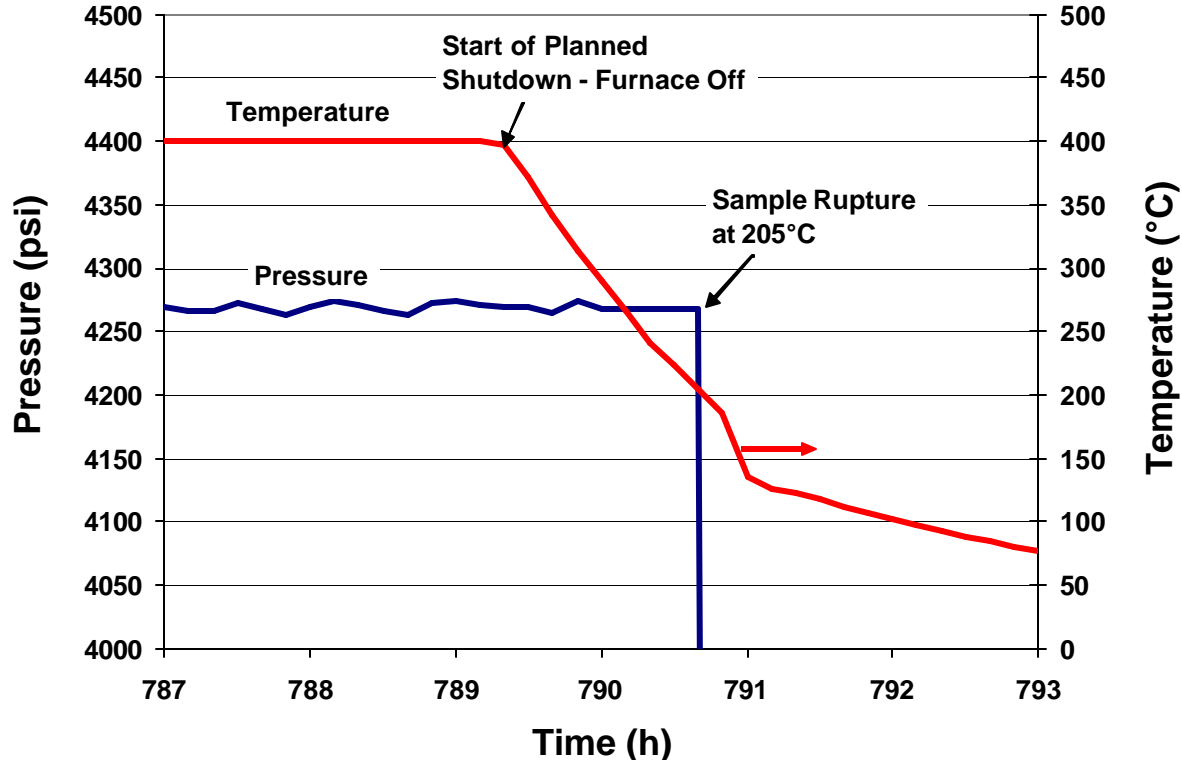
## - Shutdown history of C15

- Sample intact at the end of run at 400°C.
- Rupture occurred when temperature decreased to 205°C.

- **Unexpected rupture of the H. B. Robinson C15 sample during the final shutdown (under pressure) requires further investigation**
  - Was hydride reorientation the cause?
  - If yes, could it occur in real fuel rods? (Note: C15 with full pressure was a significant over-test for actual fuel rods.)
- **Post-creep characterization to be performed**
  - Hydride morphology/hydrogen migration
  - Bend or other mechanical tests.

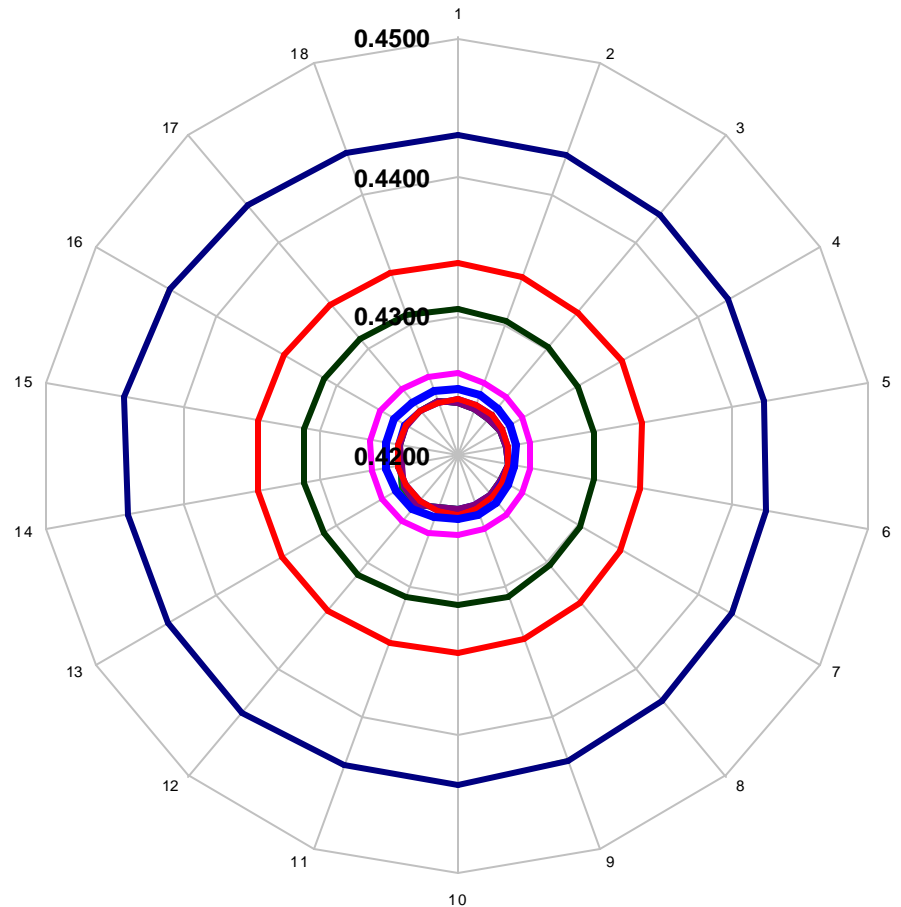
Cross Sectional Profile  
HBR A/G611C14 at 2.1 in. from top

Robinson C14 Sample shows good creep ductility:  $>3.6\%$  at  $400^{\circ}\text{C}$  and  $190\text{ MPa}$ .

- Deformation still azimuthally uniform at end of test
- Additional creep life likely

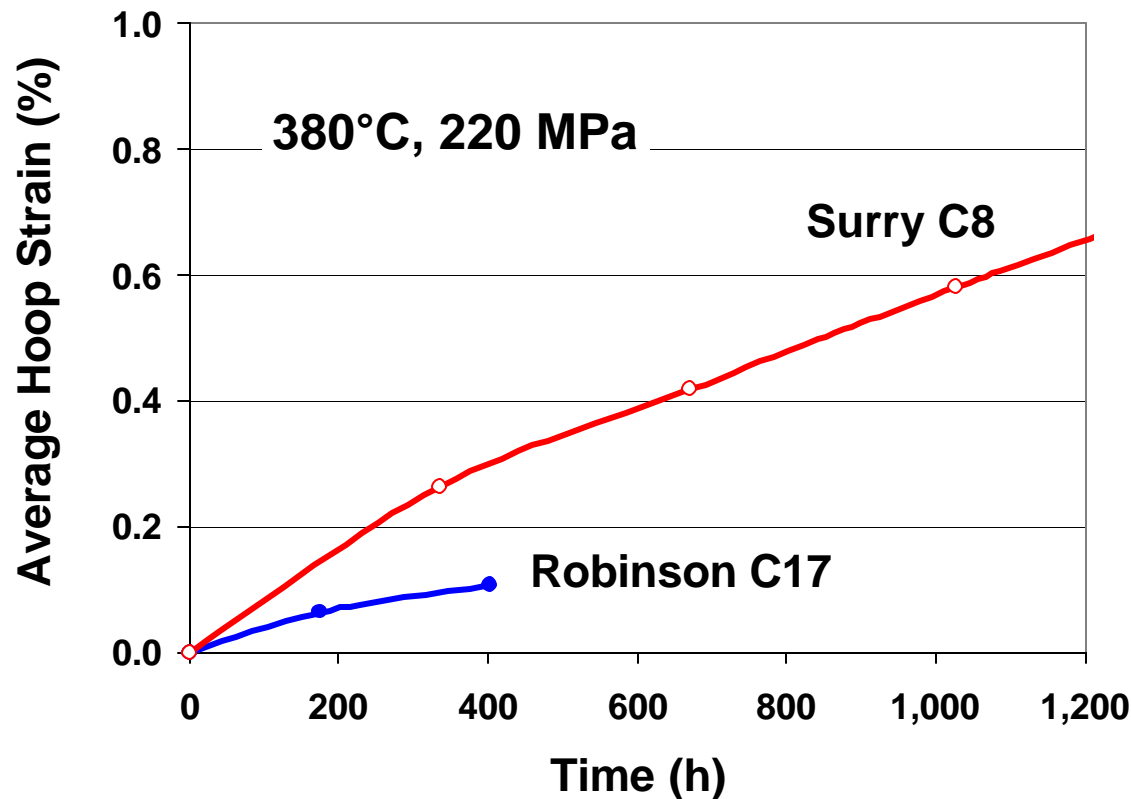
- Creep rate of H. B. Robinson appears to be smaller than that of Surry at the lower temperature of 380°C.
