Recent Results and Future GSI-191 Research

**Design Safety and Risk Analysis Group
Los Alamos National Laboratory**

**NEI PWR Sump Performance Workshop
Baltimore, Maryland
July 30-31, 2003**

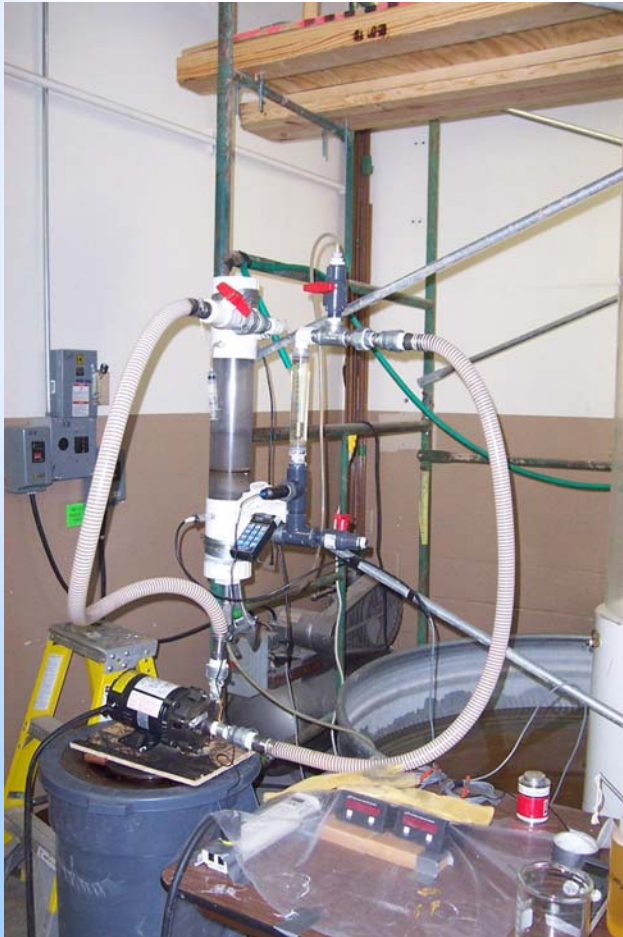
Head-loss Test Apparatus

- Diameter 1/3 of large setup
- Flow meter has 20gpm max
- 10 liter total volume
- Online temperature probe
- Flow valve in the pump outlet
- Continuous pH control
- Pump heats water to ~ 47 °C
- Replicate measurements with tap water and fiber confirm same response between large and small loops

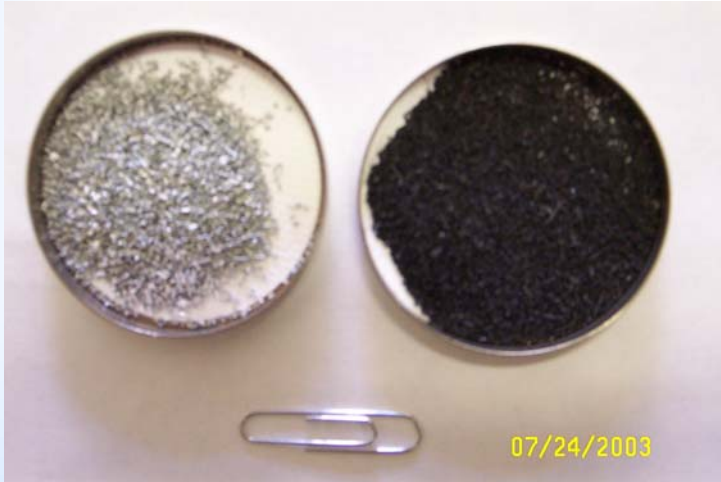
Zinc Granules

- **UNM 11-day immersion tests of zinc granules and primer chips at 80°C, pH 7 were inconclusive (max average corrosion rate 0.04 g/m²/hr)**
 - All Zinc samples turn black and gain mass

Samples Before/After Immersion

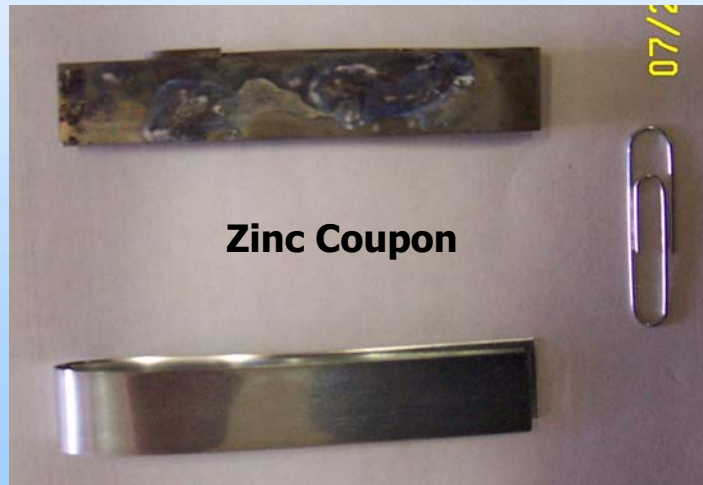
Zinc Coupon

- **STUK reports Zn corrosion rates between 0.01 g/m²/hr and 11.3 g/m²/hr under mixed temps and pH**
- **UNM 11-day immersion tests of zinc granules and bulk coupons confirms lower rate at room temp, pH 7**
