**Technical Basis for RPV Head
CRDM Nozzle Inspection Interval
H. B. Robinson Steam Electric Plant, Unit No. 2**

R-3515-00-1-NP

Dominion Engineering, Inc.

**Progress Energy Service Company, LLC
Carolina Power and Light Company
H. B. Robinson 2 Nuclear Power Plant
3581 West Entrance Road
Hartsville, SC 29550-9487**

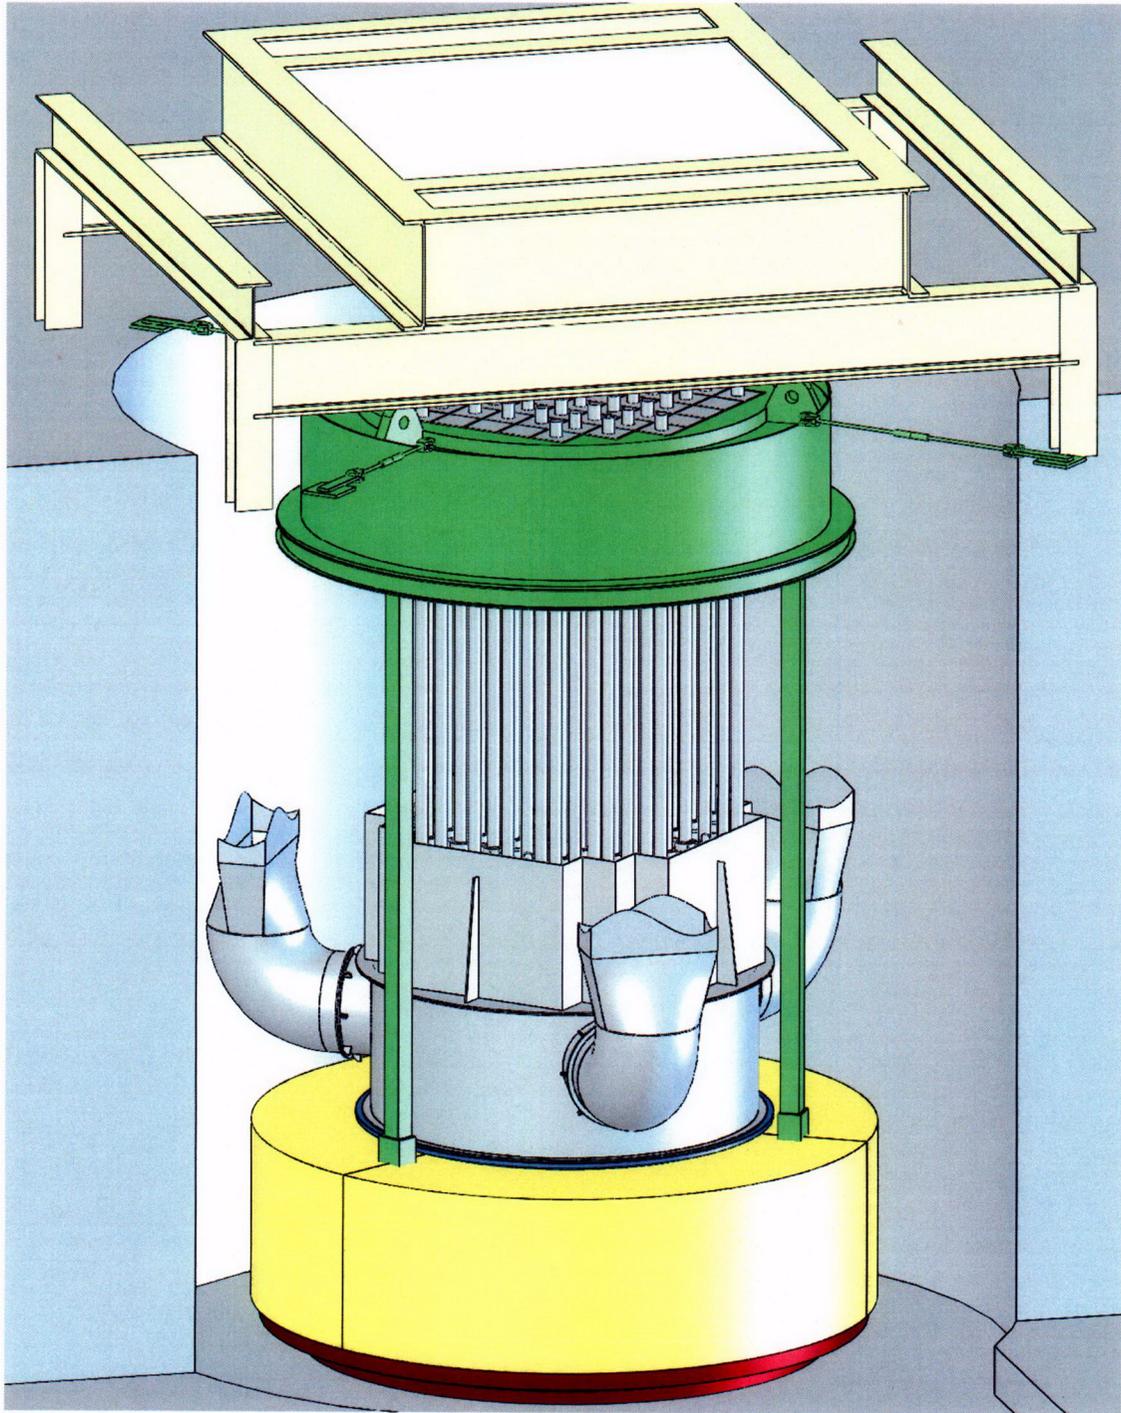
Figure 4-1
Robinson Reactor Vessel Head – Assembled Isometric

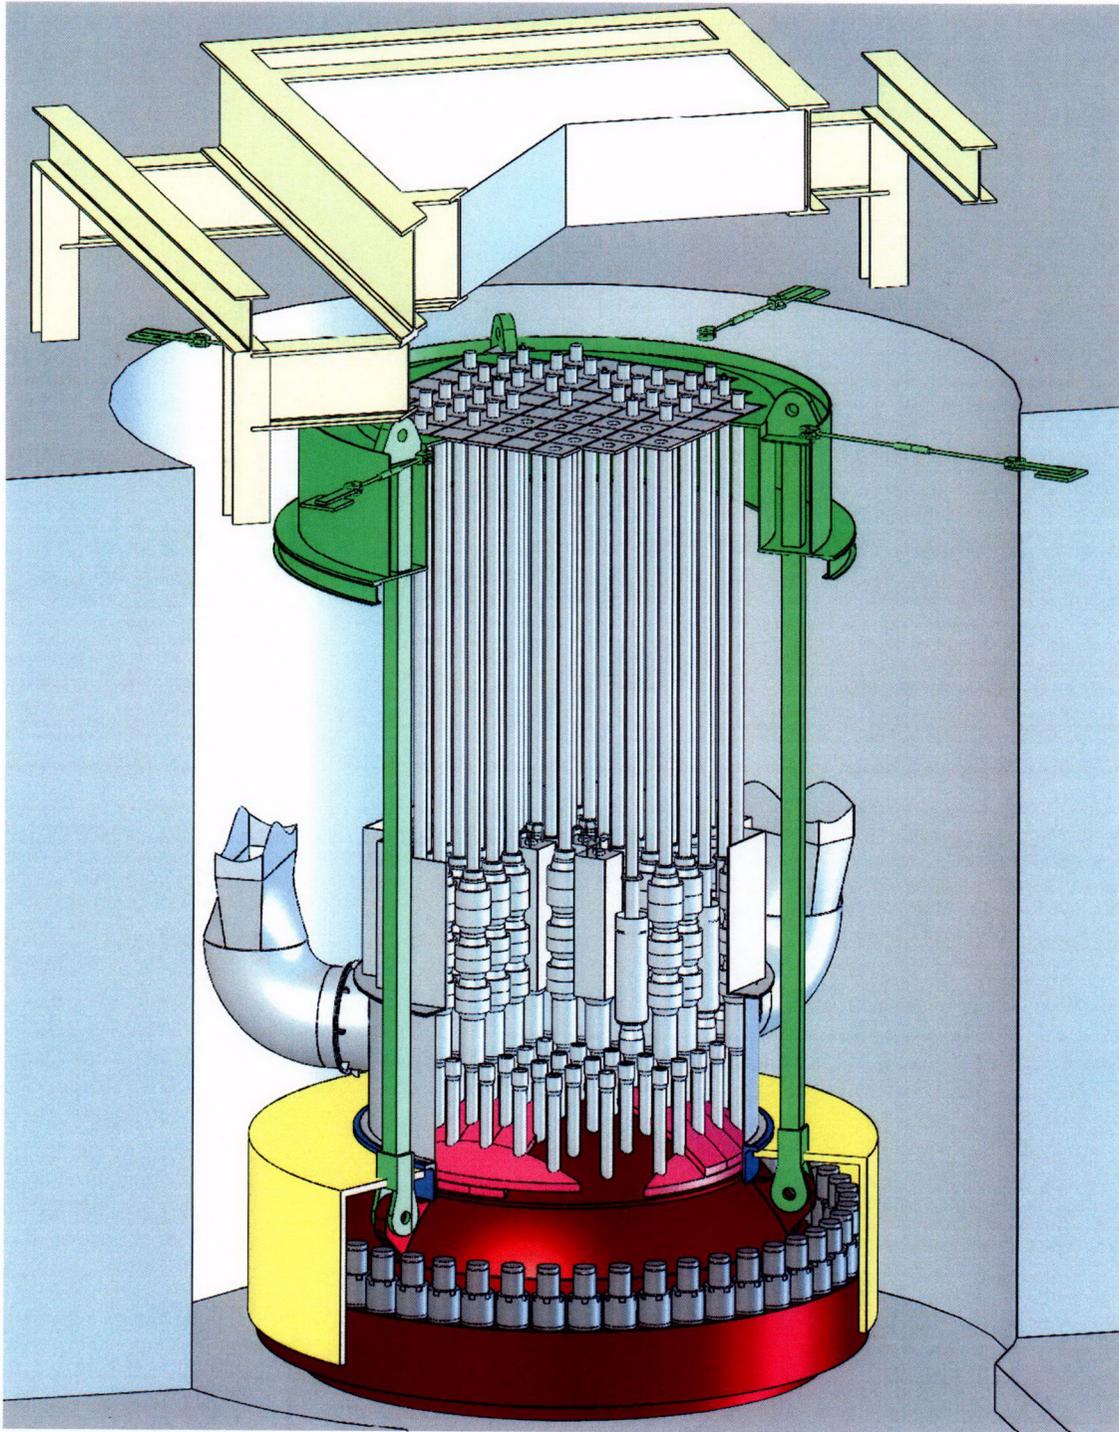
Figure 4-2
Robinson Reactor Vessel Head – Cutaway Isometric

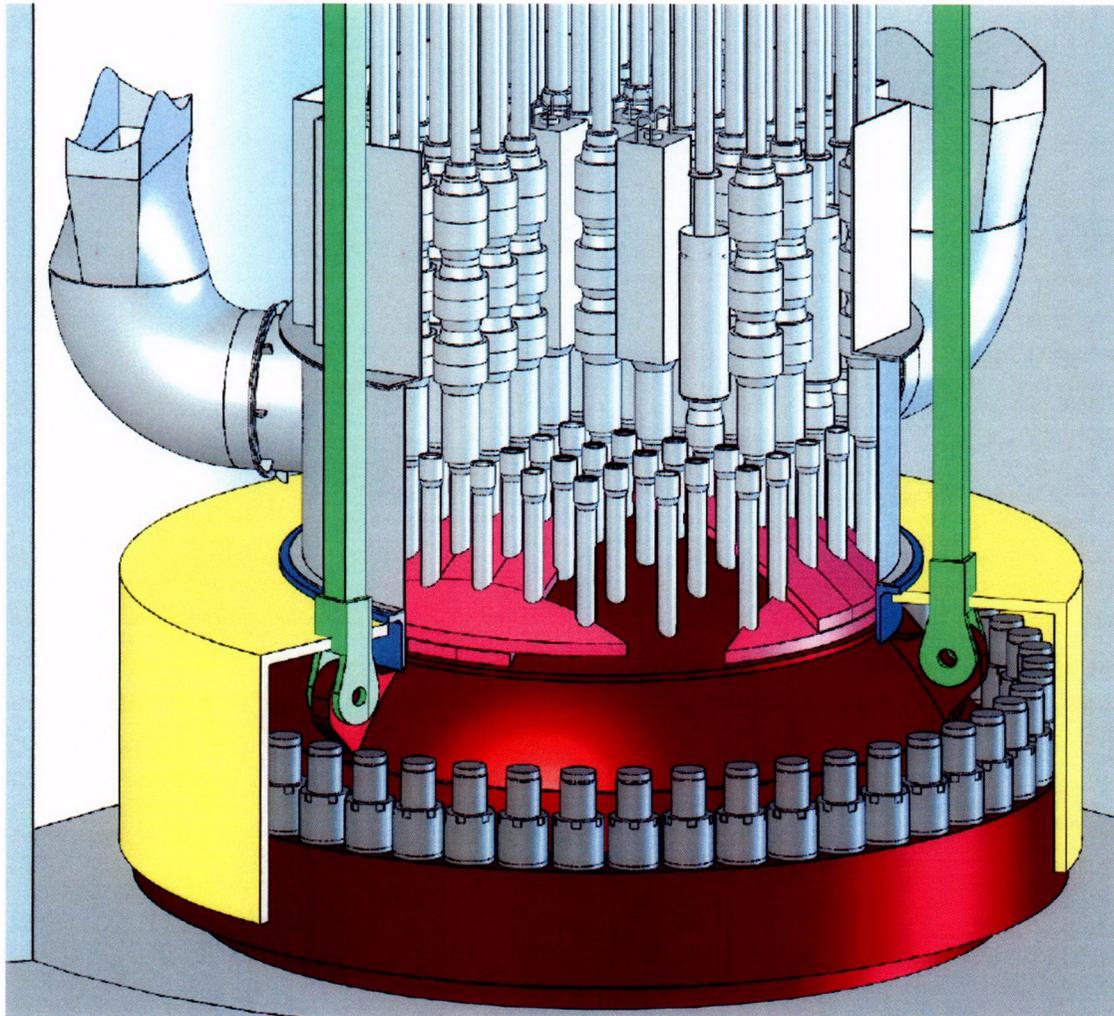
Figure 4-3
Robinson Reactor Vessel Head – Close-up Cutaway Isometric

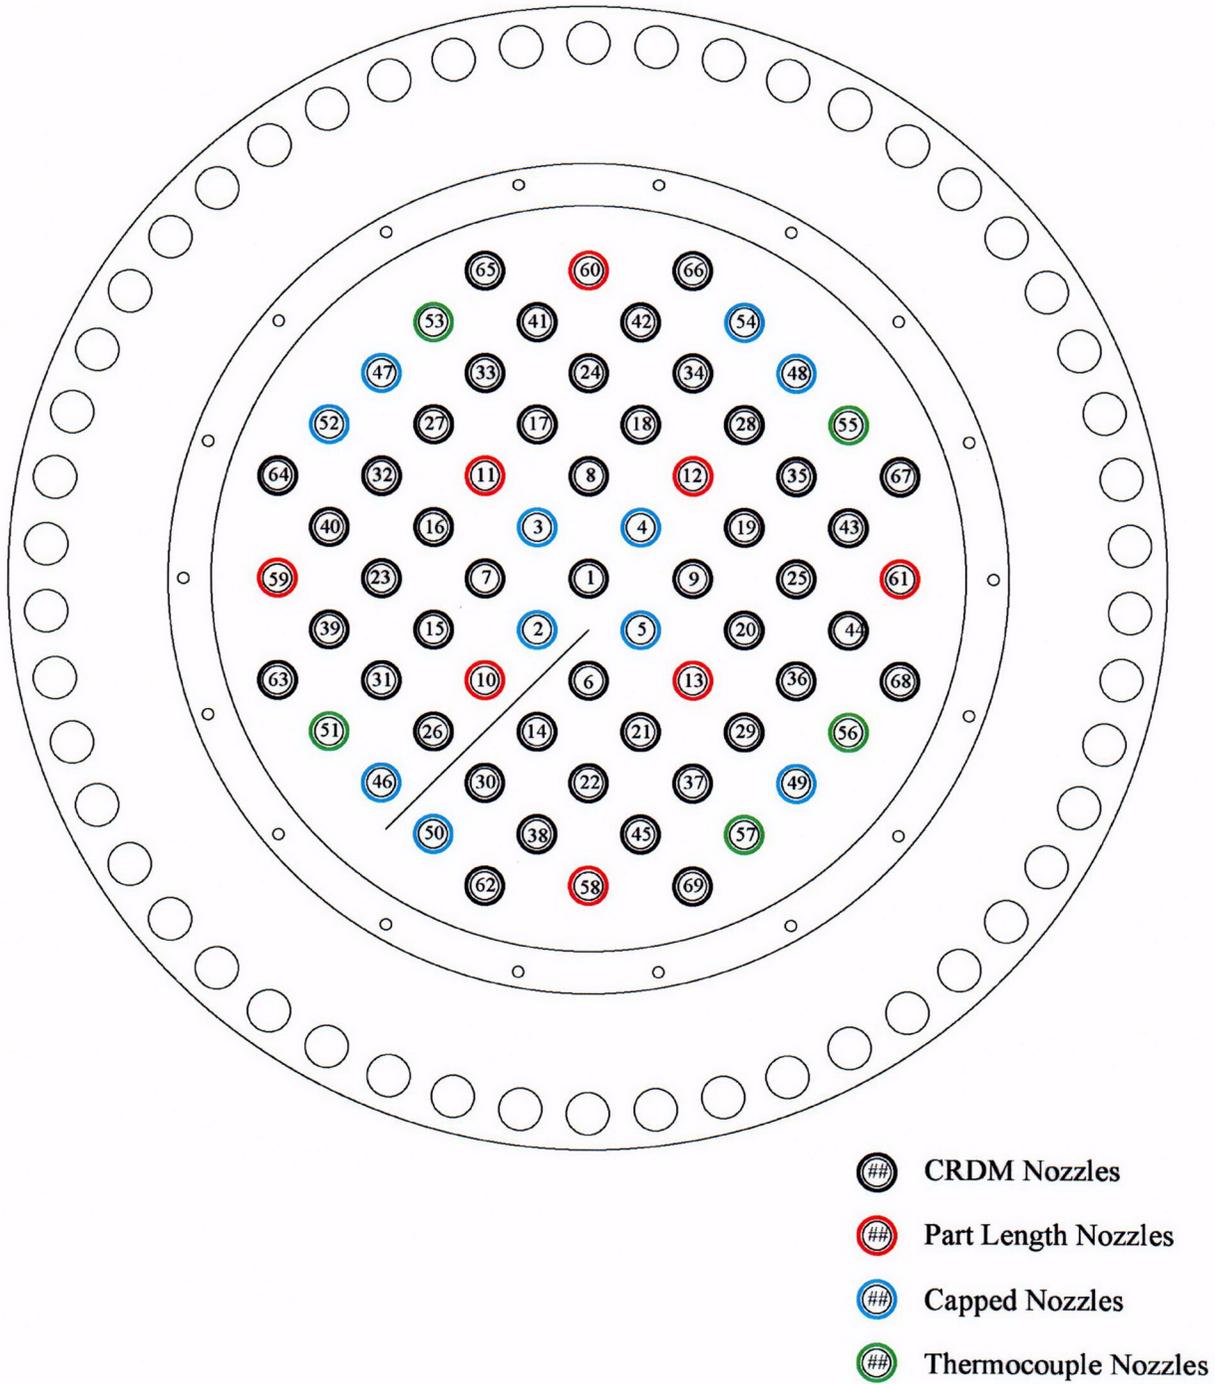
Figure 4-4
Robinson Reactor Vessel Head – Plan

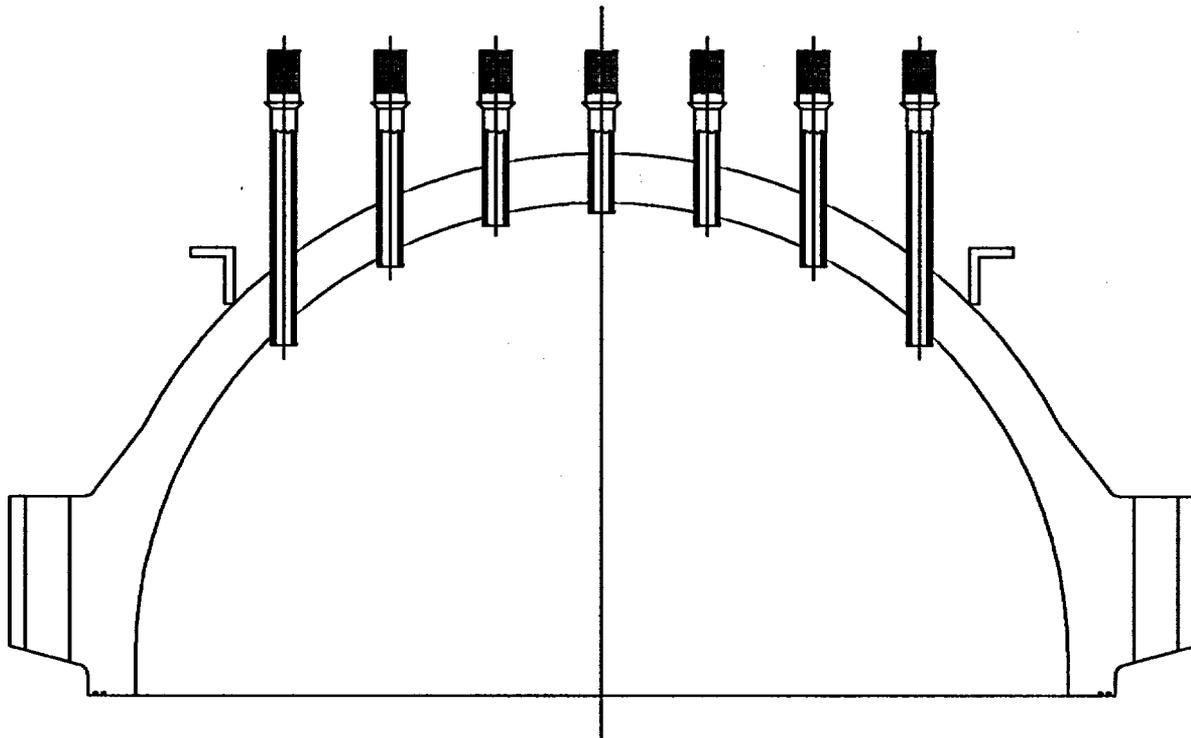
Figure 4-5
Robinson Reactor Vessel Head – Elevation

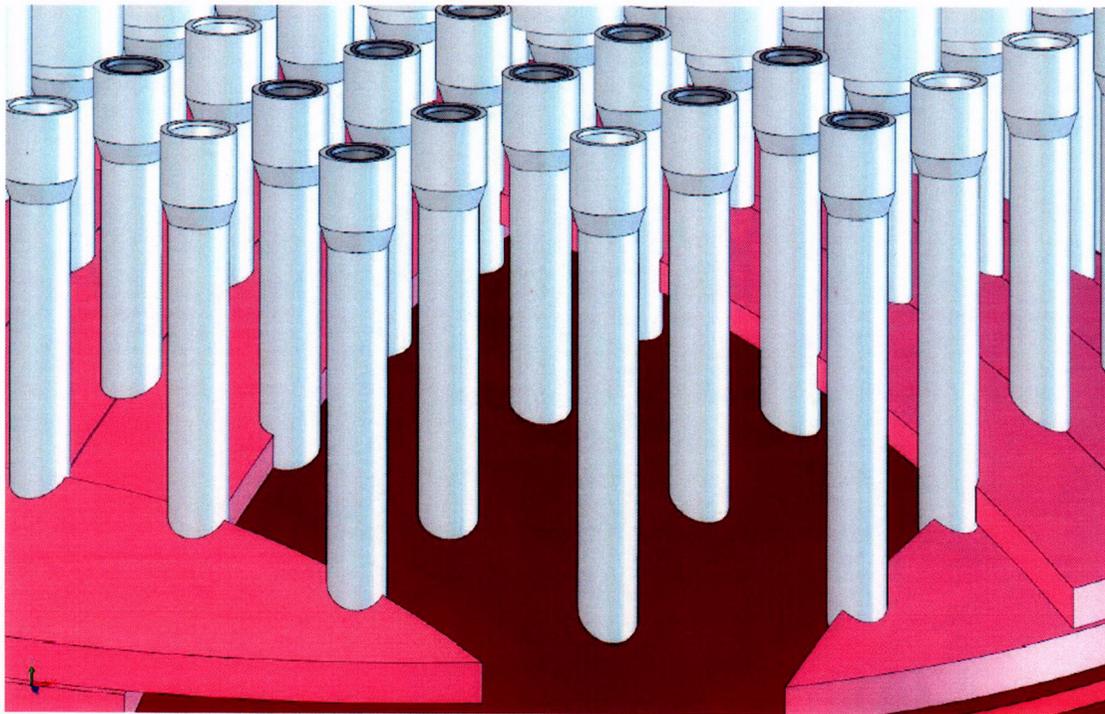
Figure 5-1
Cutaway View of Robinson Head Showing New Batt Type Insulation

As shown in Figure 5-1, the replacement insulation consists of approximately 2 inch thick insulation sewn into batts with notches cut out at each CRDM nozzle location. A first layer of batts is installed on the head followed by a second layer at a 90° angle. The overlapping batts provide complete coverage of the head with gaps limited to a small annulus around each nozzle.

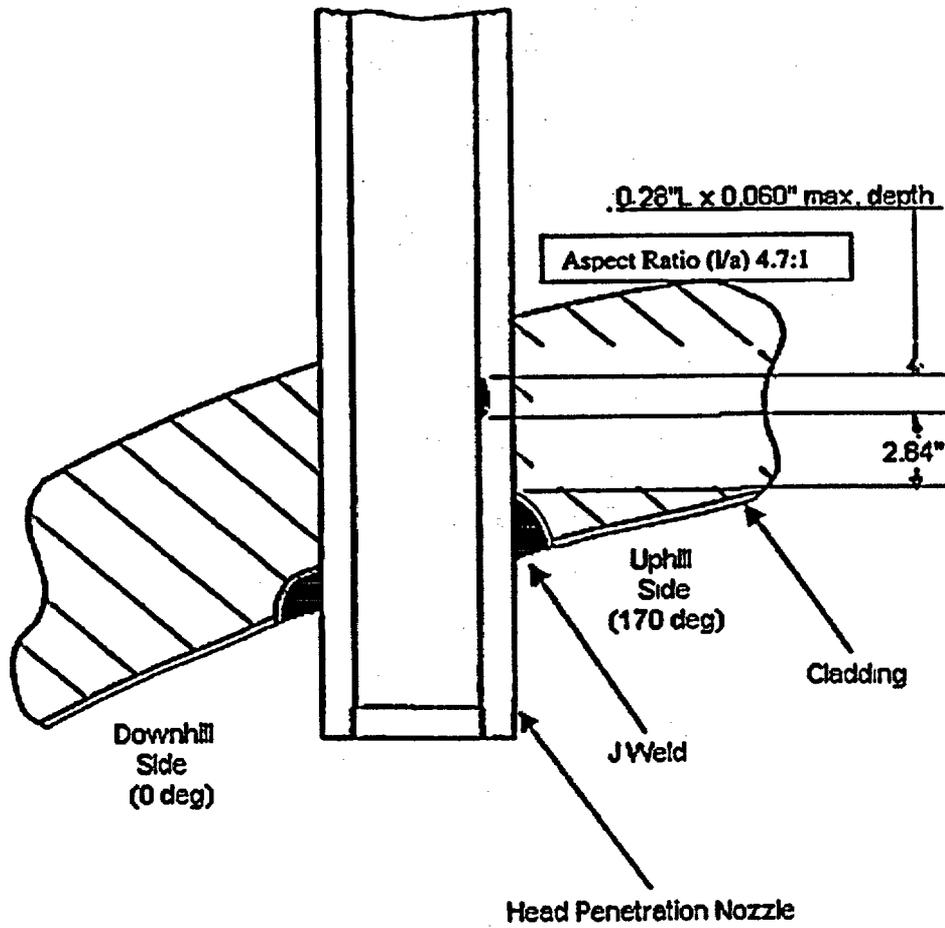
Figure 5-2
Location of Reportable Indication in Nozzle #47

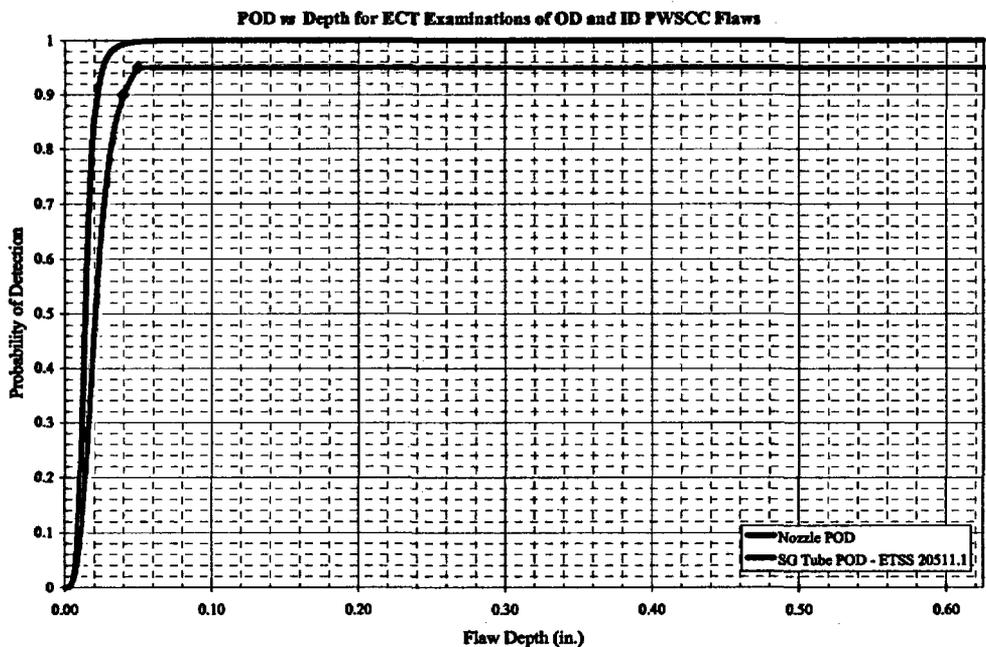
Figure 5-3
Probability of Detection by ECT of PWSCC on CRDM Nozzle Surfaces

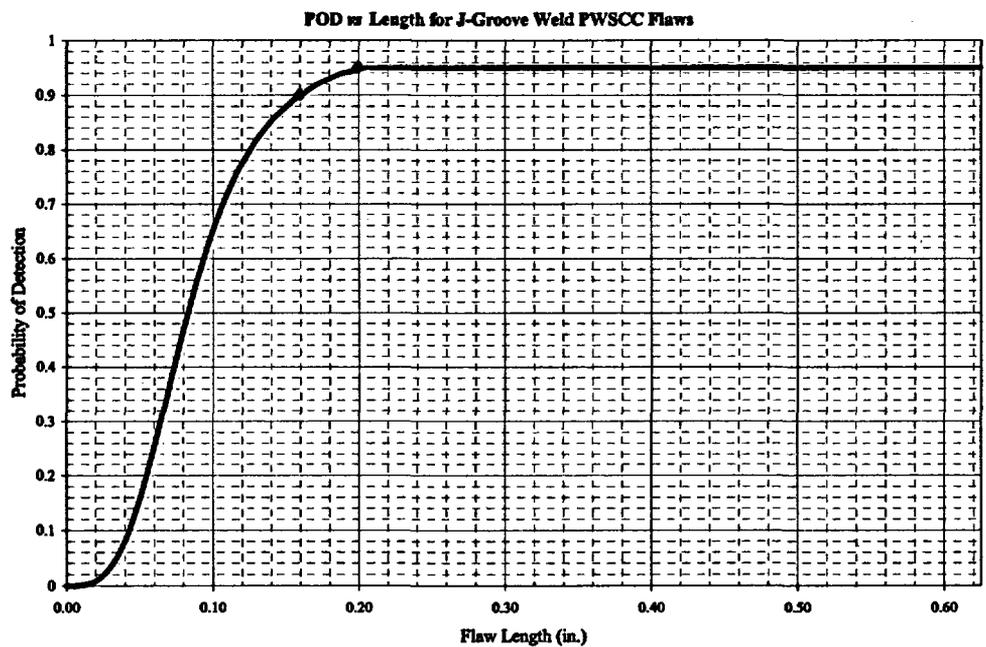
Figure 5-4
Probability of Detection by ECT of PWSCC in J-Groove Welds

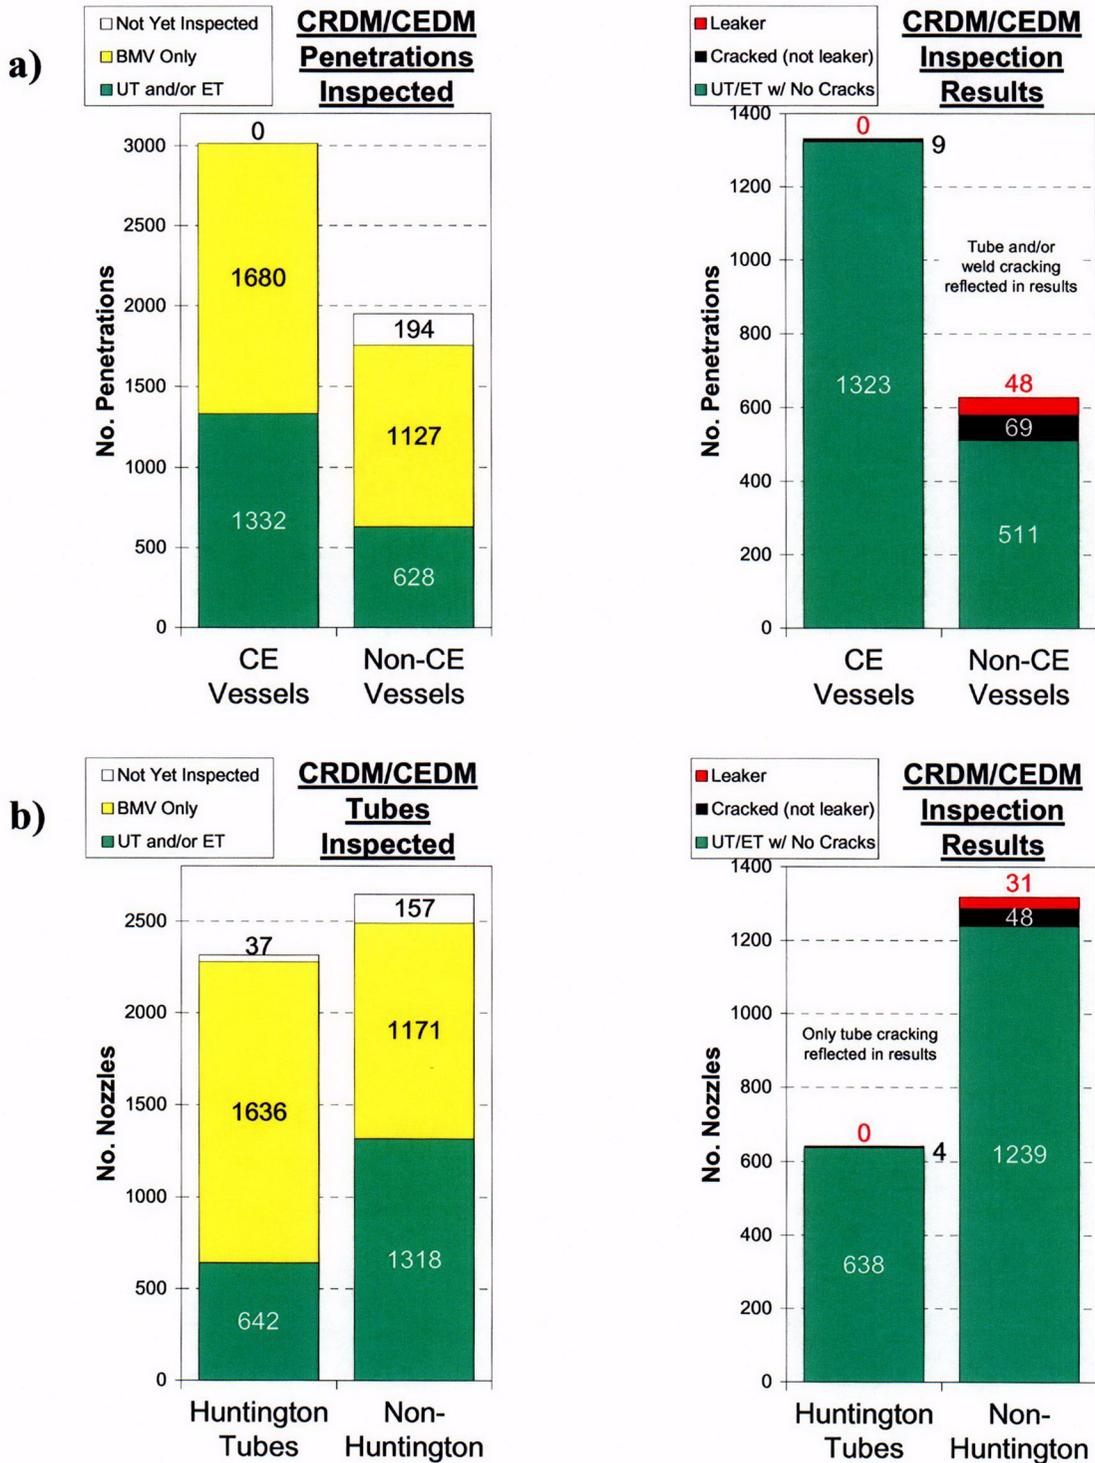
Figure 6-1
Summary Statistics for Industry Inspection Results through Spring 2003: a) Comparison for Vessels Fabricated by Combustion Engineering; b) Comparison for Nozzle Material Supplied by Huntington (For Information Only)

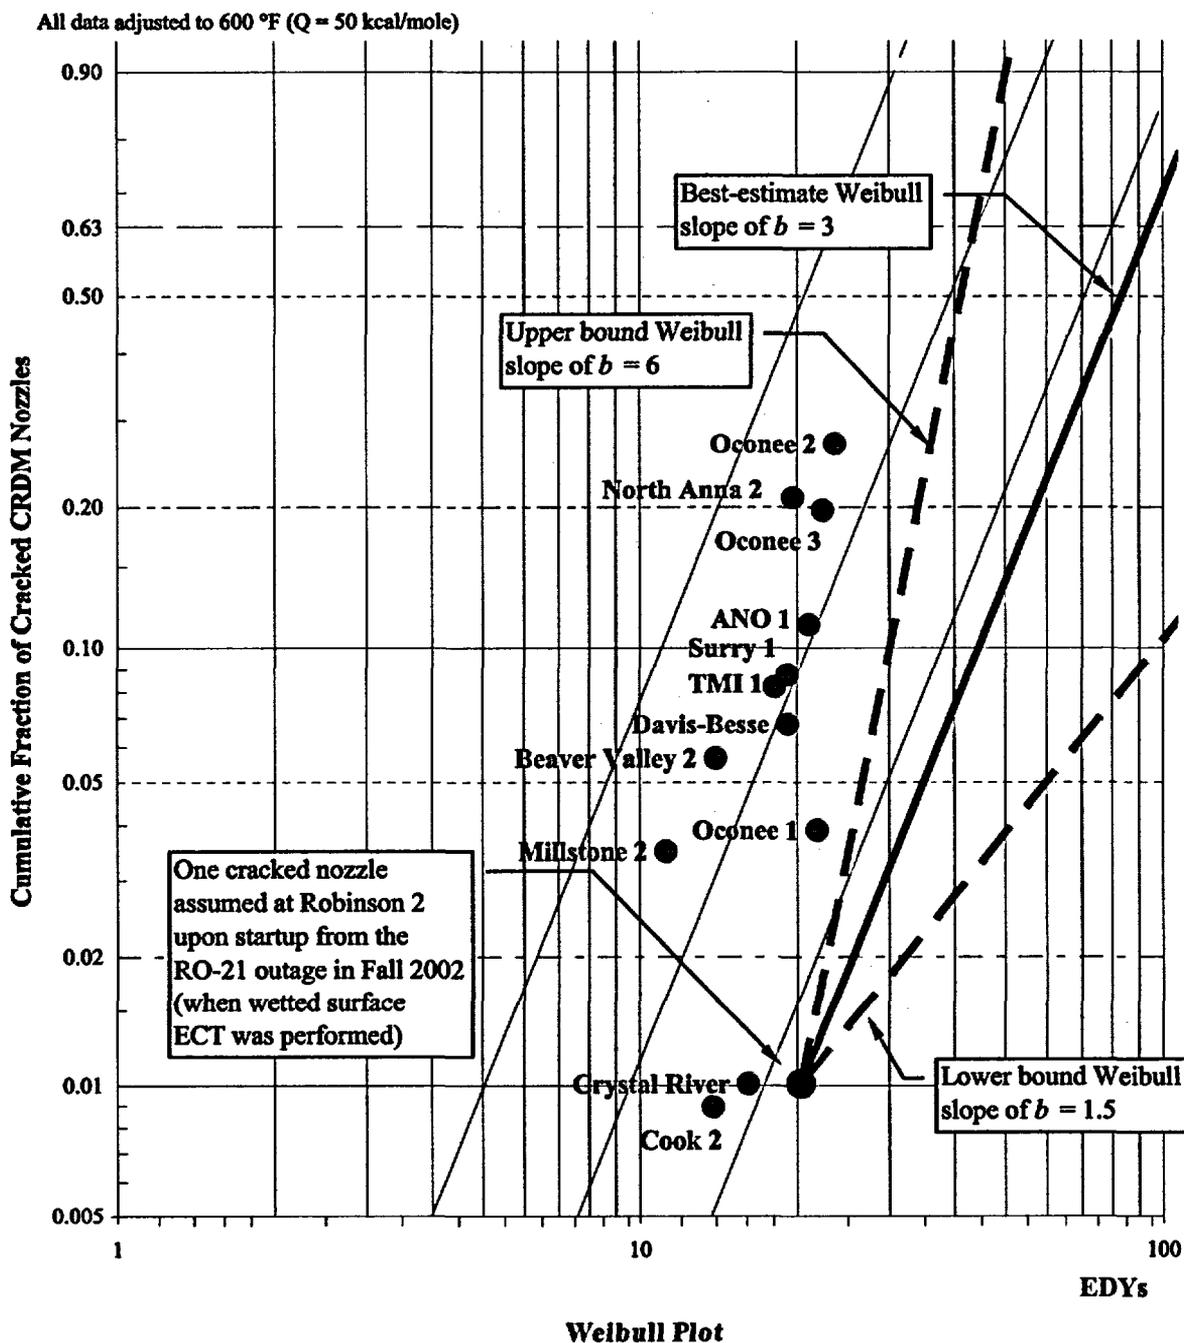
Figure 6-2
Predicted Weibull Curve for Robinson Relative to Other Plants with Reported PWSCC

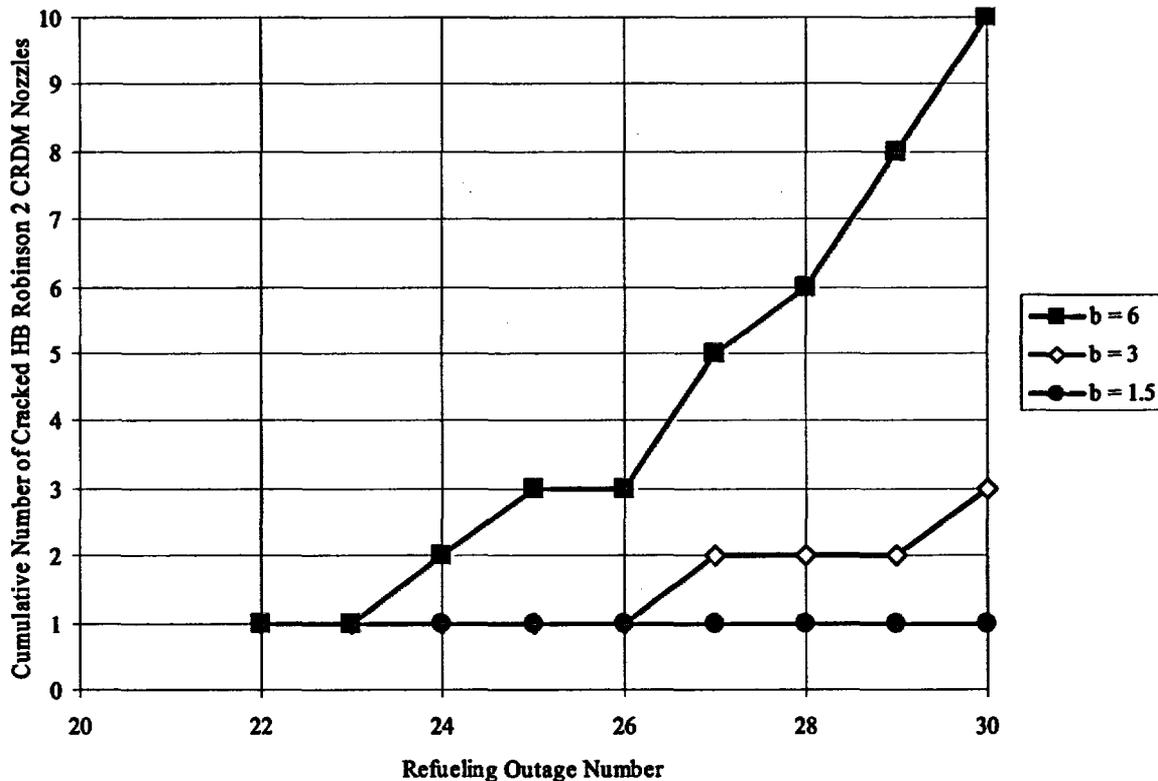
Figure 6-3
Predicted Number of Robinson Nozzles with Reportable PWSCC Cracks

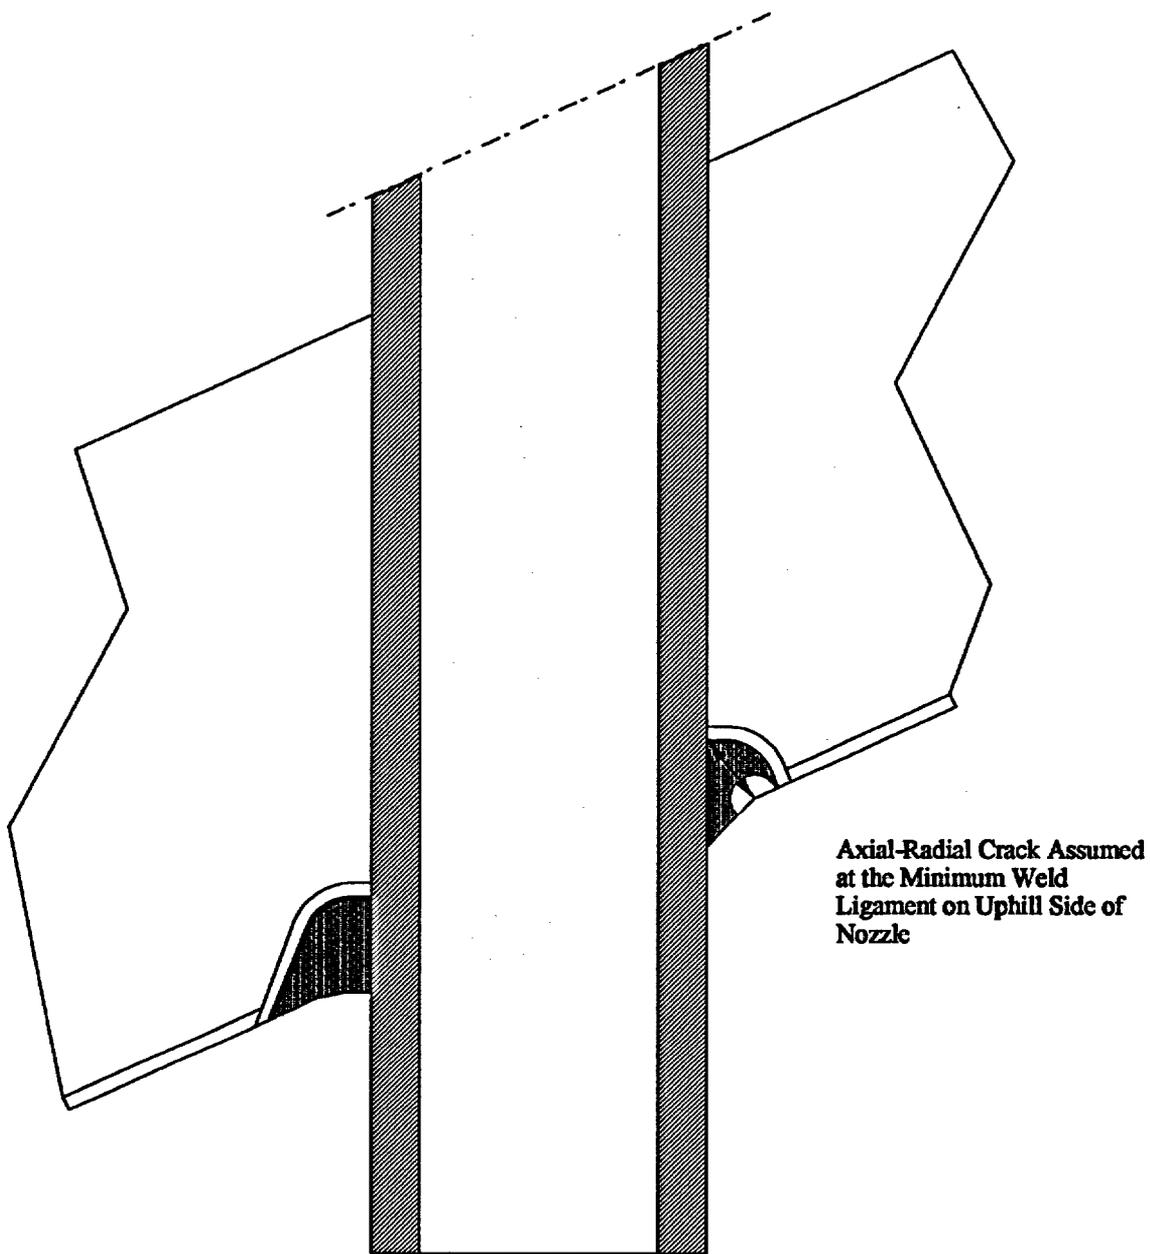
Figure 7-1
Crack Growth Path Through J-Groove Weld (27.1° Nozzle, Uphill Side)

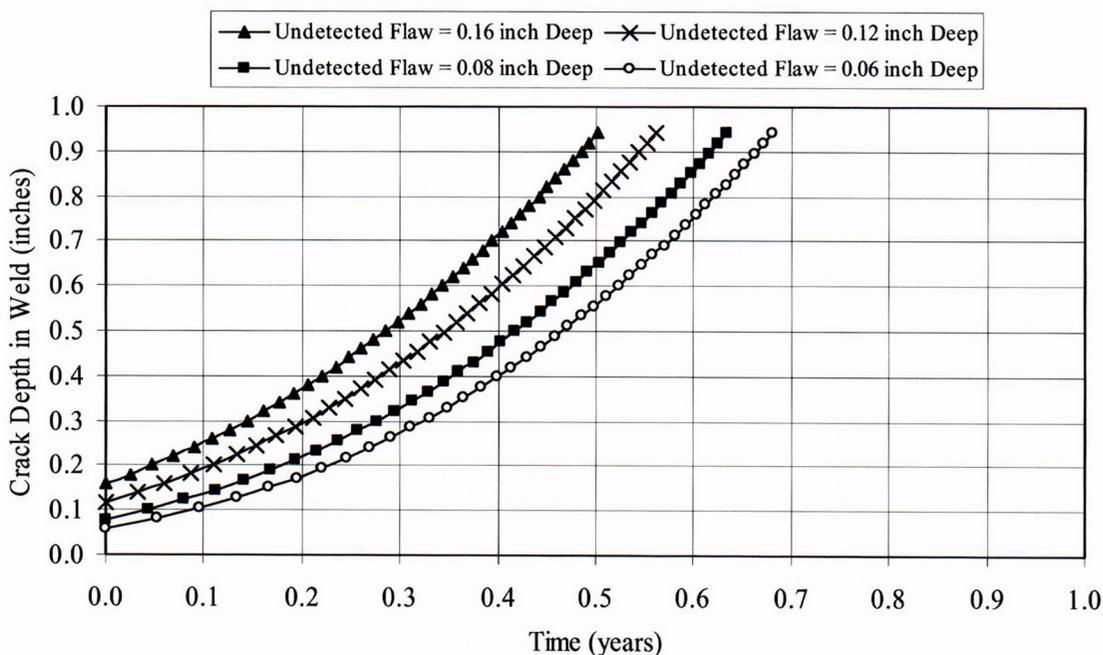
Figure 7-2
Predicted Crack Growth for Flaws in Weld of Four Initial Sizes (27.1° nozzle, Uphill Side)

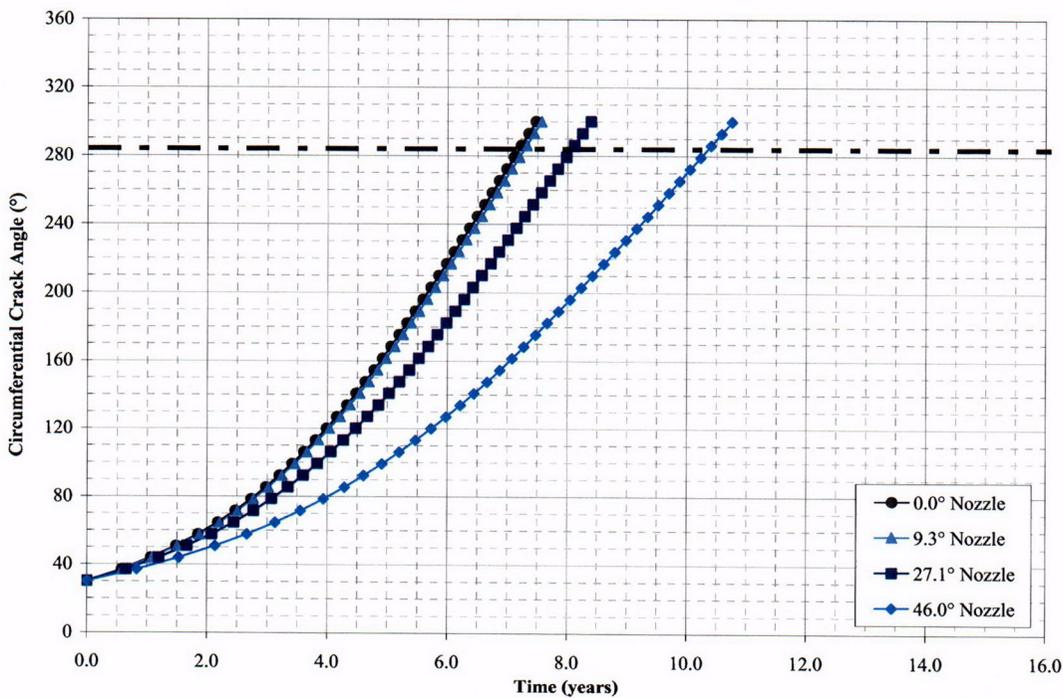
Figure 7-3
Time for 30° Through-Wall Circumferential Crack Above J-groove to Grow to 284° Limit

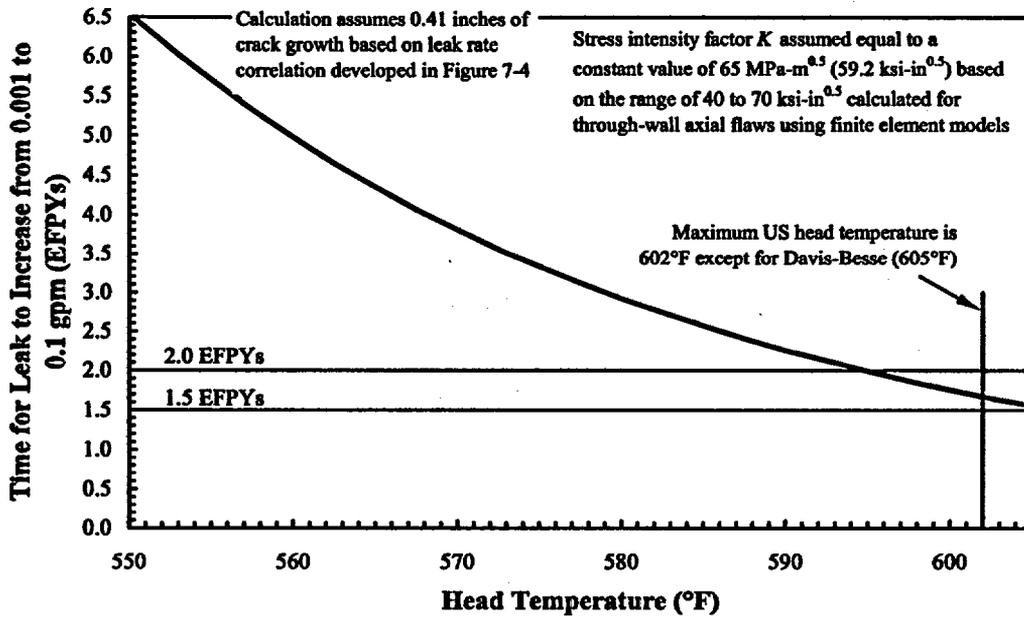
Figure 7-5
Reinspection Interval to Ensure that Supplemental Visual Inspection will Detect Leak Prior to High BAC Corrosion Rates Occurring (MRP-75) (9)

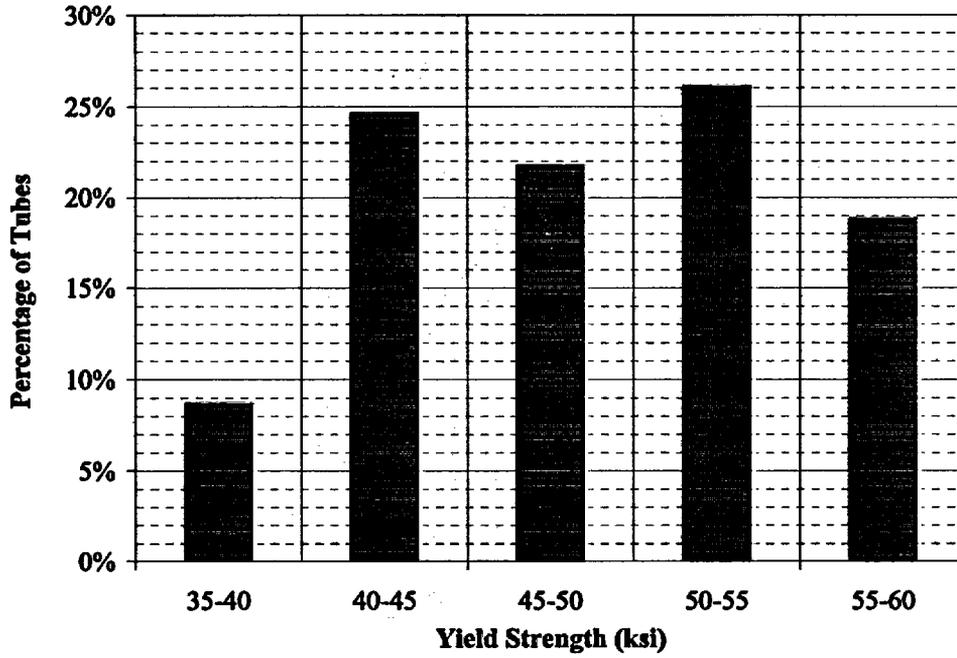
Figure 8-2
Distribution of Robinson Yield Strengths for the 69 Nozzles Based on Heat CMTRs

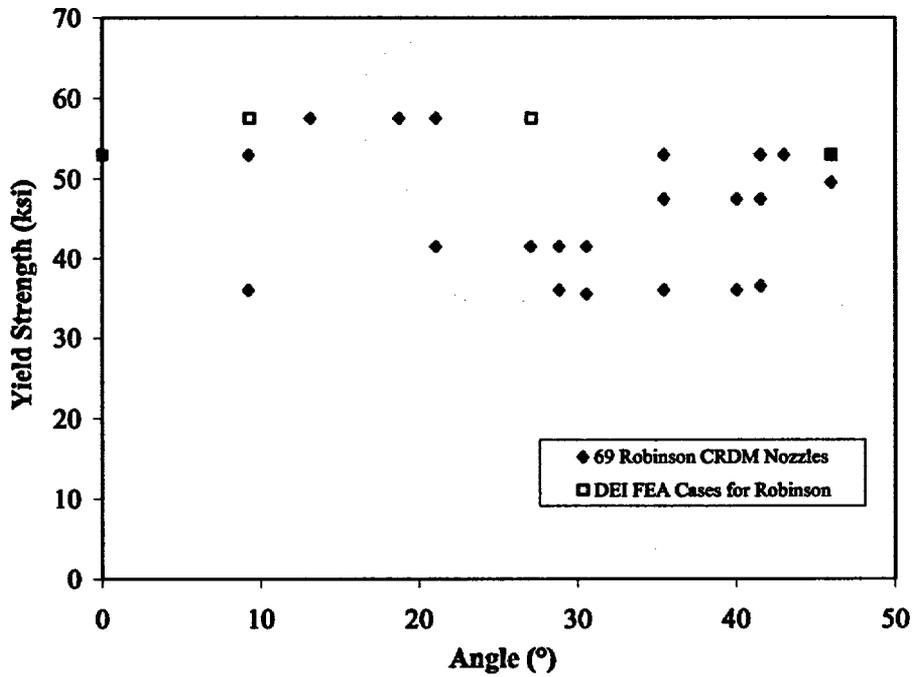
Figure 8-3
Robinson Yield Strength versus Nozzle Incidence Angle

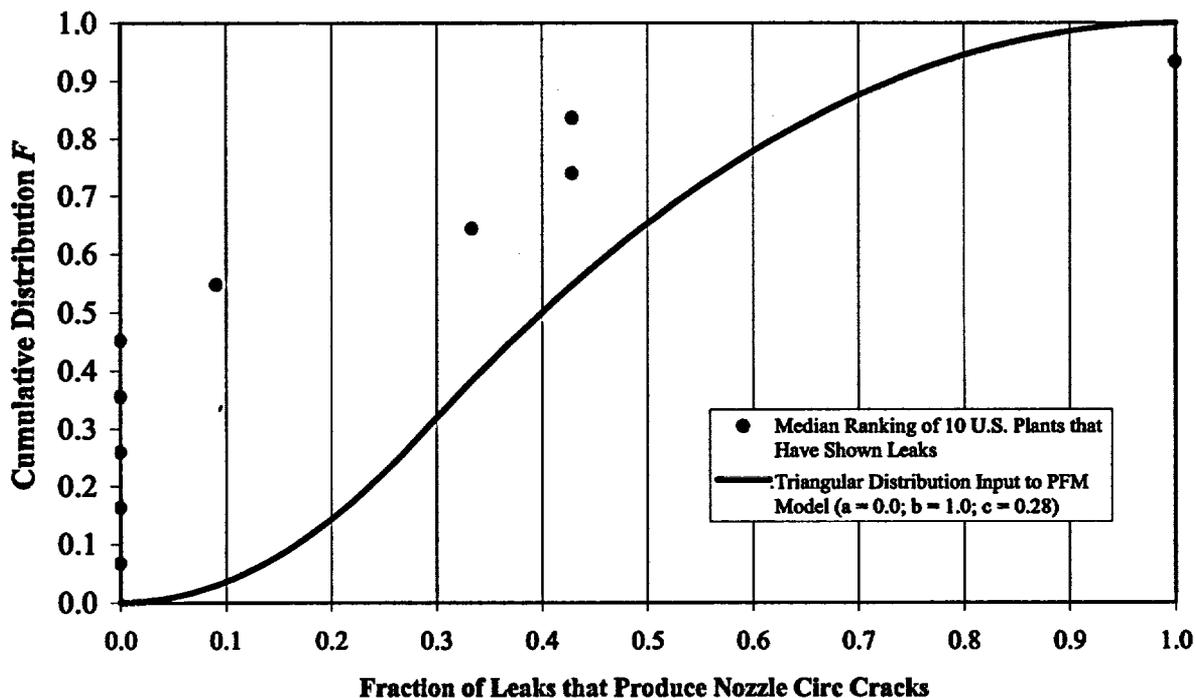
Figure 8-5
 Conservative Selection of Input Distribution to Describe the Probability that Leakage (or Weld Cracking) Leads to Circumferential Tube Cracking Above or Near the Top of the J-Groove Weld (For Information Only)

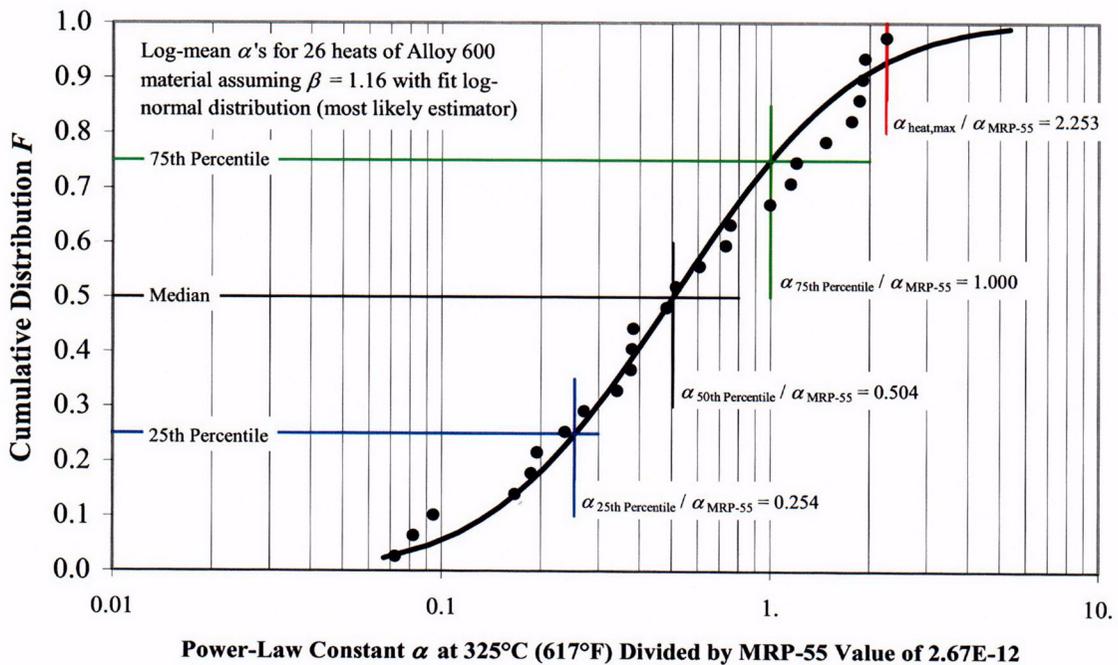
Figure 8-7
 Log-Normal Distribution Fit on a Heat Basis to Laboratory Crack Growth Rate Data Presented in MRP-55

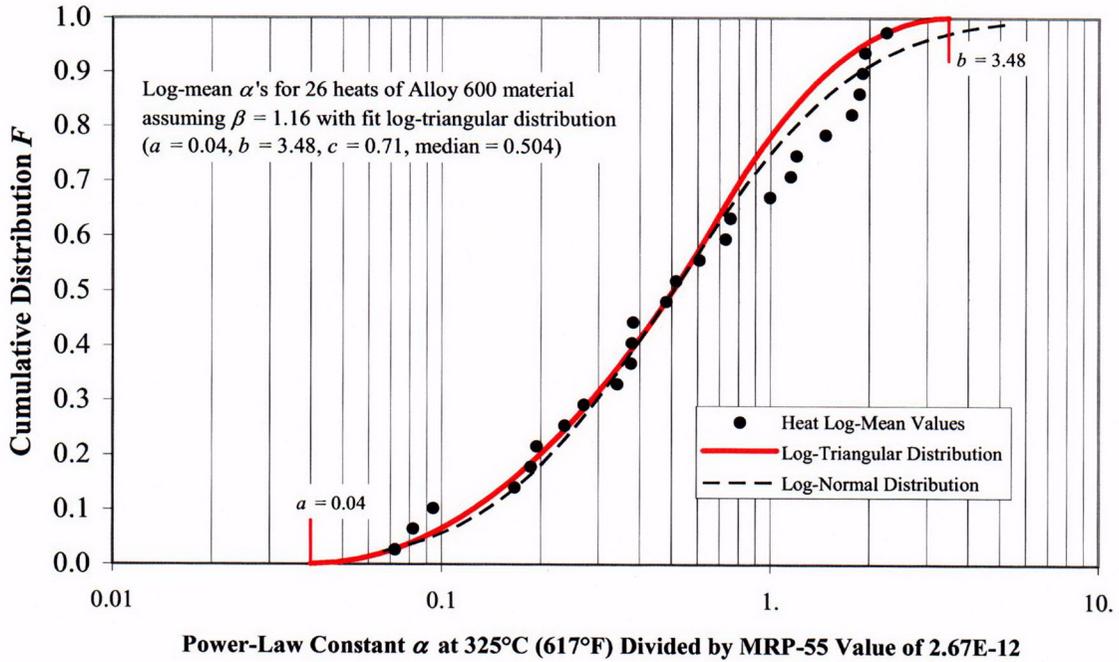
Figure 8-8
Log-Triangular Distribution Fit on a Heat Basis to Laboratory Crack Growth Rate Data Presented in MRP-55

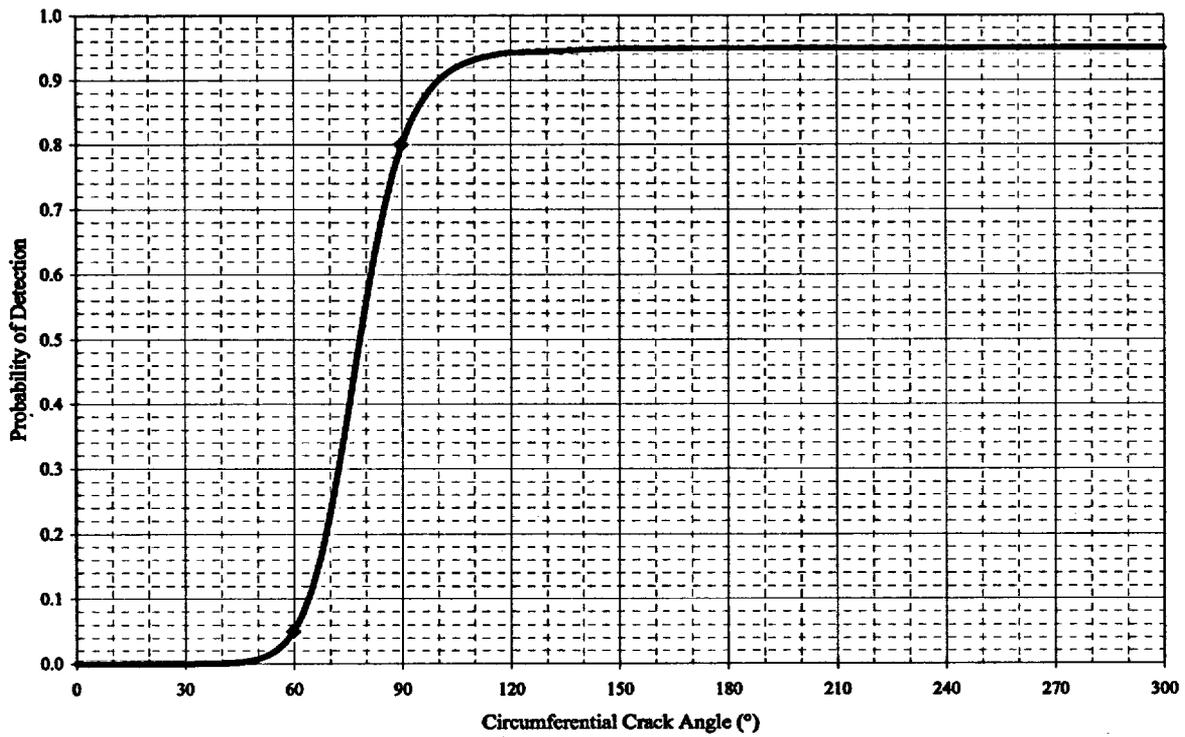
Figure 8-10
Assumed Probability of Detection for Above-Weld Circumferential Tube Cracks Given ECT
Inspection of Tube ID
