**Technical Basis for RPV Head
CRDM Nozzle Inspection Interval
H. B. Robinson Steam Electric Plant, Unit No. 2**

R-3515-00-1-NP

Dominion Engineering, Inc.

**Progress Energy Service Company, LLC
Carolina Power and Light Company
H. B. Robinson 2 Nuclear Power Plant
3581 West Entrance Road
Hartsville, SC 29550-9487**

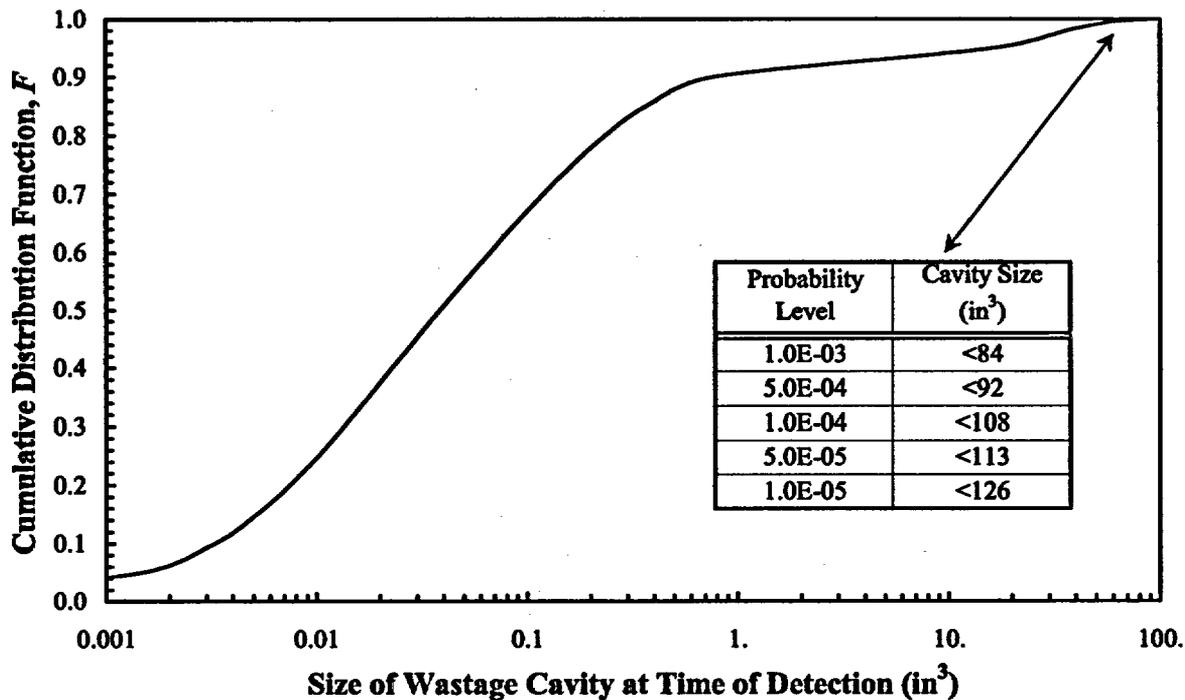
Figure 8-12
 Results of the Probabilistic Wastage Calculation
