Distribution: w/o encl.  
WM file  
WMHL r/f  
NMSS r/f  
JBMartin  
REBrowning  
MJBell  
FRCook & r/f  
HJMiller  
JOBunting  
PDR

Enclosures: BNL Quarterly Reports:  
BNL-NUREG-51499, Vol. 1, No. 3; Vol. 1,  
No. 4 and Vol. 2, No. 1.

**CONTAINER ASSESSMENT — CORROSION STUDY  
OF HLW CONTAINER MATERIALS**

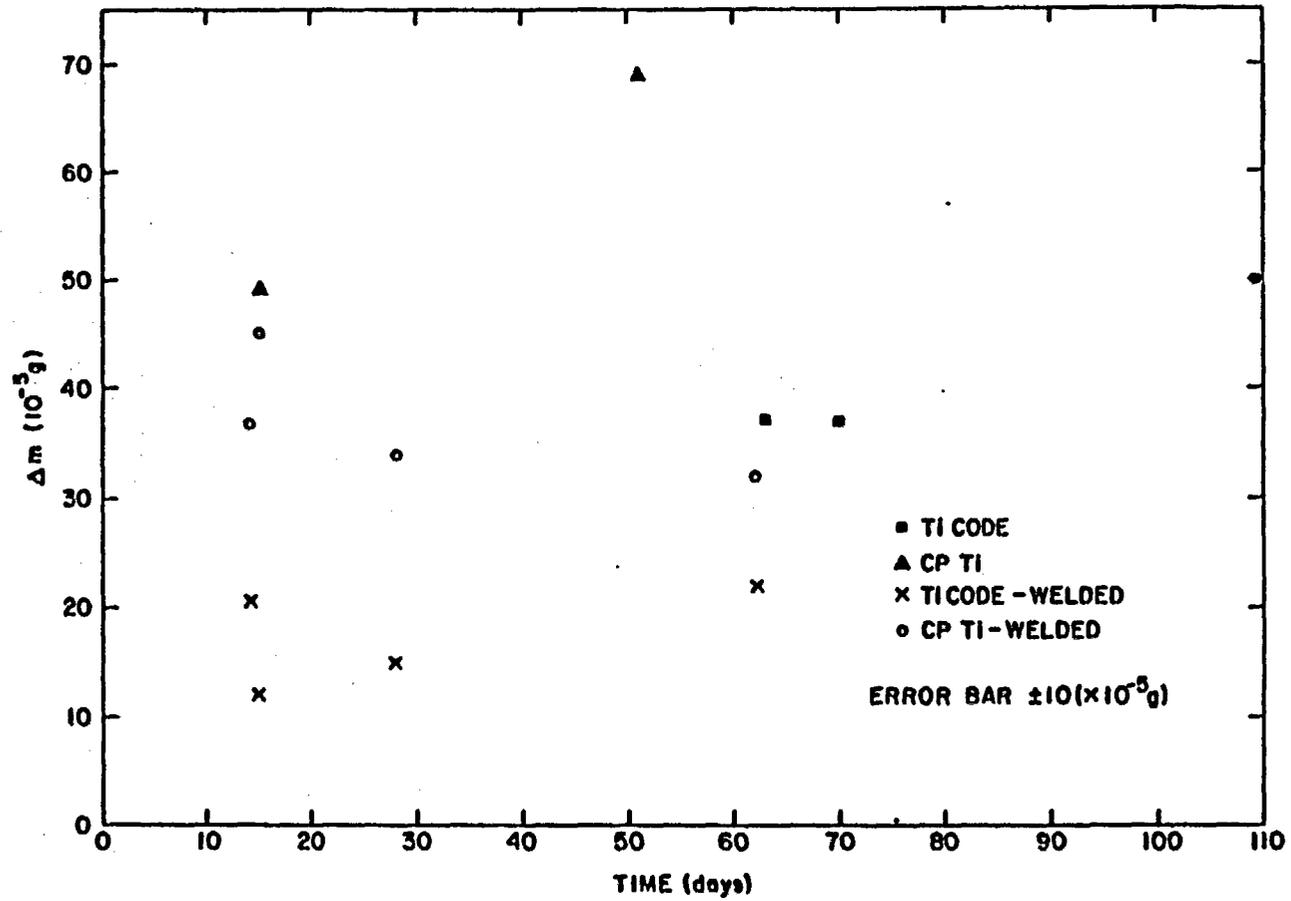
Figure 1. Weight gain data on CP titanium and TiCode-12 in Brine A.

In the last quarterly progress report<sup>1</sup> some initial corrosion rates in Brine A were reported using weight change measurements. Subsequent SEM observation of the corroded surface revealed that a significant amount of precipitation from the solution had occurred. To reduce this artifact, all samples were cleaned in boiling water. Figure 1 shows a current compilation of weight gain data in Brine A. TiCode-12 is more resistant to uniform corrosion compared with CP titanium. In general, welded samples show less weight gain.\* This can be attributed to selective attack (see Section 5). The data on non-welded samples are in reasonable agreement with previous results.<sup>2</sup>

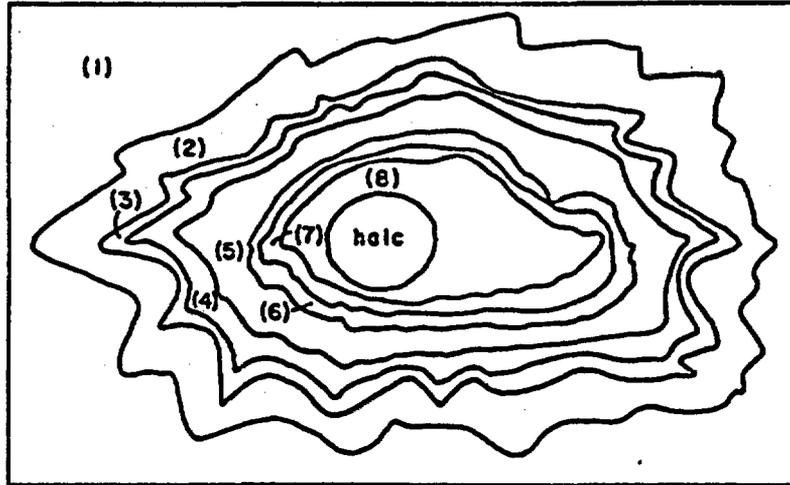
Figure 5. Schematic diagram of a scale formed in CP titanium crevice in Brine A at 150°C after 116 days' exposure.

The initial stage of crevice corrosion of CP titanium was studied in deaerated neutral Brine A solution at 150°C. Figure 5 shows the typical color bands of the scale inside the crevice. In order to determine the significance of the colors, a coupon of pure Ti (2 cm x 4 cm) was polished to 600 grit SiC paper and then heated in a gas flame. This produced many different colors on the surface of the coupon as shown in Figure 6. This coupon has the same sequence of colors as observed in crevice corroded specimens. These different colors could be caused either by the differing thickness of the oxide film<sup>4</sup> (interference colors) or by different types of oxides.<sup>5</sup> It is likely that they are interference colors caused by different thicknesses, based on the fact that the crystals in each colored region look similar in SEM photos with only grain size differences. In addition, there was no significant contrast obtained in the SEM. The crystal size observed in the greenish black region ranges up to 500 Å (Figure 7). Even when lower oxides are present or predominant, the interference colors can still be obtained by thickness variations.

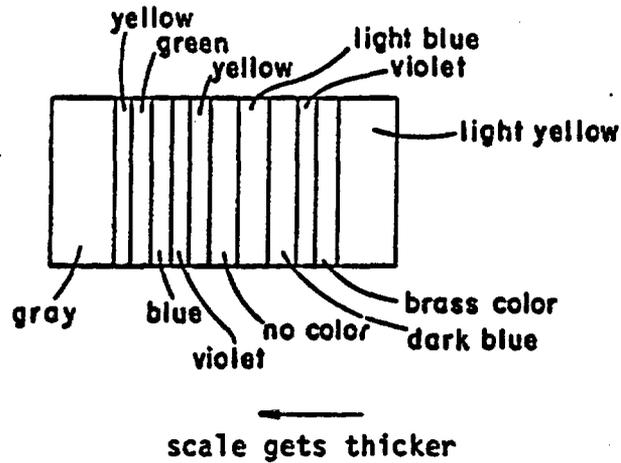
Figure 6. Schematic diagram of a scale formed by gas flame heating of CP titanium.

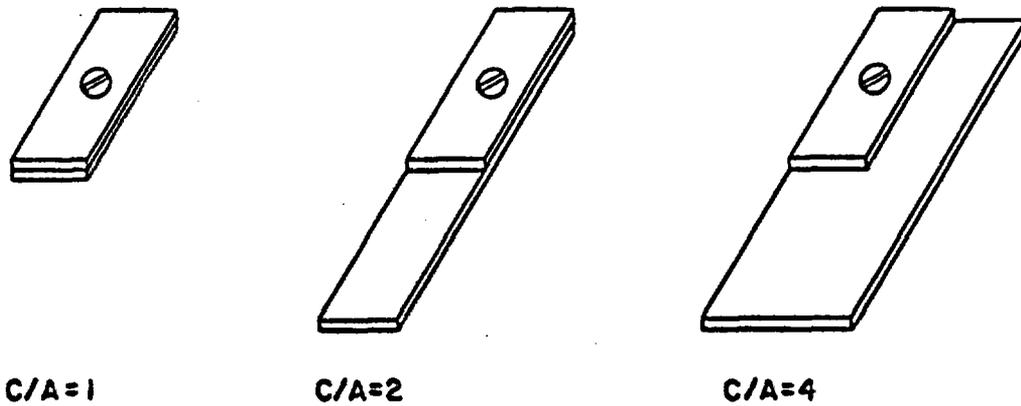
Figure 8. Crevice samples with various cathode/anode ratios.

Based on a macrocell formation hypothesis, the ratio of cathode area to anode area (C/A) could affect the anodic process inside the crevice. Three different crevice samples were prepared as shown in Figure 8, and were exposed at 150°C for 35 days in Brine A. The samples with higher C/A ratio (= 4) showed less corrosion compared with the lower C/A (= 1) ratio sample. Since the higher C/A ratio should give a higher corrosion rate<sup>6</sup> (Figure 9), the observation is contrary to that expected and may be a result of a shift in the corrosion potential inside the crevice above the active corrosion potential of pure titanium.

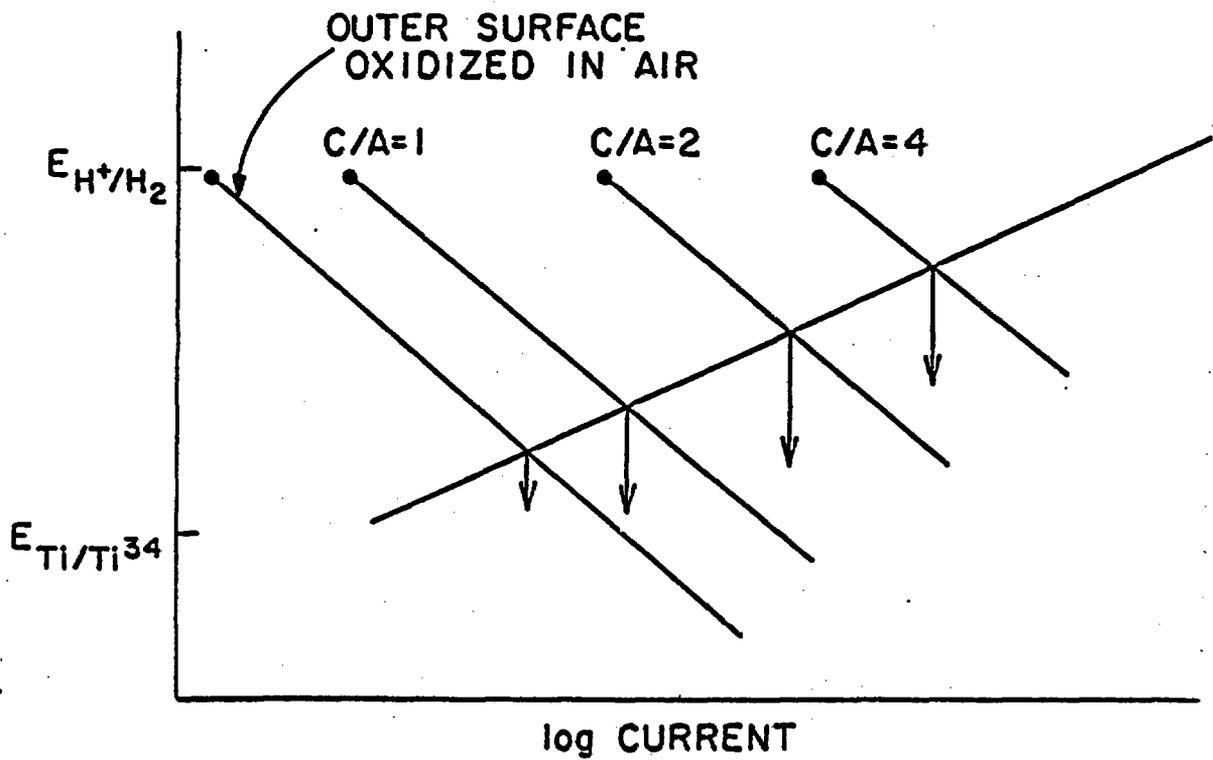
Figure 9. Effect of cathodic/anode ratio on the corrosion potential and corrosion current. Anodic curve is for titanium dissolution while cathodic curves are for hydrogen evolution reactions at various C/A ratios. The arrows indicate the corrosion currents.

The effects of surface finishes were also studied. The outer surface of two CP titanium crevice samples (2 cm x 2 cm) were oxidized in air,<sup>7</sup> and heated at 150°C in Brine A solution for 26 days. Samples with oxidized surfaces showed less crevice corrosion (weak violet and brass colored film or almost no visible corrosion), while the regularly finished sample showed a more bluish film. The outside oxide scale may have reduced the cathodic reaction and caused less corrosion (Figure 9).

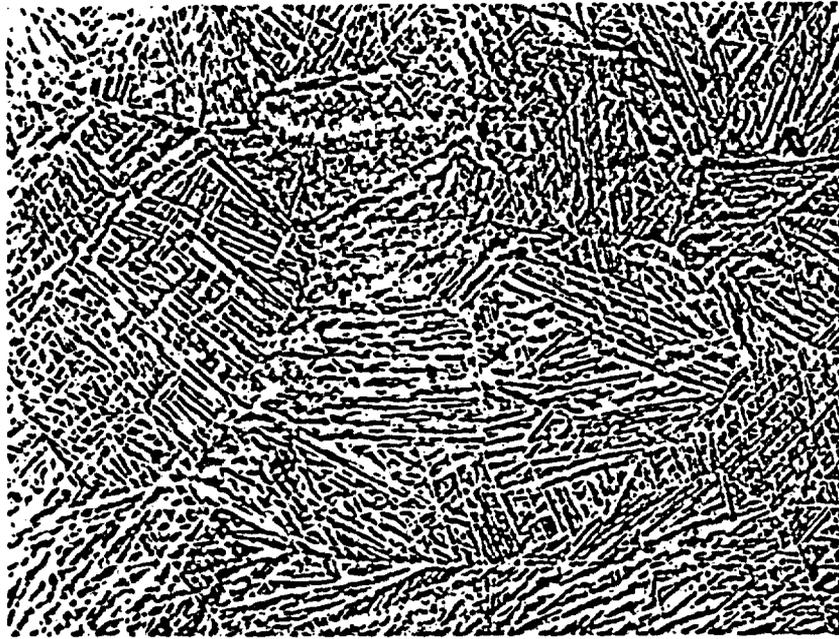
Figure 10. Microstructure of welded TiCode-12: a. heat affected zone and b. the unaffected area.

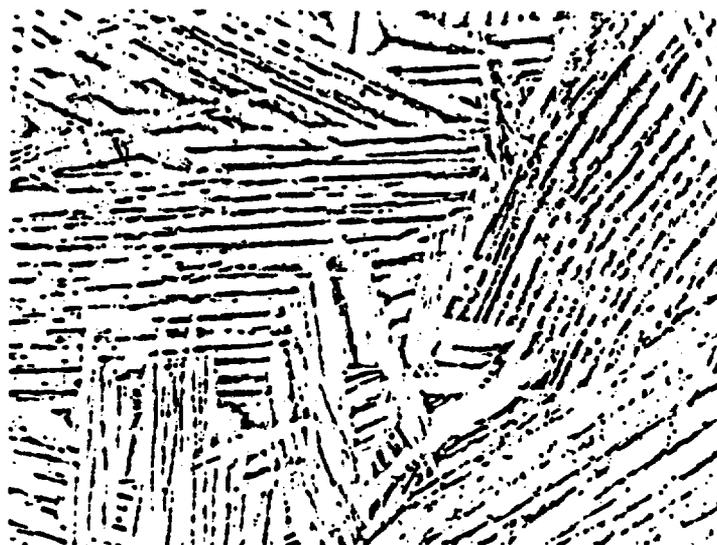
Figure 11. Recrystallized alpha phase formed in welded CP titanium.

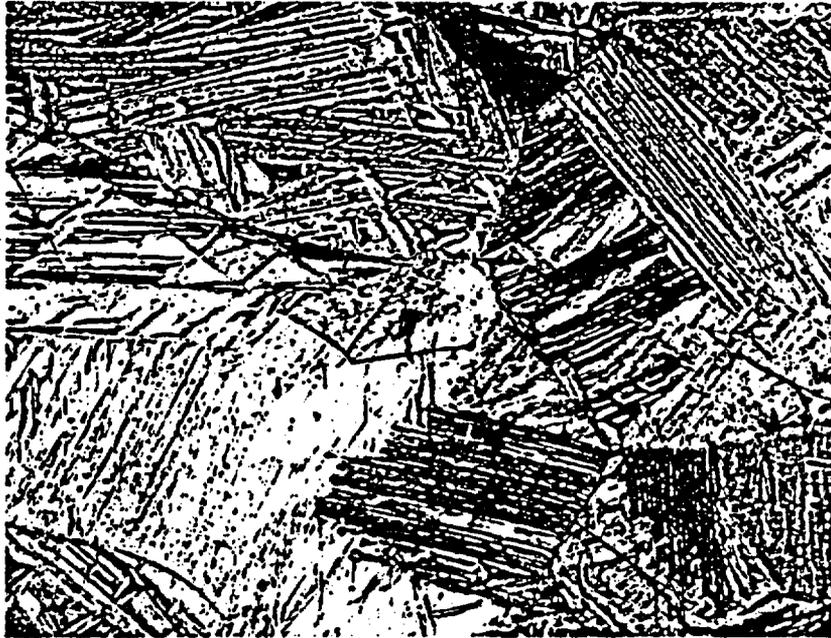
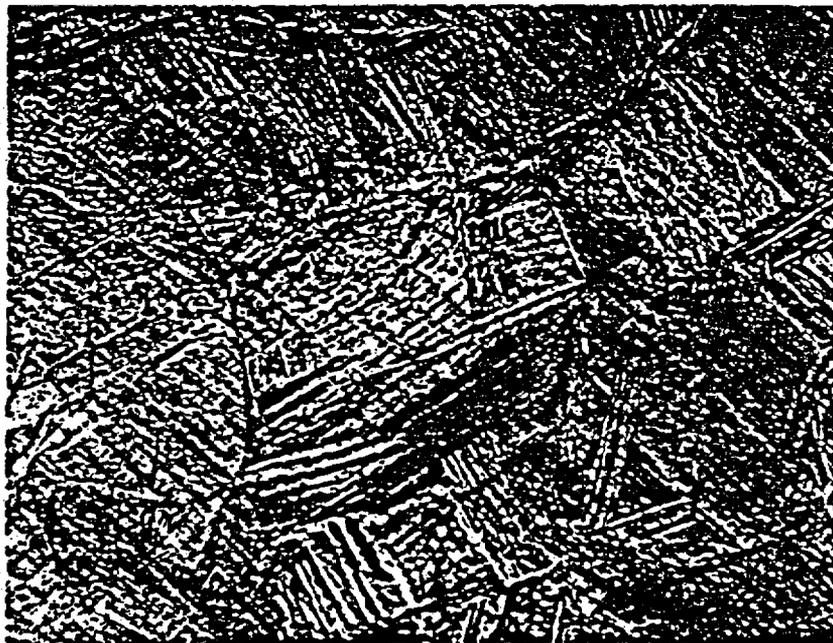
Figure 12. Heat affected zone on a typical corroded surface on welded TiCode-12.

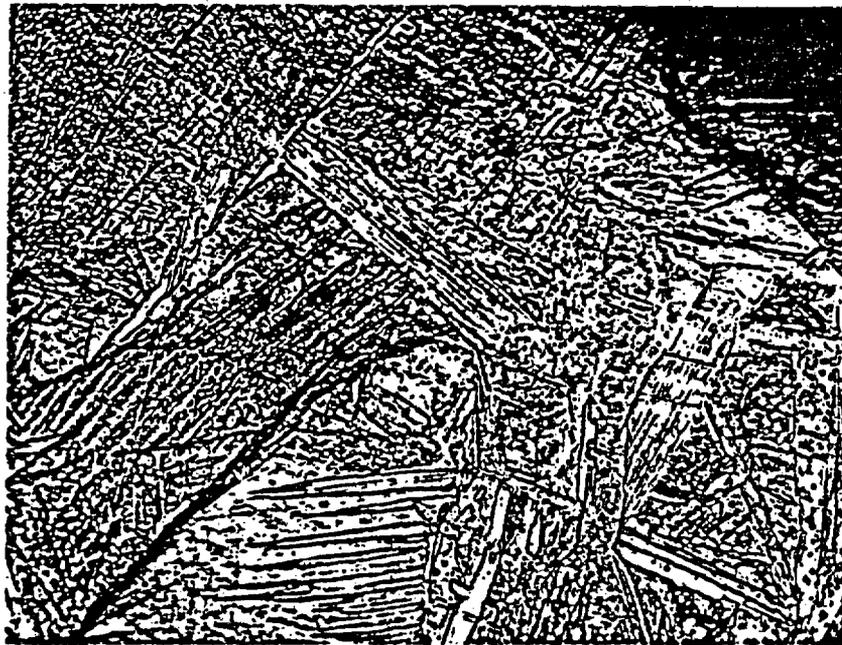
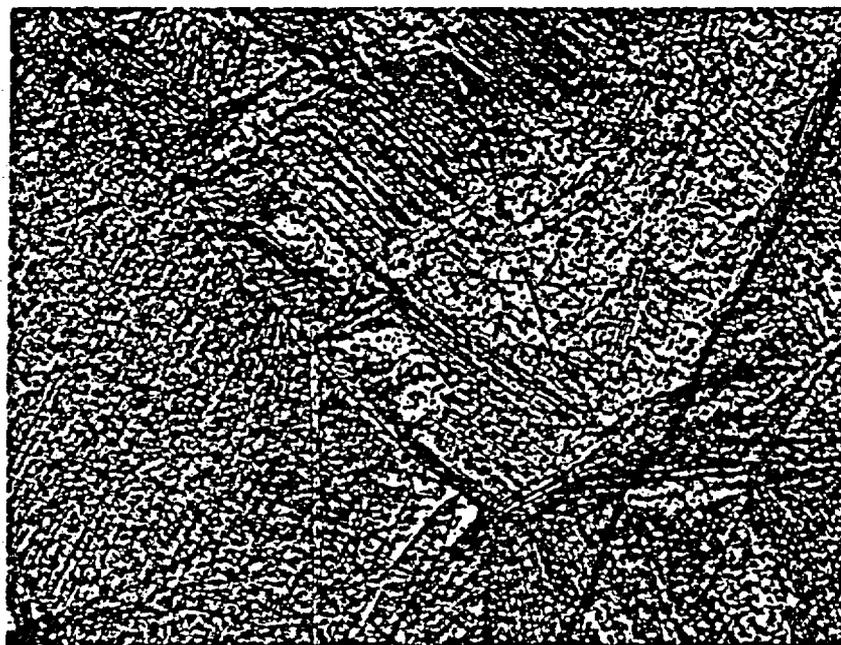
Figure 13. Heavily heat affected zone on a typical corroded surface on welded CP titanium.

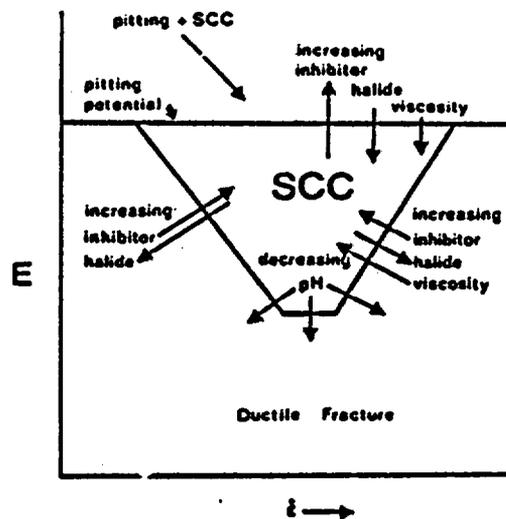
Figure 14. Schematic diagram of the relationship between potential and crack tip strain rate, determining conditions under which a crack tip cracking solution is achieved and maintained.<sup>13</sup>

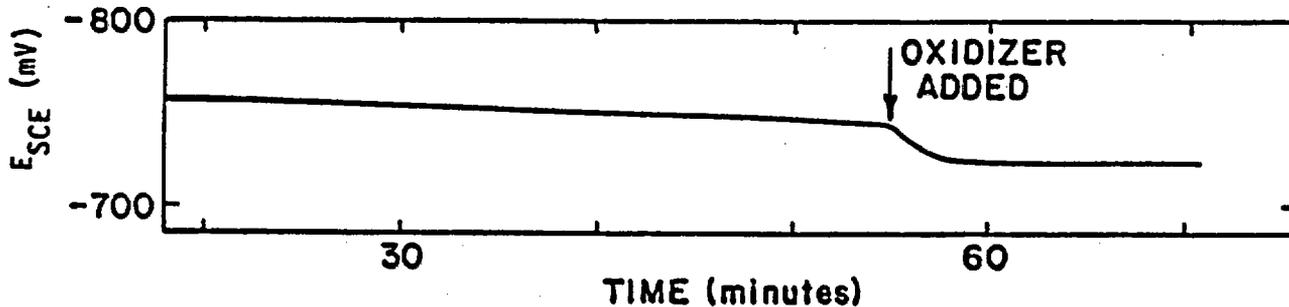
Figure 15. Corrosion potential change of TiCode-12 by the addition of an oxidizer to Brine B at room temperature.

The effect of the oxidizer (produced by radiolysis) on the open circuit corrosion potential has been studied for TiCode-12 in WIPP Brine B. For a concentration of 33,000 ppm  $HClO_3$ , change in the potential has been observed, which is an indication of enhanced susceptibility to stress corrosion cracking in this material.

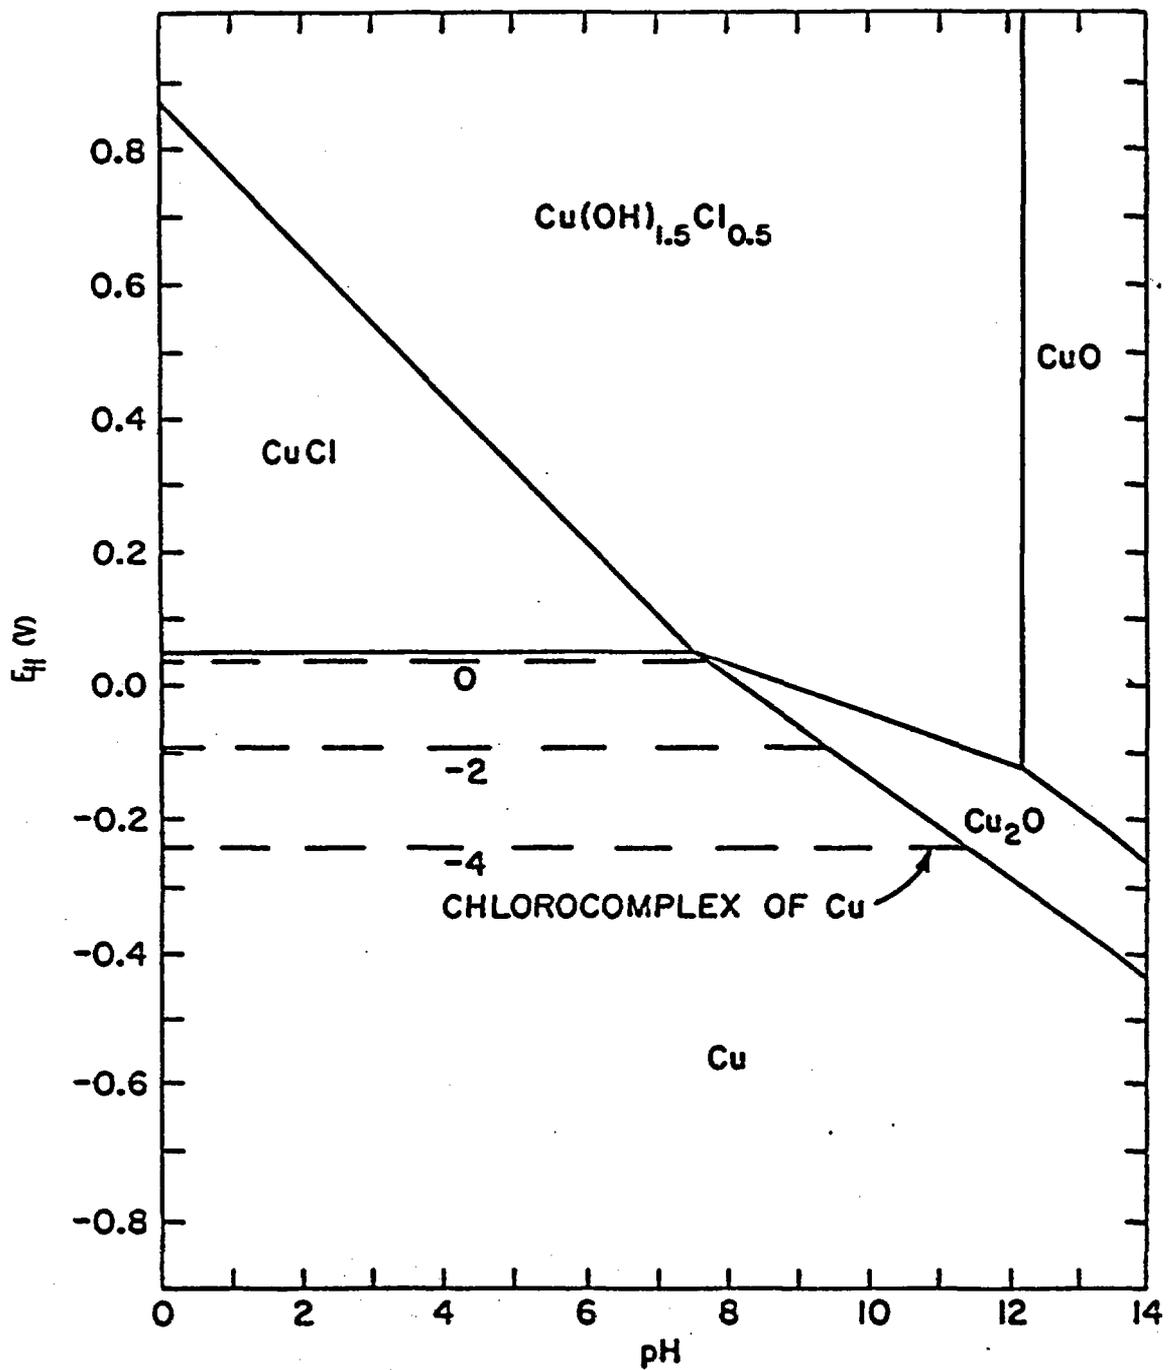
Figure 16. Potential-pH equilibrium diagram for the system copper-Brine A and B at 100°C.

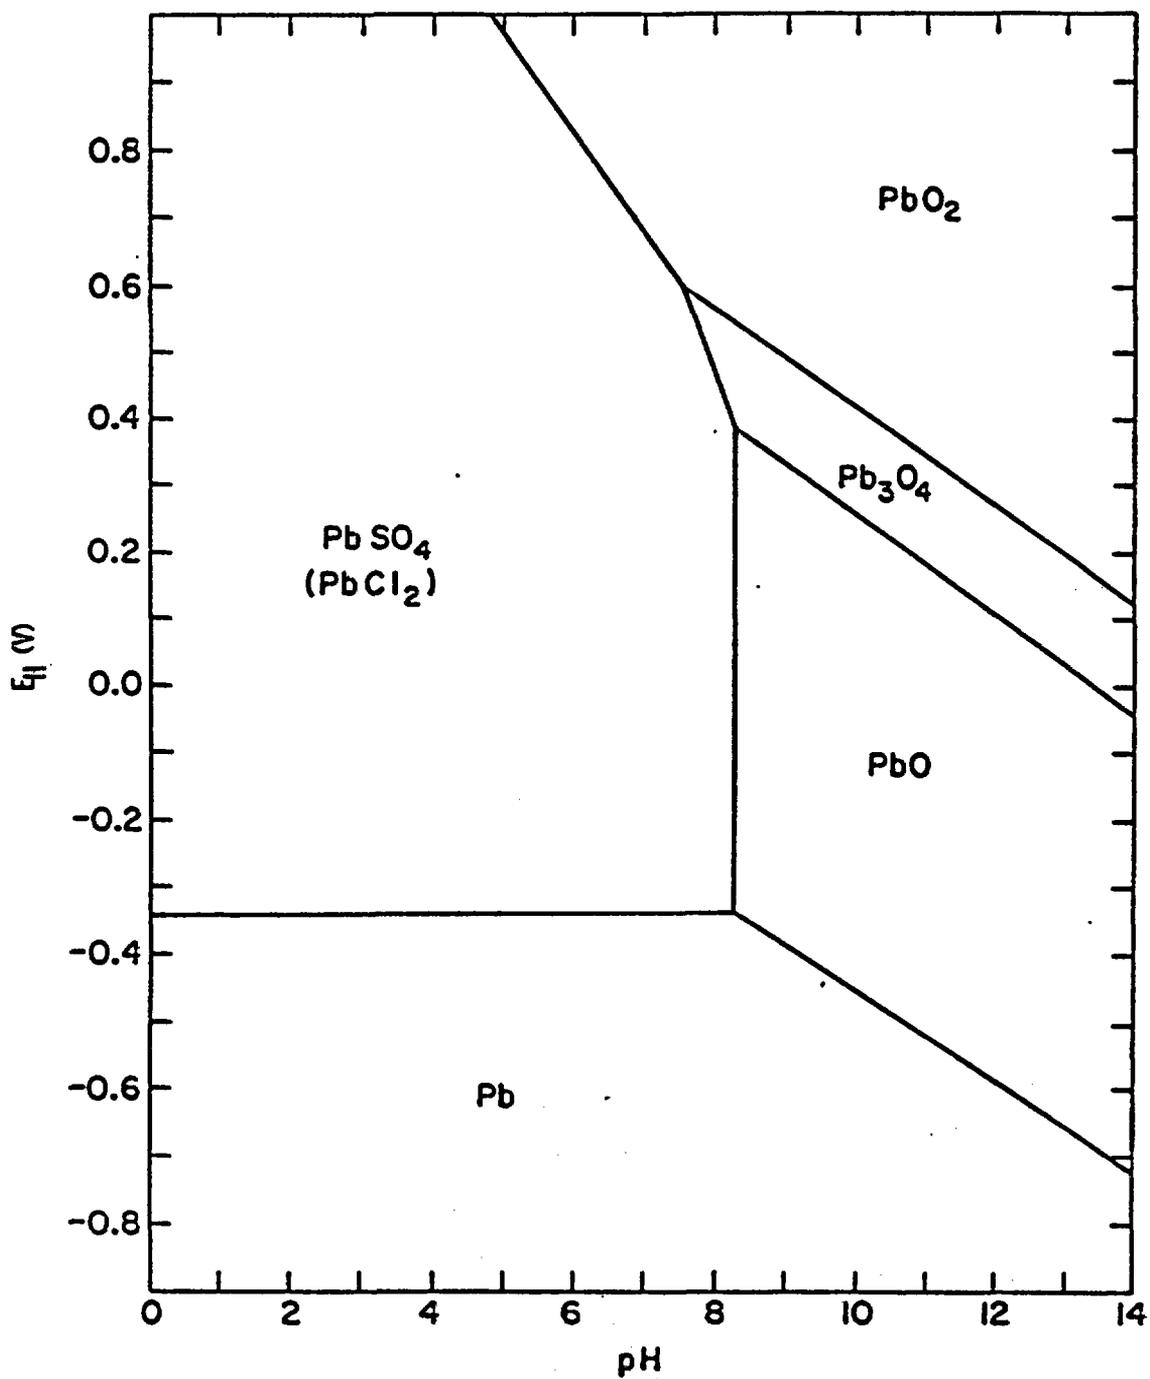
Figure 16. Potential-pH equilibrium diagram for the system lead-Brine A and B at 100°C.

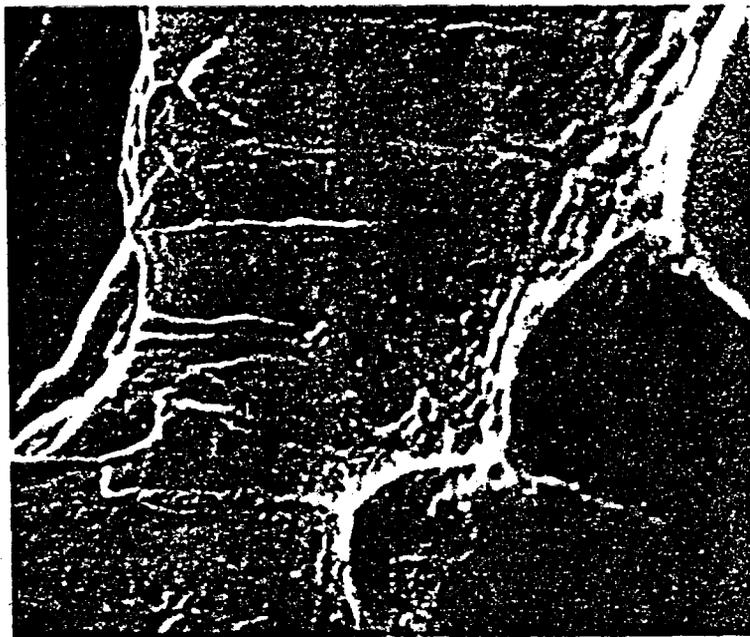
Figure 17. a. Type I cleavage and b. type II cleavage in cathodically charged and subsequently homogenized CP titanium.

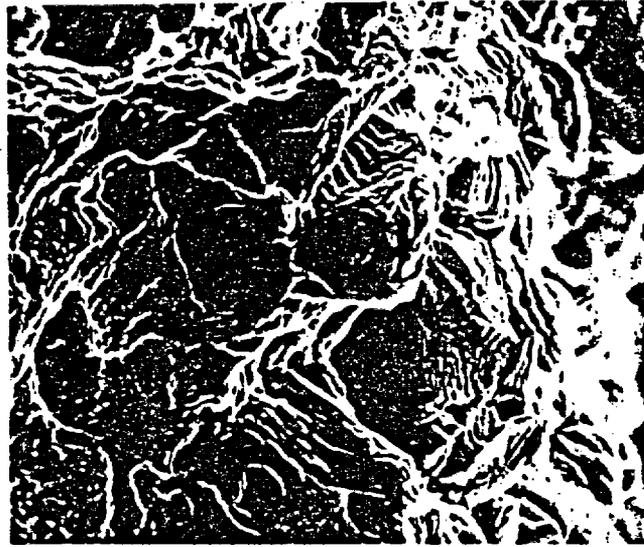
Figure 17. Crack arrest marking in cathodically charged and subsequently homogenized CP titanium.

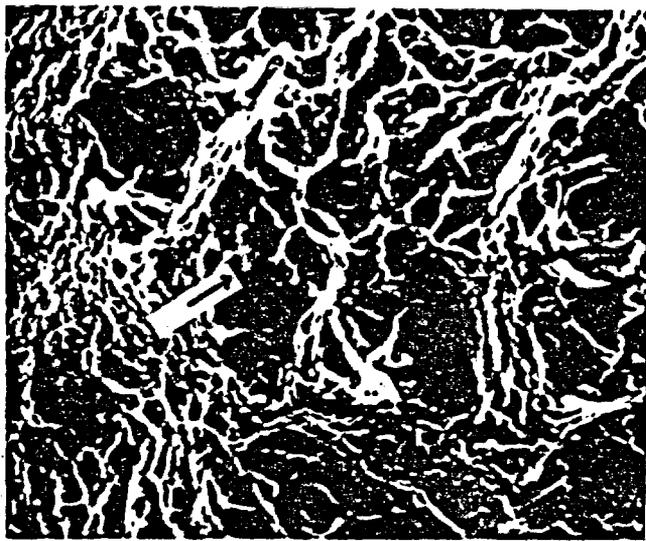
Figure 18. Beta phase observed in as received TiCode-12.

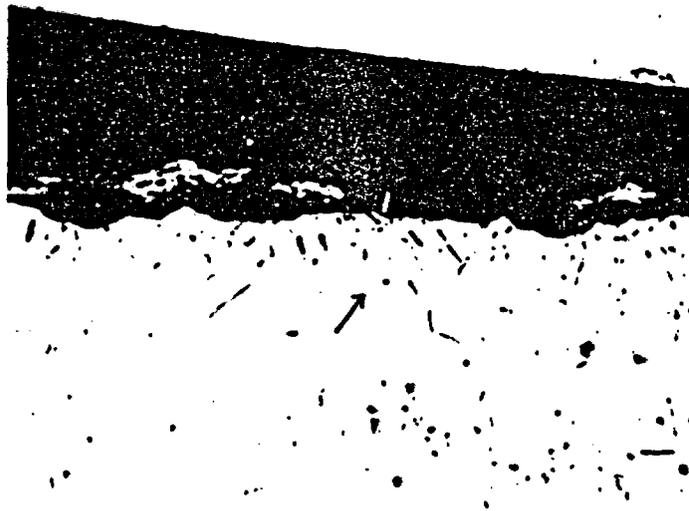
Figure 22. Hydride needles formed at the edges of cathodically charged CP titanium.

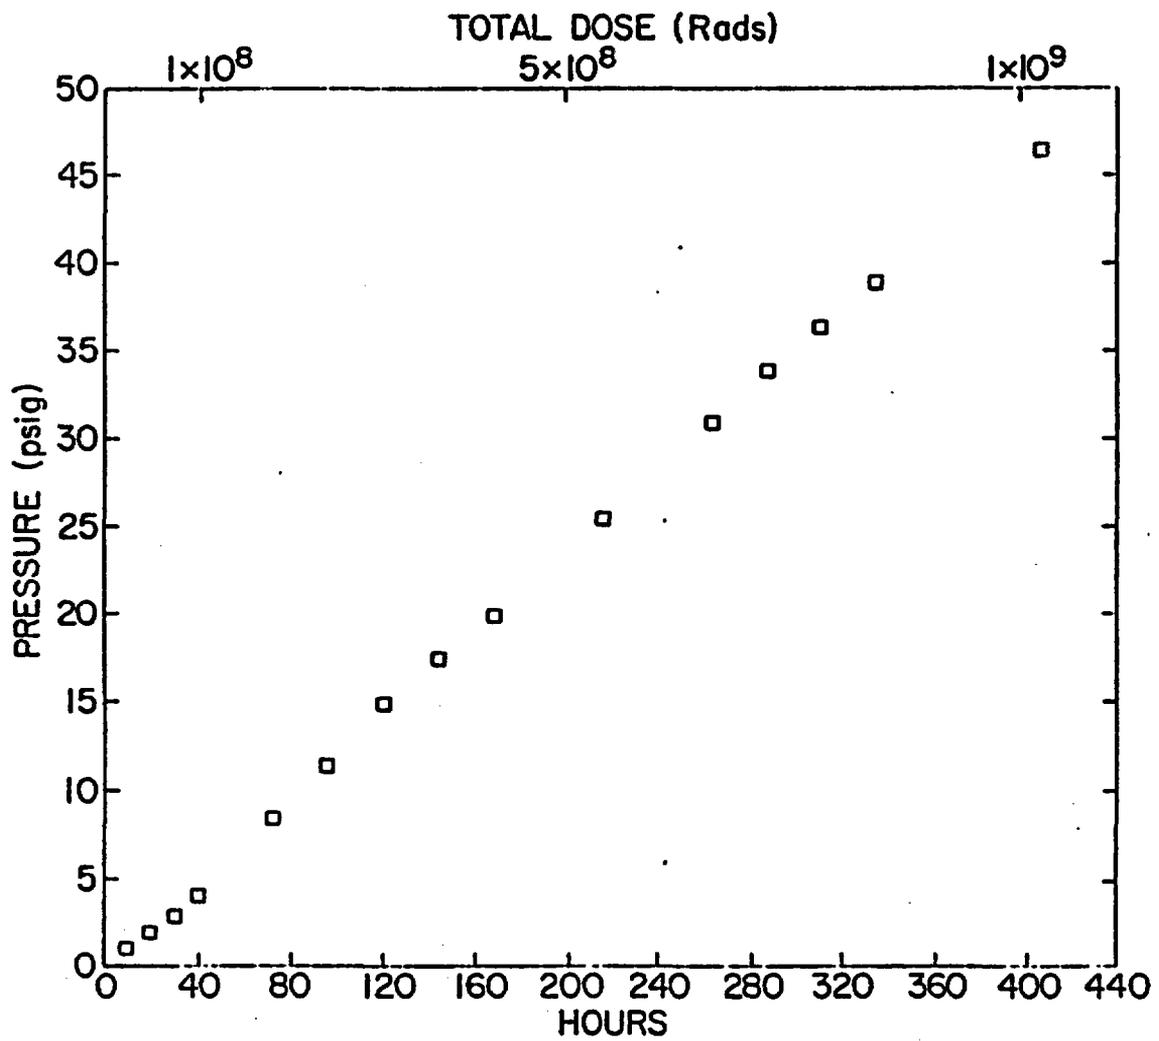
Figure 23. Pressure build-up during gamma irradiation of Brine A at a dose rate of approximately  $4 \times 10^6$  rads/hr and a total dose of  $1.2 \times 10^9$  rads.

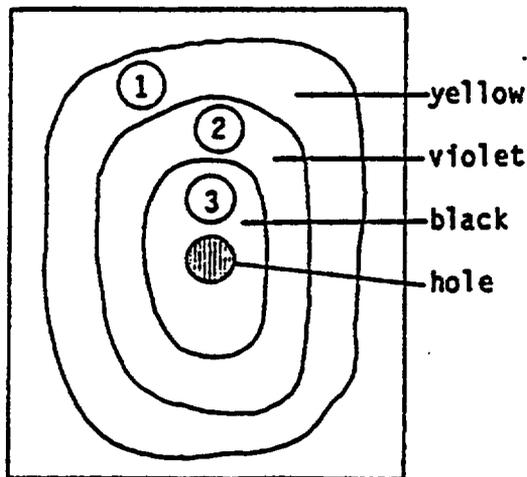
Figure 5. CP titanium crevice corrosion specimen from which TEM samples were prepared. 1, 2, and 3 denote the locations of the areas studied. The crevice specimen was immersed in Brine A at 150°C for 12 weeks.

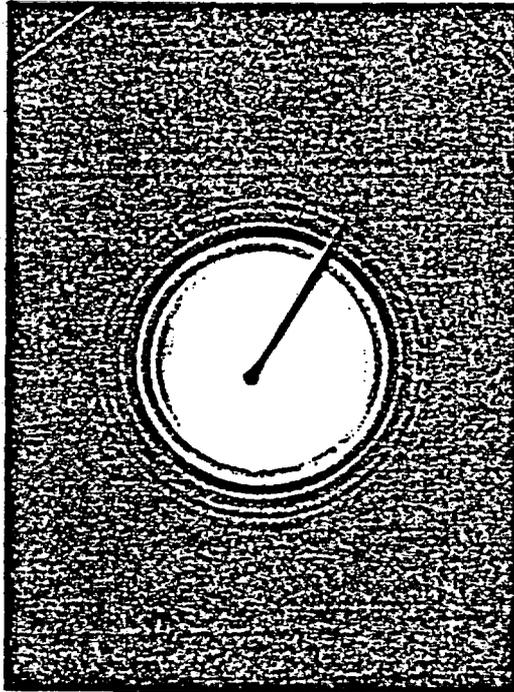
Figure 7a. Electron diffraction pattern from the violet film inside the TiCode-12 crevice.

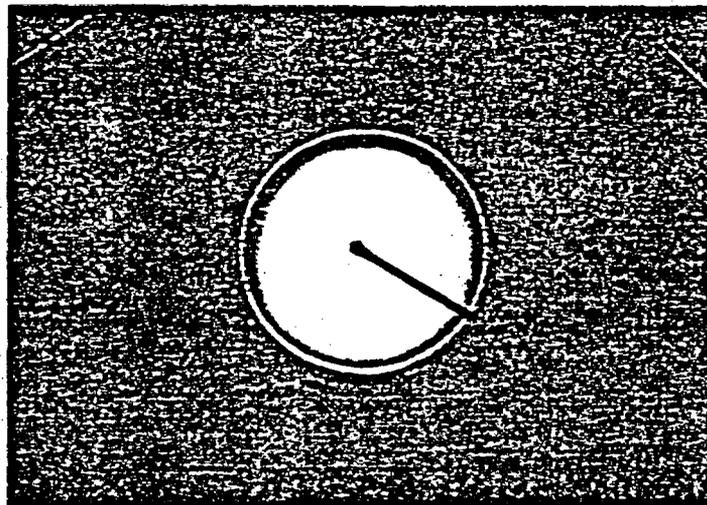
Figure 7b. Electron diffraction pattern from the blue film formed on CP titanium by gas flame oxidation in air.

To compare the difference between the oxides present in the crevices and an air-formed oxide, an oxide film was formed in air on CP titanium using a gas flame. Electron diffraction patterns obtained from this film accurately matched those of the rutile form of  $\text{TiO}_2$ . The electron diffraction patterns from the crevice corrosion product and the air-formed oxide film are compared in Figures 7a and 7b. The two patterns are distinctly different. It is interesting to note that there was no trace of the rutile form of  $\text{TiO}_2$  inside the crevices of CP titanium or TiCode-12 exposed to brine.

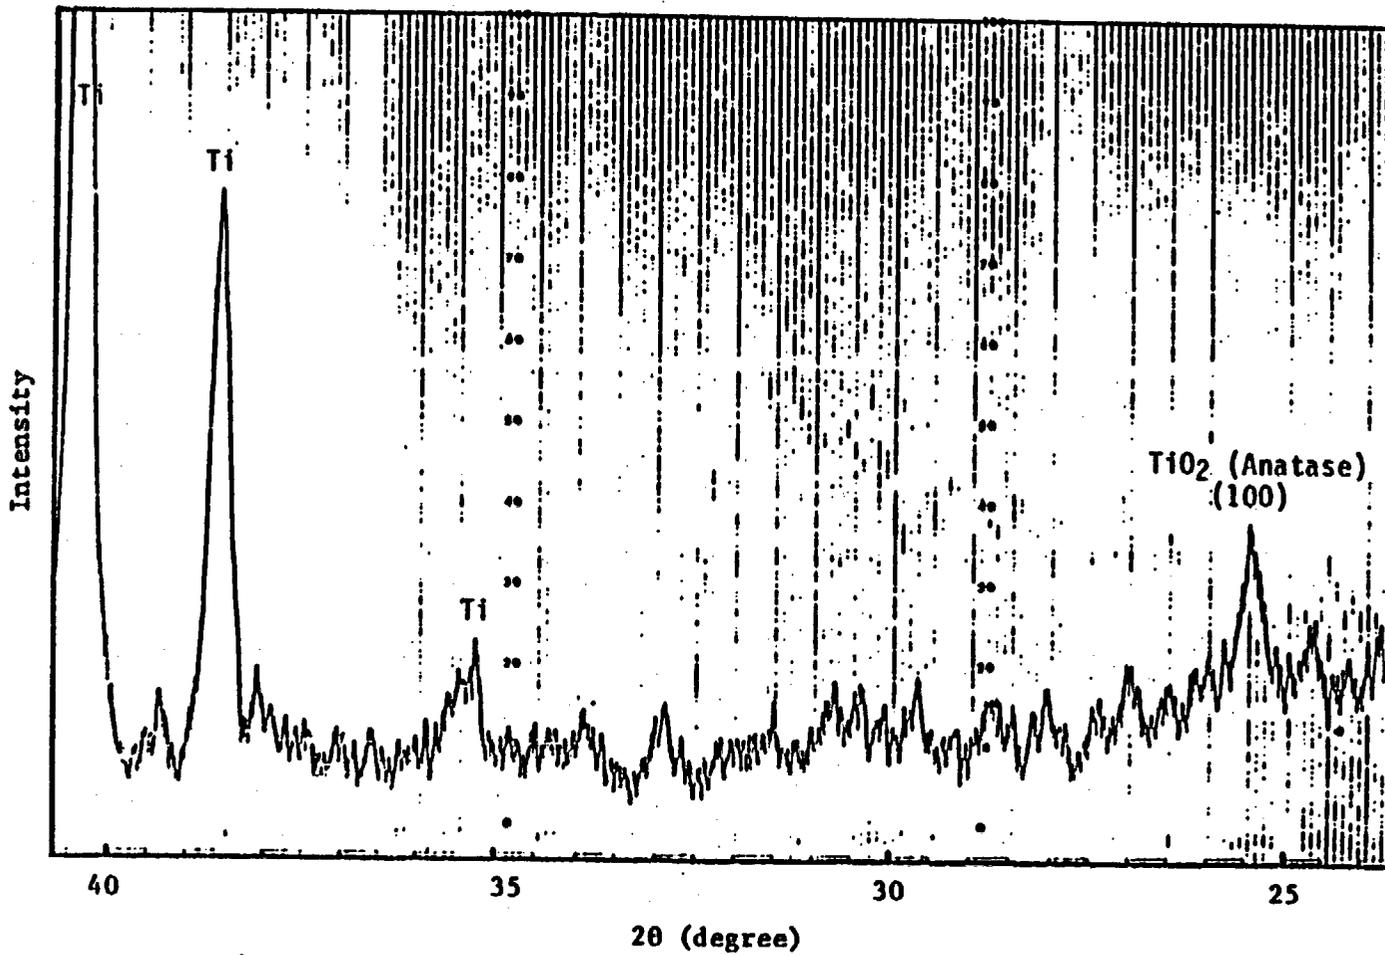
Figure 8. X-ray diffraction pattern of the crevice corrosion product of CP titanium.

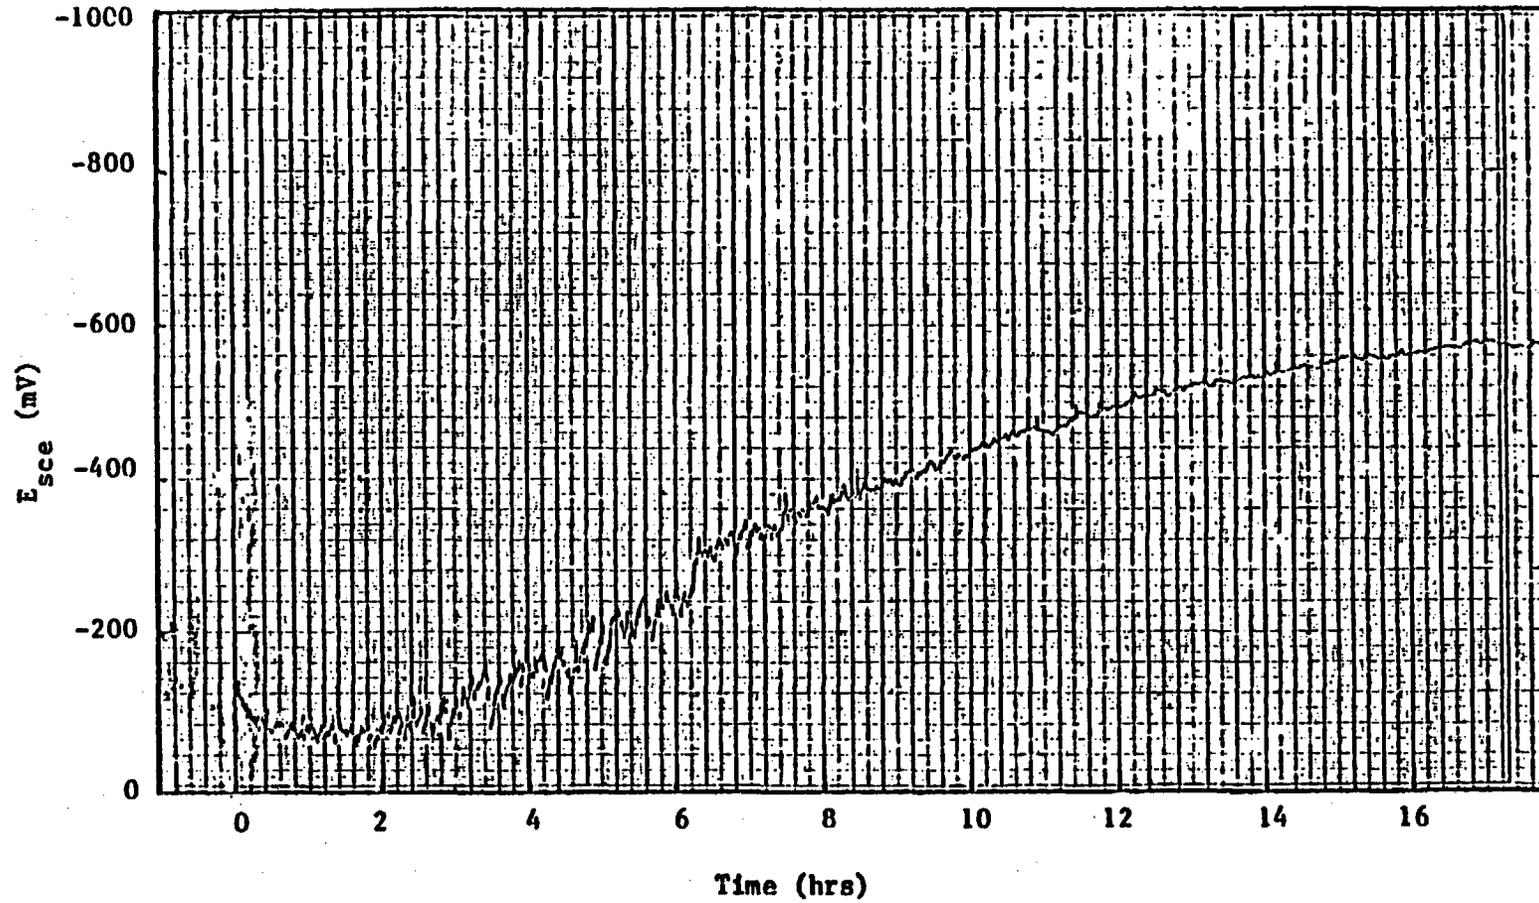
Figure 9. Open-circuit corrosion potential of CP titanium in acidified Brine A at 80°C.

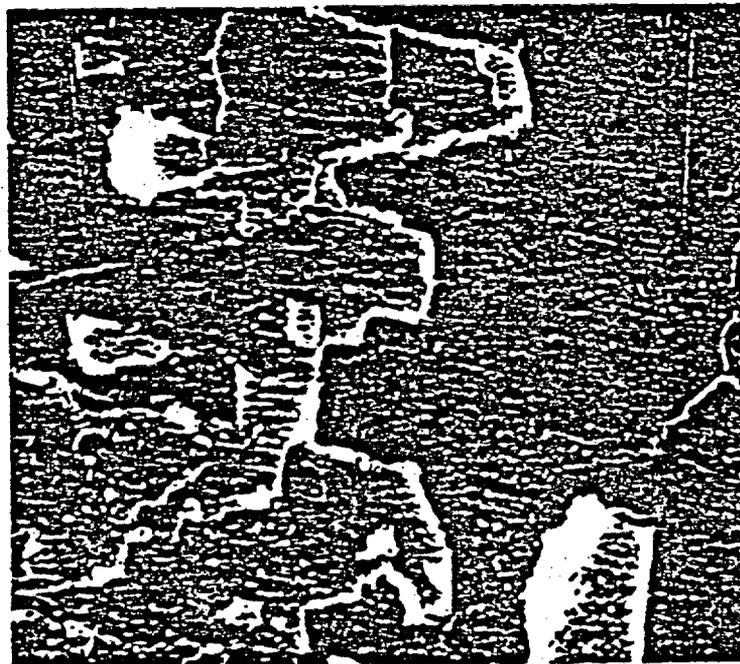
Figure 13. Hydrogen induced interface facets observed after rotation of the sample position in Figure 12.

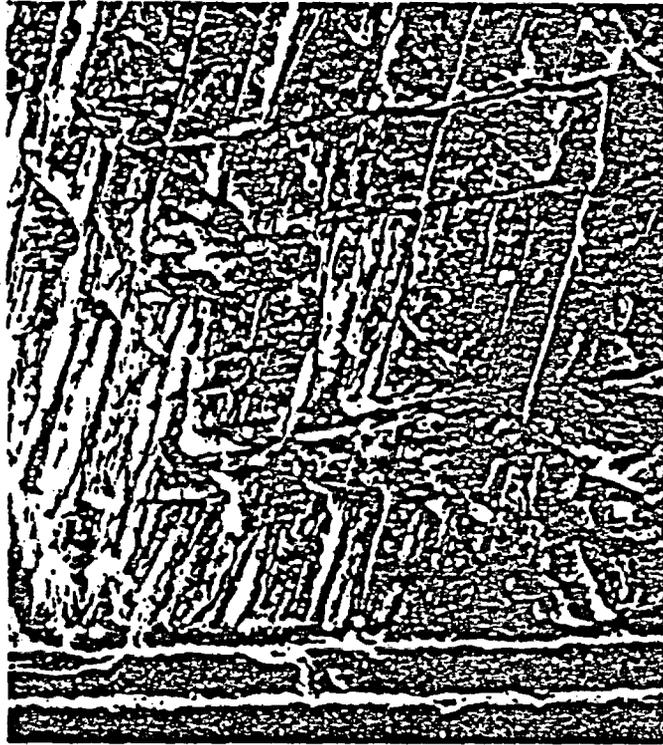
Figure 16. Fracture surface of TiCode-12 with hydrogen concentration above 5000 ppm showing crystallographic fracture, magnification 1000X.

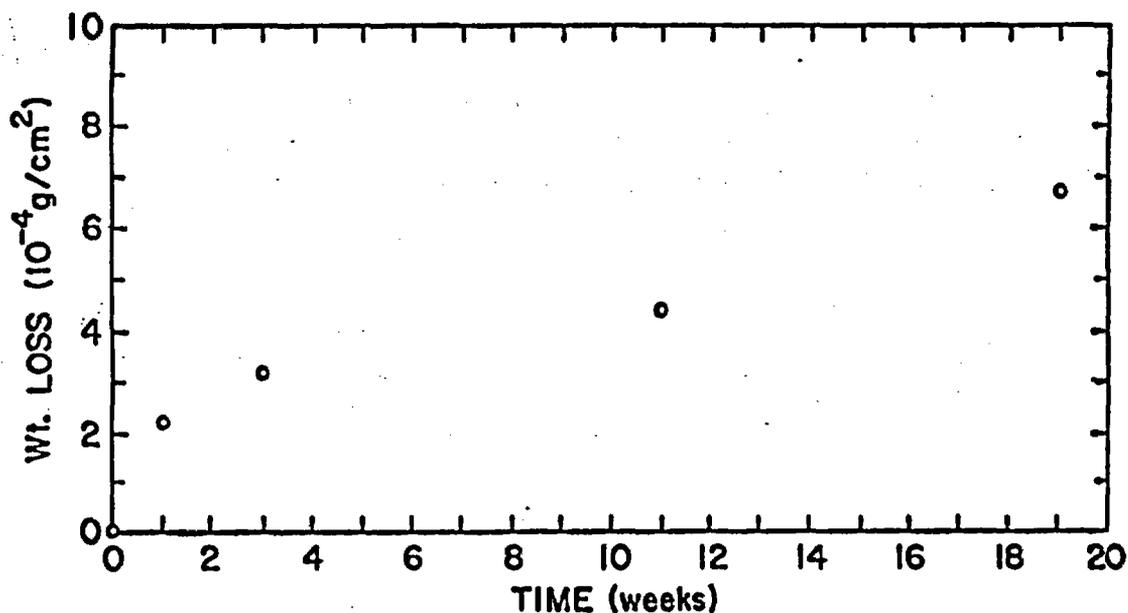
Figure 3. Kinetics of uniform corrosion for copper at 150°C.

Figure 3 shows the weight loss of copper as a function of exposure. The results are in agreement with previous results.<sup>12</sup> Oxygen consumption and solubility limits are being analyzed to understand these results. Table 4 shows the corrosion rates of TiCode-12, EB (Electron Beam Weld) TiCode-12 and EB titanium. The result for TiCode-12 is in agreement with previous data.<sup>3</sup> Welded samples generally show higher weight losses compared with non-welded samples in the same environment.

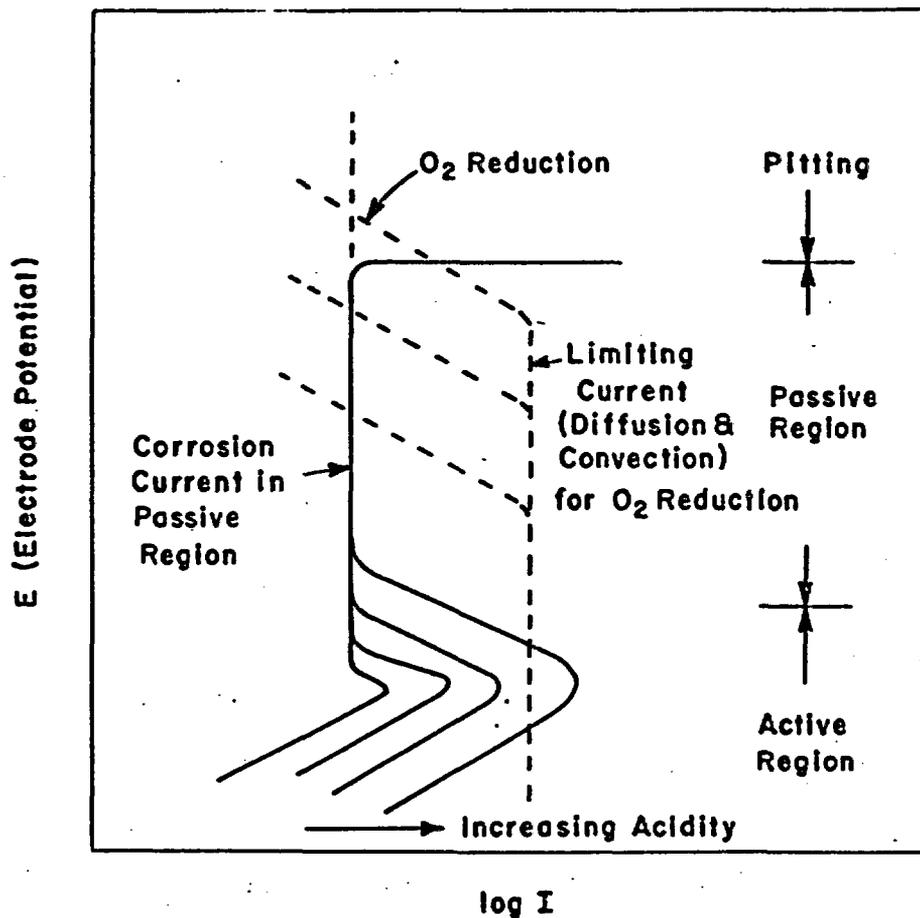
Figure 4. Schematic diagram of polarization curves for commercially pure titanium in chloride solution.<sup>13</sup>

Figure 4 shows a schematic diagram of polarization curves for commercially pure titanium in chloride<sup>13</sup> solution as a standard. At a scanning rate of 1 mV/sec, the polarization curves for pure titanium and TiCode-12 are different at room temperature (Figure 5). Titanium shows an active peak at  $\sim -770$  mV (SCE) while TiCode-12 does not.

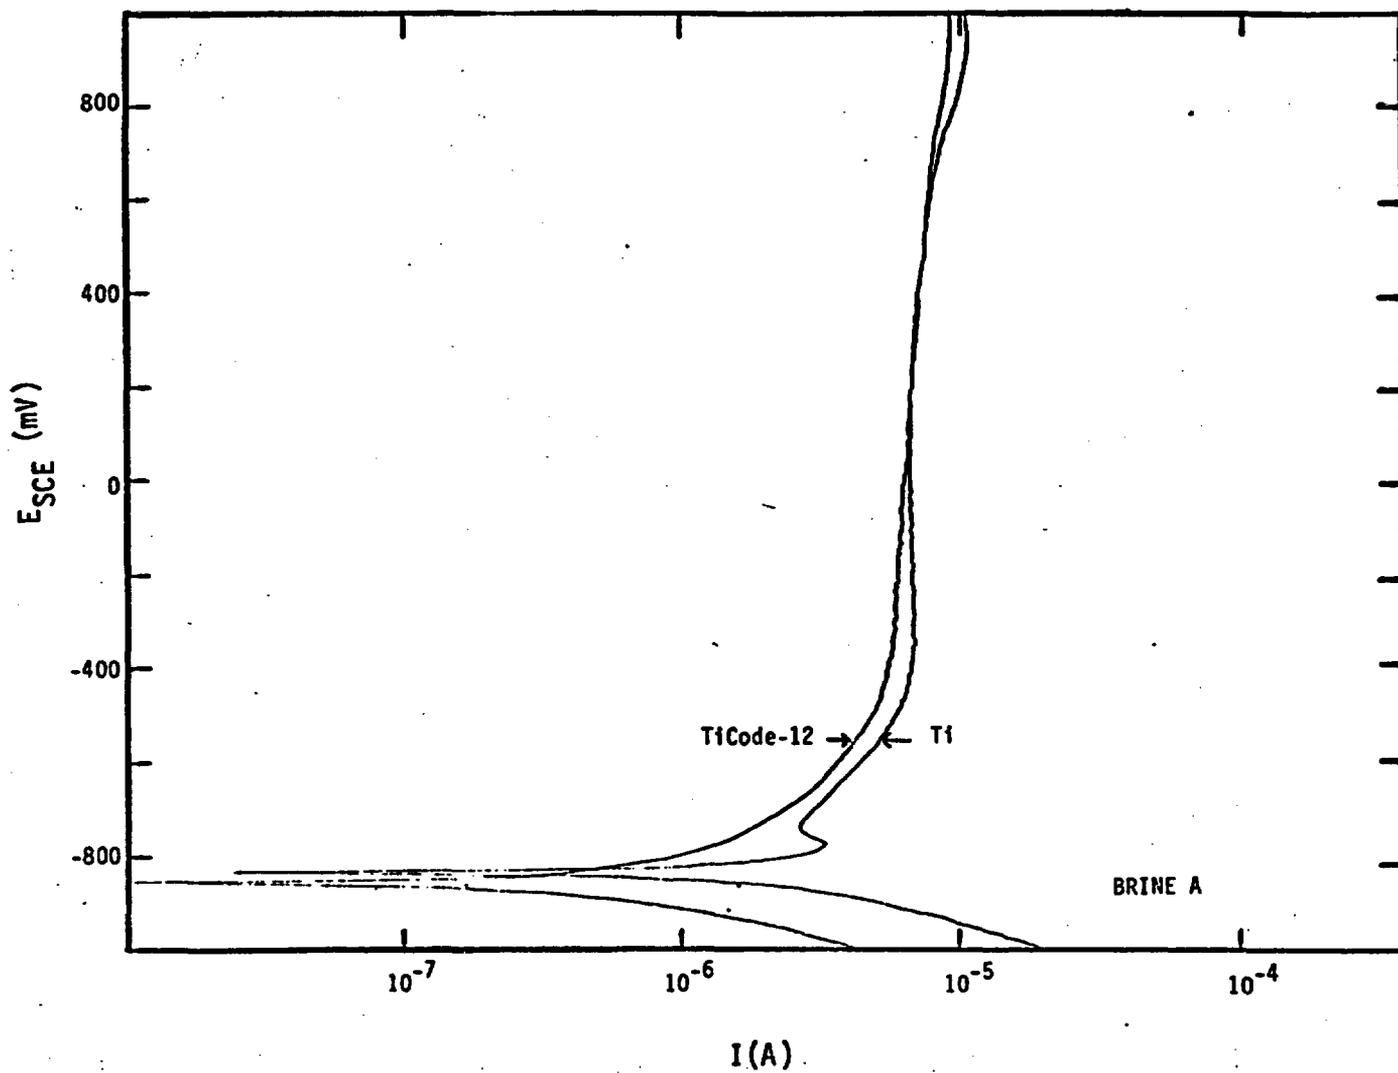
Figure 5A. The polarization curve for titanium Grade 2 and TiCode-12 in Brine A at room temperature.
