Distribution: w/o encl.  
WM file  
WMHL r/f  
NMSS r/f  
JBMartin  
REBrowning  
MJBell  
FRCook & r/f  
HJMiller  
JOBunting  
PDR

Enclosures: BNL Quarterly Reports:  
BNL-NUREG-51499, Vol. 1, No. 3; Vol. 1,  
No. 4 and Vol. 2, No. 1.

**CONTAINER ASSESSMENT — CORROSION STUDY  
OF HLW CONTAINER MATERIALS**

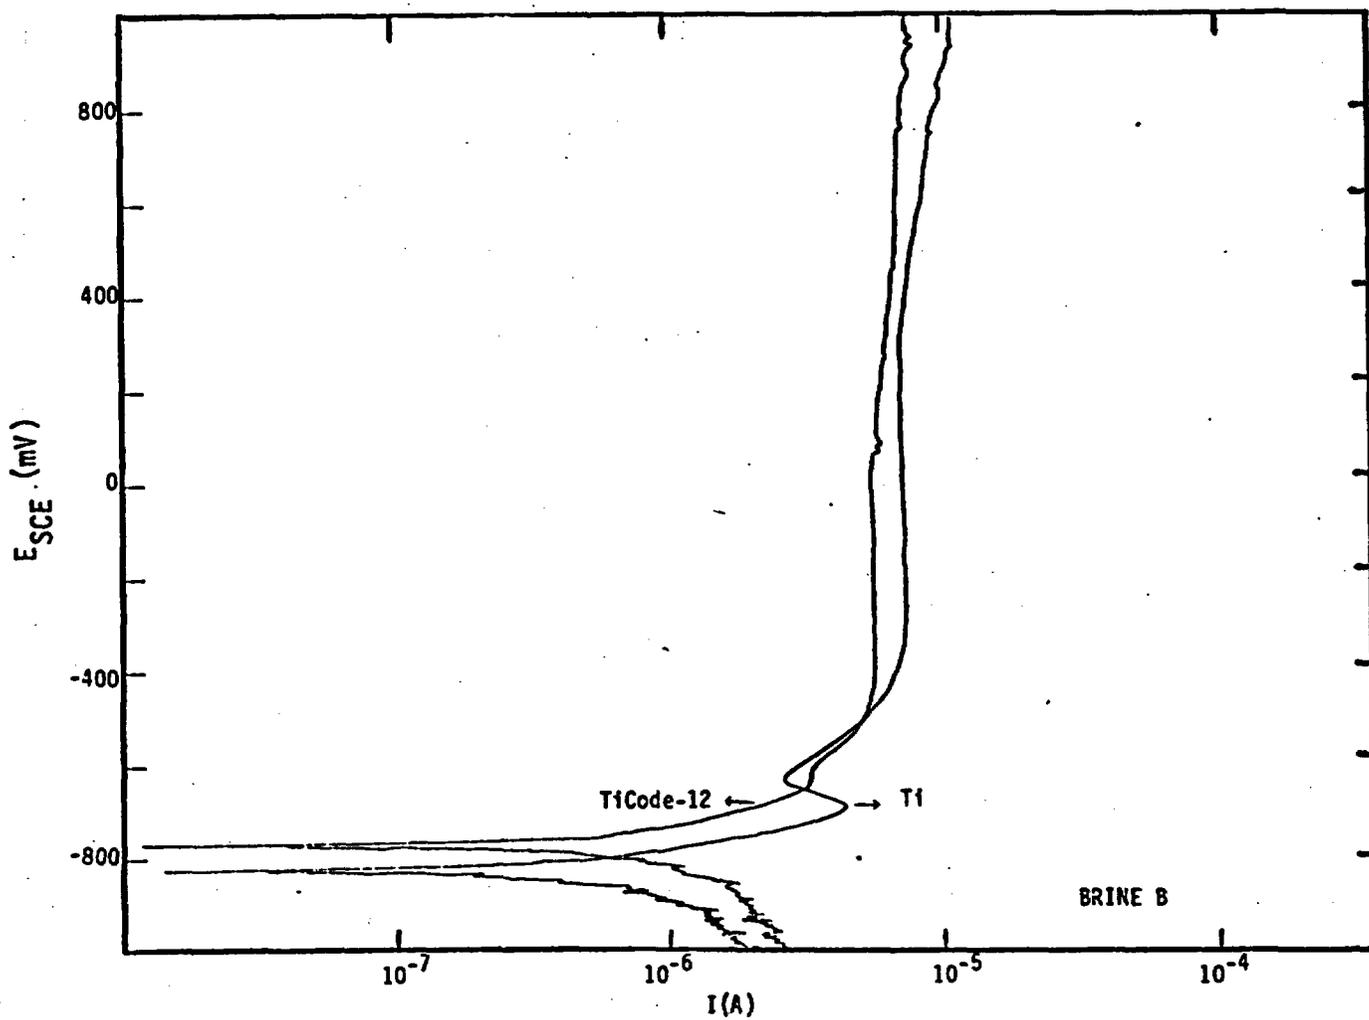
Figure 5B. The polarization curve for titanium Grade 2 and TiCode-12 in Brine B at room temperature.

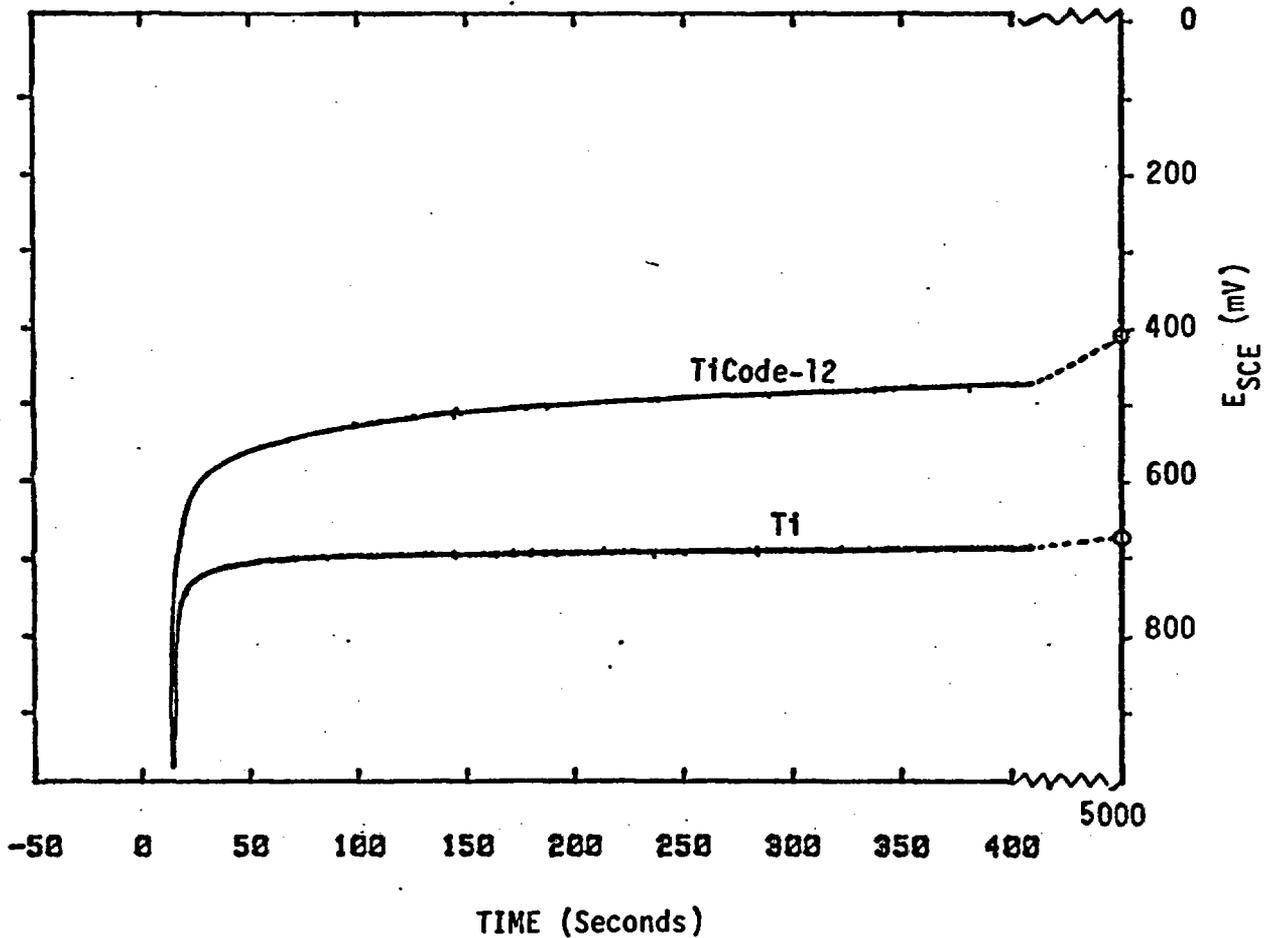
Figure 6. The open-circuit potential transient of Titanium and TiCode-12 at 85°C in 0.1 M HCl + 0.9 M KCl at 85°C.

Experiments were also performed in which the whole exposed surface of rotating titanium and TiCode-12 electrodes were abraded under a deoxygenated solution of 0.1 M HCl and 0.9 M KCl (pH 1). This solution is considered representative of a crevice corrosion environment.<sup>14</sup> Both open circuit and potentiostatic measurements were made up to 100°C. Figure 6 is an example of the open-circuit potential transient behavior of titanium and TiCode-12 at 85°C. At 50°C and above, TiCode-12 seemed to passivate spontaneously at open circuit ( $E \sim -400$  mV (SCE)), while titanium remained at a low, active potential ( $E \sim -700$  mV (SCE)).

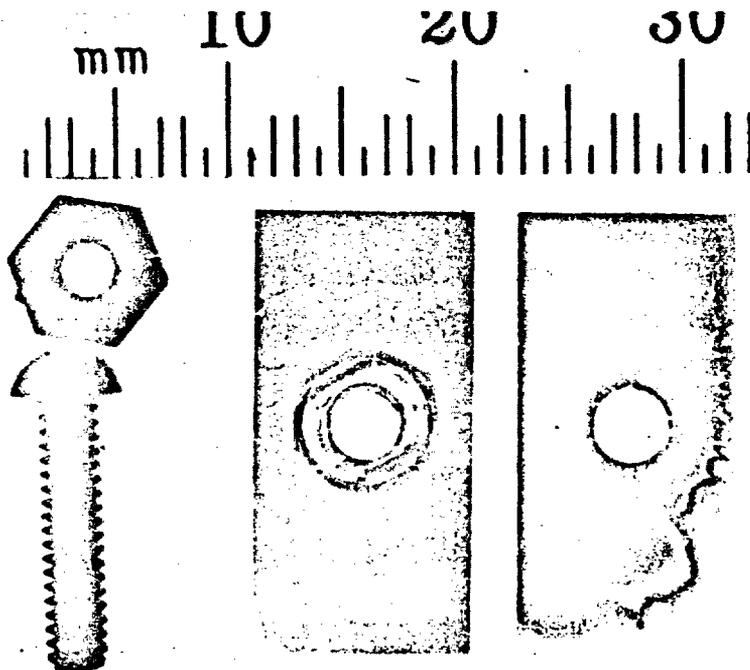
Figure 7. Simulated crevice by bolt-joining two coupons.

Titanium, TiCode-12 and EB TiCode-12 coupons were immersion-tested following the method described in the previous section on uniform corrosion. Titanium and TiCode-12 were mirror polished with 1 $\mu$  diamond paste and EB TiCode-12 was pickled to clean it. The crevice was simulated by joining two coupons with a nylon bolt through a hole made in the center of the coupons (Figure 7). The period of immersion was 12 weeks.

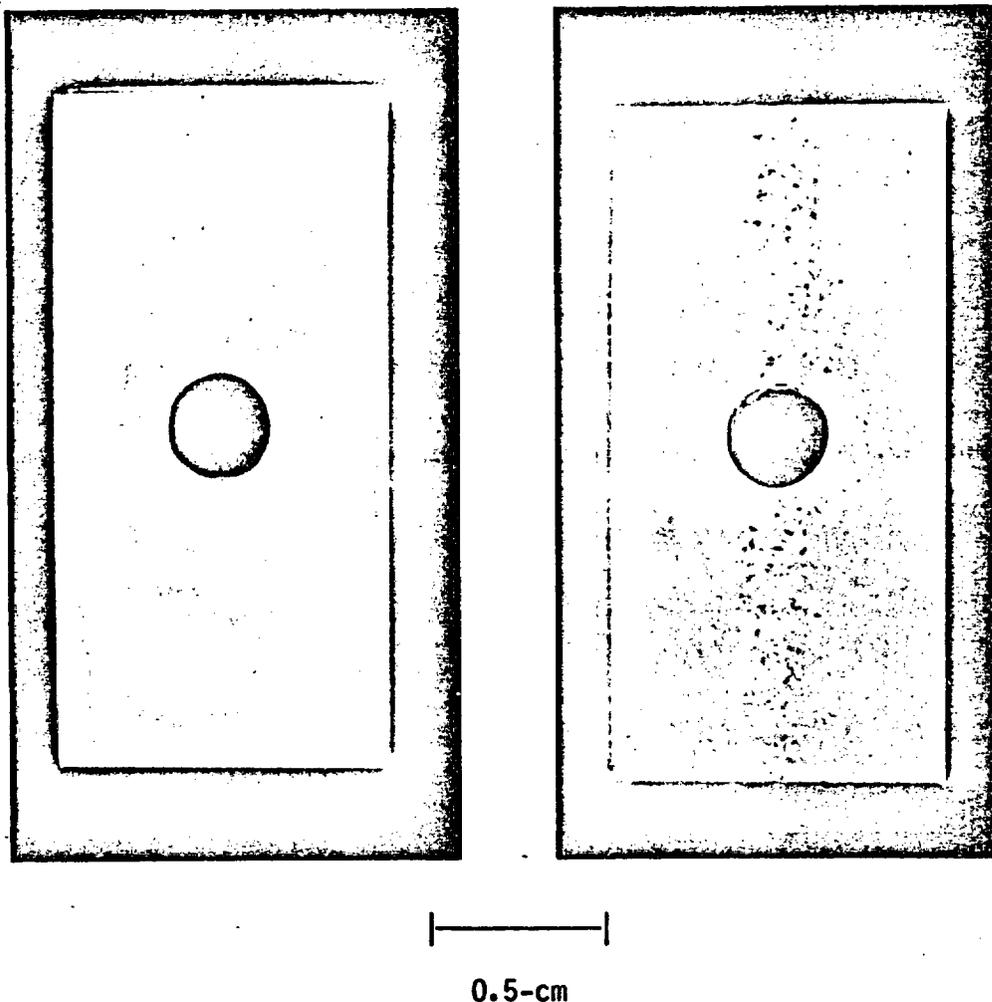
Figure 9. Corrosion product in the crevice of TiCode-12 and EB Ti-Code-12.

of immersion did not give any consistent trend in weight change probably because of the inconsistent crevice clearance. TiCode-12 and EB TiCode-12 showed only slight color change in the crevice after two weeks at this temperature (Figure 9). However, at higher temperatures (200°C), the film was formed more easily.

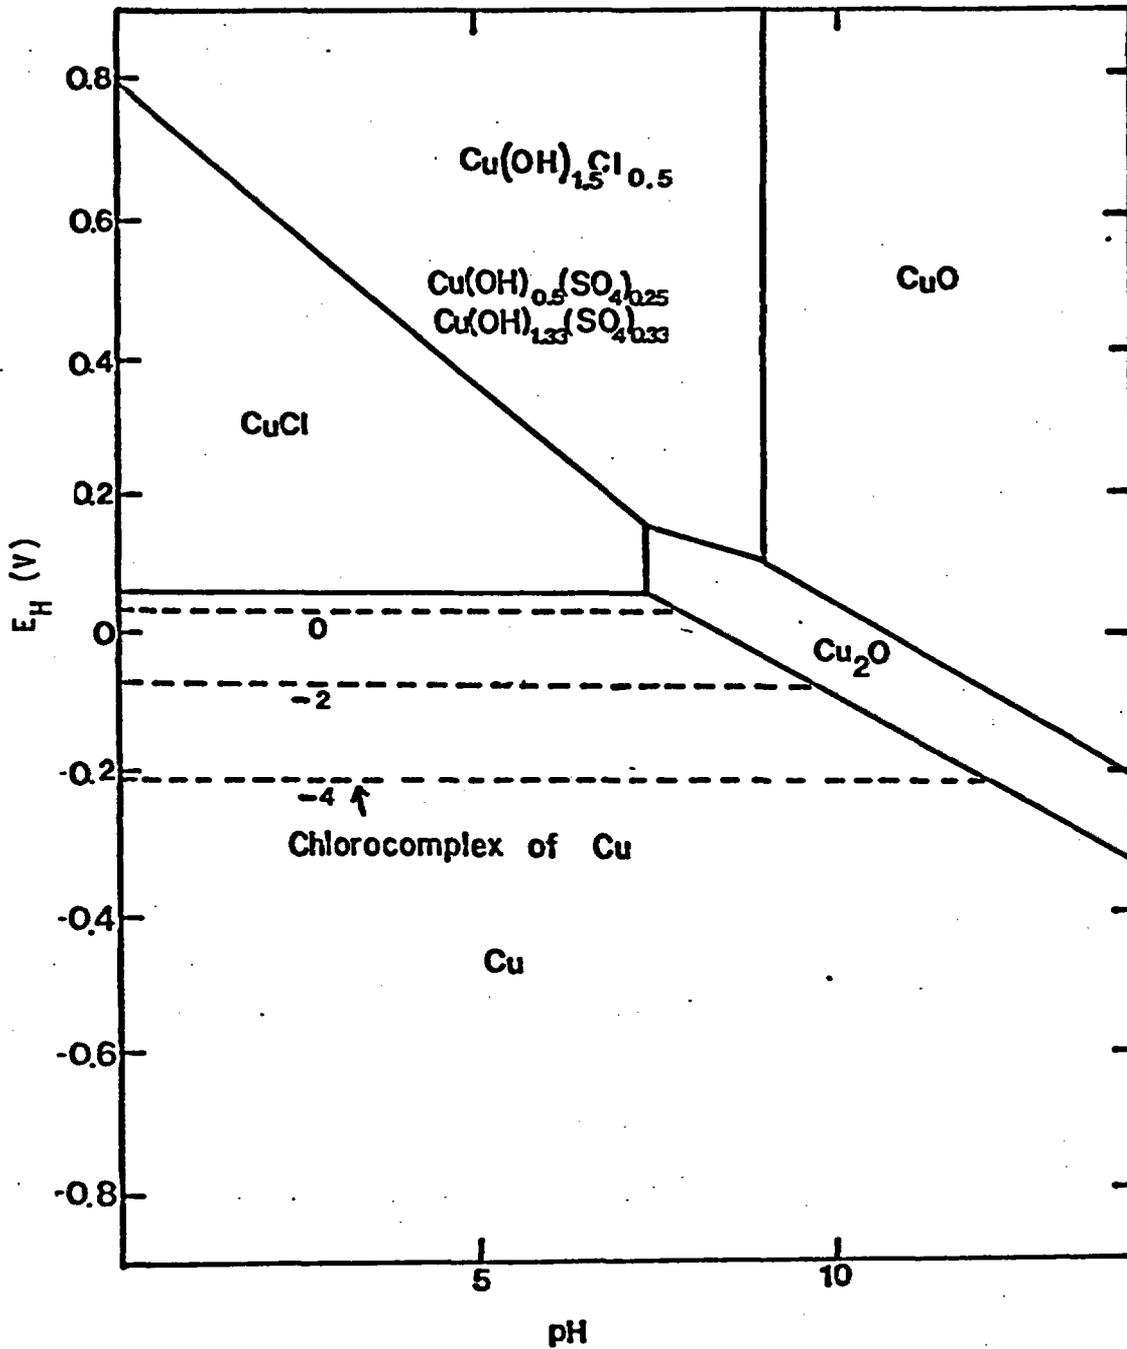
Figure 12. Potential-pH equilibrium diagram for the system Copper-Brine A and B at 25°C.

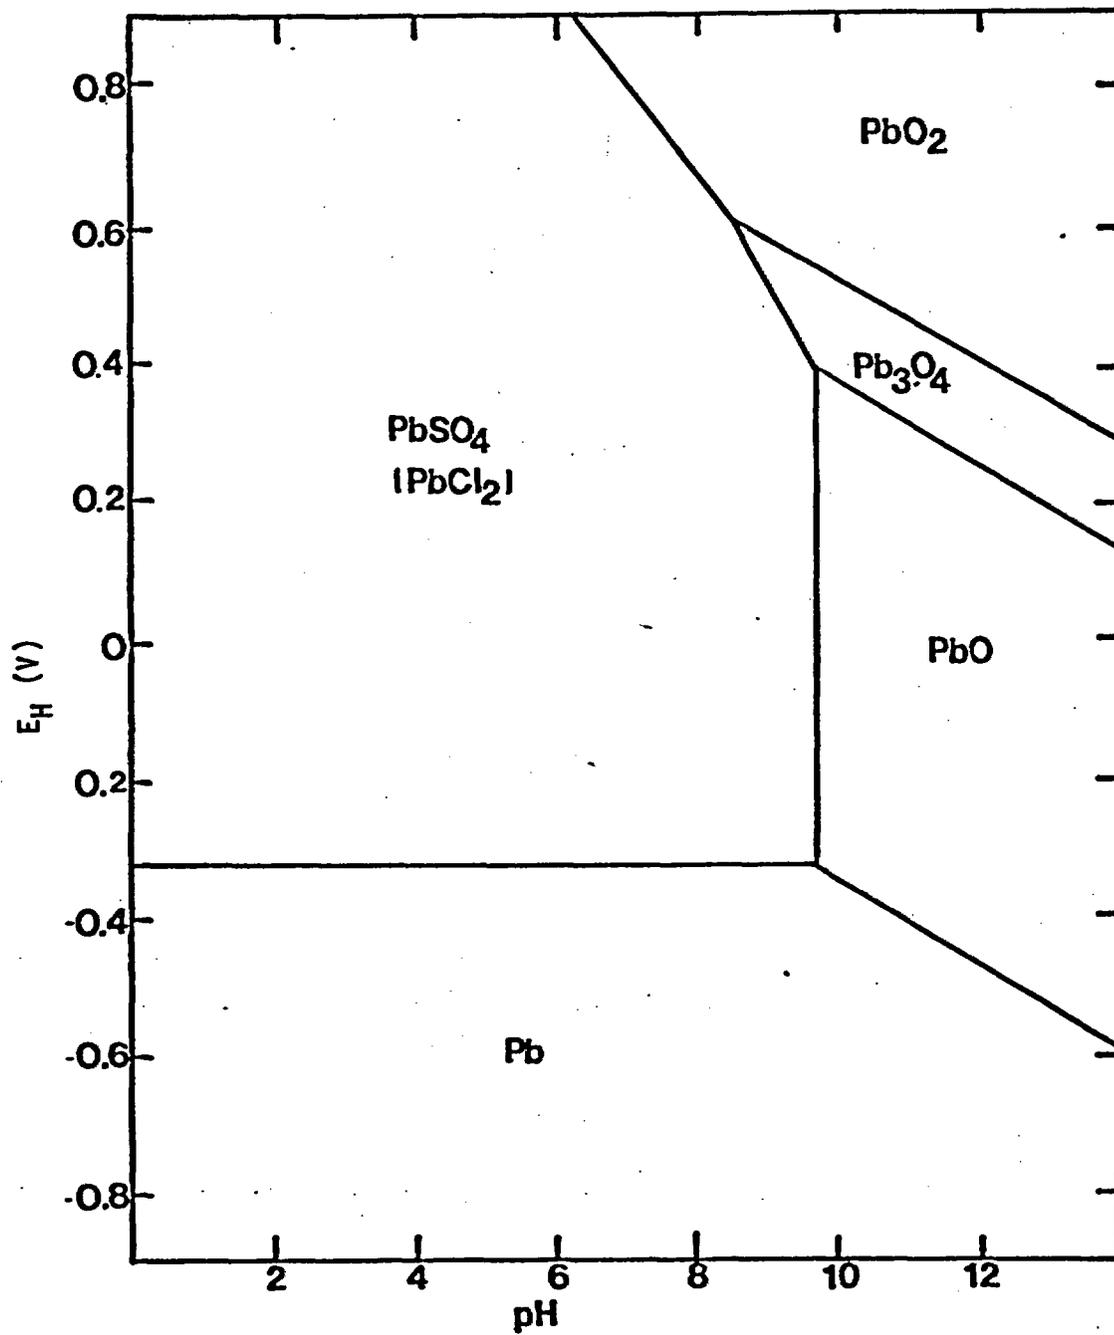
Figure 13. Potential-pH equilibrium diagram for the system Lead-Brine A and B in the absence of  $\text{HCO}_3^-$  at 25°C.

In the case of lead as a radiation shielding material, the stability of PbSO<sub>4</sub> and PbCl<sub>2</sub> have been introduced (Figure 13) compared to their absence

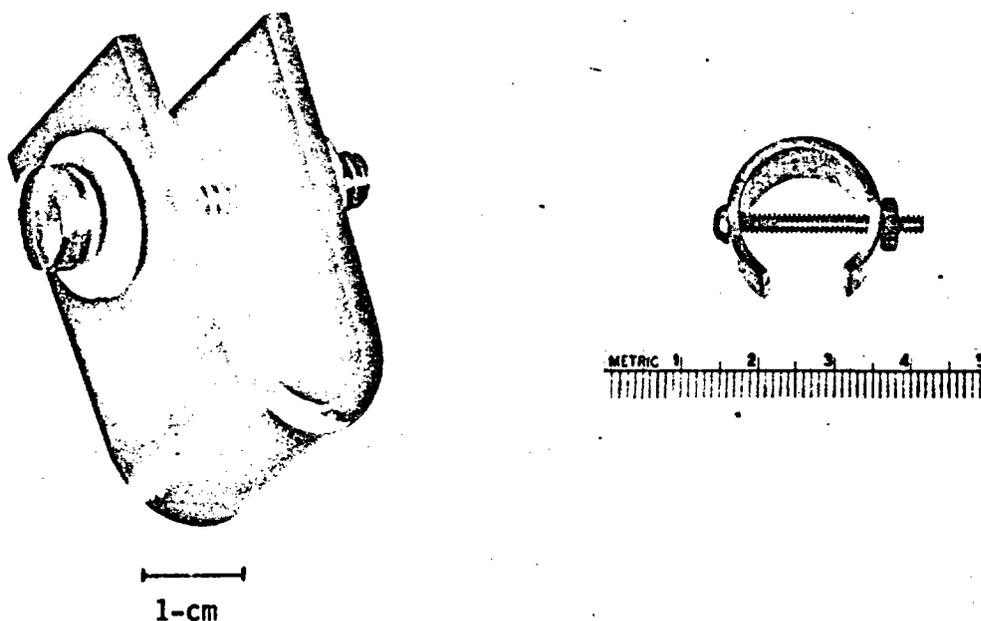
Figure 14. C-ring and U-bend specimens for stress corrosion testing.

U-bend and C-ring specimens were designed following ASTM standards<sup>23,24</sup> as shown in Figure 14 for titanium. Part of the C-rings were precracked to provide stress concentration.<sup>25</sup> The stress levels of C-rings are being estimated.<sup>26</sup> Because it is difficult to detect stress corrosion susceptibility of TiCode-12 at 150°C in Brine A or B<sup>2</sup>, samples will be immersed in concentrated chloride solutions, such as LiCl<sup>27</sup>, in order to increase susceptibility. The components of the slow strain rate machine are in the laboratory being assembled. The ac Impedance and Scanning Reference Electrode Techniques are ready for pitting studies.

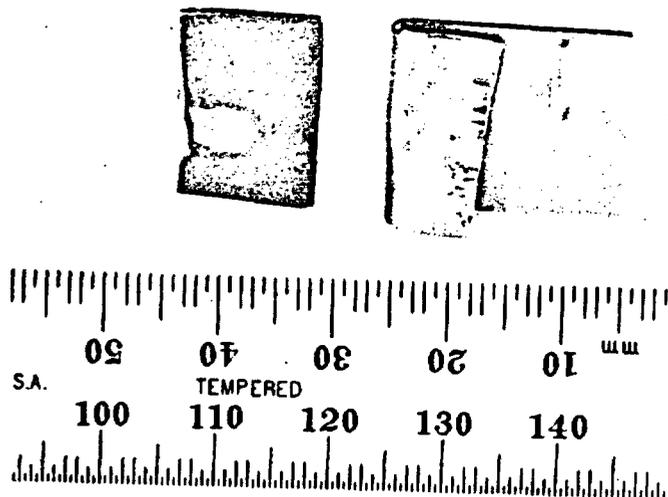
Figure 17. Buckling test result on hydrogenated and nonhydrogenated TiCode-12.

and 230°C. This method of charging allows larger amounts of hydrogen to be absorbed than by using aqueous solutions at atmospheric pressure. The hydrogenated sample fractured upon buckling while the nonhydrogenated sample did not (Figure 17). The subsequent microstructure confirmed this embrittlement effect (Figure 18).
