MAY 13 1988

Corrosion Behavior of Low Carbon Steel in High pH Aqueous Media

Anna C. Fraker and Jonice S. Harris

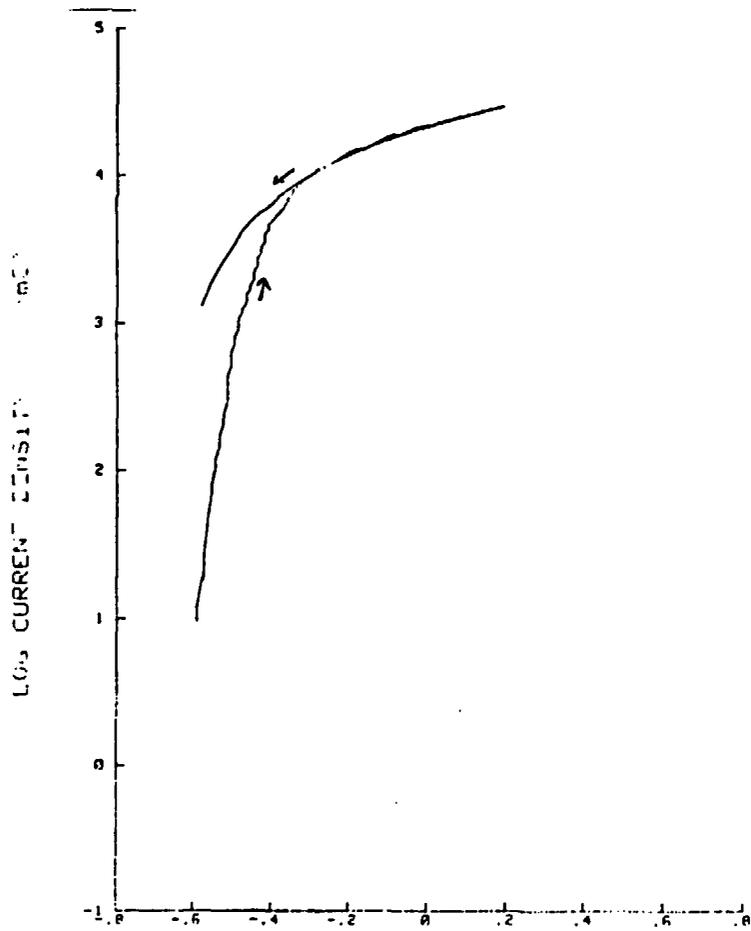
Figure 1. Cyclic anodic polarization curve for A27 steel in GR-4 water at 95°C.

Anodic Polarization. An example of a cyclic anodic polarization curve is shown in Figure 1 where the log of the current density is plotted versus the applied potential. This is an example of the test labeled "A" in Table 4. Arrows on the curve indicate the direction of the applied potential during the test.

This curve shows that no passivation occurred and that the current density increased from the beginning. The current levels off somewhat at high currents due to the presence of a thick film which limits diffusion. This film is constantly breaking up and falling off of the specimen causing sudden rises in the current. This is not a protective film. The reversal of the potential does not show the hysteresis in the current. The increased current in the remaining portion of the curve may be due to increased specimen area as a result of the corrosion during the test.

Figure 2 is a cyclic anodic polarization curve for the test represented by "B" in Table 4. This curve starts from a lower corrosion potential and also shows that no passivation occurred. Here, as in the test of Figure 1, with increasing applied potential, the current reaches a level where it levels off due to the formation of a thick film and limited diffusion. The current level in the remaining portion of the curve is different from that of Figure 1 and is lower. This may indicate increased protectiveness of the film or some reaction of the film with the basalt, bentonite and water mixture.

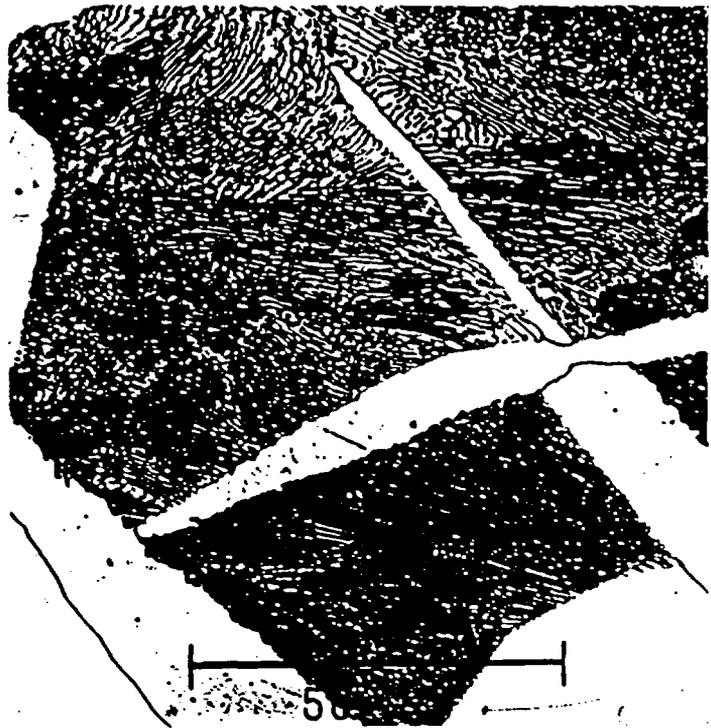
Microstructures. Examples of the microstructure of two uncorroded specimens are shown at two different magnifications in the micrographs of figures 3 and 4. This microstructure consists of areas of ferrite (labeled f) and pearlite (labeled p). After anodic polarization, the specimen surface becomes uneven and three dimensional in appearance due to the corrosive attack. The pearlite is attacked more severely than the ferrite, as shown in Figure 5. Figure 6 shows an area with some localized attack. These areas, which could be identified as pits, are shallow and crystallographic, but these are not pits in the normal sense of the term.

Fig. 3. A27 steel, uncorroded.

Fig. 4. A27 steel, uncorroded.
