From: Adeline Saso > R-III
To: John Grobe
Date: 7/31/02 8:27AM
Subject: ANS Pres

Reactor Vessel Head Degradation Location

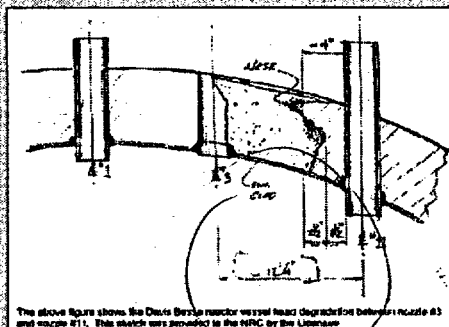
The above figure shows the Davis Besse reactor vessel head degradation between nozzle #3 and nozzle #11. This sketch was provided to the NRC by the licensee.

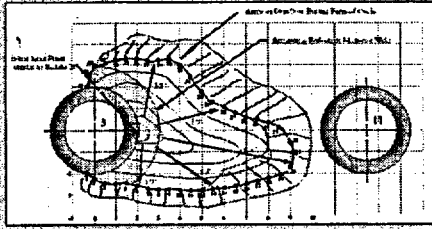
Wastage Geometry

(to be obtained from April 07 (2005) measurements)

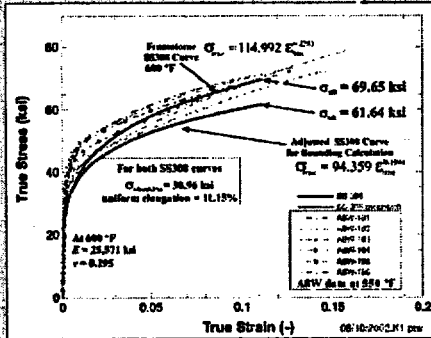
Cladding Tensile Properties

(to be obtained from available data)

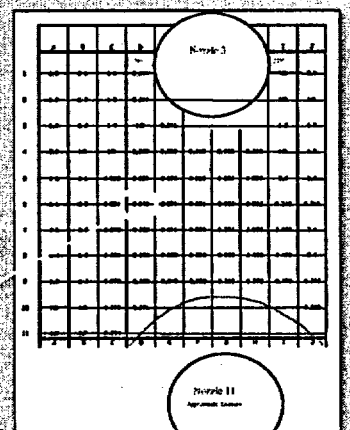
Cladding Thickness

(to be obtained from available data)

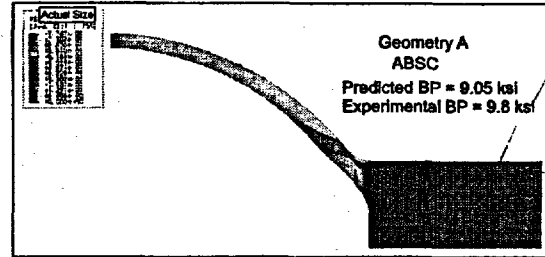
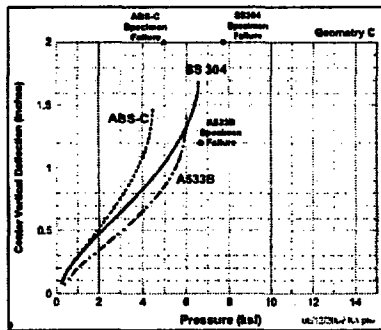
- disc burst tests reported by P. Riccardella [ASME '72 PVP]
 - 6-in. diameter
 - 1/8 and 1/4-in. thick
- Experiments used to quantify uncertainty and bias in using FE analyses to predict rupture of an unsupported membrane subjected to pressure loading
- This statistical distribution is then used along with 3D FE model of Davis Besse cavity to assess probability of cladding rupture in the "as found" condition
