# V. C. Summer Nuclear Station

# V. C. Summer Nuclear Station Management Organizational Changes

RF-14 RHR Retro Fit  
Modification  
VC SUMMER  
Westinghouse  
FlowServe

# Brief Overview of RHR Project

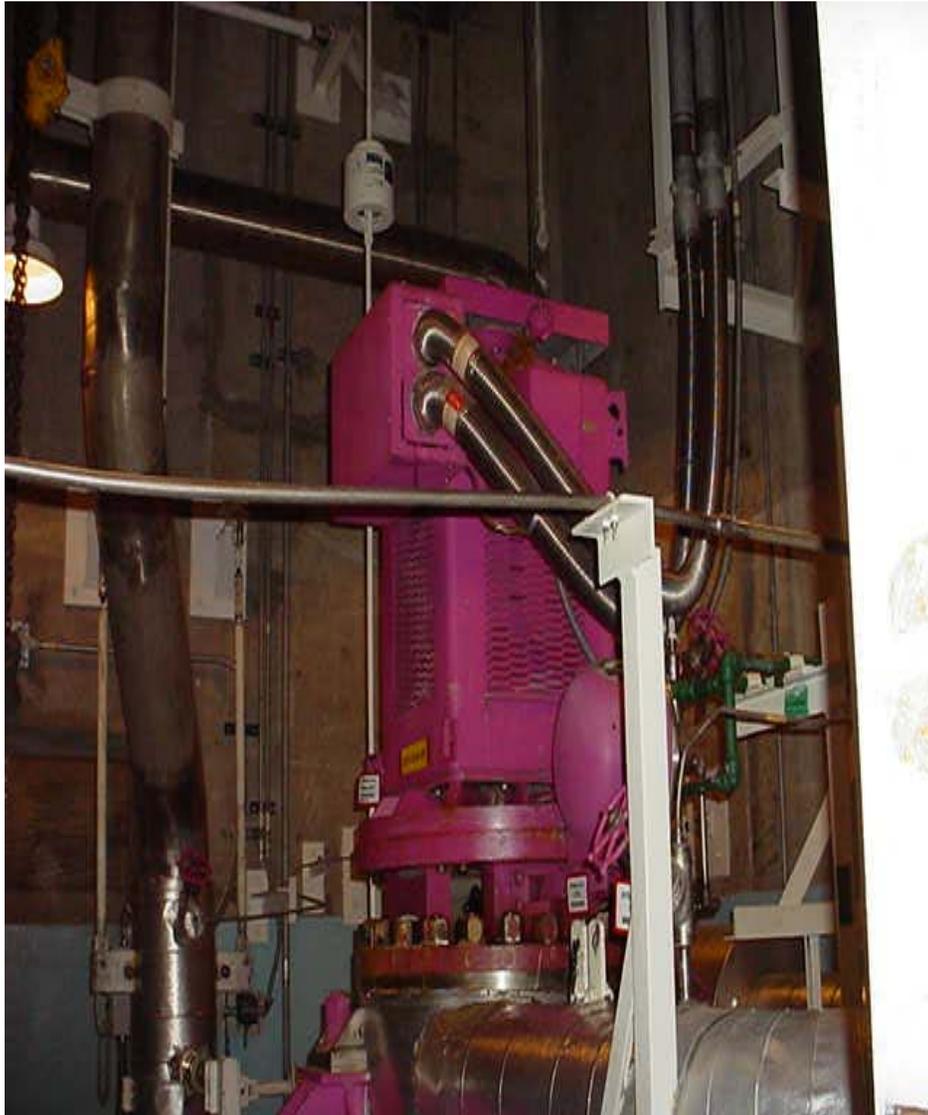
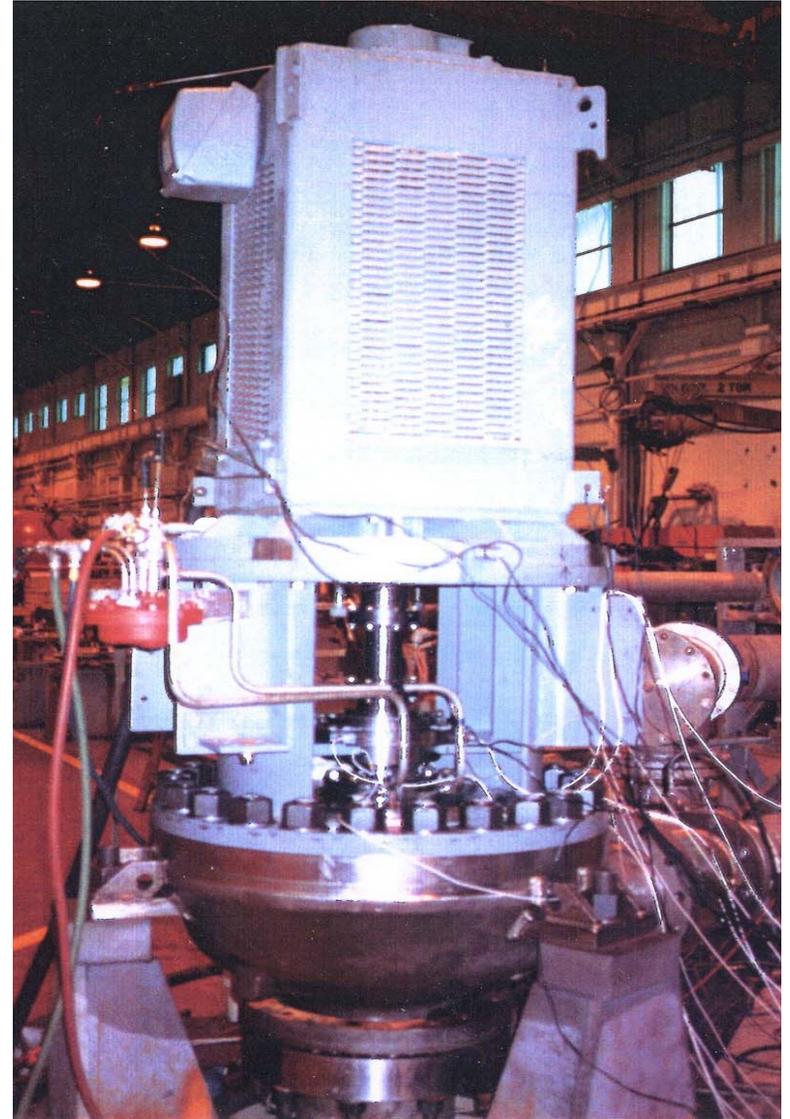
# Spare Model 8X20 WD/WDF

- Scope of modification “A” RHR Pump
  - Support stand
  - Spacer coupling
  - Upper & lower hub Assembly
- Project duration 5 days
- ALARA estimate 2.75 REM
