CORROSION TESTING OF TYPE 304L
STAINLESS STEEL IN TUFF
GROUNDWATER ENVIRONMENTS

R. E. Westerman
S. G. Pitman
J. H. Haberman

Work Performed at
Pacific Northwest Laboratory
Richland, WA 99352

November 1987

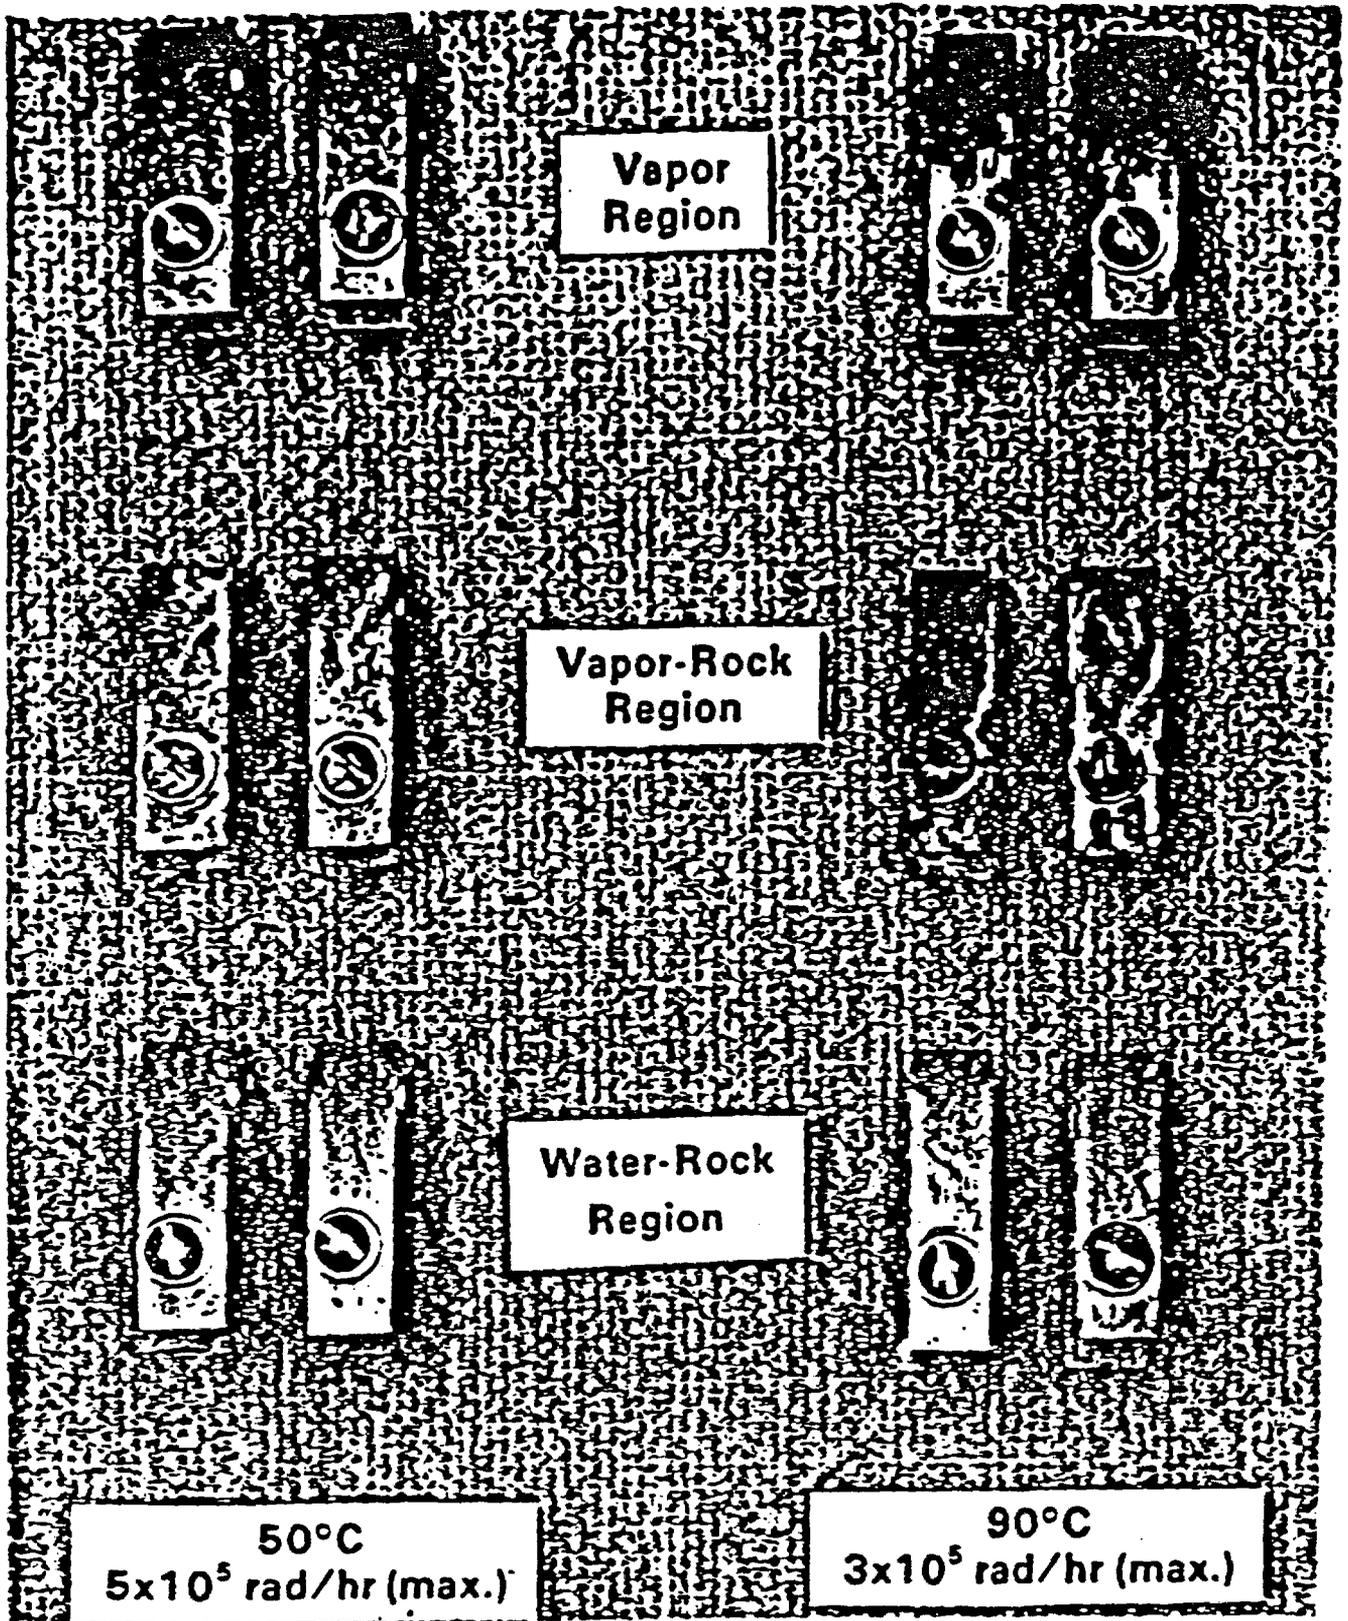
FIGURE 5.1. Appearance of Specimens at Conclusion of Irradiation-Corrosion Tests. Test duration: 25 months, 50°C test; 23 months, 90°C test. Only a representative sample of the test specimens is shown.

At each programmed specimen examination, those specimens showing obvious cracks were removed from the test, while those not showing obvious cracks were replaced in the test autoclaves in their original positions. The 50°C test was concluded after 25 months; the 90°C test, after 23 months. In general, specimens exposed in the rock/vapor and vapor-only regions of the autoclaves showed the most surface corrosion, primarily consisting of patches of red-brown corrosion product. No signs of significant pitting attack were observed on any of the specimens. Specimens exposed in the water/rock regions of the test autoclaves maintained surfaces free of significant corrosion. The appearance of a representative group of specimens at the conclusion of the tests is shown in Figure 5.1. The specimens were not cleaned before being photographed.

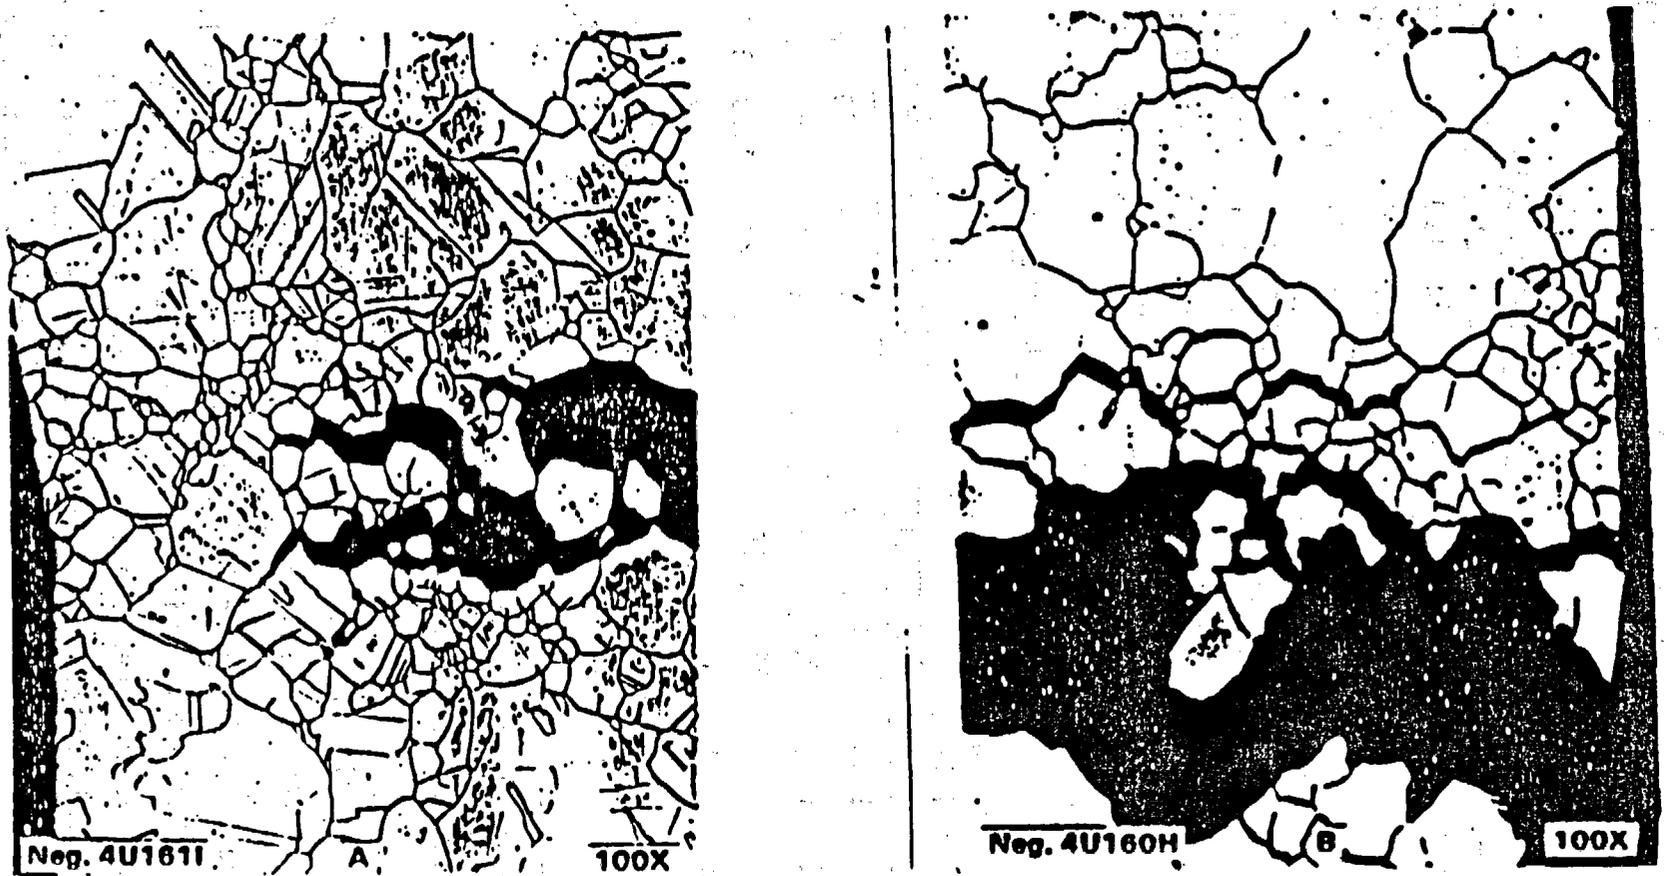
FIGURE 5.2. Intergranular Cracking of Sensitized 304 SS Specimens After 1-Month Exposures in (a) the 50°C Test, Vapor-Only Region (Specimen P455); and (b) the 90°C Test, Rock/Water Region (Specimen P464)

Typically, failed specimens of sensitized 304 SS showed intergranular cracking. Examples of this behavior are shown in Figure 5.2, which shows specimens exhibiting cracks after 1 month in the vapor-only region of the 50°C autoclave and in the water/rock region of the 90°C autoclave.

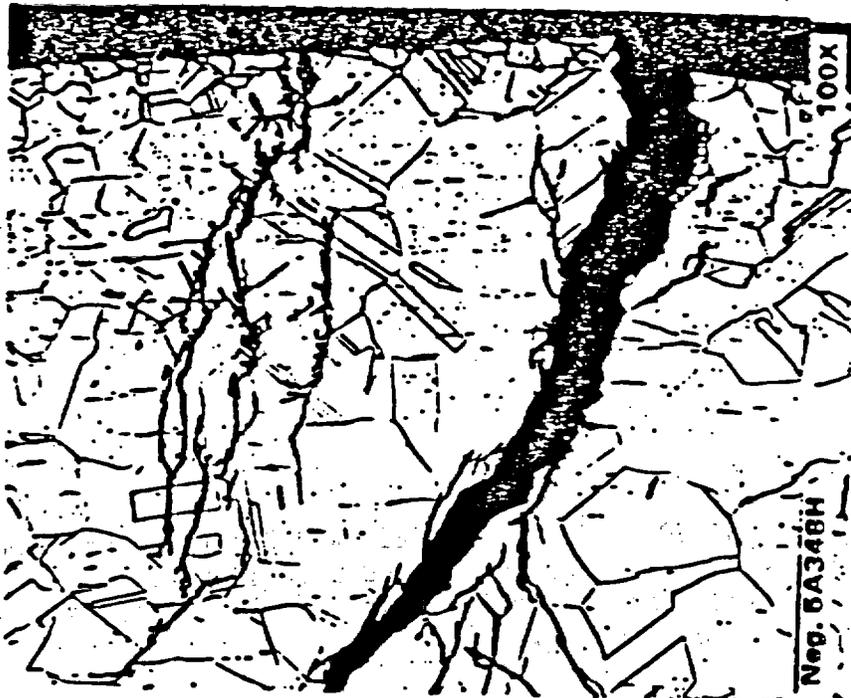
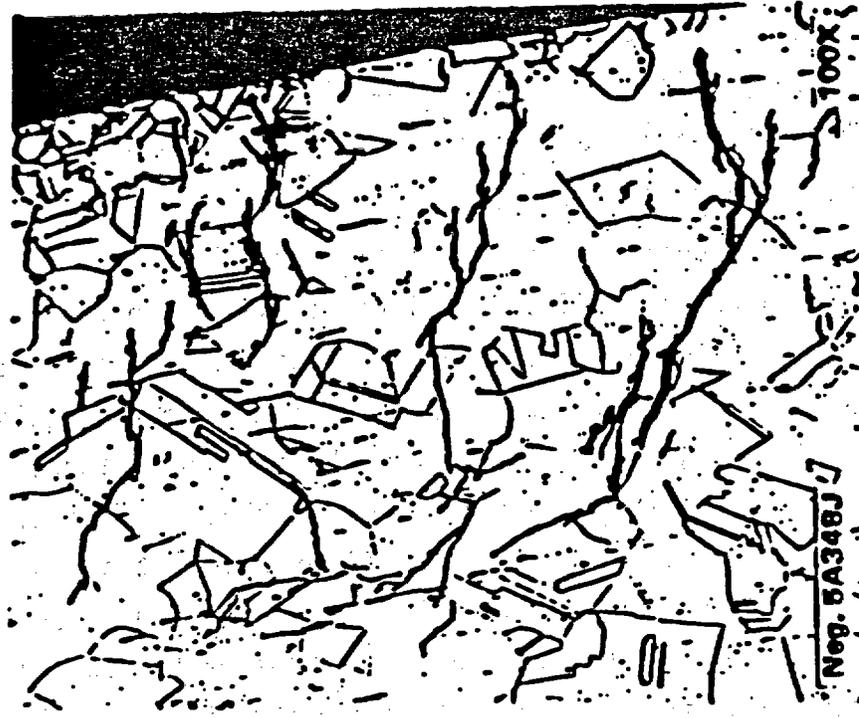
FIGURE 5.3. Transgranular Cracking of Solution-Annealed-and-Sensitized 304L SS (Specimen P434). The specimen was exposed for 14 months to the vapor-only region of the 90°C autoclave test system.

Micrographs of Specimen P434 are shown in Figure 5.3. Only transgranular cracking was observed in this specimen, with the exception of a narrow band of material near the specimen surface, where evidence of intergranular corrosion may be seen. This effect may be due to carbon contamination of the stainless steel surface during material processing operations. Abraham et al. (1986)

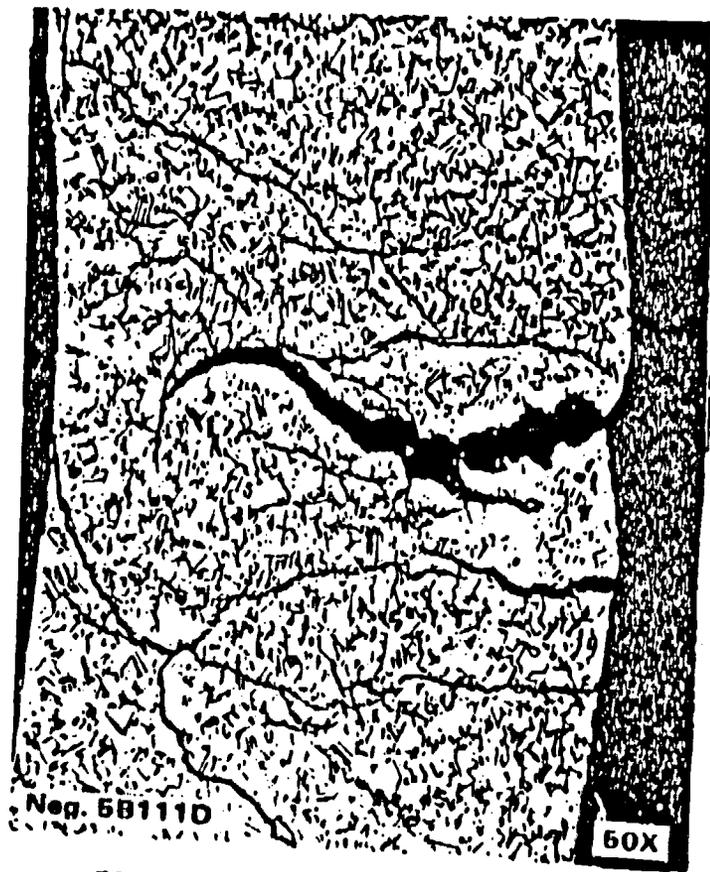
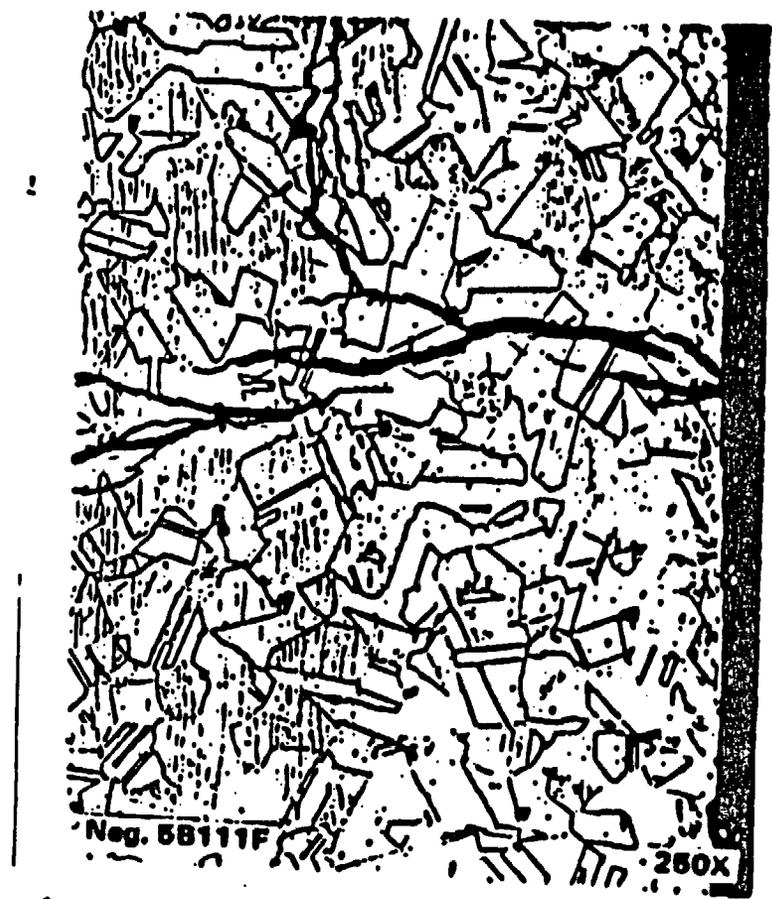
FIGURE 5.5. Transgranular Fracture Mode of Solution-Annealed 304L SS U-Bend (Specimen P422) After 23 Months in the Vapor-Only Region of the 90°C, 3×10^5 rad/h Test Autoclave

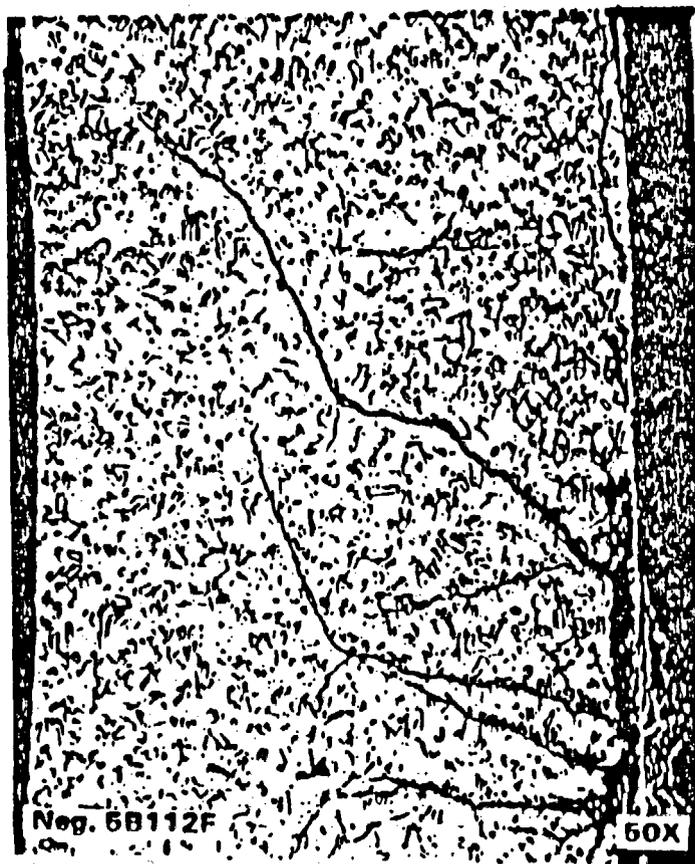
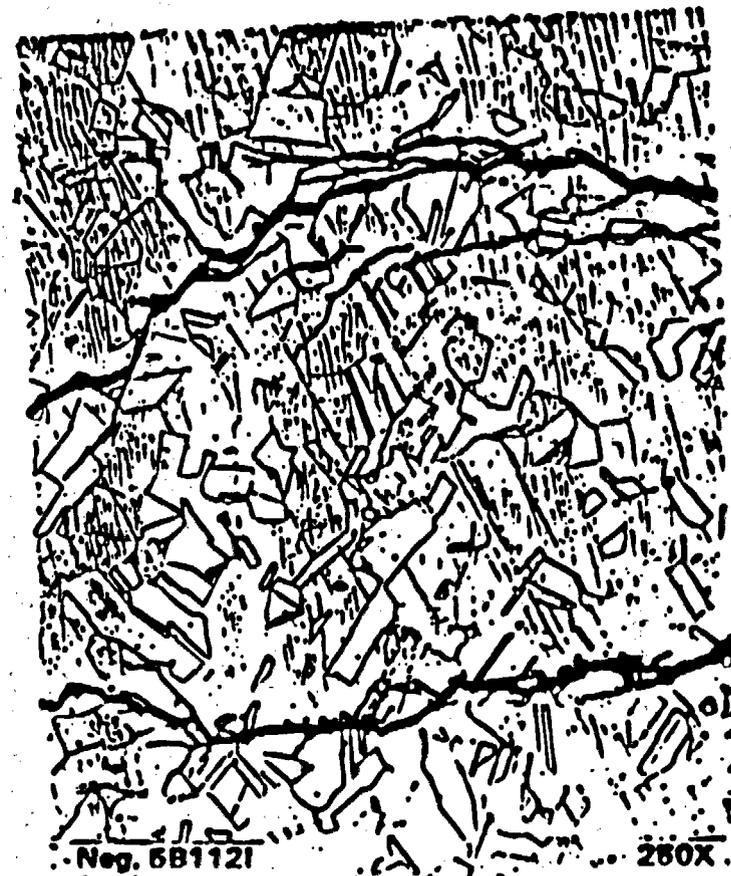
FIGURE 5.6. Transgranular Fracture Mode of Solution-Annealed 304 SS U-Bend (Specimen P446) After 23 Months in the Vapor-Only Region of the 90°C, 3×10^5 rad/h Test Autoclave

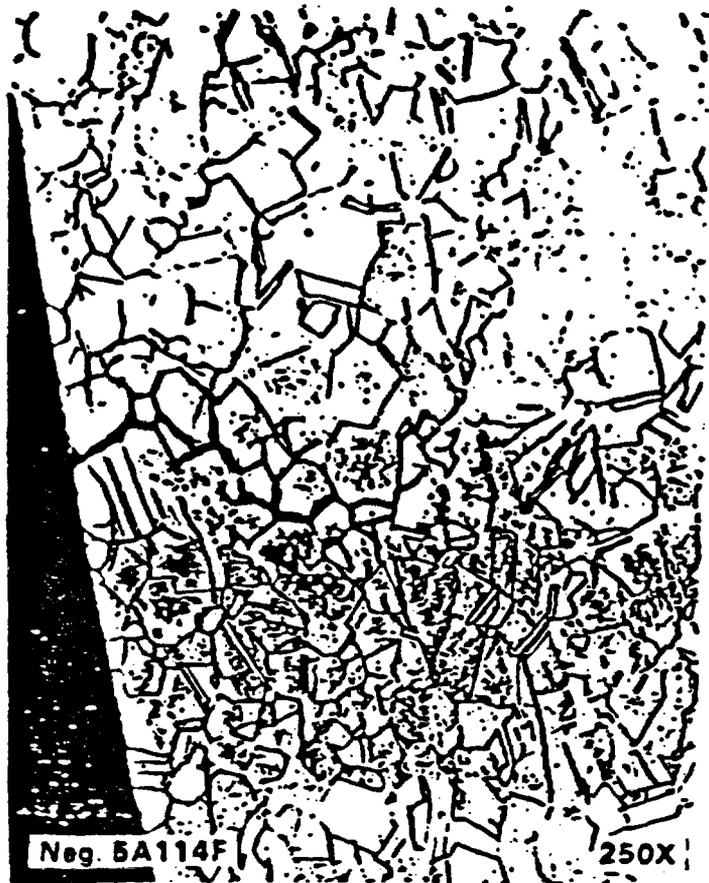
FIGURE 5.7. Intergranular Cracking Failure of Solution-Annealed-and-Sensitized 304 SS U-Bend After 1-Year Exposure in 200°C Boildown Test (specimen Q330)

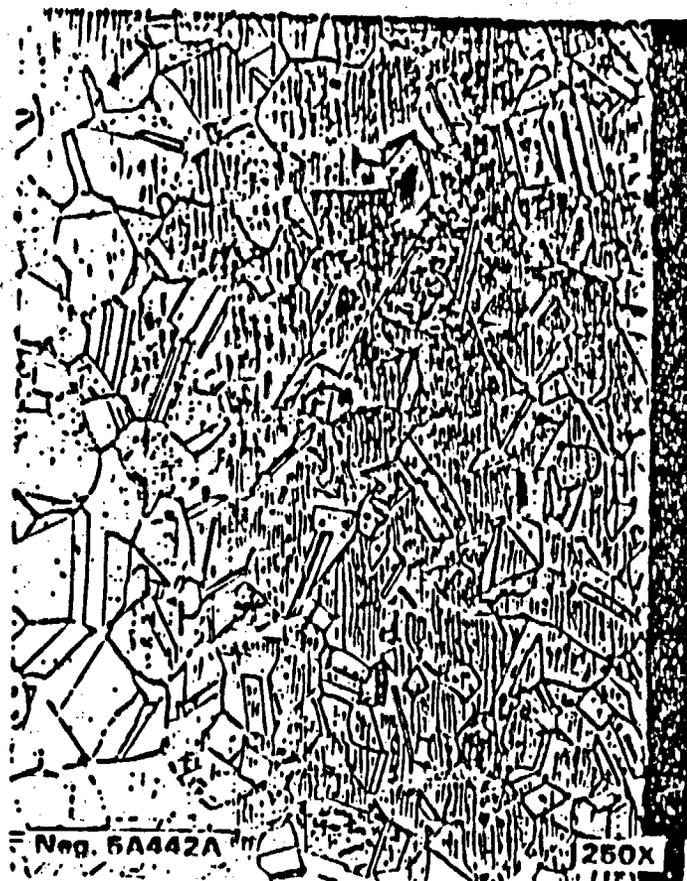
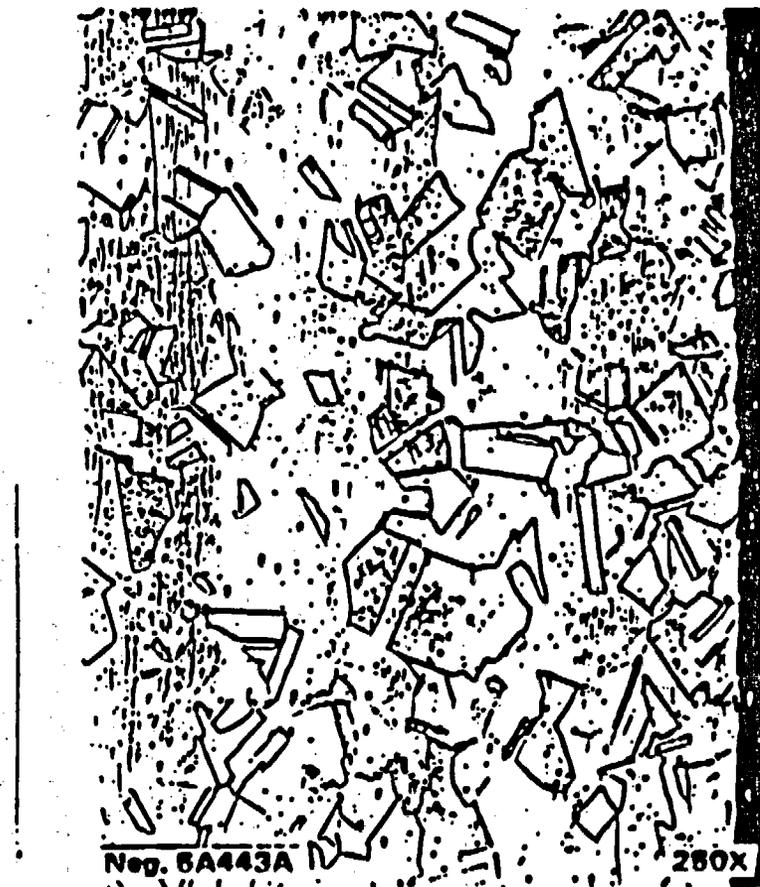
FIGURE 5.8. Solution-Annealed-and-Sensitized 304L SS After 1-Year Exposure in 200°C Boil-down Test. No cracking was observed in any 304L SS specimen in this test. The specimen on the left (R085) received a 24-h at 700°C sensitization heat treatment; the specimen on the right (R053) received a 24-h at 550°C sensitization heat treatment.

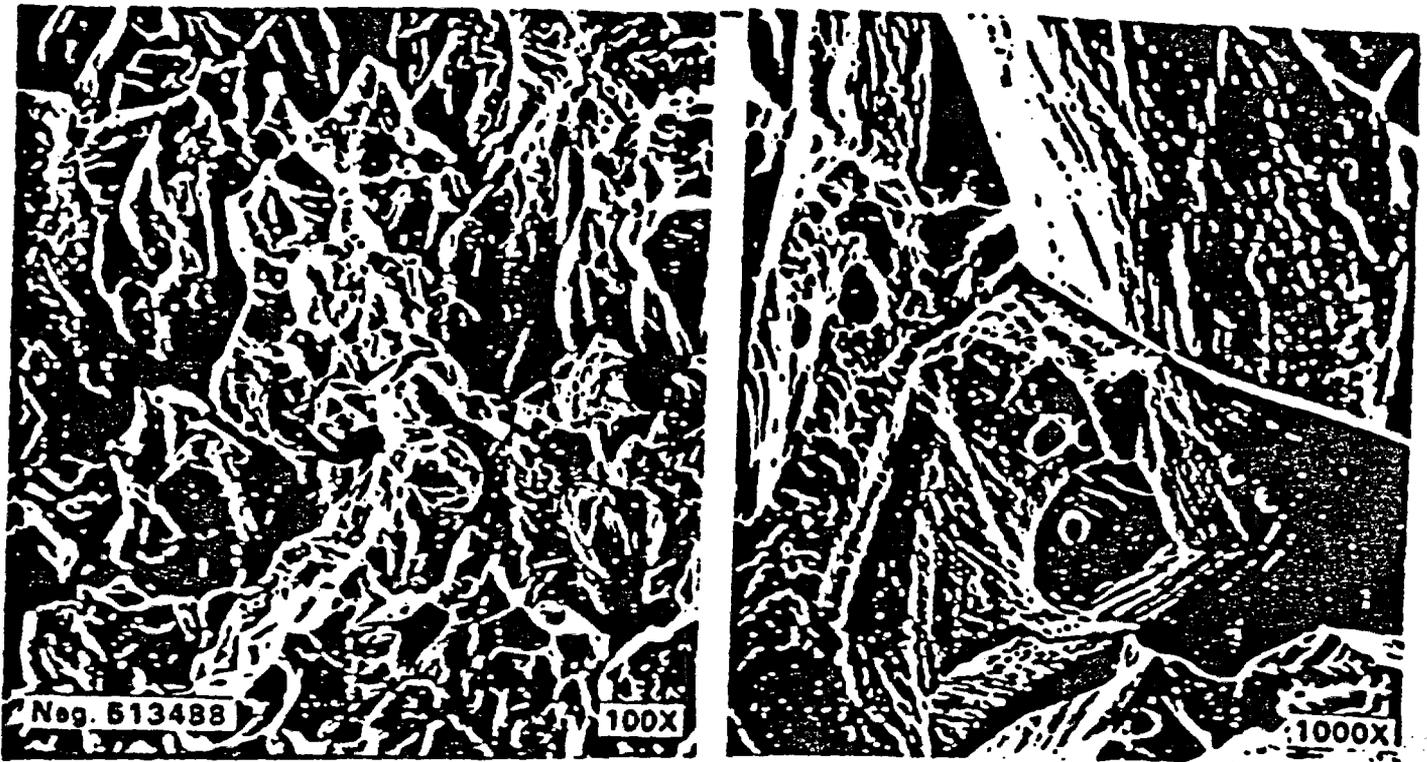
FIGURE 5.11. Fracture Surface of Solution-Annealed-and-Sensitized 304 SS Specimen (P410) Strained to Failure in 150°C J-13 Well Water at a Strain Rate of 1×10^{-6} /s

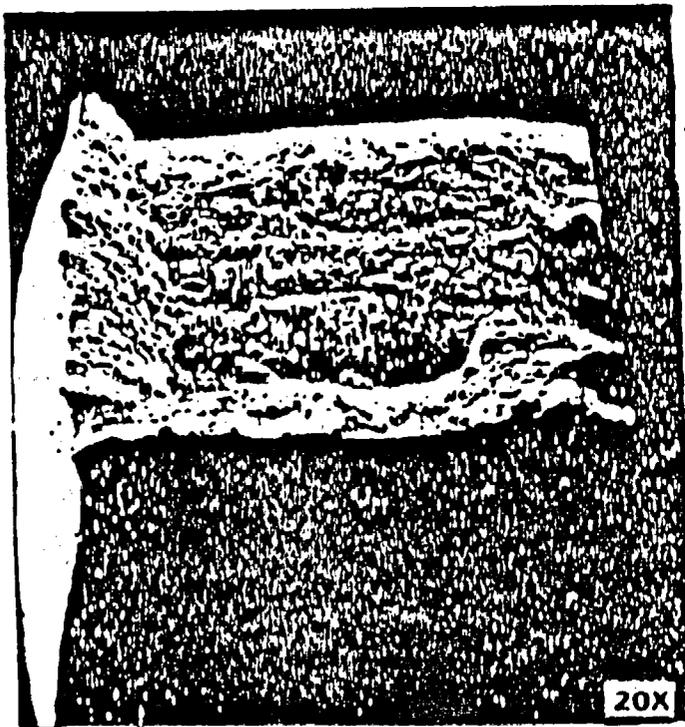
FIGURE 5.13. Fracture Surface of a Solution-Annealed-and-Sensitized (168 h at 700°C) 304 SS Specimen (153) Strained to Failure in 95°C J-13 Well Water at a Strain Rate of $1 \times 10^{-6}/s$

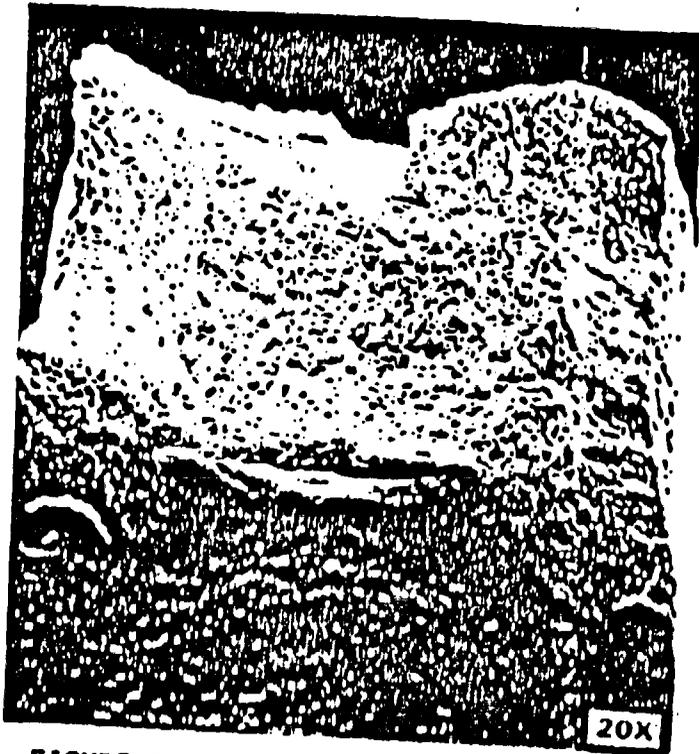
FIGURE 5.14. Fracture Surface of a Solution-Annealed-and-Sensitized (168 h at 250°C) 316L SS Specimen (135) Strained to Failure at 1×10^{-6} /s

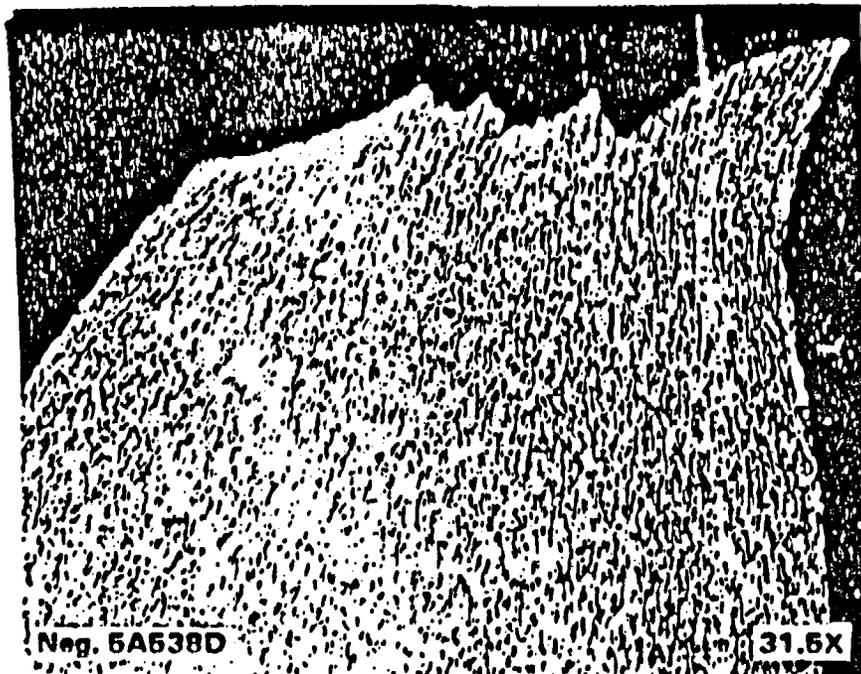
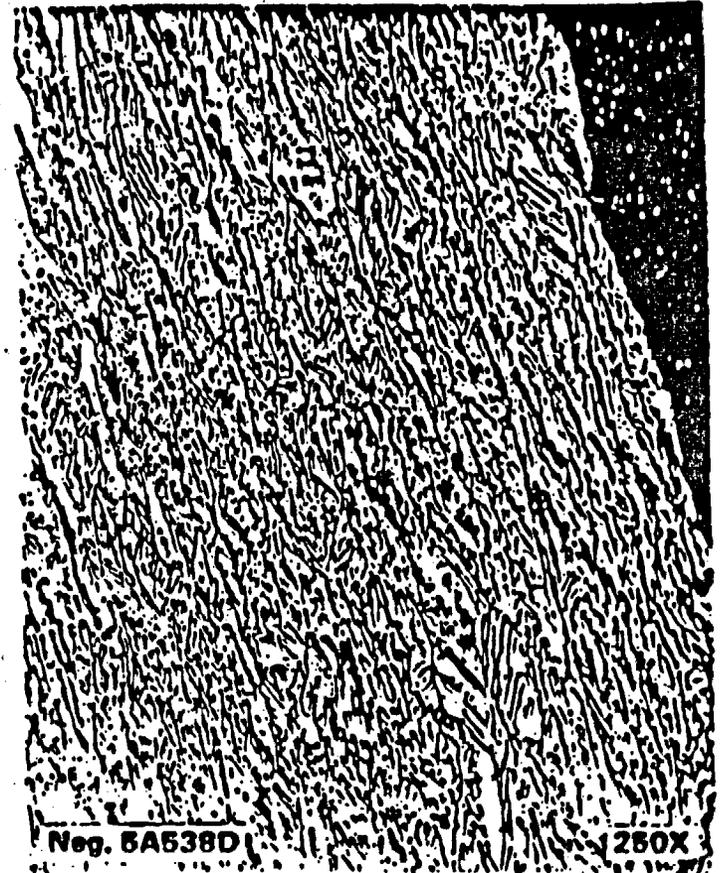
FIGURE 5.15. Microstructure of Solution-Annealed 304 SS Specimen (P396)

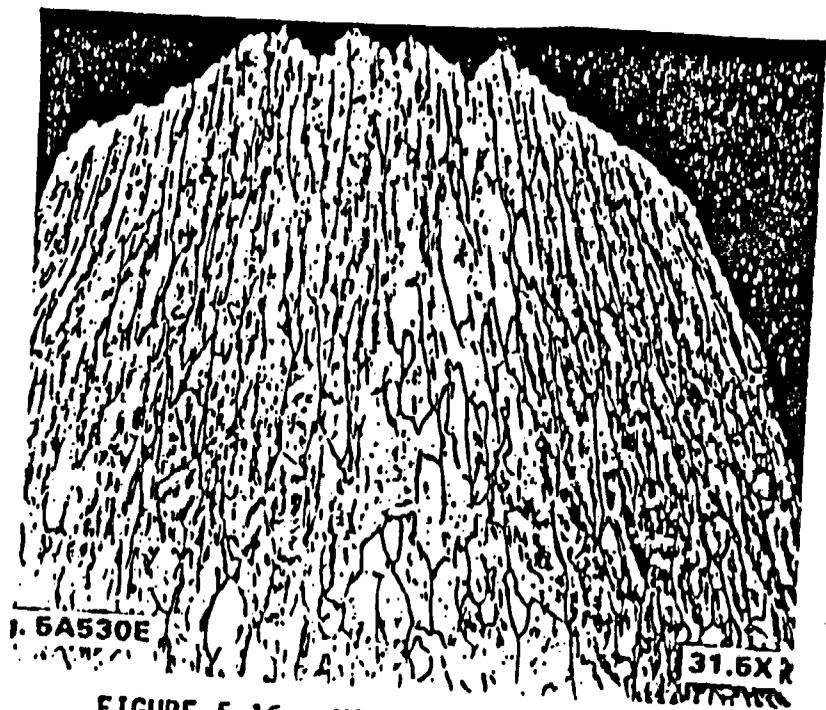
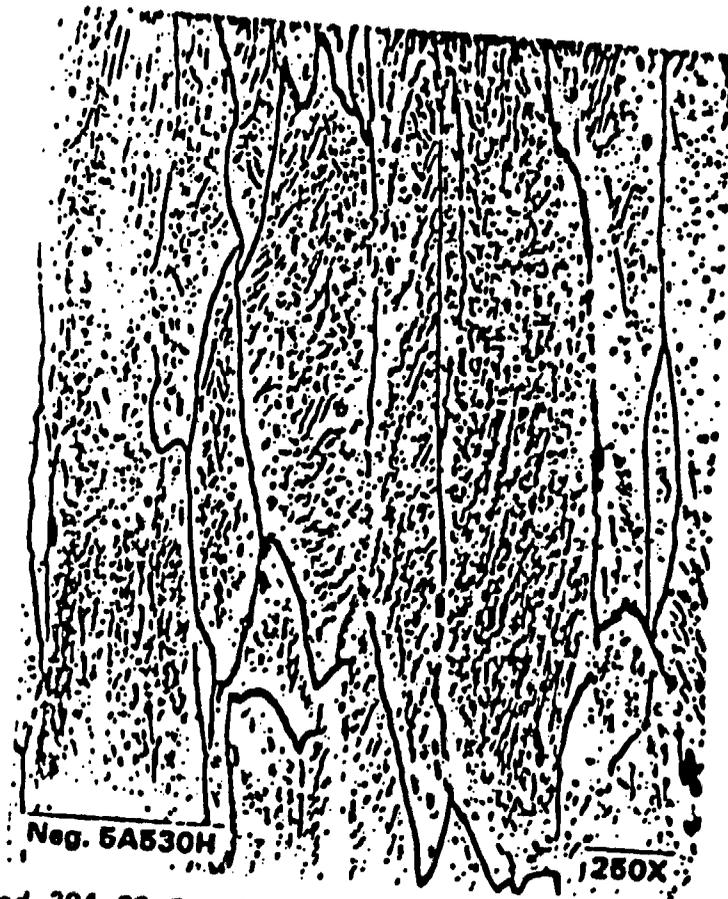
FIGURE 5.16. Microstructure of Solution-Annealed 304 SS Specimen (P409) Sensitized at 600°C for 24 h

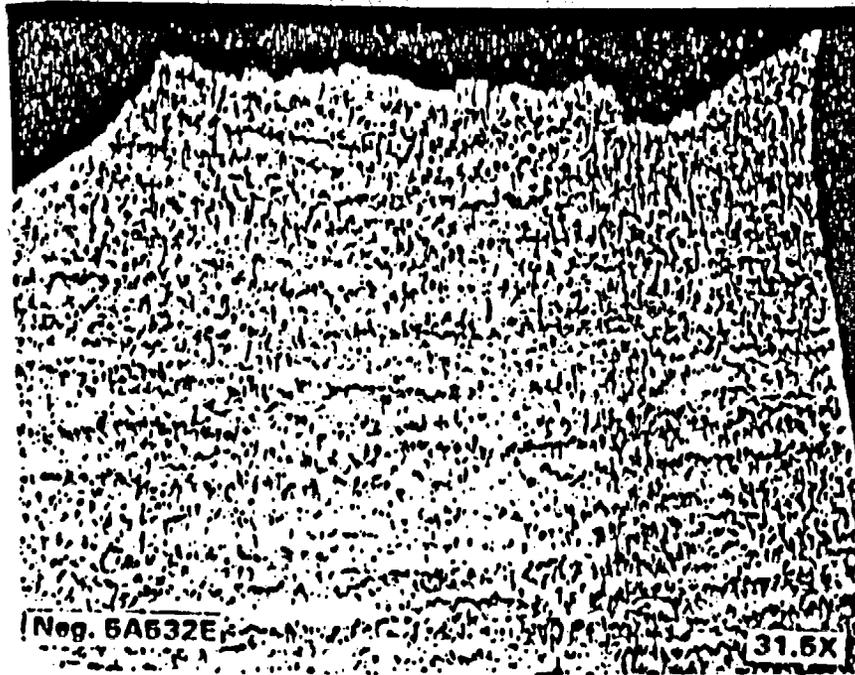
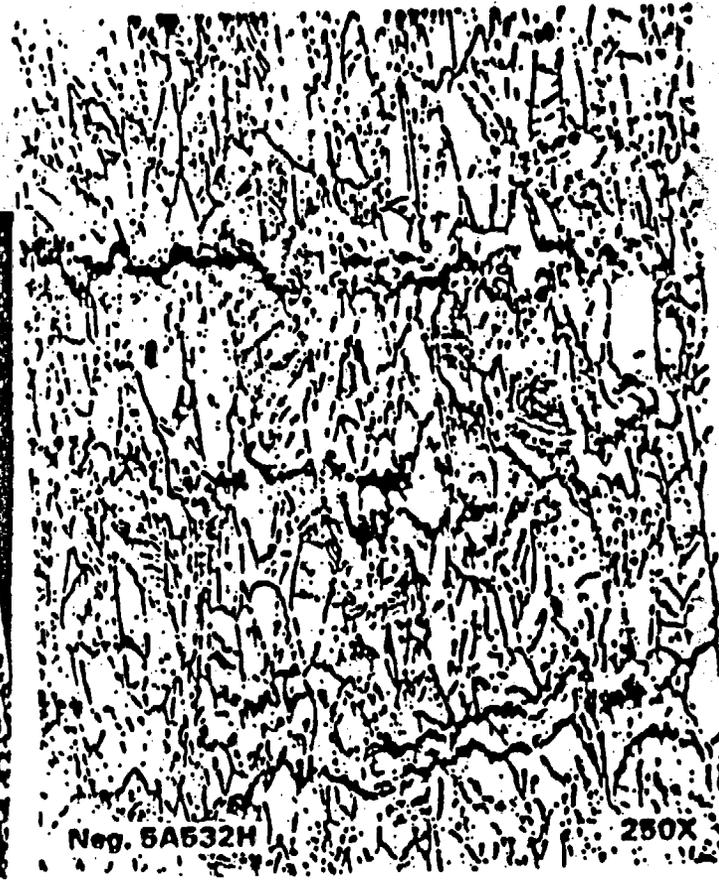
FIGURE 5.17. Microstructure of Solution-Annealed 304 SS Specimen (153) Sensitized at 700°C for 168 h

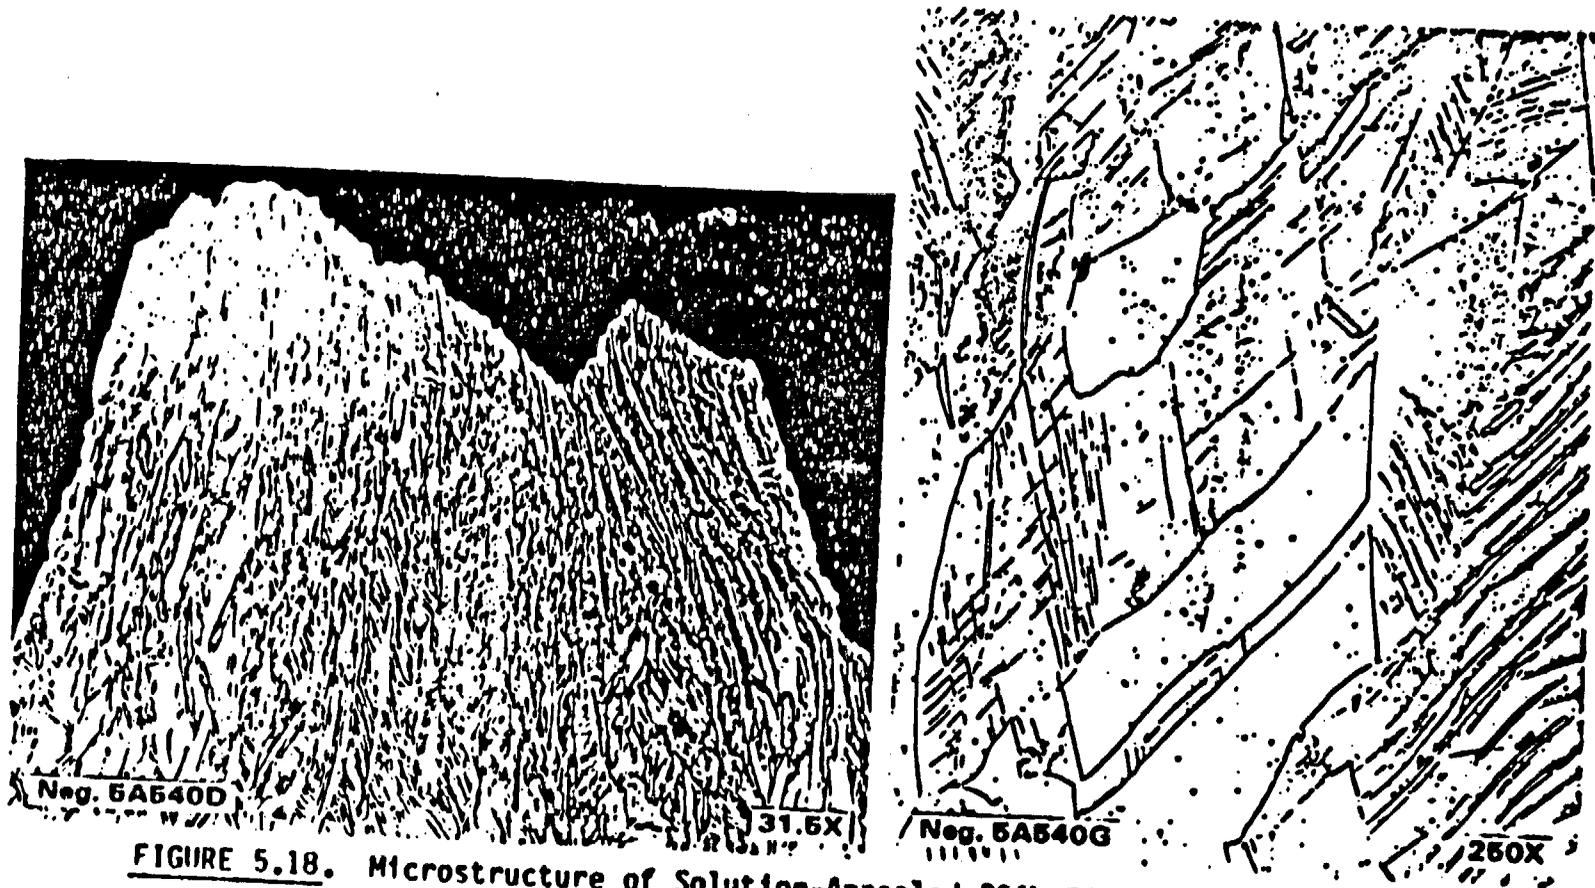
FIGURE 5.18. Microstructure of Solution-Annealed 304L SS Specimen (P384)

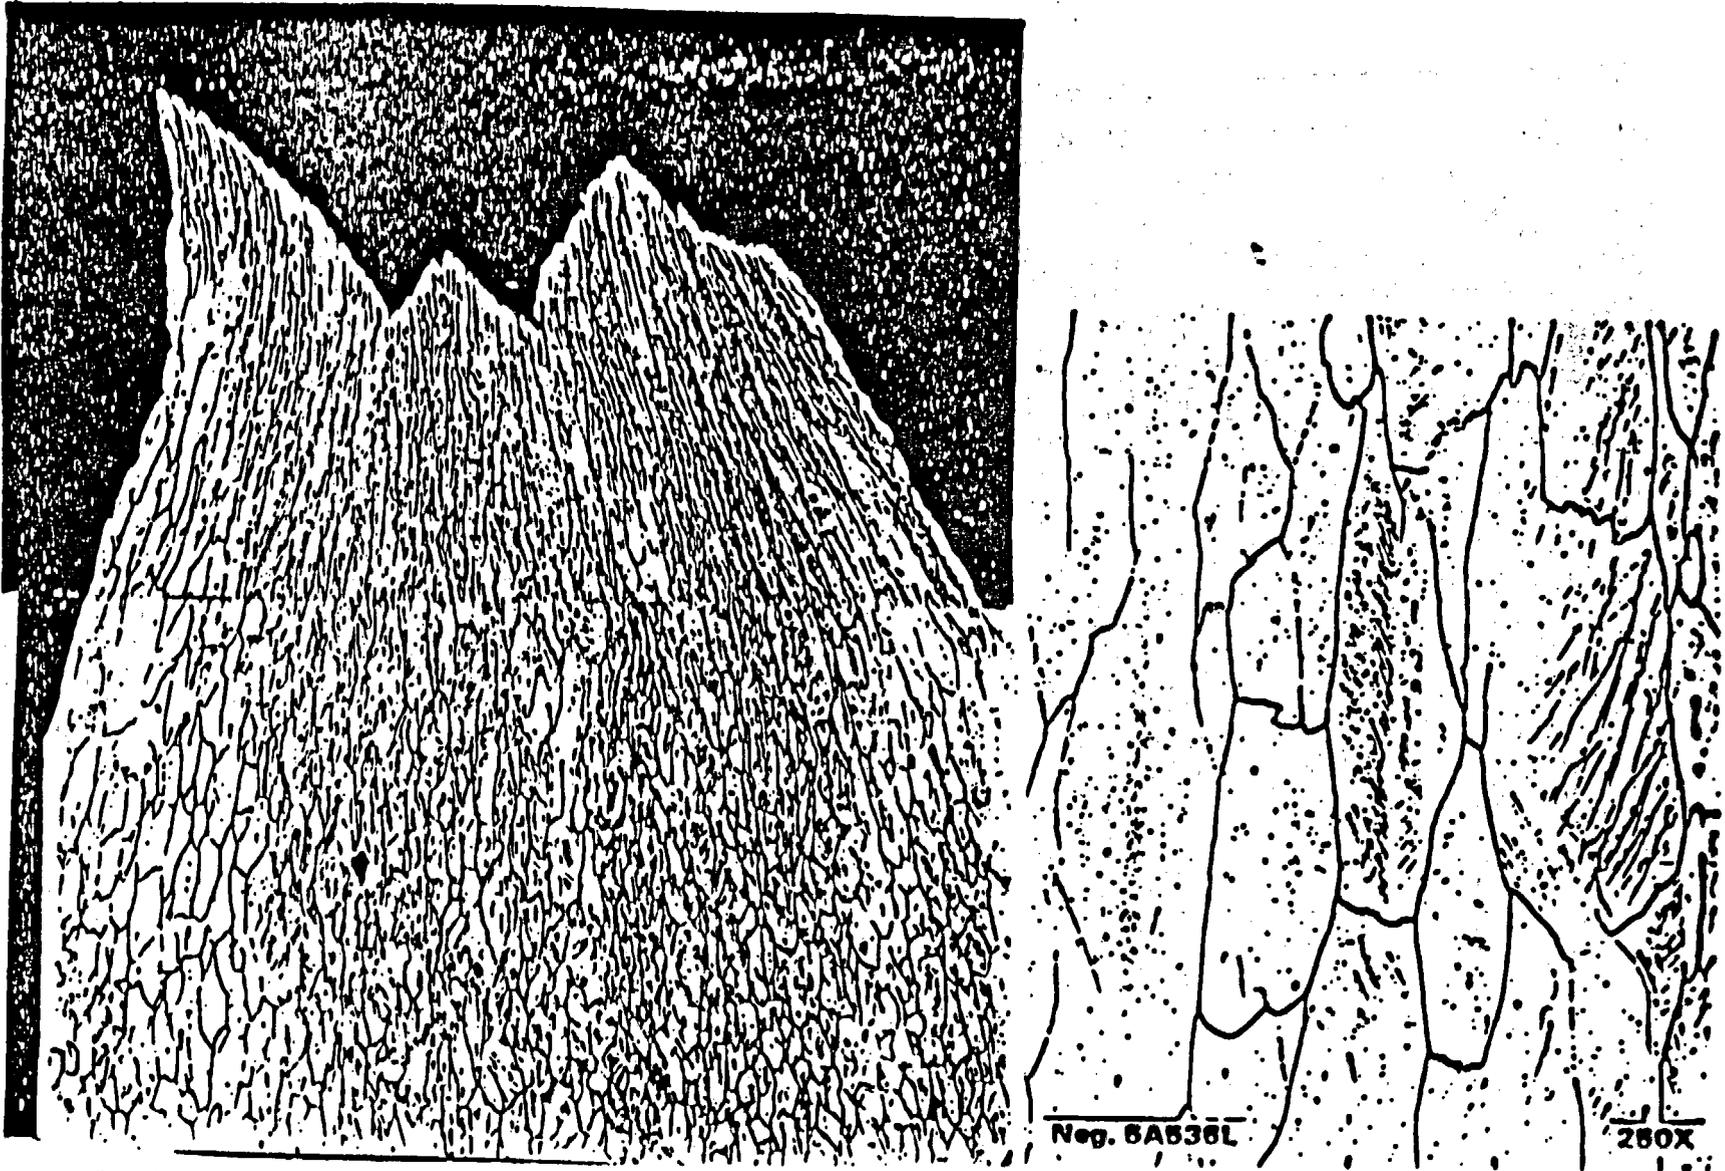
FIGURE 5.19. Microstructure of Solution-Annealed 304L SS Specimen (240) Sensitized at 600°C for 10 h

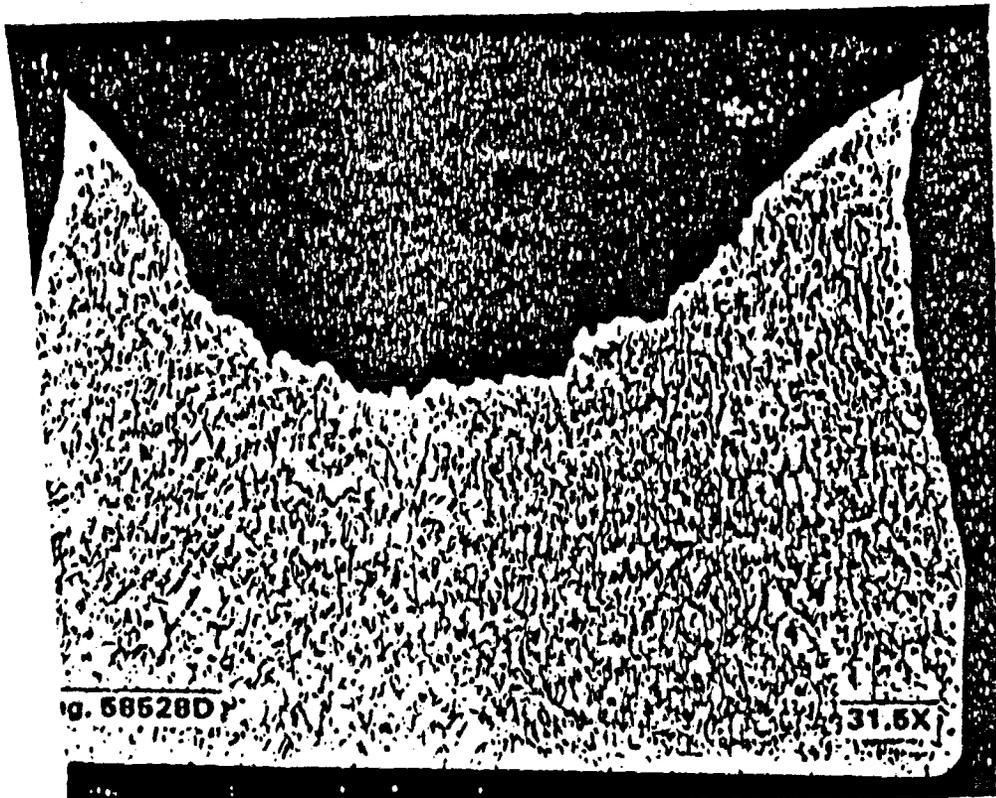
FIGURE 5.20. Microstructure of 316L SS Specimen (133) Cold Worked and Heated to 250°C for 168 h

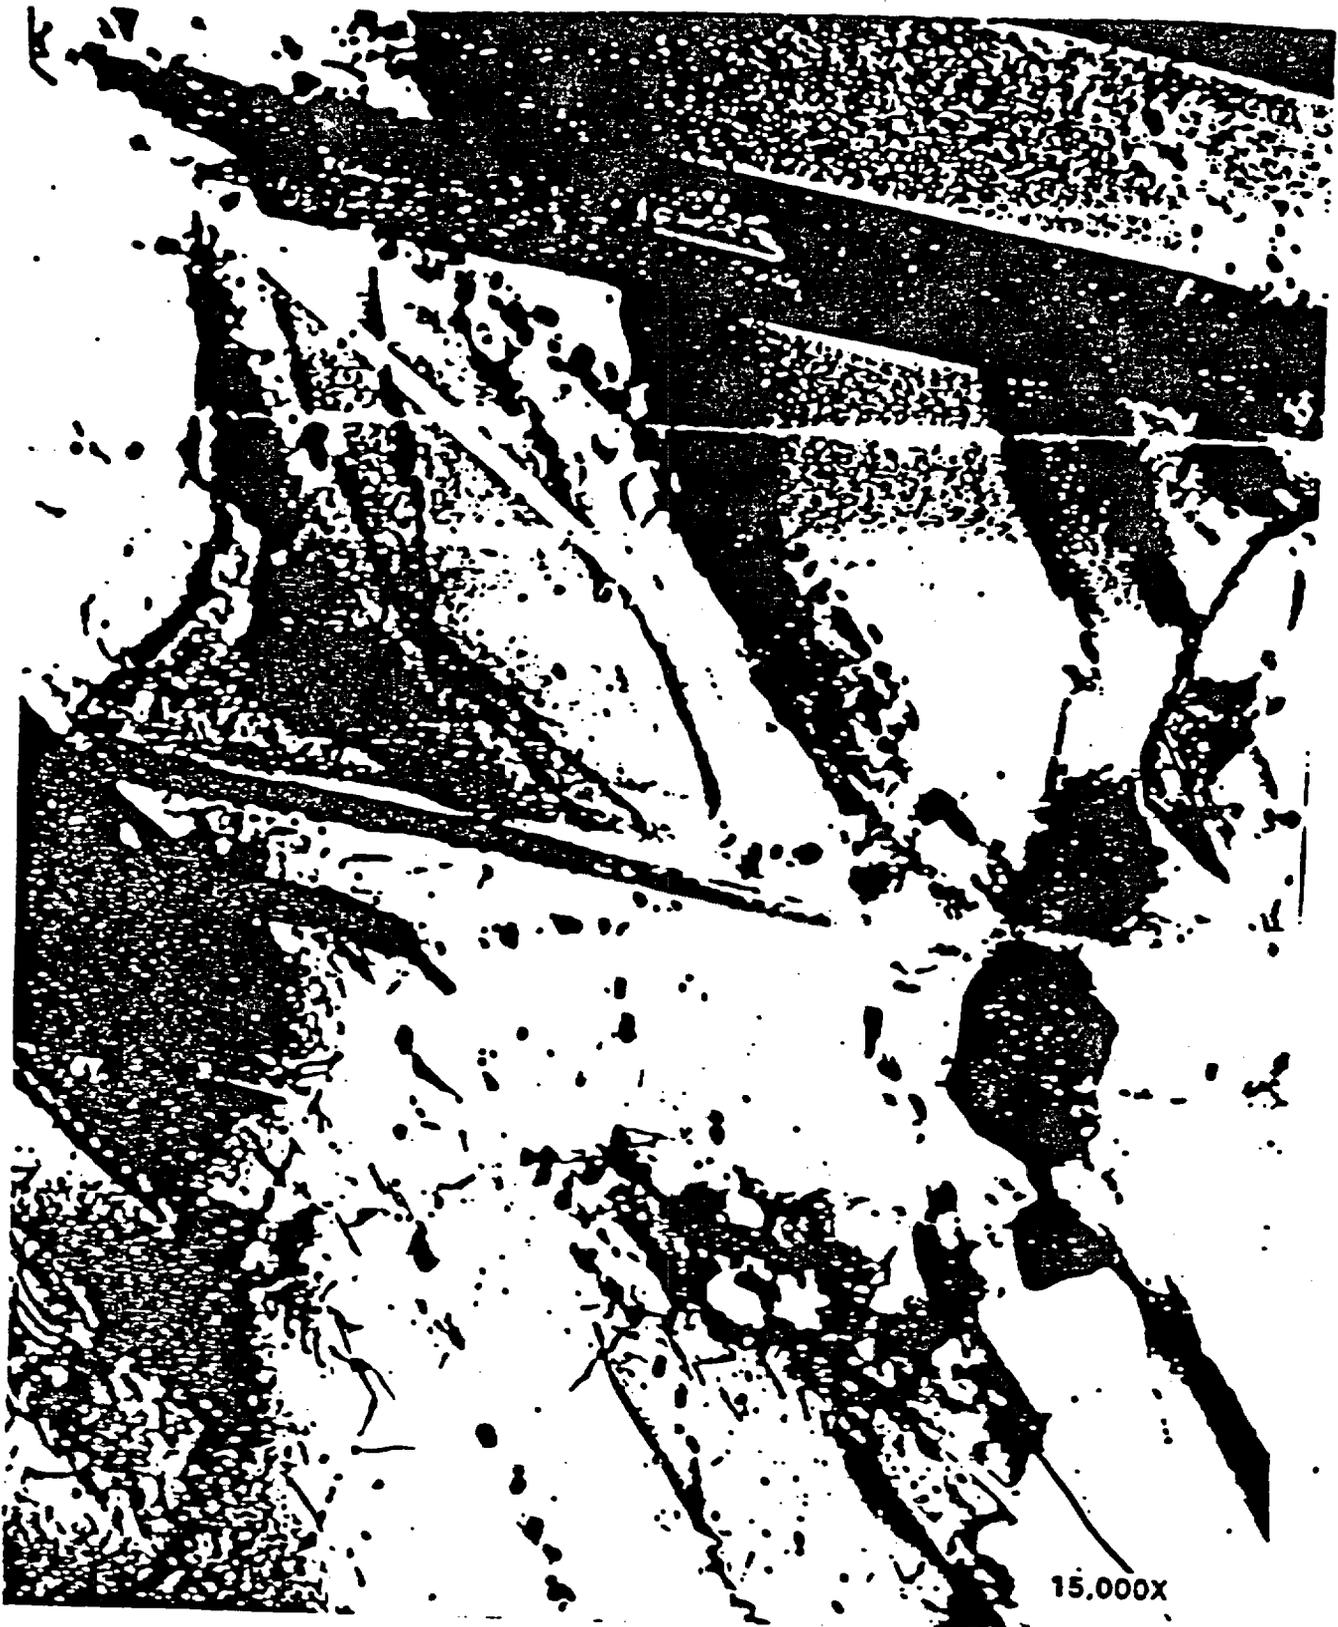
FIGURE 5.22. TEM Micrograph of 304 SS Specimen (153) Heated to 700°C for 168 h
