CORROSION TESTING OF TYPE 304L
STAINLESS STEEL IN TUFF
GROUNDWATER ENVIRONMENTS

R. E. Westerman
S. G. Pitman
J. H. Haberman

Work Performed at
Pacific Northwest Laboratory
Richland, WA 99352

November 1987

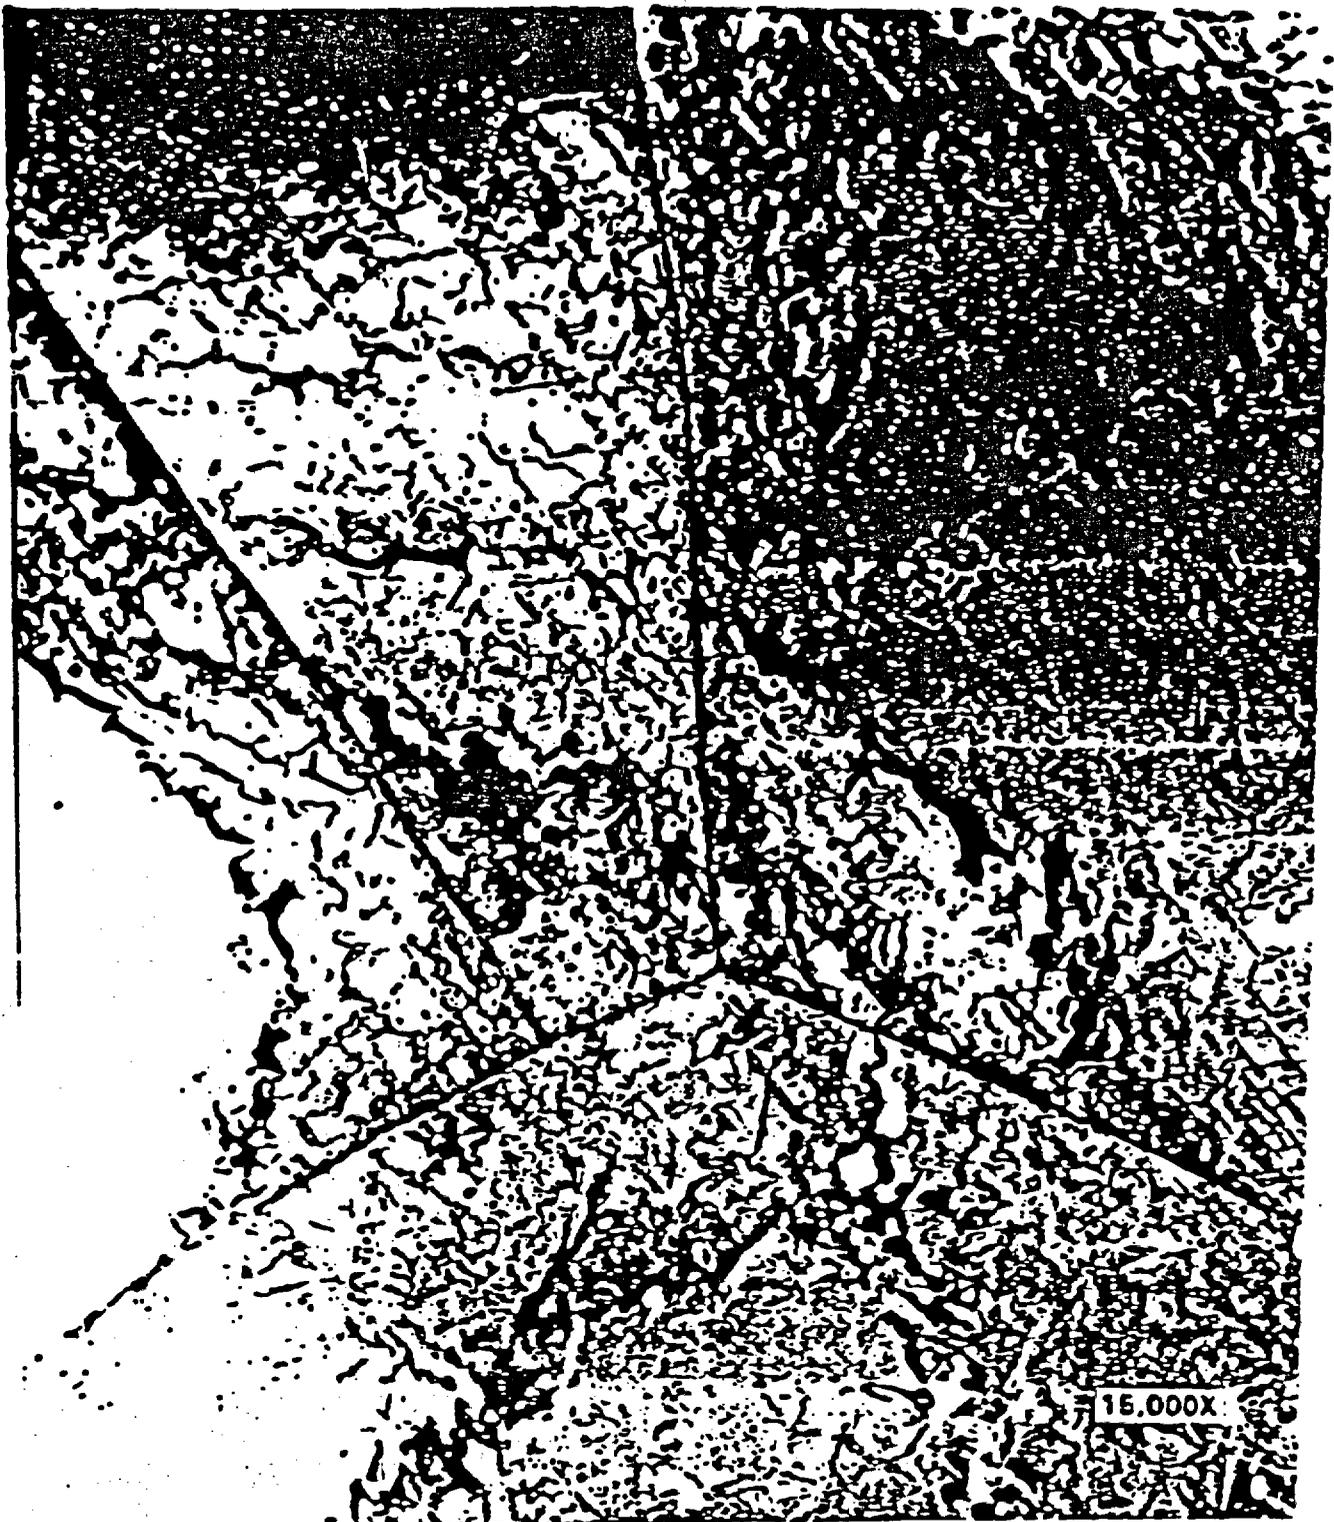
FIGURE 5.23. TEM Micrograph of Solution-Annealed 304L SS Specimen (P233), Showing Clean Grain Boundaries at Triple Point

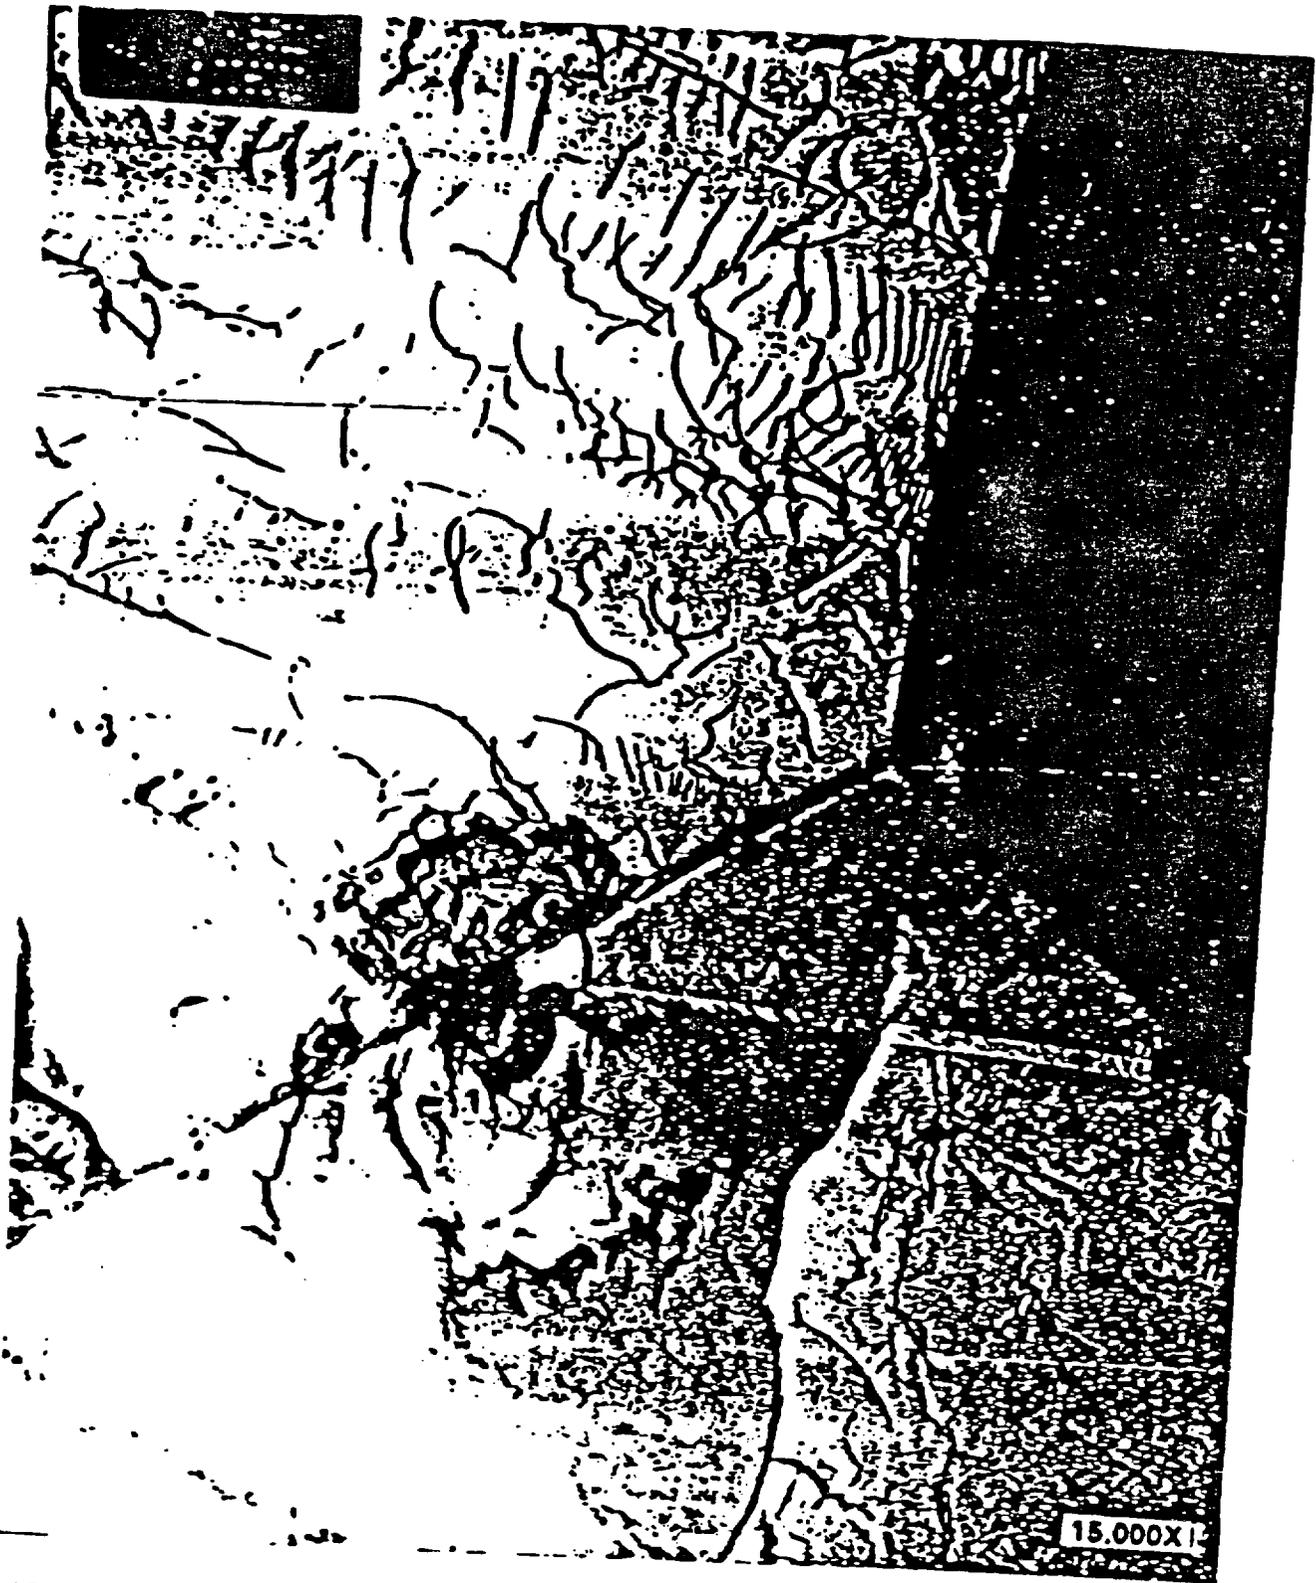
FIGURE 5.24. TEM Micrograph of 304L SS Specimen (P384) Solution-Annealed and Heated to 600°C for 24 h, Showing Clean Grain Boundaries at Triple Point
