CONTAINER ASSESSMENT - CORROSION STUDY  
OF HLW CONTAINER MATERIALS

QUARTERLY PROGRESS REPORT  
July-September 1983

T. M. Ahn, H. Jain and P. Soo

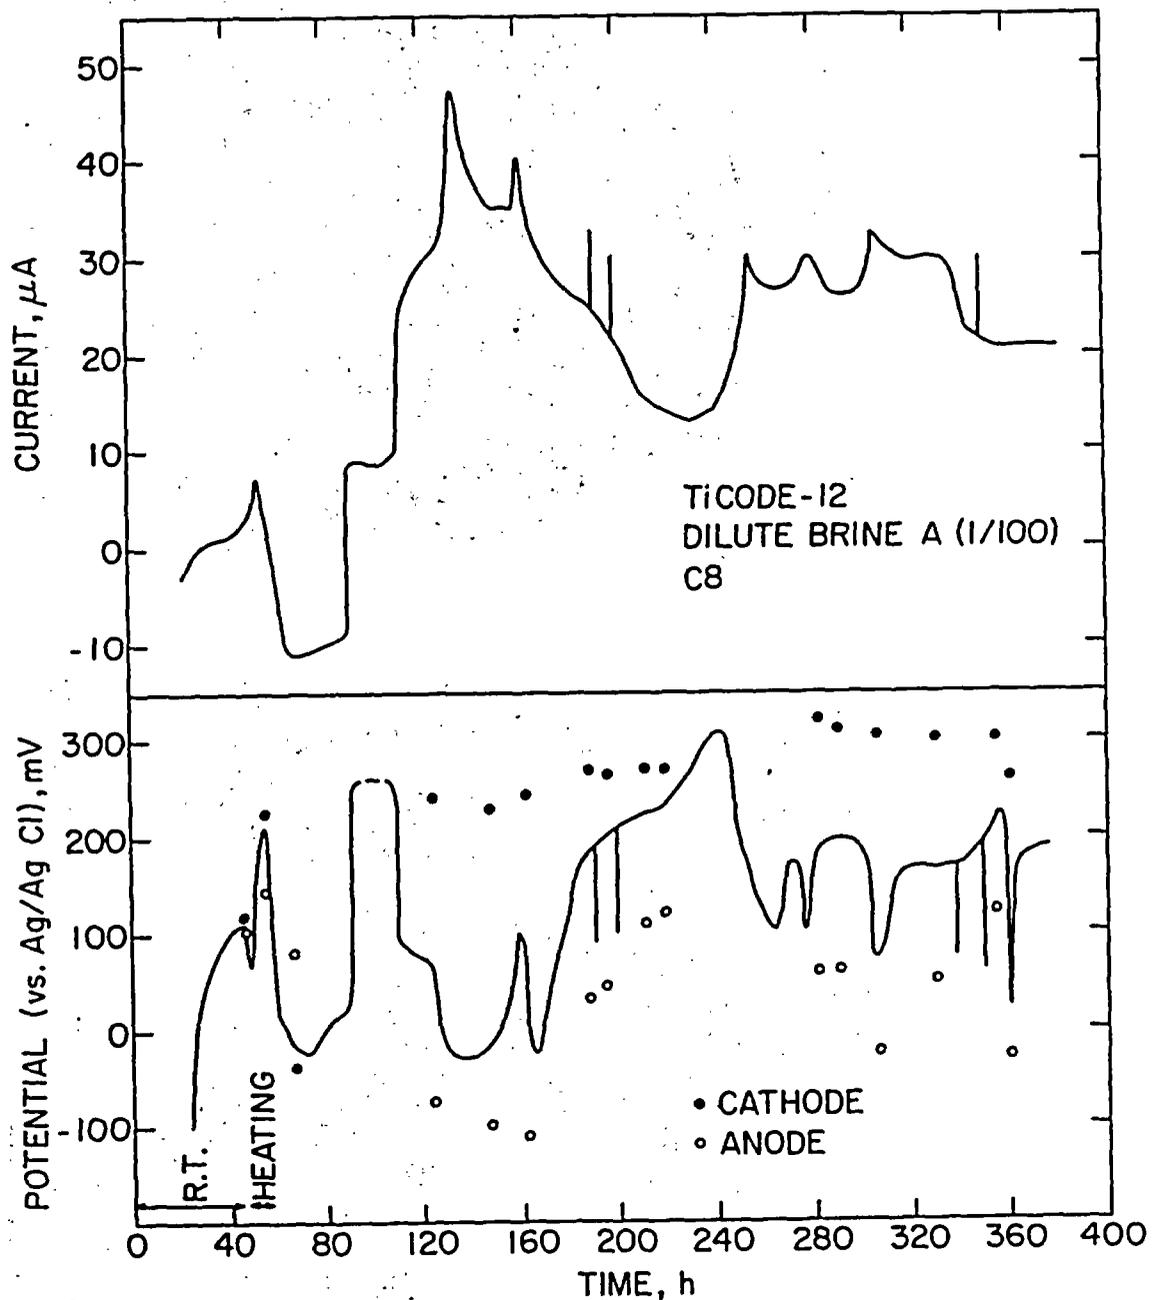
Figure 2.1. Time dependence of current and potential for Grade-12 titanium in one hundred times diluted Brine A. The closed and open circles represent uncoupled potentials of the freely exposed cathode disk and the anode assembly, respectively. The steady state temperature is  $\sim 150^{\circ}\text{C}$ . The broken line between 90 and 110 hours on the potential curve represents the period during which the potential overshot the recorder scale.

The general features of the variation of current and potential with time are essentially the same for various test conditions, as described in Reference 1. However, in view of the later results shown in Figure 2.1 we note that although a negative current or the drop in potential starts with the heating of the autoclave, it is not limited to the initial solution heating period. Thus, this period of the test may not be characterized as simply a response to the changing temperature, but may be a distinct stage within the incubation period. During this stage the uncoupled potential of the cathode shows a much larger change than that of the anode. The negative current is then consistent with the fact that the cathode is at a lower potential than the anode. At the end of this period, the crevice potential rises, the cathode is once again at a higher potential than the anode, and the current becomes negligible.

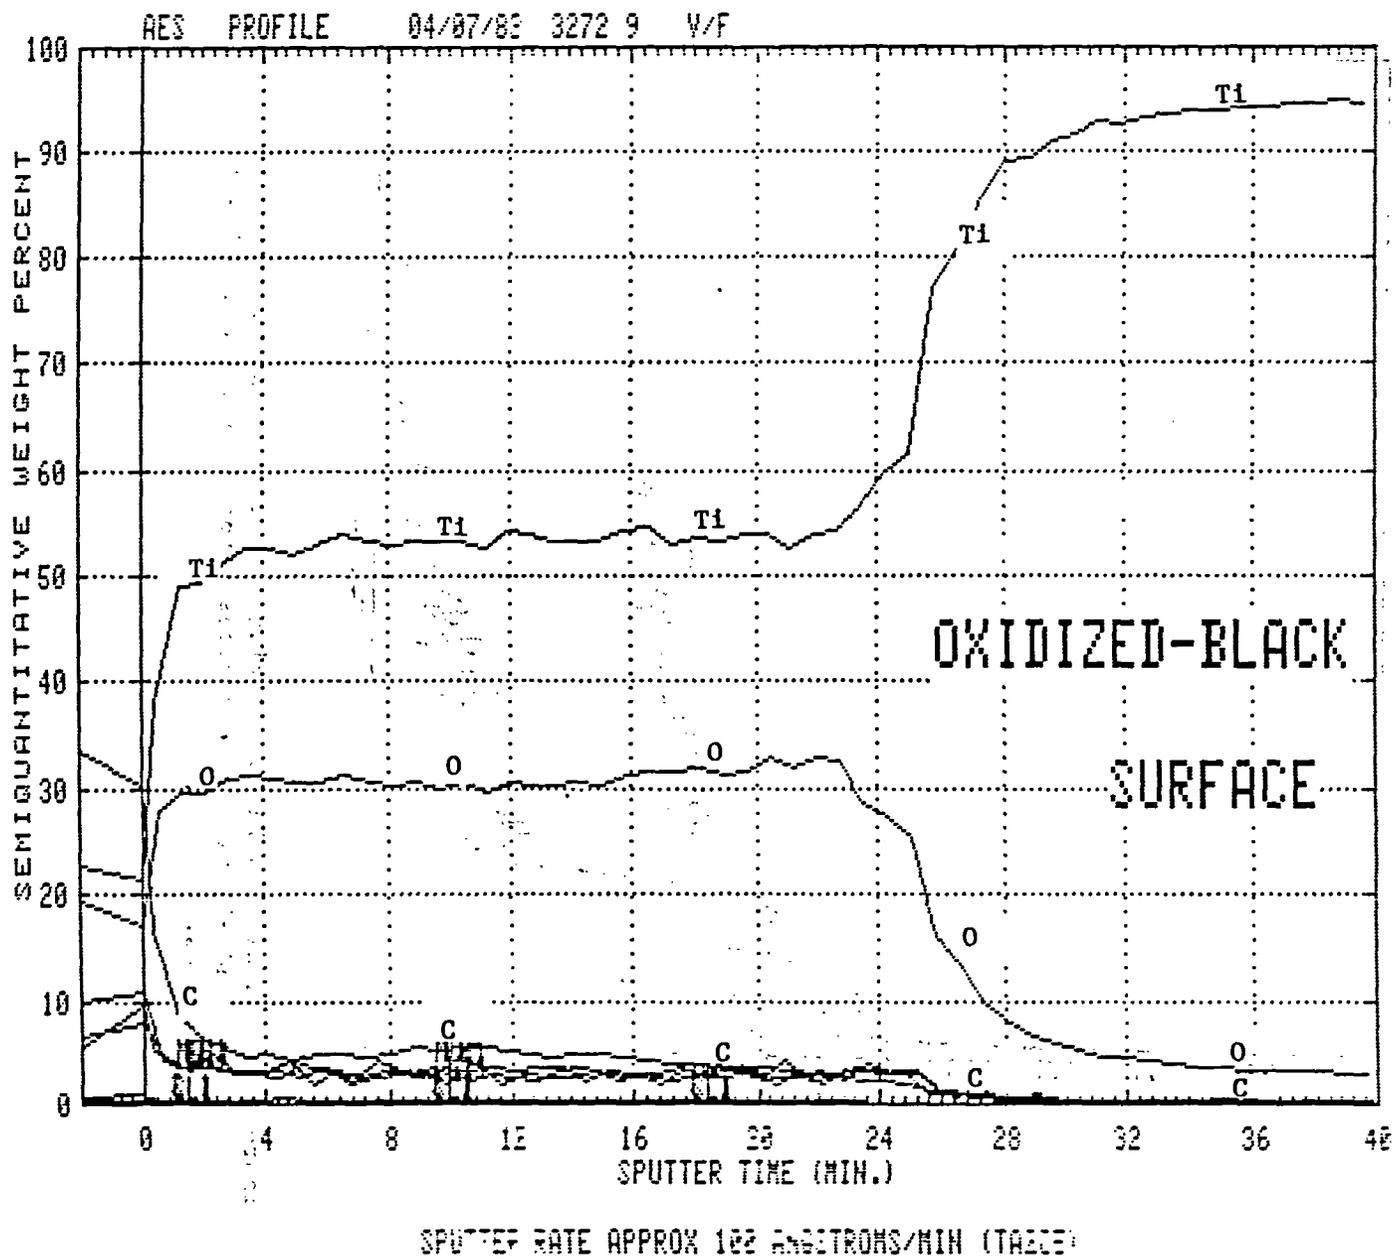
Figure 2.4. Auger profiles of the corrosion products in Grade-12 titanium crevices exposed to aerated Brine A for two weeks.

Auger spectroscopy results\*\*, shown in Figure 2.4, gave no indication of Ni or Mo enrichment. Previously we have reported the enrichment of Mo in EDAX analysis.<sup>6</sup> To confirm these results, Rutherford Backscattering has also been used\*\*\*. The results again show that no Mo and Ni are present (Figure 2.5). Based on these results it is possible that the corrosion products originate from the hydrolysis of dissolved ions. The energetics of the hydrolysis is known to be favorable for Ti and unfavorable for Ni, but the hydrolysis of Mo depends on the pH of the solution.<sup>7</sup> Therefore, local variation of pH may

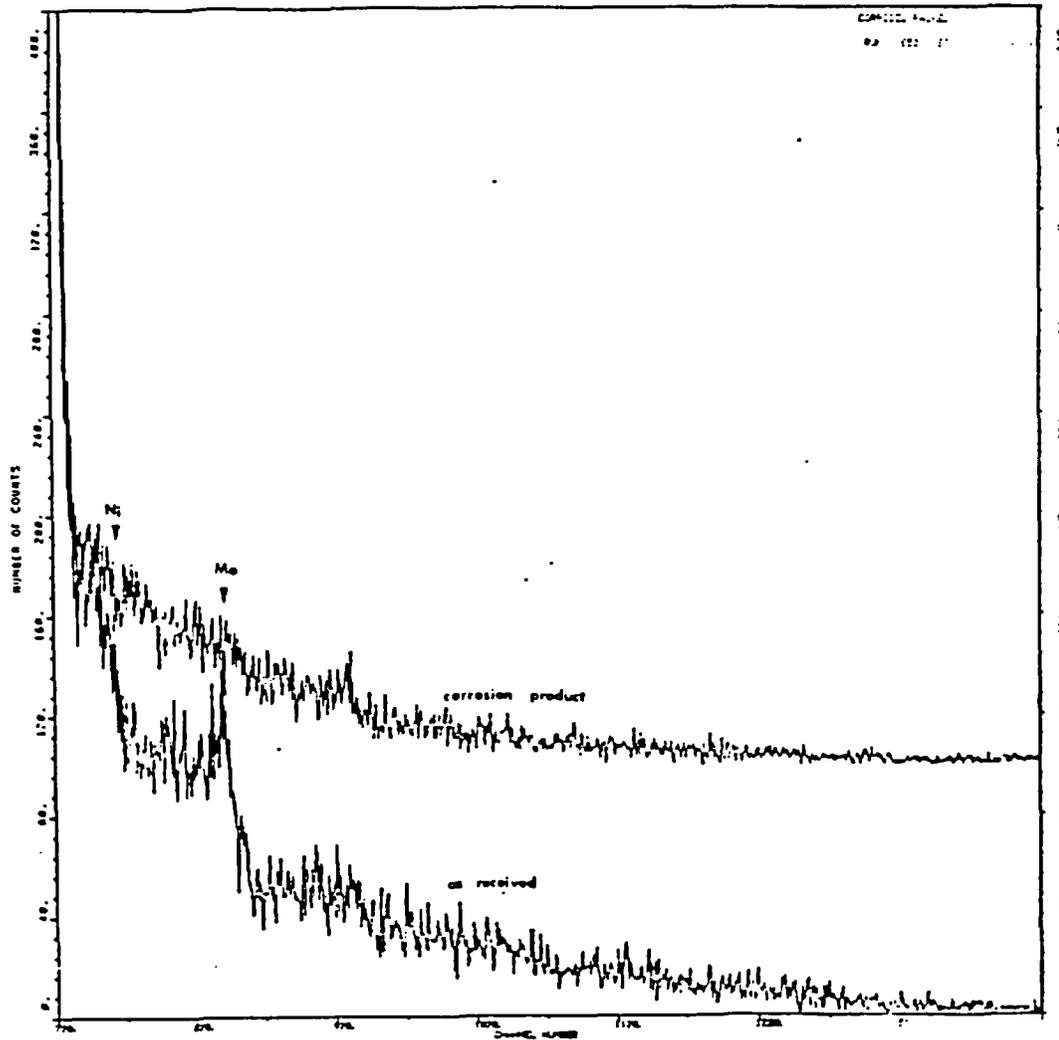
Figure 2.5. Rutherford backscattering profiles of the corrosion products in Grade-12 titanium crevices exposed to aerated Brine A for two weeks.

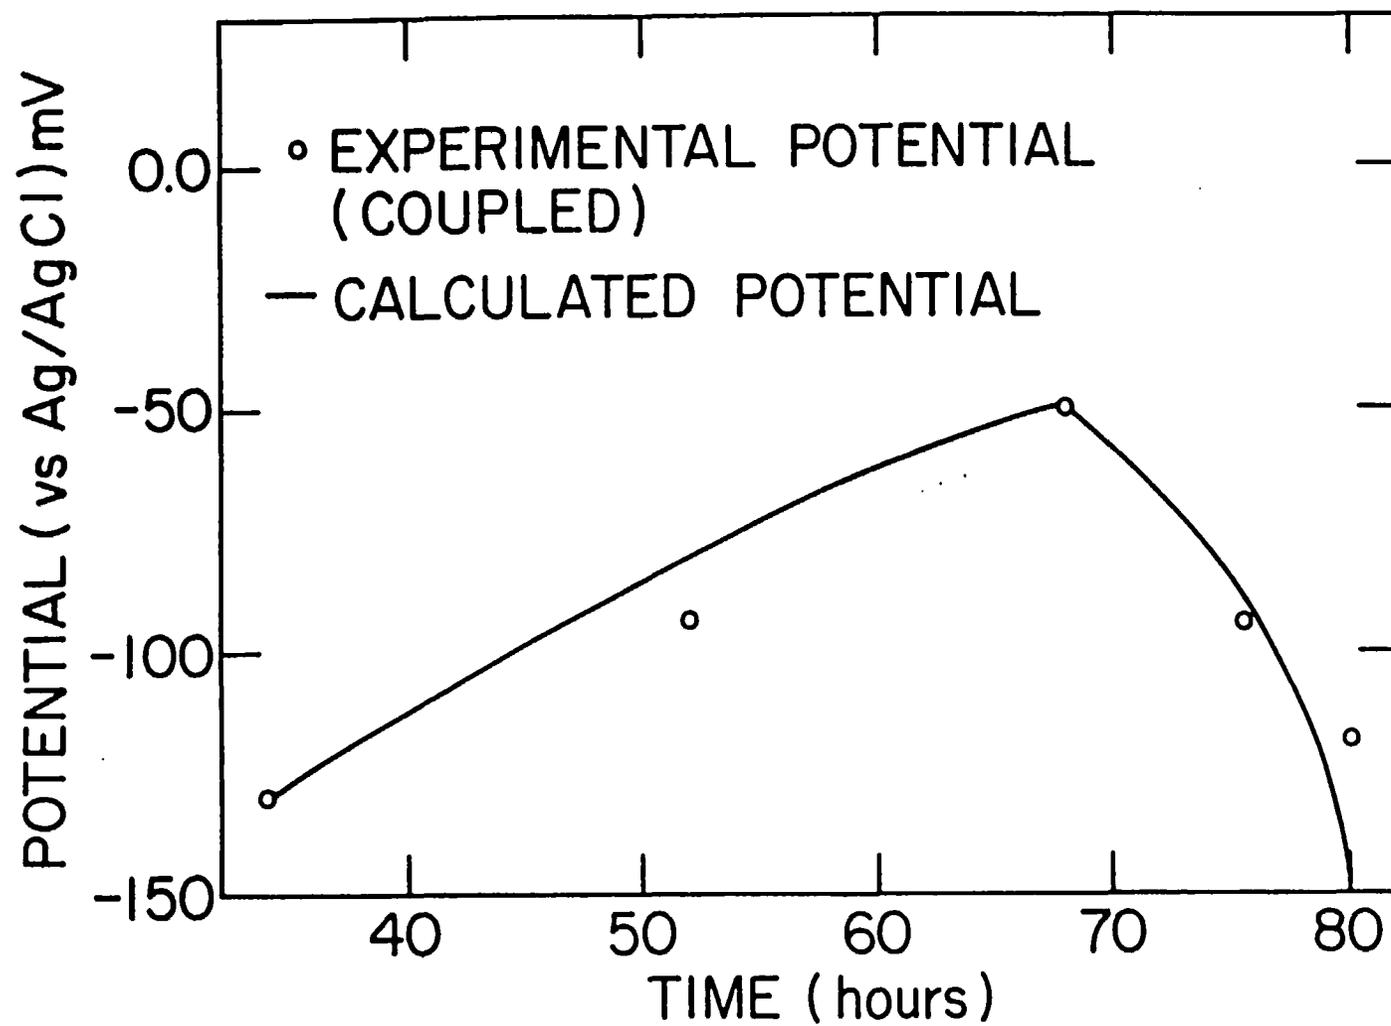
Figure 2.6. Experimental potential (open circles) and calculated potential (solid line) of coupled Grade-12 titanium crevices in aerated neutral Brine A at 150°C.

The best fit to our experimental data is shown in Figure 2.6 for  $\delta = 0.3$  cm (effective distance of concentration gradient),  $I_p = 7.6 \times 10^{-10}$  amp/cm<sup>2</sup>

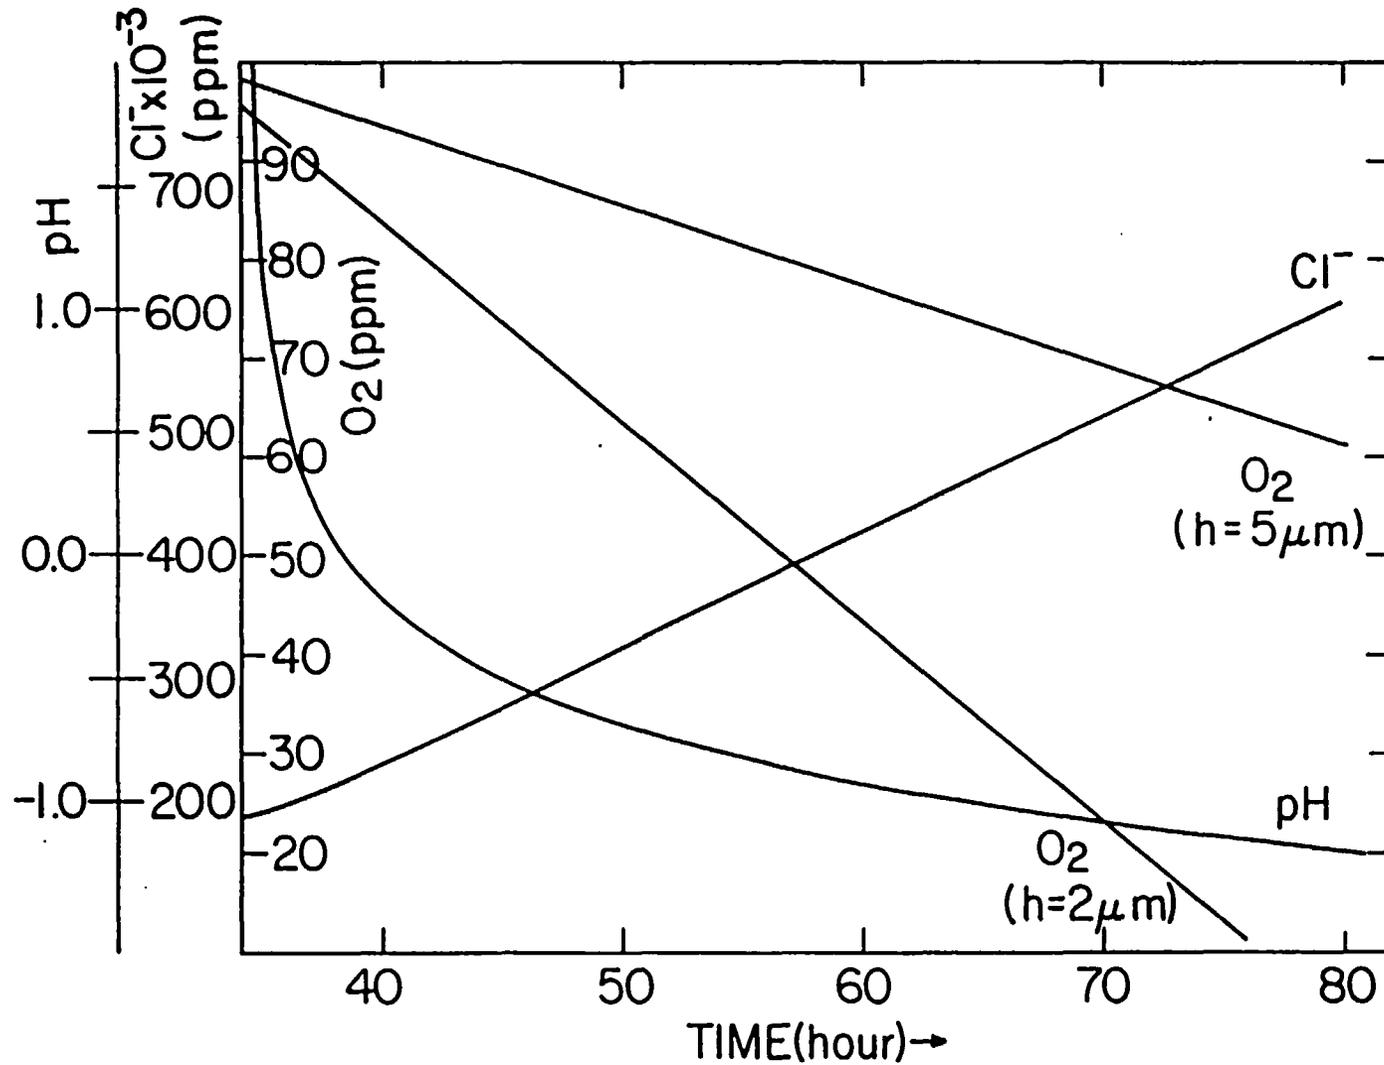
Figure 2.7. Calculated concentration profiles in the crevice of Grade-12 titanium in aerated neutral Brine A at 150°C.

The above outline of a crevice corrosion model may be used as a basis for long term corrosion prediction. Using pH = -1.19 in Figure 2.7 and the critical value of chloride ion concentration for passivity breakdown as 190,000 ppm (near-saturation of brine with chloride ions) a map (Figure 2.8) is drawn in the space of temperature and the initial chloride concentration  $C_i(\text{Cl}^-)$  necessary to attain the critical concentration at various times (detailed

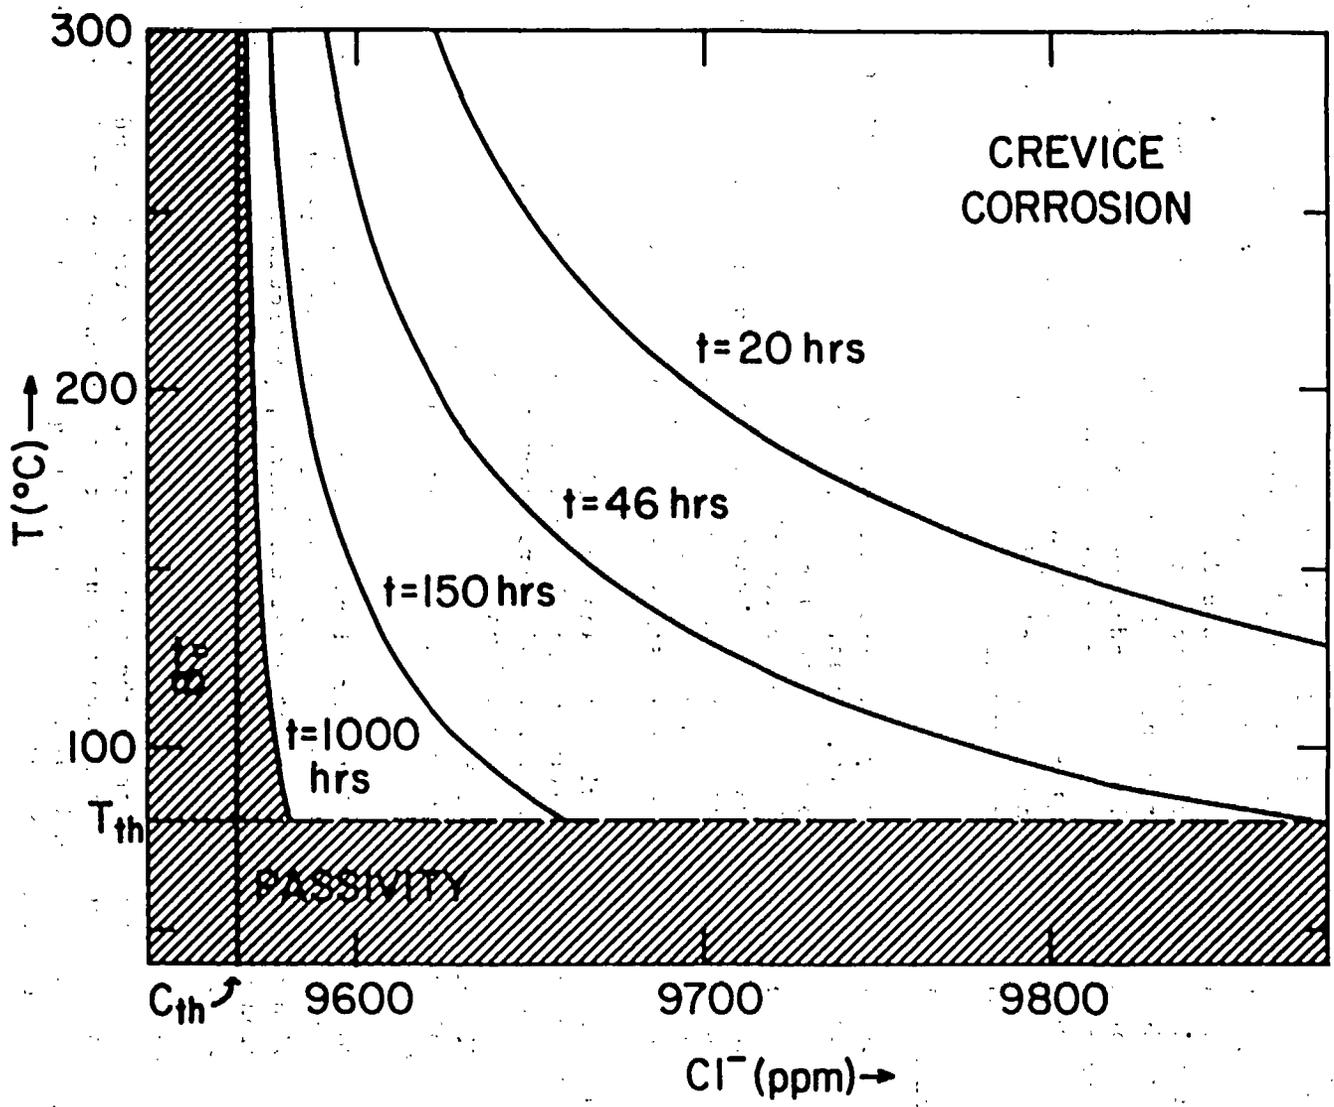
Figure 2.8. Calculated immunity domain of crevice corrosion of Grade-12 titanium in aerated neutral Brine A at 150°C.

equation is given in Reference 9). Such domains have been experimentally determined in CP-Ti and Ti-Pd alloy.<sup>23</sup> Therefore, our simple formulation is promising. Further, this calculation permits the extrapolation to long term behavior. Inside the unshaded area of Figure 2.8, crevice corrosion occurs while the hatched area shows immunity to crevice corrosion. The boundary of the two domains is also affected by the corrosion time. The domain for crevice corrosion (unshaded area) is enlarged as corrosion times are increased. At infinite corrosion time, the boundary becomes a straight line designated by  $C_{th}$ , below which crevice corrosion does not occur even at infinite corrosion time. Note that the curves in Figure 2.8 have been calculated on the basis of a corrosion current which is independent of test temperature. When the temperature dependence of the current is considered the curves in this Figure will be modified.<sup>5,8</sup> Also, the model developed shows that there will be a temperature limit,  $T_{th}$ , below which mass flow in the corrosion system ceases. Since the calculated  $T_{th}$  is lower than the freezing point of the test solution, it does not have a significant meaning at low temperatures where the solution becomes frozen.

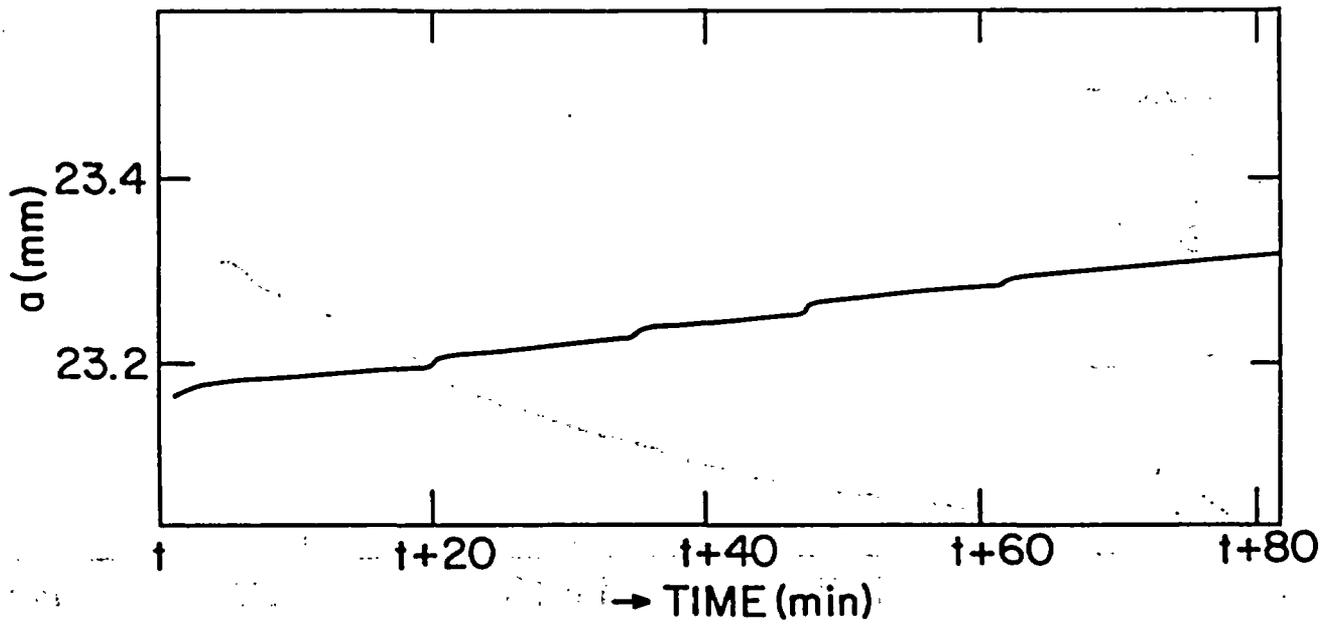
Figure 3.1. Crack length - time curve observed in the beginning of crack growth for extended times. This curve is from a test on an as-received Grade-12 sample at 20°C.

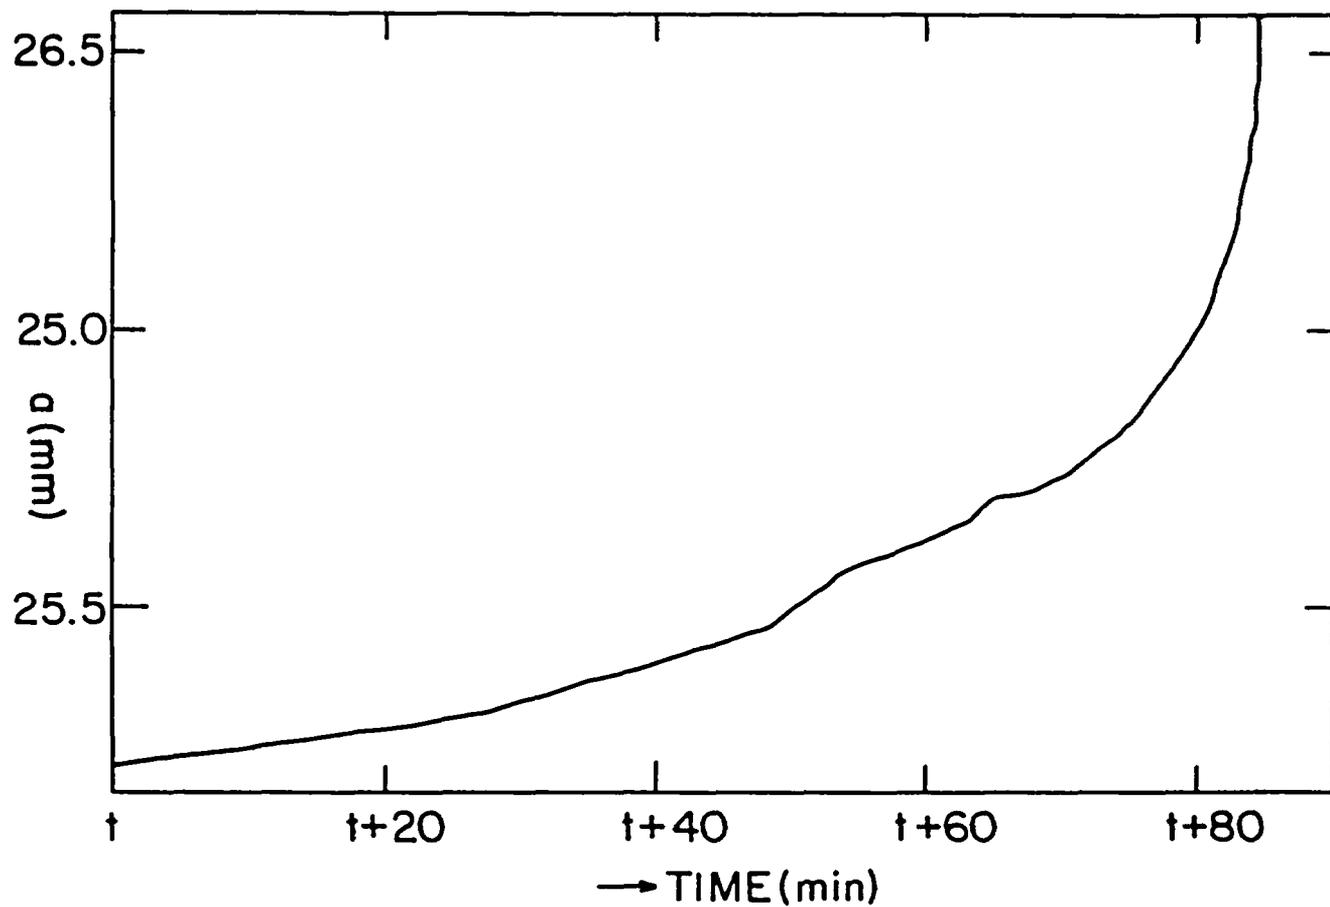
Figure 3.2. Crack length - time curve observed in the final stage of crack growth. This curve is from a test on an as-received Grade-12 sample at 50°C.

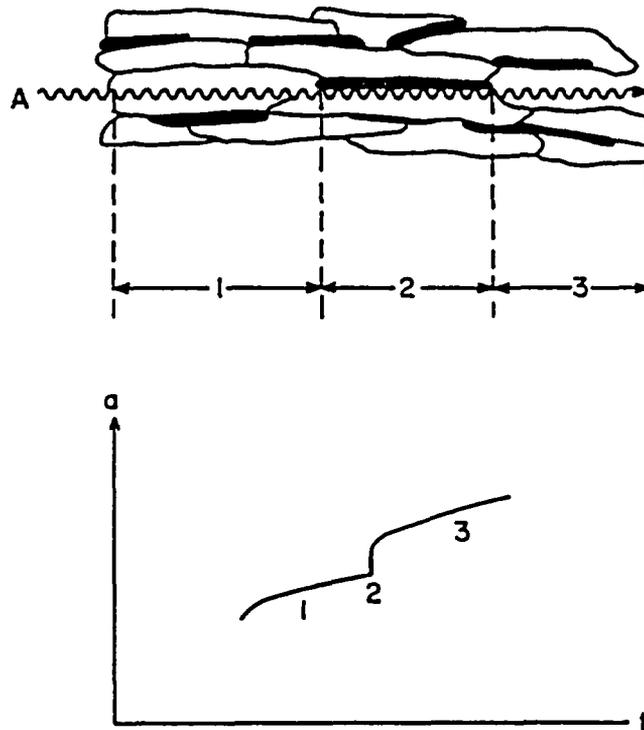
Figure 3.4. A schematic of crack growth as the crack front passes through the alpha and beta regions.

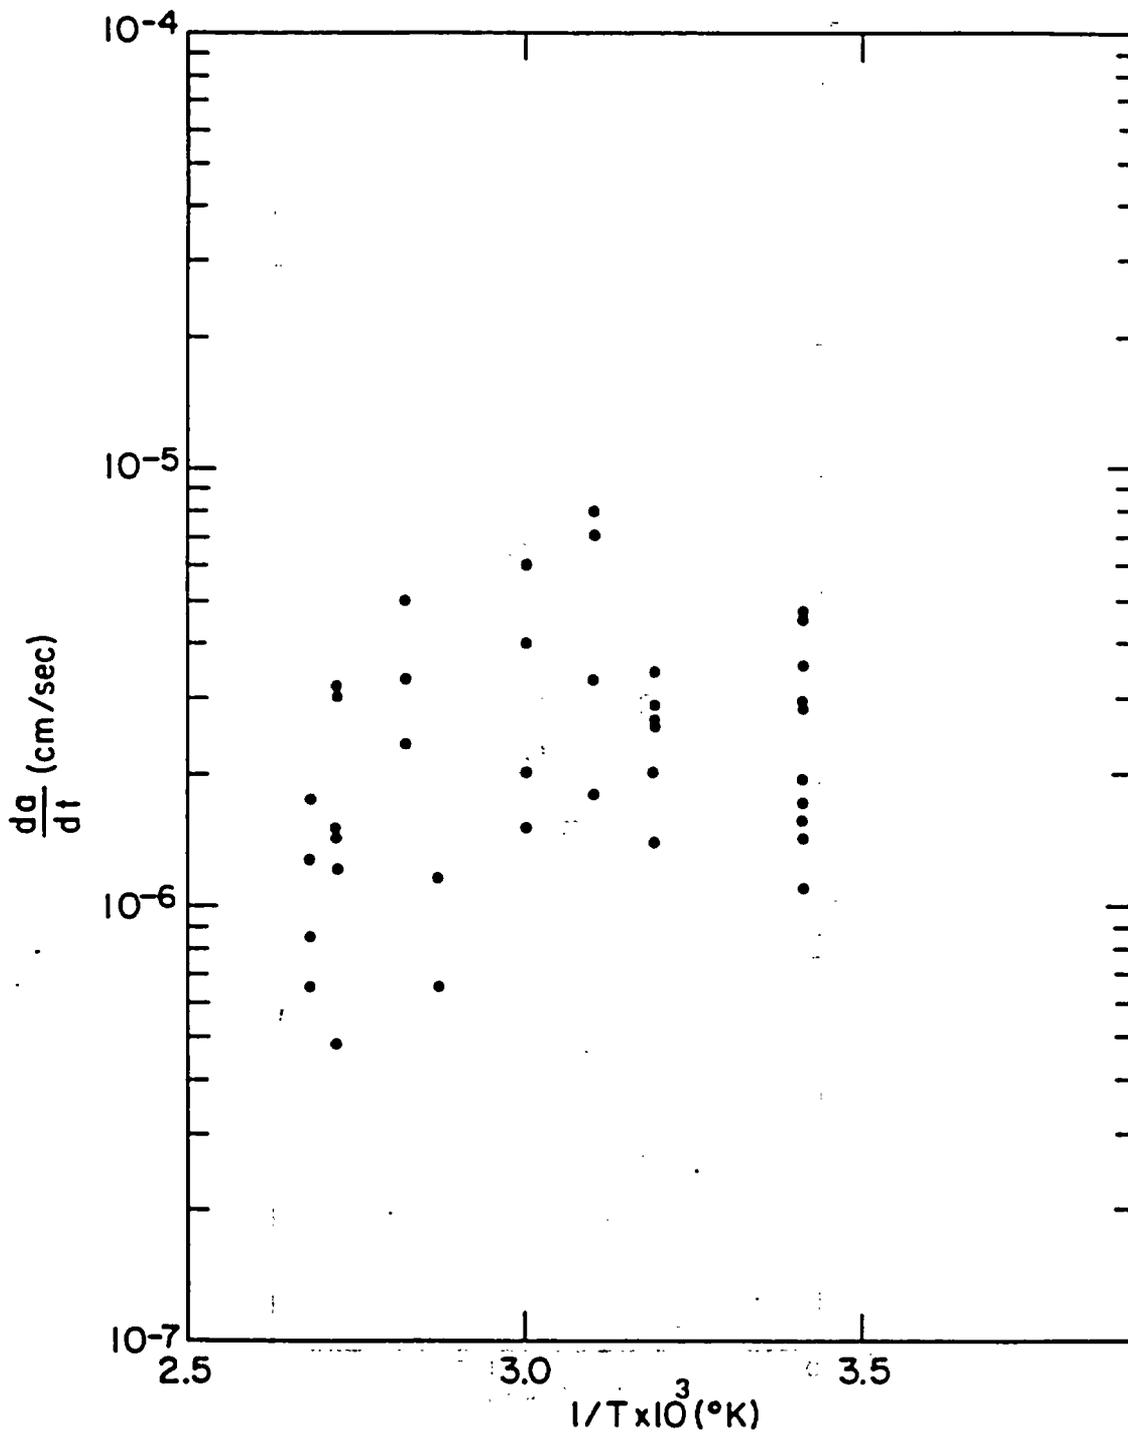
Figure 3.5. The measured slow crack growth rates of as-received Grade-12 titanium for  $K = 60$  to  $80 \text{ MPa}\sqrt{\text{m}}$  at various temperatures.

Figure 3.5 gives the temperature dependence of crack velocity obtained from the solid circles in Figure 3.6 (open circles represent the fast stage II transient crack growth stage in Figure 3.4) at stress intensity values from 60 to 80 MPa $\sqrt{m}$ . This curve is for the same microstructure and hydrogen concentration in the specimen (35-40 ppm). As expected, a maximum is observed. The details will be discussed in the next section.

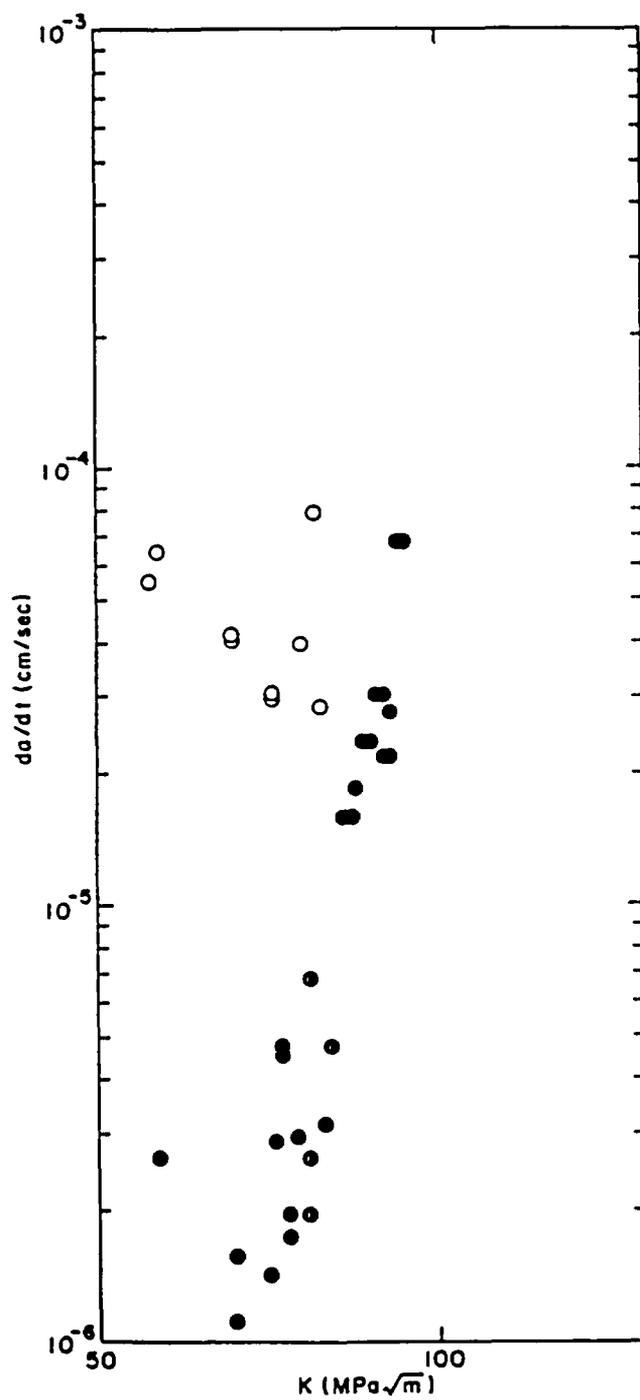
Figure 3.6. Slow crack growth rates of as-received Grade-12 titanium at room temperature. Solid circles represent the steady state (1 and 3 in Figure 3.4) and open circles represent the transient state (2 in Figure 3.4).

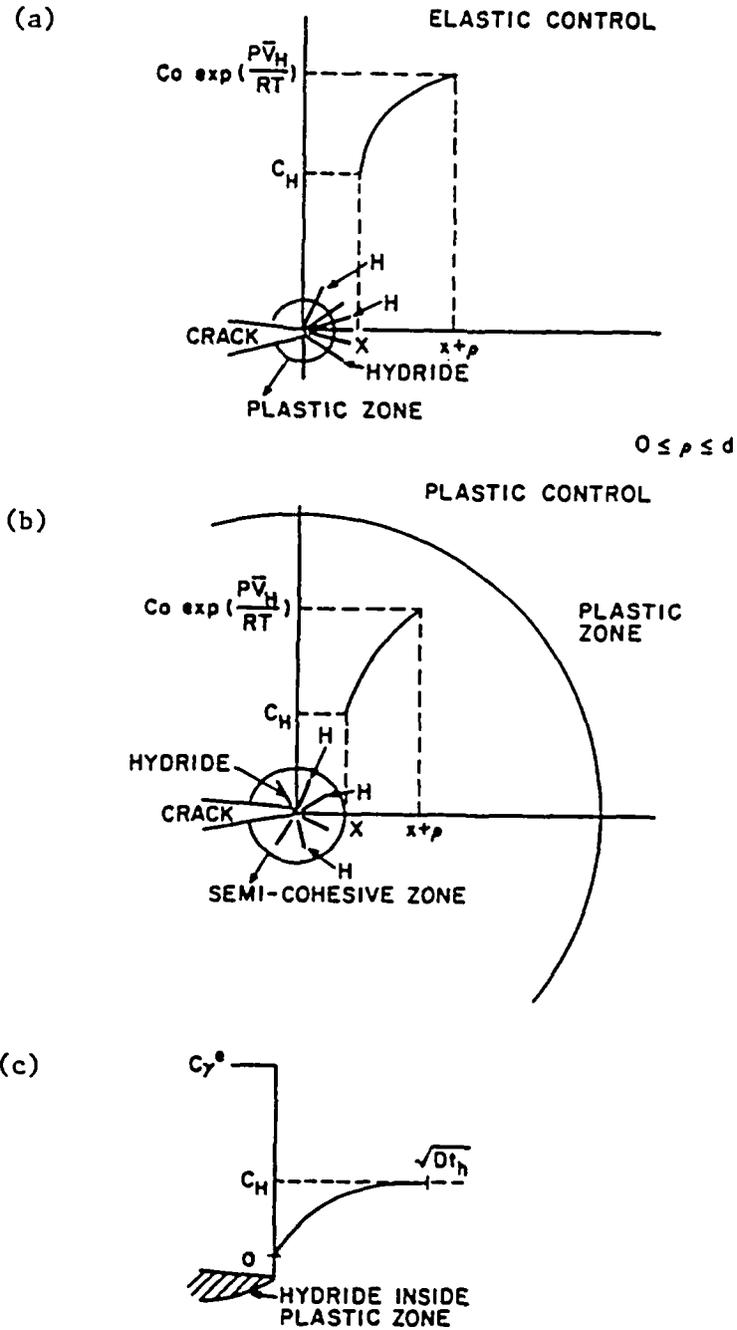
Figure 3.7. A schematic of hydride growth at crack tip (a) stage I, (b) stage II, (c) hydrogen concentration in front of a growing hydride.  $C_H$  is the hydrogen concentration at the interface due to the formation of a concentration profile.  $D$  is the hydrogen pipe diffusivity. The rest of the parameters are given in Appendix 3-1.

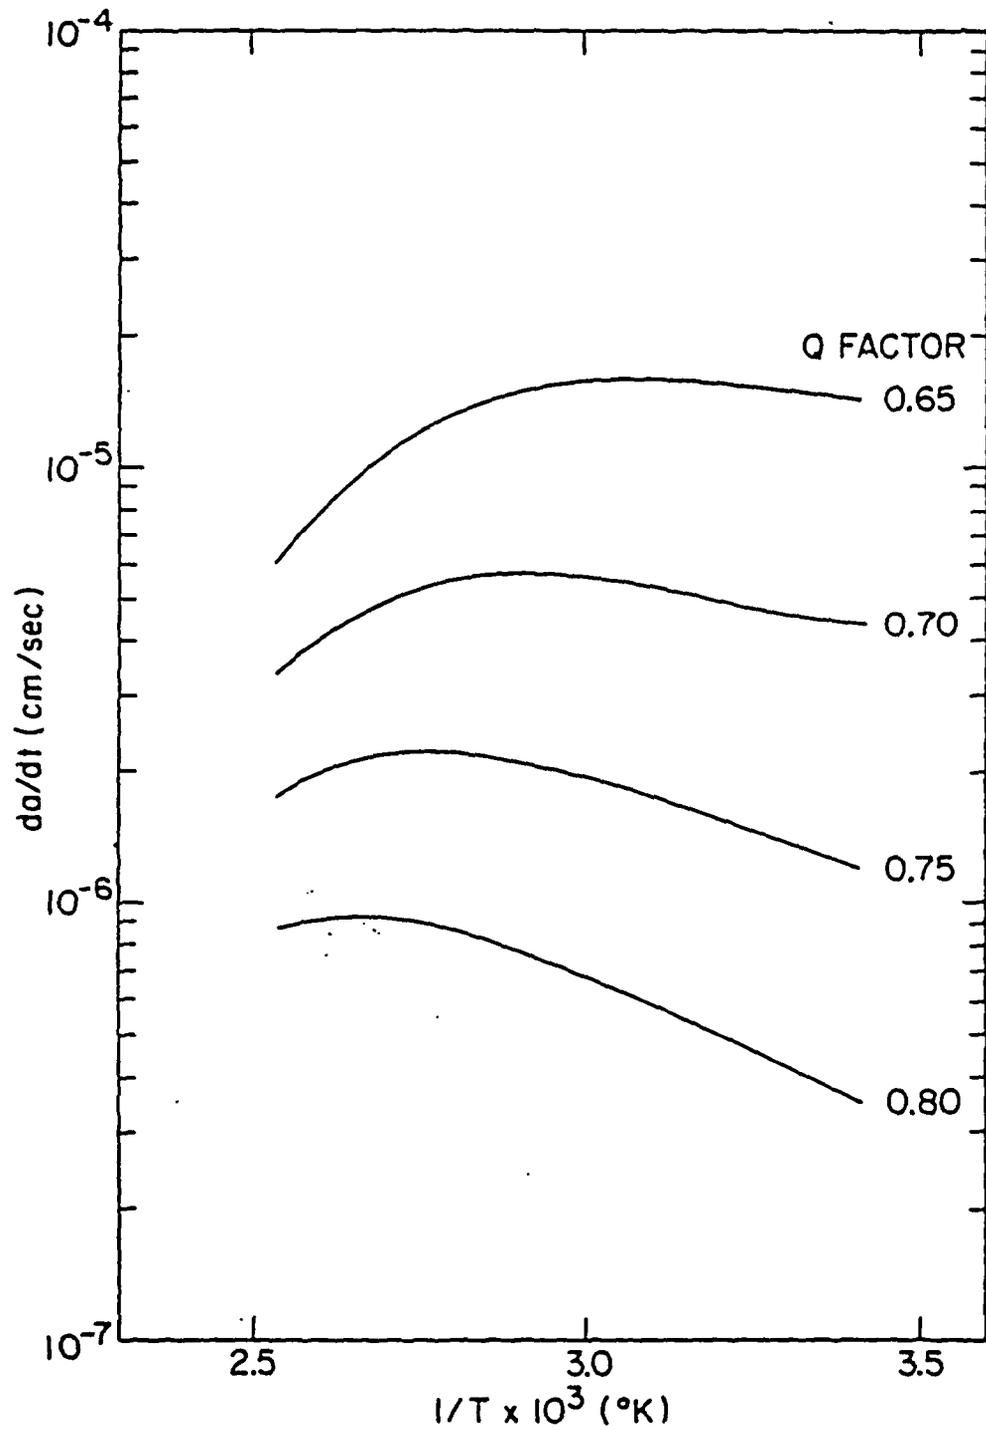
Figure 3.8. Calculated slow crack growth rates of as-received Grade-12 titanium controlled by hydrogen pipe diffusion for all K values at various temperatures. The Q factor is a ratio of activation energy of pipe diffusion to that of lattice diffusion.

The threshold stress intensity,  $K_{th}$  is obtained using Equation (1) and Equation (3), and the parameters used in obtaining Figures 3.8 and 3.9. At  $150^\circ C$  and  $C_0 = 35$  ppm with a hydrogen accumulation factor of 2 in the alpha phase adjacent to the beta phase,<sup>4,5</sup> the  $K_{th}$  value is found to be 4.86 MPa $\sqrt{m}$ . At and below  $K = K_{th}$ , the incubation time<sup>2,6</sup> for hydride nucleation is infinity. As mentioned before, to check whether there are  $K$  values greater than  $K_{th}$  which give also very long incubation time, the incubation time is calculated for various  $K$ -values above the  $K_{th}$  value. If  $K$  is increased to  $K_{th}$  plus a maximum of  $2 \times 10^{-6}\%$  of  $K_{th}$ , the incubation time is reduced to be 85-250 seconds within the parameter variations used in Figure 3.8. Therefore, there are no such  $K$  values in practice and we may conclude that the container will not fail when it is subjected to a stress intensity below 4.86 MPa $\sqrt{m}$  at  $150^\circ C$  and an initial hydrogen concentration of 35 ppm for very extended time periods. Table 3.1 shows an estimated minimum crack size allowed from the  $K_{th}$  values at various applied stress levels. It is

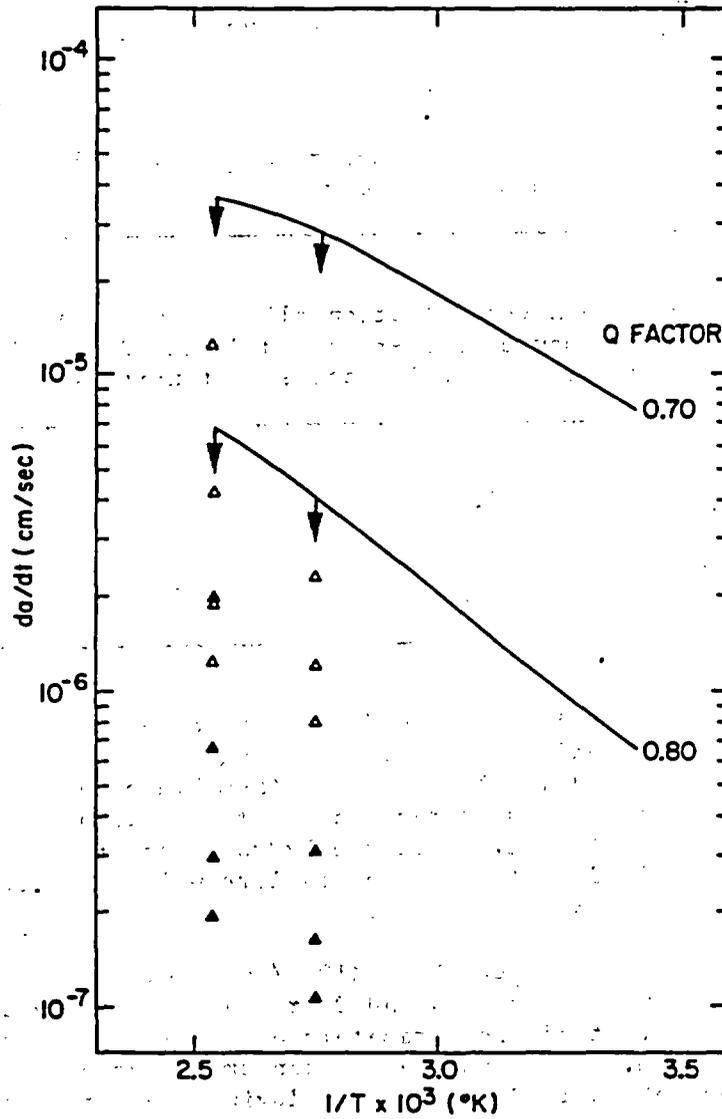
Figure 3.9. Calculated crack growth rates of as-received Grade-12 titanium assuming hydrogen pipe diffusion kinetics plus nucleation kinetics (triangles). For nucleation control, four triangles are for  $K = 42, 56, 80, 127 \text{ MPa}\sqrt{\text{m}}$ , respectively, at  $120^{\circ}\text{C}$  and three triangles are for  $42, 56, 80 \text{ MPa m}$ , respectively, at  $90^{\circ}\text{C}$ . Open triangles are for  $Q = 0.70$  and solid triangles are for  $Q = 0.80$ .

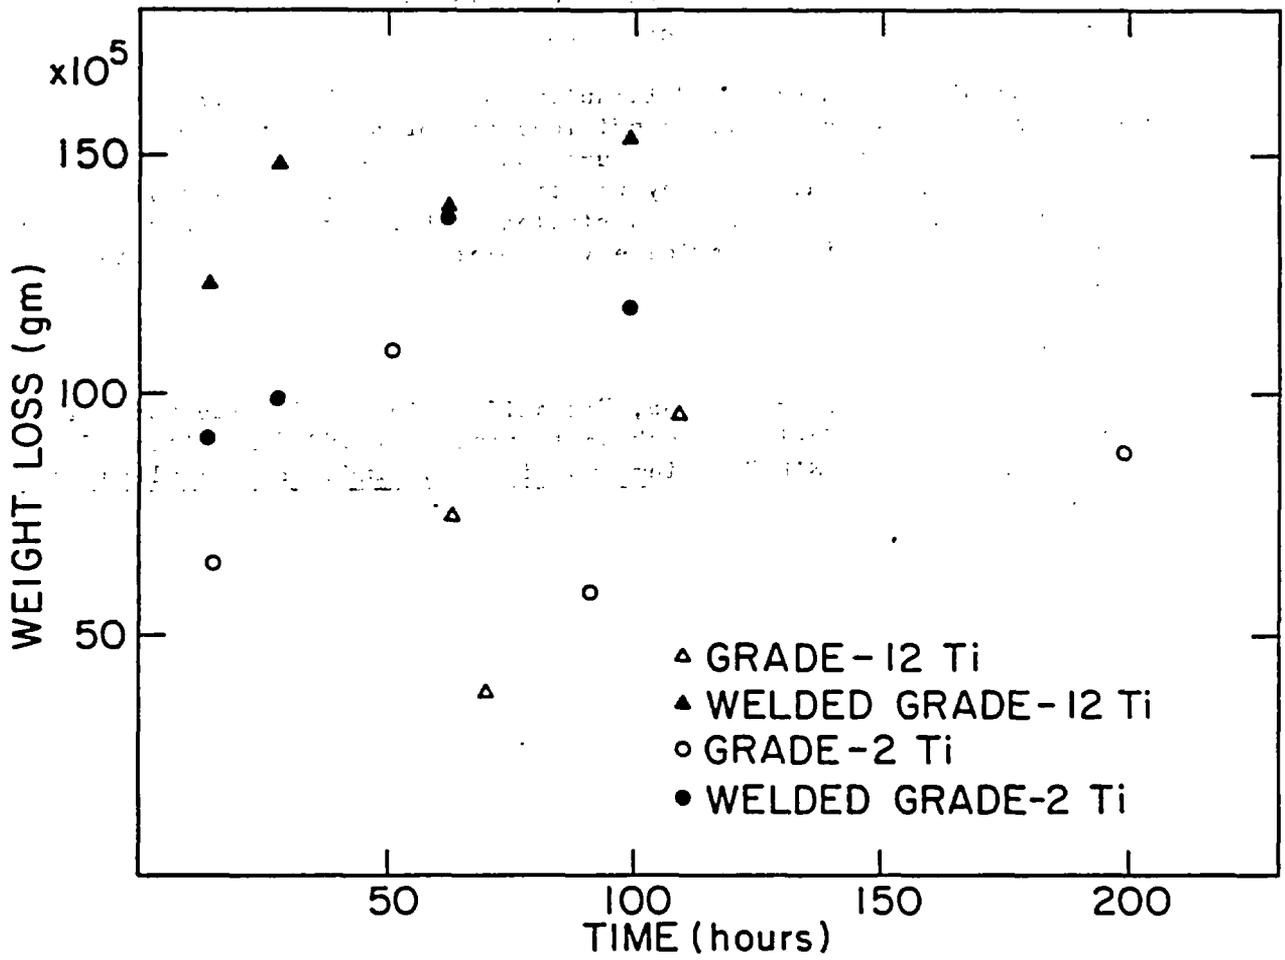
Figure 7.1. Long term weight loss data of single and welded coupons of Grade-12 and Grade-2 Ti in Brine A at 150°C.

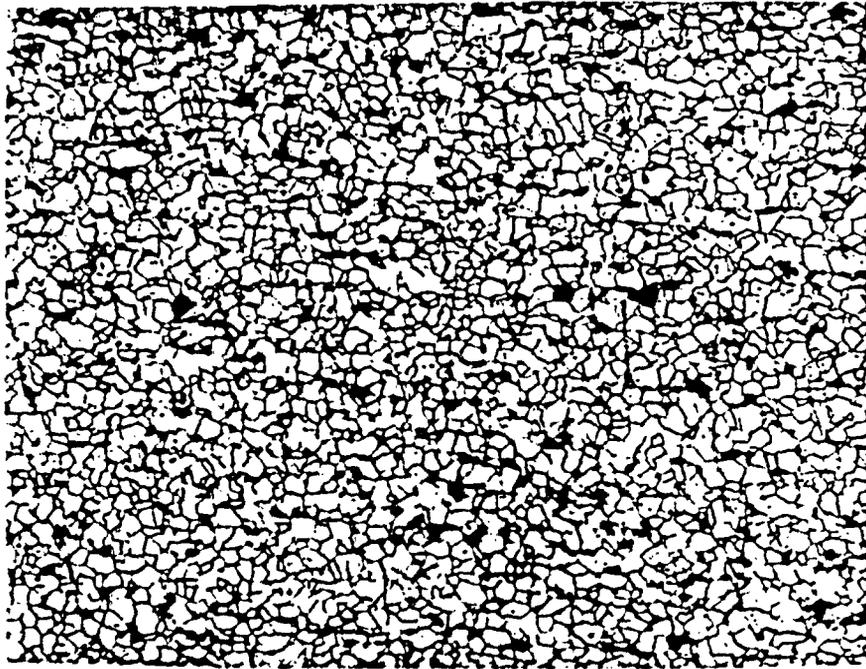
Figure 1. Initial microstructure of ASTM A216-Grade WCA cast steel rod.

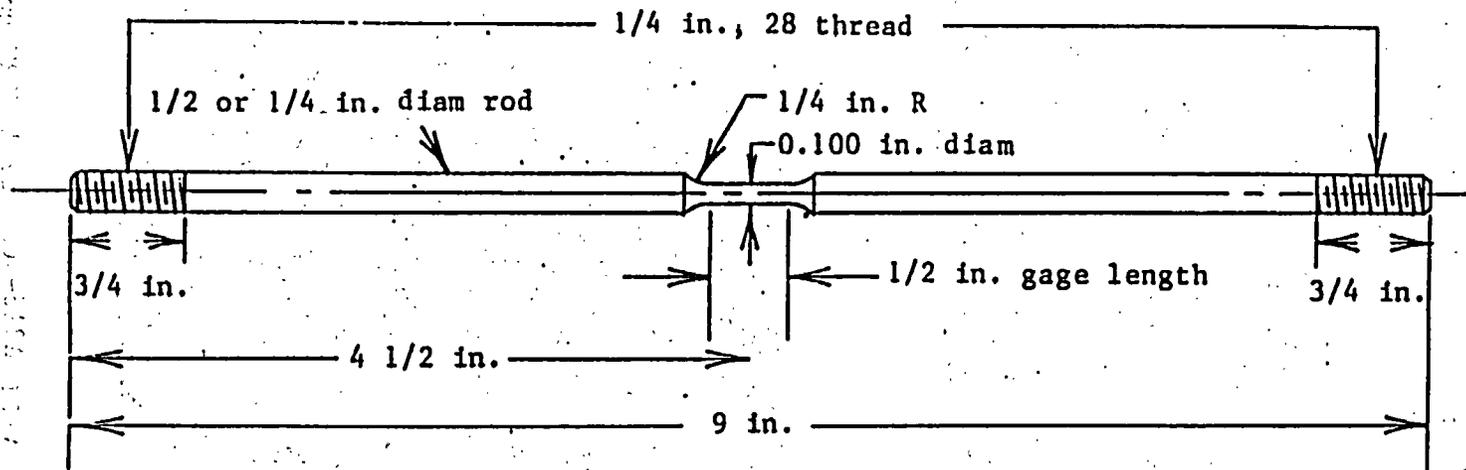
Figure 2. CERT test specimen configuration for stress corrosion cracking and hydrogen embrittlement tests.
