CONTAINER ASSESSMENT - CORROSION STUDY  
OF HLW CONTAINER MATERIALS

QUARTERLY PROGRESS REPORT  
July-September 1983

T. M. Ahn, H. Jain and P. Soo

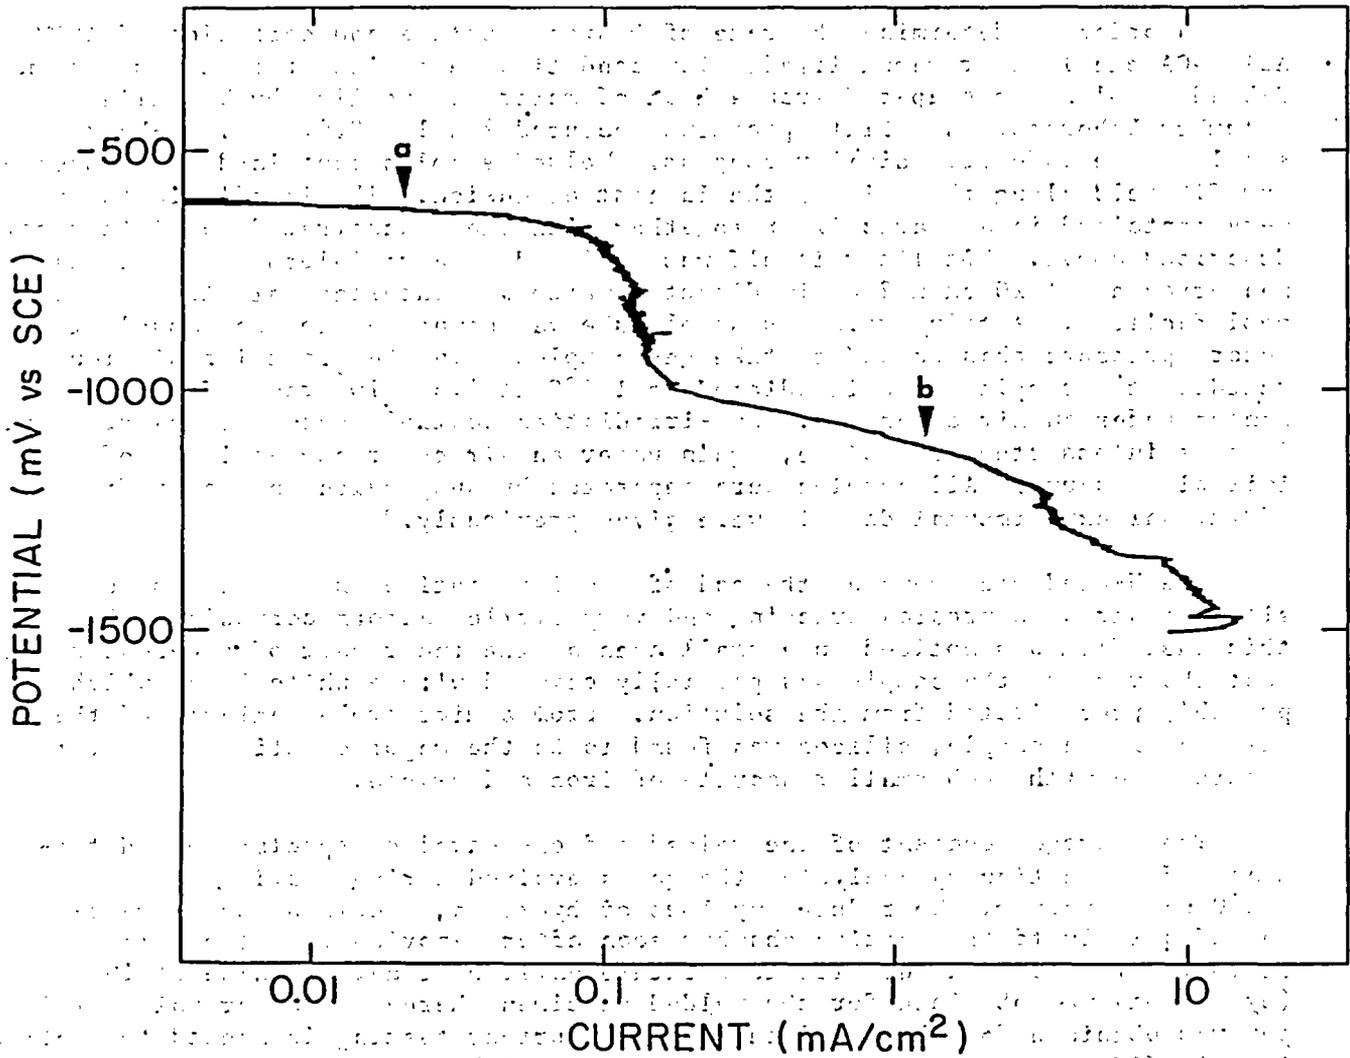
**Figure 8. Cathodic polarization curve of ASTM A216-WCA steel at 85°C. Point (a) represents the oxygen reduction potential while point (b) represents the hydrogen reduction potential.**

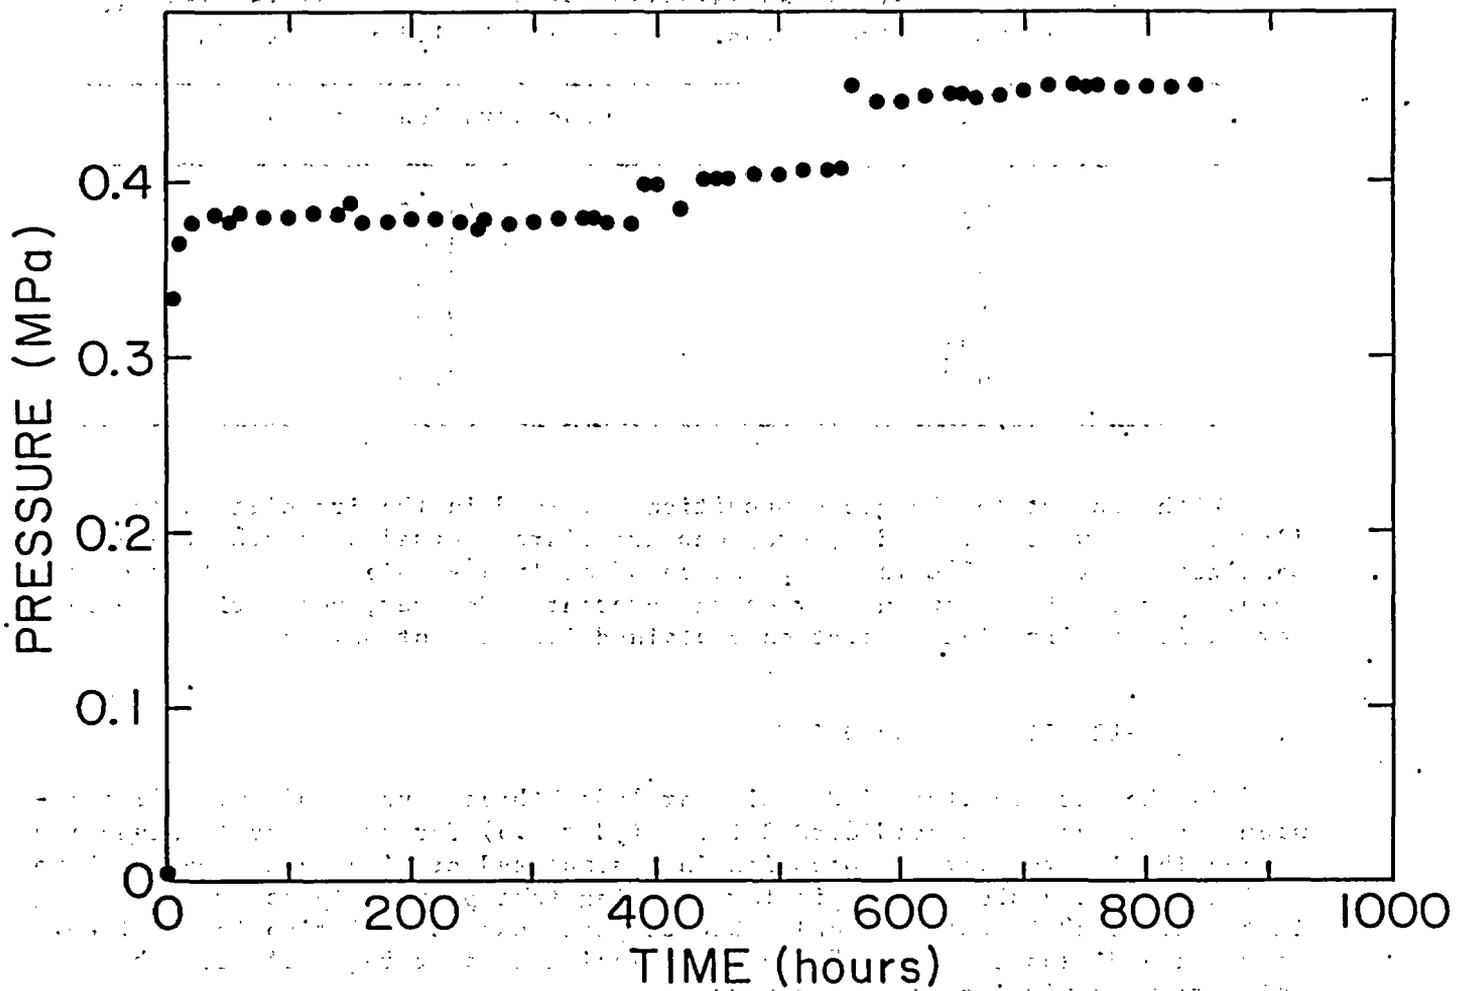
Figure 11. Gas pressure changes during gamma irradiation of concentrated Grande Ronde basaltic water/cast steel system at 150°C. The dose rate was  $1.36 \times 10^6$  rad/h.

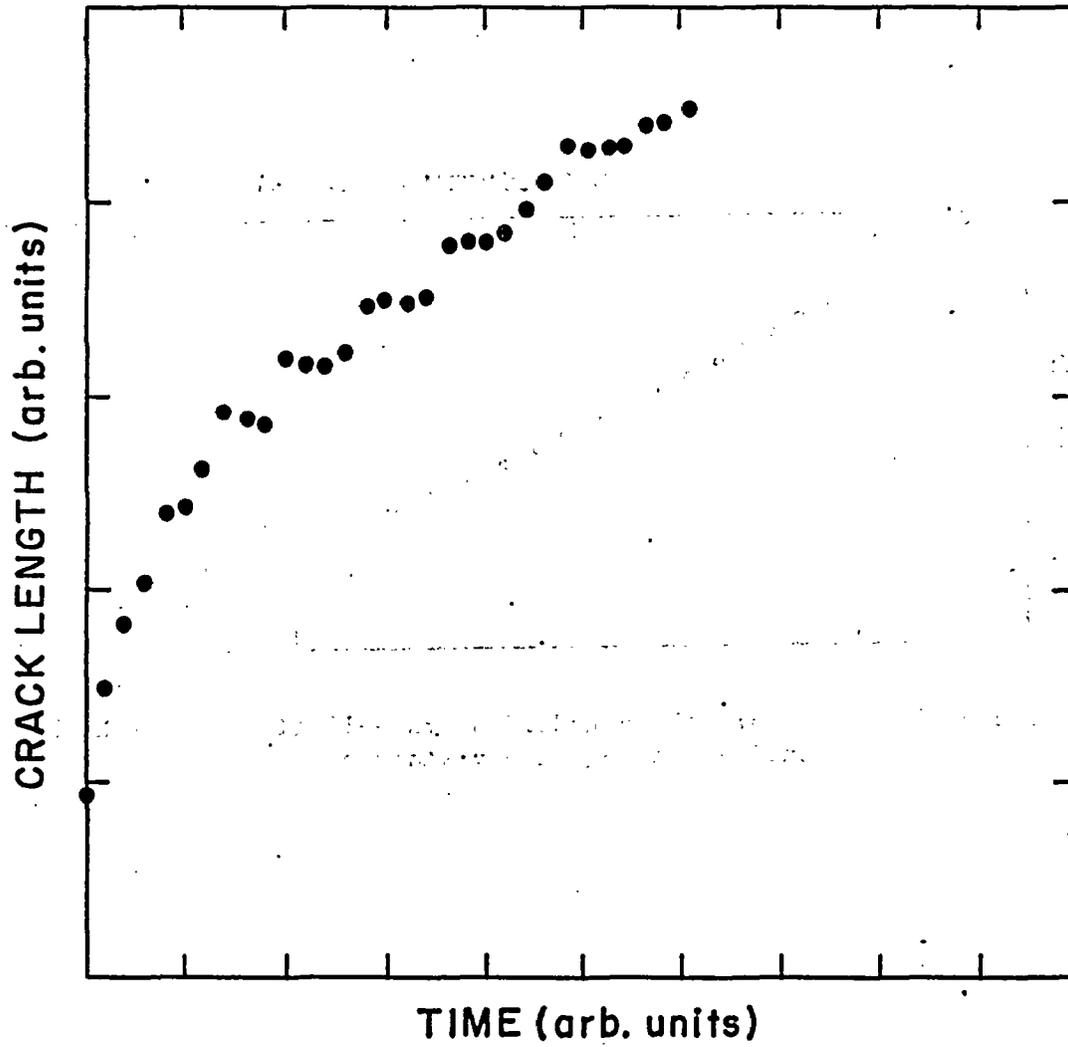
Figure 14. Early stage of crack growth in hydrided Grade-12 titanium showing transient growth (parabolic) behavior and some superimposed incremental crack jumps.

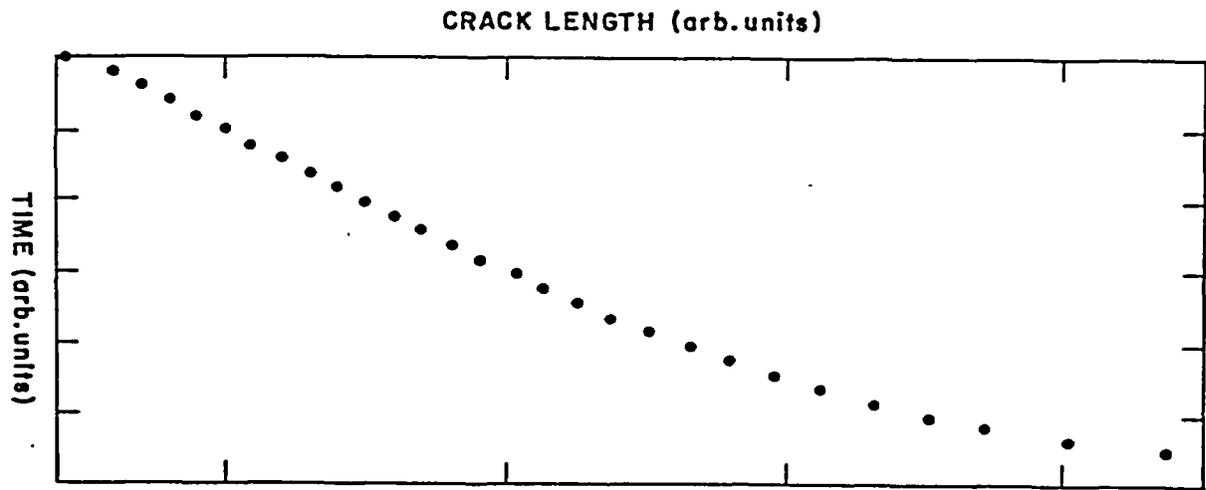
Figure 15. Crack growth in hydrided Grade-12 titanium at high stress intensity showing steady state growth.

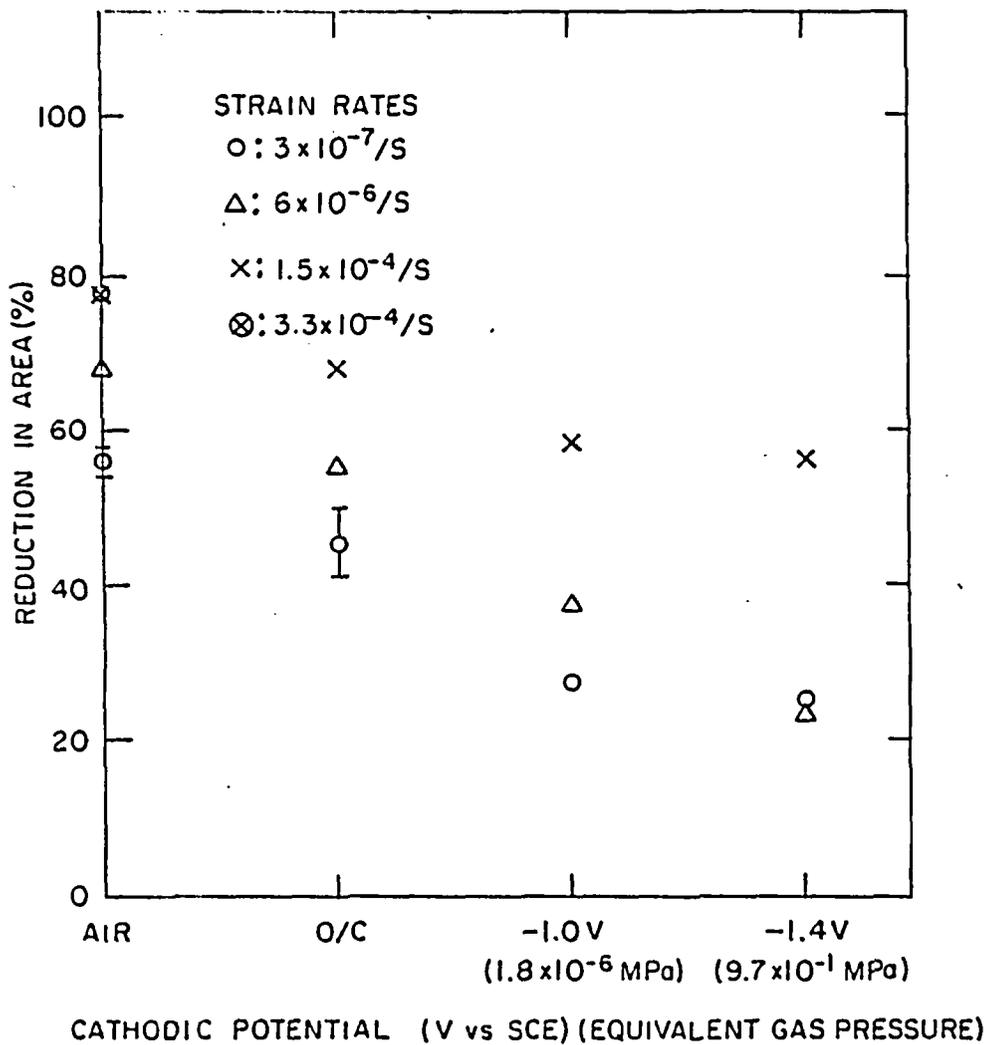
Figure 2. Reduction in area versus applied potential in CERT tests for hydrogen embrittlement of ASTM A216-Grade WCA steel in concentrated ( $\times 7.7$ ) basaltic groundwater at 80-85°C.

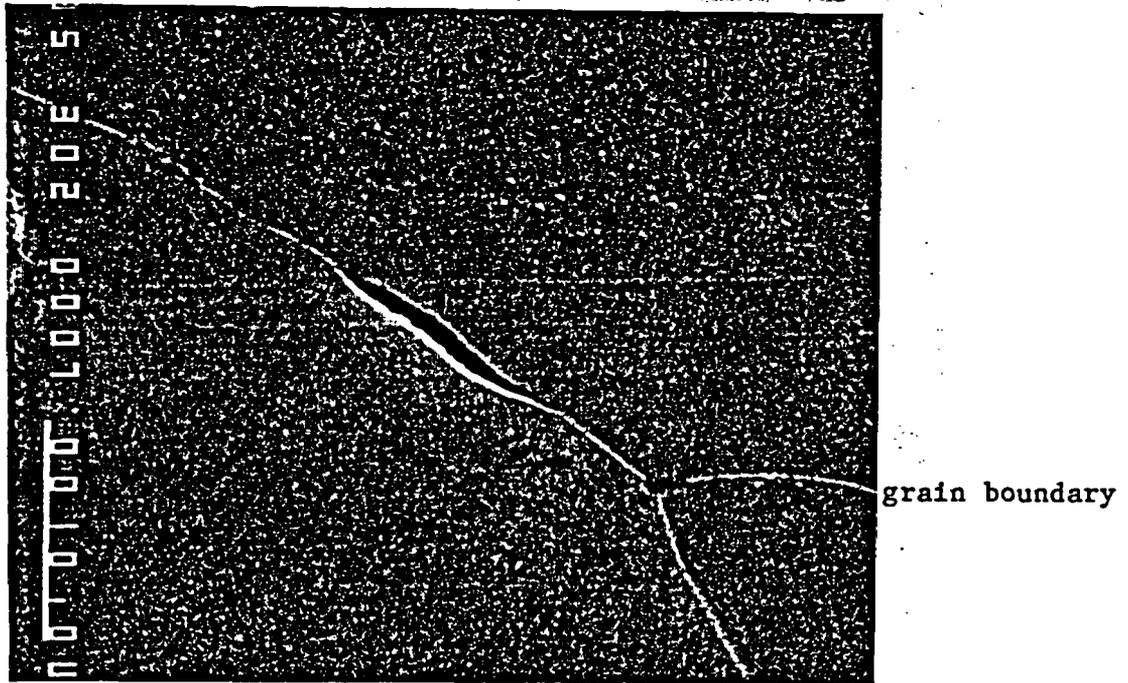
Figure 3. Surface cracking and internal cracking observed in ASTM A216-Grade WCA steel exposed to concentrated (x7.7) basaltic groundwater under a gamma dose rate of  $1.3 \times 10^6$  rad/h at  $150^\circ\text{C}$  for two months.

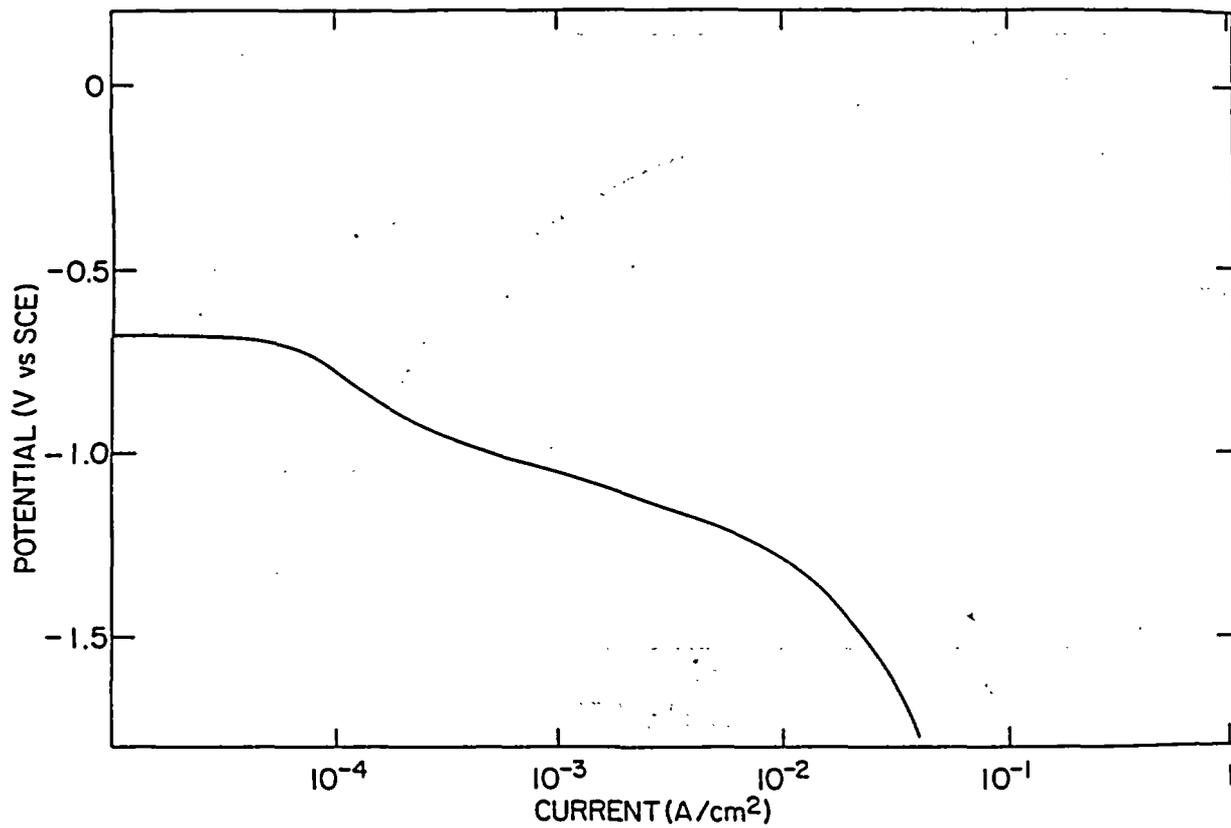
Figure 7. Cathodic polarization curve of ASTM A216-Grade WCA steel in concentrated (x7.7) basaltic water at 80°C. The scan rate was 0.2 mV/sec.

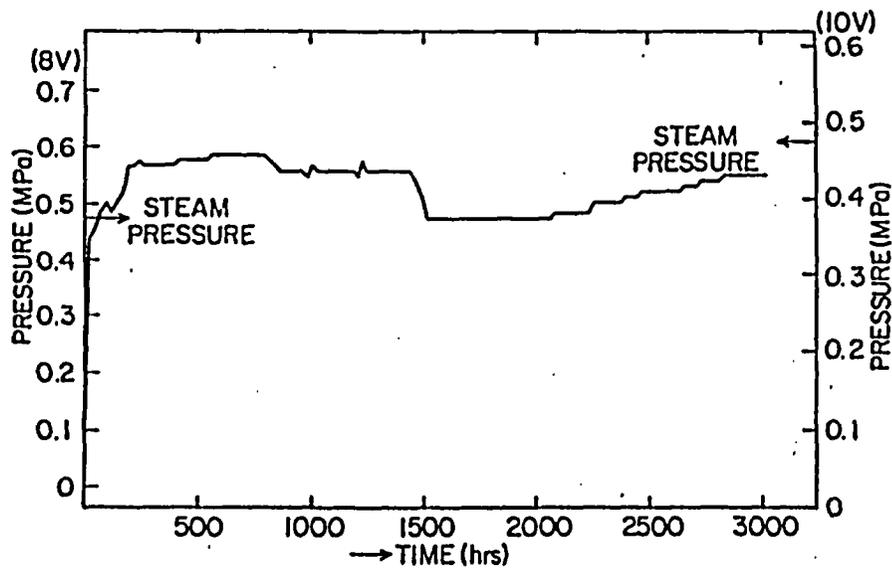
Figure 6. Gas pressure changes during the gamma irradiation of concentrated basaltic water/metal systems at 150°C for four months. The dose rate was  $1.36 \times 10^6$  rad/h. Absolute values of pressure scales are not known.

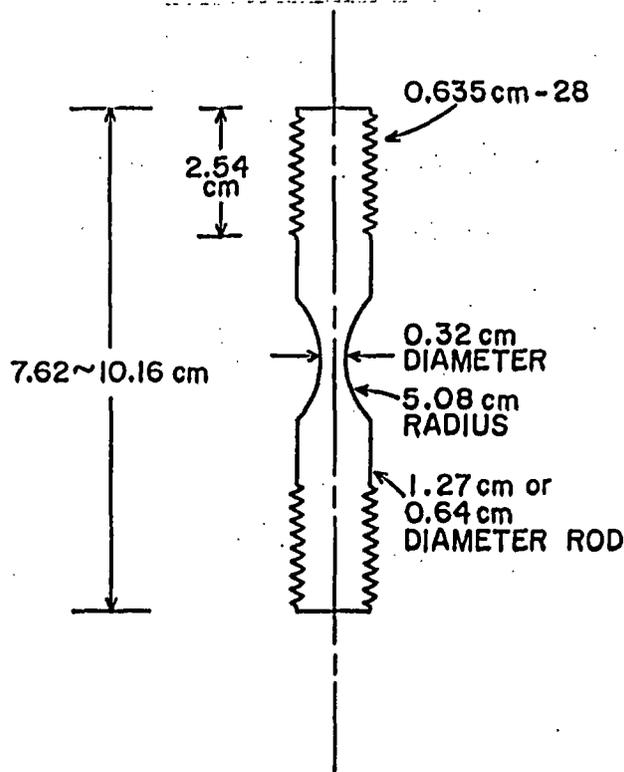
Figure 7. Corrosion fatigue specimen configuration of ASTM A216-Grade WCA cast steel rod.

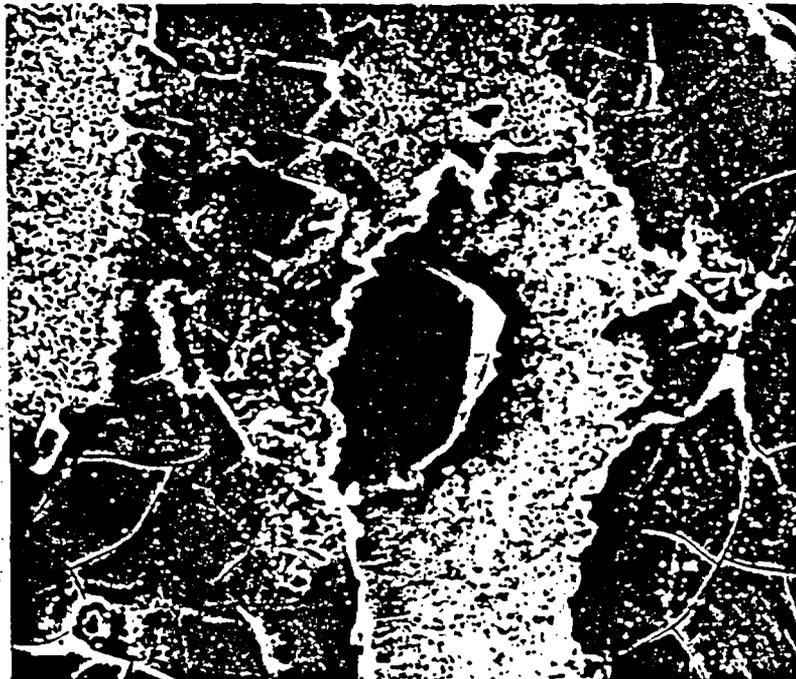
Figure 12. Surface morphology of Ferrovac-E immersed in concentrated basaltic groundwater at 150°C for two months under a gamma dose rate of  $1.36 \times 10^6$  rad/h. The majority of the exposed surface area was not attacked and there was no salt deposition. Only two or three spots were corroded as shown in (a) and (b), (a) pit mark and (b) shiny black corrosion product.

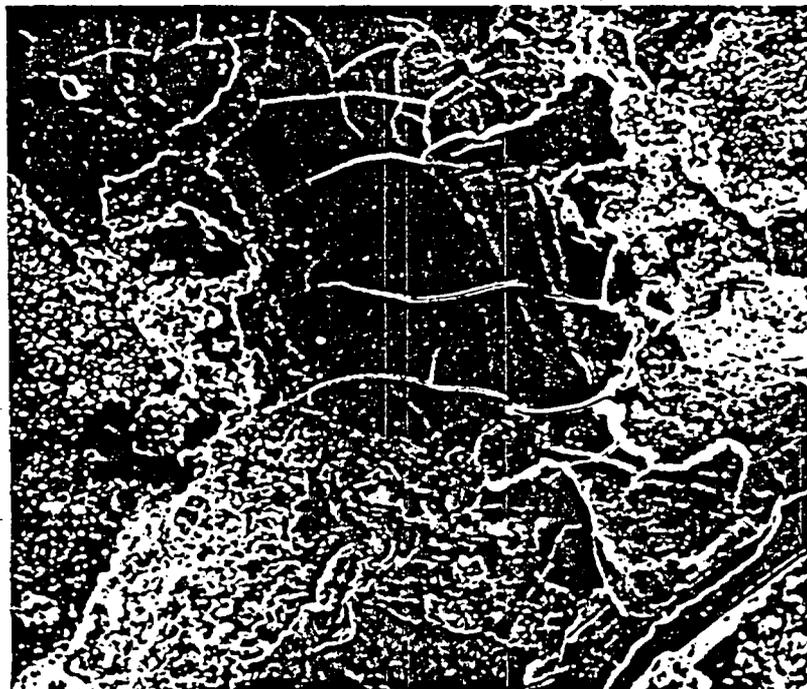
Figure 13. Surface morphology of ASTM A216-Grade WCA cast steel after immersion in concentrated basaltic groundwater at 150°C for two months under a gamma dose rate of  $1.36 \times 10^6$  rad/h. The majority of the exposed surface area was covered with a salt deposit and there was no significant corrosion except for a few spots adjacent to a glass spacer, (a) pit formation and corrosion product in attacked area, (b) etching of metal substrate beneath the deposited salt layer.

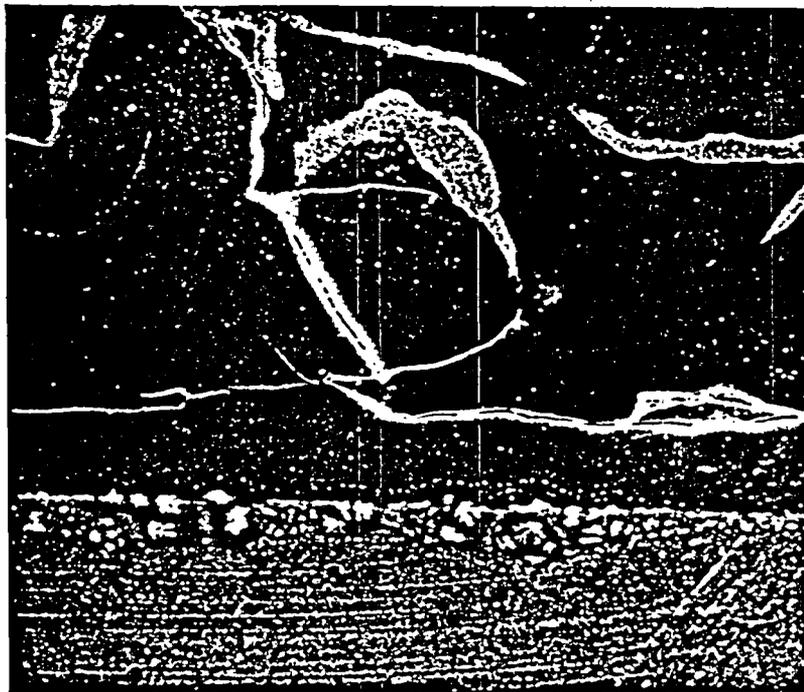
Figure 15. An SEM micrograph for an ASTM A216-Grade WCA steel specimen, exposed to concentrated basaltic groundwater for two months at 150°C, showing a very irregular oxide thickness on the base metal.

In contrast to the steel specimens subjected to gamma irradiation, unirradiated specimens showed a thick dark brown layer of rust on the surface. An SEM micrograph of the specimen cross-section shows that the thickness of the oxide layer varies from a few microns to several tens of microns (Figure 15). In the last quarterly progress report<sup>(1)</sup>, some pitting was also reported but the present samples did not show this effect. Apparently, pitting seems to be the initial penetration mode, and subsequent pit coalescence gives a more uniform corrosion. Currently, the corrosion rates are being measured by removing the rust formed.
