Wissenschaftliche Berichte  
FZKA 5587.

**Corrosion Studies on  
Selected Packaging  
Materials for Disposal  
of Heat-Generating  
Radioactive Wastes in  
Rock-Salt Formations**

**E. Smallos, J. A. Gago, I. Azkarate, B. Fieh**  
Institut für Nukleare Entsorgungstechnik

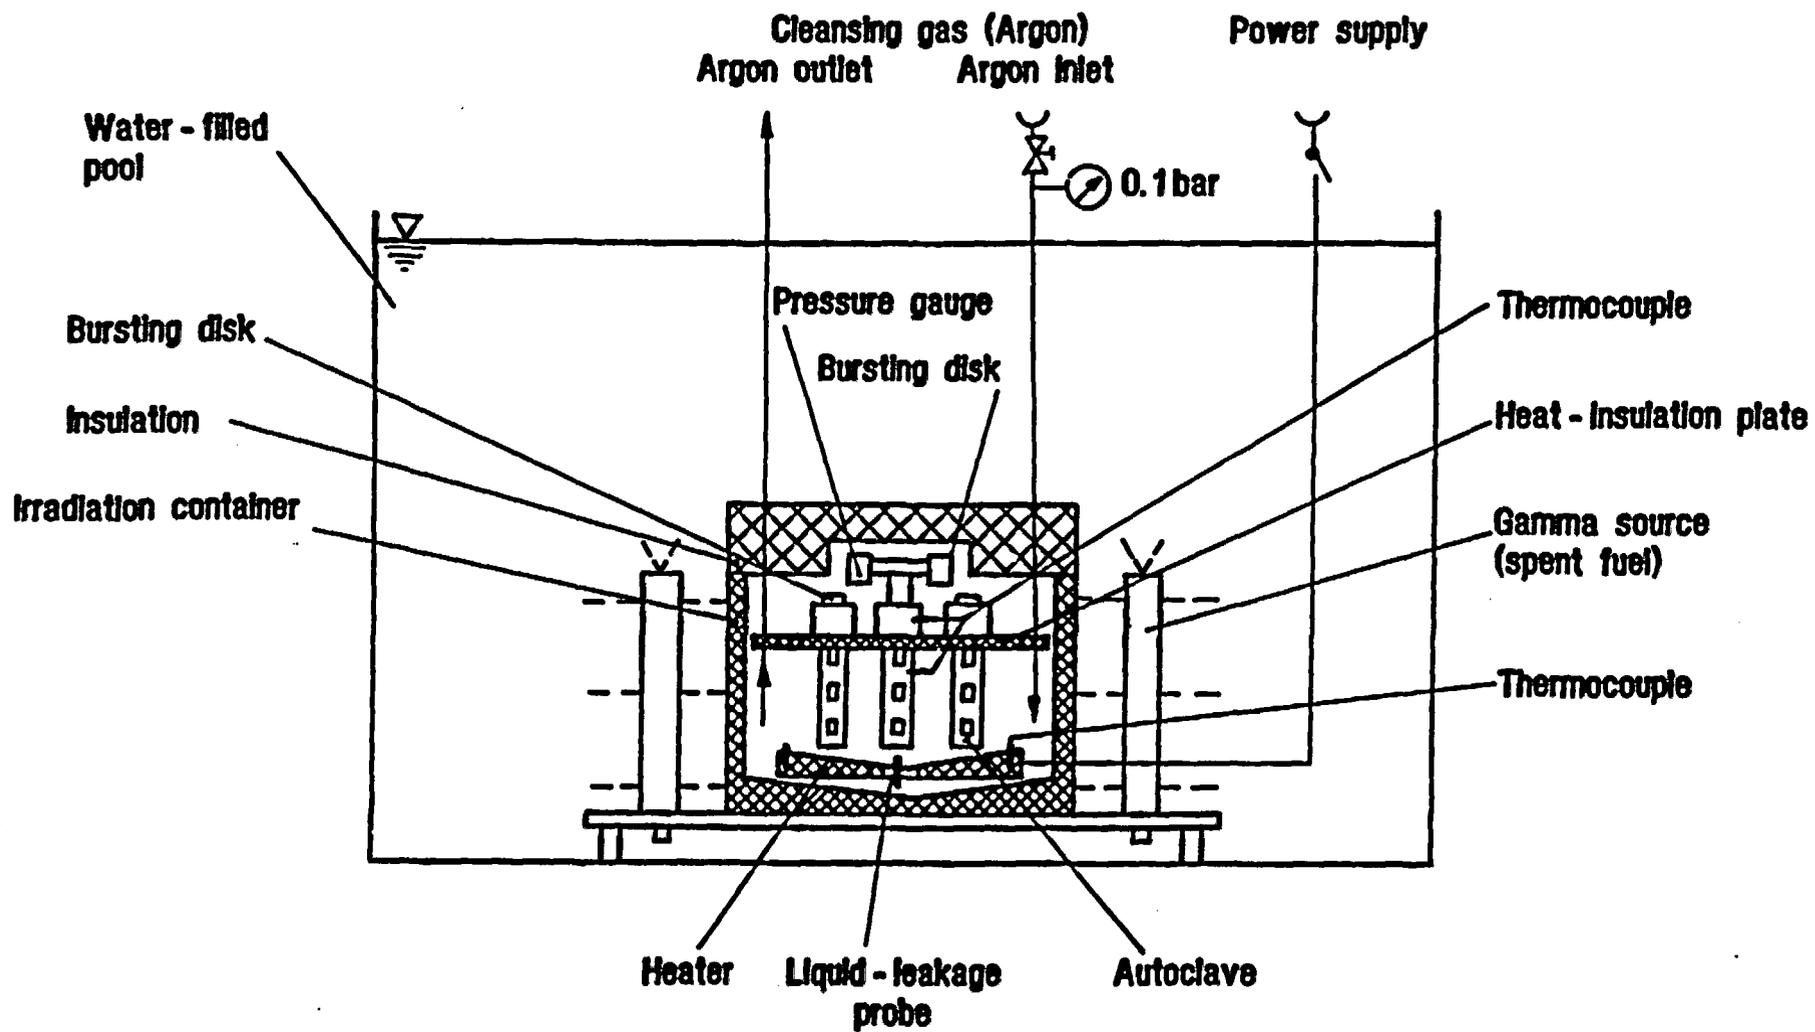
Fig. 1: Schematic of irradiation-corrosion test facility

The corrosion experiments under gamma irradiation were performed in the spent fuel storage pool of KFA Jülich. The radiation source were spent fuel elements with a gamma energy spectrum similar to that of 10-years-old vitrified HLWC. The experimental set-up is shown schematically in Fig. 1. For the experiments, autoclaves made of the corrosion resistant alloy Ti 99.8-Pd with insert vessels of Duran glass were used. The autoclaves were placed in a circular configuration into heated cylindrical stainless steel containers (irradiation containers). Each glass insert contained 120 ml of brine and three specimens of 60 cm<sup>2</sup> total surface, which were totally immersed into the brine. This gave a brine volume to

specimen surface ratio of 2 ml/cm<sup>2</sup>. The specimens were suspended from a frame made of a glass-fibrereinforced plastic. For irradiation, the stainless steel containers were positioned at the bottom of the 6 m deep water-filled spent fuel element storage pool. The specimens and brines were heated to the test temperature of 150°C using heaters. To determine the corrosion kinetics, the specimens were examined at various test times.

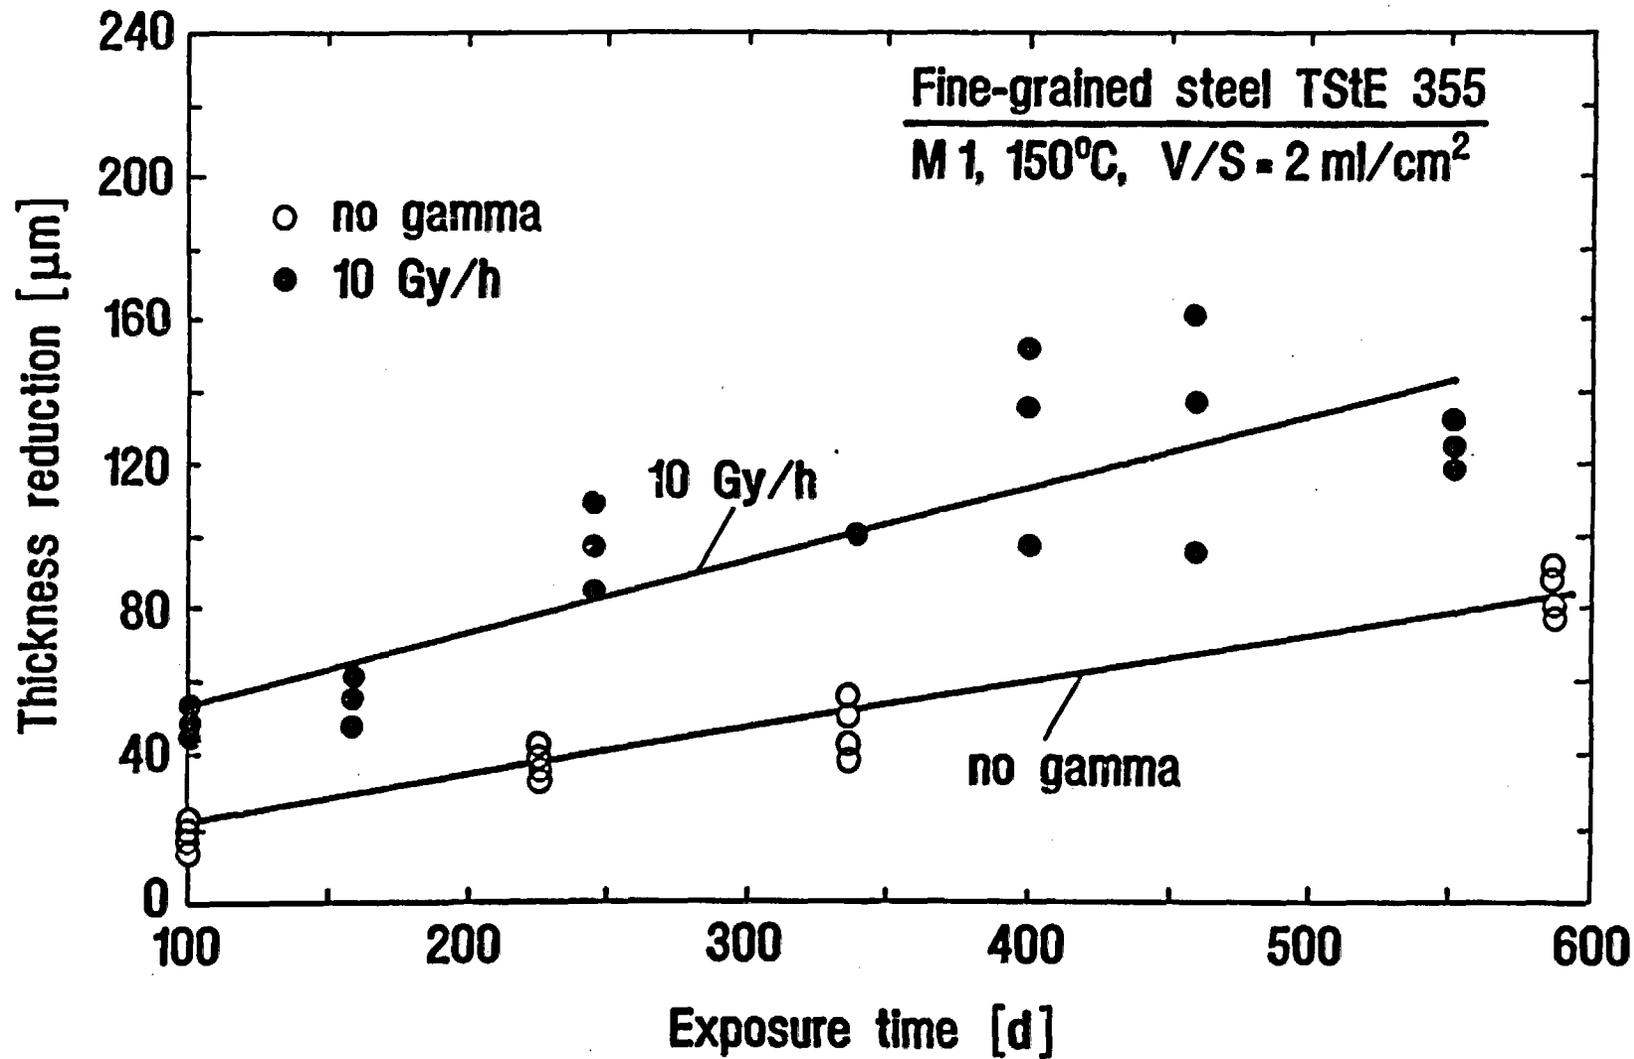
Fig. 2: Thickness reduction of the TStE 355 steel in the MgCl<sub>2</sub>-rich brine 1 (Q-brine) with and without gamma radiation (T=150°C)

The time-dependence of the thickness reduction of the TStE 355 steel in the liquid phase of irradiated (10 Gy/h) and unirradiated brines at 150°C and a V/S-ratio of 2 ml/cm<sup>2</sup> is plotted in Figs. 2-4. The results show a linearly increase of the thickness reduction with exposure time. The results of the linear regression analyses for the thickness reduction of the steel in the test brines are compiled in Table 3. In both cases with and without gamma radiation, the corrosion rates (B) of the steel in the MgCl<sub>2</sub>-rich brines 1 and 2 are significantly higher than in the NaCl-rich brine 3. The higher corrosivity of the MgCl<sub>2</sub>-rich brines compared to the NaCl-rich brine is attributed to their higher HCl concentration. This could be explained by the higher Cl<sup>-</sup>-concentration and the hydrolysis of Mg<sup>2+</sup>. The acceleration of steel corrosion in brines containing high amounts of MgCl<sub>2</sub> is in line with the results reported by Westerman et al. [7].

The imposition of a 10 Gy/h radiation field on the 150°C brine environment increases the linear corrosion rates of the steel specimens in the brines 1 and 2 from about 47 µm/a to 72 µm/a, and from 120 µm/a to 162 µm/a, respectively. In brine 3, the corrosion rate in the 10 Gy/h irradiated environment (13.7 µm/a) is very close to the value attained in the unirradiated system (15.3 µm/a).

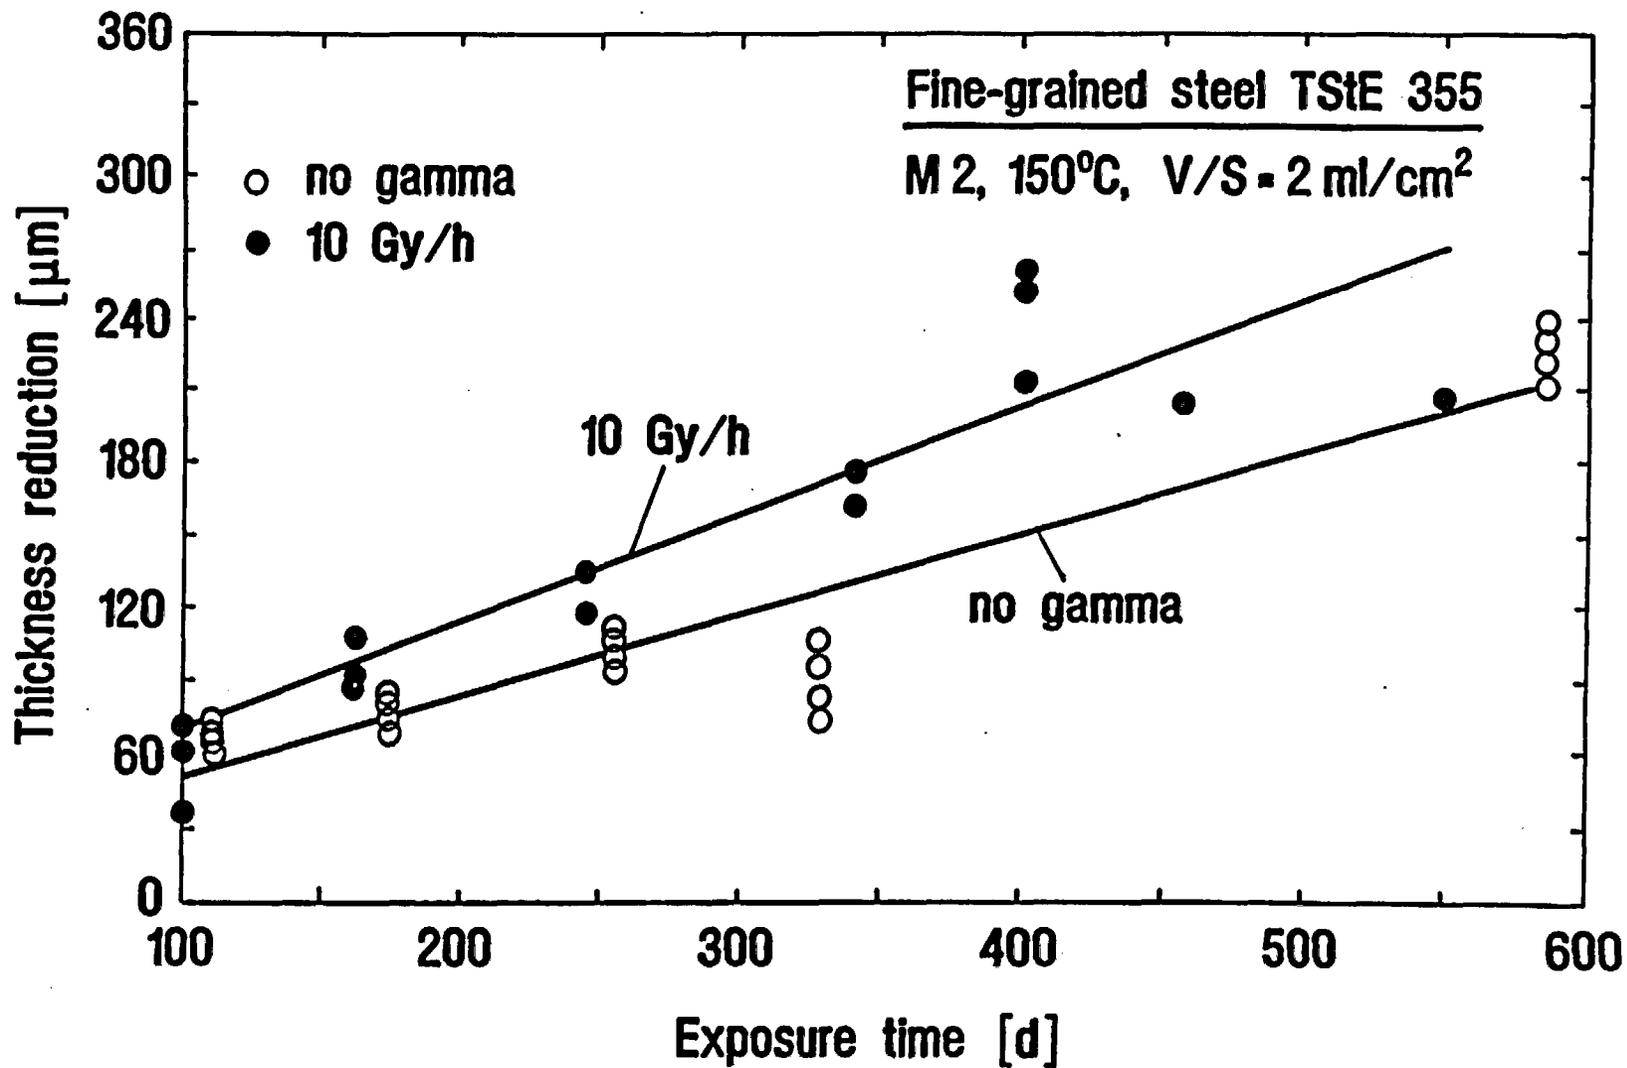
Fig. 3: Thickness reduction of the TStE 355 steel in the MgCl<sub>2</sub>-rich brine 2 with and without gamma radiation (T=150°C)

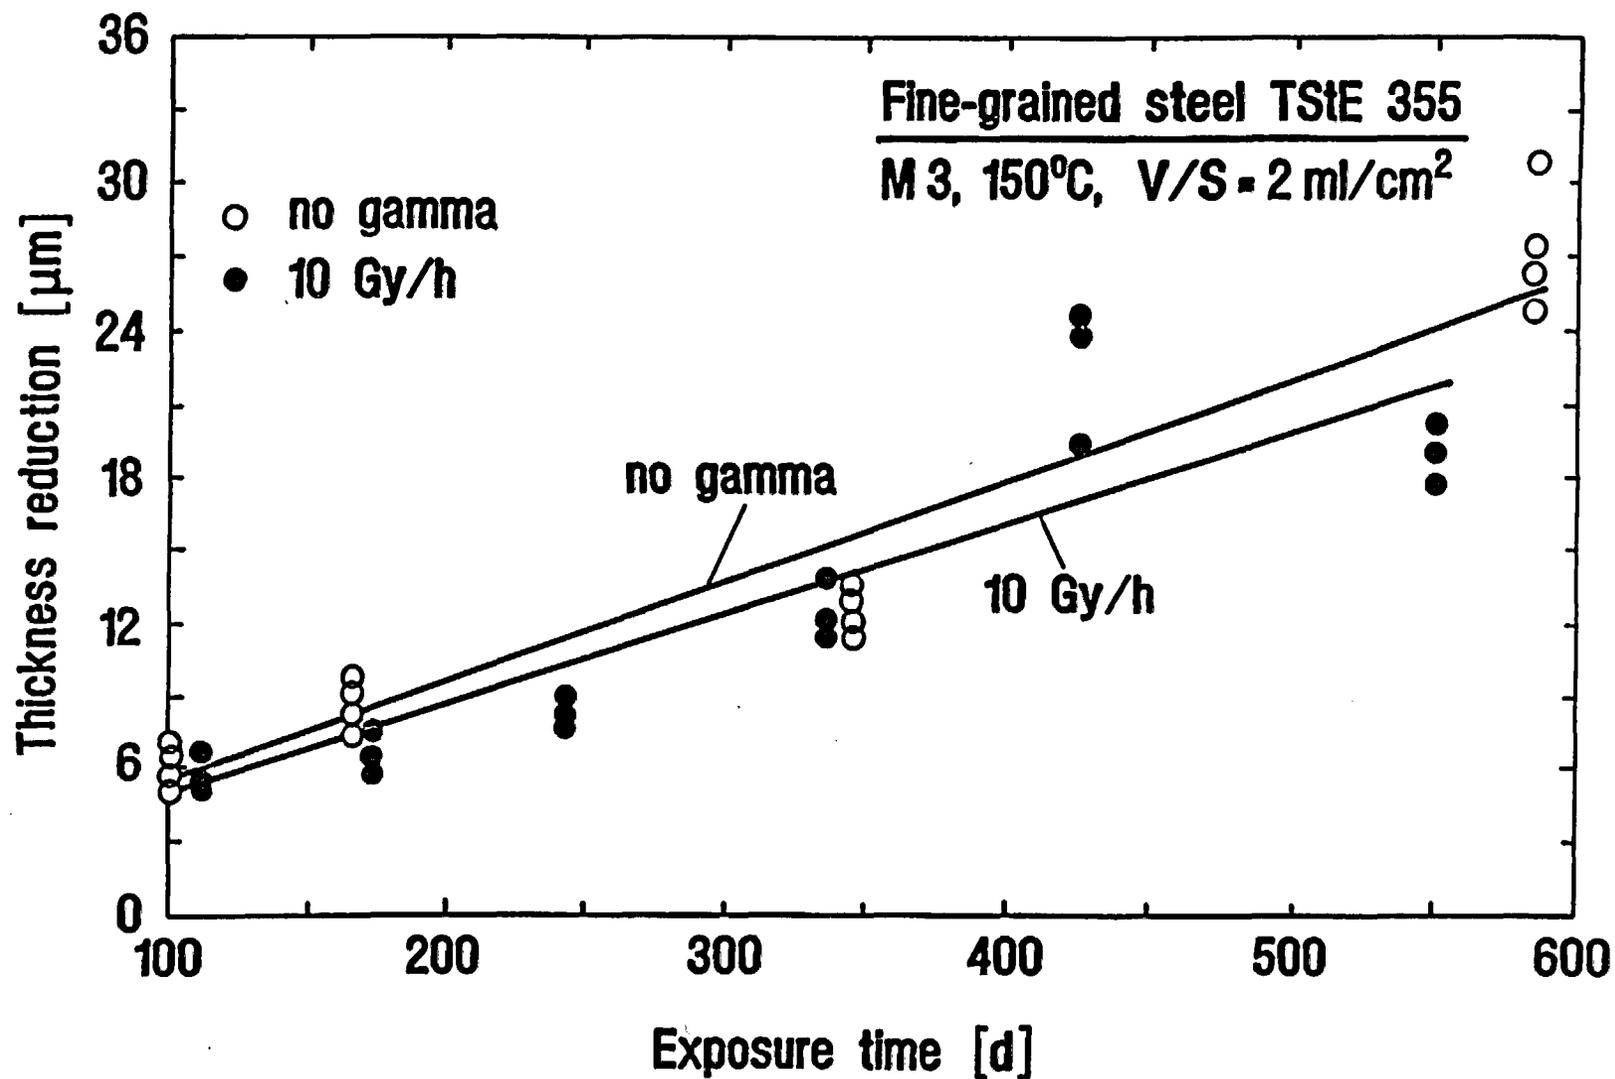
Fig. 4: Thickness reduction of the TStE 355 steel in the NaCl-rich brine 3 with and without gamma radiation ( $T=150^\circ\text{C}$ )

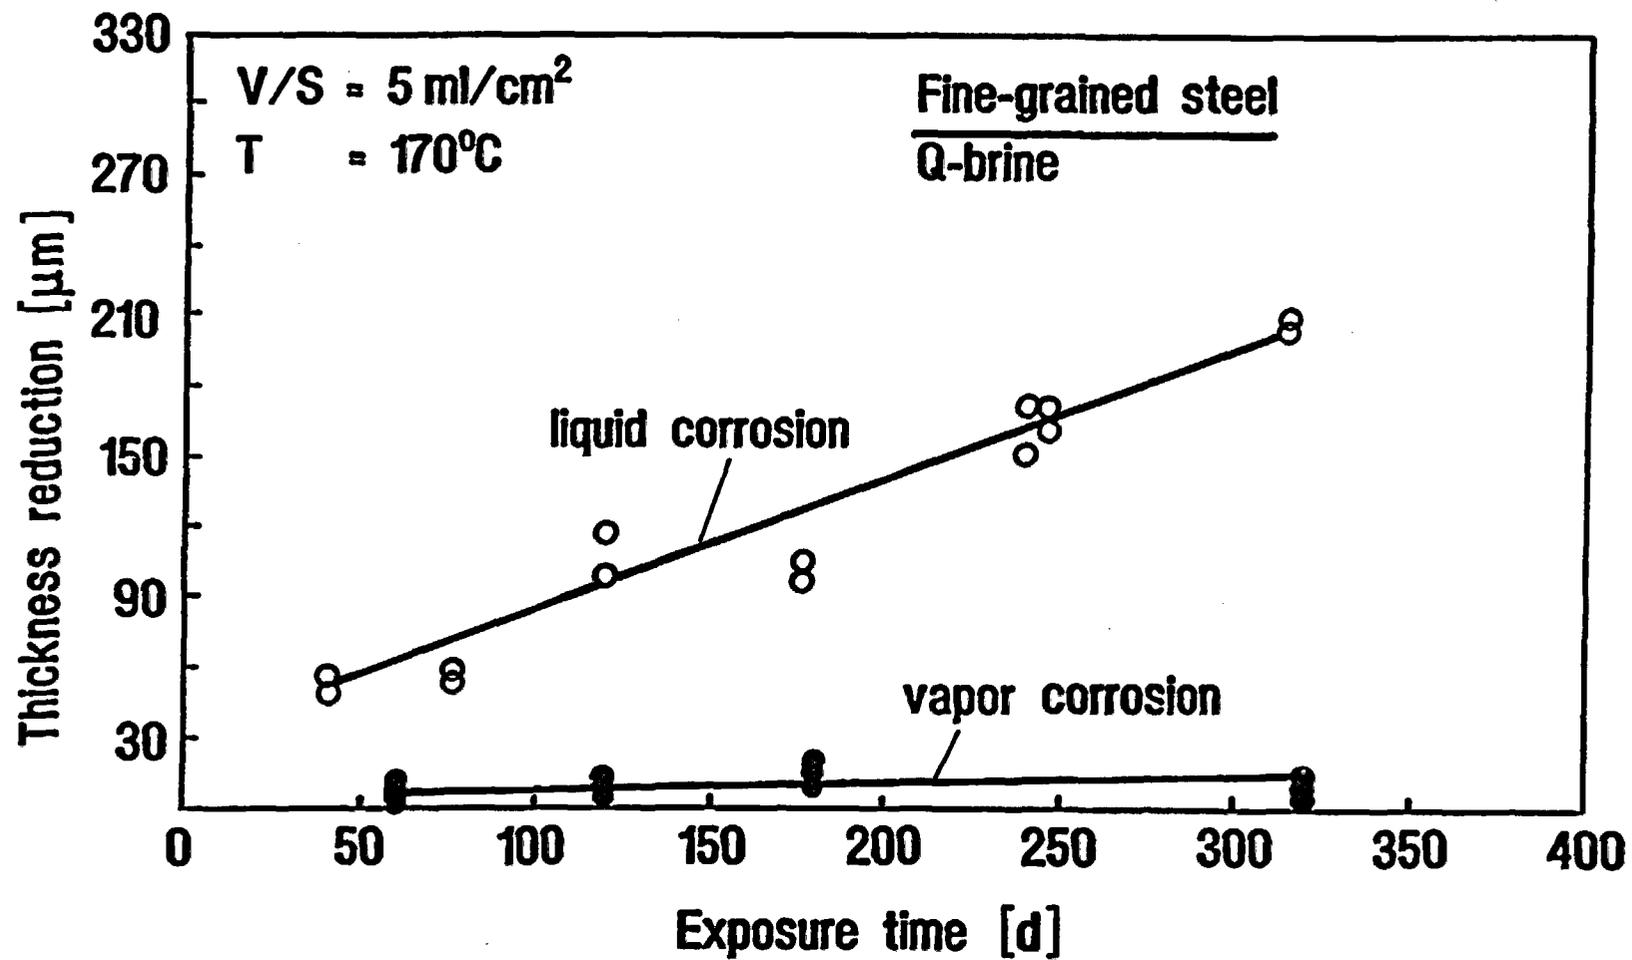
Fig. 6: Thickness reduction of the fine-grained steel TStE 355 at 170°C in Q-brine

The regression analysis of the time-dependent thickness reduction of the steel at 170°C in the vapor phase of the brines shows that a linear equation fits the experimental data well. This is in good agreement with the results obtained in the liquid phase of the brines. The experimental data of the vapor-phase corrosion and the regression line are plotted in Figs. 6 through 9. The results of the linear regression analysis of the thickness reduction of the steel in the various brines are compiled in Table 4. For comparison, the corrosion results in the liquid

In the vapor phase of the Na<sub>2</sub>S-free brine, the linear corrosion rate of the steel is about 10  $\mu\text{m/a}$  and, hence, significantly lower than that in the liquid phase (about 200  $\mu\text{m/a}$ ). By Na<sub>2</sub>S additions of  $6 \times 10^{-4}$  -  $6 \times 10^{-3}$  M/l to the brine, the vapor-phase corrosion rates increase to about 20-40  $\mu\text{m/a}$ . However, the values remain clearly lower than those in the liquid phase (about 192-317  $\mu\text{m/a}$ ). Both in the liquid and in the vapor phase of the brines, the maximum corrosion rate occur at a Na<sub>2</sub>S concentration of  $3 \times 10^{-3}$  M/l. At the higher Na<sub>2</sub>S concentration of  $6 \times 10^{-3}$  M/l the corrosion rate decreases. This effect may probably be attributed to the formation of a denser corrosion layer at the higher Na<sub>2</sub>S concentration, as was observed in the metallographic examinations.

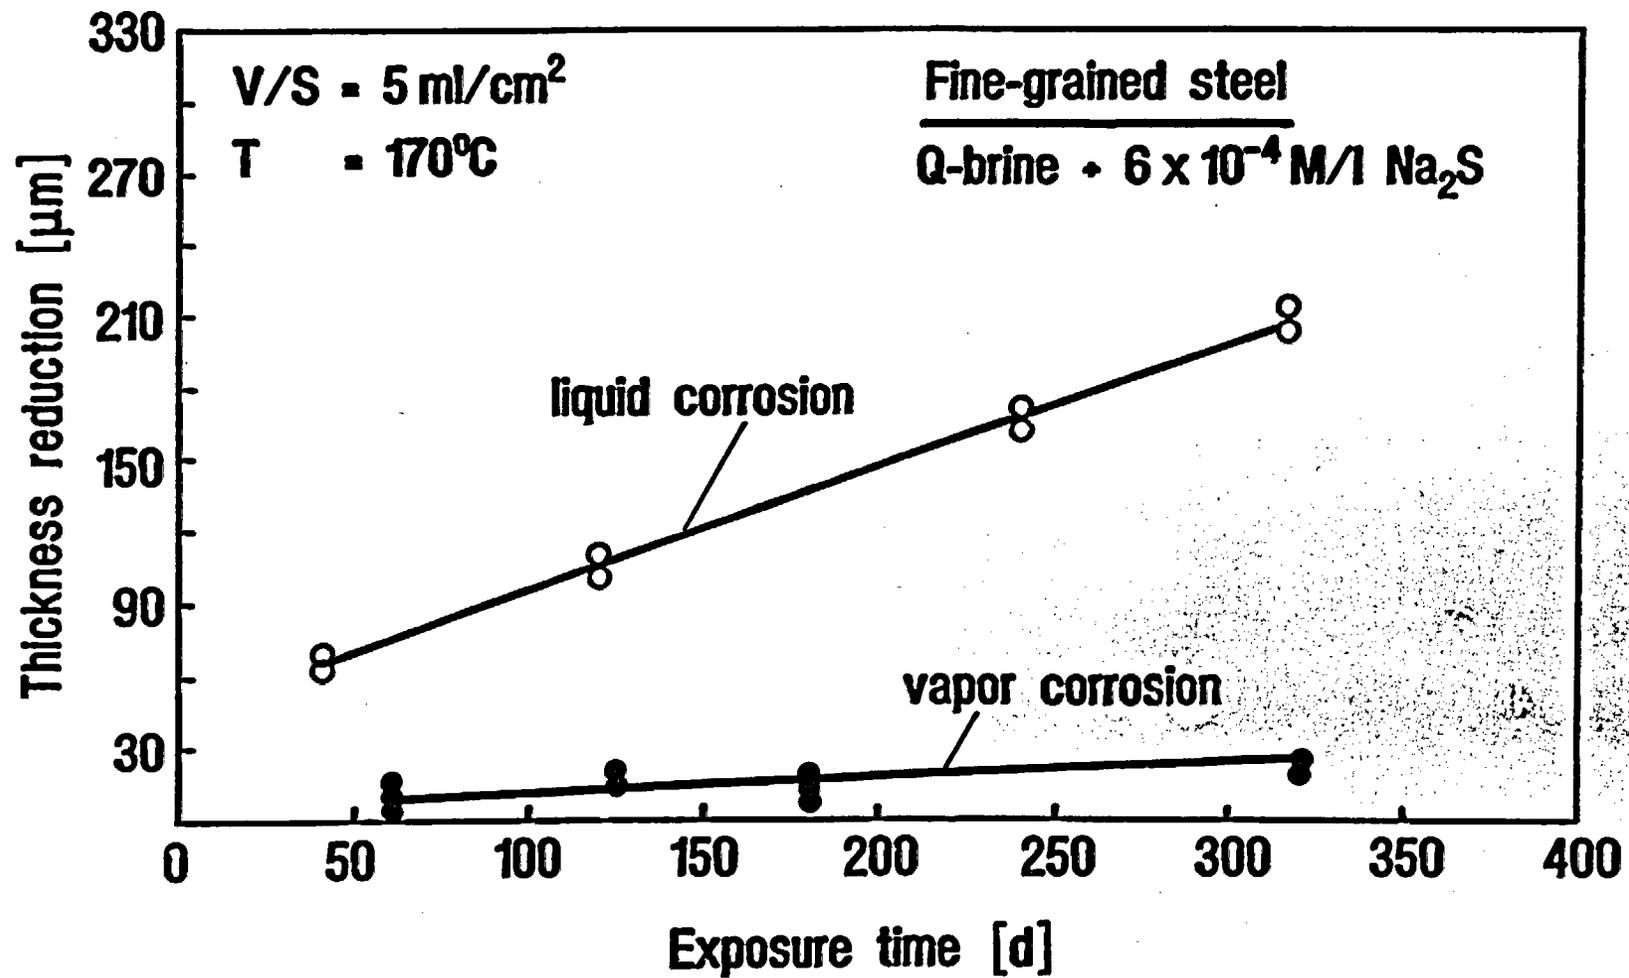
Fig. 7: Thickness reduction of the fine-grained steel TSIE 355 at 170°C in Q-brine + 6x10<sup>-4</sup> M/l Na<sub>2</sub>S

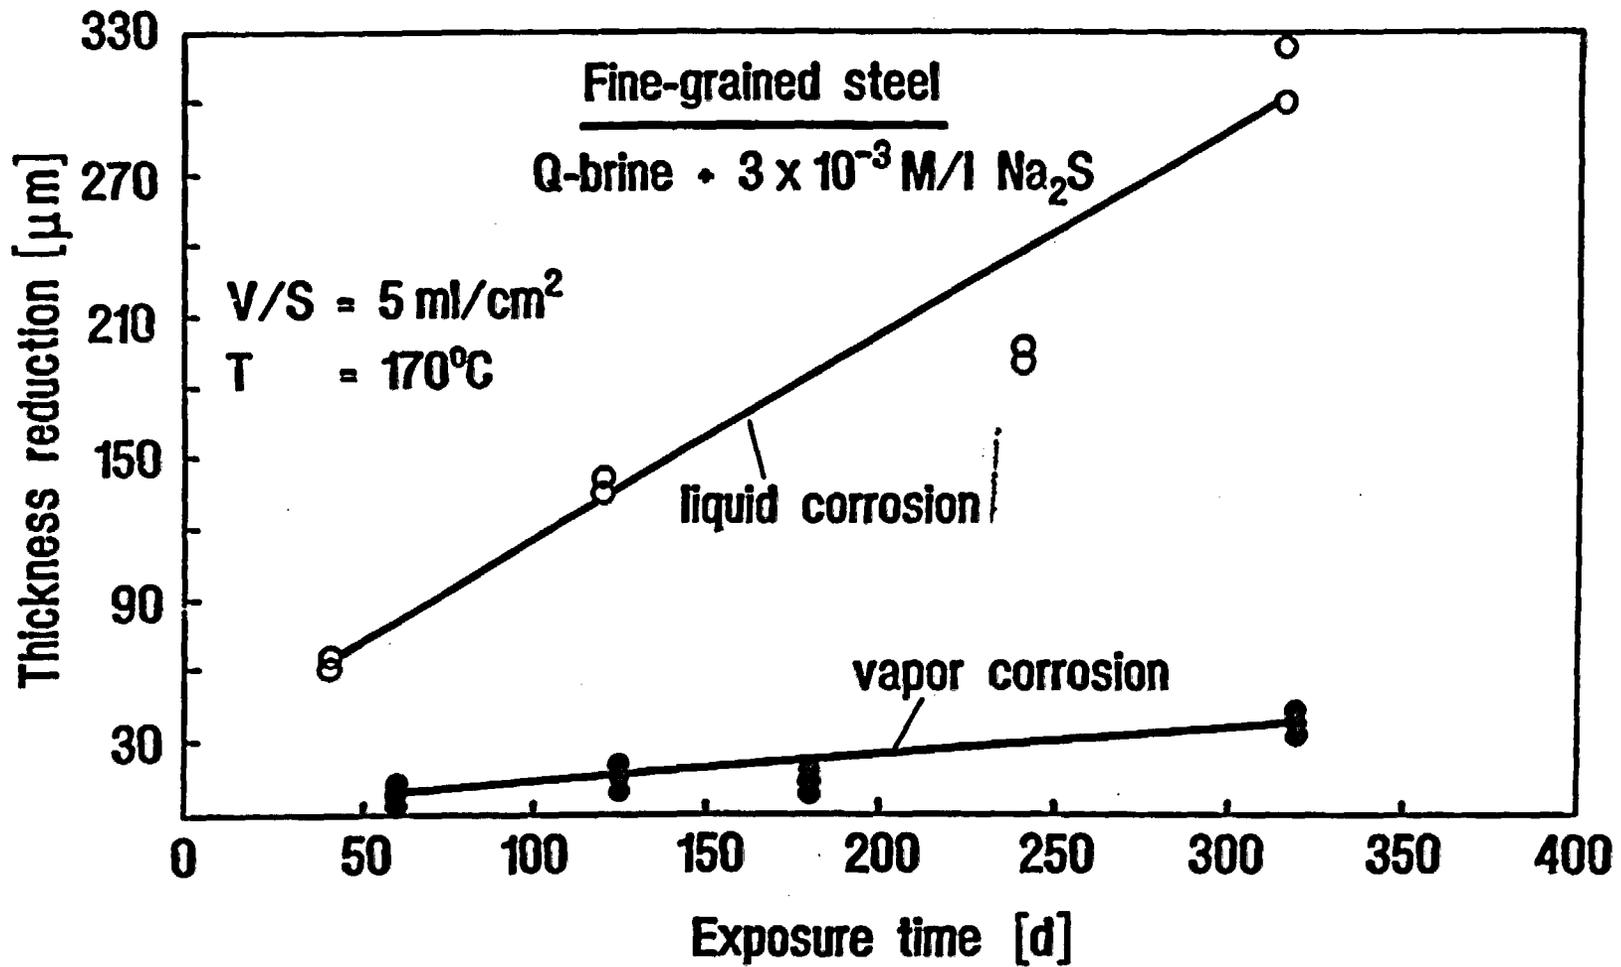
Fig. 8: Thickness reduction of the fine-grained steel TS1E 355 at 170°C in Q-brine +  $3 \times 10^{-3}$  M/l  $\text{Na}_2\text{S}$

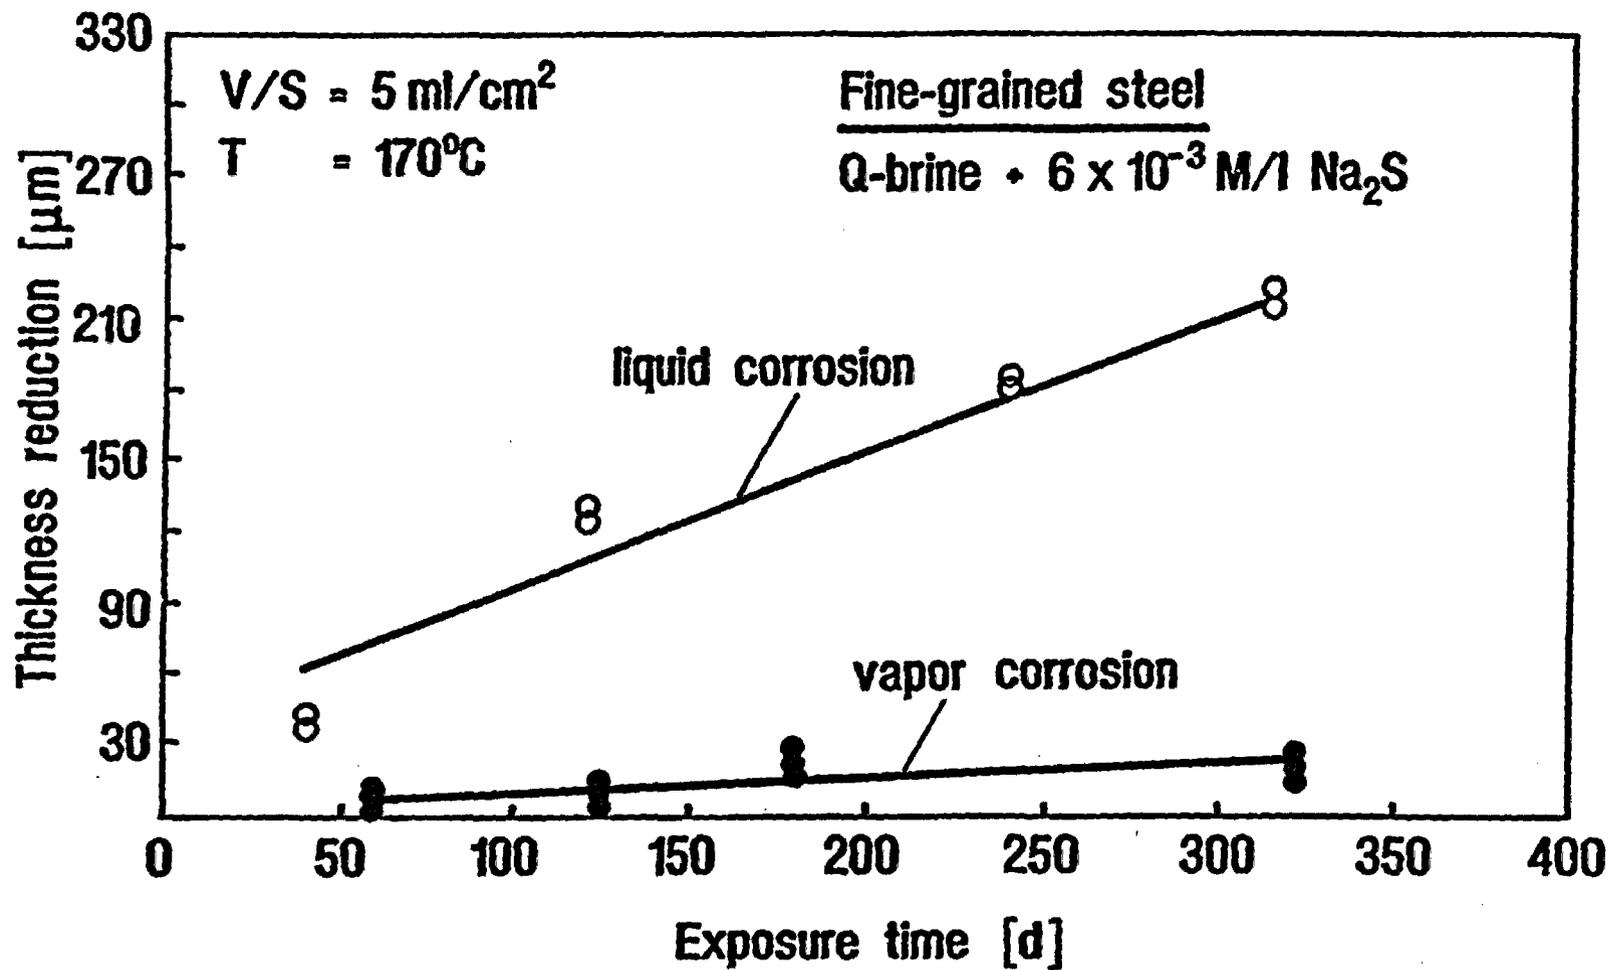
Fig. 9: Thickness reduction of the fine-grained steel TSIE 355 at 170°C in Q-brine + 6x10<sup>-3</sup> M/l Na<sub>2</sub>S

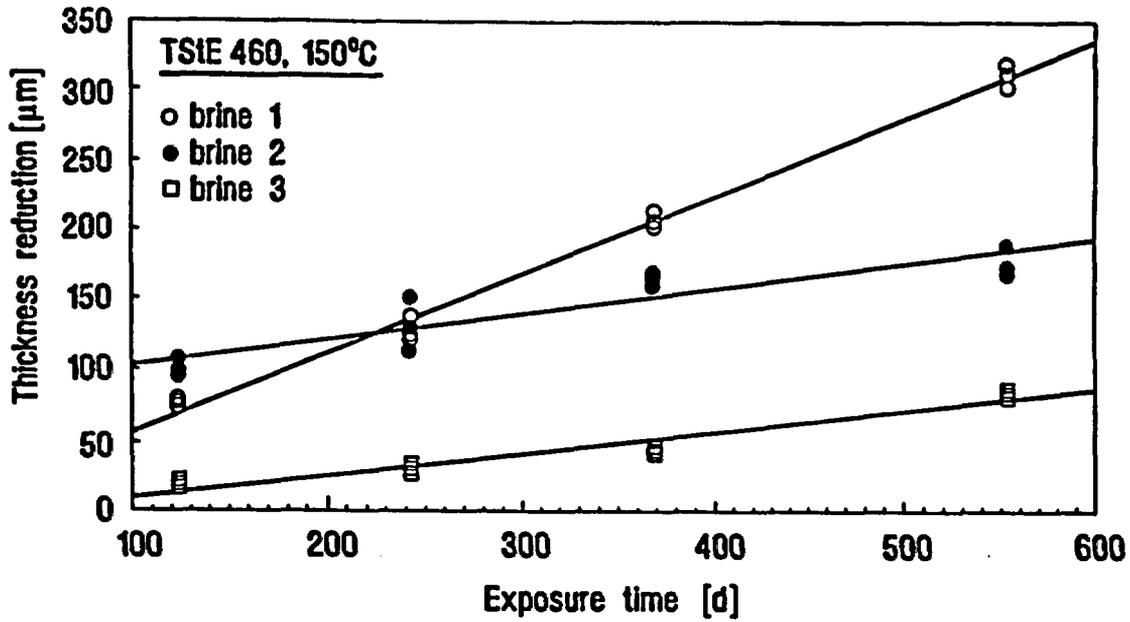
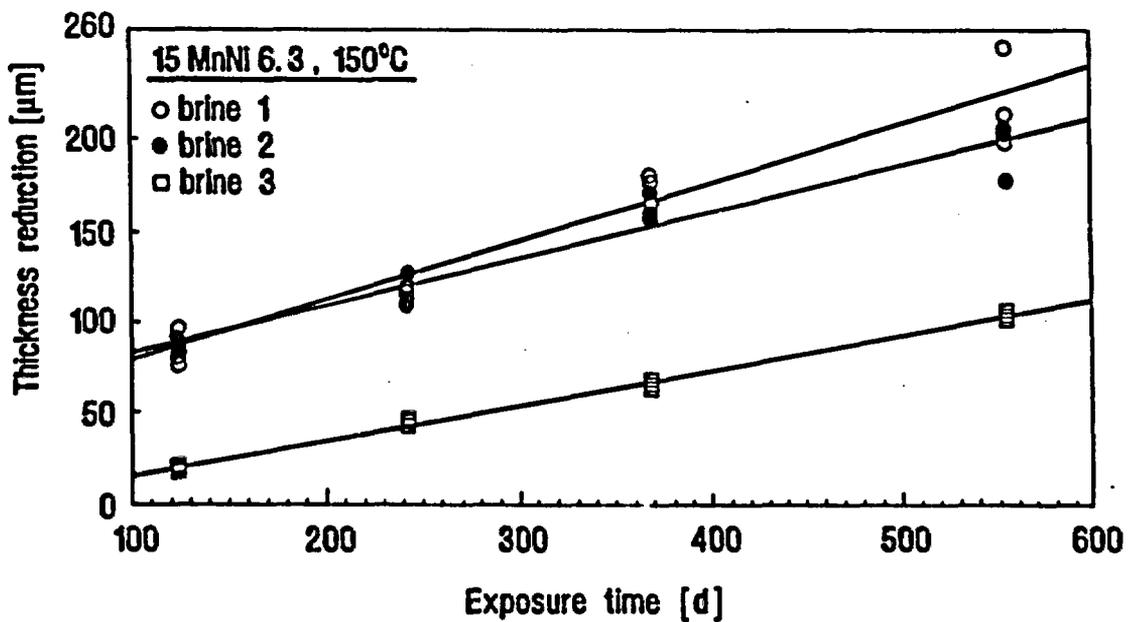
Fig.14: Thickness reduction of the steels TS1E 460 and 15MnNi 6.3 in salt brines at 150°C

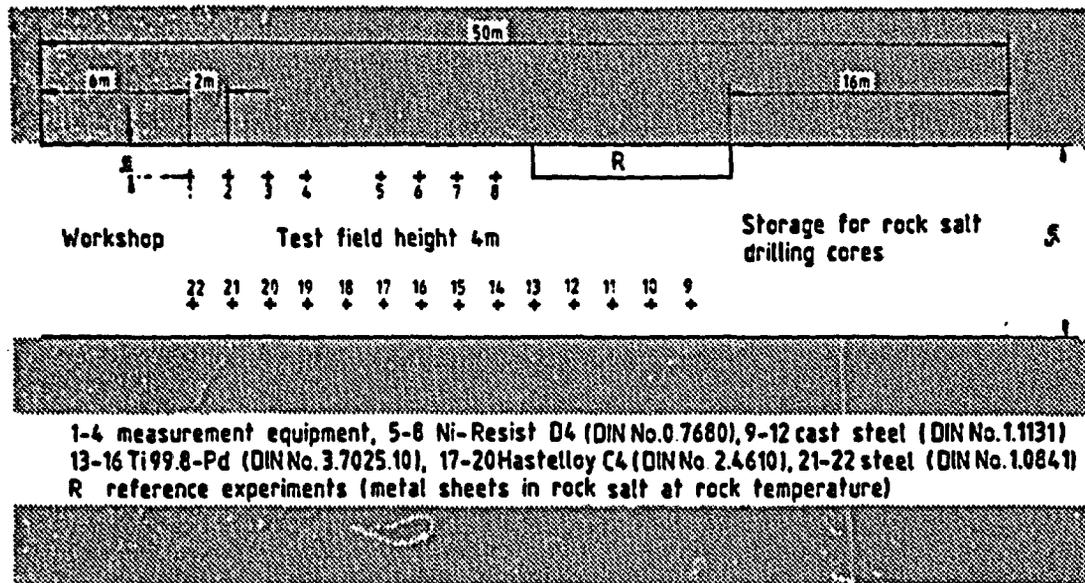
Fig. 17: Layout of the in-situ corrosion test field on the 775 m level in the Asse salt mine and arrangement of the emplacement boreholes

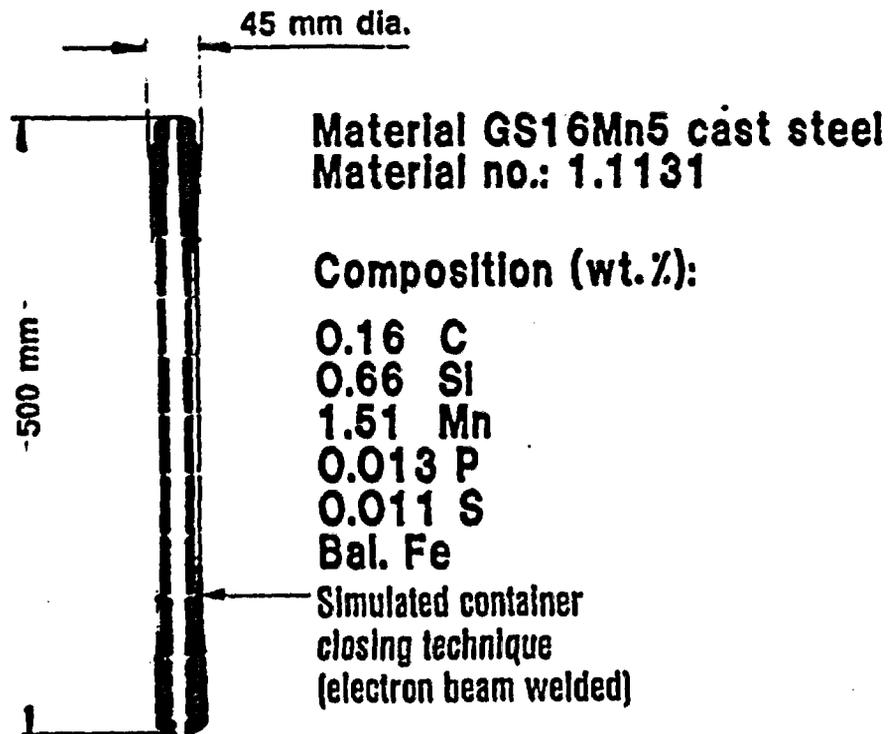
Fig. 18: Chemical composition and dimensions of a cast steel specimen

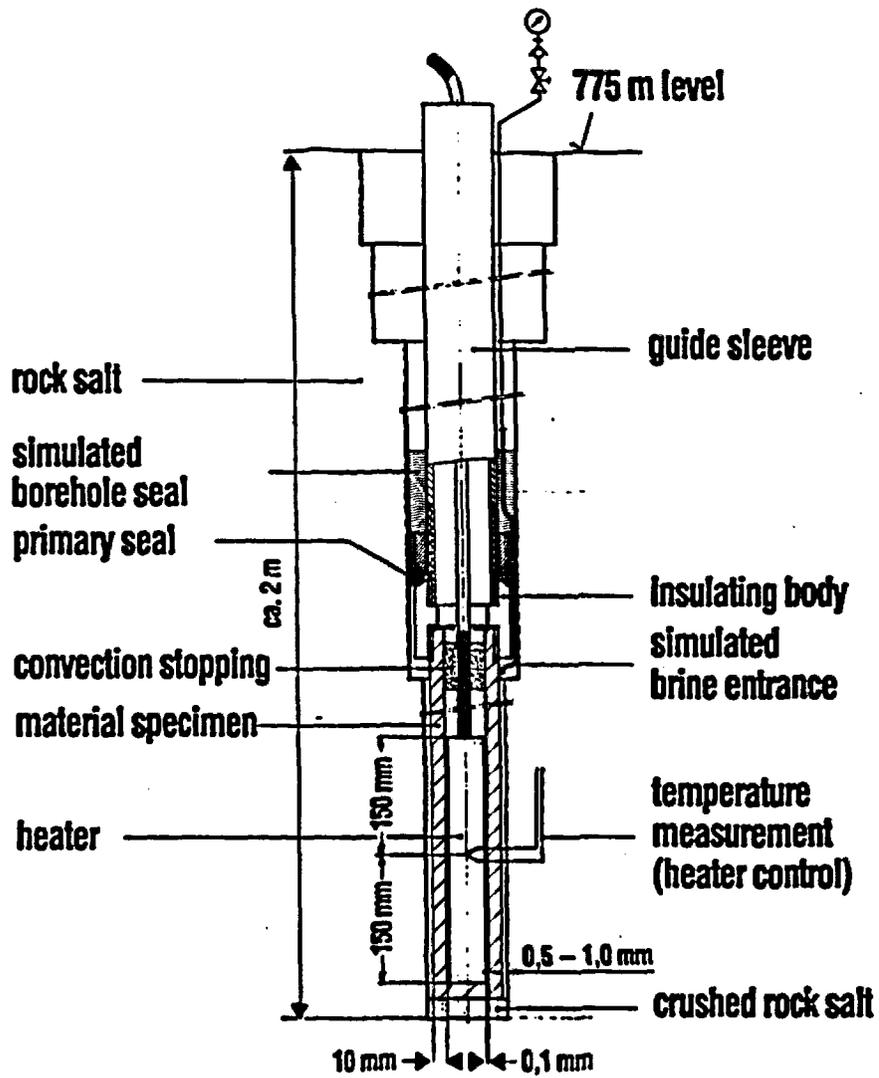
Fig. 19: Vertical cross-section of the test assembly

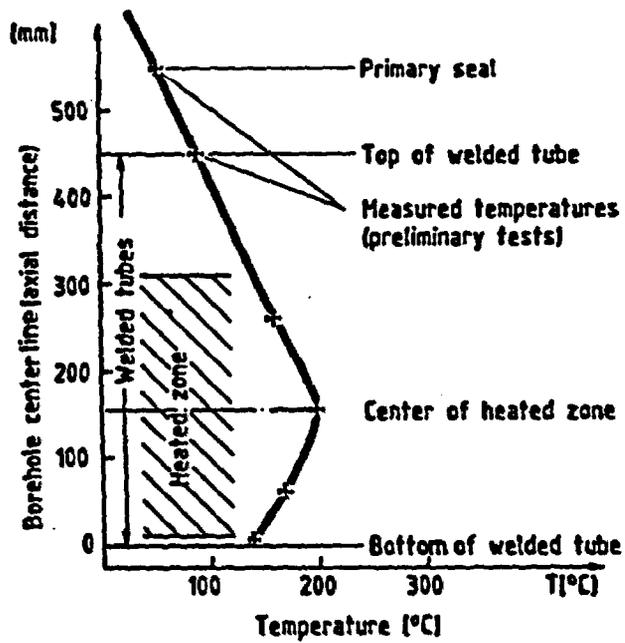
Fig. 21: Vertical temperature distribution on the welded tube wall

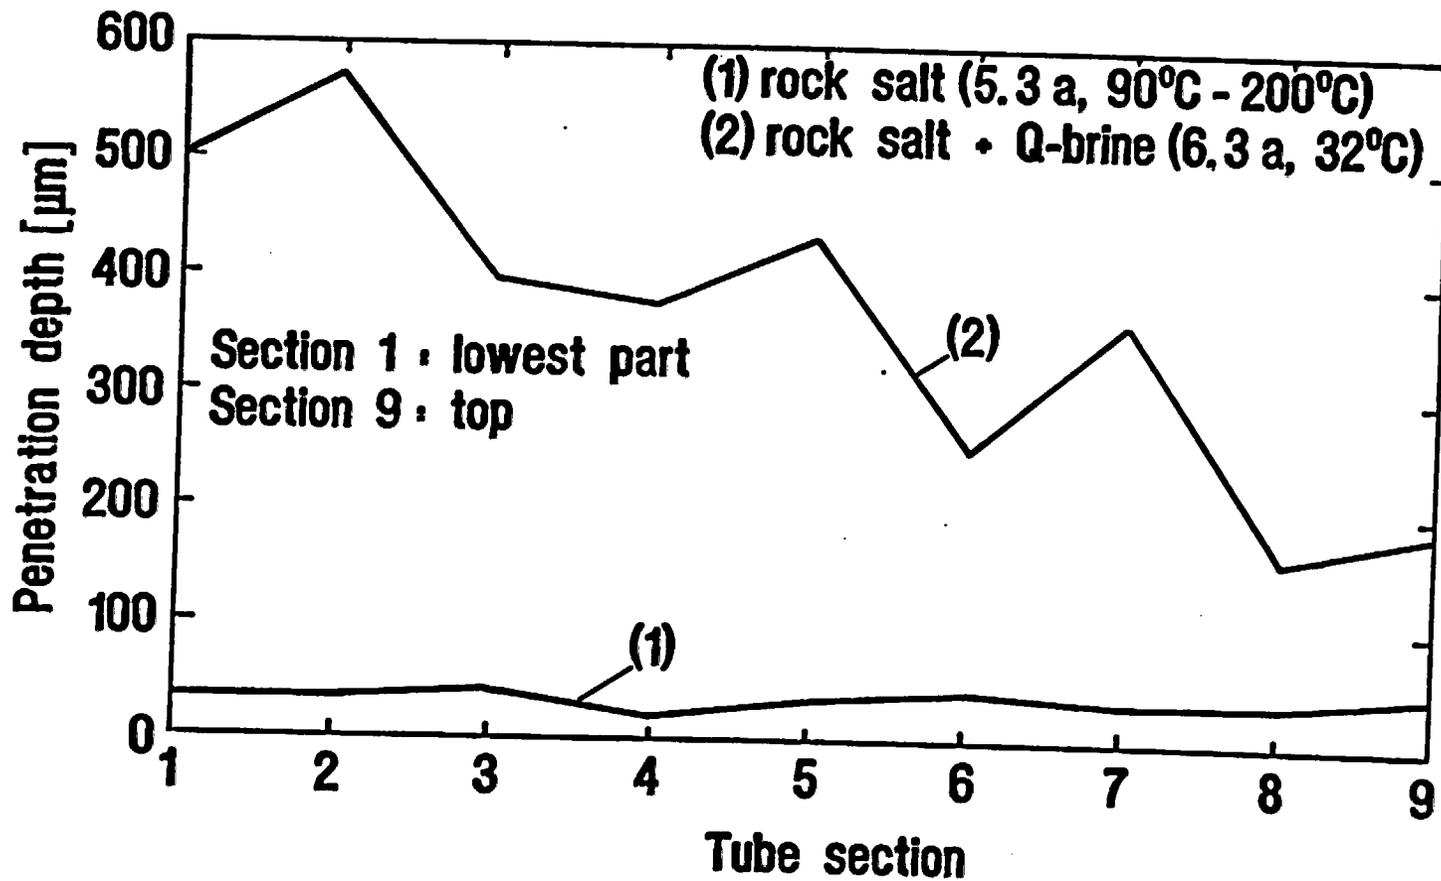
Fig. 24: Surface profilometry results of in-situ tested cast steel tubes. Maximum depth of non-uniform corrosion in rock salt and rock salt+brine

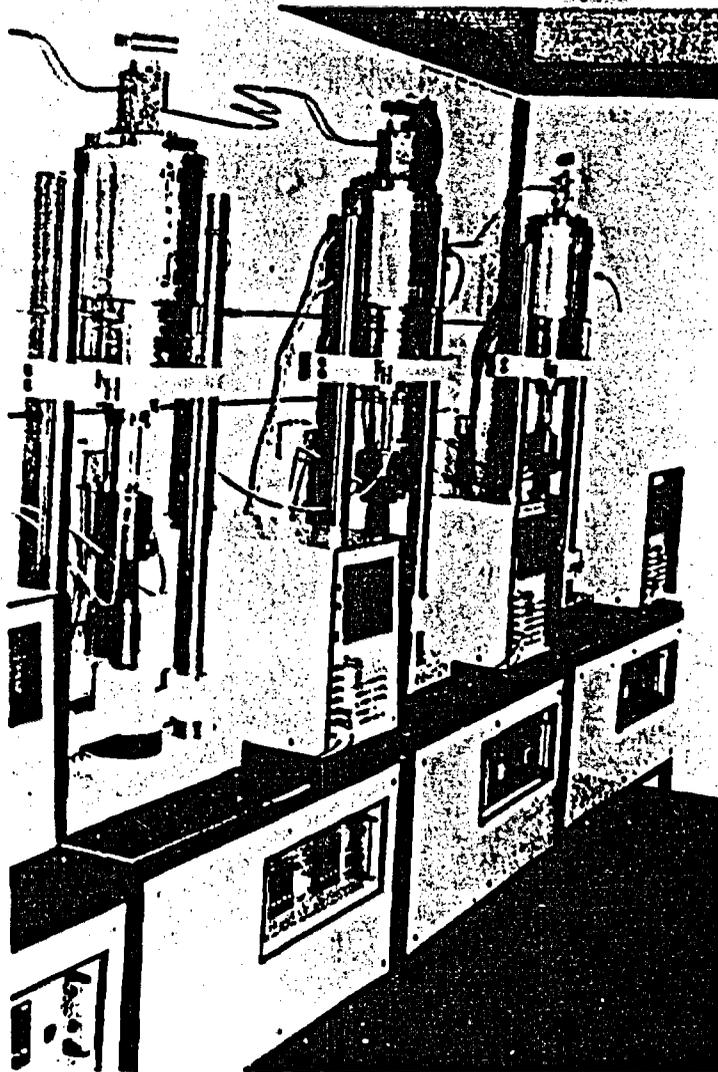
**Fig. 29: Slow strain rate testing machine with auto-clave**

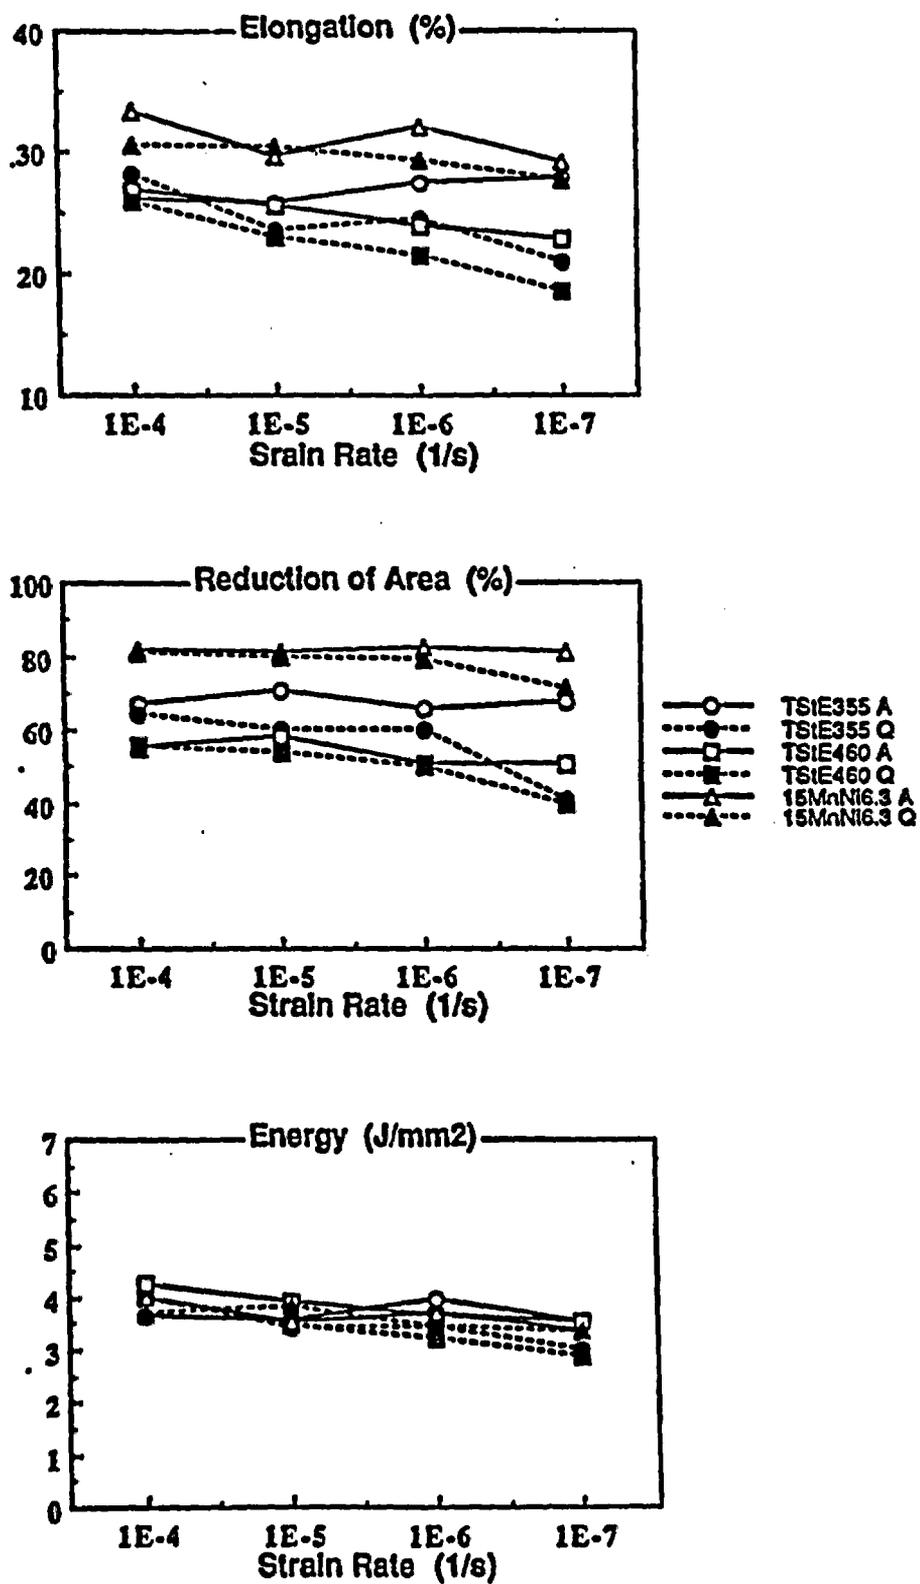
Fig. 30: Elongation, reduction of area and energy versus strain rate for the steels TSIE 355, TSIE 460 and 15MnNi 6.3 tested at 25°C and 13 MPa in argon and Q-brine
