Wissenschaftliche Berichte  
FZKA 5587.

**Corrosion Studies on  
Selected Packaging  
Materials for Disposal  
of Heat-Generating  
Radioactive Wastes in  
Rock-Salt Formations**

**E. Smallos, J. A. Gago, I. Azkarate, B. Fieh**  
Institut für Nukleare Entsorgungstechnik

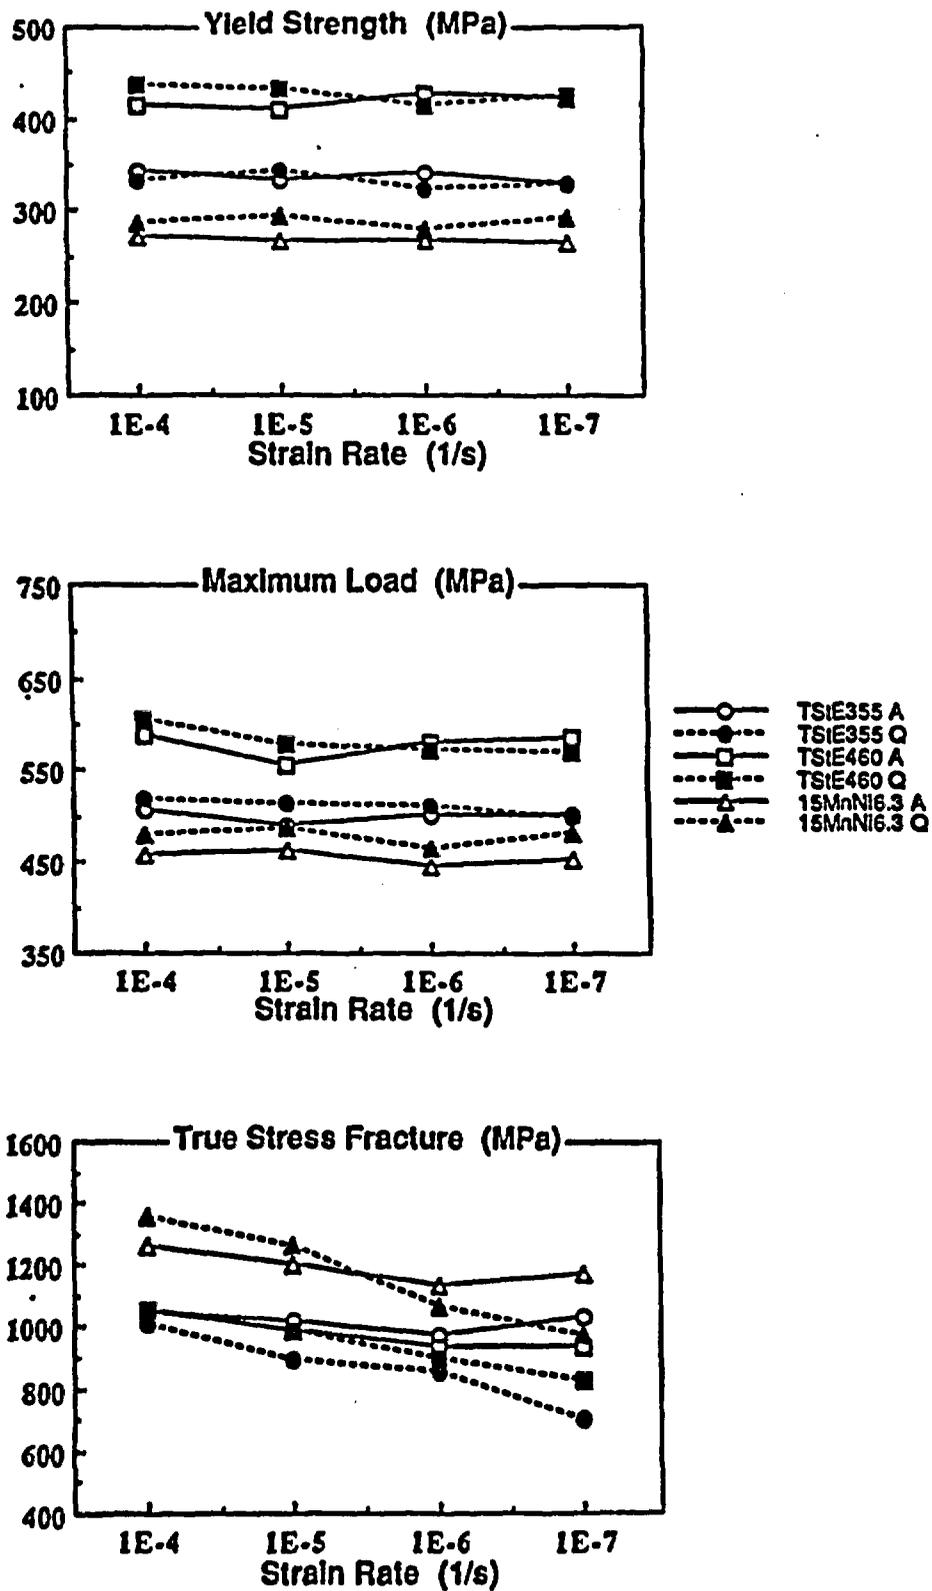
Fig. 31: Yield strength, maximum load and true stress fracture versus strain rate for the steels TSIE 355, TSIE 460 and 15MnNi 6.3 tested at 25°C and 13 MPa in argon and Q-brine

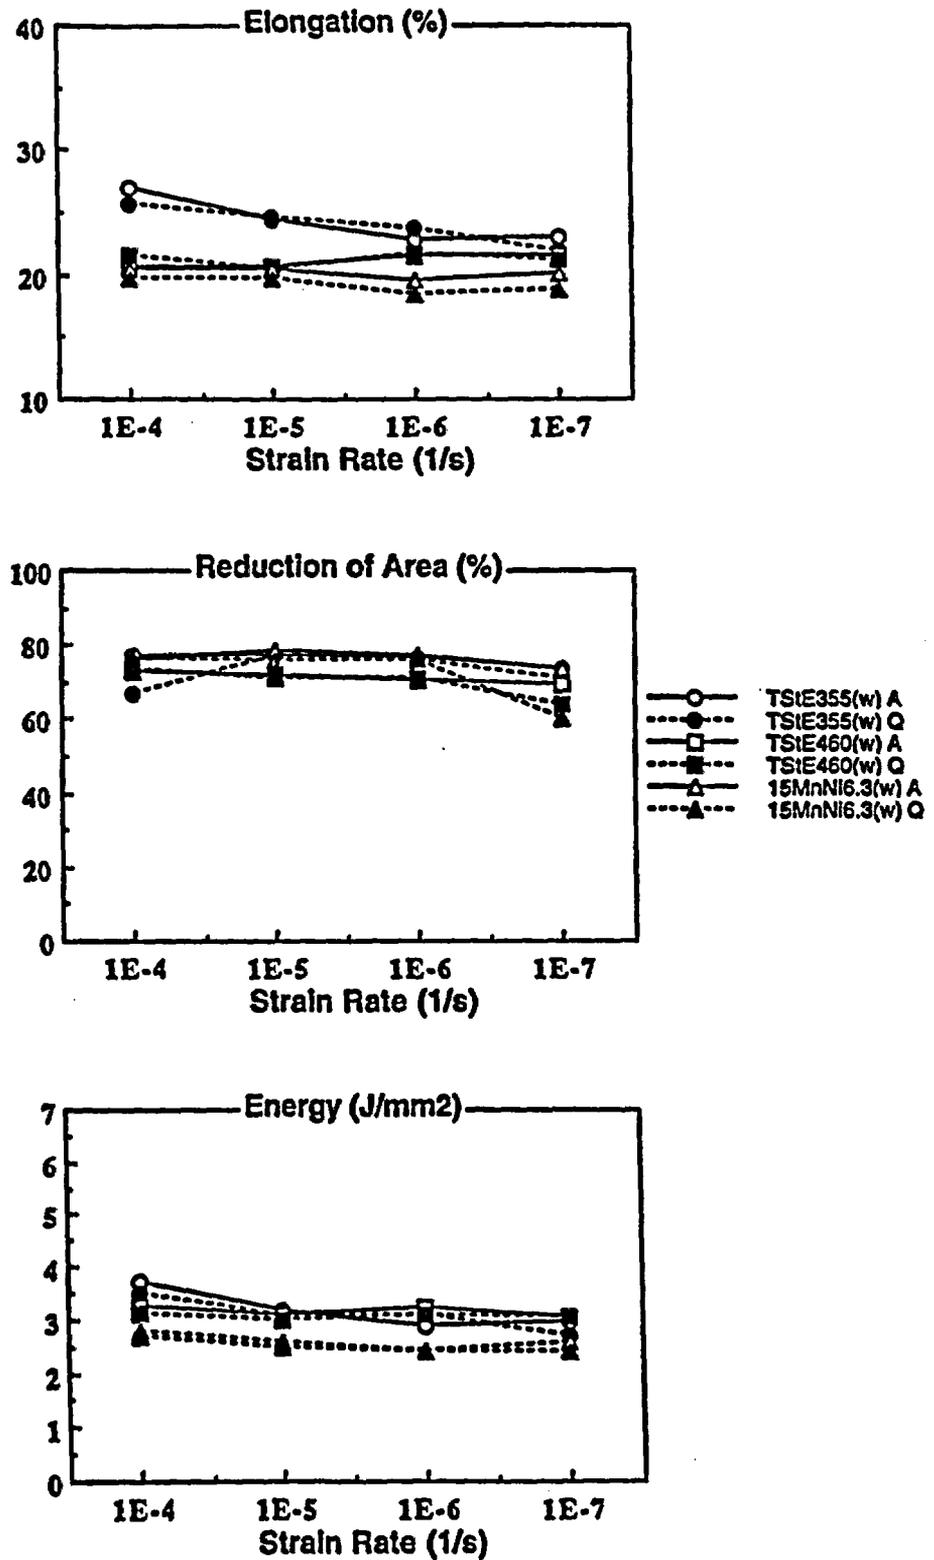
Fig. 32: Elongation, reduction of area and energy versus strain rate for the MAG welded steels TSIE 355, TSIE 460 and 15MnNi 6.3 tested at 25°C in argon and Q-brine

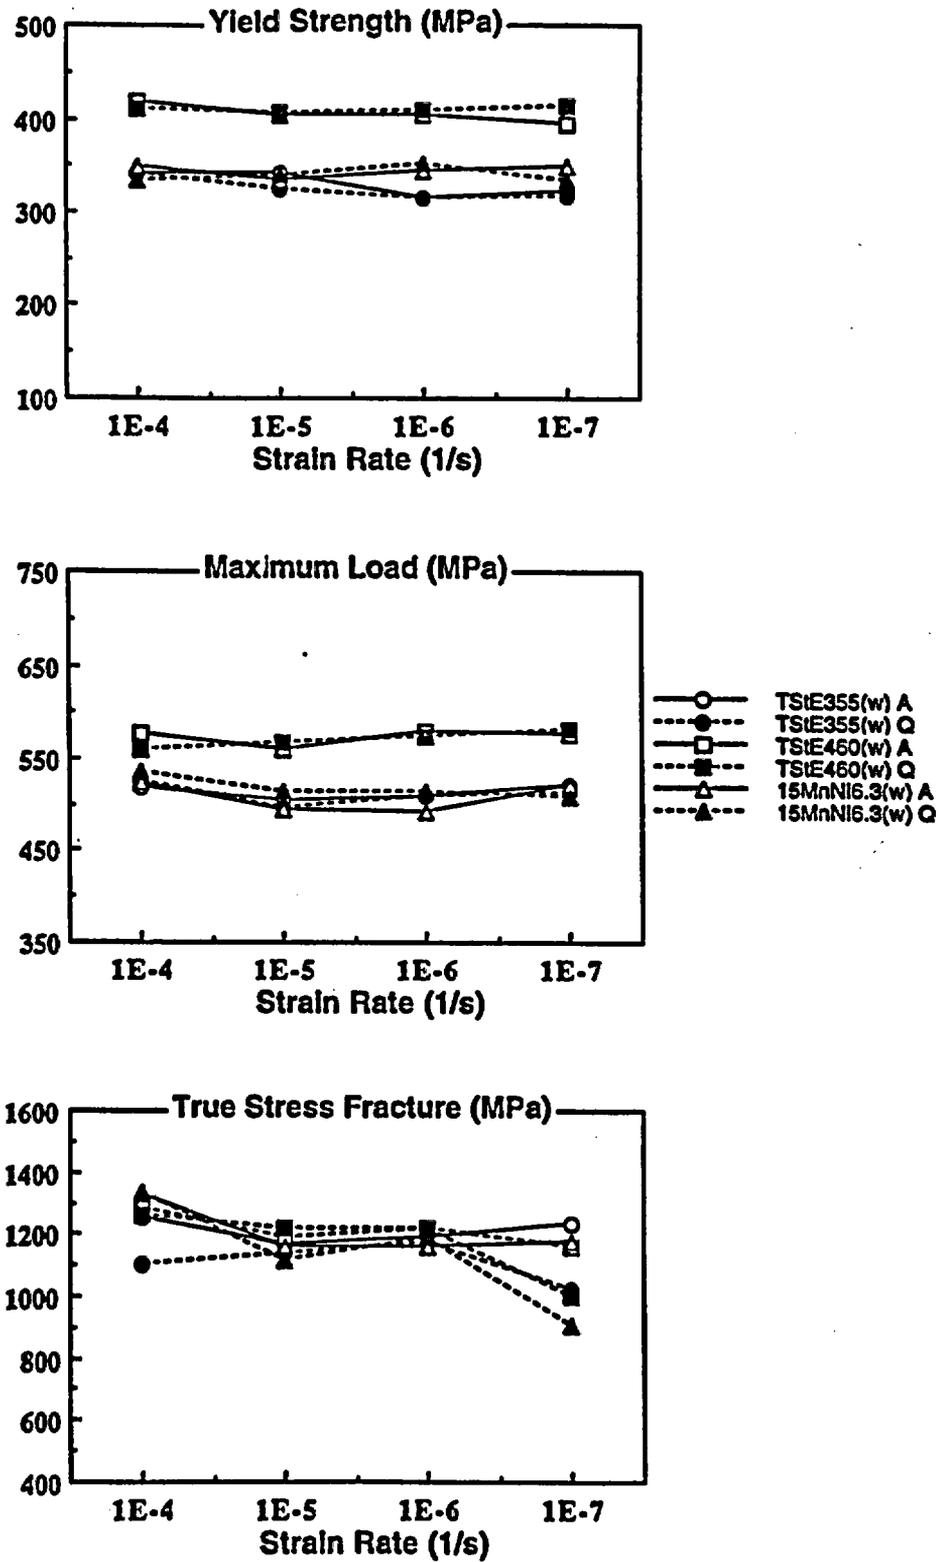
Fig. 33: Yield strength, maximum load and true stress fracture versus strain rate for the MAG welded steels TSIE 355, TSIE 460 and 15MnNi 6.3 tested at 25°C in argon and Q-brine

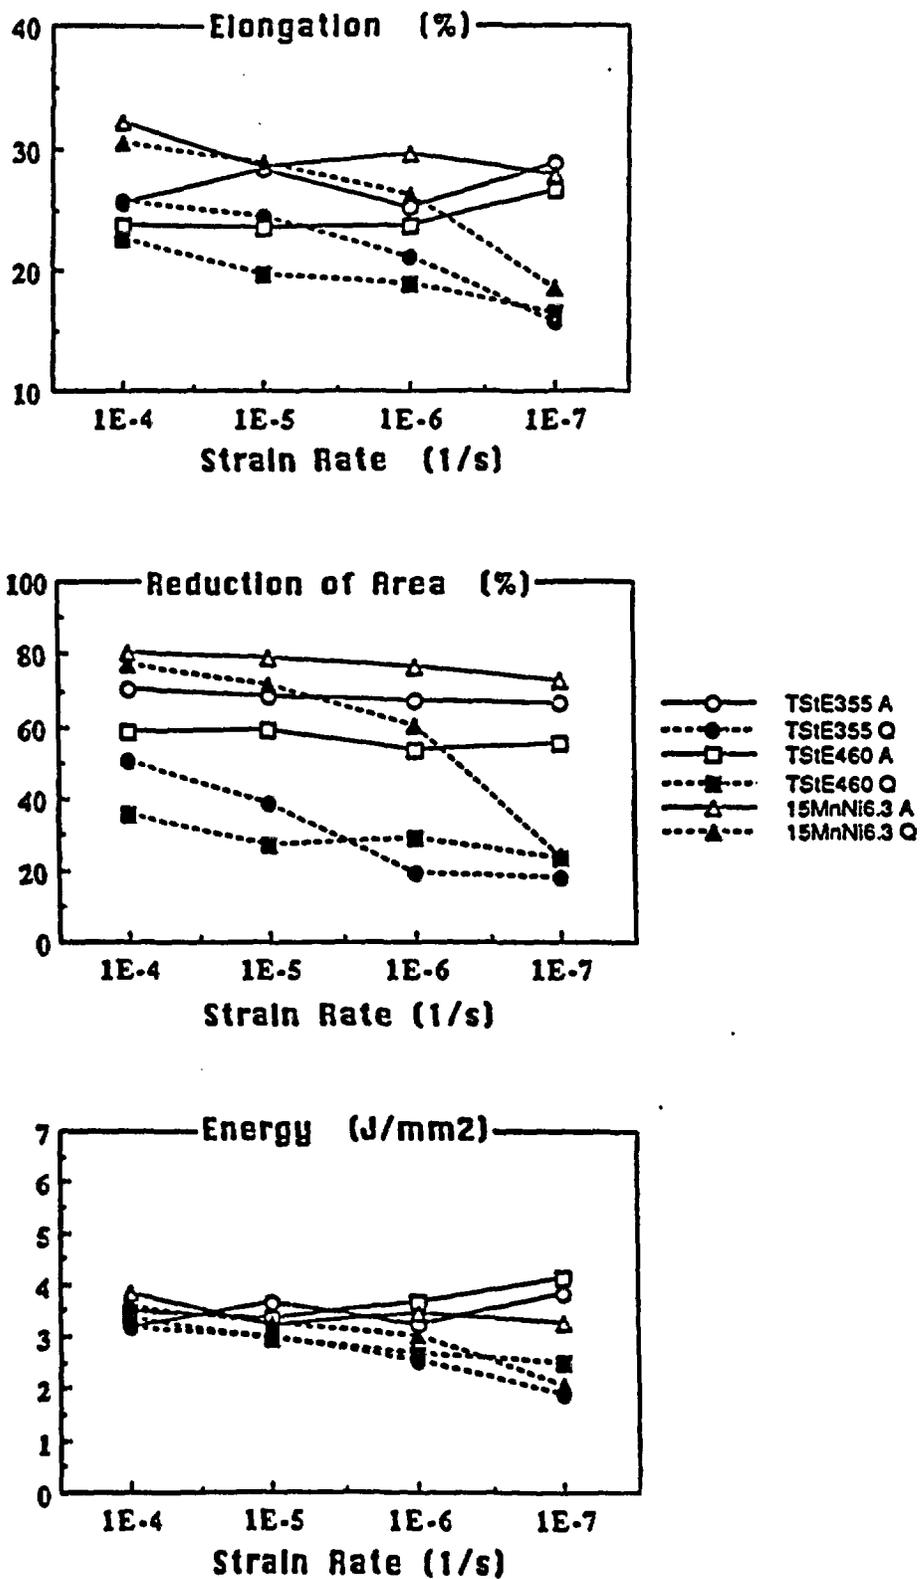
Fig. 38: Elongation, reduction of area and energy versus strain rate for the steels TS1E 355, TS1E 460 and 15MnNi 6.3 tested at 90°C and 13 MPa in argon and Q-brine

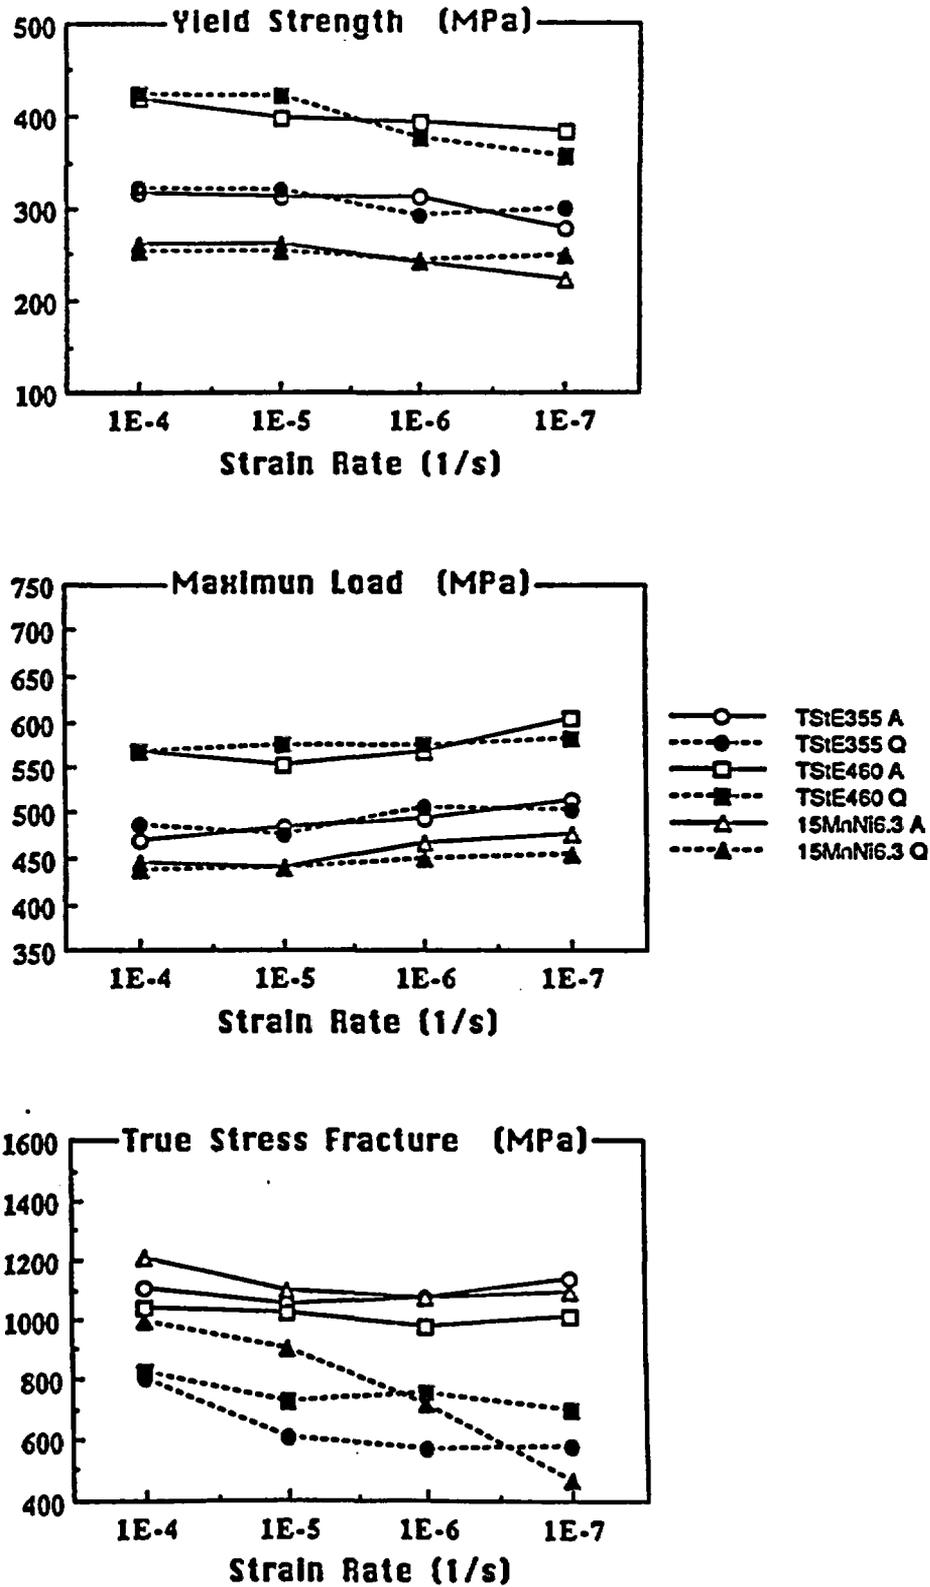
Fig. 39: Yield strength, maximum load and true stress fracture versus strain rate for the steels TSiE 355, TSiE 460 and 15MnNi 6.3 tested at 90°C and 13 MPa in argon and Q-brine

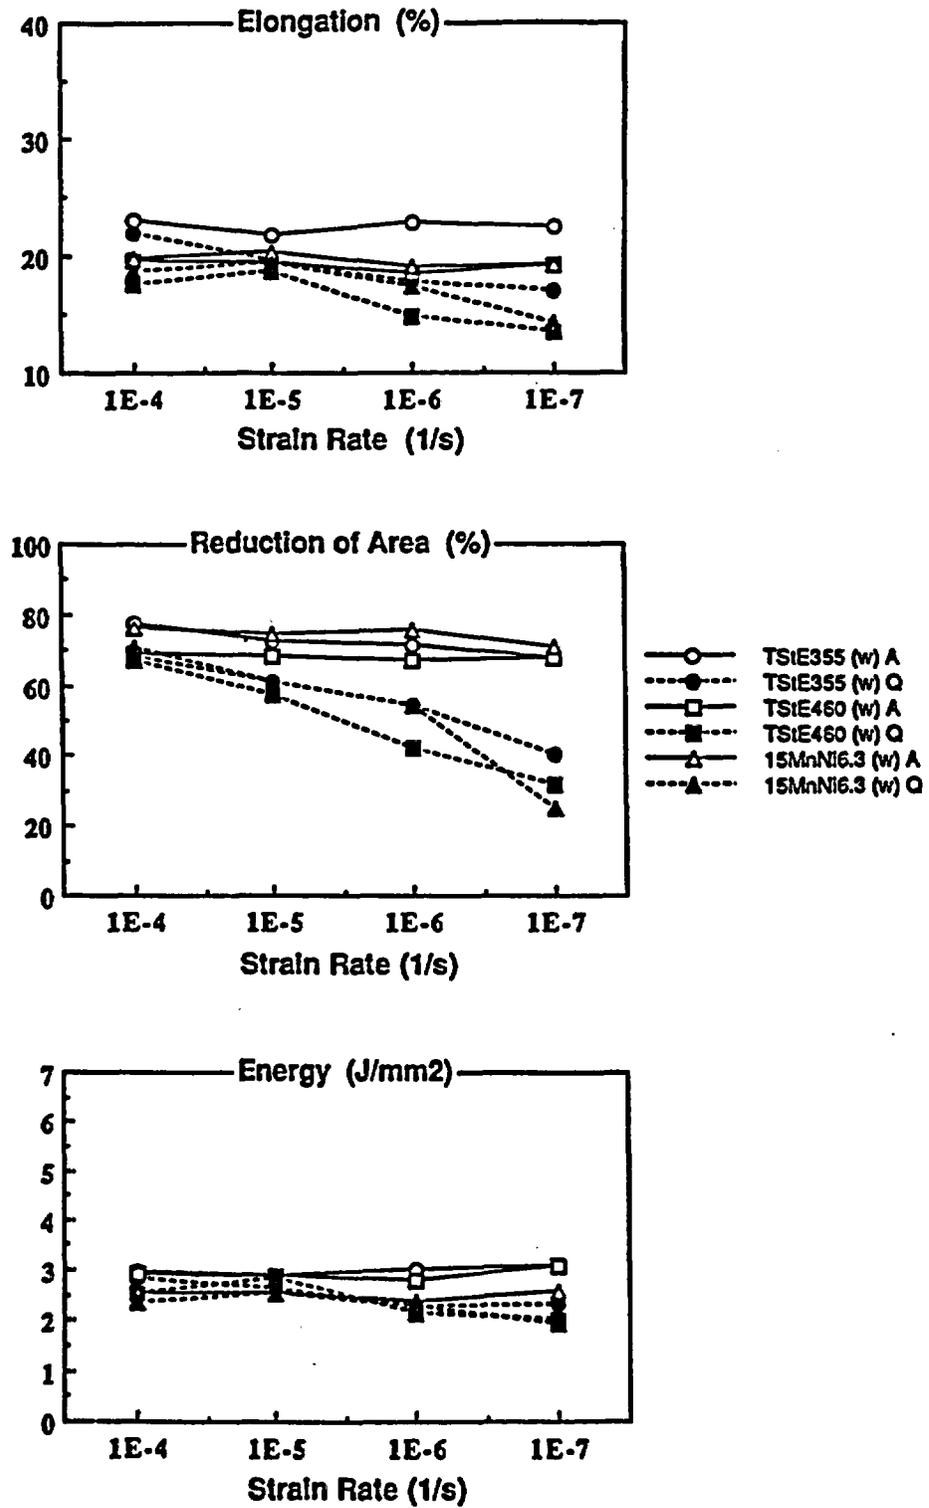
Fig. 40: Elongation, reduction of area and energy versus strain rate for the steels TSIE 355, TSIE 460 and 15MnNi 6.3 tested at 90°C in argon and Q-brine

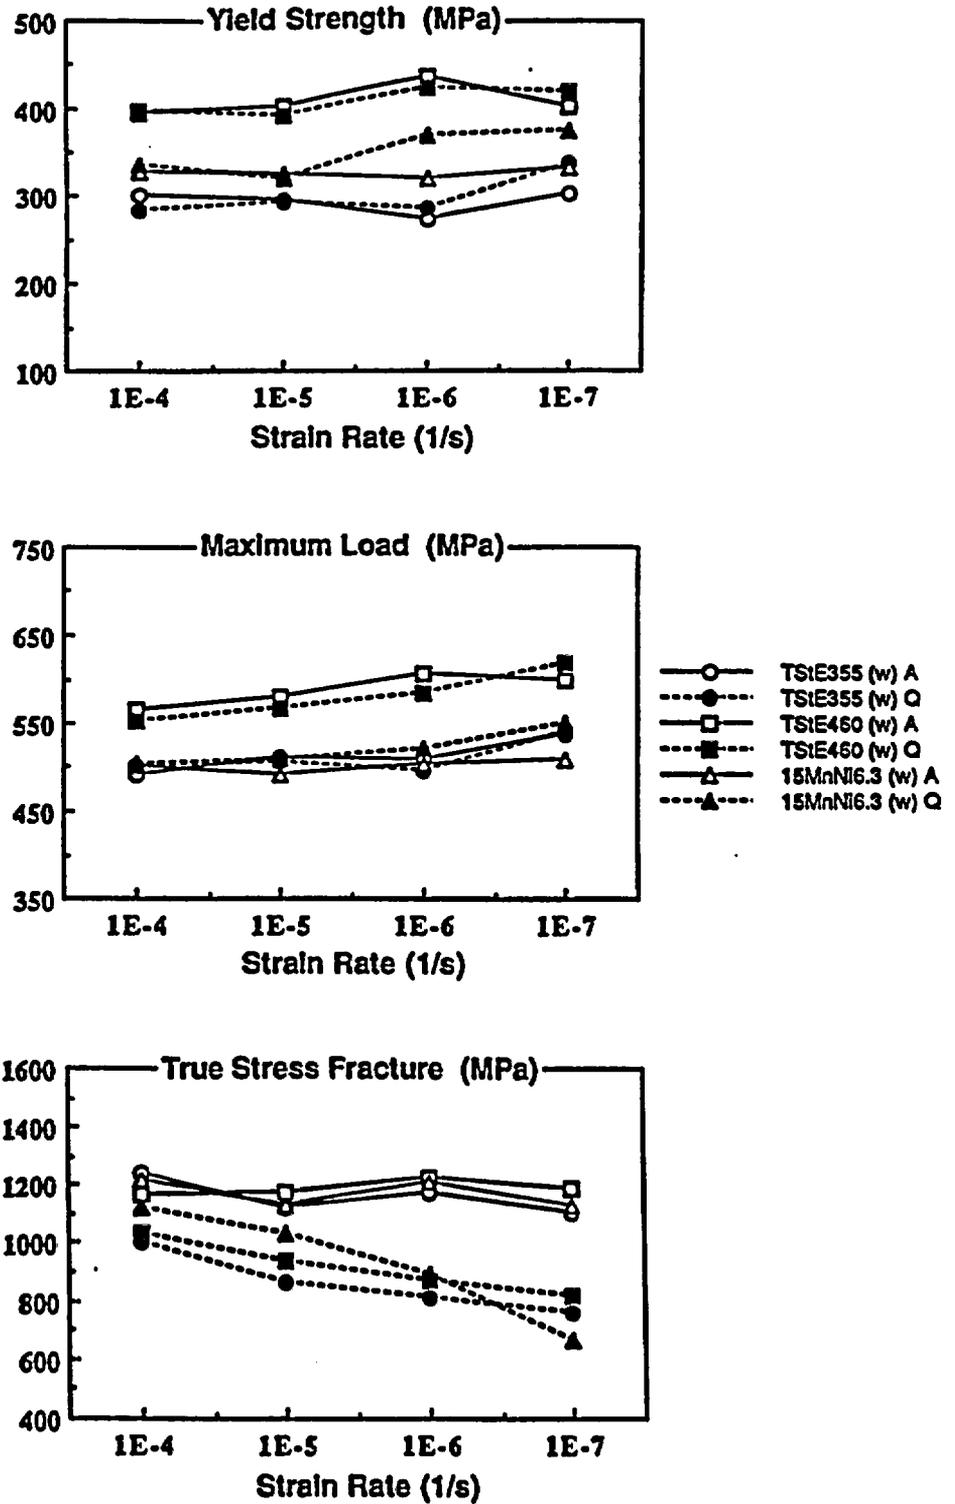
Fig. 41: Yield strength, maximum load and true stress fracture versus strain rate for the MAG welded steels TSIE 355, TSIE 460 and 15MnNi 6.3 tested at 90°C in argon and Q-brine

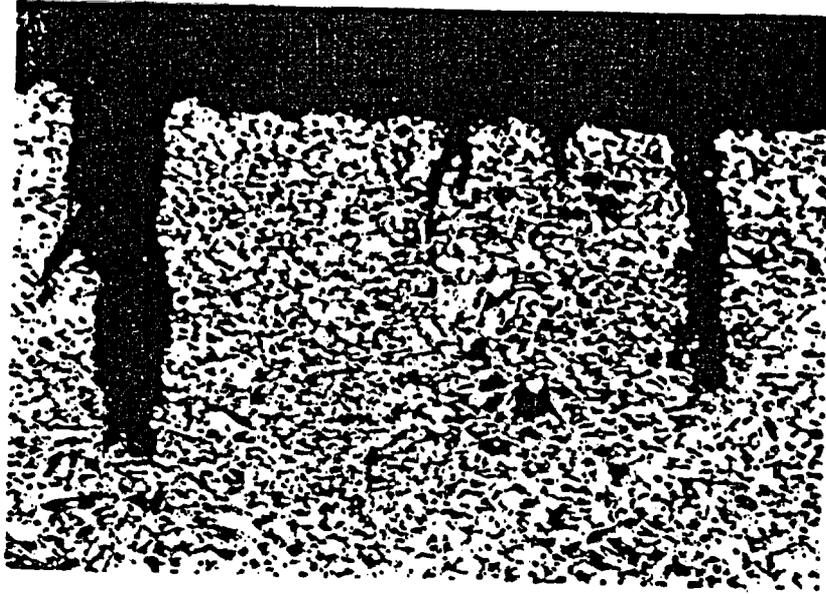
Fig. 44: Optical micrograph of a 15MnNi 6.3 steel specimen tested in Q-brine at 90°C and  $10^{-7}\text{s}^{-1}$  (x 100)

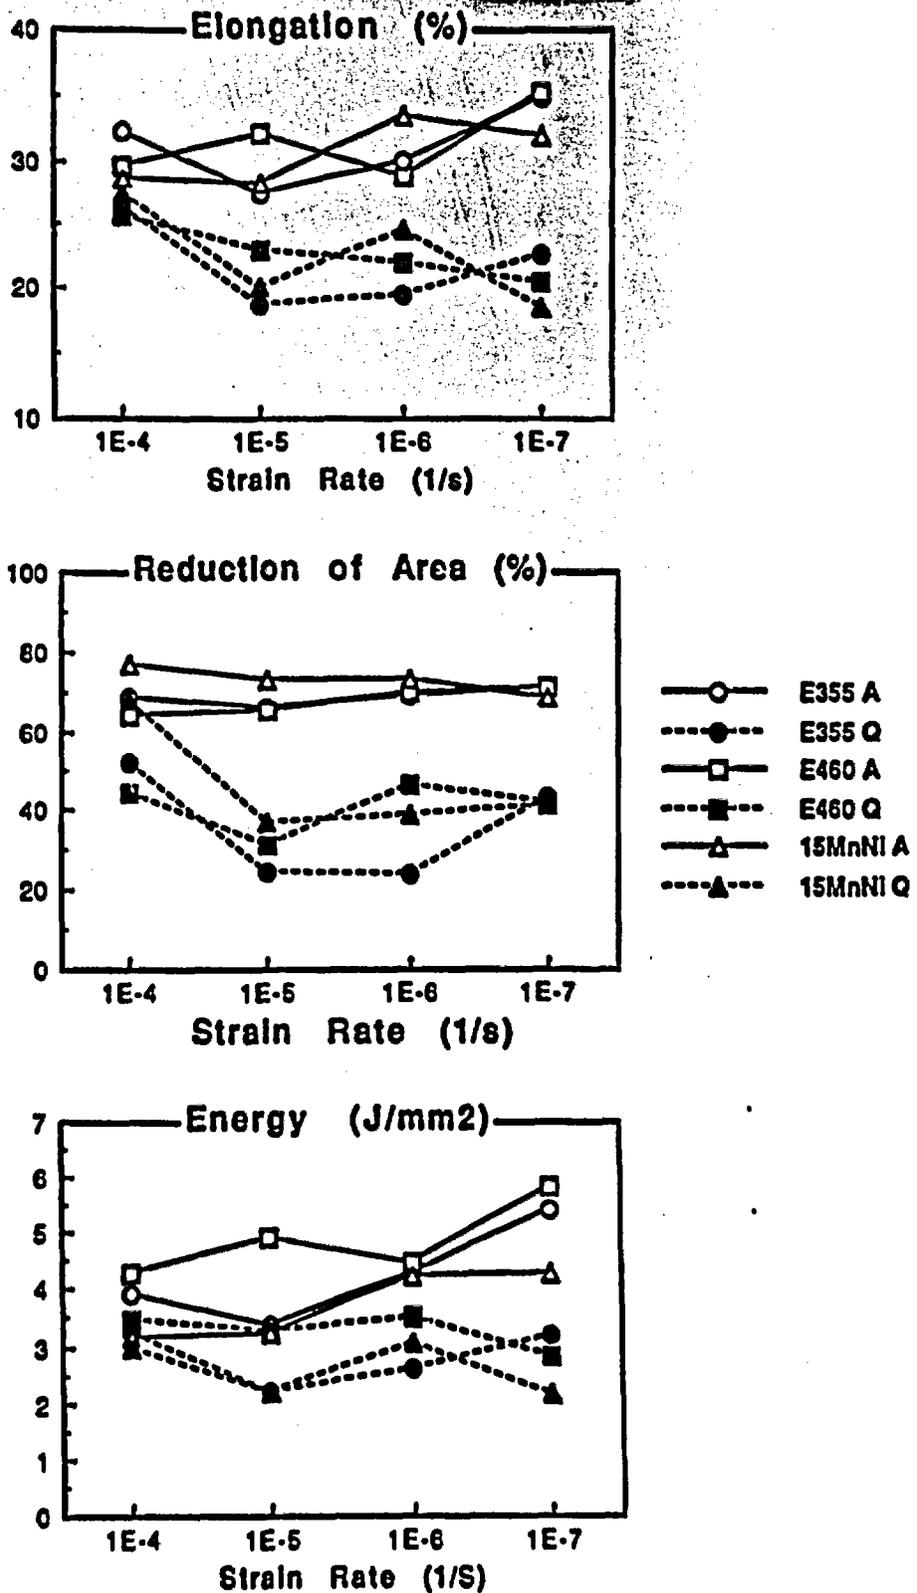
Fig. 48: Elongation, reduction of area and energy versus strain rate for the steels TSIE 355, TSIE 460 and 15MnNI 6.3 tested at 170°C and 13 MPa in argon and Q-brine

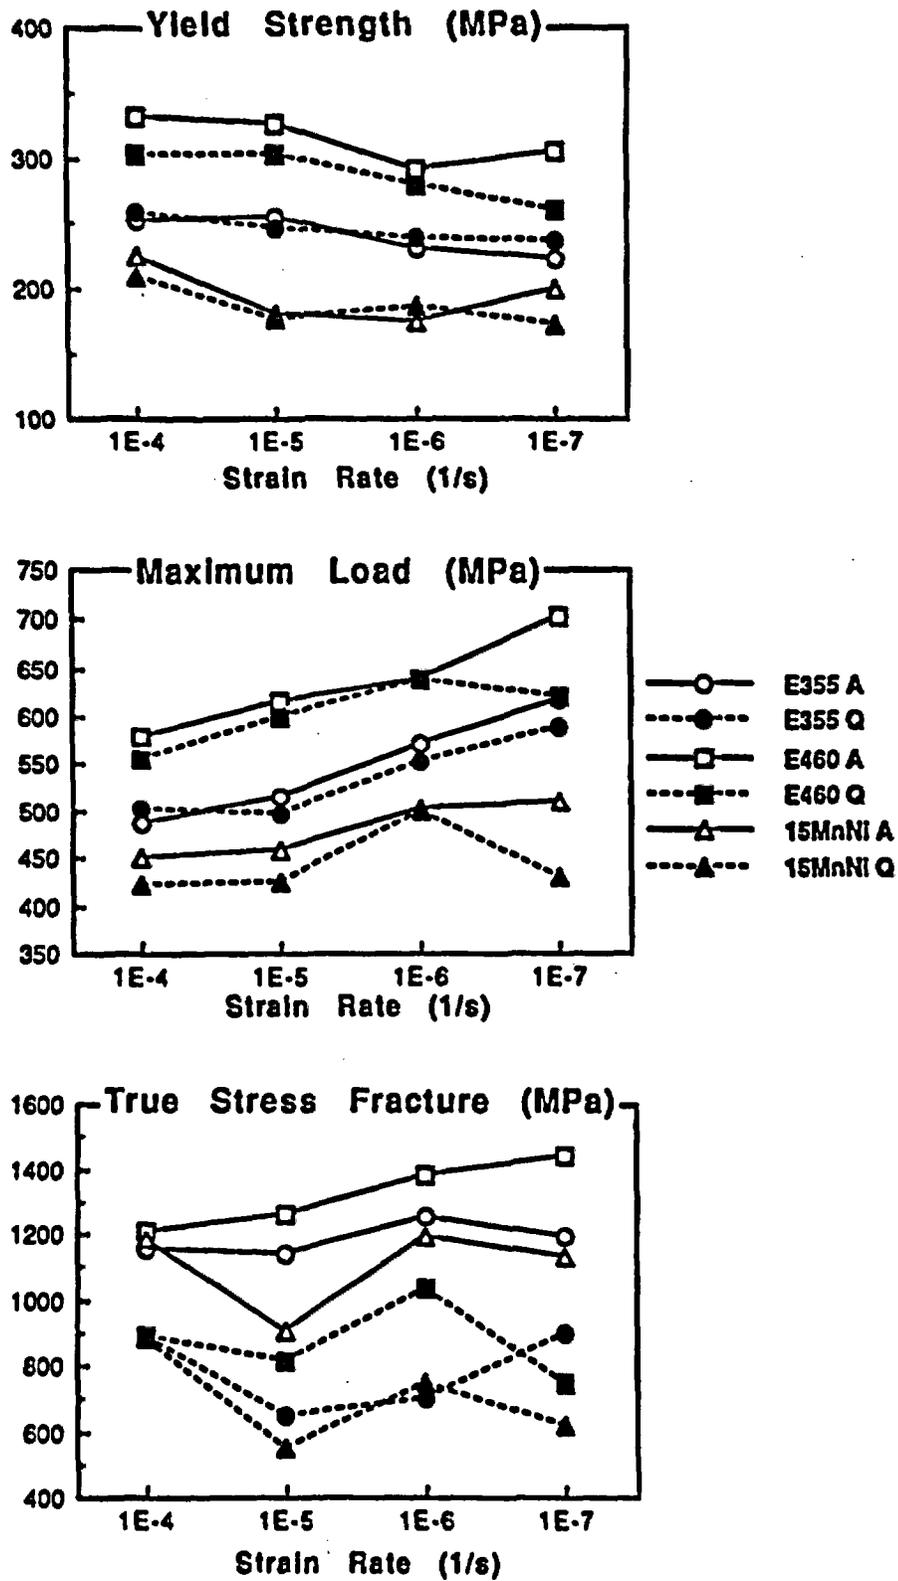
Fig. 49: Yield strength, maximum load and true stress fracture versus strain rate for the steels TS/E 355, TS/E 460 and 15MnNi 6.3 tested at 170°C and 13 MPa in argon and Q-brine

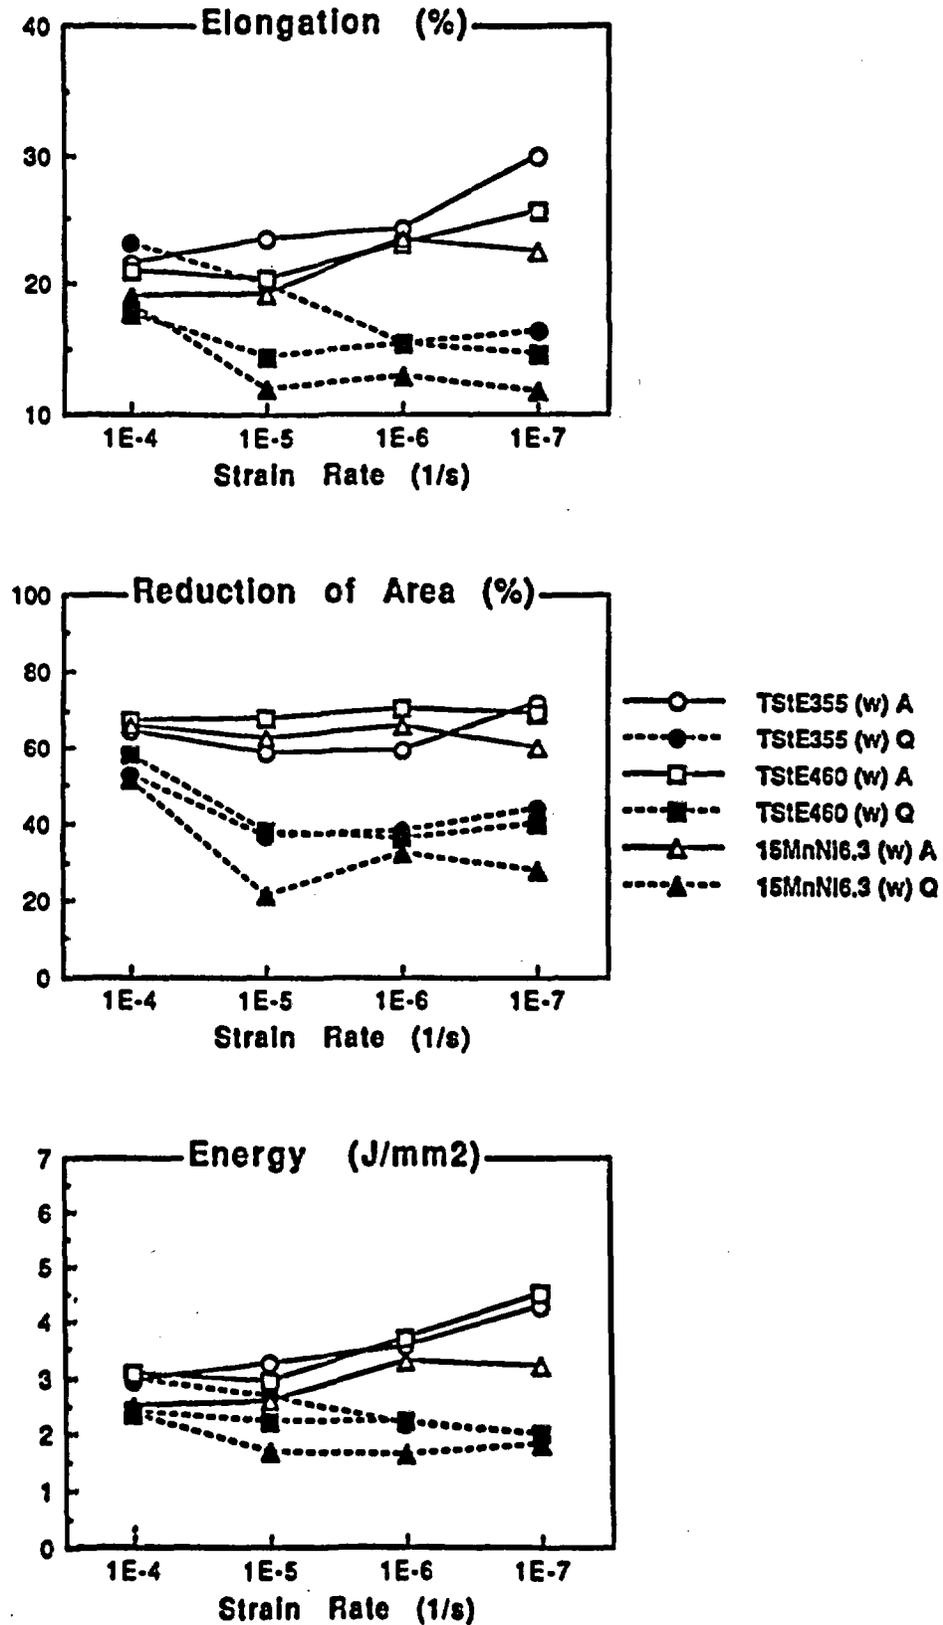
Fig. 50: Elongation, reduction of area and energy versus strain rate for the MAG welded steels TS1E 355, TS1E 460 and 15MnNi 6.3 tested at 170°C and 13 MPa in argon and Q-brine

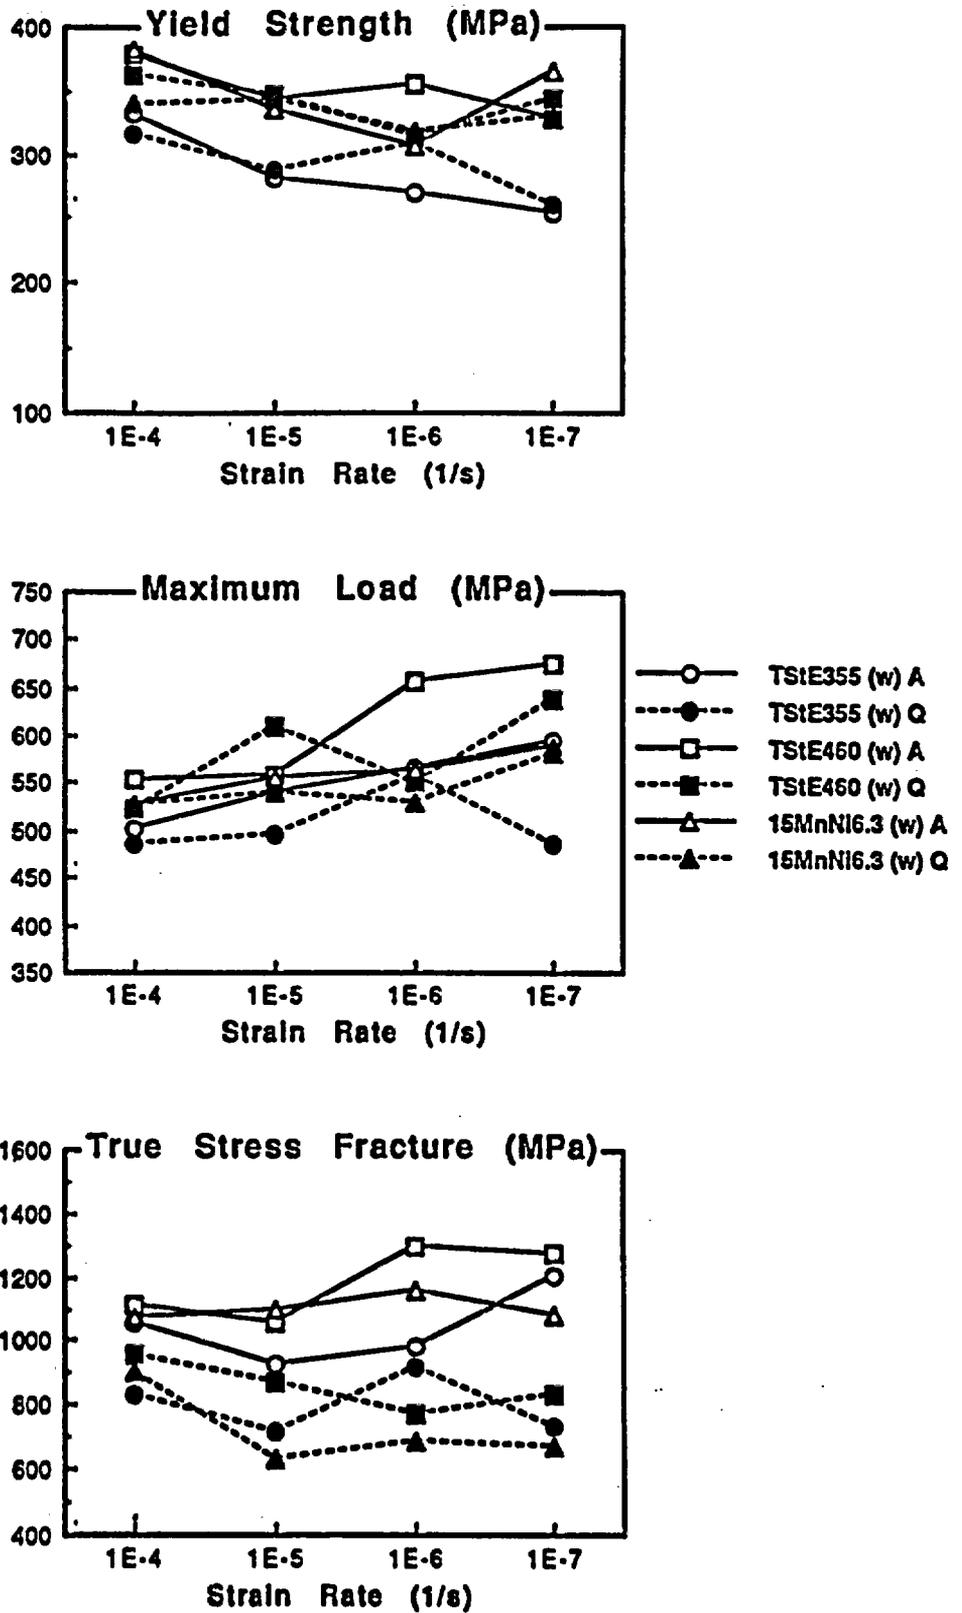
Fig. 51: Yield strength, maximum load and true stress fracture versus strain rate for the MAG welded steels TStE 355, TStE 460 and 15MnNi 6.3 tested at 170°C and 13 MPa in argon and Q-brine

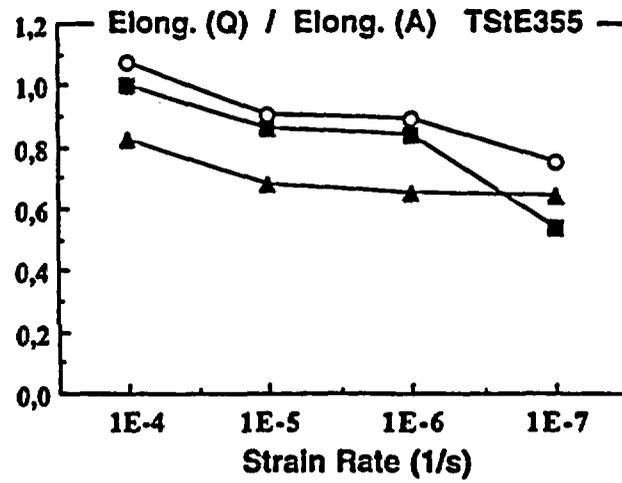
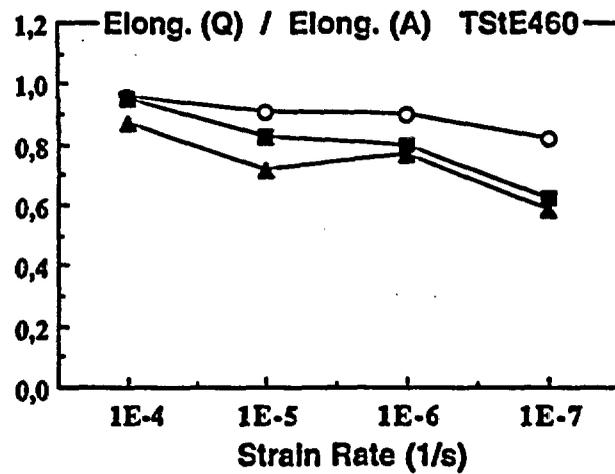
Fig. 60: Ratio of elongations in Q-brine and argon versus strain rate for the TStE 355, TStE 460 and 15MnNi 6.3 steels at various temperatures

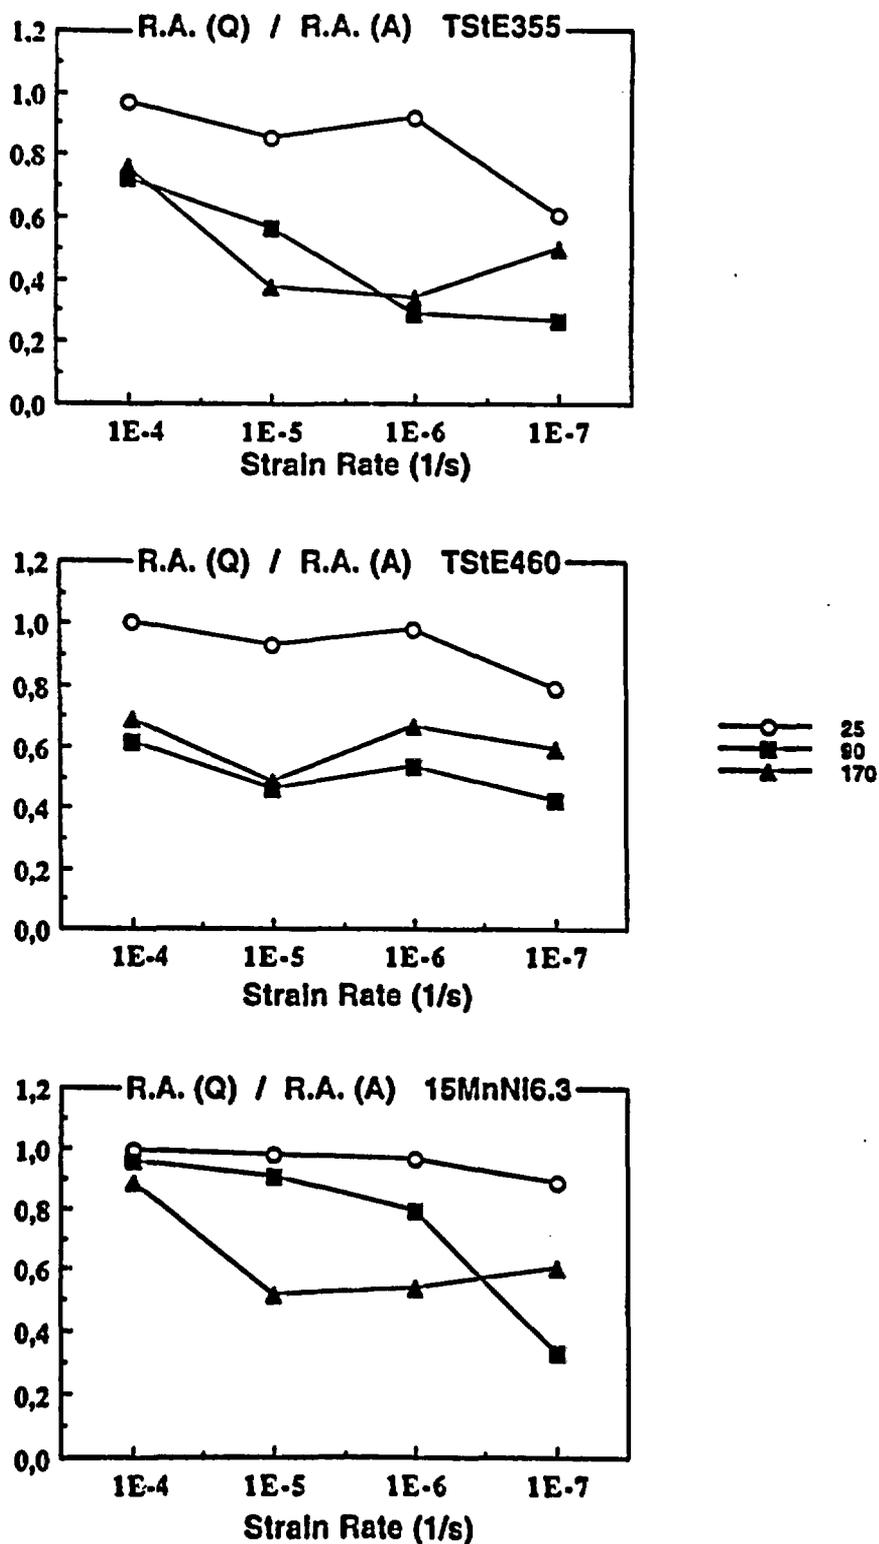
Fig. 61: Ratio of reduction of areas in Q-brine and argon versus strain rate for the TS1E 355, TS1E 460 and 15MnNi 6.3 steels at various temperatures

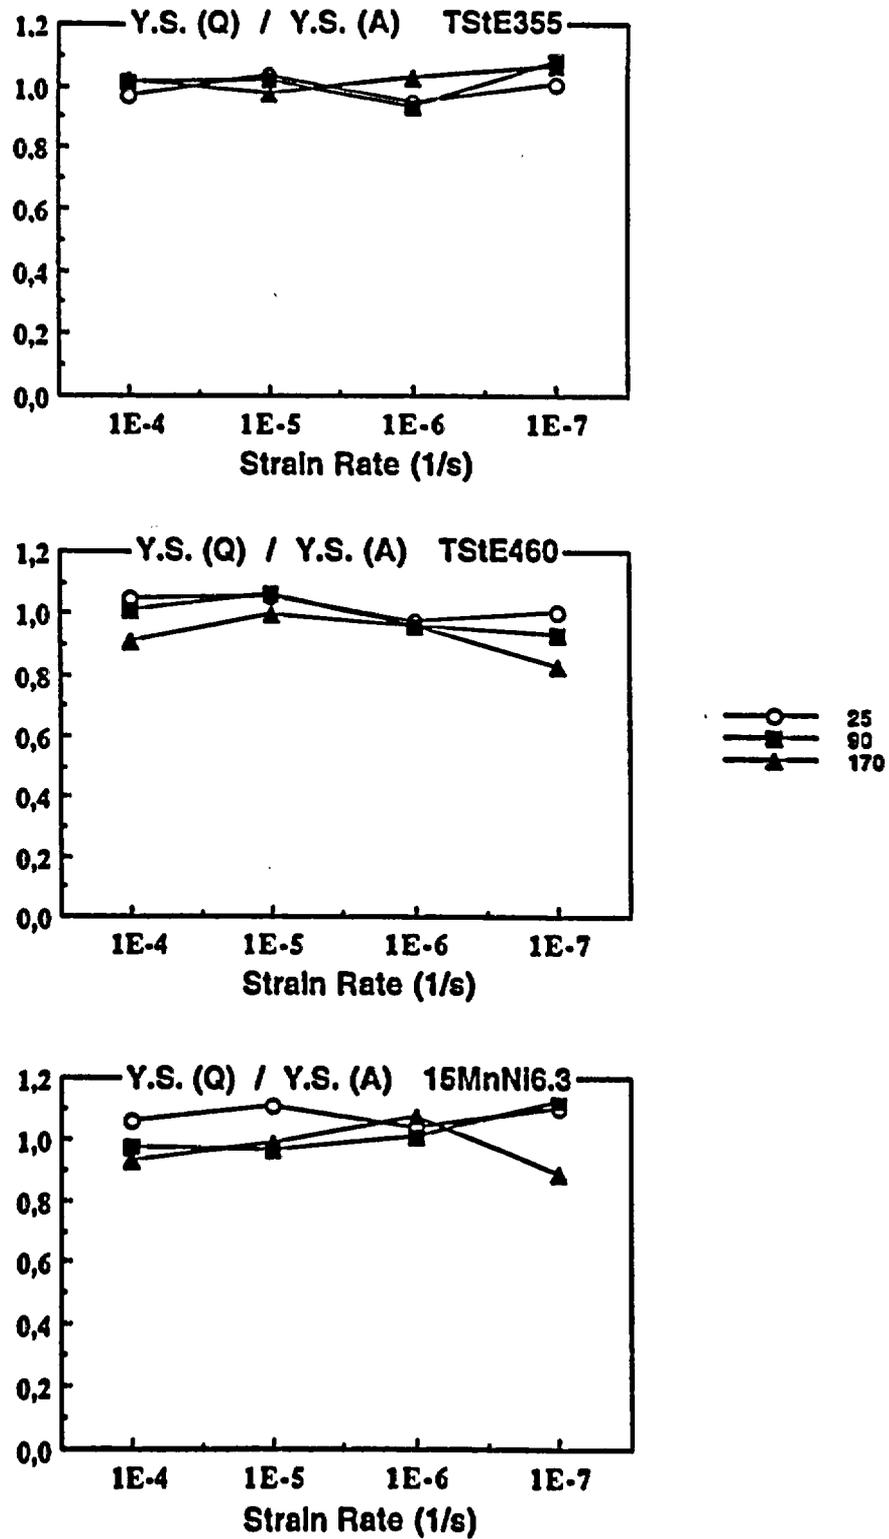
Fig. 63: Ratio of yield strengths in Q-brine and argon versus strain rate for the TStE 355, TStE 460 and 15MnNi 6.3 steels at various temperatures

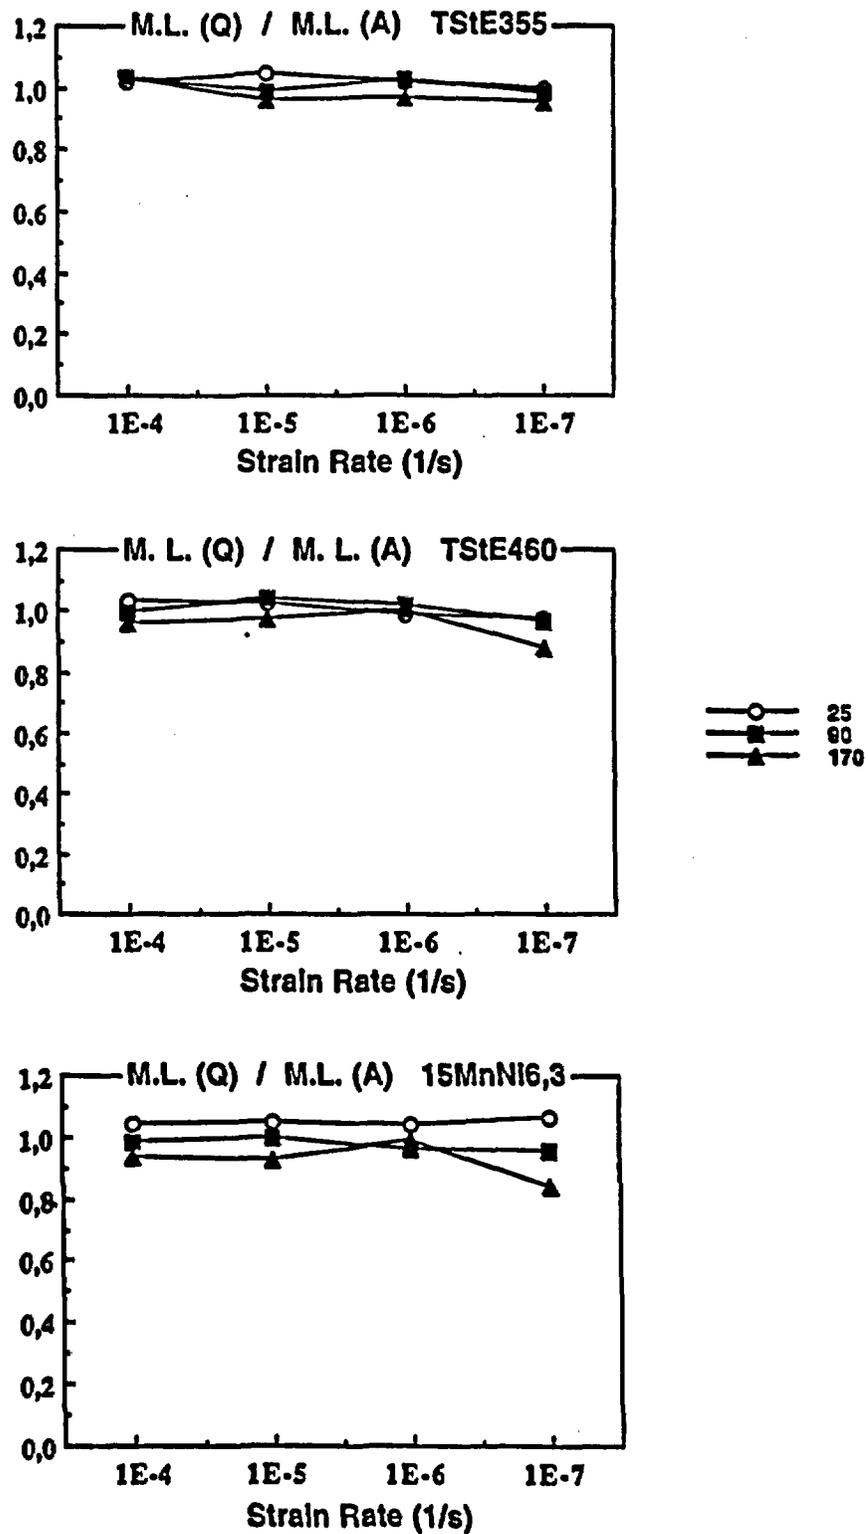
Fig. 64: Ratio of maximum loads in Q-brine and argon versus strain rate for the TStE 355, TStE 460 and 15MnNi 6.3 steels at various temperatures

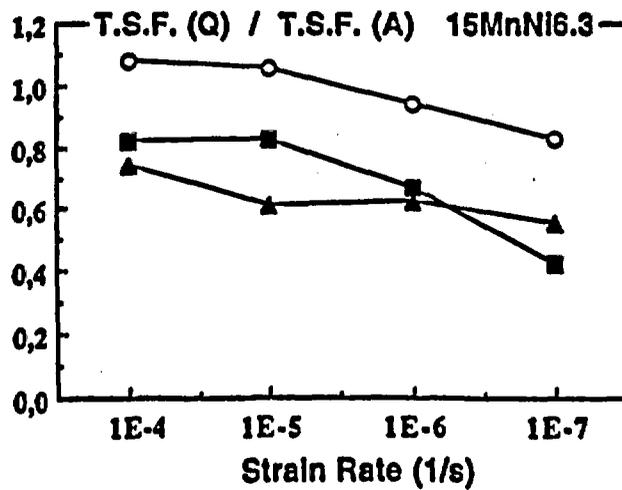
Fig. 65: Ratio of true stresses at fracture in Q-brine and argon versus strain rate for the TS1E 355, TS1E 460 and 15MnNi 6.3 steels at various temperatures

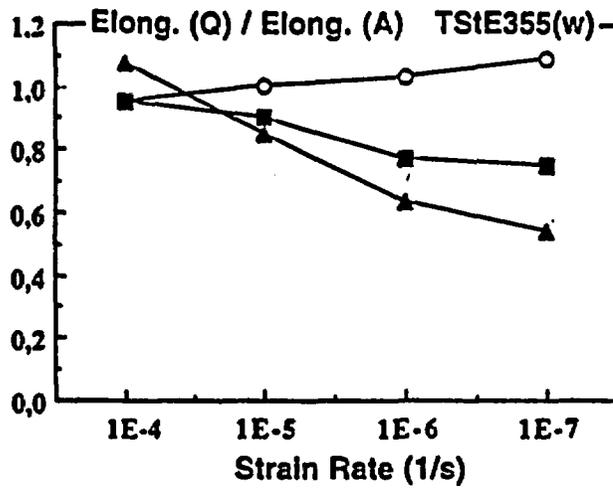
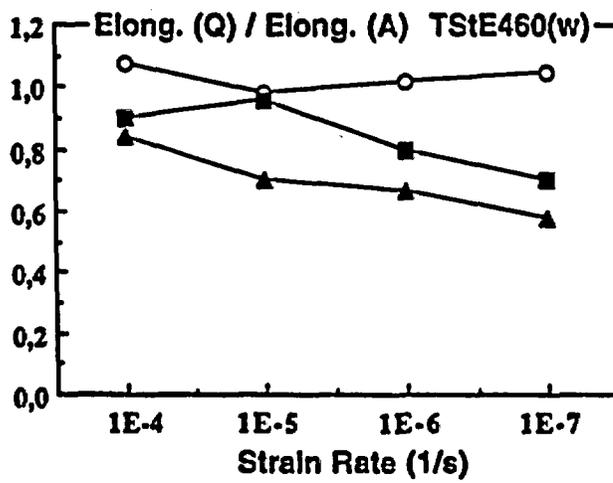
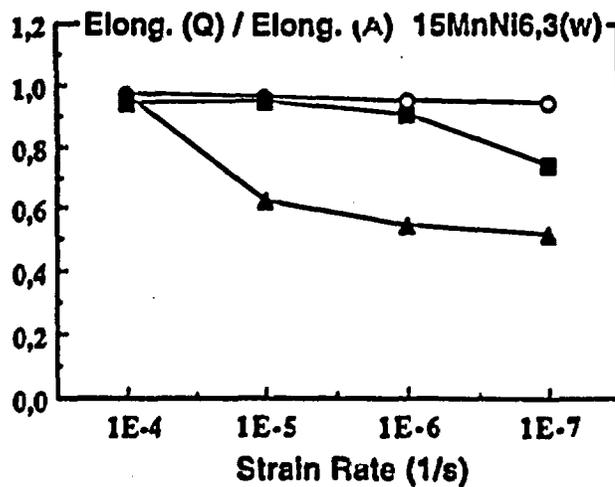
Fig. 66: Ratio of elongations in Q-brine and argon versus strain rate for the MAG welded TStE 355, TStE 460 and 15MnNi 6.3 steels at various temperatures
