Wissenschaftliche Berichte  
FZKA 5587.

**Corrosion Studies on  
Selected Packaging  
Materials for Disposal  
of Heat-Generating  
Radioactive Wastes in  
Rock-Salt Formations**

**E. Smallos, J. A. Gago, I. Azkarate, B. Fieh**  
Institut für Nukleare Entsorgungstechnik

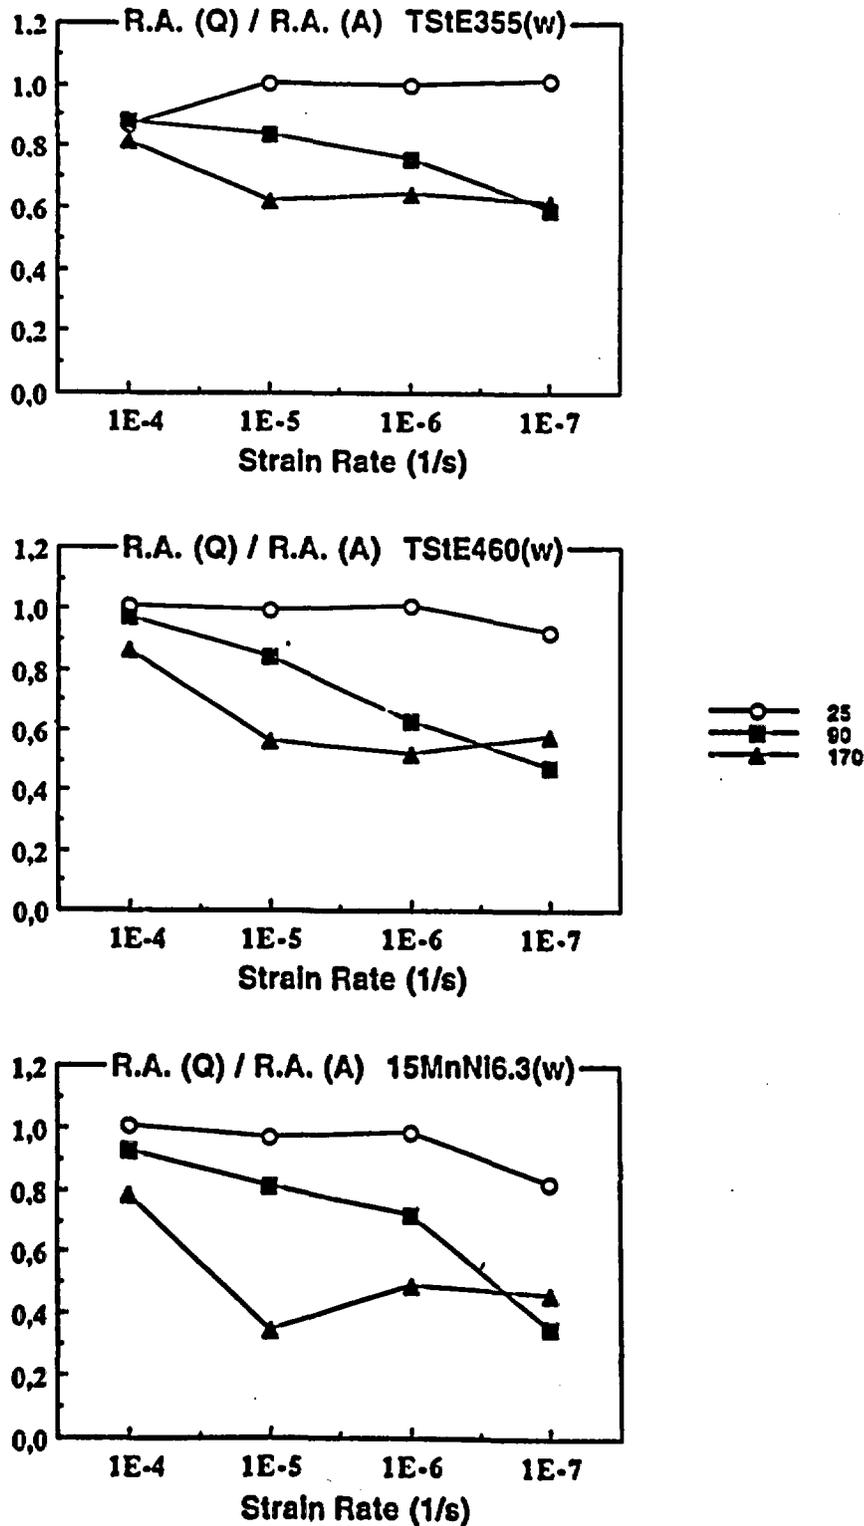
Fig. 67: Ratio of reduction of areas in Q-brine and argon versus strain rate for the MAG welded TS1E 355, TS1E 460 and 15MnNi 6.3 steels at various temperatures

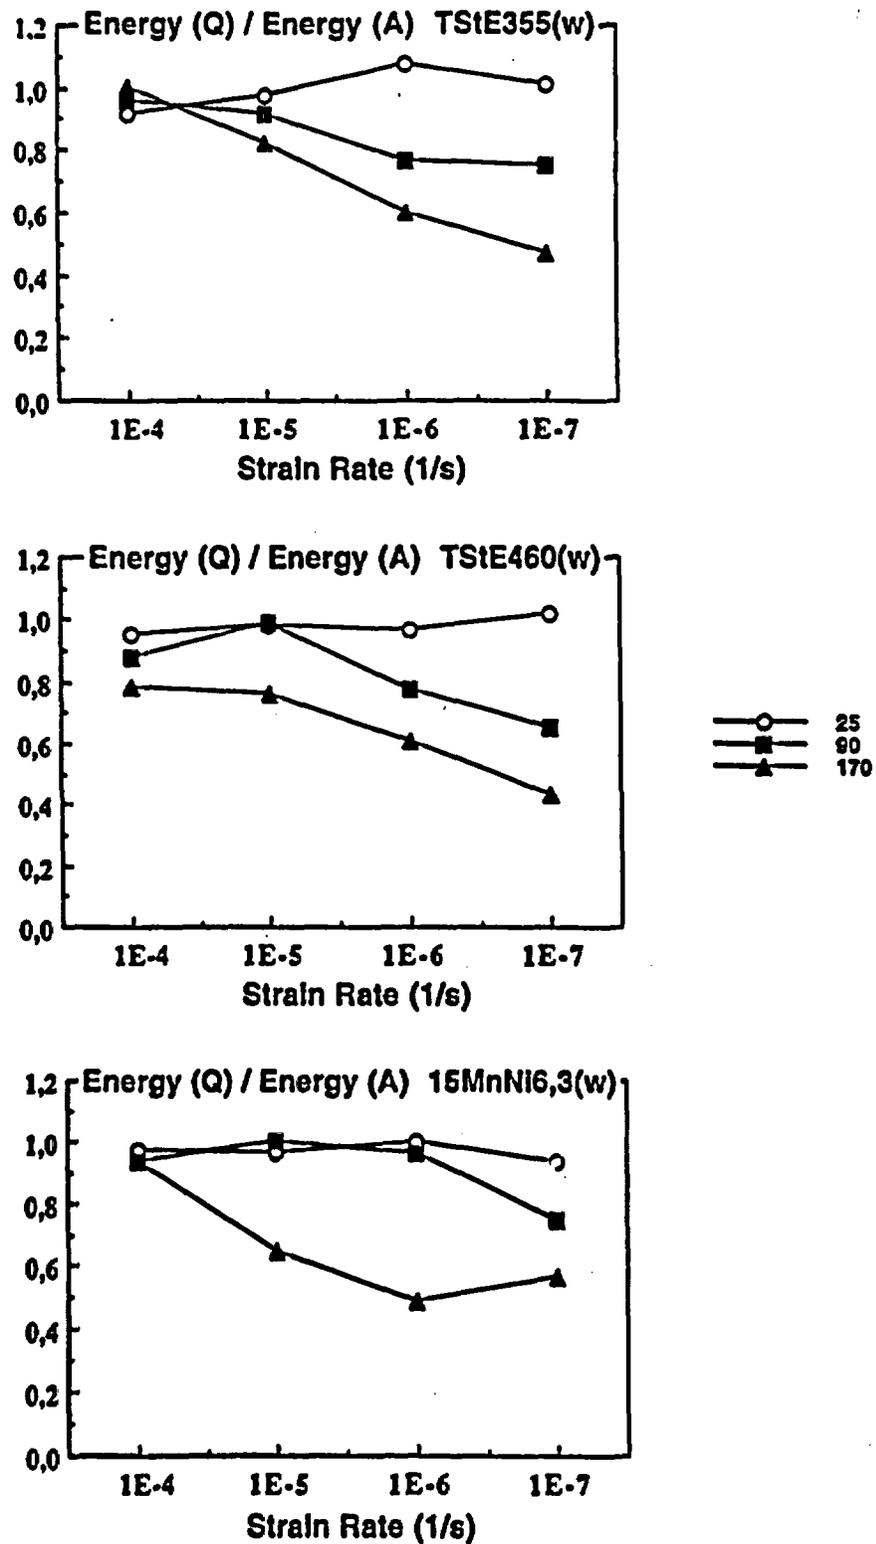
Fig. 68: Ratio of energies in Q-brine and argon versus strain rate for the MAG welded TStE 355, TStE 460 and 15MnNi 6.3 steels at various temperatures

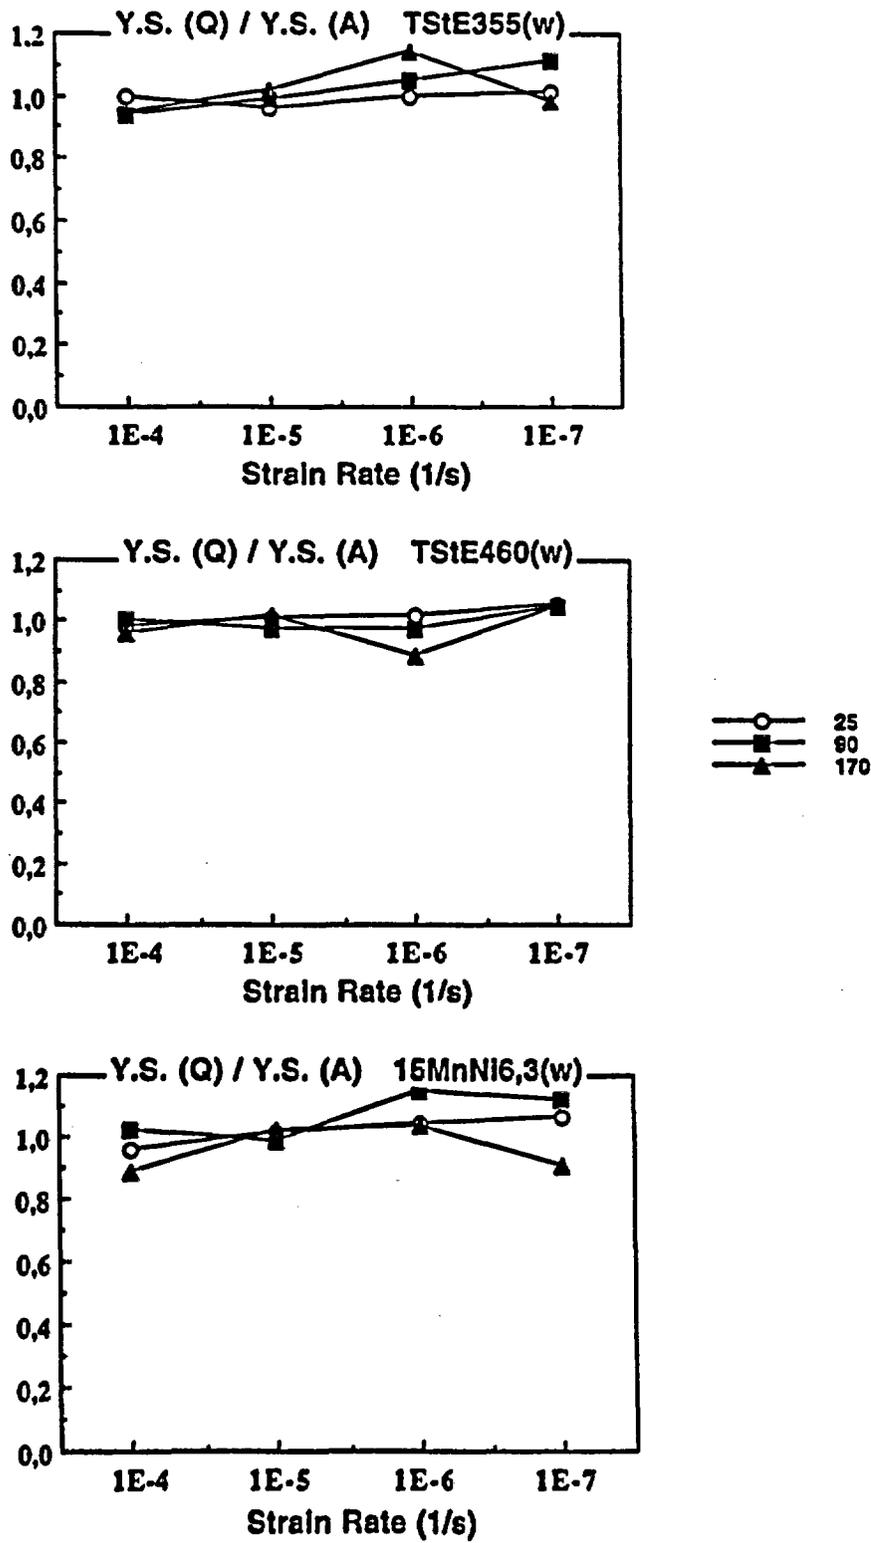
Fig. 69: Ratio of yield strengths in Q-brine and argon versus strain rate for the MAG welded TStE 355, TStE 460 and 15MnNi 6.3 steels at various temperatures

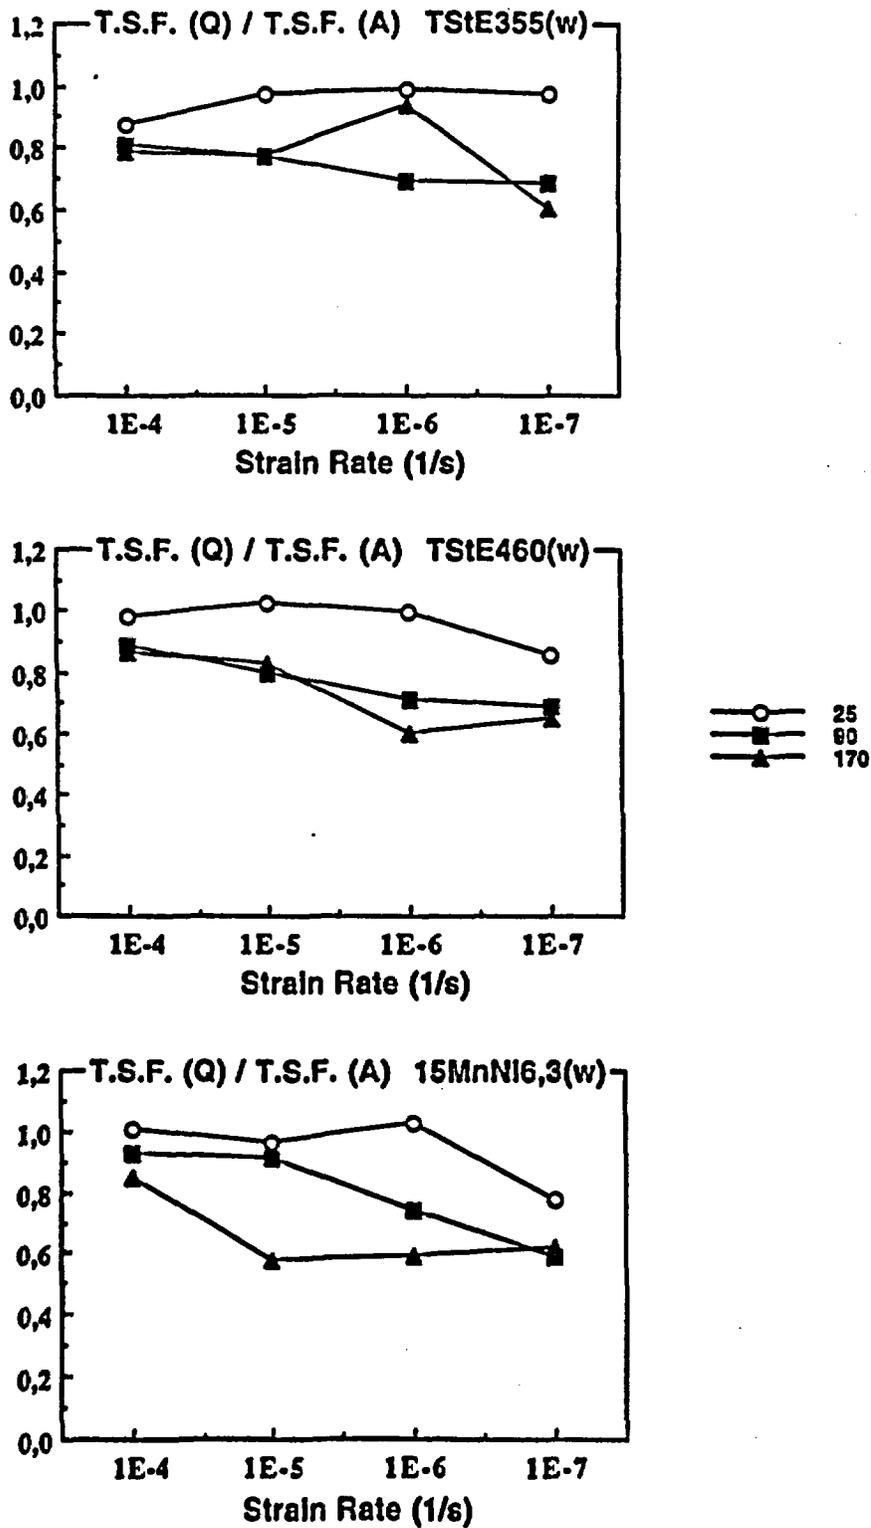
Fig. 71: Ratio of true stresses at fracture in Q-brine and argon versus strain rate for the MAG welded TSIE 355, TSIE 460 and 15MnNi 6.3 steels at various temperatures

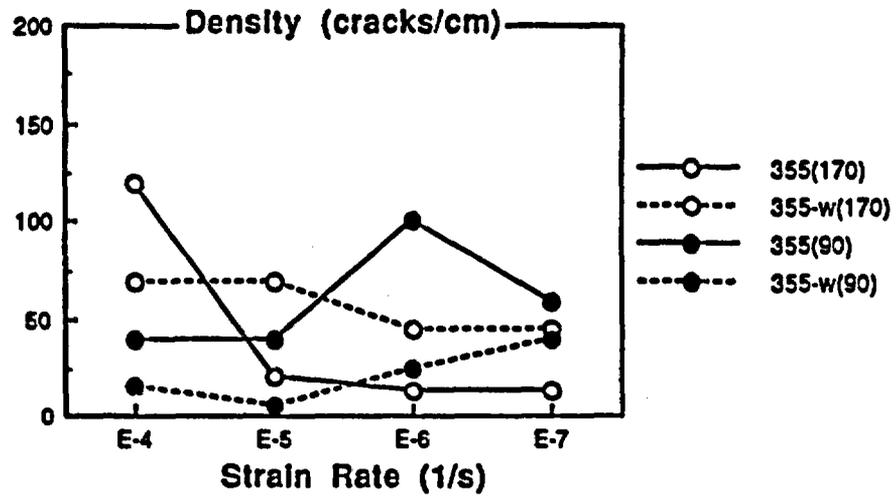
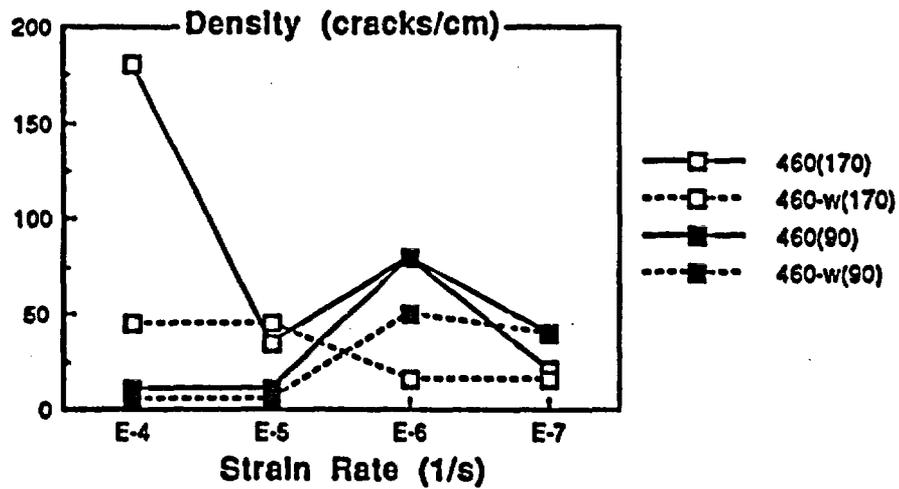
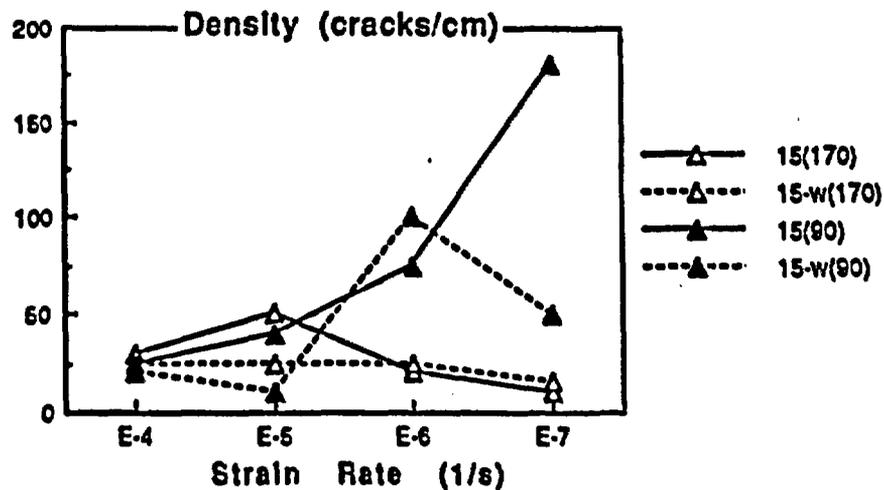
Fig. 72: Crack density obtained for the steels TSIE 355, TSIE 460 and 15MnNi 6.3 after slow strain rate testing in Q-brine under various conditions ( $T = 90^{\circ}\text{C}$ ,  $170^{\circ}\text{C}$ ,  $w = \text{welded material}$ )

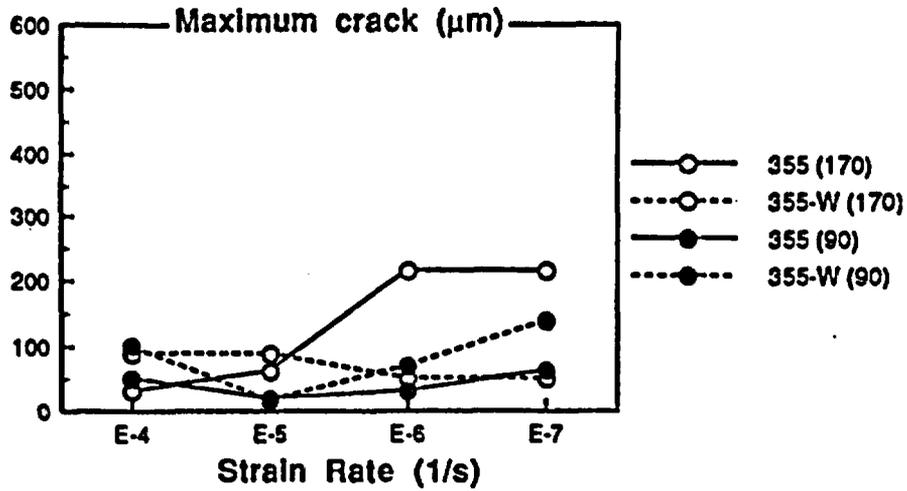
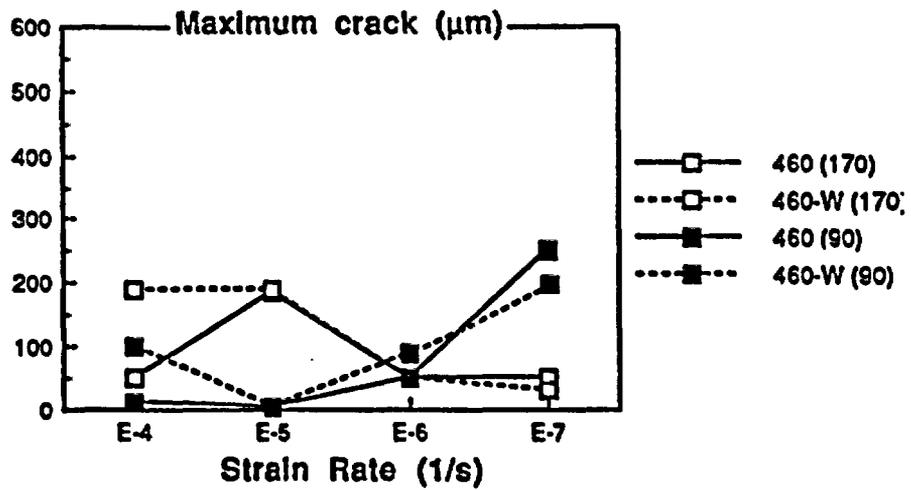
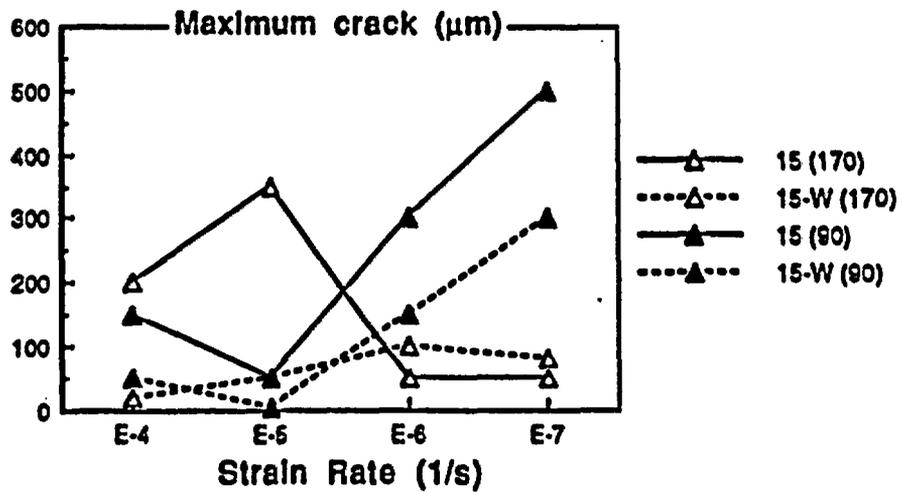
Fig. 73: Maximum crack length obtained for the steels TStE 355, TStE 460 and 15MnNi 6.3 after slow strain rate testing in Q-brine under various conditions ( $T = 90^\circ\text{C}$ ,  $170^\circ\text{C}$ , w = welded material)

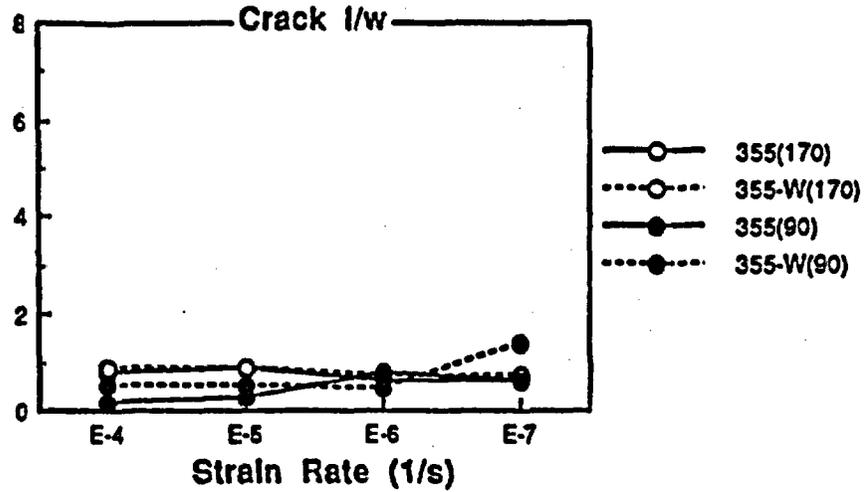
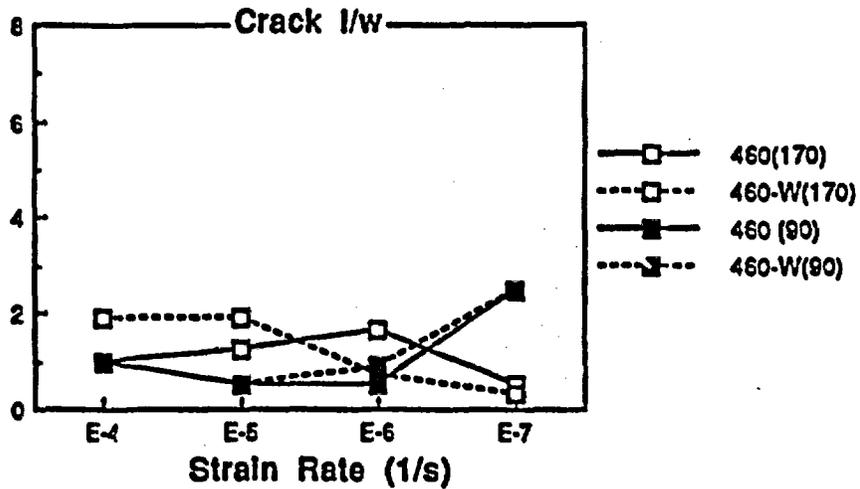
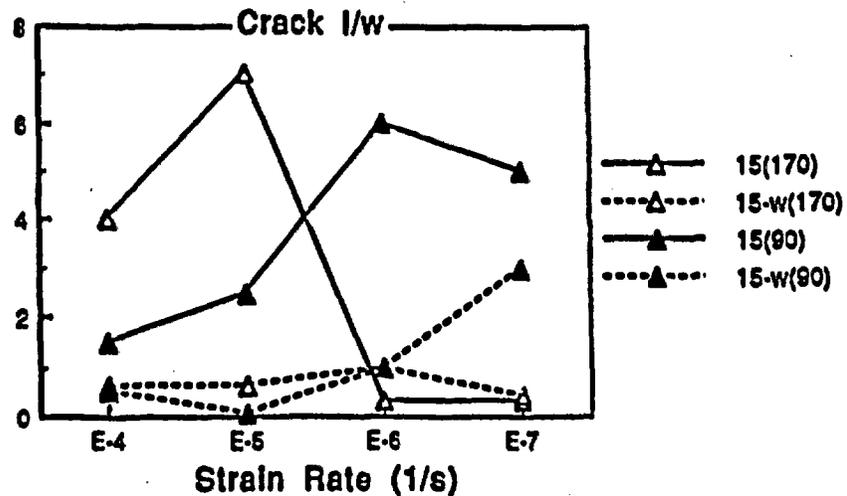
Fig. 74: Crack length to wide ratio obtained for the steels TSIE 355, TSIE 460 and 15MnNi 6.3 after slow strain rate testing in Q-brine under various conditions ( $T = 90^{\circ}\text{C}$ ,  $170^{\circ}\text{C}$ ,  $w = \text{welded material}$ )
