Publication Date: September 1995

**Westinghouse Savannah River Company  
Savannah River Site  
Aiken, SC 29808**

WSRC-TR-95-0343

**Corrosion of Aluminum-Clad Alloys in Wet Spent Fuel  
Storage**

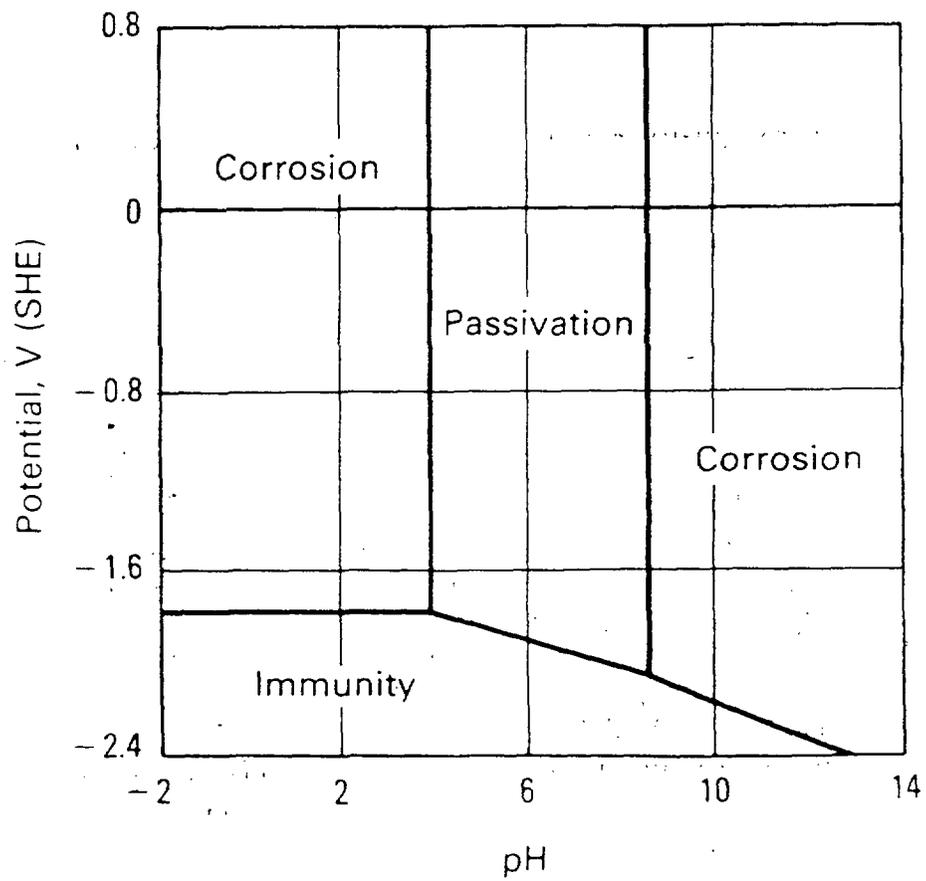
Figure 3. Pourbaix Diagram (From Reference 10)

The conditions for the thermodynamic stability of the oxide film on aluminum is shown by the Pourbaix diagram in Figure 3. In this case, the aluminum has a Bayerite film ( $\text{Al}_2\text{O}_3 \cdot 3\text{H}_2\text{O}$ ) at 25°C. The diagram shows that aluminum is passive (protected by its oxide film) in the pH range of about 4 to 8.5. These limits can vary with temperature, form of oxide present, and with the presence of substances that can form soluble complexes or insoluble salts with aluminum. A similar diagram exists for the Boehmite film.

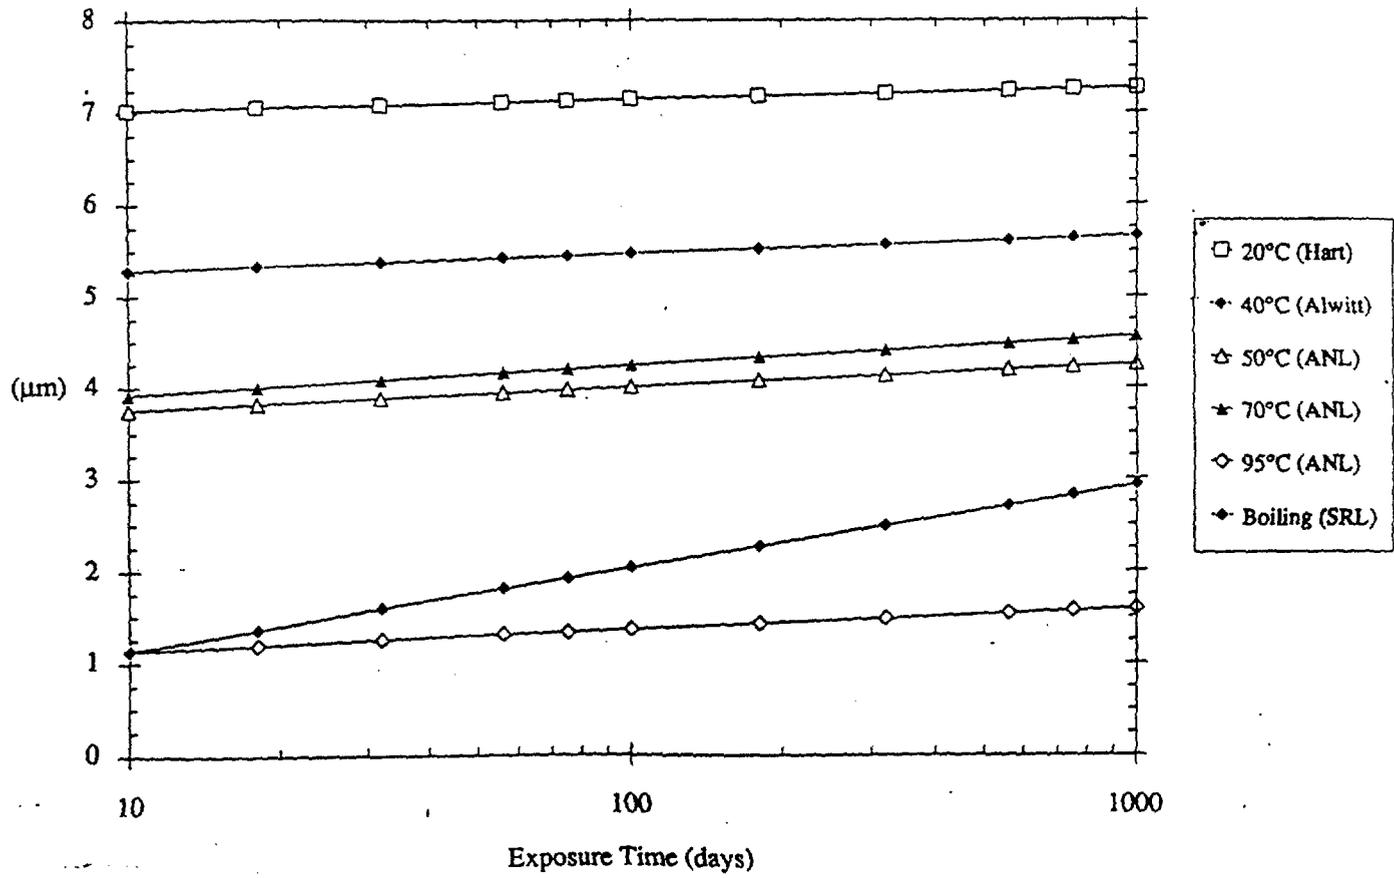
Figure 4. Aluminum Oxide Growth versus Time (From Reference 4)

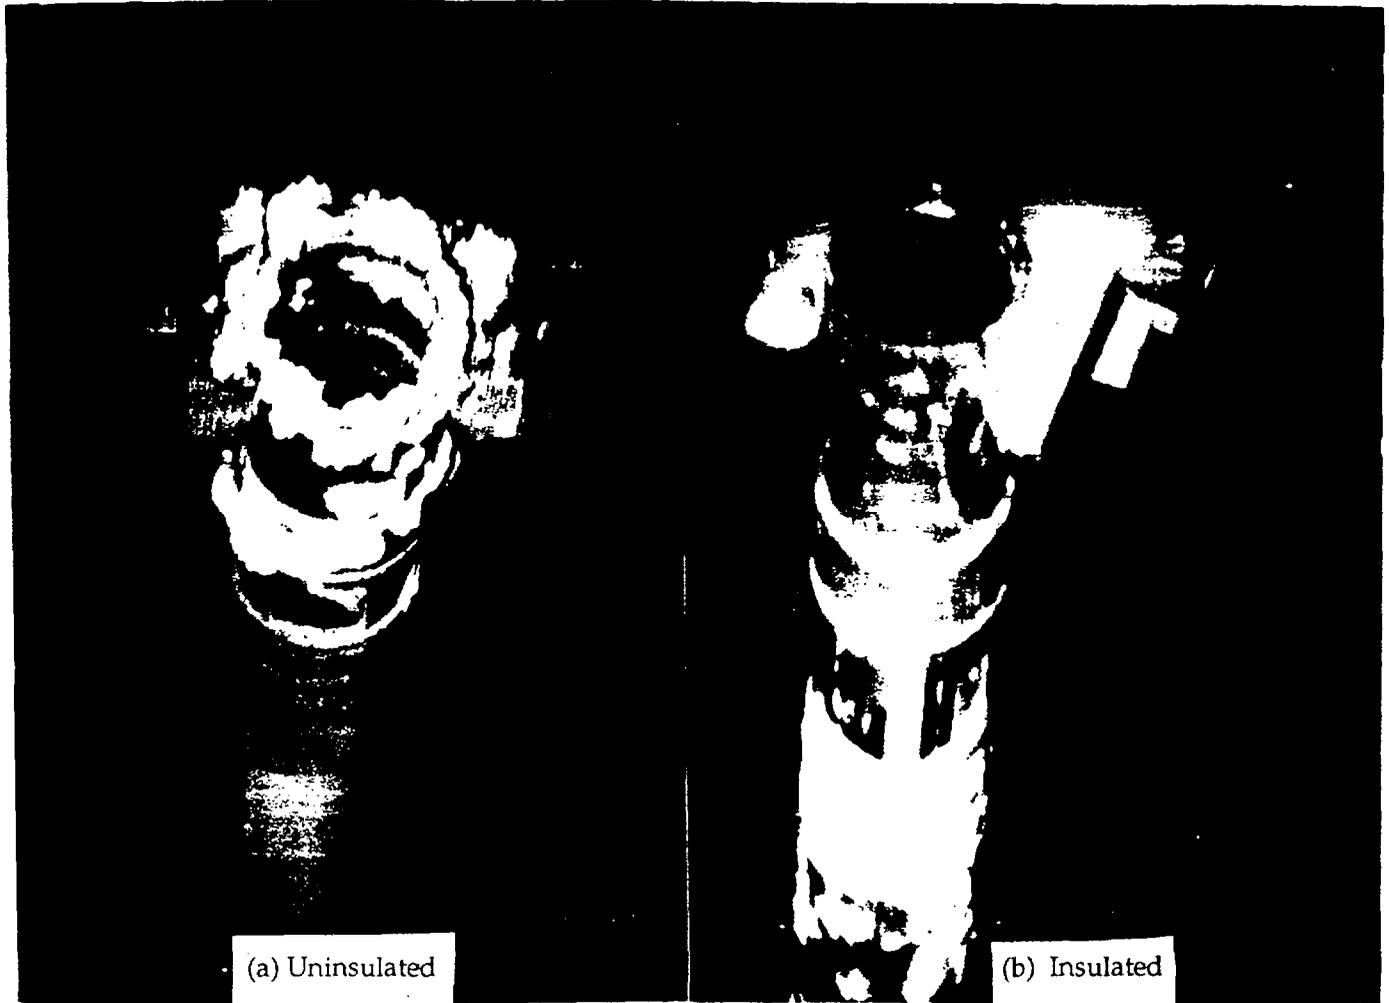
Figure 5. Aluminum/304L Galvanic Couple in the Basin

Galvanic corrosion occurs when a metal or alloy is electrically coupled to another metal, usually dissimilar, in the same electrolyte. In the case spent nuclear fuel storage, galvanic corrosion is evident throughout the basins. It is clearly visible, as shown in Figure 5, at SRS where the fuel hangers are 304 stainless steel and the fuel assembly is aluminum clad. Notice the aluminum oxide forming at the point of contact with the stainless steel

for the uninsulated case. When a polymeric insulation was placed at the contact point there was little oxide formed. There was, however, oxide formed on the fuel tube at a joint between two different aluminum alloys. The excessive oxide on this fuel tube is likely due to the absence of the high temperature, protective oxide coating which is present on the uninsulated irradiated fuel, but absent on the dummy, unirradiated assembly used for testing. The electrolyte, in this case, is the basin water and the conductivity of the water plays a key role in the flow of electrons and the corrosion of the metal.

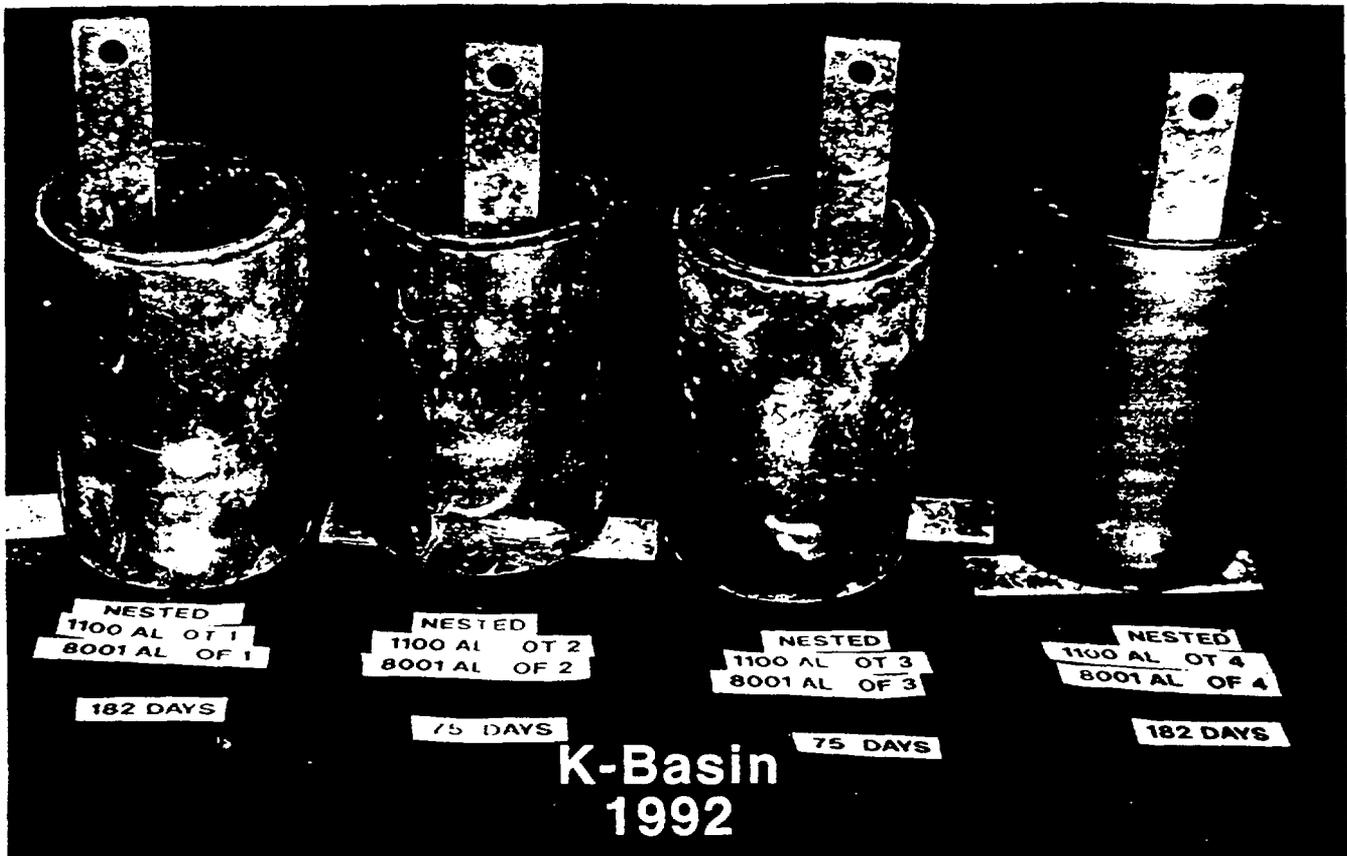
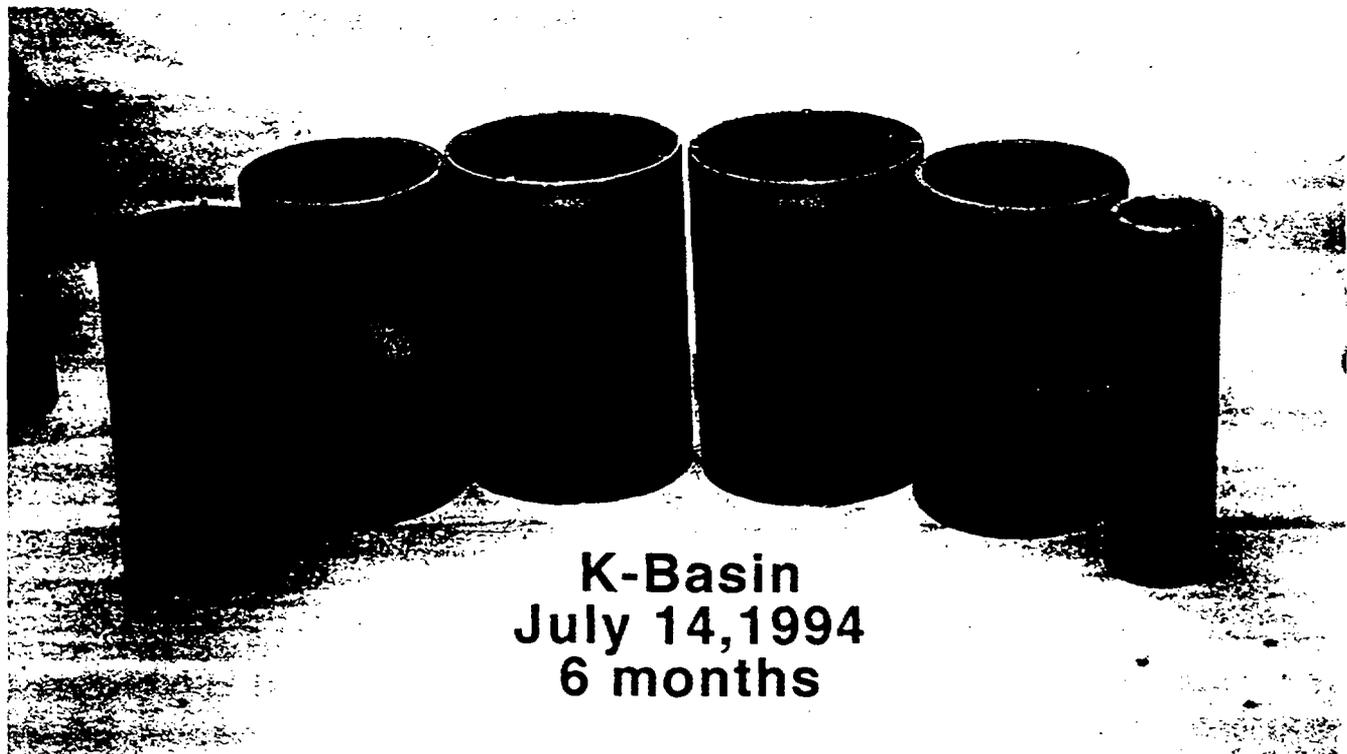
Figure 7. Comparison of K-Basin Corrosion 1992 versus 1994

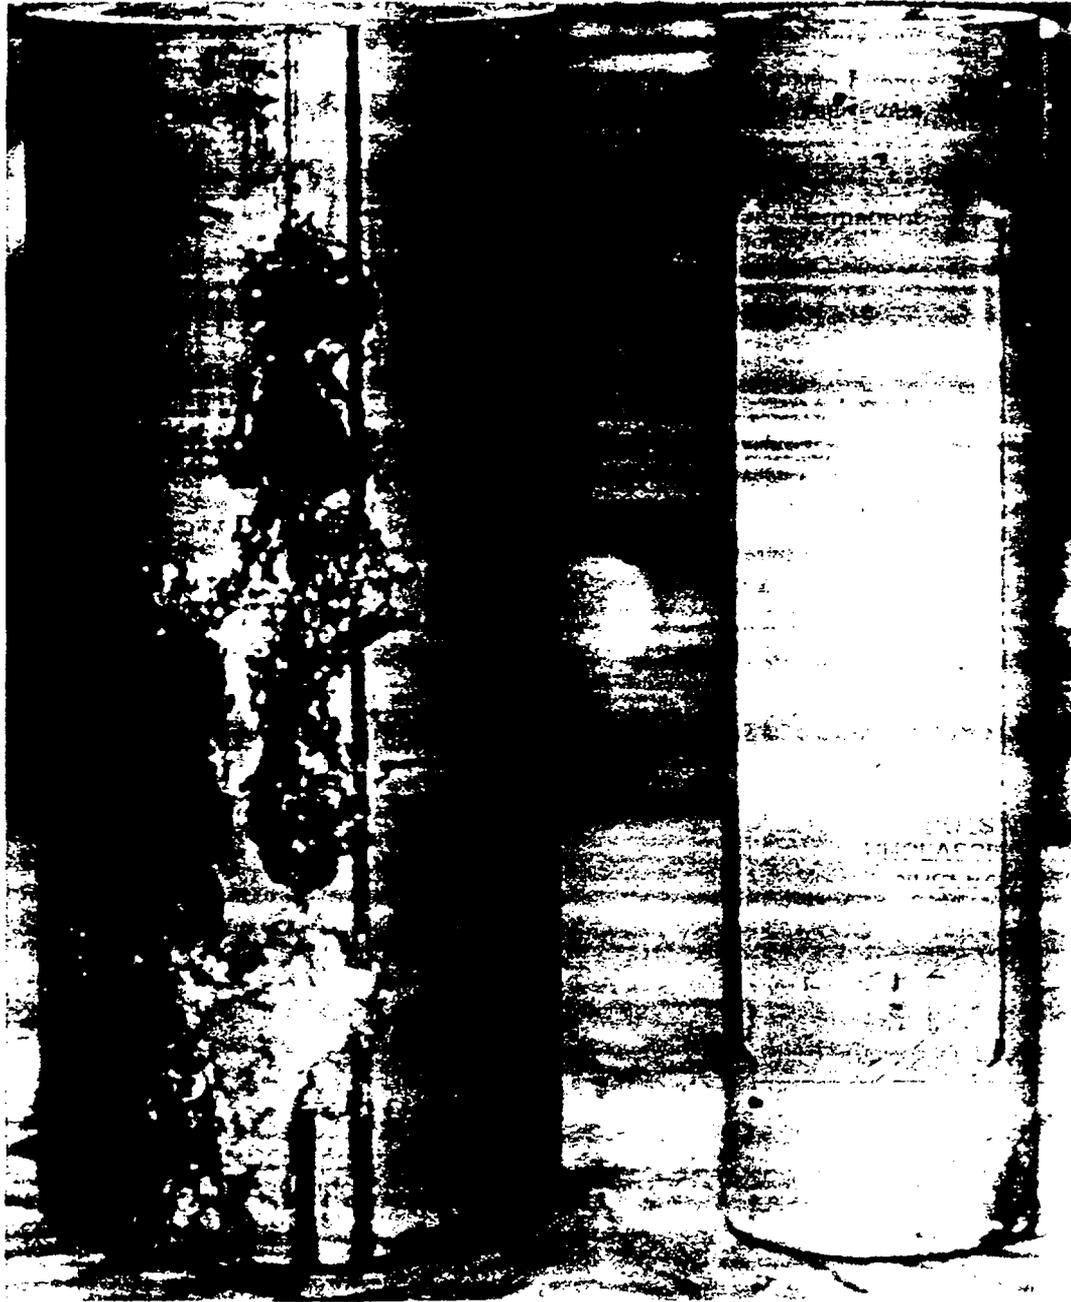
Figure 9. Mark 31A as Removed from L-Basin

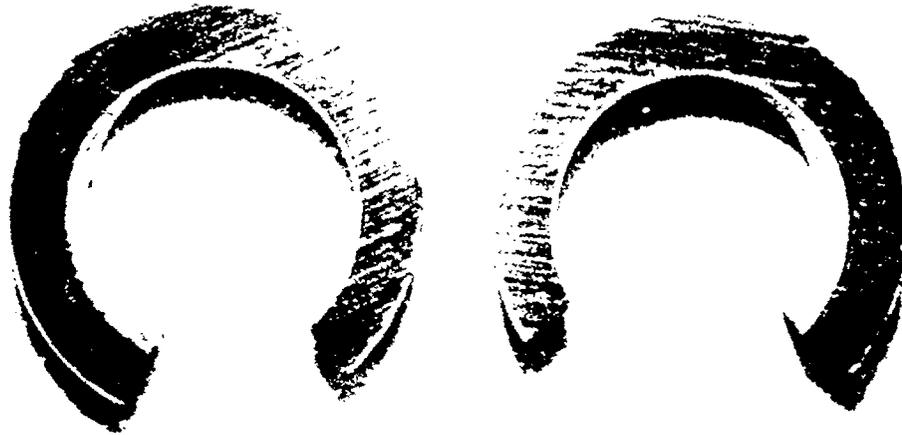
Figure 11. Cross Section of Outer Slug Showing Overall Integrity
