NUREG/CR-5448
EGG-2576

Aging Evaluation of Class 1E Batteries: Seismic Testing

**Idaho National Engineering Laboratory
EG&G Idaho, Inc.**

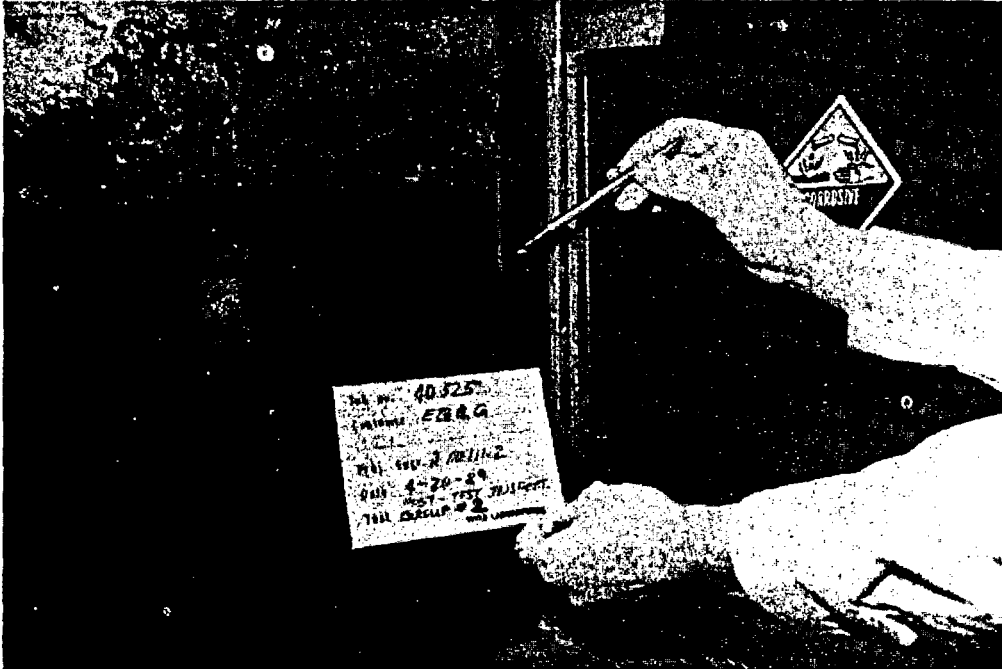
PHOTOGRAPH 7

POST-TEST SERIES 2 CONDITION
OF BATTERY #45

NOTE THE EXTENT OF THE ROD SCRAPING.

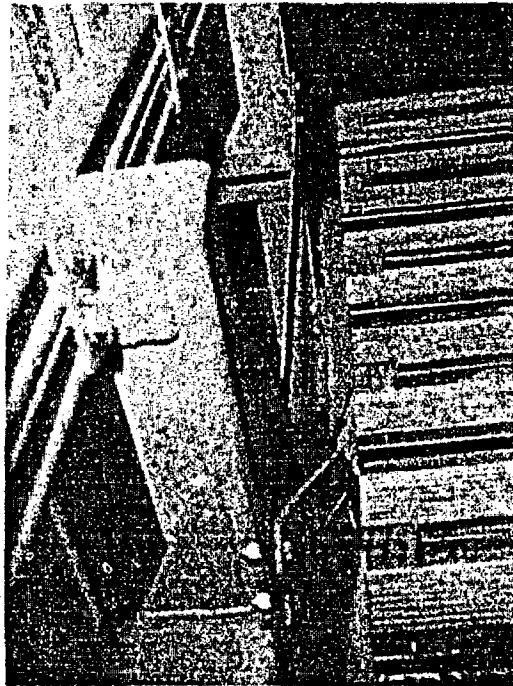
PHOTOGRAPH 13

POST-TEST RUN 7 CONDITION
OF THE BATTERY RACK CROSS BRACES
(FRONT SIDE)

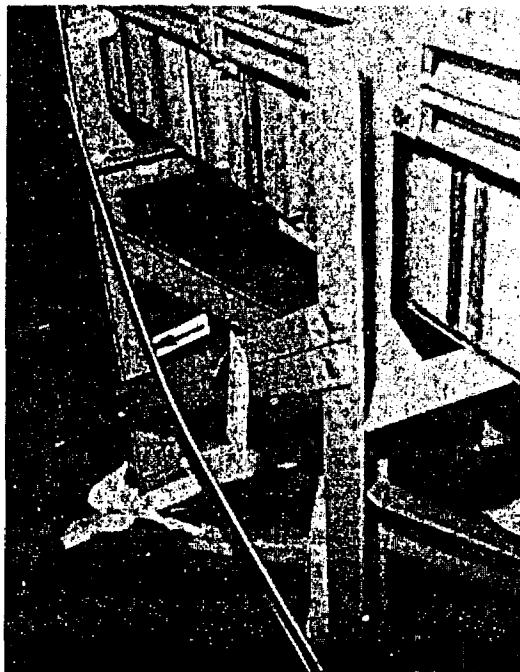
PHOTOGRAPH 15

POST-TEST RUN 7 CONDITION
OF BATTERY RACK CROSS BRACES
(REAR SIDE)

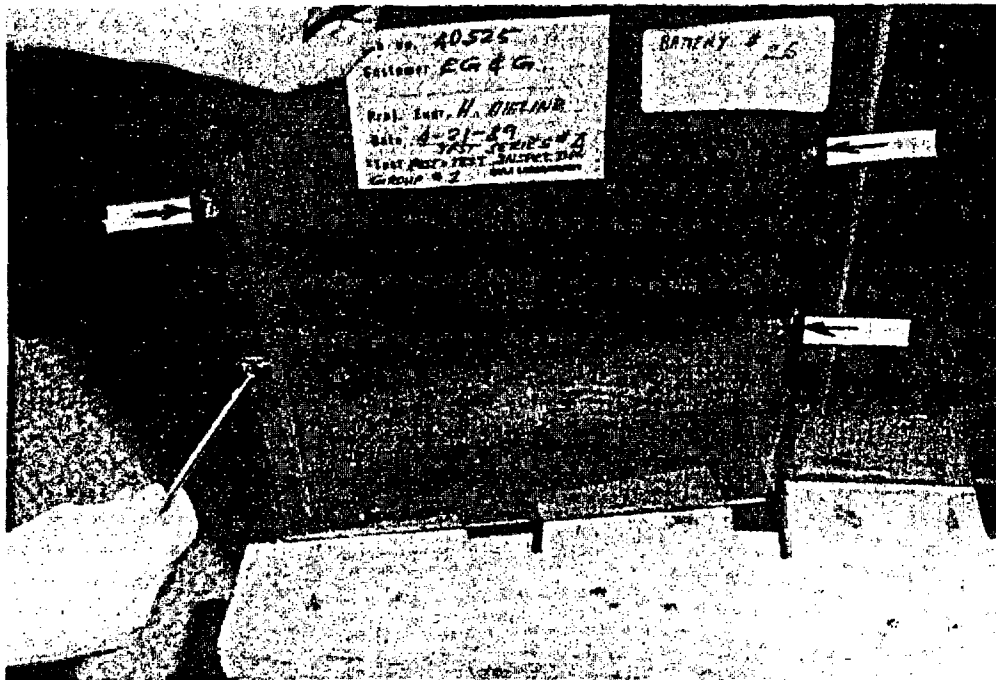
PHOTOGRAPH 21

POST-SERIES 4 CONDITION OF BATTERY #26
NOTE THE EXTENT OF TIE ROD SCRAPING.

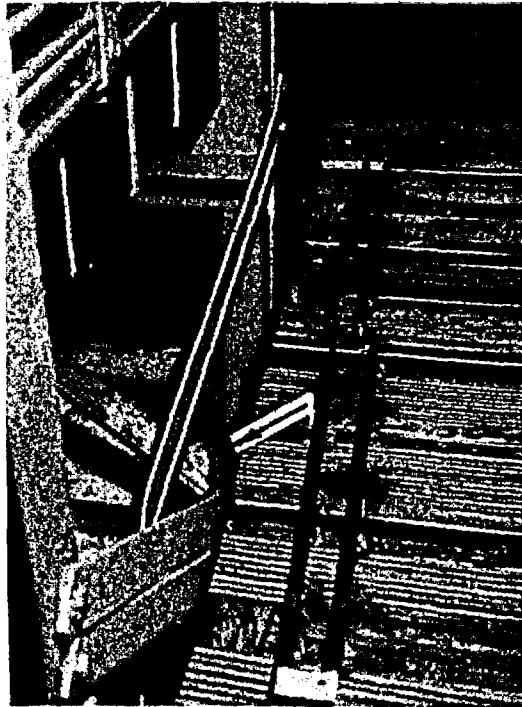
PHOTOGRAPH 23

POST-TEST SERIES 4 CONDITION
OF
BATTERY RACK ASSEMBLY

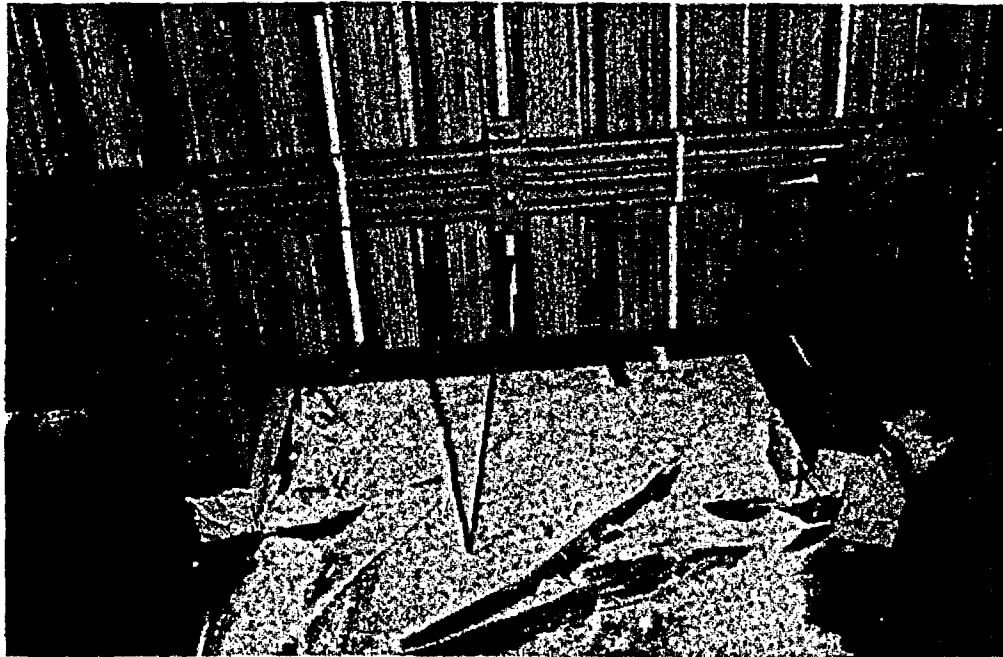
PHOTOGRAPH 24

POST-TEST SERIES 4 CONDITION
OF
BATTERY RACK ASSEMBLY
NOTE BROKEN TIE ROD
B-42

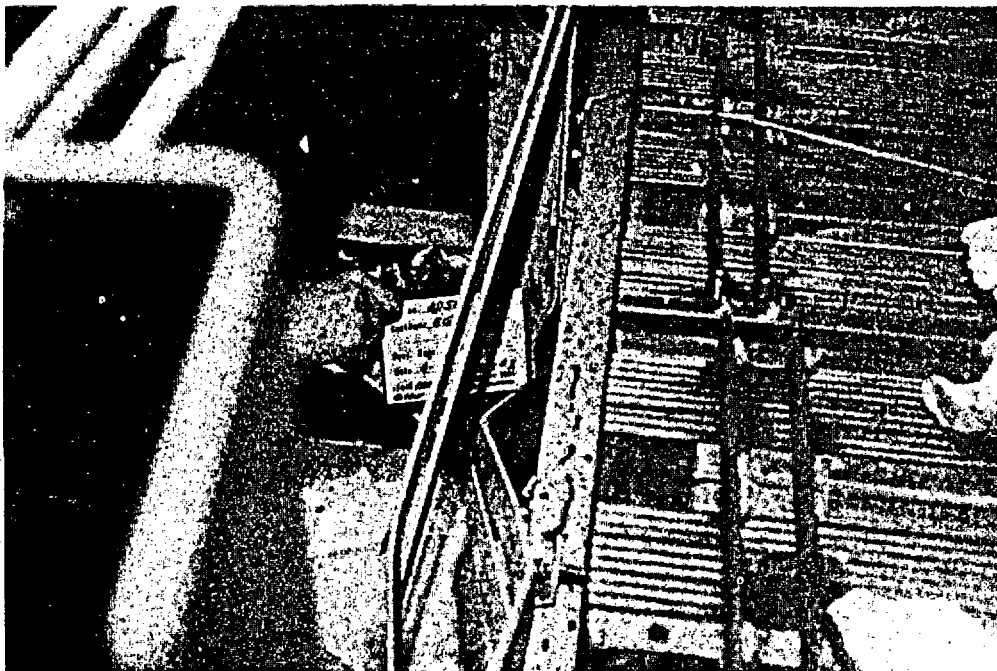
PHOTOGRAPH 26

POST-SERIES 4 CONDITION
OF
BATTERY RACK ASSEMBLY B-43

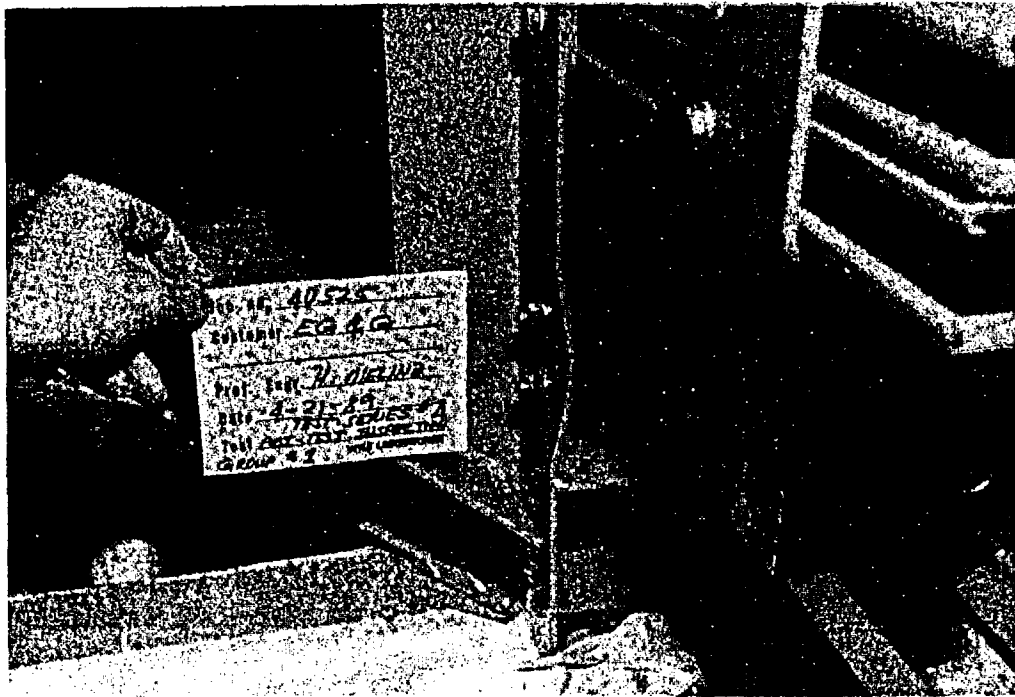
PHOTOGRAPH 27

POST-SERIES 4 CONDITION
OF
BATTERY RACK ASSEMBLY
