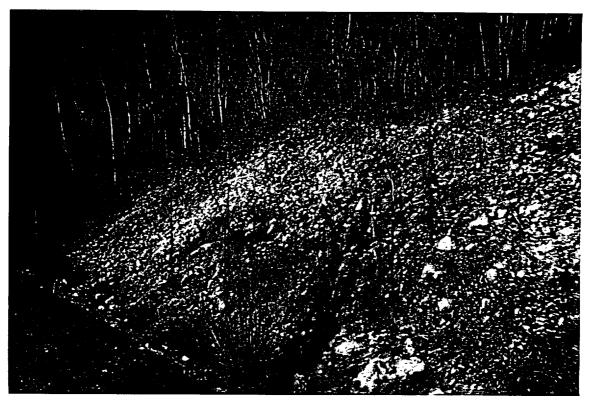
Photo 3. Area 4: View of southside of railroad right-of-way where some low level radioactive material in the form of colored glass and/or refracting brick used or produced by the Hazel-Atlas Glass of refractory was deposited on hillside.

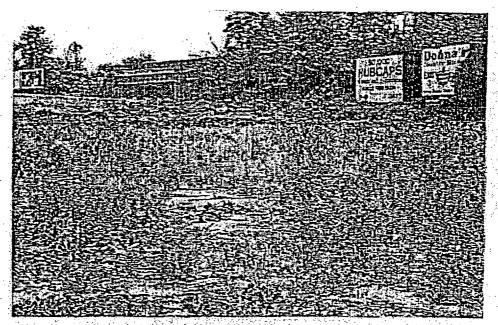
Photograph 4 (08-20-96) Wetland E is a wet meadow that has formed over the fill in the tar impoundment. Limited exposed areas of tar are visible in the foreground of this picture.
