## Hunters Point Shipyard

# FINAL HISTORICAL RADIOLOGICAL ASSESSMENT

History of the Use of General Radioactive Materials  
1939 – 2003

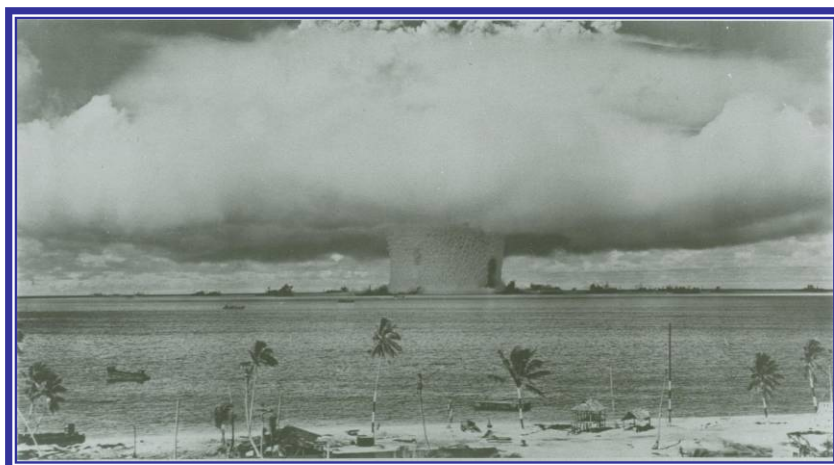
**Shot Baker Underwater Burst**

The Shot Baker underwater burst was far more damaging radiologically. A cable

suspended the bomb approximately 60 feet under a specially modified barge. This setup ensured that the weapon would detonate on target. While extensive damage was expected from the detonation, the severity of radiological effects was not anticipated.

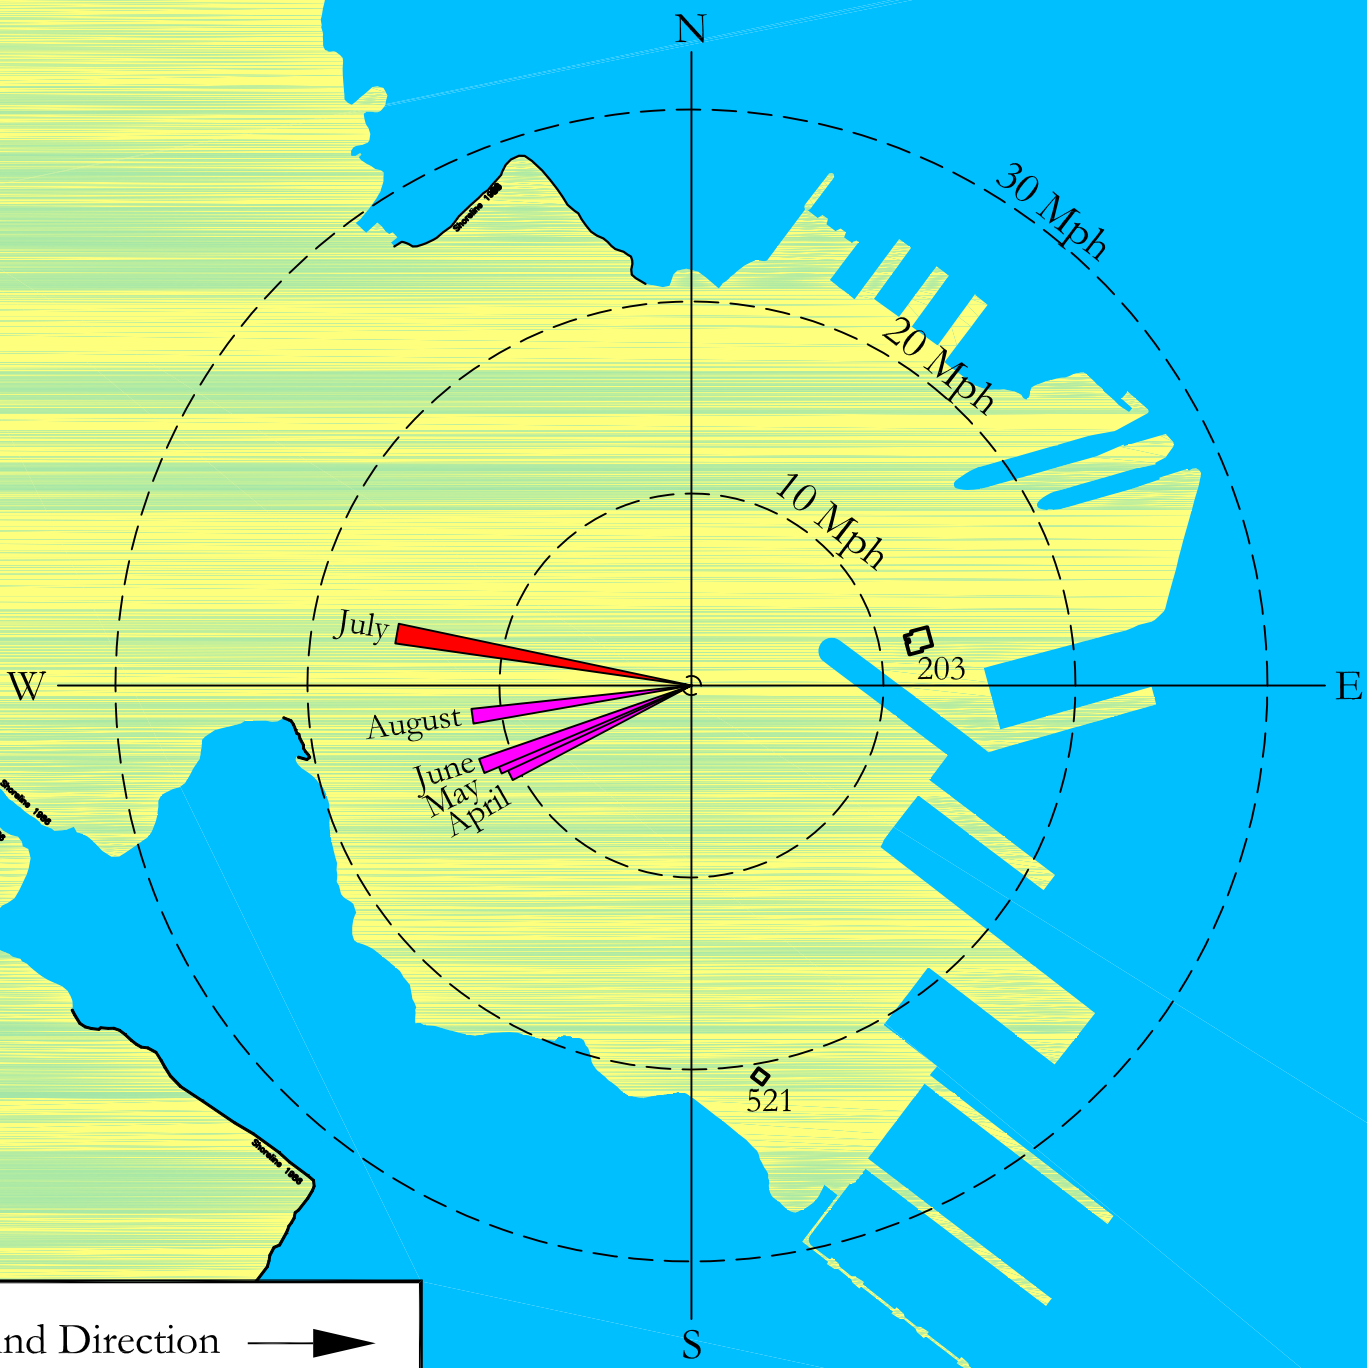
Figure 6.2.1  
 1947 Average Wind Conditions

Historical research based on the estimated dates of fuel burning determined that the wind direction was generally from San Francisco out over the Bay. Figure 6.2.1 depicts wind direction during the period the fuel was burned. Tables 6-3A through 6-3E provide details on the daily weather conditions in San Francisco in 1947.

Average Wind Direction based on data for Weather Station '023272' - San Francisco' 4.6 Miles Northwest of Shipyard supplied by The National Climatic Data Center (NCDC), Department of Commerce, National Oceanic and Atmospheric Administration (NOAA), National Environmental Satellite, Data and Information Service (NESDIS).

Wind Direction →

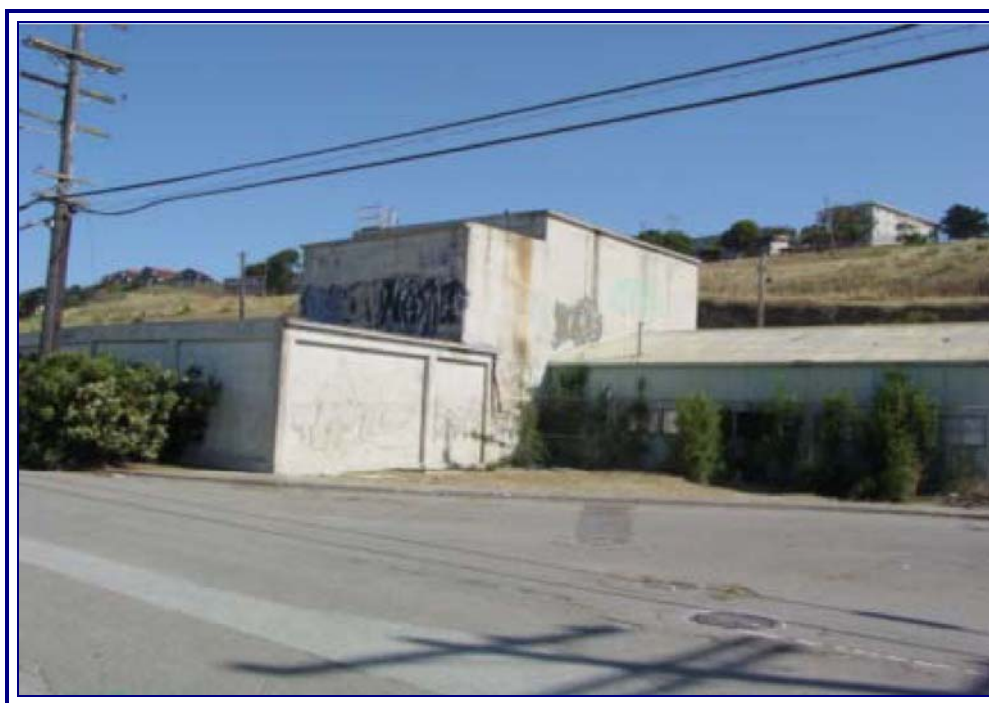
#### 8.3.1.1 Building 816

**Site Description:** Originally was a windowless, two-story concrete structure completed in December 1953 (HRA-1051, p 1 of 3). Building wing to the right in the photograph was added from 1956 to 1957 and houses the neutron pit. The upper floor housed the Van de Graaff accelerator and its associated mechanical/electrical equipment. The ground floor was devoted to a laboratory, machine shop, and control room (HRA-2113, p 7). One of the unique features of the building is a 4-foot-thick, 30-ton door at the south end. A steel addition was constructed to perform low intensity proton experiments (HRA-177). Figure 8.3.1.1 provides a site plan, and Figure 8.3.1.1FP provides a floor plan of the building in 1954.

**Former Uses:** Two-Megaelectron volt (MeV) Van de Graaff Neutron Generator, chemical-biological laboratory, offices, and machine shop (HRA-2113, p 7).

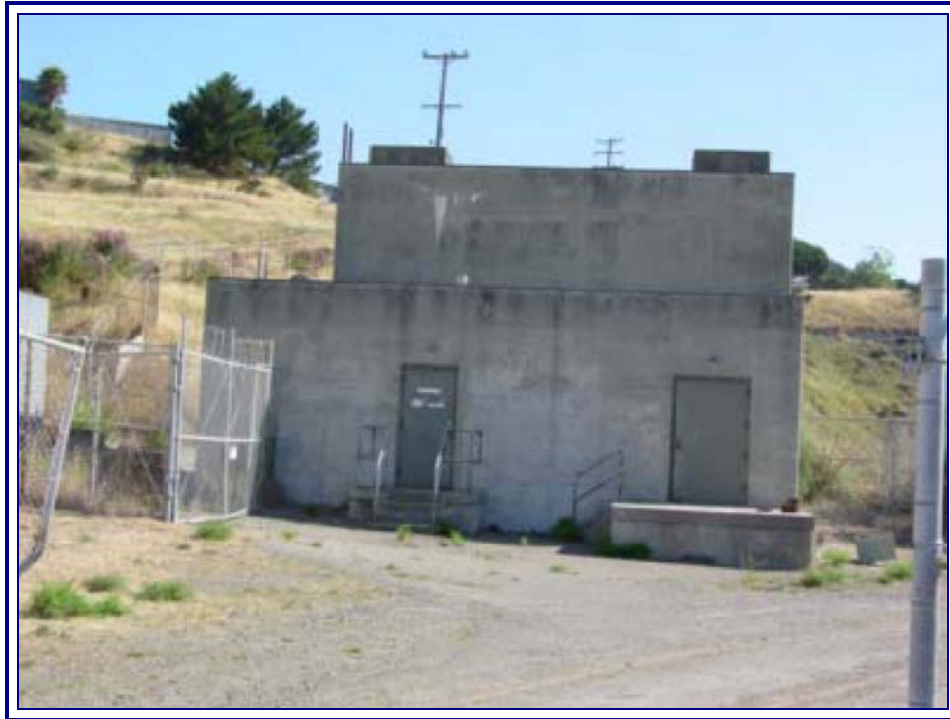
### 8.3.1.2 *Building 821*

**Site Description:** A two-story concrete laboratory building, used for the study of animal irradiation through electro-magnetic means (non-radionuclide generated). An electrical power substation is located outside of the western side of the building. [Figure 8.3.1.2](#) provides a site plan.

**Former Uses:** One-MeV X-ray generator ([HRA-2772, p 20](#)) and X-ray laboratory.

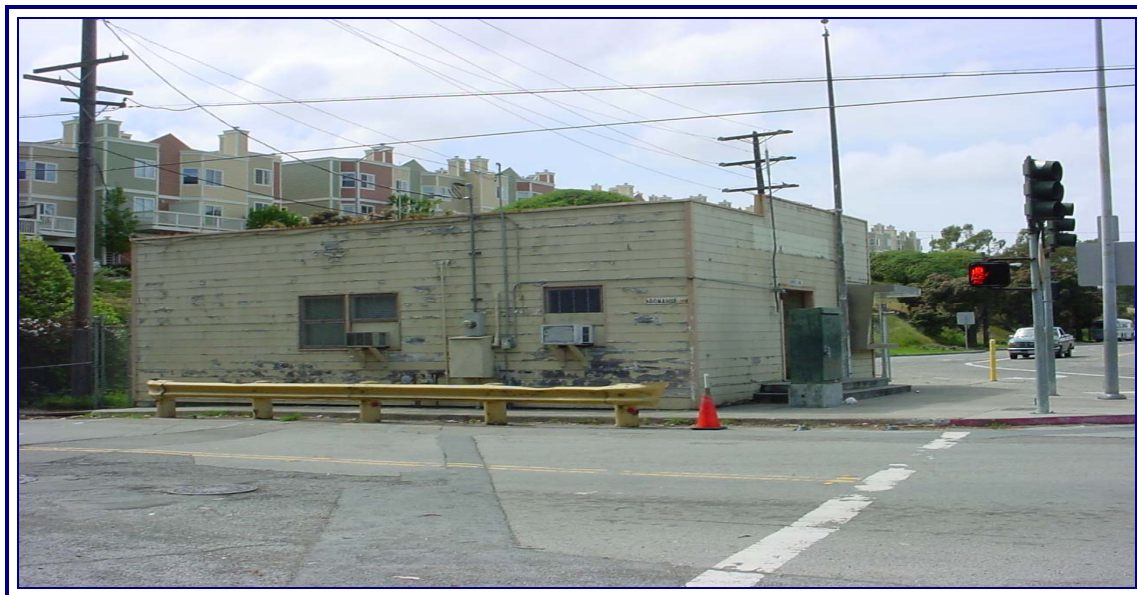
### 8.3.1.3 Building 322 Site

**Building Description:** The former Building 322 was of WW II era administration building design, built from standardized Bureau of Yards and Docks plans ([HRA-1118, p 22](#)). A site plan is provided in [Figure 8.3.1.2](#) above.

**Former Uses:** NRDL Office ([HRA-1327 Encl 1, p 1](#)), NRDL Instruments Branch offices prior to 1959 ([HRA-2928, p 5](#)), moved to Parcel A for use as the North Gate Pass Office in 1959 following clearance surveys by NRDL ([HRA-333, p 16](#); [HRA-4705](#)). No further NRDL use while located in Parcel A. Information on the former site in Parcel D can be found in [Section 8.3.4.5](#).

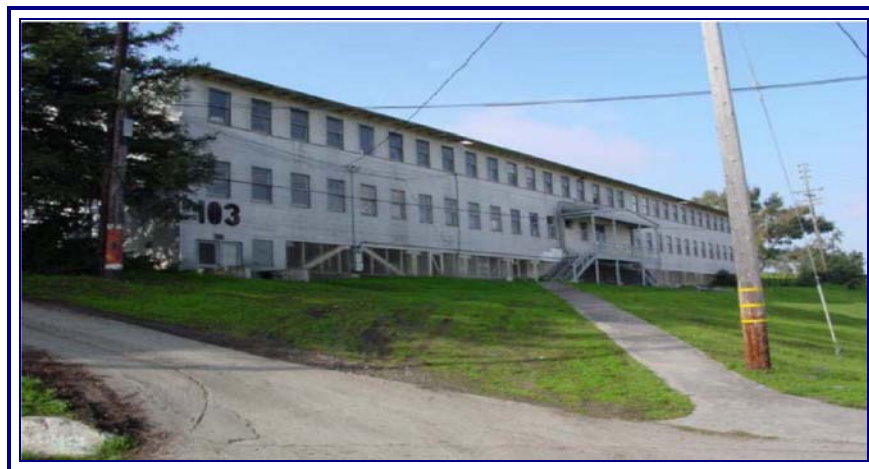
### 8.3.2.1 *Building 103*

**Site Description:** Built as a standard WW II wooden barracks, Building 103 is a long, narrow rectangular building topped by a shallow gabled roof with narrow eaves. It sits alongside a pair of similar buildings at the base of the hill ([HRA-1118, p 58](#)). A site plan is provided in [Figure 8.3.2.1](#).

**Former Uses:** Submarine barracks, 1951 ([HRA-2963](#)); decontamination center for OPERATION CROSSROADS personnel ([HRA-1483](#)).

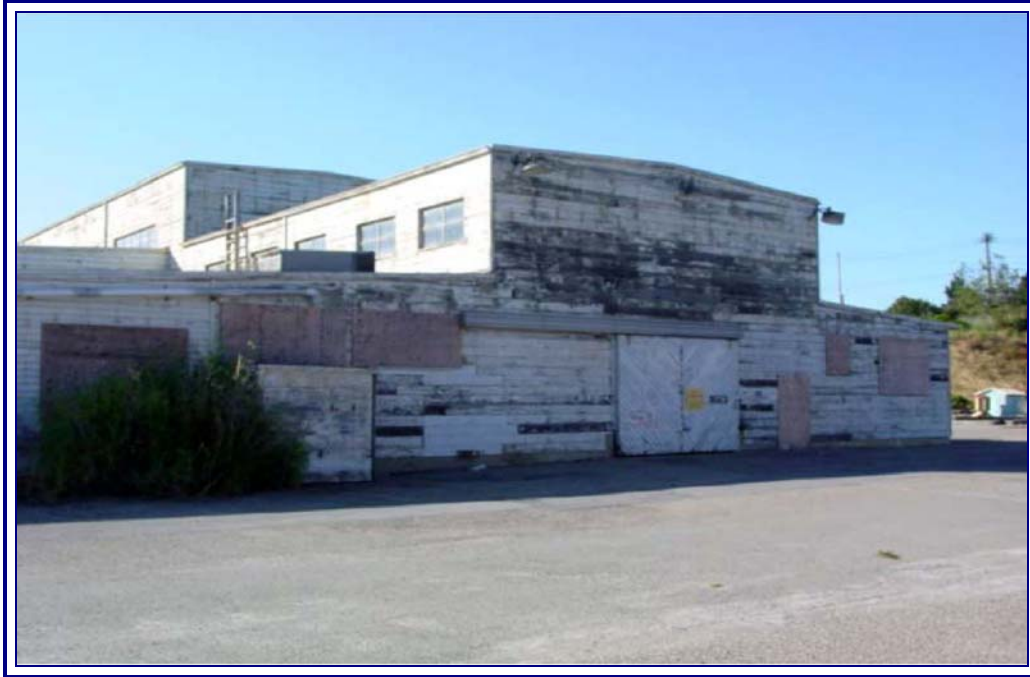
### 8.3.2.2 *Building 113*

**Site Description:** Building 113 is a rambling three-story wood-framed shop located in the ex-submarine repair area. It is sided in horizontal boards and has a shallow gabled roof. The building has a central three-story element, a T-shaped two-story element, and a rectangular first story. A site plan is provided in [Figure 8.3.2.2](#), and a floor plan is provided in [Figure 8.3.2.2FP](#).

**Former Uses:** Tug maintenance, salvage diver facility, torpedo storage and overhaul (1951-1964), and sample storage from atomic weapons tests ([HRA-2705 Encl A](#)).

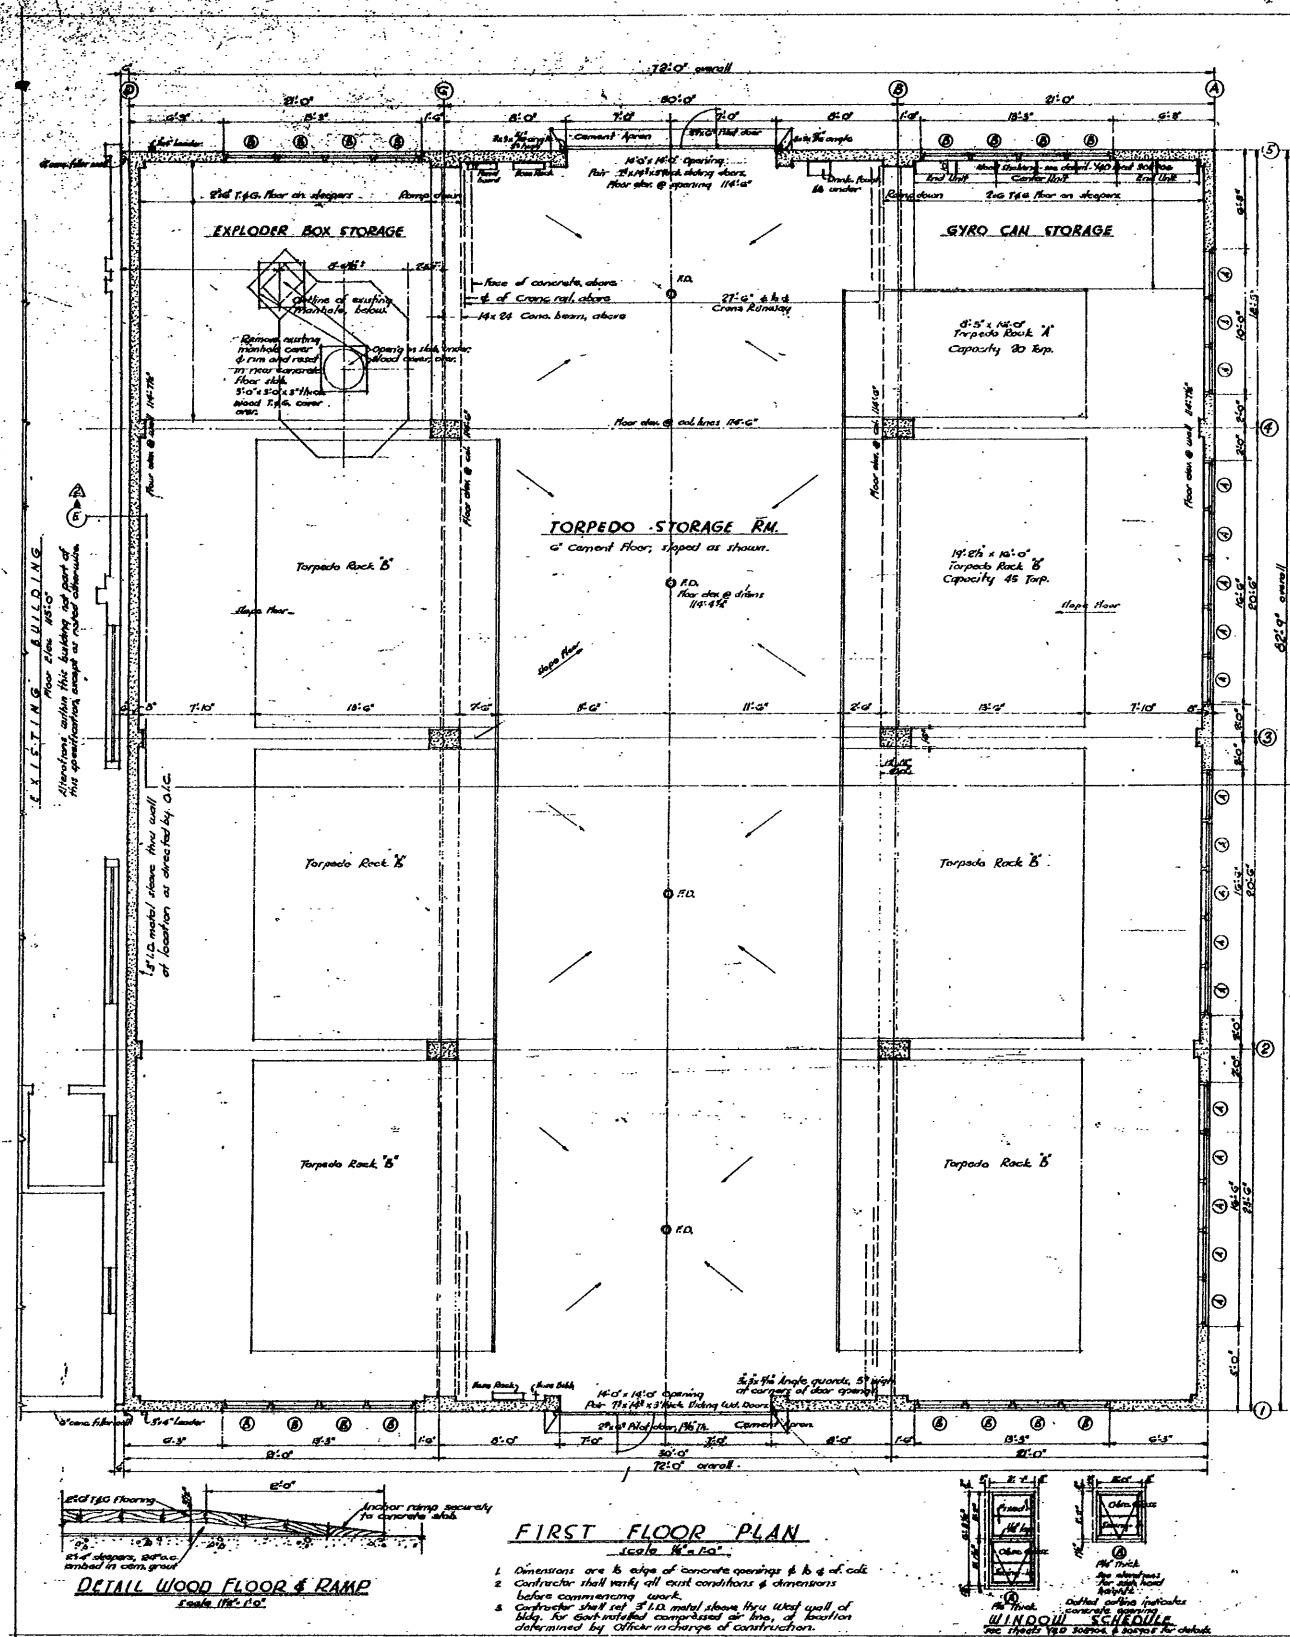
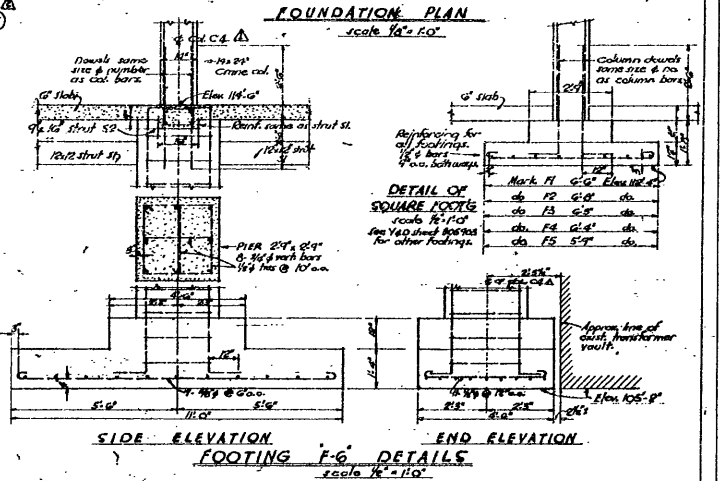
Figure 8.3.2.2 FP  
 Building 113 - Floor Plan

CHECKED BY: <i>SLB</i> CHECKED ON: <i>11-13-03</i> DRAWN BY: <i>SLB</i> MECH. ENGINEER: <i>SLB</i> ELECTRICAL ENGINEER: <i>SLB</i> PROJECT MANAGER: <i>WJW</i>	BLANCHARD, MAHER & WARD ARCHITECTS 309 WINE ST. - SAN FRANCISCO, CALIFORNIA U.S. NAVAL DRYDOCKS HUNTERS POINT SAN FRANCISCO, CALIFORNIA ANCHORS OF NAVAL YARD BARGE BUILDING TORPEDO STORAGE BUILDING FOUNDATION & FLOOR PLANS
PROJECT NO. 14050 SHEET 2 OF 10 SPECIFICATION NO. 14050	APPROVED: <i>TJW</i> 11/13/03 T. J. & S. D. PHILIP, INC. 16074-31 305901

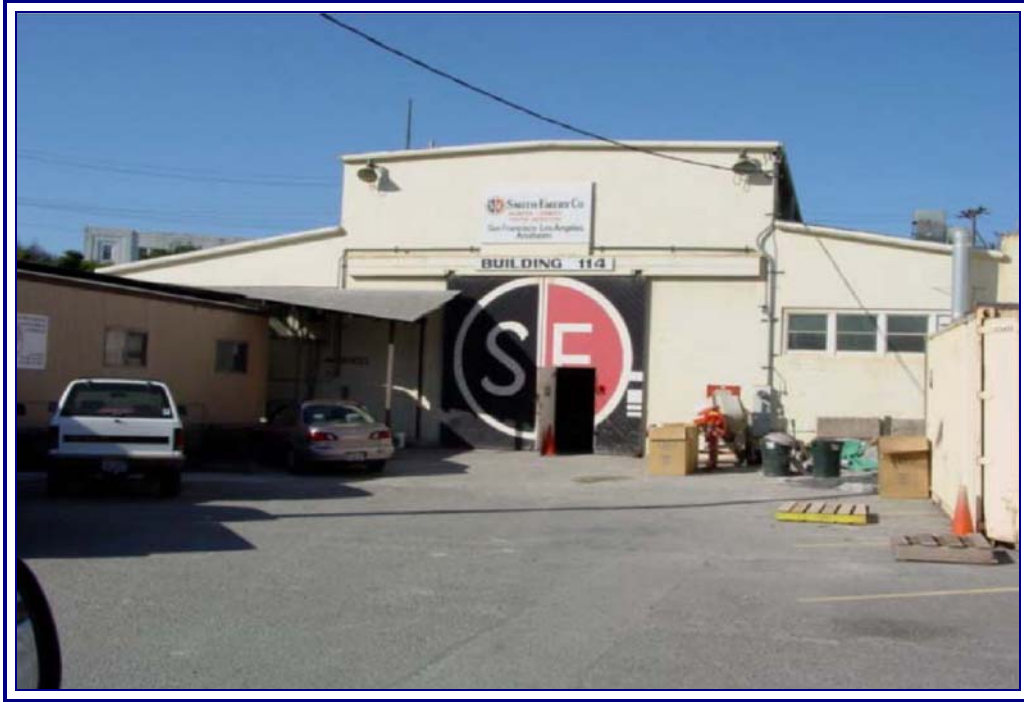
### 8.3.2.3 Building 113A

**Site Description:** Building 113A is a 25-by-25-foot concrete storage vault enclosed by a corrugated, metal-sided, shallow gabled roofed structure that is immediately adjacent to Building 113 (HRA-2798). The building is currently labeled as Building 114, although this is historically incorrect. Figure 8.3.2.2 above provides a site plan of Building 113A, and a floor plan is provided in Figure 8.3.2.3FP.

**Former Uses:** Torpedo storage building, Non-Destructive Test Facility (Radiography) (HRA-1472 Supplement 1), Machine and Maintenance Shop, Shipyard Analytical Laboratory, Radioactive Material Storage Building, Radiographer's Vault, and radioactive waste storage facility. The building was also used to store sheet lead removed from Building 364 (HRA-600, p 2).

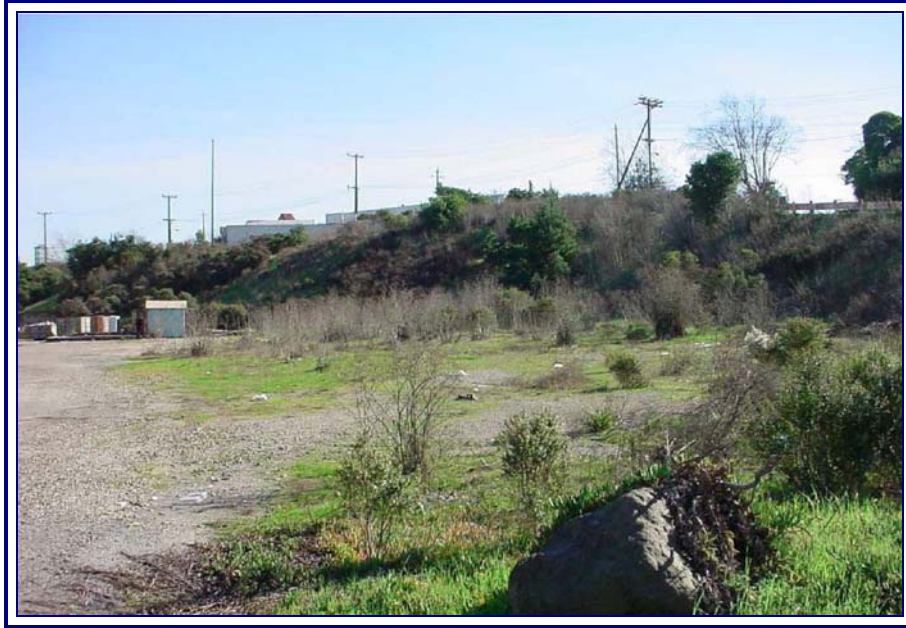
#### 8.3.2.4 *Building 114 Site*

**Site Description:** Building has been demolished, and actual building descriptions are not available. It has been incorrectly identified as Building 113A in other documents. A site plan is provided in [Figure 8.3.2.2](#) above.

**Former Uses:** NRDL Design Branch and Technical Library – 1951 ([HRA-2963](#)).

**Recommended Actions:** Scoping Survey.

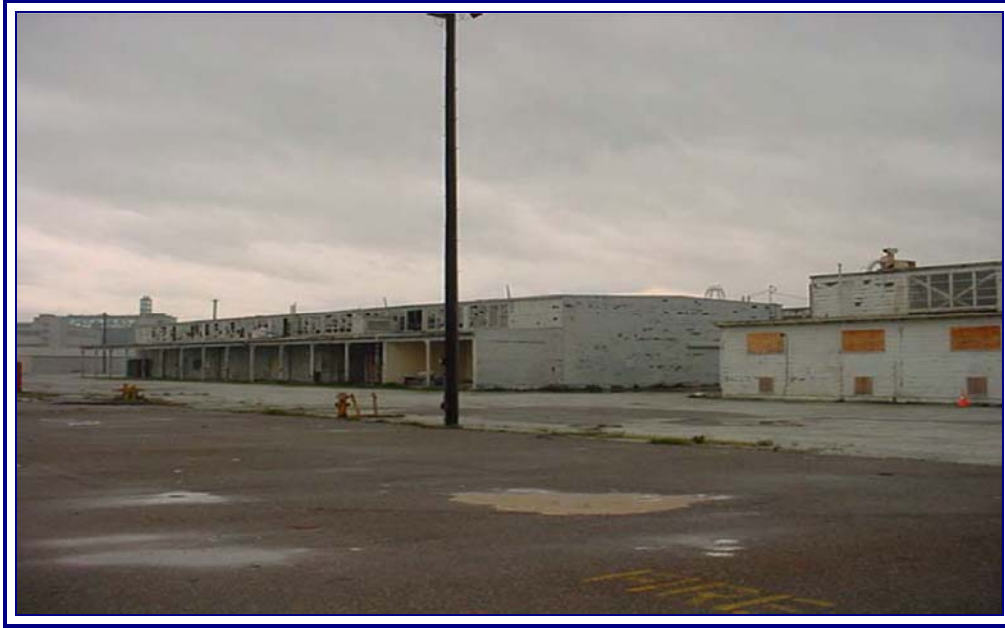
### 8.3.2.5 *Building 130*

**Site Description:** Building 130 is a wood-framed shop building located in the former submarine repair area. Built in 1944, the building differs from other shops in that it includes open sheds on both sides and an almost flat, shallow gabled roof. The building also includes wooden sliding industrial doors at either end. A site plan of Building 130 is provided in [Figure 8.3.2.5](#).

**Former Uses:** Occupied by Protective Finishes Company (1994), PRC used the building as a LLRW storage area (Ra-226 and IDW in 1994) ([HRA-1118, p 58](#)), Shop Service (1968 to 1973), pipe fitter shop, general shops, ship repair shop, machine shop, and metal working shop.

2002 NWT Phase V investigation. Elevated readings noted and attributed to naturally occurring radionuclides. Survey complete.

**Recommended Actions:** Review Final Status Survey Report.

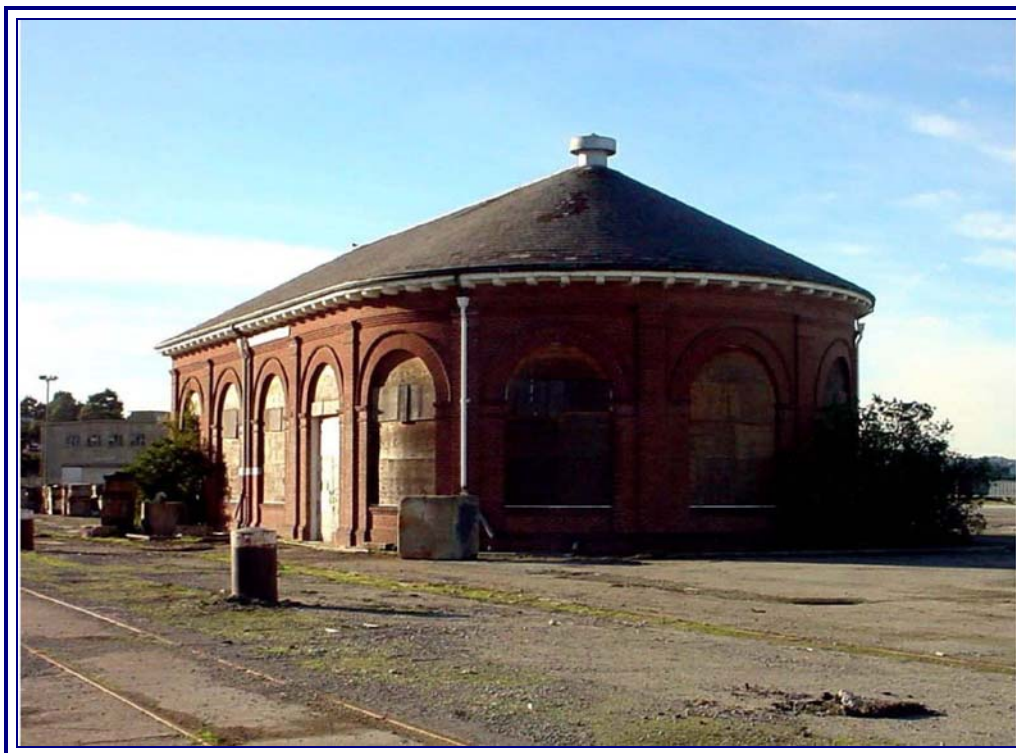
### 8.3.2.6 *Building 140 and Discharge Channel*

**Site Description:** Building A is a one-story brick building shaped as a rectangle with a rounded eastern end resembling an apse. The building measures about 96 by 56 feet and is located north of Drydock 3, about midway along the drydock ([HRA-1117, p 133](#)). A channel for water from Drydock 3 passes in a straight line north from the drydock through the pumphouse to the Bay ([HRA-4689](#)). A site plan of Building 140 is provided in [Figure 8.3.2.6](#).

**Former Uses:** Drydock Pumphouse No. 3 and discharge channel ([HRA-1117, p 133](#)).

**Recommended Actions:** Scoping Survey of structure, equipment, and discharge channel. Characterization and remediation if contamination is found. Final Status Survey.

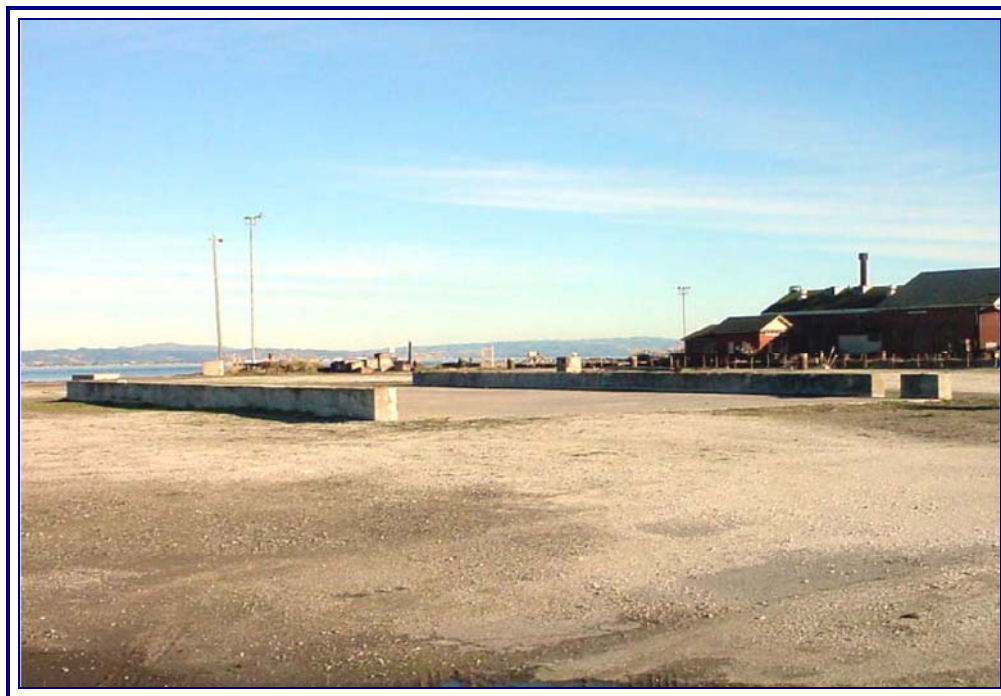
### 8.3.2.7 *Building 142*

**Site Description:** Building 142 is a partially demolished concrete air raid shelter thought to be similar to Building 224. It is unclear from historical references whether this structure was above or below ground ([HRA-2963](#)). A site plan is provided in [Figure 8.3.2.6](#) above.

**Former Uses:** Air Raid Shelter A ([HRA-2963](#)), weapons test high-level sample storage, and low background sample counting room ([HRA-405](#)).

**Recommended Actions:** Scoping Survey. Characterization Survey and remediation if contamination is found. Final Status Survey.

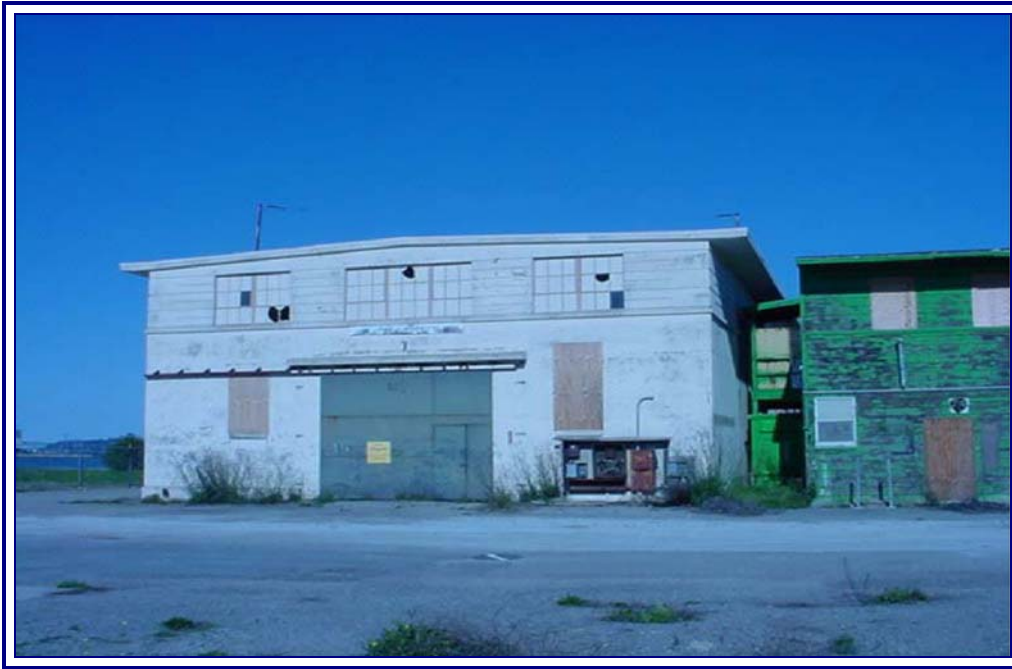
### 8.3.2.8 *Building 146*

**Site Description:** Building 146 is a wood-framed, shallow gabled roofed shop with windows throughout that was built in 1945. The building is two storied, sided in stucco on the first story and asbestos shingles on the second. Large sliding wooden doors provide access to the building. A site plan is provided in [Figure 8.3.2.8](#), and a floor plan is provided in [Figure 8.3.2.8FP](#).

**Former Uses:** Industrial and Photo Laboratory (1951-1964), General Shops, Radioactive Waste Storage Area, and Radioluminescent Device Turn-In Building ([HRA-2811, p 2](#); [HRA-2829](#)).

**Recommended Actions:** Characterization Survey. Remediation if contamination is found. Final Status Survey.

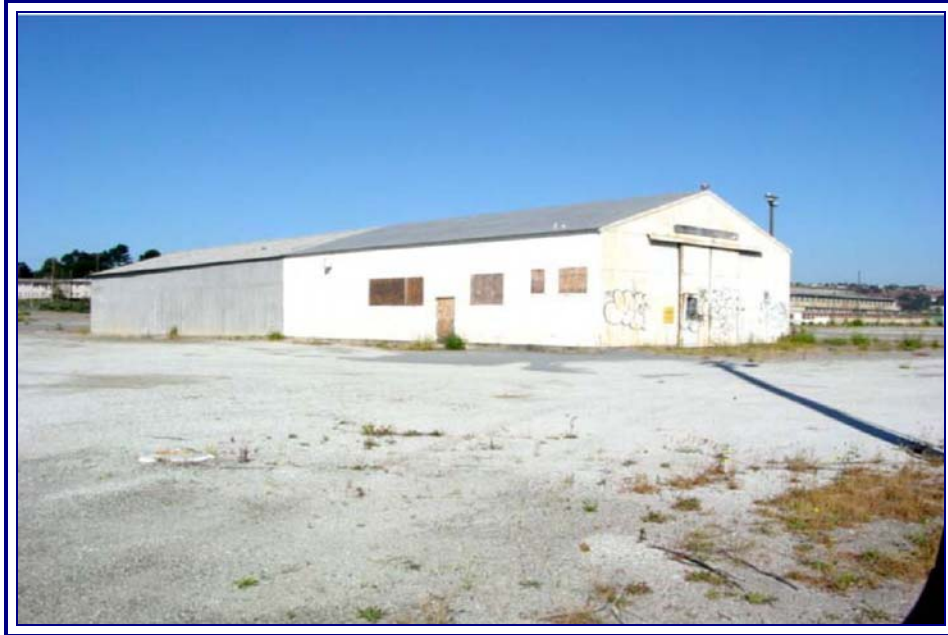
8.3.2.9 *Building 157*

**Site Description:** Building 157 is a corrugated metal, wood-framed structure approximately 40 feet by 140 feet in size. Specific historical descriptions of the building were not found. A site plan is provided in [Figure 8.3.2.9](#).

**Former Uses:** Shipyard Industrial Laboratory, non-destructive testing, Sound Laboratory, Metals Testing Center (Radiography), and Metal Shop ([HRA-547](#)).

**Recommended Actions:** Scoping Survey. Characterization and remediation if contamination is found. Final Status Survey.

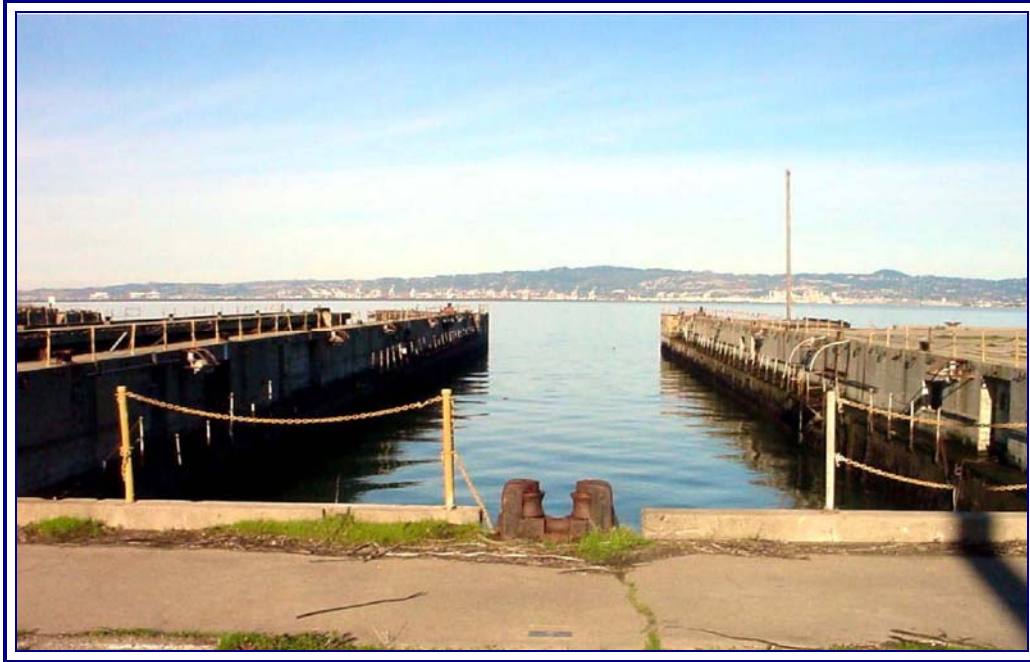
### 8.3.2.10 Drydock 5

**Site Description:** Built in 1944, the chief function of Drydock 5 was submarine repair, but it was also capable of housing destroyers and other relatively small vessels. The drydock is 420 feet by 60 feet, with a gate that is hinged at the bottom that flaps down to allow the vessel to enter. The drydock was dewatered by four 20,000-gallons per minute (gpm) pumps. Two pumps were located at each side of the Bay end of the dock (HRA-4683). A drydock site plan is provided in [Figure 8.3.2.10](#).

**Former Uses:** Decontamination of ships from OPERATION CROSSROADS and Ship Repair (Submarines).

**Recommended Actions:** Scoping Survey of structure and pumping equipment.  
Characterization and remediation if contamination is found. Final Status Survey.

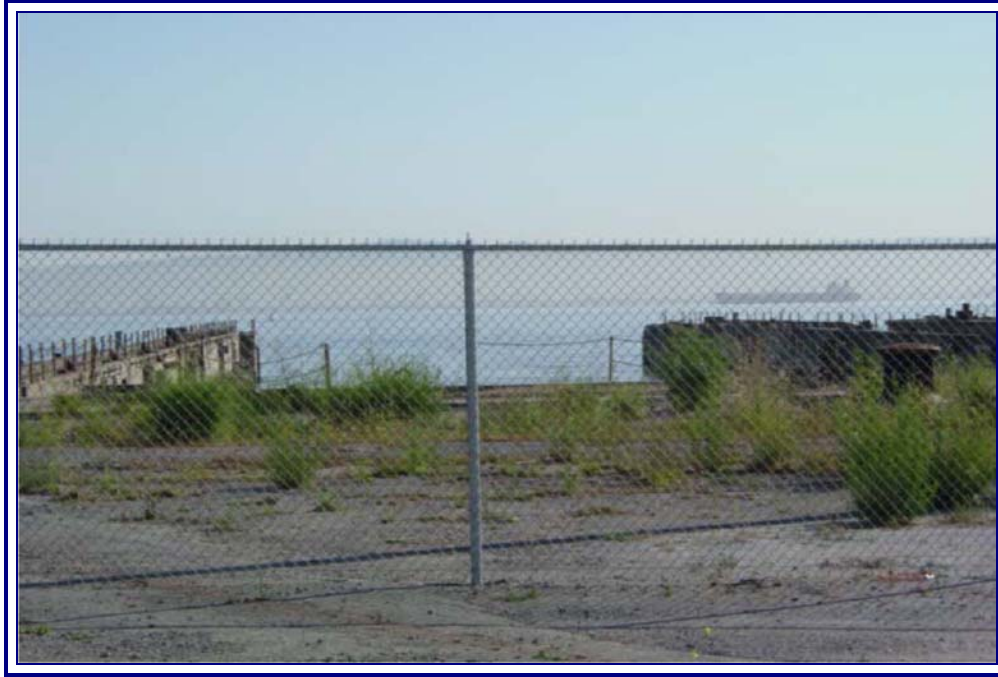
### 8.3.2.11 Drydock 6

**Site Description:** Drydock 6 was built in 1944 for submarine repair, but was also capable of housing destroyers and other relatively small vessels. The drydock is 420 feet by 75 feet, with a gate that is hinged at the bottom that flaps down to allow the vessel to enter. The drydock was dewatered by four 20,000-gpm pumps. Two pumps were located at each side of the Bay end of the dock ([HRA-4683](#)). A drydock site plan of is provided in [Figure 8.3.2.10](#) above.

**Former Uses:** Decontamination Drydock for OPERATION CROSSROADS and Ship Repair (Submarines).

**Recommended Actions:** Review Final Status Survey Report.

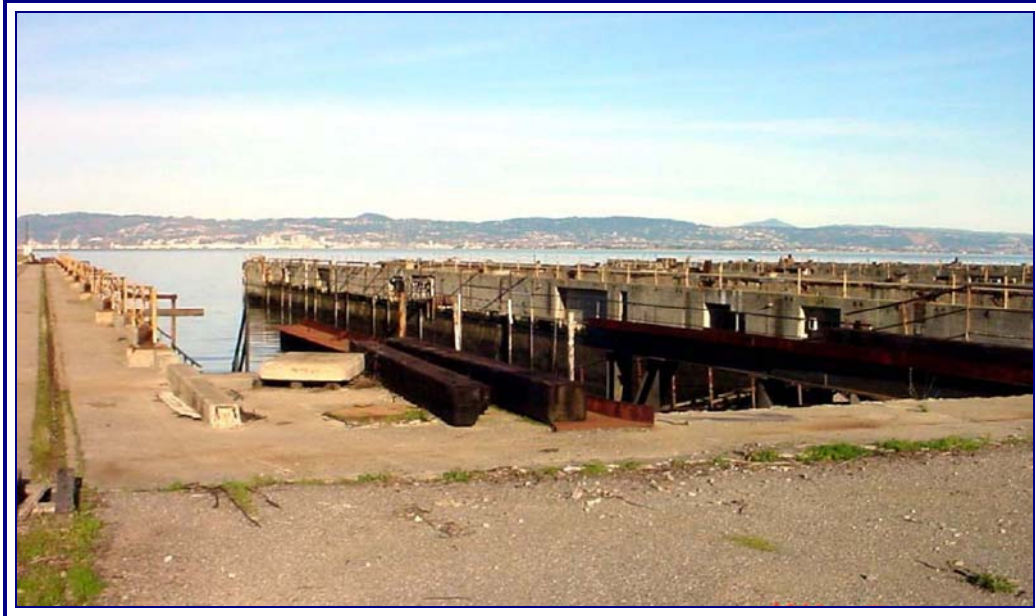
8.3.2.12 *Drydock 7*

**Site Description:** Drydock 7 was built in 1944 for submarine repair, but was also capable of housing destroyers and other relatively small vessels. The drydock is 420 feet by 60 feet, with a gate that is hinged at the bottom that flaps down to allow the vessel to enter. The drydock was dewatered by four 20,000-gpm pumps. Two pumps were located at each side of the Bay end of the dock ([HRA-4683](#)). A drydock site plan is provided in [Figure 8.3.2.10](#) above.

**Former Uses:** Possible Decontamination Drydock for OPERATION CROSSROADS and Ship Repair (Submarines).

**Recommended Actions:** Scoping Survey of structure and pumping equipment.  
Characterization and remediation if contamination is found. Final Status Survey.

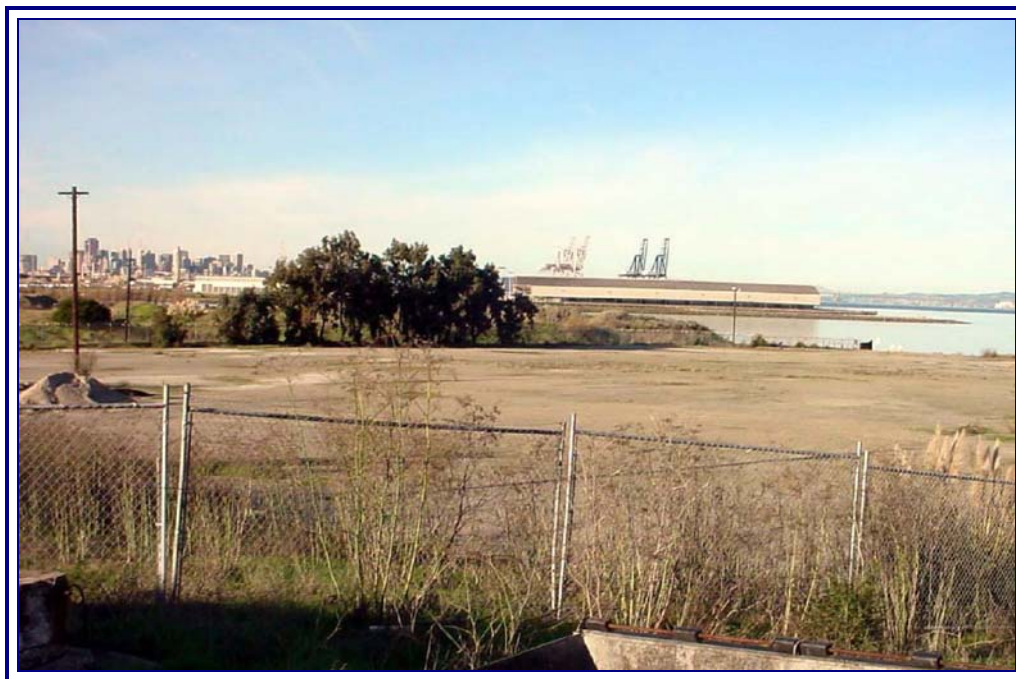
8.3.2.13 IR-07

**Site Description:** IR-07 is a former disposal area located northeast of Building 916 and on a line 25 feet below Donahue Street. IR-07 is approximately 700 feet by 700 feet in size. A site plan is provided in [Figure 8.3.2.13](#).

**Former Uses:** Flat land area built by the Navy used to support conventional (non-nuclear) submarine maintenance. Potential disposal of waste from decontamination of ships from OPERATION CROSSROADS.

- 1999 IT Corporation sandblast media samples. No activity exceeding background levels.
- 1994 EPA soil samples. No detectable activity above background
- 1993 PRC, Phase II Radiological Investigation. No readings exceeding background.
- 1992 Phase I SCRS. General area gamma anomalies were noted in sandy soils, soil samples indicated Ra-226 and daughters and other naturally occurring radionuclides.
- 1988 HLA - conducted survey; results indicated background levels.

**Recommended Actions:** Scoping Survey. Characterization and remediation if contamination is found. Final Status Survey.

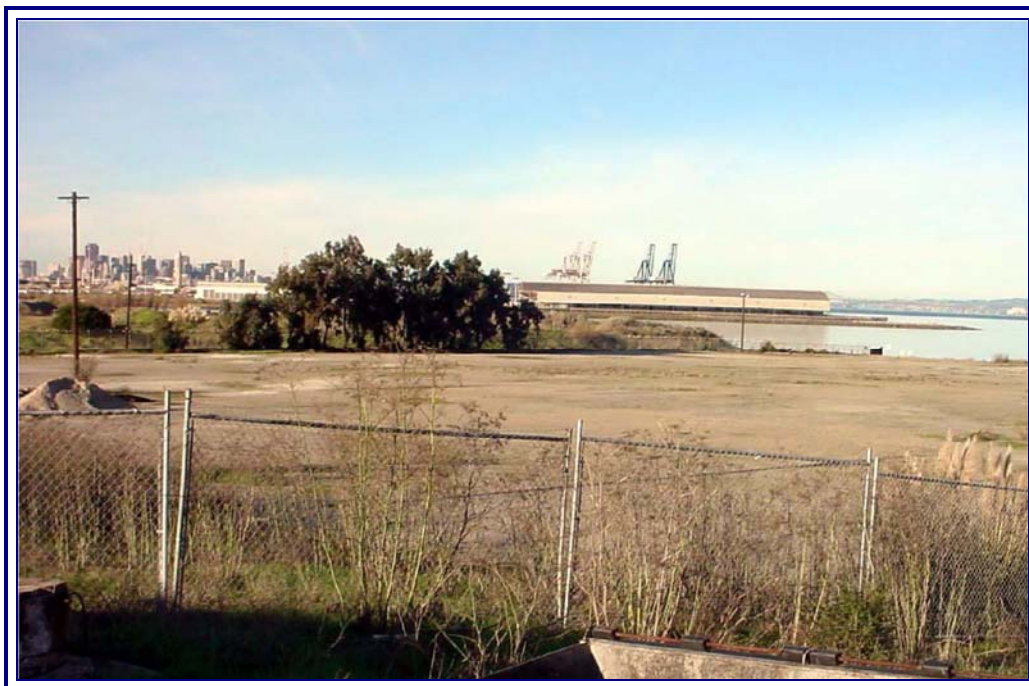
### 8.3.2.14 IR-18

**Site Description:** IR-18 is a former fill area approximately one-third of which is located northeast of Building 916 and on a line 25 feet below Donahue Street. IR-18 is approximately 500 feet by 500 feet in size. A site plan is provided in [Figure 8.3.2.13](#) above.

**Former Uses:** Flat land area built by the Navy. Waste oil disposal area ([HRA-2991](#)), potentially used for disposal of OPERATION CROSSROADS decontamination materials, and recreational vehicle camping/parking.

- 1994 EPA soil samples. No detectable activity above background. EPA attributed activity to naturally occurring granitic materials.
- 1992 Phase I SCRS. General area gamma anomalies were noted in sandy soils; soil samples indicated Ra-226 and daughters and other naturally occurring radionuclides.
- 1992 PRC radon flux testing – No levels exceeding background levels.

**Recommended Actions:** Scoping Survey. Characterization and remediation if contamination is found. Final Status Survey.

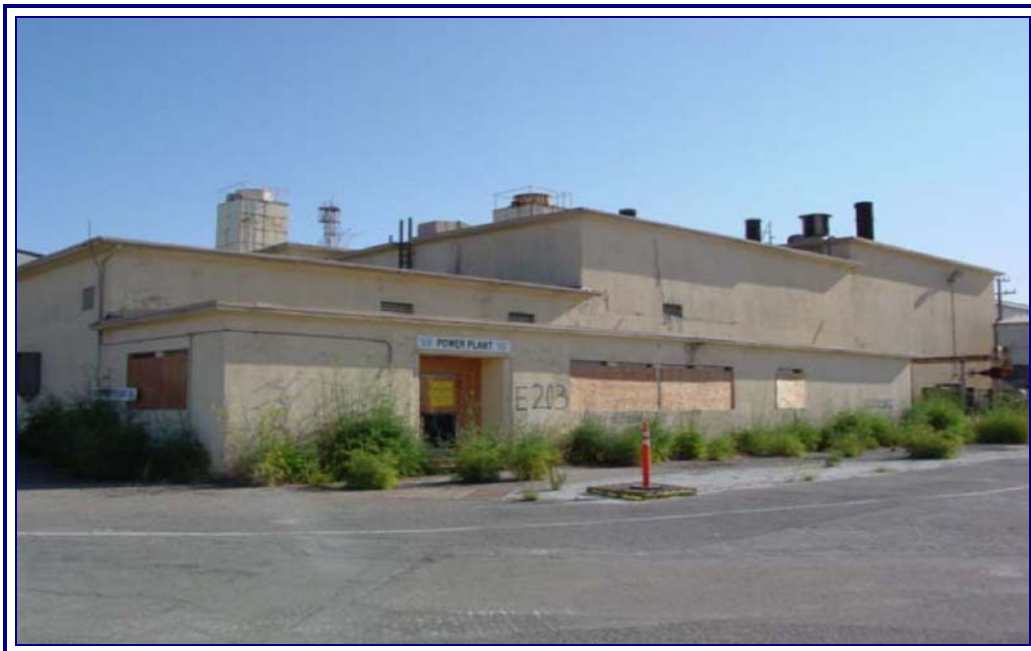
#### 8.3.3.1 Building 203

**Site Description:** Building 203 is a large reinforced concrete building housing a power plant (HRA-2963). Constructed in 1943 and extended in 1945, the building measures 152 feet by 137 feet (HRA-1118, p 58). The building is also referred to as Substation H (HRA-4667). It has a flat reinforced concrete roof with a slight overhang. The building includes a major addition that is sided in corrugated metal, likely the 1945 extension. A building site plan is provided in Figure 8.3.3.1, and a floor plan is provided in Figure 8.3.3.1FP.

**Former Uses:** Power Plant (HRA-1118, p 58; HRA-2963; HRA-4667). This is one of two sites suspected of burning of fuel oil from three OPERATION CROSSROADS target ships.

**Recommended Actions:** Scoping Survey. Characterization and remediation if contamination is found. Final Status Survey.

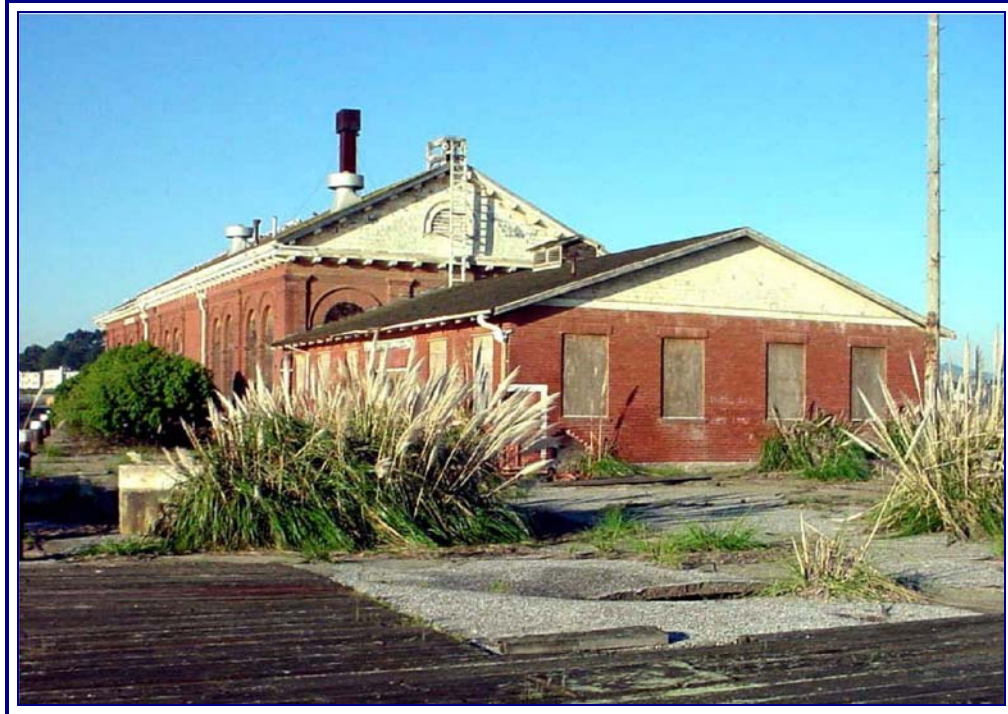
### 8.3.3.2 *Building 205 and Discharge Channel*

**Site Description:** Building 205 is a single-story L-shaped brick building, measuring 211 by 61 feet. Two WW II era additions were made to the rear of the original building. The building houses the pumping machinery for Drydock 2 ([HRA-1119, p 54](#); [HRA-4667](#)). A discharge tunnel connects the building to the drydock. There is also a channel connecting the building to Drydock 3 ([HRA-4686](#)). A site plan is provided in [Figure 8.3.3.2](#).

**Former Uses:** Pumphouse for Drydock 2.

**Recommended Actions:** Scoping Survey. Characterization and remediation if contamination is found. Final Status Survey.

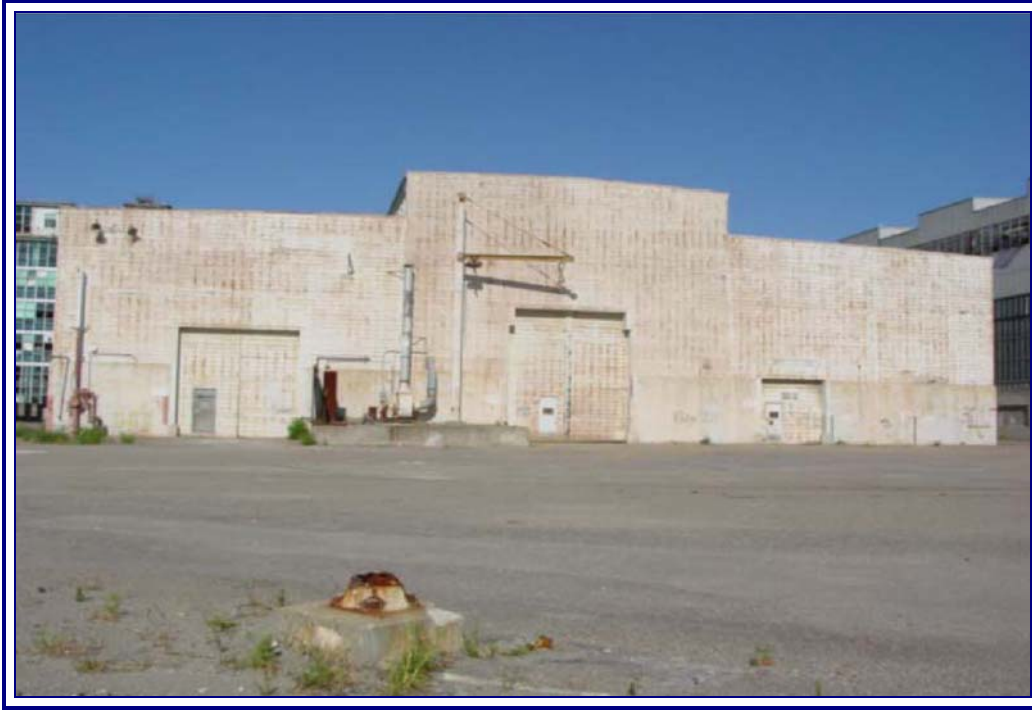
### 8.3.3.3 *Building 211*

**Site Description:** Building 211 is a three-story concrete-framed, curtain-walled building that was built in 1942 (HRA-1118, p 92). It is a large warehouse-type building, with a large gantry for craning materials to the upper stories. Building 211 is attached to Building 253 (HRA-1118, p 94). A building site plan is provided in Figure 8.3.3.2 above.
