## Hunters Point Shipyard

# FINAL HISTORICAL RADIOLOGICAL ASSESSMENT

History of the Use of General Radioactive Materials  
1939 – 2003

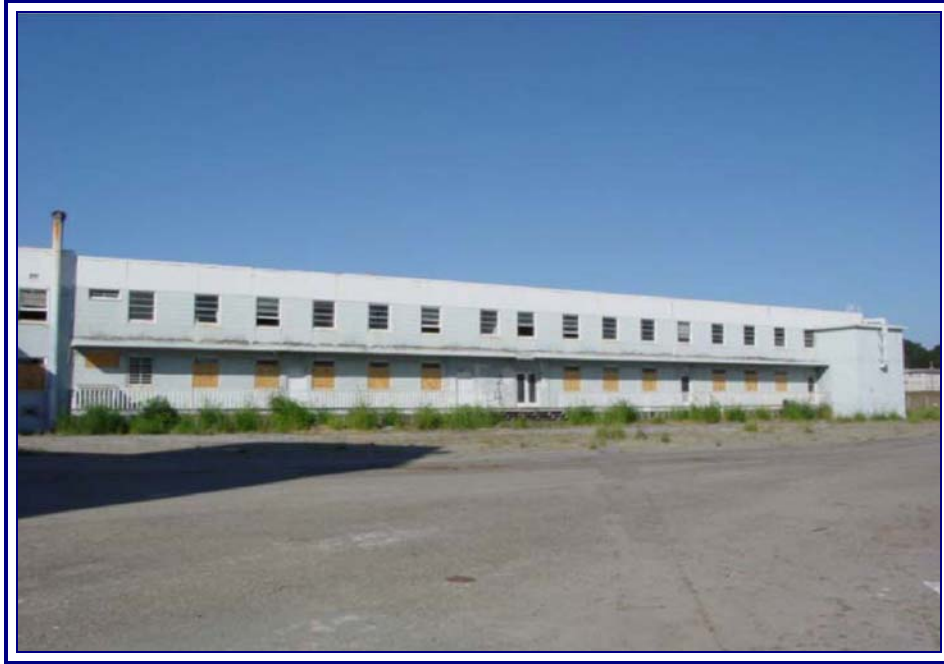
#### 8.3.3.4 *Building 214*

**Site Description:** Building 214 is of typical wooden WW II era administration building design, built from standardized Bureau of Yards and Docks plans ([HRA-1118, p 108](#)). A building site plan is provided in [Figure 8.3.3.2](#) above.

**Former Uses:** Combat Weapons Systems Office ([HRA-4667](#)), administrative offices ([HRA-2963](#)), Accounting and Bond Office, Triple A office space, and NRDL Health Physics counting room in Room 105 ([HRA-3052 Encl 3](#)).

1996 PRC – survey found no detectable activity in building.

**Recommended Actions:** Review Final Status Survey Report.

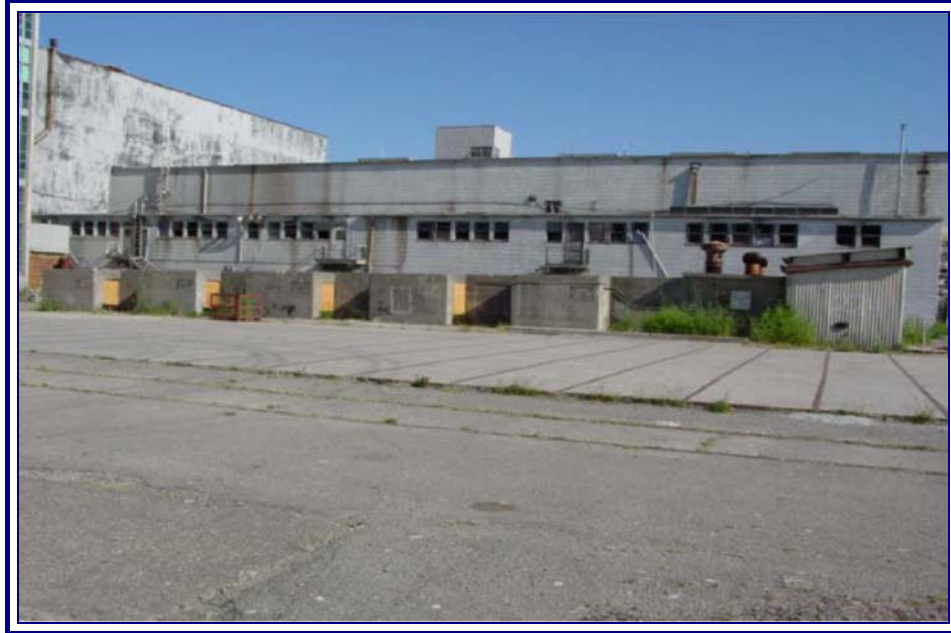
### 8.3.3.5 *Building 224*

**Site Description:** Building 224 is a reinforced concrete bomb shelter (in foreground) that was built in the main industrial area of HPS in 1944. The building is mostly underground, rising only 3 feet out of the ground ([HRA-1118, p 86](#)). Metal doors and stairwells lead to a series of small rooms. A building site plan is provided in [Figure 8.3.3.2](#) above.

**Former Uses:** Air raid shelter and OPERATIONS CROSSROADS and GREENHOUSE sample storage ([HRA-405](#); [HRA-4667](#)).

**Recommended Actions:** Review Final Status Survey Report.

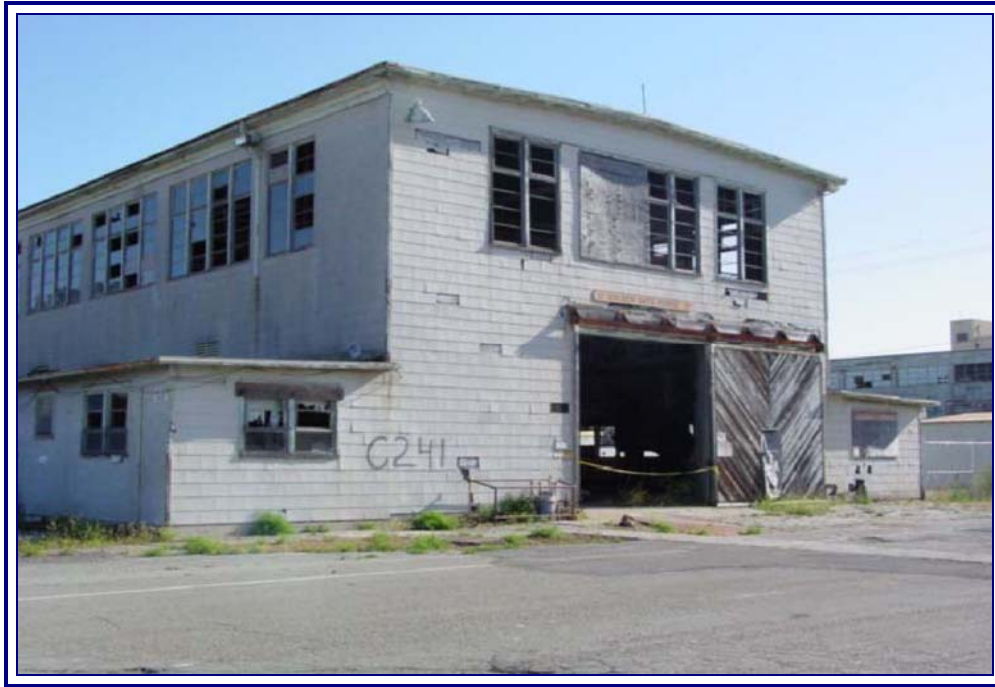
8.3.3.6 *Building 241*

**Site Description:** Building 241 is a large wood-framed, monitored (lights and ventilation) shop building, including a shallow, almost flat, gabled roof with monitors and shallow shed-roofed forms at either side. A building site plan is provided in [Figure 8.3.3.6](#).

**Former Uses:** Forge Shop ([HRA-2963](#)).

**Recommended Actions:** Review Final Status Survey Report.

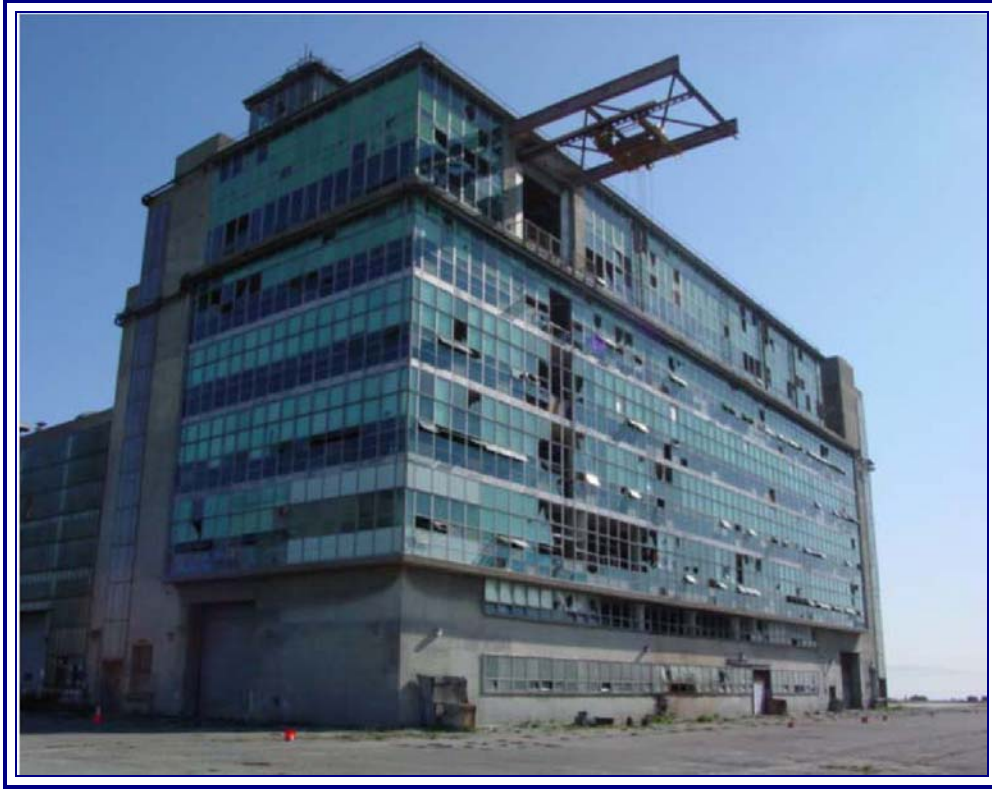
### 8.3.3.7 *Building 253*

**Site Description:** Building 253 is a six-story concrete-framed, glass curtain-walled building built between 1944 and 1947. The building has a large gantry for the craning of equipment to the upper stories and a periscope tower extending vertically from the roof. Building 253 is attached to Building 211 ([HRA-1118, pp 94-96](#)). The glazing for Building 253 is standard glass. A building site plan is provided in [Figure 8.3.3.2](#) above, and a floor plan (first floor) is provided in [Figure 8.3.3.7FP](#).

**Former Uses:** Radiography and instrument calibration through 1974 ([HRA-601, p 9](#)); Gauge Shop ([HRA-601, p 10](#)); Electronics, Optical, and Ordnance Shops ([HRA-2963](#)); Weapons Shop ([HRA-372, p 14](#)); Electrical Shop ([HRA-372, p 17](#)); storage of equipment from OPERATION CROSSROADS ships; Maritime Administration Ship Parts Storage (1994); and probable location of radium paint activities (Gauge Shop).

- 2003 NWT partial building Characterization Survey.
- 2002 NWT Phase V investigation. Extensive low-level contamination (Cs-137 and Ra-226) found in and on the building and in the building ventilation system. Remediation completed on roof.
- 1974 Shipyard closure survey of sixth floor. No detectable activity based on limits for the period.

Surface Soil: None  
Subsurface Soil: Moderate from drain line leakage  
Sediment: High  
Surface Water: None  
Groundwater: None  
Air: None  
Structures: High  
Drainage Systems: High

**Recommended Actions:** Complete Characterization Survey and remediate known areas of contamination. Final Status Survey once remediation is completed.

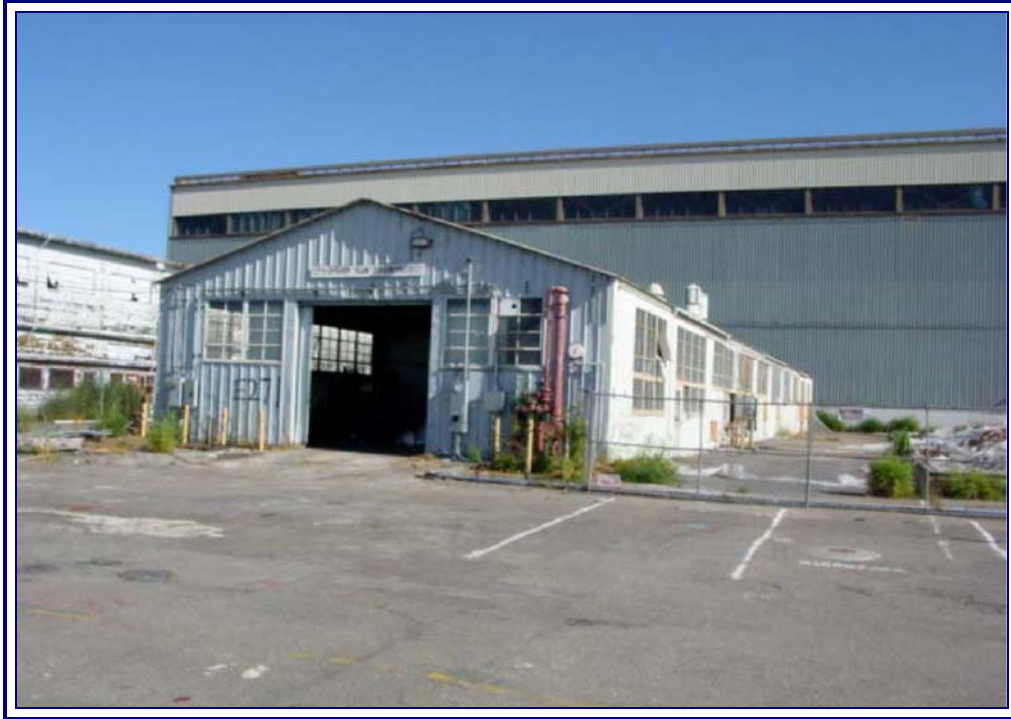
### 8.3.3.8 *Building 271*

**Site Description:** Building 271 is a single-width, metal-sided shop building that was built in 1947 and manufactured by the Butler Company or in the manner of Butler Company buildings. This prefabricated, standard building was used on military bases due to limited budgets ([HRA-1118, p 106](#)). A building site plan is provided in [Figure 8.3.3.8](#).

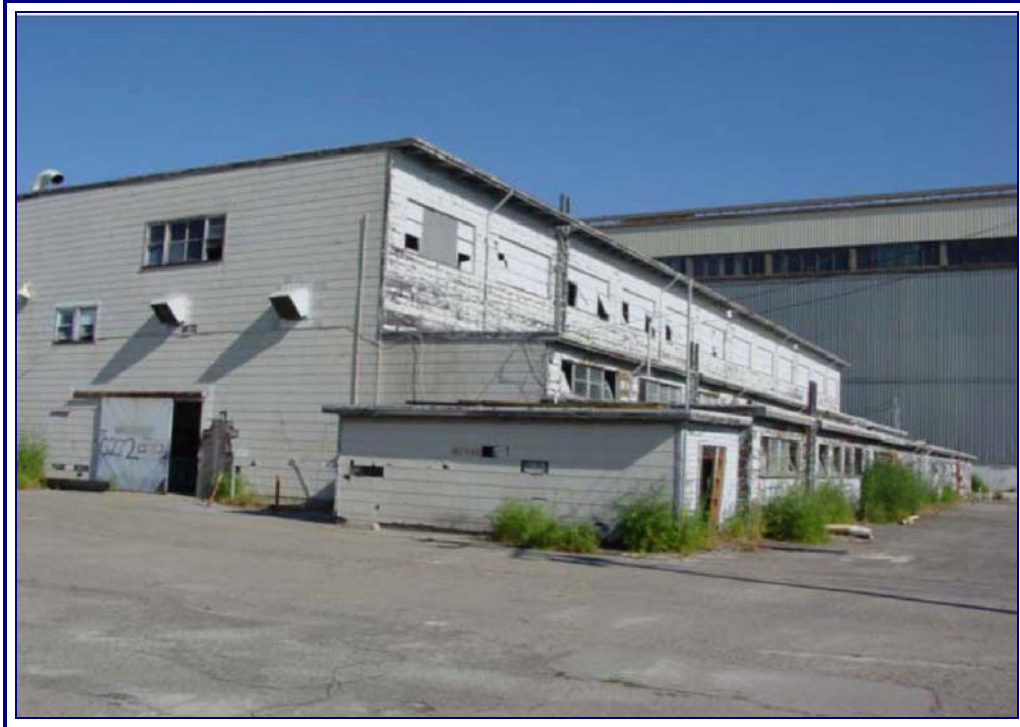
### 8.3.3.9 *Building 272*

**Site Description:** Building 272 is a large wood-framed shop building that includes a shallow, almost flat, gabled roof with monitors and with shallow shed-roofed forms at either side. A building site plan is provided in [Figure 8.3.3.8](#) above.

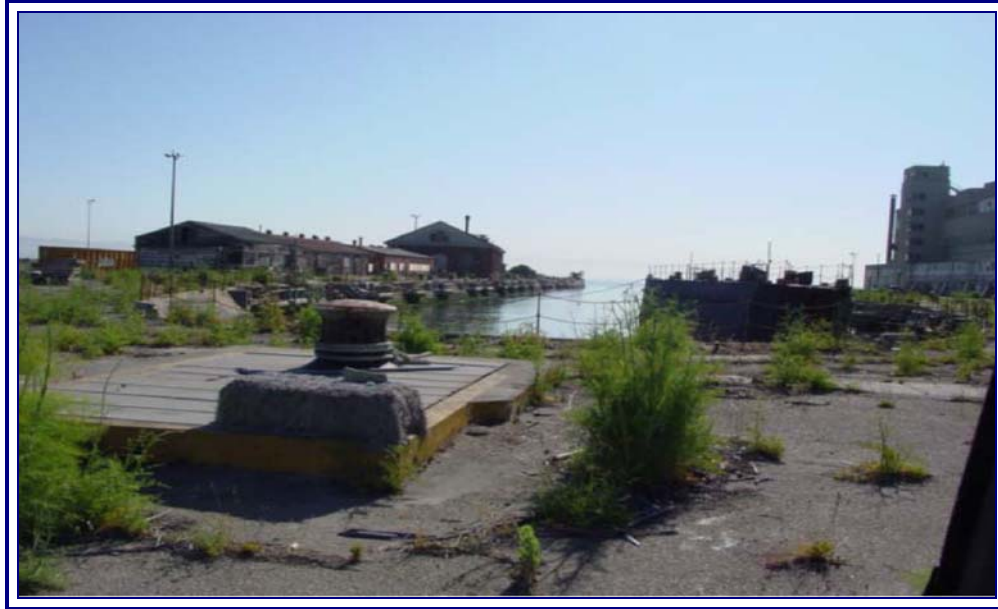
### 8.3.3.10 Drydock 2

**Site Description:** Drydock 2 is a graving drydock, measuring 750 feet by 122 feet at ground level and 712 feet by 74 feet at the bottom. It is approximately 30 feet deep (HRA-1117, p 149). The drydock was filled through 13 30-inch culverts in the steel caisson. A discharge channel runs east from the drydock to the Bay (HRA-4749). A drydock site plan is provided in Figure 8.3.3.10.

**Former Uses:** Drydock, OPERATION CROSSROADS ship decontamination, decontamination of YAG-39 and YAG-40, and possible removal of radium devices from ships.

2002 NWT Phase V investigation. Seven radium-bearing devices found and removed from the wall of the drydock. Surveys completed.

**Recommended Actions:** Review Final Status Survey Report.

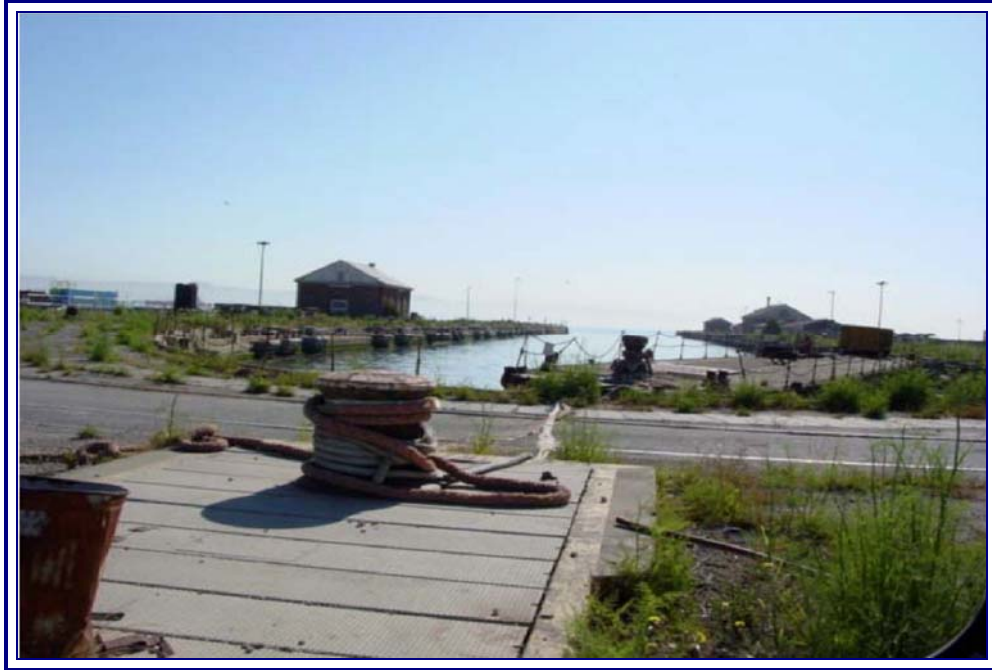
### 8.3.3.11 Drydock 3

**Site Description:** Drydock 3 is a graving drydock that is located north of and parallel to Drydock 2. It measures 1,076 feet by 153 feet at ground level and 1,020 feet by 110 feet at the bottom. This drydock used granite blocks at the gate area; however, the gates have been removed ([HRA-1117, p 139](#)). A channel for water from Drydock 3 passes in a straight line north from the drydock through Pumphouse 3 (Building 140) to the Bay ([HRA-4689](#)). A drydock site plan is provided in [Figure 8.3.3.10](#) above.

**Former Uses:** Drydock, OPERATION CROSSROADS ship decontamination, possible removal of radium devices from ships, and decontamination of YAG-39 and YAG-40.

- 2002 NWT Phase V investigation. Three radium-bearing devices found and removed. Resurvey completed.
- 1947 Surveys during CROSSROADS decontamination activities; background with instruments of the period ([HRA-506](#)).

**Recommended Actions:** Review Final Status Survey Report.

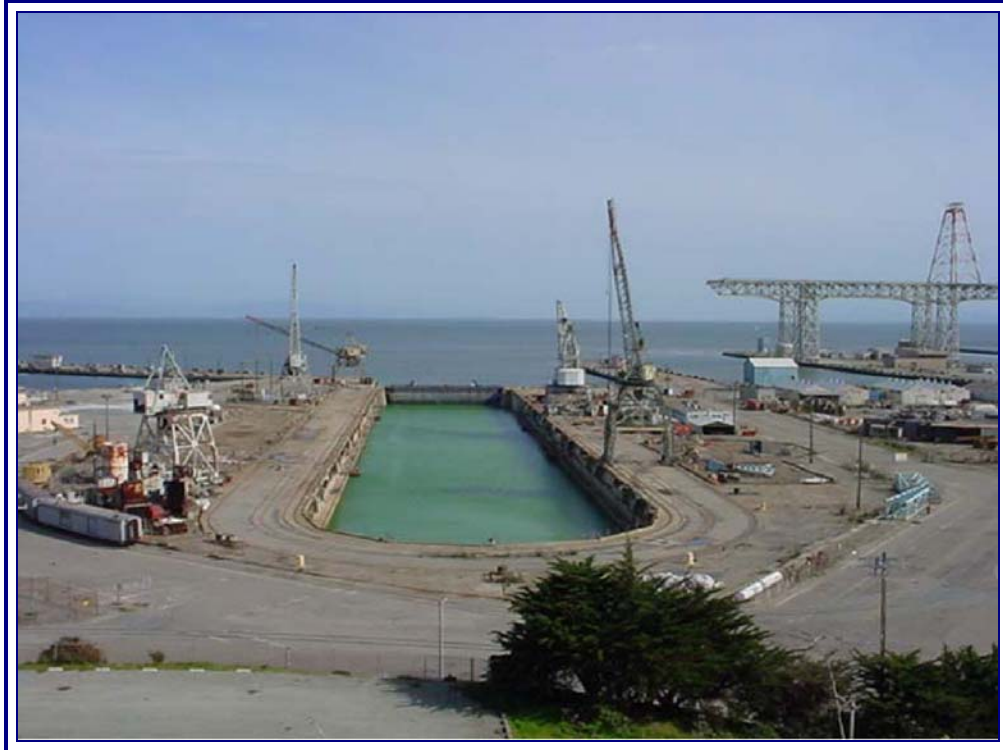
### 8.3.3.12 Drydock 4

**Site Description:** Drydock 4 is a 1,092-by-143 foot, 53-foot-deep concrete graving drydock, with a rounded northwest end. Access steps are recessed into the wall, and the floor is flat, while the walls are slightly sloping. The drydock is outlined by a crane track that permits access to ships in the dock from all angles. Two or more smaller ships could be docked for servicing at the same time (HRA-1117, pp 157-160). A drainage system from the southeast corner of the drydock runs eastward to the Bay (HRA-4691). A drydock site plan is provided in Figure 8.3.3.12.

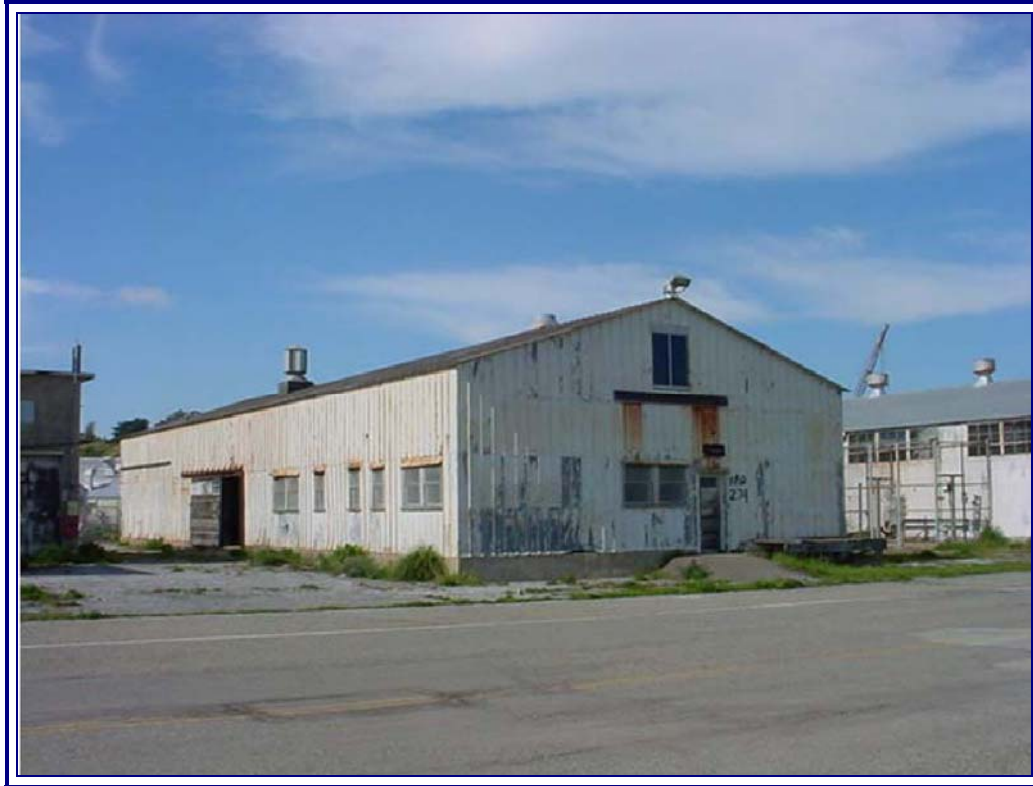
#### 8.3.4.1 *Building 274*

**Site Description:** Building 274 is a shallow gable-roofed, corrugated, metal-sided shop building, measuring 100 feet by 40 feet. A building site plan is provided in [Figure 8.3.4.1](#).

**Former Uses:** Decontamination training ([HRA-174](#); [HRA-333 p 3](#); [HRA-4667](#)) and office space ([HRA-1118 p 48](#)).

**Recommended Actions:** Review Final Status Survey Report.

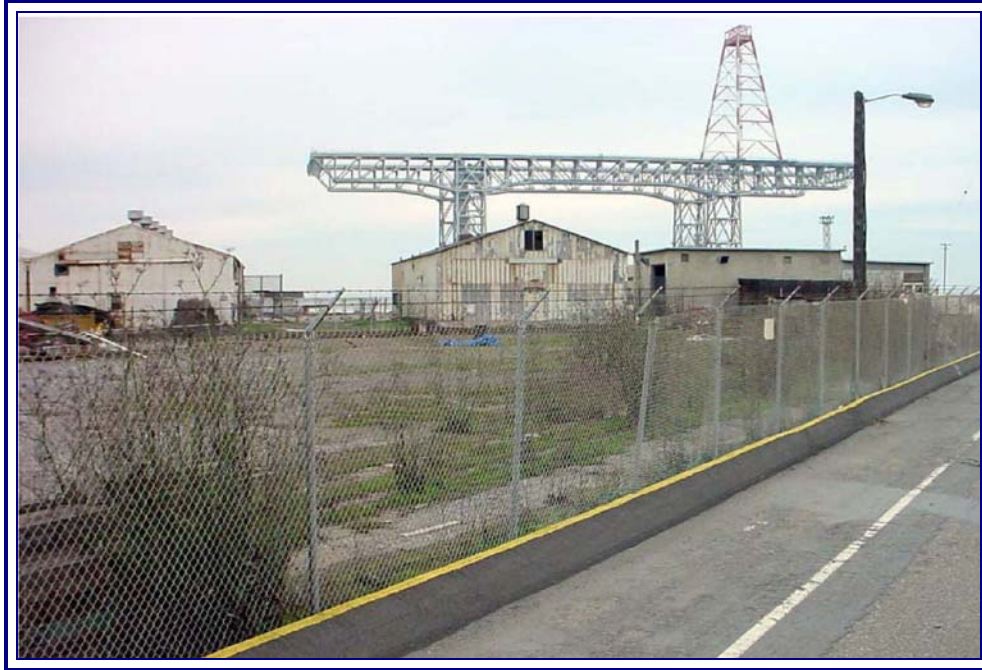
#### 8.3.4.2 *Building 313 Site*

**Site Description:** Building 313 was a temporary wooden building, measuring approximately 3,600 square feet ([HRA-1327 Encl 1, p 1](#)). It was adjacent to Building 313A. A building site plan is provided in [Figure 8.3.4.1](#) above.

**Former Uses:** NRDL Instrumentation Laboratory and stockroom ([HRA-2963](#)) and storage ([HRA-274](#)).

2002 NWT Phase V investigation. Cs-137 found above action levels. Area remediated. Resurvey complete.

**Recommended Actions:** Review Final Status Survey Report.

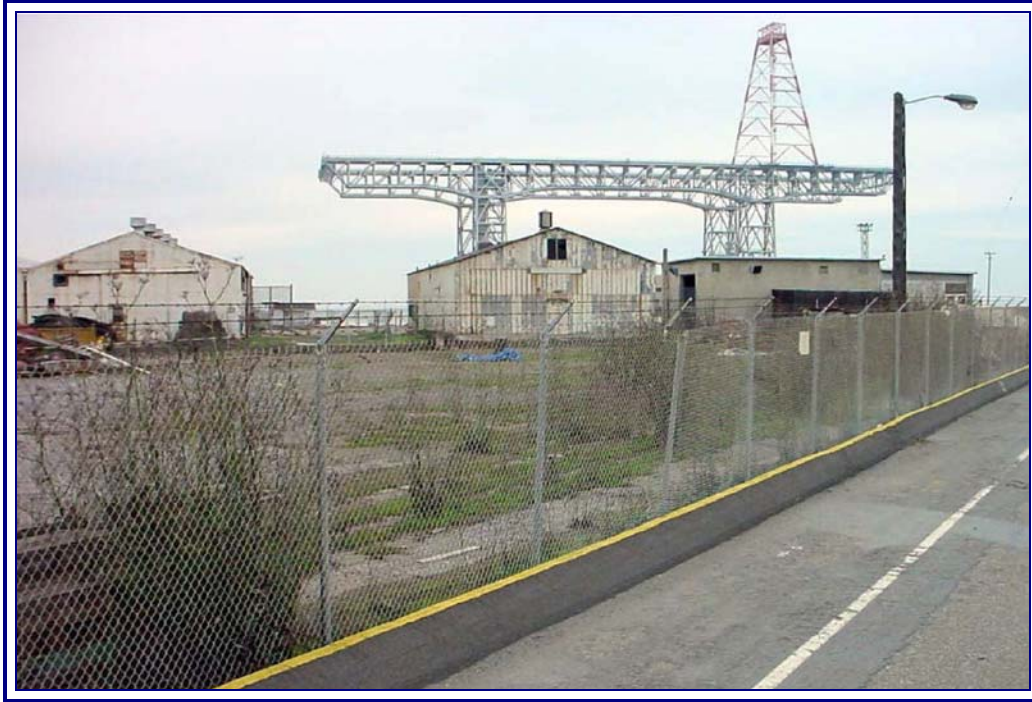
### 8.3.4.3 Building 313A Site

**Site Description:** Building 313A measured approximately 750 square feet and was described as a small Homoja building ([HRA-1327 Encl 1, p1](#)). The building was adjacent to Building 313. A building site plan is provided in [Figure 8.3.4.1](#) above.

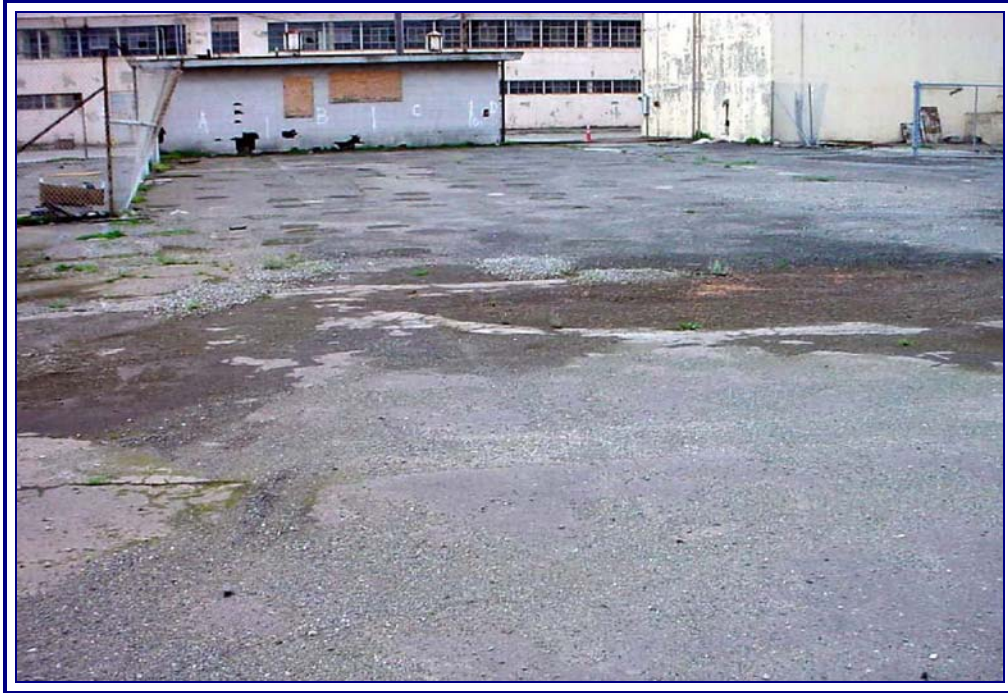
**8.3.4.4 Building 317 Site**

**Site Description:** Building 317 measured approximately 100 feet by 30 feet and was located behind Buildings 364 and 365. A site plan is provided in [Figure 8.3.4.4](#).

**Former Uses:** Temporary animal quarters for NRDL ([HRA-1752 Encl 3, p 2](#)).

2002 NWT Phase V investigations. Survey complete. Cs-137 exceeding release criteria found. Remediated and resurveyed.

**Recommended Actions:** Review Final Status Survey Report.

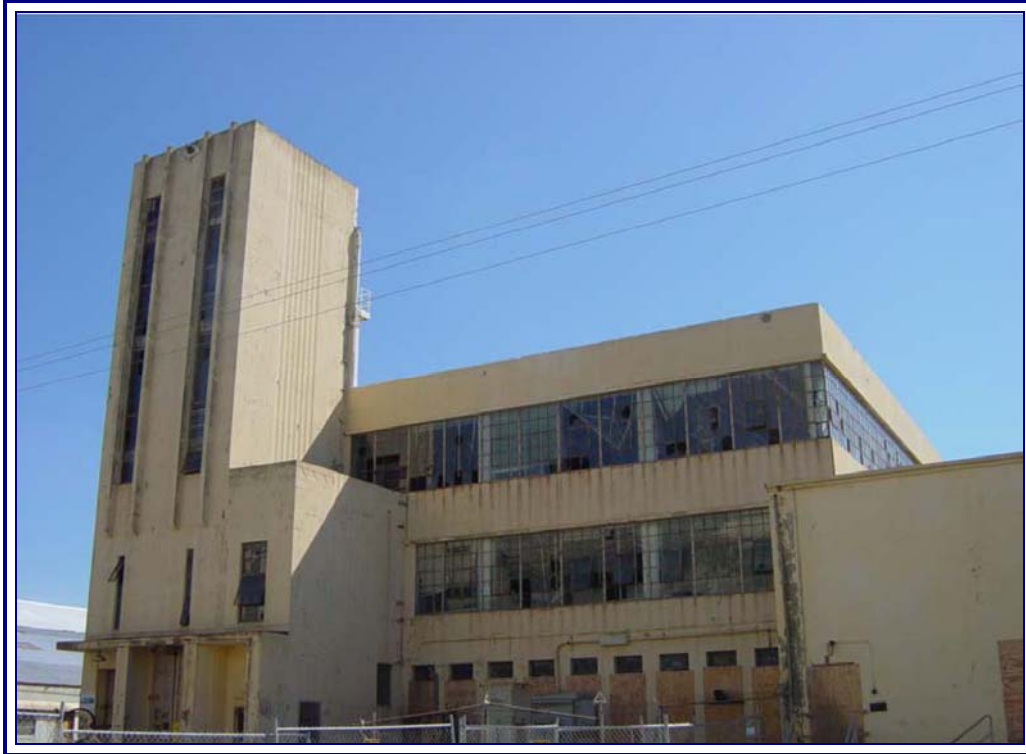
**Site Description:** Building 351 is a WW II era reinforced concrete shop building constructed in 1945 and enlarged at a later date. The core building is three stories, with a flat roof and a five-story tower at the northwest corner ([HRA-1118, p 170](#)). A building site plan is provided in [Figure 8.3.4.4](#) above, and a floor plan is provided in [Figure 8.3.4.6FP](#) (first and second floors).

**Recommended Actions:** Review Final Status Survey Report.

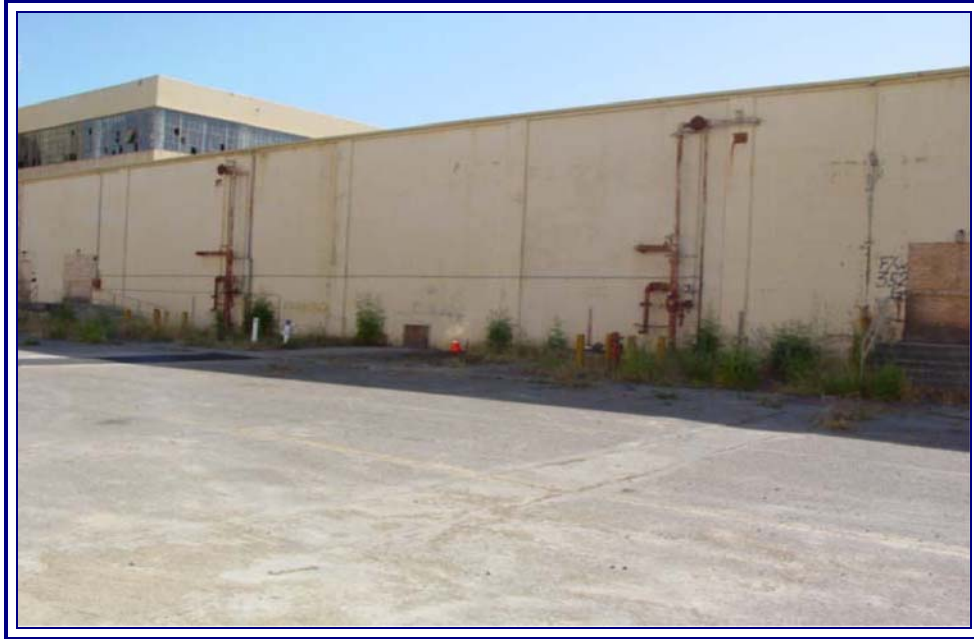
**Site Description:** Building 351A is an addition connected to the south end of Building 351. It is a one-story concrete building constructed over a crawlspace. A building site plan is provided in [Figure 8.3.4.4](#) above, and a floor plan is provided in [Figure 8.3.4.7FP](#).

Surface Soil: Moderate  
Subsurface Soil: Moderate from drain line leakage.  
Sediment: Moderate  
Surface Water: None  
Groundwater: None  
Air: None  
Structures: Moderate (crawlspace)  
Drainage Systems: Moderate (crawlspace)

Surface Soil: Moderate  
Subsurface Soil: Moderate from drain line leakage.  
Sediment: Low  
Surface Water: None  
Groundwater: None  
Air: None  
Structures: Low (crawlspace)  
Drainage Systems: Low (crawlspace)

**Recommended Actions:** Remediate known area of contamination. Complete Final Status Survey.

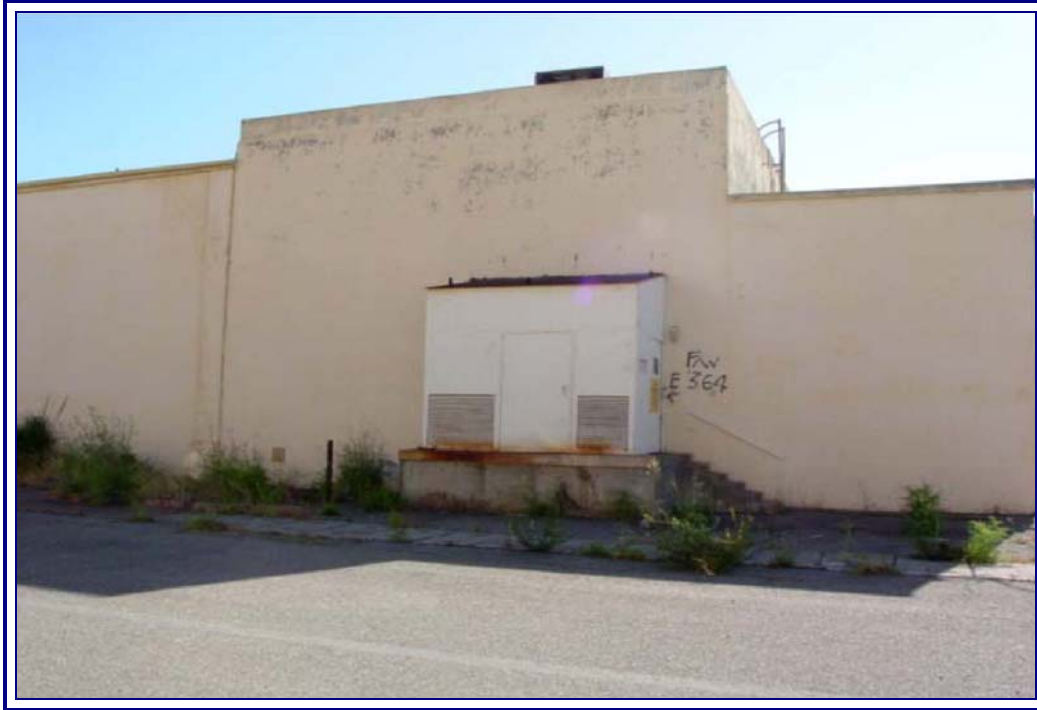
**Site Description:** Building 364 measures approximately 40 feet by 50 feet. A liquid radioactive waste collection area to the rear of the building contained a subsurface sump with a pumphouse on a concrete pad and two holding tanks. A building site plan is provided in [Figure 8.3.4.4](#) above, and a floor plan is provided in [Figure 8.3.4.8FP](#).

Surface Soil: Moderate  
Subsurface Soil: Low  
Sediment: Moderate  
Surface Water: None  
Groundwater: None  
Air: None  
Structures: Moderate  
Drainage Systems: Moderate

**Recommended Actions:** Remediate known areas of contamination. Final Status Survey following remediation.

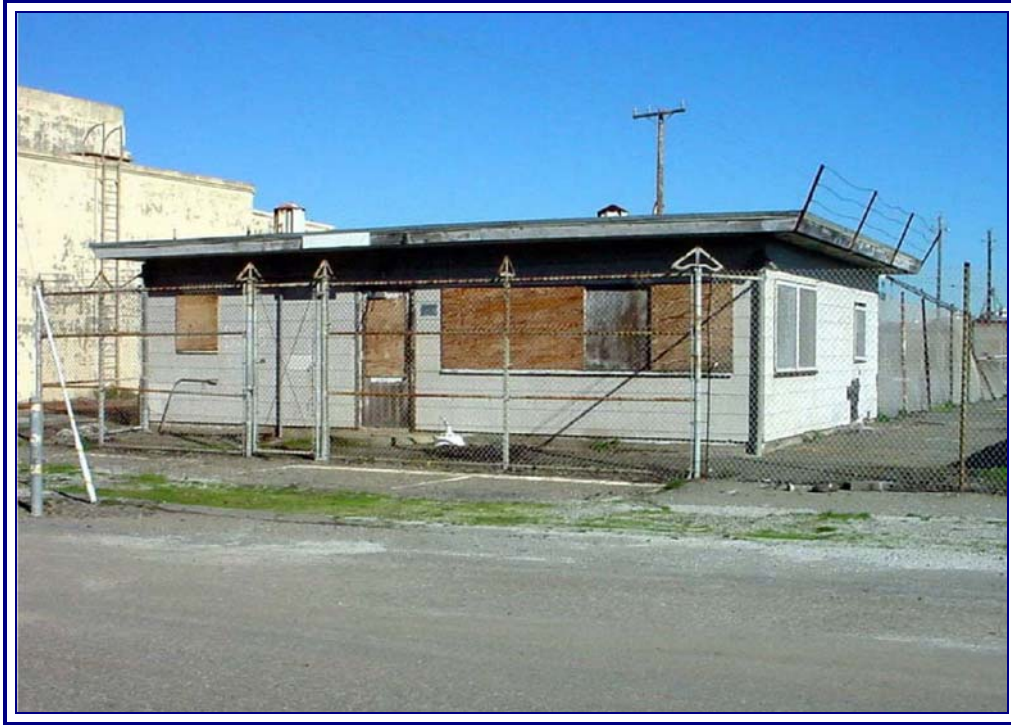
**Site Description:** Building 365 is a one-story wooden structure with a concrete foundation and measures 30 feet by 40 feet. A building site plan is provided in [Figure 8.3.4.4](#) above.

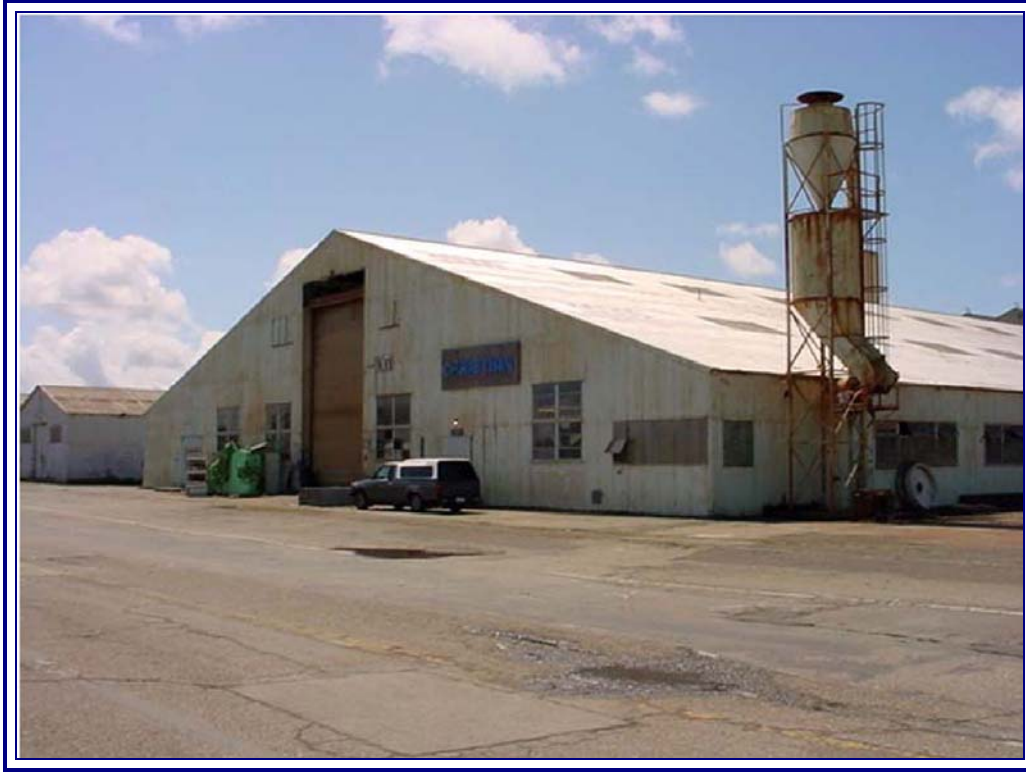
**Site Description:** Building 366 is a large corrugated metal, gable-roofed Butler-type structure, measuring approximately 280 feet by 130 feet. A building site plan is provided in [Figure 8.3.4.10](#).

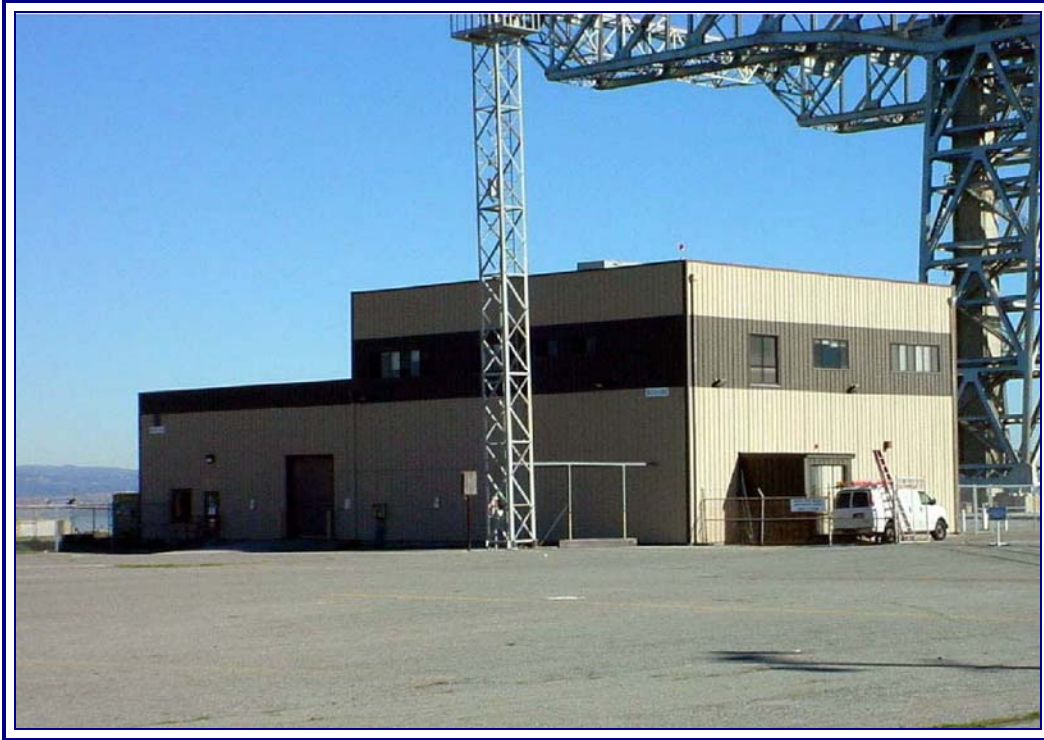
**Site Description:** Building 383 was built on the Gun Mole Pier in 1985 (HRA-1118, p 49). It is a two-story steel and concrete, flat-roofed building, measuring approximately 110 feet by 60 feet. The area where the building is currently located has been identified as the site of a small building where radioluminescent devices were turned in after they were removed from ships. A building site plan is provided in Figure 8.3.4.11.

2002 NWT Phase V investigations. Surveys complete. Found radioactive night vision device. Device did not exceed release limits. No spread of contamination. Device left in place.

**Recommended Actions:** Review Final Status Survey Report.

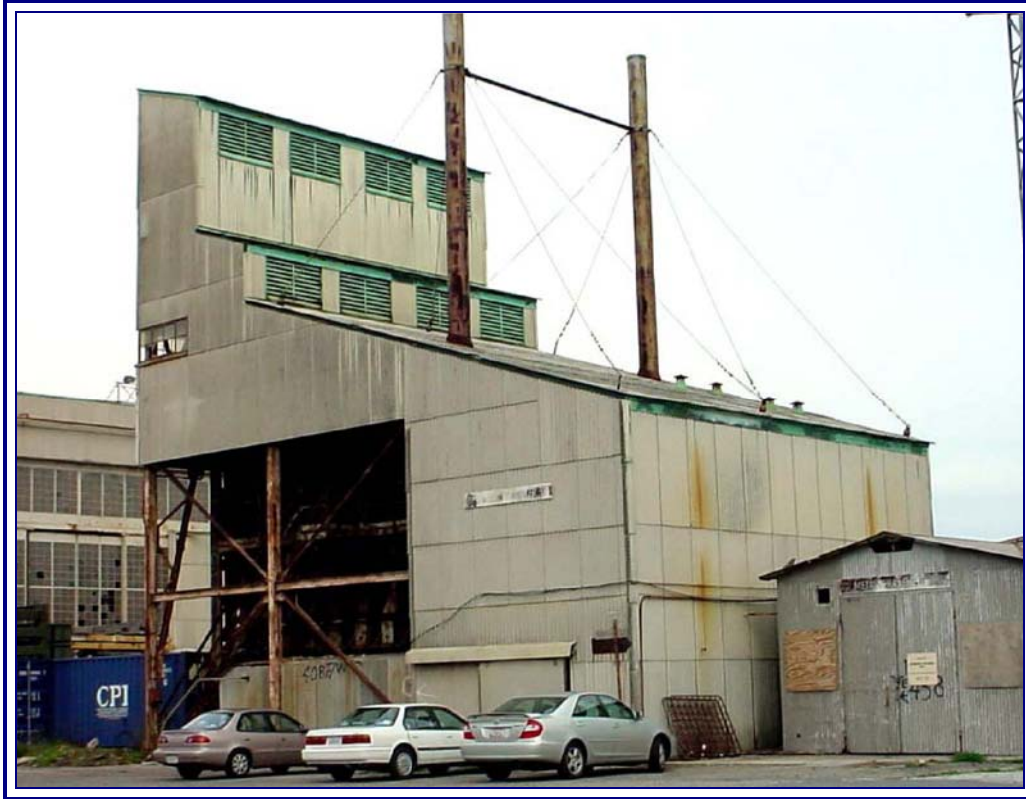
**Site Description:** Building 408 houses a furnace/smelter that was constructed in 1947. The building is the equivalent of three stories at its northern side, dropping to one story at the south. It is open-sided on the north. Most of the east and west sides are sided in transite, a corrugated asbestos-concrete material. A firebrick-lined hearth occupies most of the open area at the north. Natural gas burners exist on the east and west sides of the hearth. A pair of smokestacks extends from the lower rear segment of the building. A building site plan is provided in [Figure 8.3.4.12](#).

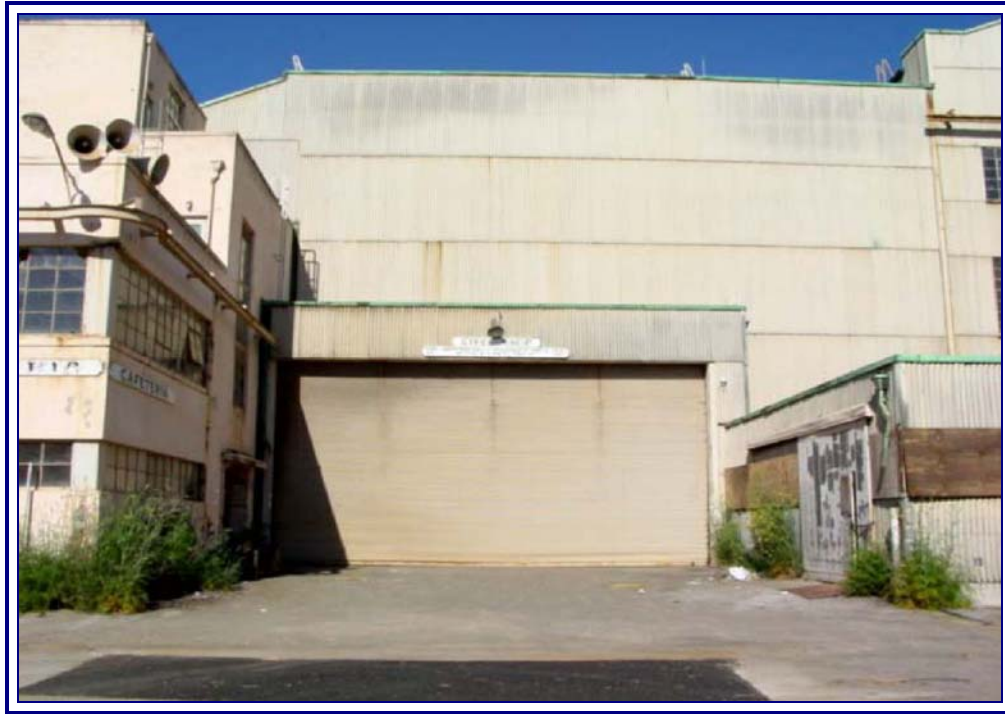
**Site Description:** Building 411 is a large curtain-walled, steel-framed building with a flat roof, located in the southern waterfront area. The building includes a saw-toothed series of rooftop monitors as well as bands of steel industrial sash and large glazed industrial doors. The building has two levels, with a taller segment to the north (HRA-1118, pp 143-145). A building site plan is provided in Figure 8.3.4.12 above.

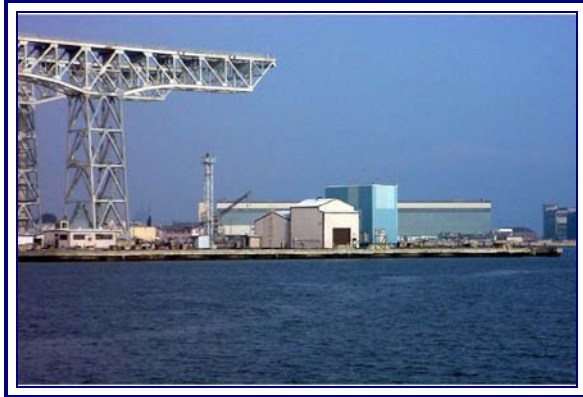
**Bay End**

**Site Description:** The Gun Mole Pier is a large flat area also known as the re-gunning pier. Buildings *360, 370, 374, 375, 376, 377, 378, 379, 380, 382, 383, 384,* and *385* are currently (in italics), or have been located, on the Gun Mole. The major feature is a large 450-ton gantry crane originally used to remove gun turrets from ships. A site plan is provided in [Figure 8.3.4.14](#), and a site layout is provided in [Figure 8.3.4.14FP](#).

**Recommended Actions:** Review Characterization Report for Phase V surveys and complete further Characterization Surveys. Final Status Survey pending results of characterization.

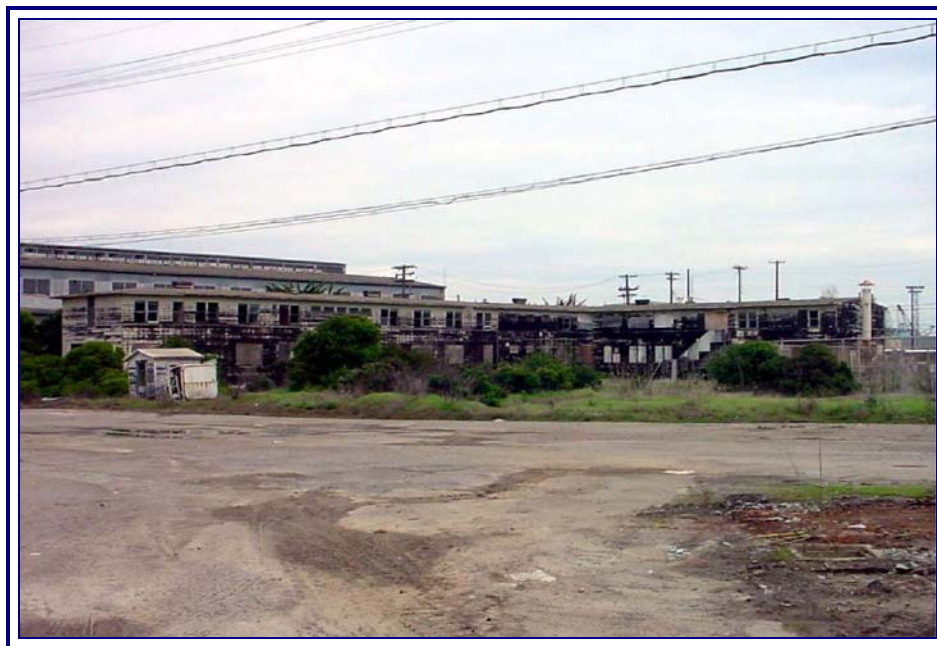
**Site Description:** Building 500 is a two-story T-shaped wooden WW II temporary building, measuring 13,450 square feet on the foundation. A building site plan is provided in [Figure 8.3.4.15](#).

**Recommended Actions:** Scoping Survey. Characterization Survey if contamination is identified. Final Status Survey if no contamination identified.

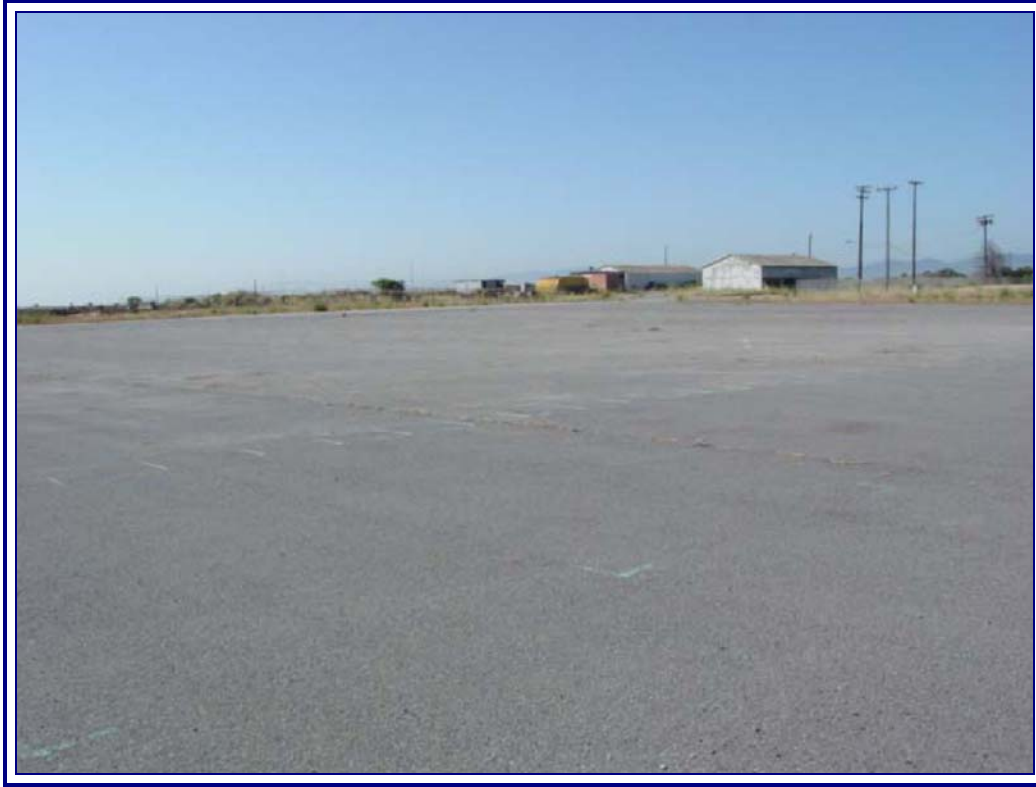
**Site Description:** The site was hand drawn on a 1949 map and annotated “Bldgs Now Occupied by NRDL” ([HRA-4755](#)). It is approximately 300 feet north-northwest of Berth 21. A site plan is provided in [Figure 8.3.4.17](#).

**Recommended Actions:** Review Final Status Survey Report.

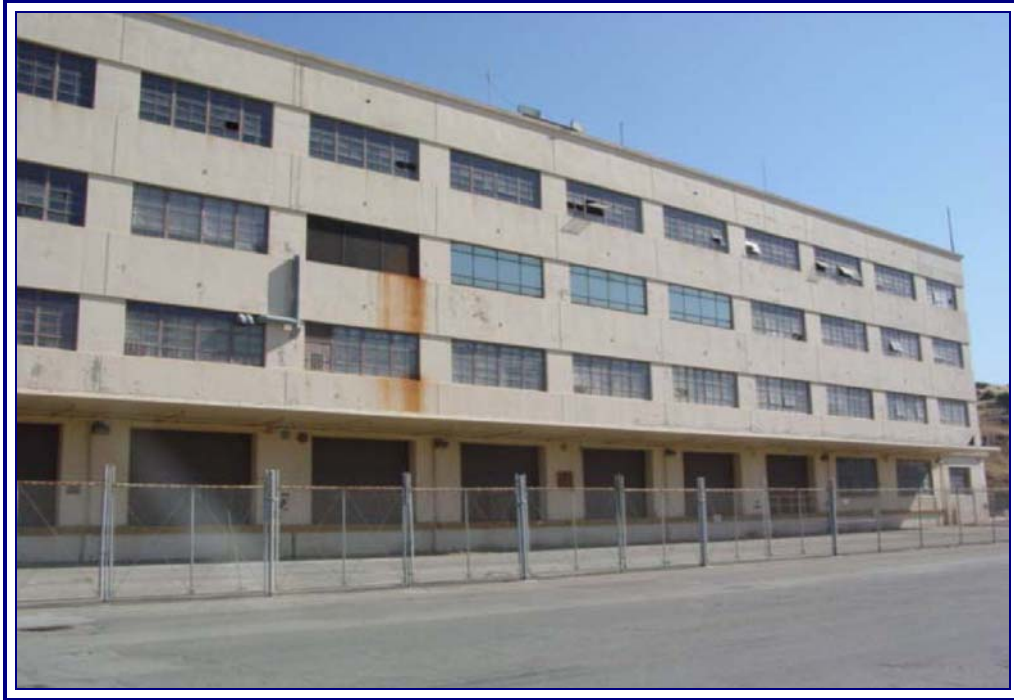
**Site Description:** A large, 262-by-262-foot, four-story reinforced concrete, flat-roofed warehouse that includes banks of industrial steel sash in horizontal bands across all four stories, except at the front (south) of the first floor. The front has a bank of steel roll-up industrial doors extending the length of the concrete loading dock area. The loading dock is sheltered by a concrete canopy (HRA-1118, pp 70-71). Figure 8.3.4.18 provides a map of the site location.

**Contamination Potential:** Unlikely. A leaking 300- $\mu$ Ci Sr-90 check source was found in the Disaster Control inventory, and the Disaster Control Center was located in Building 813; however, spread of contamination from this source would be unlikely (HRA-2829).

**Recommended Actions:** Scoping Survey. Characterization Survey if contamination identified. Final Status Survey if no contamination is identified.

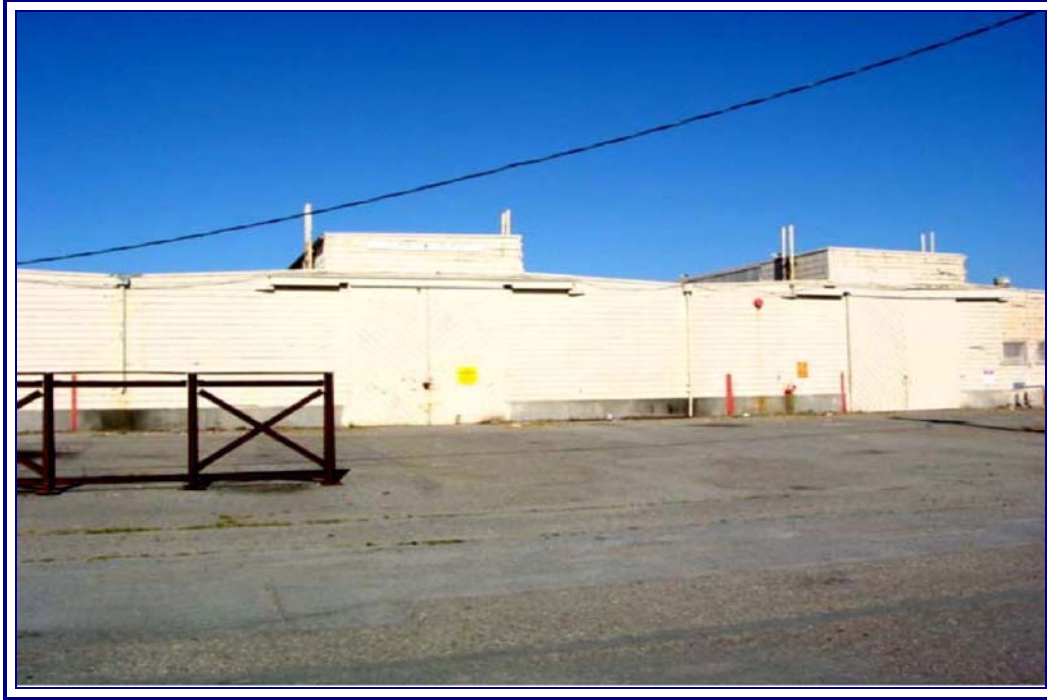
**Site Description:** Building 406 is a common wood-framed, flush weather-boarded warehouse and shop-type building from WW II. The building is approximately 40,000 square feet ([HRA-171, p 6](#)) and includes a central light and ventilation monitor joined by shallow shed roofs at either side. At the center of the building is a pair of wooden sliding industrial doors, surfaced with diagonal boards. A building site plan is provided in [Figure 8.3.5.1](#).

**Recommended Actions:** Review Final Status Survey Report.
