## Hunters Point Shipyard

# FINAL HISTORICAL RADIOLOGICAL ASSESSMENT

History of the Use of General Radioactive Materials  
1939 – 2003

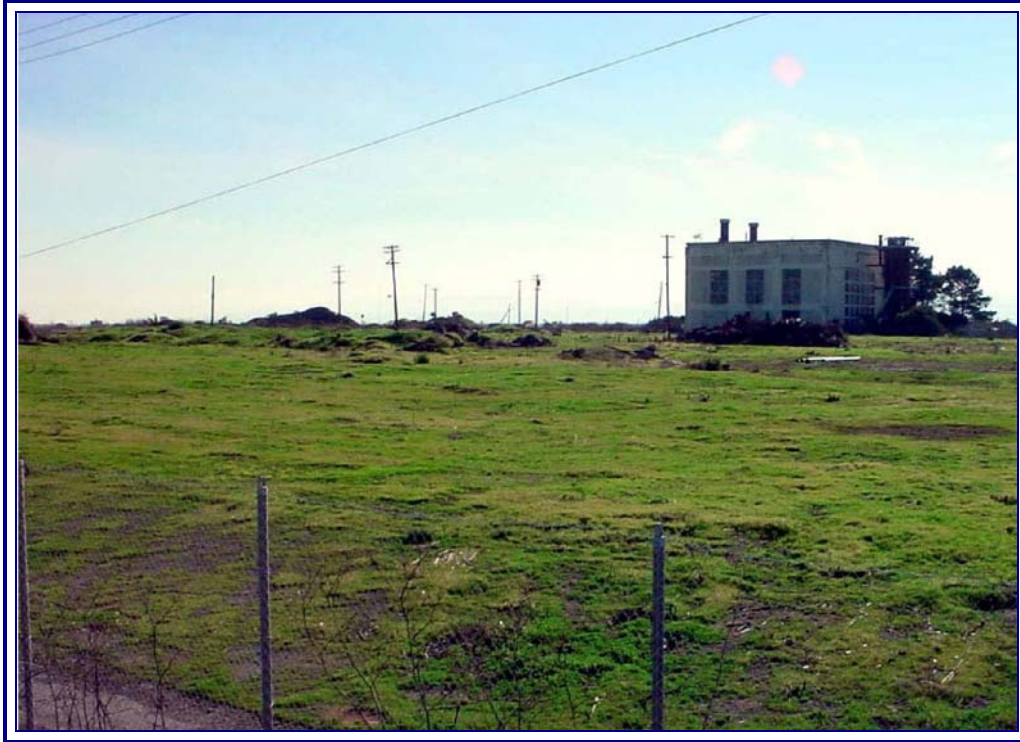
**Site Description:** The area of HPS where the 500 series buildings were located is of significance because the original RADLAB/NRDL facilities were located there. In addition to the buildings described individually below, temporary structures were constructed, used, and removed, and radioactive materials were transported and stored outdoors. There were drain lines in buildings in the area, a dust collection system was constructed outside Building 506 for use by NRDL, and there is anecdotal indication of a spill of Sr-90 near Building 506. A site plan is provided in [Figure 8.3.5.3](#).

**Recommended Actions:** Scoping Survey. Characterization Survey if contamination is identified. Final Status Survey following remediation if contamination is identified.

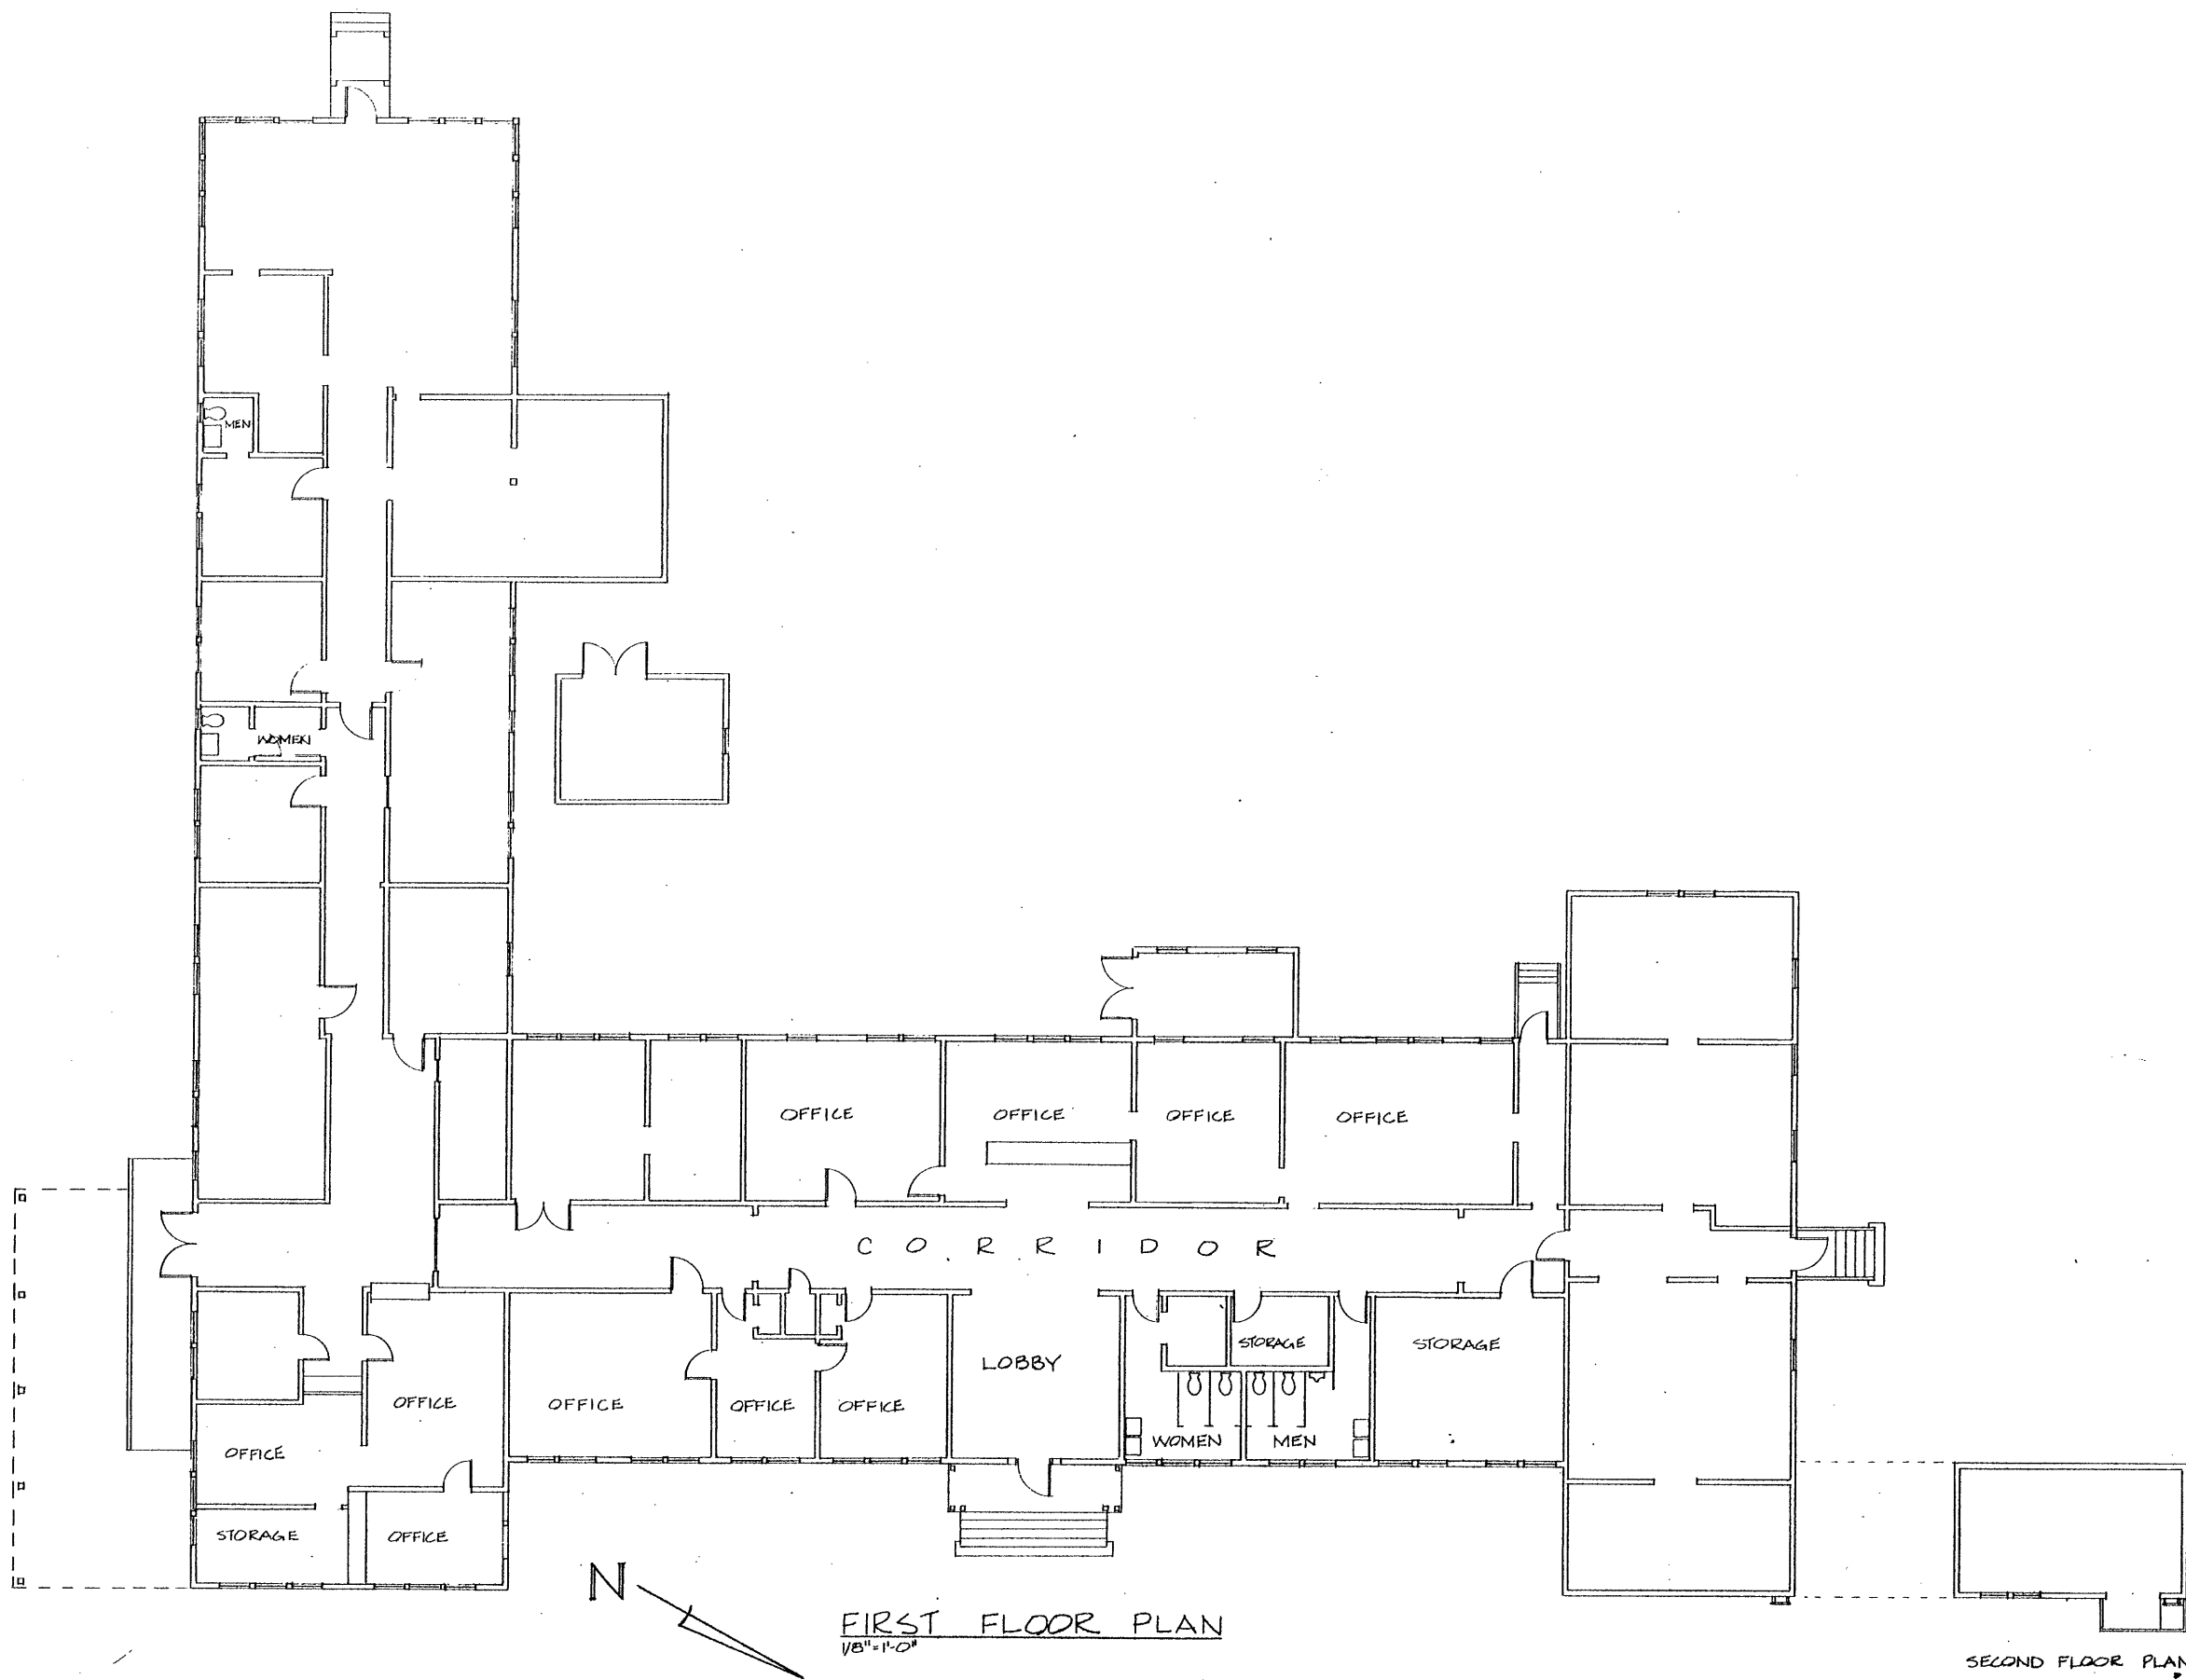
Figure 8.3.5.4 FP  
Building 506 - Floor Plan

**Site Description:** From correlations of available historical maps, the former Building 506 was irregular in construction and measured 9,375 square feet at the foundation. A site plan is provided in [Figure 8.3.5.3](#) above, and a floor plan is provided in [Figure 8.3.5.4FP](#).

- 2002 NWT Phase V investigations. Class 3 survey complete.
- 1996 PRC Phase III investigation. Survey results below release limit for the period.
- 1978 RASO survey of former NRDL buildings. Three areas of elevated activity noted and decontaminated below release limits for the period.
- 1969 Final AEC clearance given 24 December 1969.
- 1969 NRDL release survey. H-3 contamination found and removed.

- Surface Soil: Low
- Subsurface Soil: Low
- Sediment: Moderate
- Surface Water: None
- Groundwater: None
- Air: None
- Structures: None
- Drainage Systems: Moderate

**Recommended Actions:** Scoping Survey based on recent drainage system information from historical drawings. Characterization Survey if contamination is identified. Final Status Survey following remediation if contamination is identified.

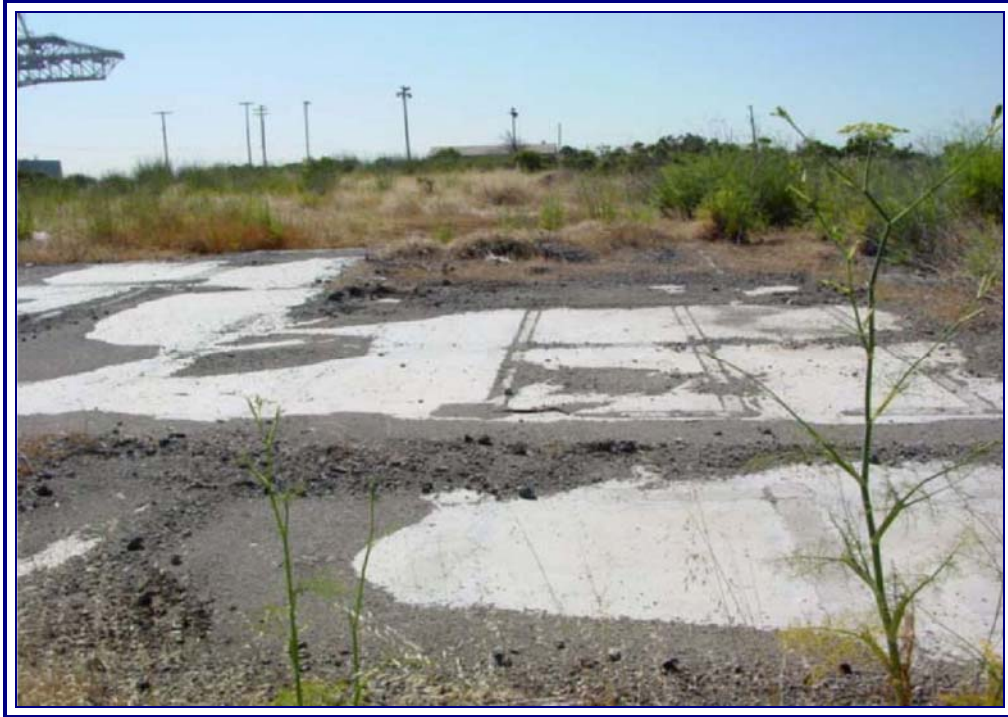
**8.3.5.10 Former Building 517 Site**

**Site Description:** The original Building 517 measured approximately 50 feet by 50 feet. A site plan is provided in [Figure 8.3.5.3](#) above.

**Former Uses:** Former brig and NRDL Cobalt Animal Irradiation Facility ([HRA-136](#); [HRA-232](#)).

- 2002 NWT Phase V investigations. Class 3 survey complete. No readings exceeding release limits.
- 1996 Phase III investigations. Survey and soil sampling. Anomalous count rates. Further investigation recommended.
- 1978 RASO scoping survey.
- 1970 AEC survey for clearance January 1970.

**Recommended Actions:** Characterization Survey of site and remaining drainage systems. Remediation if contamination is identified. Final Status Survey following remediation.

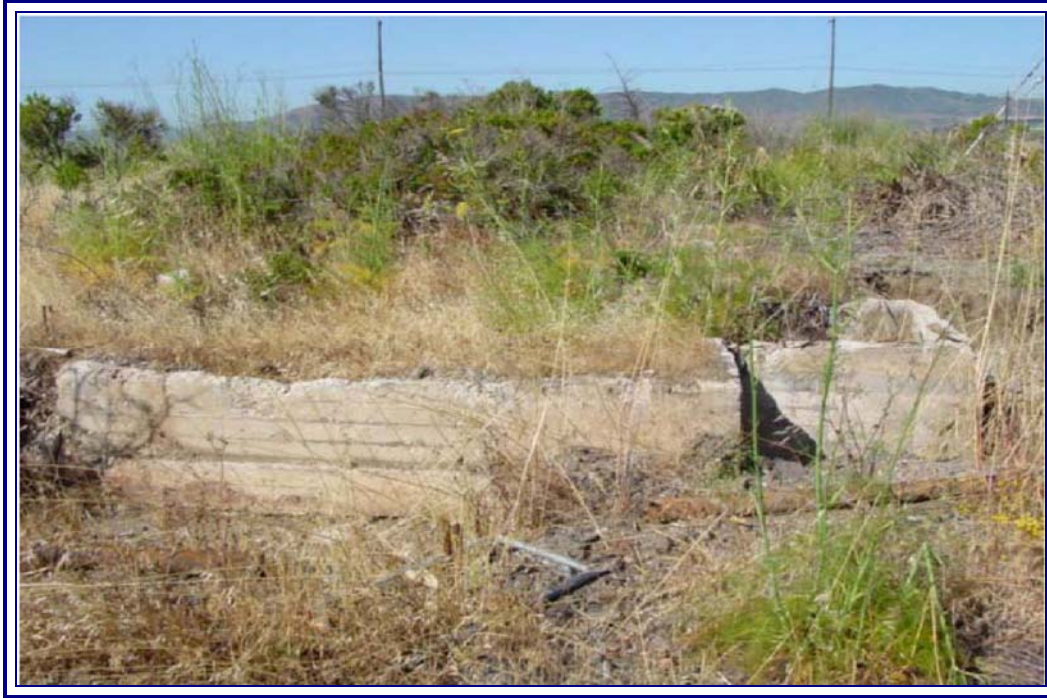
### 8.3.5.11 Former Building 520 Site

**Site Description:** The original Building 520 was irregular in construction and measured approximately 7,040 square feet at its foundation. A site plan is provided in [Figure 8.3.5.3](#) above.

2002 NWT Phase V investigations. Radium contamination found near foundation.

**Contamination Potential:** Known-Continued Access; contamination is likely in drain system piping based on radium contamination found immediately adjacent to building foundation.

**Recommended Actions:** Characterization Survey of site and remaining drainage systems. Remediation if contamination is identified. Final Status Survey following remediation.

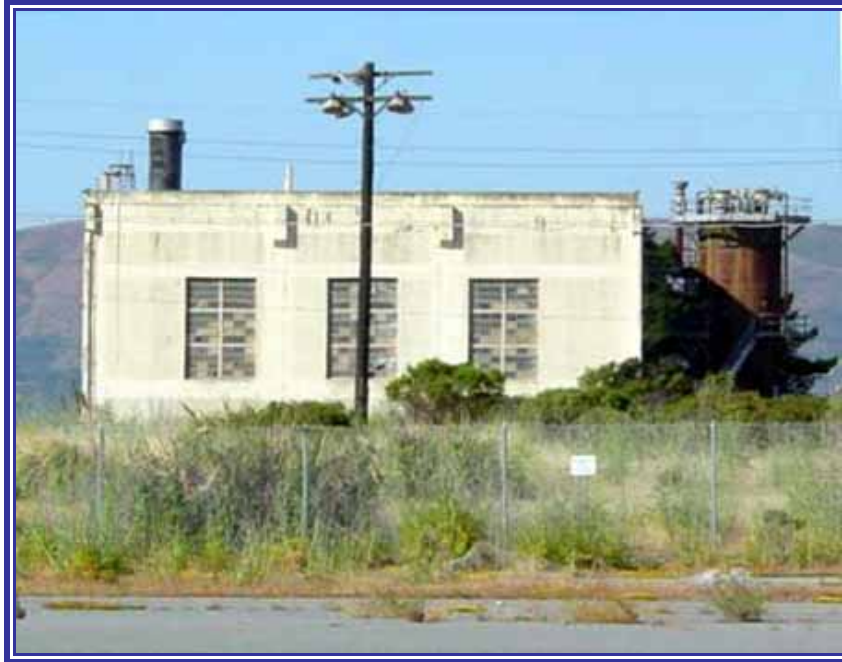
8.3.5.12 **Building 521**

**Site Description:** Building 521 is constructed of concrete and measures approximately 7,040 square feet at its foundation. A building site plan is provided in [Figure 8.3.5.3](#) above.

**Former Uses:** Power Plant. This is one of two suspected sites of fuel oil burning from three OPERATION CROSSROADS target ships.

**Recommended Actions:** Scoping Survey.

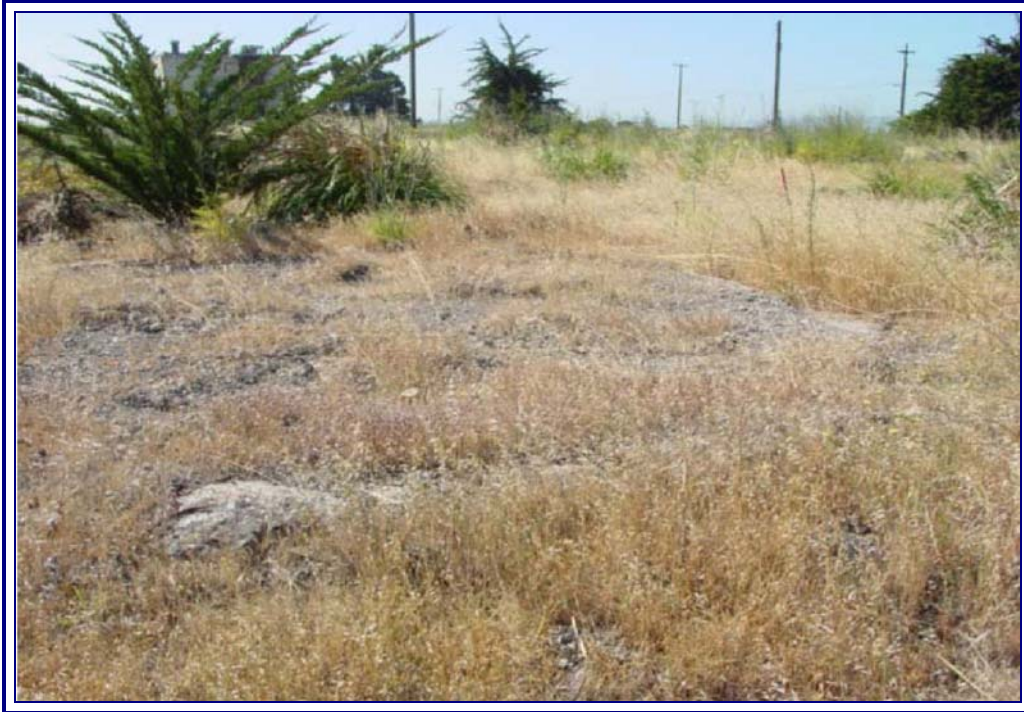
### 8.3.5.13 Former Building 529 Site

**Site Description:** The original Building 529 measured 17 feet by 29.5 feet. It included an underground isotope storage vault and waste sump. A site plan is provided in [Figure 8.3.5.3](#) above, a floor plan is provided in [Figure 8.3.5.13FP](#), and a plot plan is provided in [Figure 8.3.5.13PP](#).

**Former Uses:** NRDL Isotope Storage Facility (Vault) ([HRA-147](#); [HRA-339](#); [HRA-412](#)) and Neutron Generator ([HRA-289](#); [HRA-2772](#), p 13). When the building was renovated for installation of the neutron generator, the vault was filled with compacted sand and capped with 8 inches of concrete.

**Current Uses:** Demolished. Foundation, underground isotope vault, and drainage system remain.

- 2001 NWT Phase V investigations. Contaminated underground piping found.
- 1996 PRC Phase III investigations. Survey and soil sampling. Identified potential buried point source. Recommended investigation and removal.
- 1978 RASO survey ([HRA-600, p 2](#)). Reported less than MDA of 64 dpm.
- 1969 NRDL survey. No radiation detected in building.
- 1969 AEC survey. Final AEC clearance given 24 December 1969.

**Recommended Actions:** Characterization Survey based on historical information indicating underground isotope storage vault sealed in place and contamination found in drainage system. Phase V Class 3 Survey Report will be reviewed. Drainage system will require remediation of known areas of contamination. Final Status Survey following remediation.

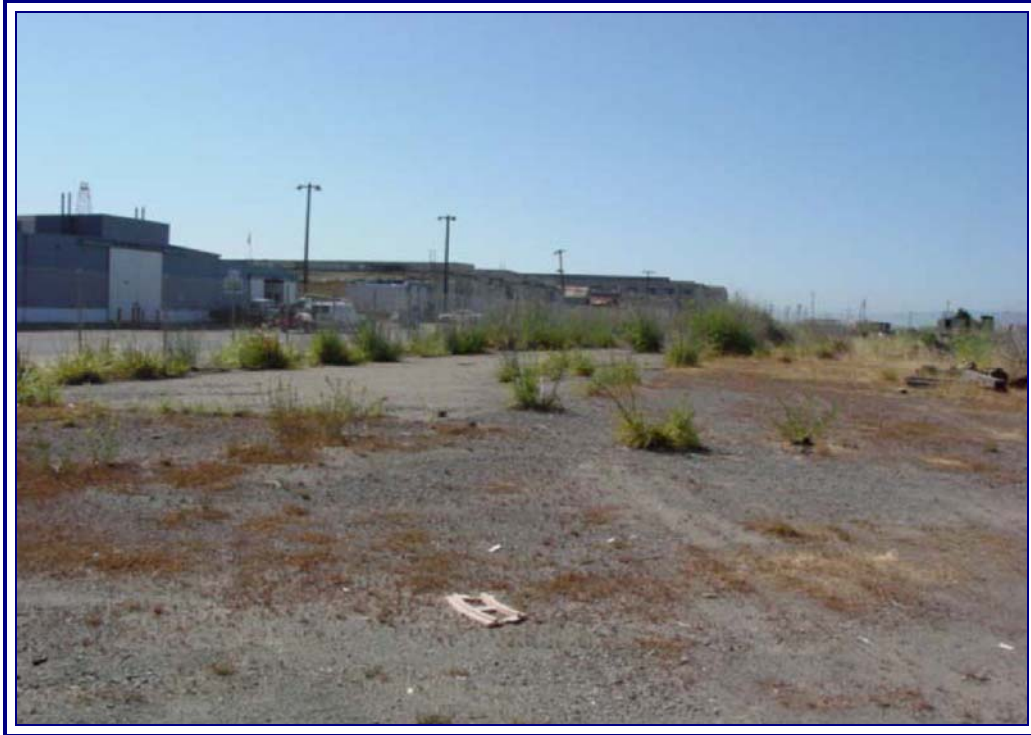
**8.3.5.14 Former Building 701 Site**

**Site Description:** The original Building 701 measured approximately 50 feet by 110 feet. A site plan is provided in [Figure 8.3.5.14](#).

**Former Uses:** Storage building that NRDL requested for “temporary” (120 days) storage of samples in 1947 ([HRA-1752, p 3](#)). Building still in use by NRDL in 1950 ([HRA-1327 Encl 1, p 3](#)). Still listed as used by NRDL in 1954 ([HRA-448, p 6](#)).

1992 PRC Phase I survey. No anomalies noted.

**Recommended Actions:** Review Final Status Survey Report.

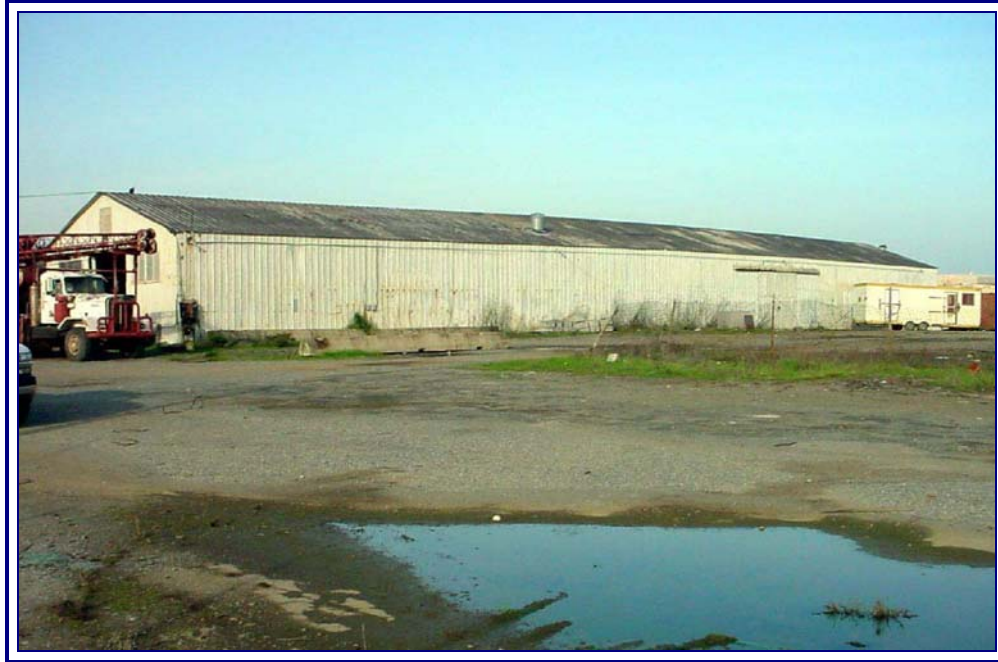
**8.3.5.15 Building 704 Radioactive Material Storage Area**

**Site Description:** Building 704, a metal-sheathed shop building, stands as a marker for an area designated as a “Radioactive Material Storage” area on a 1949 map ([HRA-4081](#)). This storage area was south of the building and adjacent to the animal pens/kennels (see [Section 8.3.5.16](#) below). A site plan is provided in [Figure 8.3.5.15](#).

**Former Uses:** Radioactive material storage area.

**Recommended Actions:** Scoping Survey.

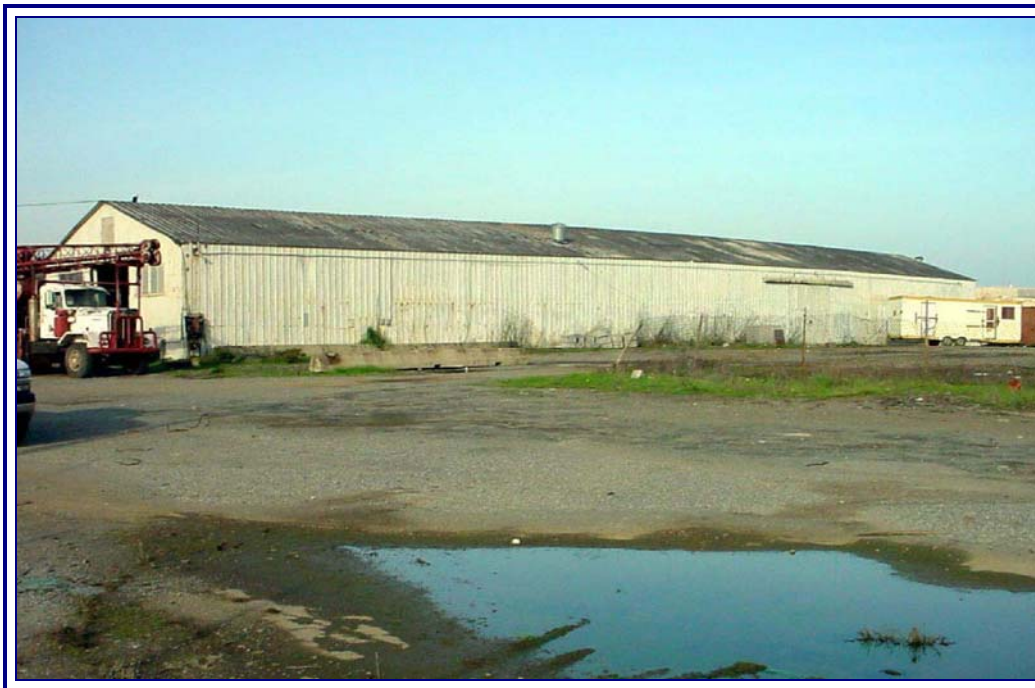
**8.3.5.16 Building 704 Area Animal Pens**

**Site Description:** Two former animal pens were identified on a 1949 map adjacent to the radioactive material storage area south of Building 704. The animal pens measured approximately 18 feet by 20 feet and 20 feet by 12 feet ([HRA-4081](#)). A site plan is provided in [Figure 8.3.5.15](#) above.

**Former Uses:** Animal pens for NRDL.

**Recommended Actions:** Scoping Survey.

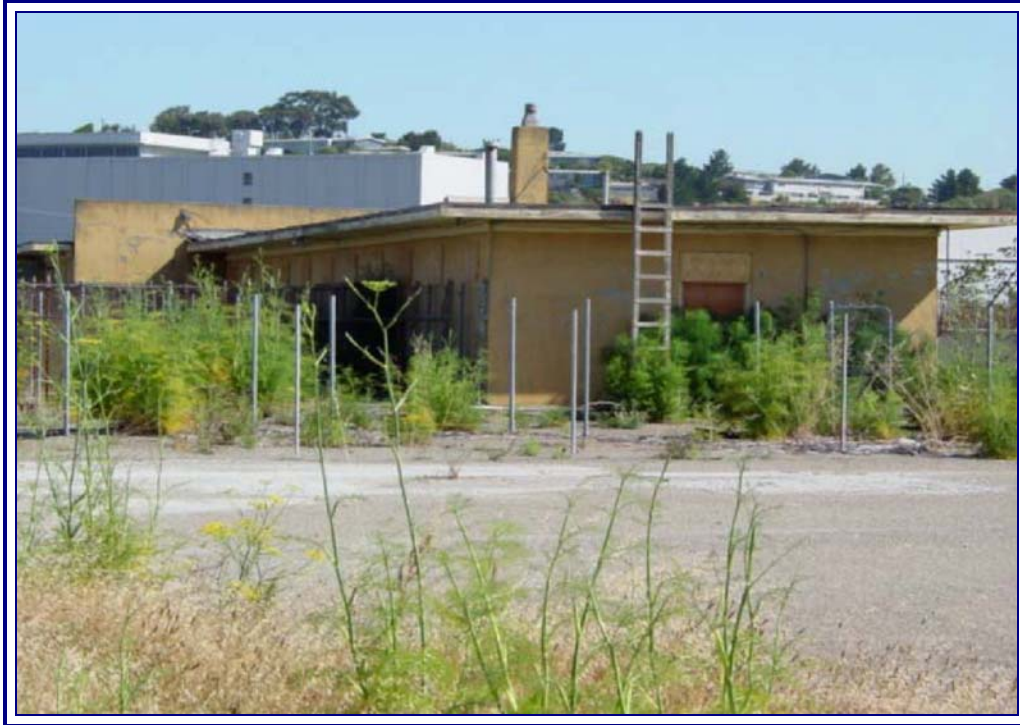
### 8.3.5.17 *Building 707 and Kennels*

**Site Description:** Building 707 is irregular in construction and measures approximately 13,000 square feet, including kennels. A site plan is provided in [Figure 8.3.5.15](#) above, and a floor plan is provided in [Figure 8.3.5.17FP](#).

**Former Uses:** Research animal facility used by NRDL for animal breeding and housing ([HRA-136, p 1](#); [HRA-147, p 1](#); [HRA-170, p 1](#); [HRA-1327 Encl 1, p 4](#)), Waste Processing and Storage Facility ([HRA-1038 Attachment I](#); [HRA-590, pp 3-4](#)), formerly leased to Pet Express as an animal clinic.

**Recommended Actions:** Characterization Surveys required based on historical information concerning drainage systems and known contamination under concrete pad. Remediate known areas of contamination. Final Status Survey following remediation.

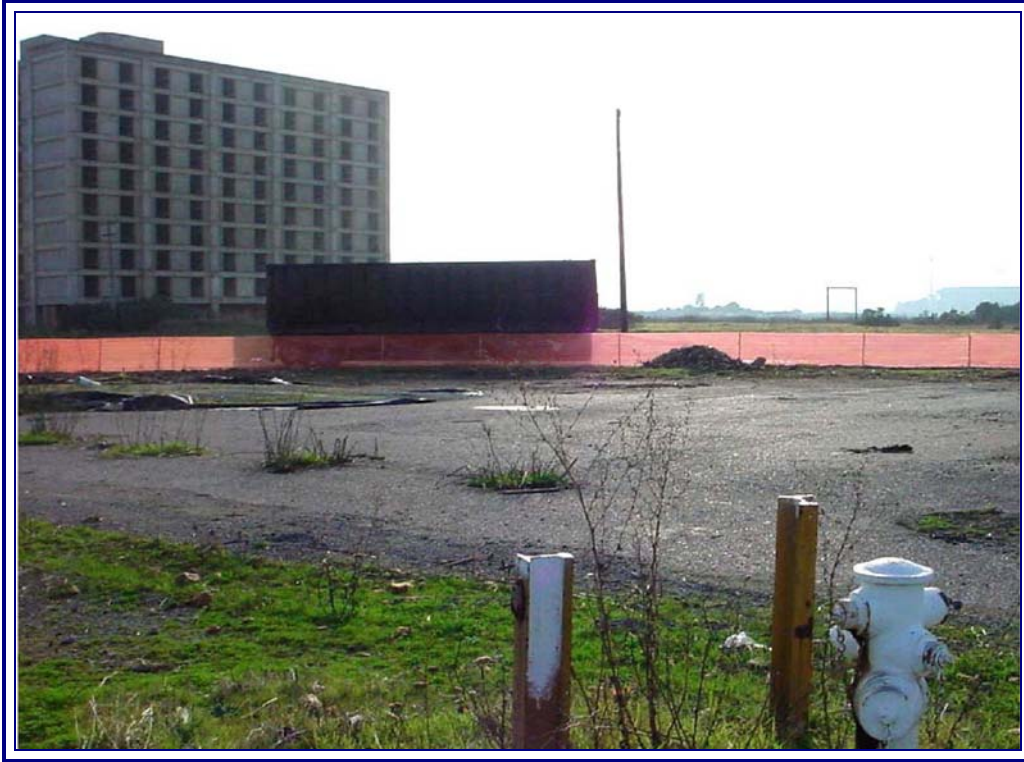
8.3.5.18 *Building 707B Site*

**Site Description:** An exact description is not available; however, this building is thought to have been of the same type as Building 708 (707A), a 50-by-20-foot Quonset hut.

**Former Uses:** NRDL Animal Colony.

**Recommended Actions:** Additional Characterization Survey as part of Building 707 Triangle Area surveys. Remediation of any identified contamination. Final Status Survey following remediation.

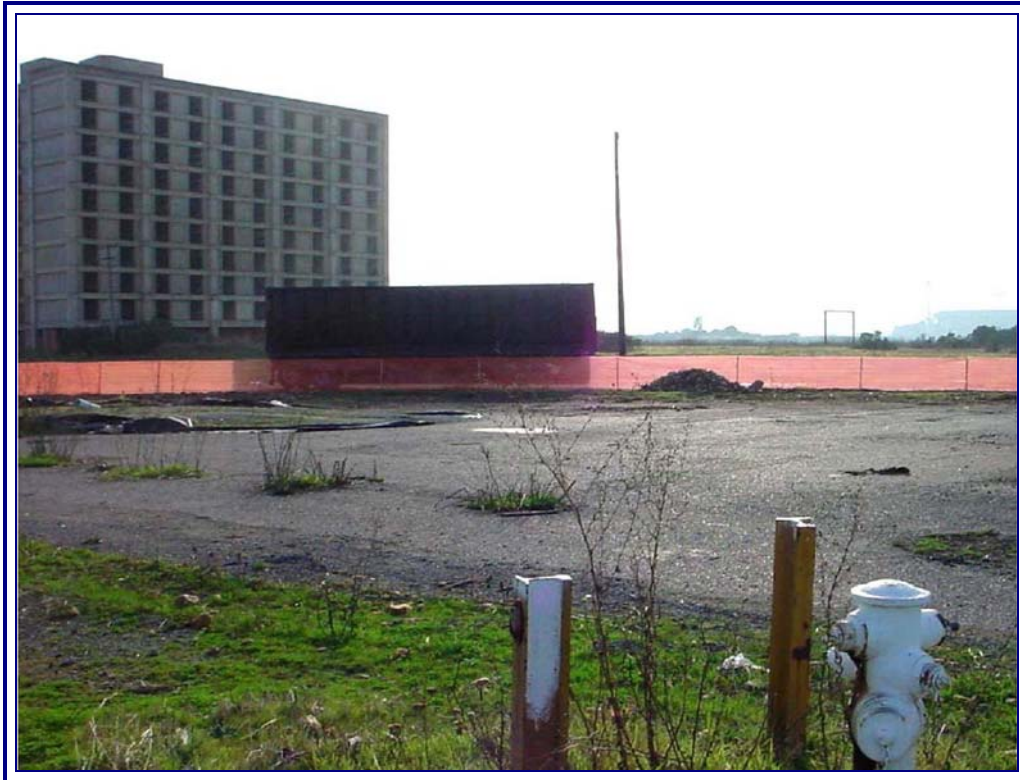
**8.3.5.19 Building 707C Site**

**Site Description:** An exact description is not available; however, Building 707C is thought to have been of the same type as Building 708 (707A), a 50-by-20-foot Quonset hut.

**Former Uses:** Nuclear weapons test support and experimentation and equipment issue and receiving area ([HRA-1045](#)).

**Recommended Actions:** Characterization Survey as part of Building 707 Triangle Area surveys. Remediation of any identified contamination. Final Status Survey to follow remediation.

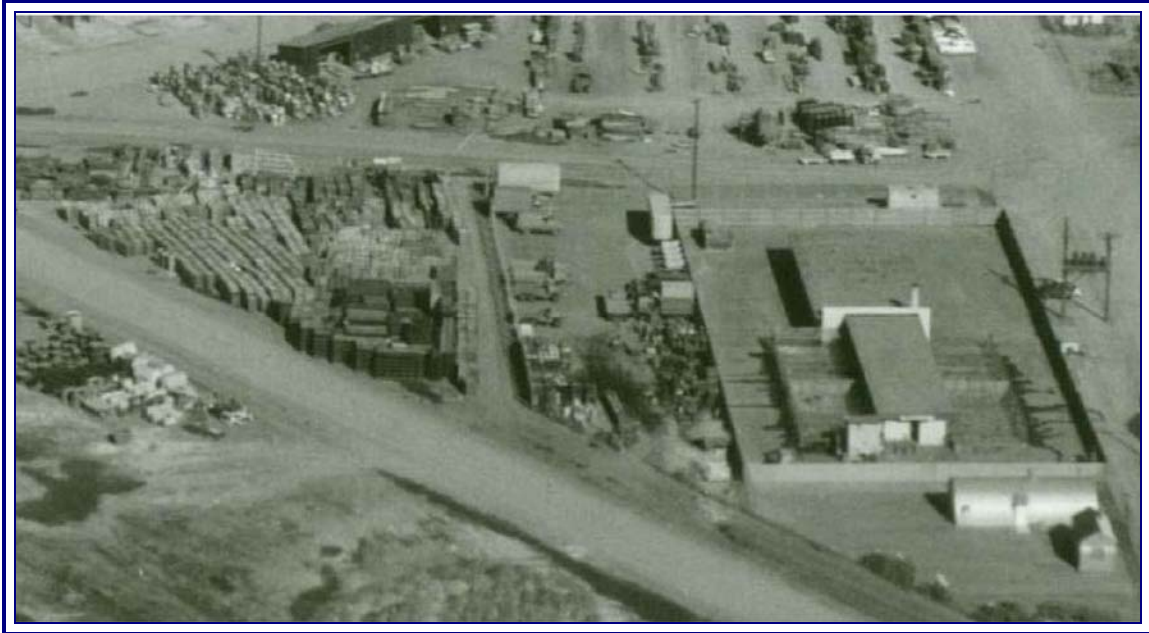
### 8.3.5.20 Building 707 Triangle Area

**Building 707 Triangle Area in 1961**

**Site Description:** This site is triangular in shape and measures approximately 223,000 square feet. This location is bounded by “J” Street, “I” Street, and 6th Avenue. A site plan is provided in [Figure 8.3.5.20](#).

**Recommended Actions:** Characterization Survey, remediation, and resurvey for areas exceeding release limits. Final Status Survey following remediation.

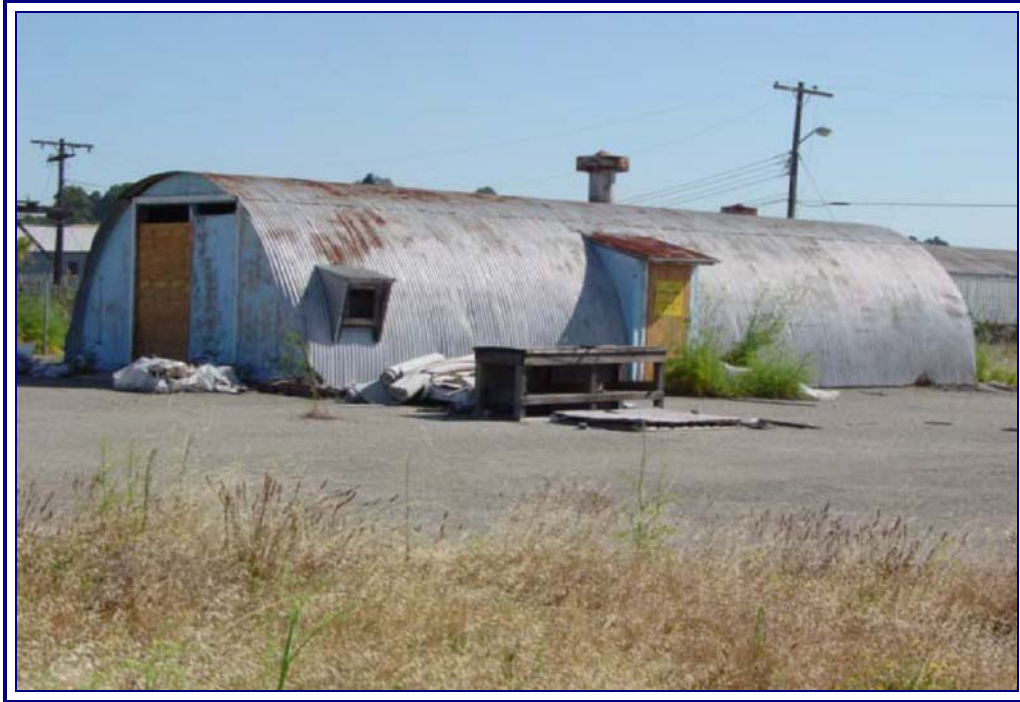
**8.3.5.21 Building 708 (also known as Building 707A)**

**Site Description:** Building 708 is a Quonset hut adjacent to Building 707. It measures approximately 50 feet by 20 feet. A site plan is provided in [Figure 8.3.5.15](#) above, and a floor plan is provided in [Figure 8.3.5.21FP](#).

**Former Uses:** Research Animal Facility ([HRA-136](#); [HRA-147](#)), Bio-Medical Facility ([HRA-1327 Encl 1, p 4](#)), and Animal Psychology Facility.

**Recommended Actions:** Review Final Status Survey Report.

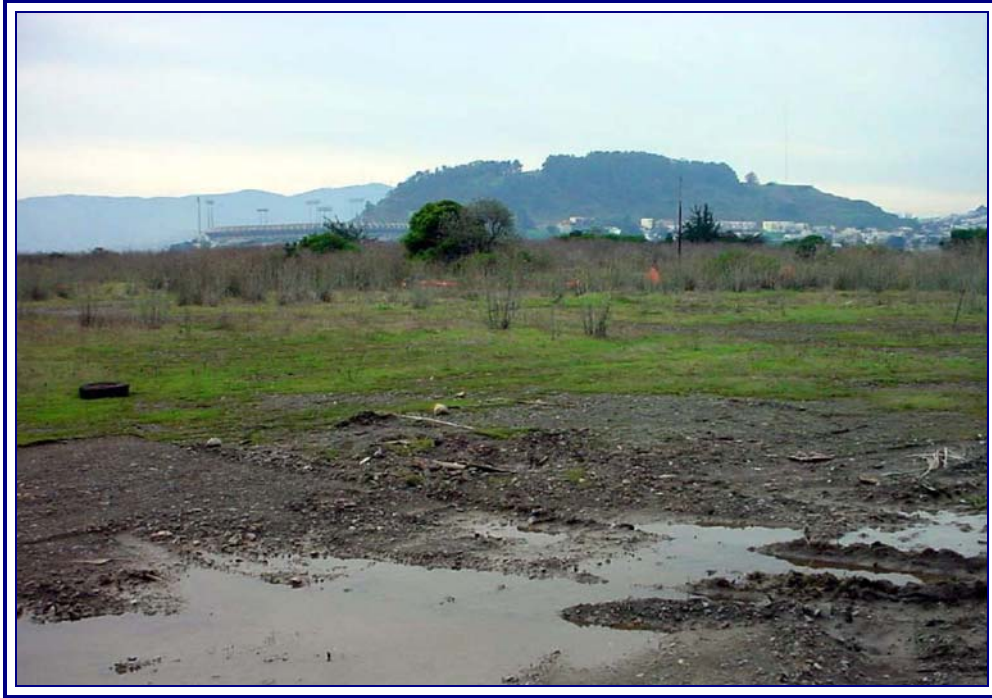
8.3.5.22 *Building S-719 Site*

**Site Description:** The original structure measured approximately 30 feet by 24 feet. A site plan is provided as [Figure 8.3.5.20](#) above.

**Former Uses:** Incinerator ([HRA-333, p 31 of 32](#)). Potentially used by NRDL animal facility at Building 707 ([HRA-170 Encl 2, p 2](#)).

**Recommended Actions:** Scoping Survey. Characterization Survey if contamination is identified. Final Status Survey as final action.

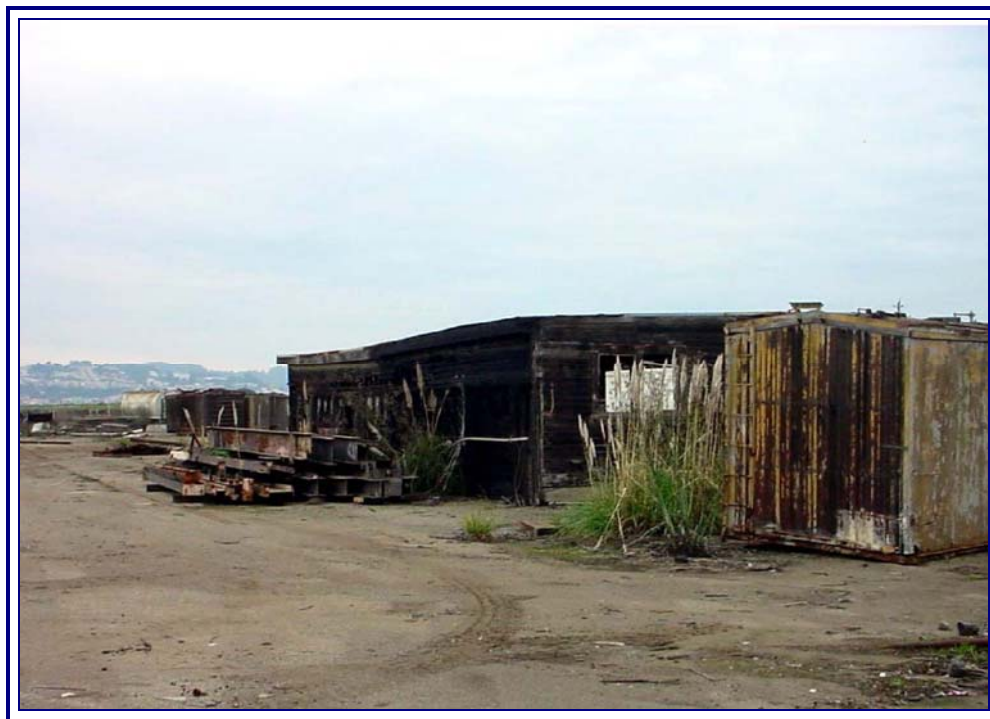
### 8.3.5.23 *Building 807 Site*

**Site Description:** The former Building 807 measured approximately 60 feet by 28 feet. Construction type is unknown. A building site plan is provided in [Figure 8.3.5.14](#) above.

**Former Uses:** Scrap yard processing shed. Possibly received scrap materials from ship decontamination.

**Recommended Actions:** Scoping Survey. Characterization Survey if contamination is identified. Final Status Survey.

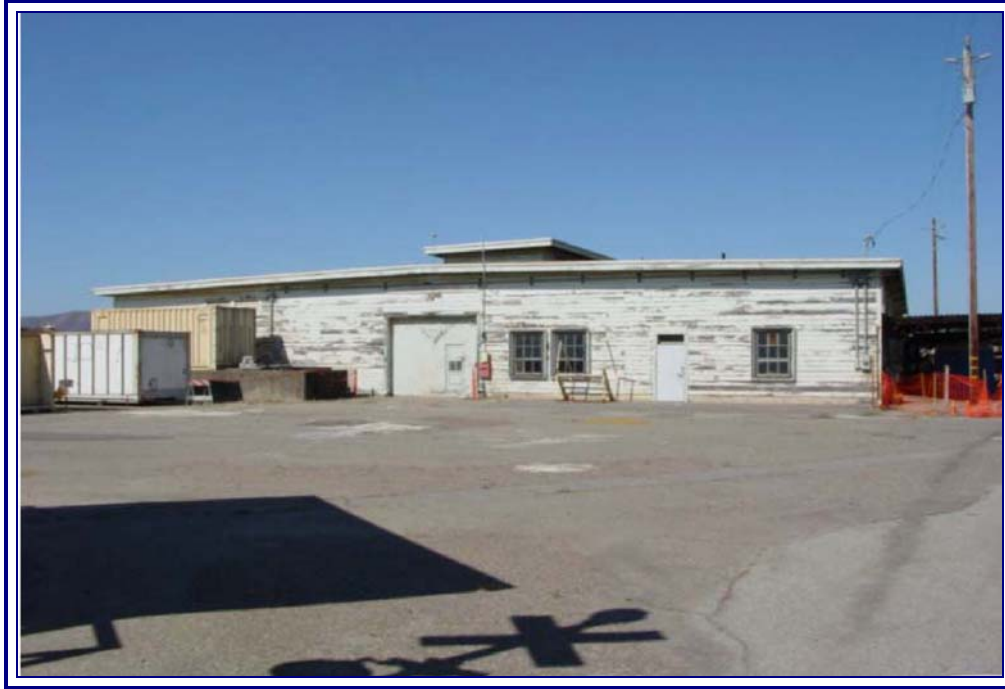
#### 8.3.5.24 Building 810

**Site Description:** Building 810 is a wood-framed structure, sided in flush weatherboard. The building includes a flat roof with shallow shed-roofed elements on all sides. The monitor includes vents but no windows. At the center of the building is a large sliding industrial door with a small access window. A building site plan is provided in [Figure 8.3.5.14](#) above.

**Former Uses:** LLRW and IDW storage location (PRC) ([HRA-1447](#)), storehouse, paint shop, and paint and oil storage ([HRA-136, p 13](#)).

**Recommended Actions:** Scoping Survey of building and loading dock.  
Characterization Survey of areas surrounding known contaminated area. Remediate known areas of contaminated soils. Final Status Survey following remediation.

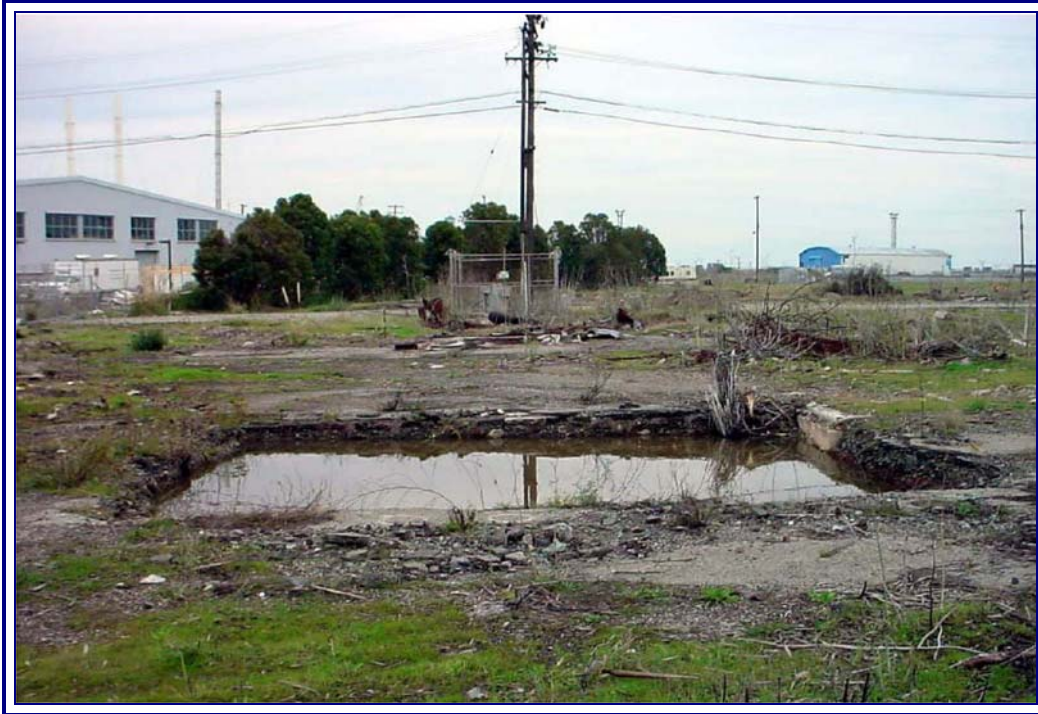
8.3.5.25 *Former Shack 79 Site*

**Site Description:** This area was identified on a list of shipyard shacks and was numbered 79. The type of construction is unknown but thought to be wood, as were other temporary structures. Dimensions were not available, and the shack was located behind Building 506.

**Former Uses:** NRDL support for radioactive material ([HRA-1018](#)).

**Recommended Actions:** Characterization Survey. Remediation if contamination is identified. Final Status Survey.

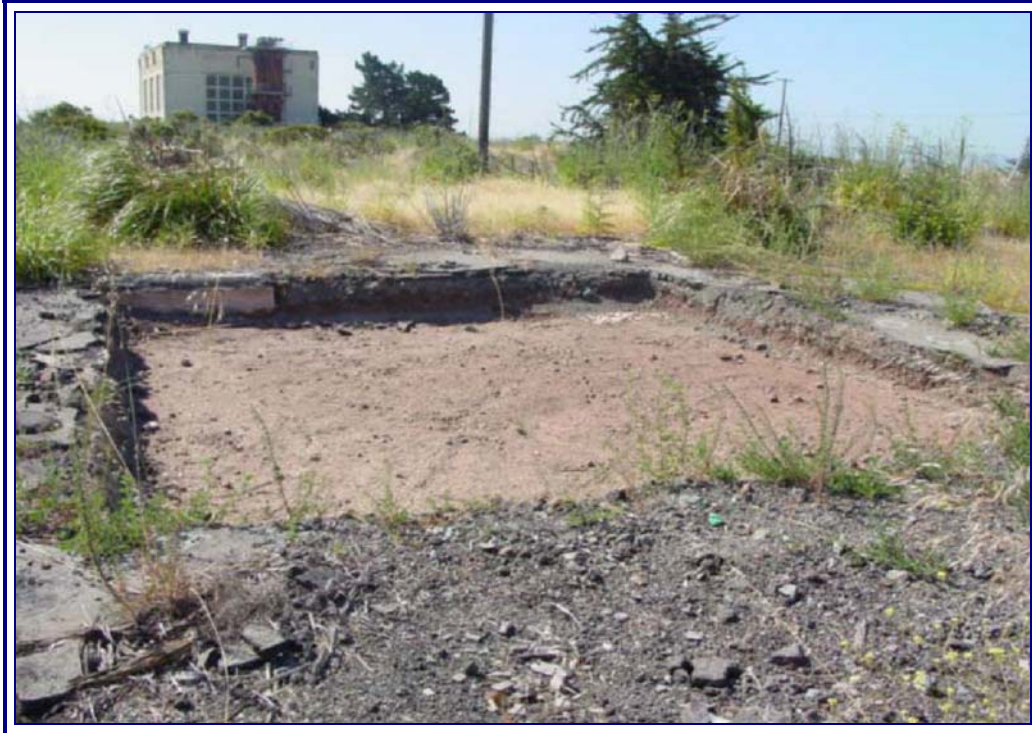
**8.3.5.26 Former Shack 80 (Behind Building 506) Site**

**Site Description:** This area was identified on a list of shipyard shacks and was numbered 80. The type of construction is unknown but thought to be wood, as were other temporary structures. Dimensions were not available, and the shack was located behind Building 506.

**Former Uses:** NRDL Support; shack reported to have been moved from behind Building 506 to Building 704 area for “lab operations” ([HRA-1018](#)).

2002 NWT Phase V investigations. Elevated Cs-137 levels found in soil and remediated. Expanded resurvey indicated additional locations of elevated Cs-137 levels.

**Recommended Actions:** Remediate known areas of contamination. Perform Class 1 Final Status Survey following remediation.

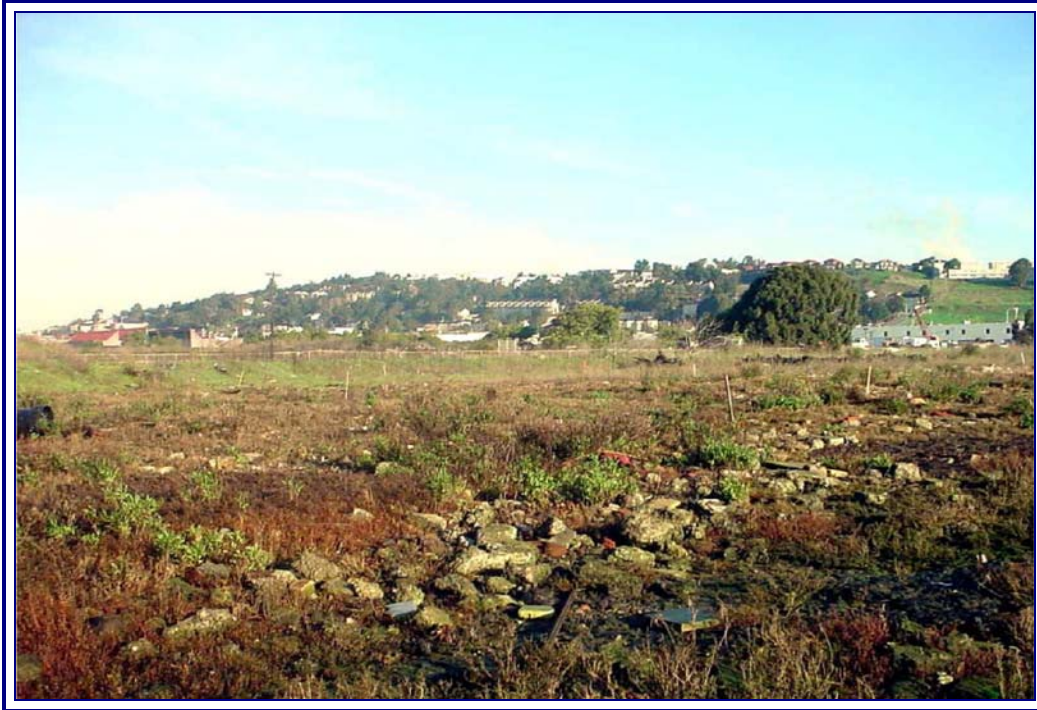
8.3.5.27 *Experimental Shielding Range*

**Site Description:** An open field area located on the southwest end of IR-01/21 (HRA-4506). The site has three parts: a fan-shaped, post-exposure reflection/refraction field, measuring 150 feet in radius; a 60-by-35-foot site designated Area A; and a 60-by-50-foot area designated Area B. Site was enclosed on the west side by a soil berm (HRA-26, p 11). It was also known as the South Gate Range. A site plan is provided in Figure 8.3.5.27.

**Former Uses:** Experimental Shielding Range.

**Recommended Actions:** Review Phase V Characterization Survey results. Remediate known areas of elevated readings. Perform Final Status Survey.

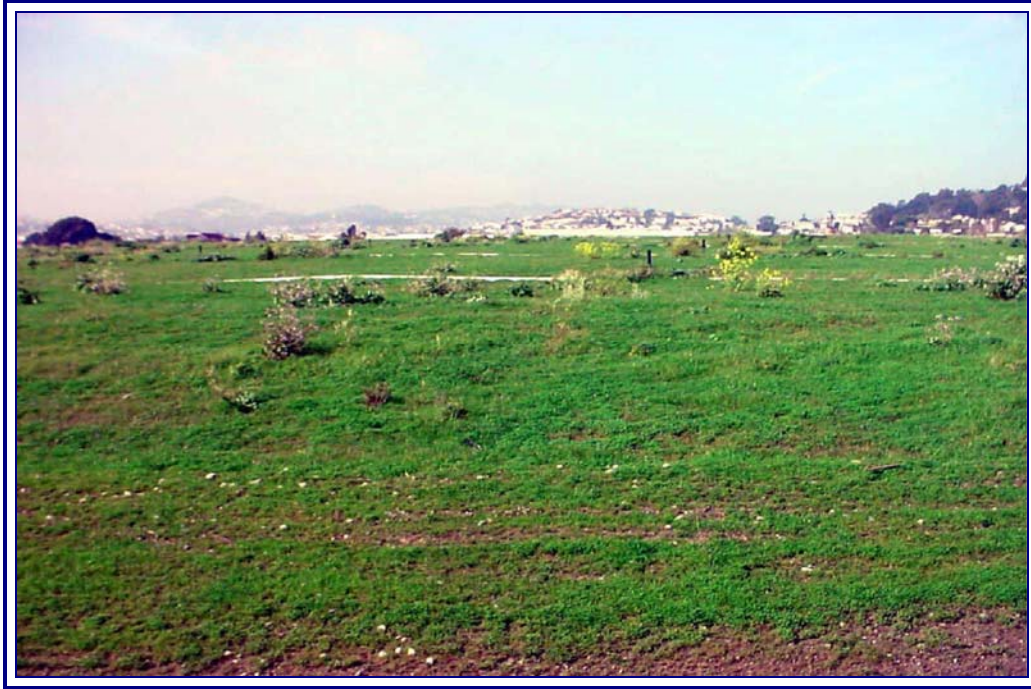
8.3.5.28 *IR-01/21, Industrial Landfill Area*

**Site Description:** Irregular land area, measuring approximately 1,525,000 square feet, 120 feet southeast of Building 820, 80 feet south of Building 830, 150 feet southwest of Building 810, and immediately west and adjacent to IR-02. A site plan is provided in [Figure 8.3.5.28](#).

**Former Uses:** Landfill used from 1940s to 1974 for disposal of industrial and solid wastes; domestic wastes and refuse; building construction and demolition wastes; dredge spoil materials; sandblast waste; shop industrial, chemical, and solvent wastes; ship solid and liquid wastes from repair activities; and radioluminescent devices, primarily containing Ra-226. Potentially used for disposal of wastes from decontamination of OPERATION CROSSROADS ships.

- 2002-2003 NWT Phase V investigations. Gamma survey indicated several locations of elevated levels.
- 1993 PRC Phase II investigations. Walkover survey and radon flux testing indicated radioactive material. Excavation and survey detected 111 discrete Ra-226 point sources.
- 1991 PRC Phase I investigation. Anomalies found.
- 1988 HLA site reconnaissance survey. Survey points within background ranges.

**Recommended Actions:** Review Phase V Characterization Survey results. Remediate known areas of elevated readings. Perform Final Status Survey.
